Tropical Cyclone Debbie Damage to buildings in the Whitsunday Region

CTS Technical Report No 63

This edition: 03 June 2017

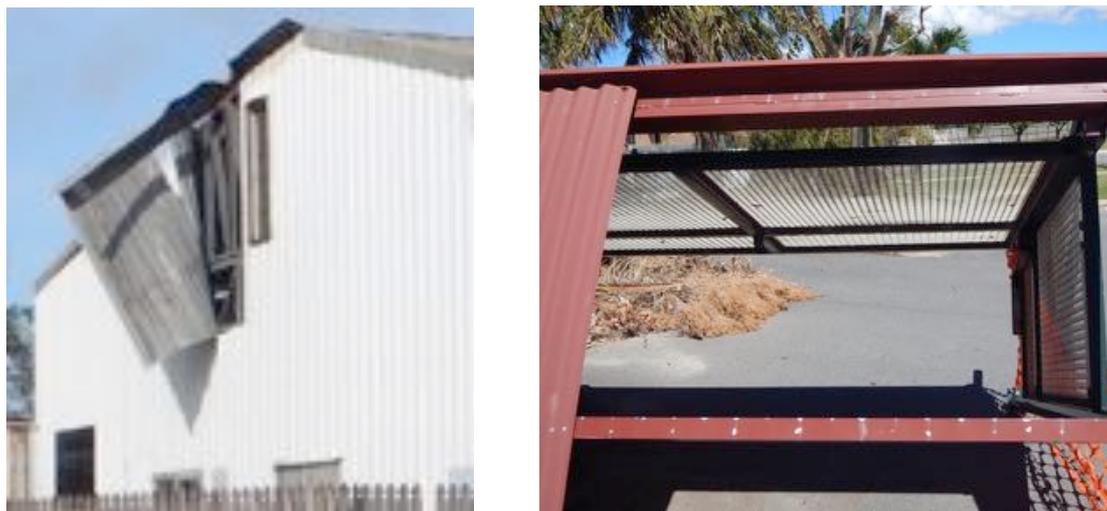
The majority of failures of pierced-fixed metal cladding systems were in older housing where the roofing had come off the house while still attached to the battens. In contemporary construction, where the cladding had separated from purlins or battens, the damage was usually near edges of walls or roofs. The failures observed involved systems that were not installed to appropriate specifications, and in some cases, flashing damage may have contributed to the damage (Figure 4.2).

Figure 4.2 Damage to pierced-fixed cladding

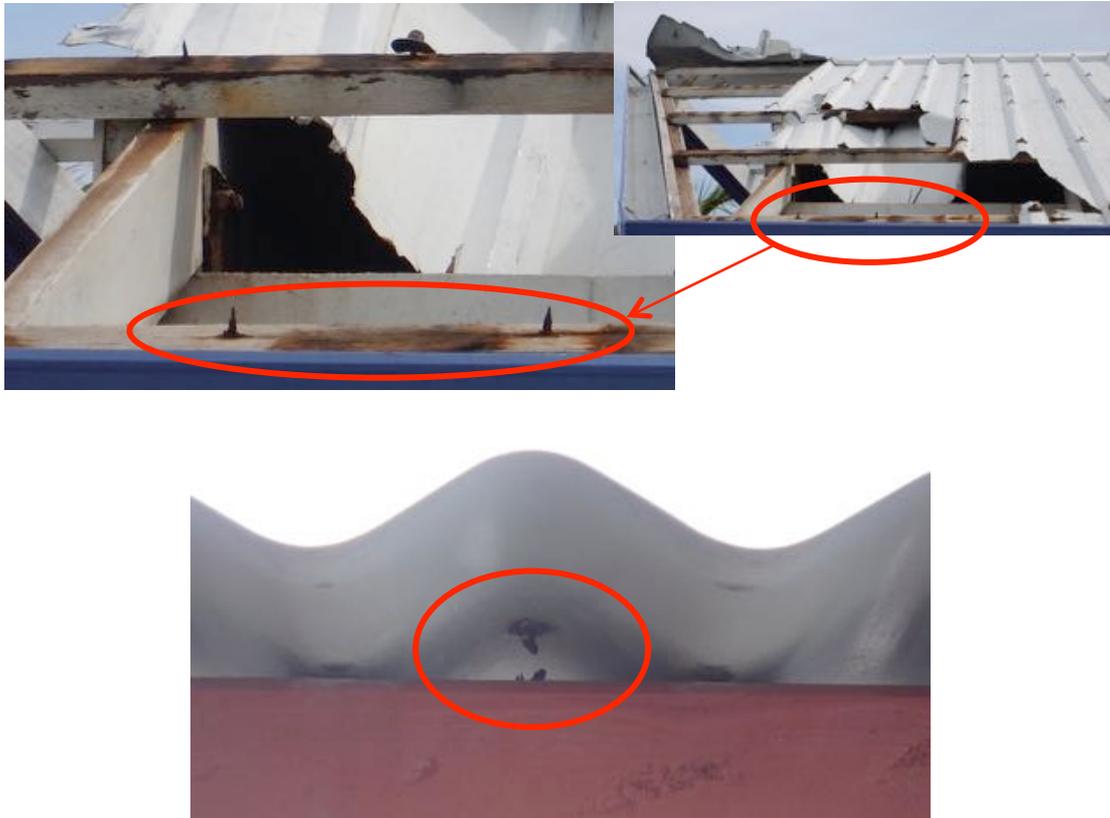
Failure of cladding systems was initiated by loss of strength from corroded fasteners. This was evident for contemporary structures adjacent to the marine environment.

Figure 4.4 Corrosion of fasteners

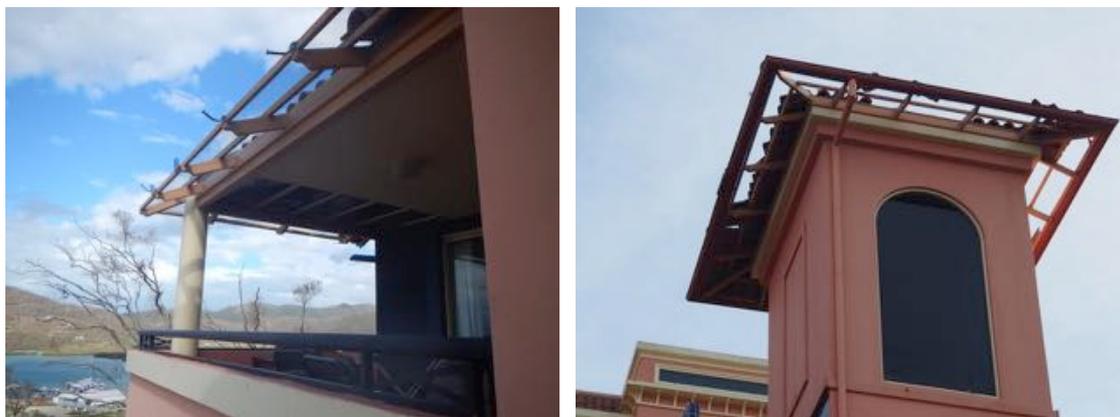
Figure 4.7 shows tile failure on a building in an exposed location that should have had a high design wind speed. Although there were several other similarly exposed properties with tile roofs in the area, this building was the only one with major tile damage. Tiles on this building may have experienced an increased net wind load on tiles where the eaves were unlined. Clips could not be seen on some rows of tiles. Even where wire clips were observed, some tiles had become dislodged.

Figure 4.7 Tile roofing failure on exposed strata property

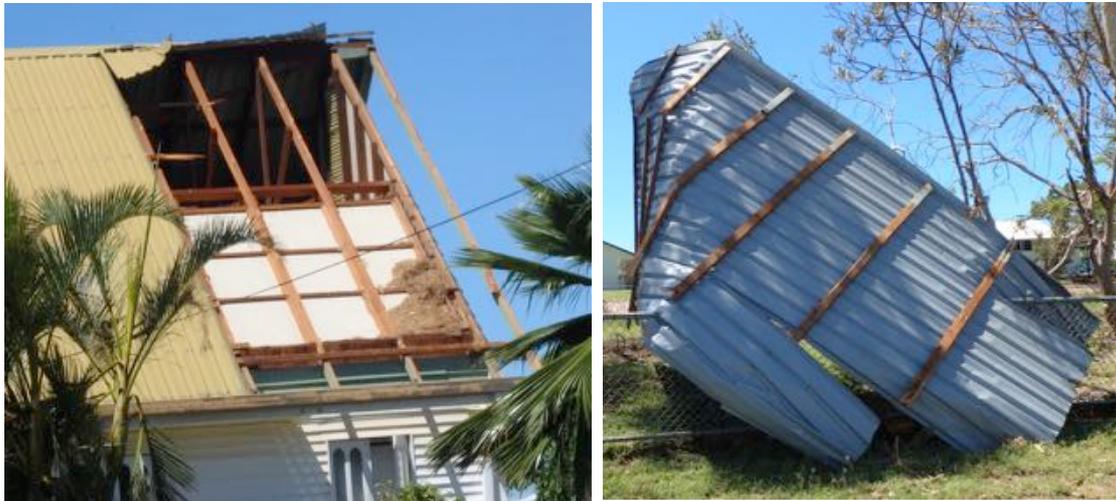
Some older large buildings used exactly the same batten-to-rafter connections as older houses (one or two nails per connection). These low capacity connections together with the large loads from the taller buildings led to failure of these connections as shown in Figure 4.9. The damaged roof was a side roof panel at the windward end of the building. Both battens and rafters were hardwood timbers, which would have been installed green and seasoned in service. The nails had withdrawn from the rafters.

Figure 4.9 Failure of nailed batten-to-rafter connections in older large building

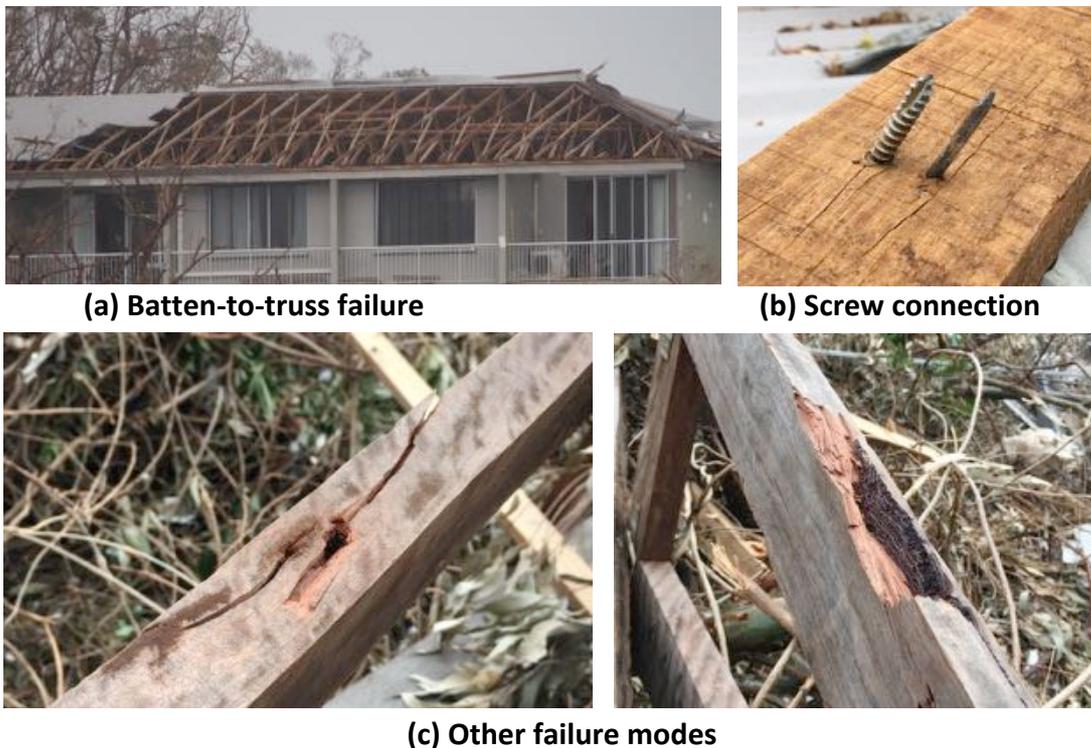
The main failure mode was withdrawal of the screws from the trusses as shown in Figure 4.11(b). However, in some cases where the screws held particularly well into the trusses, failure was by pull through in the batten or tear-out of the screws from the truss as shown in Figure 4.11(c).

Figure 4.11 Failure of batten-to-truss screws

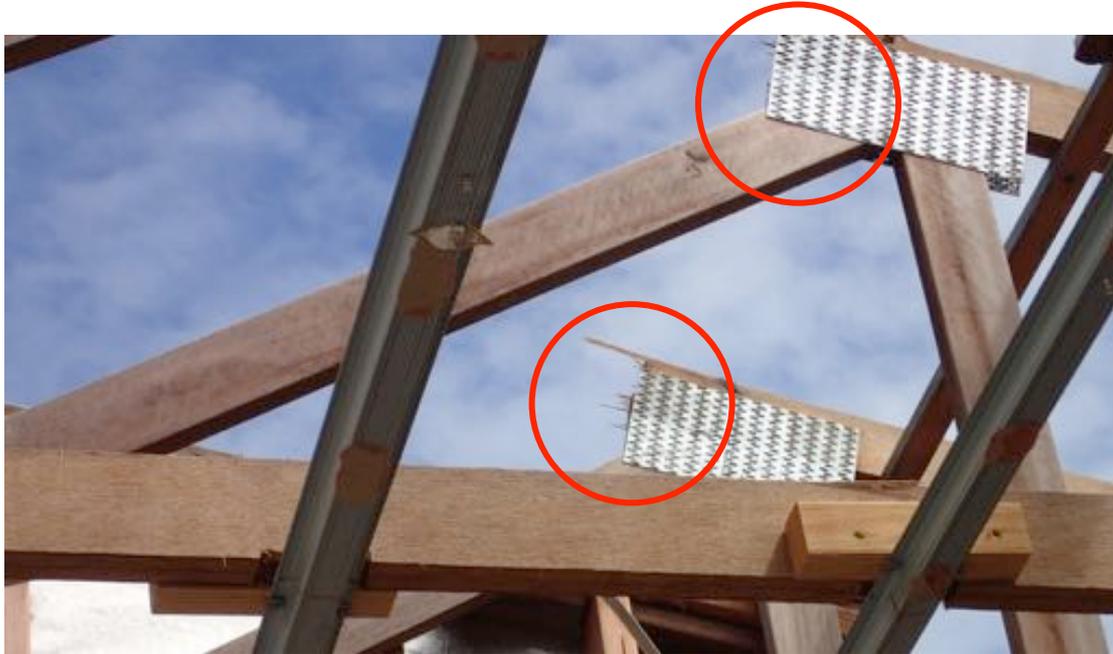
In general, roof structures of most buildings performed well during TC Debbie. There were only a few cases where trusses had failed. In some of these, the truss failure may have been a secondary failure as failure of batten to rafter/truss connection progressed throughout the roof as discussed in Section 4.4 and shown in Figure 4.12.

Figure 4.12 Failure of truss top chords following failure of batten-to-rafter connections

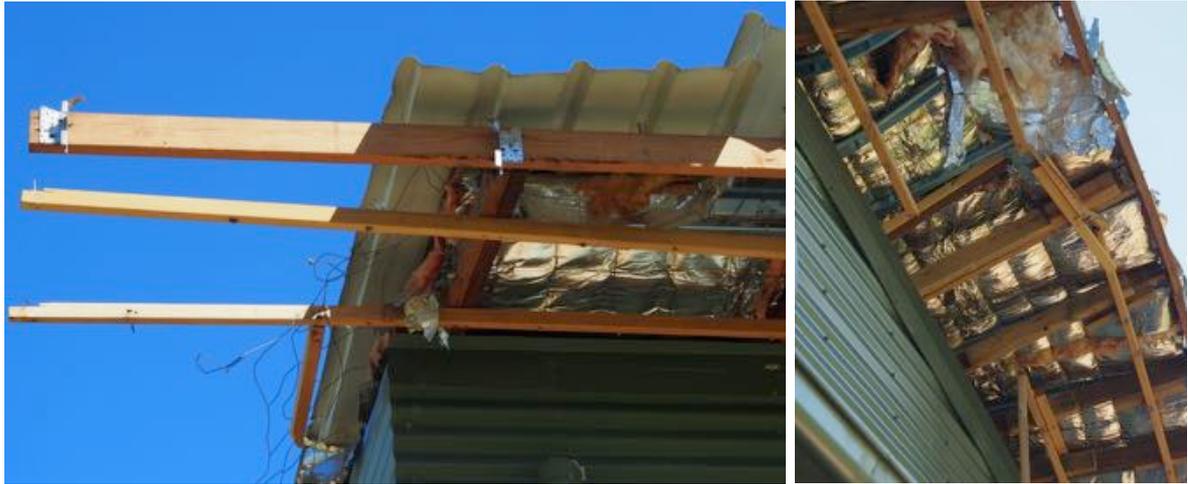
- Figure 4.13 shows a large building with a skillion roof with 900 mm outriggers that had only a single backspan.
- Figure 4.14 shows two photos of a house with outriggers fixed to the remaining roof structure with metal brackets. The outriggers were true cantilevers with no backspan and the metal brackets did not have the capacity to resist the moment caused by wind pressures on the windward wall.

Figure 4.13 Failure of roof structure caused by excessive roof cantilever

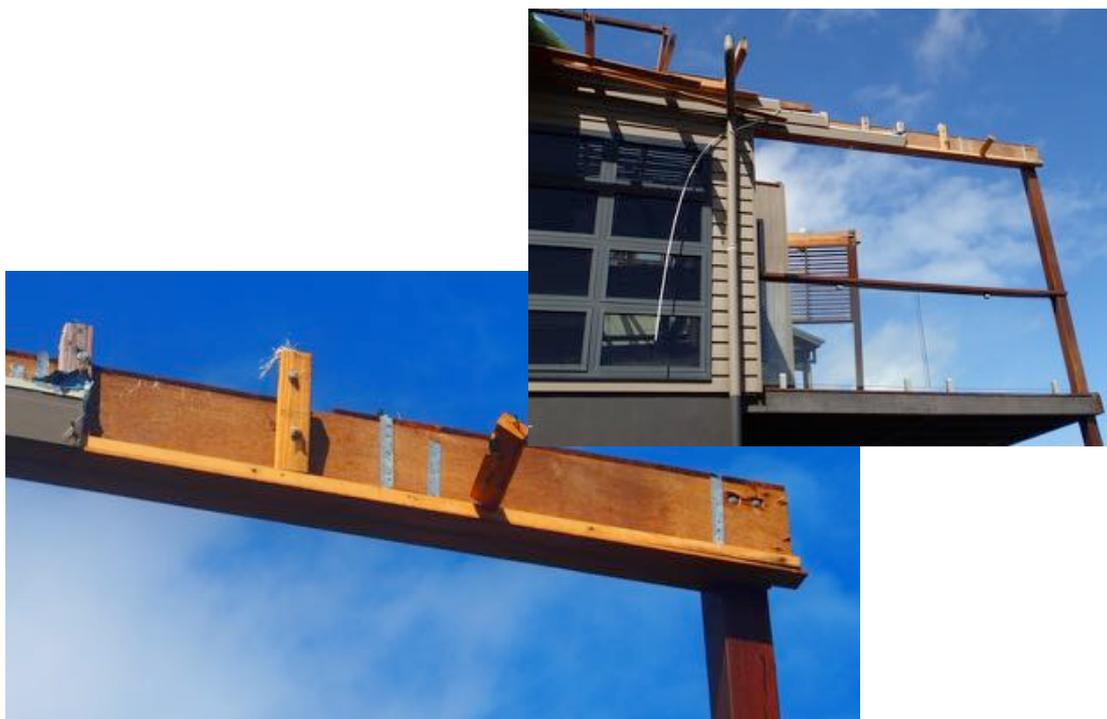
Figure 4.17 shows LVL verandah beams from which roof trusses had been lost. It is clear that the straps between the trusses and the verandah beam had broken. The strap on the windward edge of the verandah appears to have had only one leg, which may have reduced its effectiveness and triggered the failure. As the verandah roof was connected to the house roof, part of the house roof was also lost. The failure was arrested once it reached a portion of the roof that had two straps per truss heel as the tie down.

Figure 4.17 Failure of roof truss to verandah beam connection

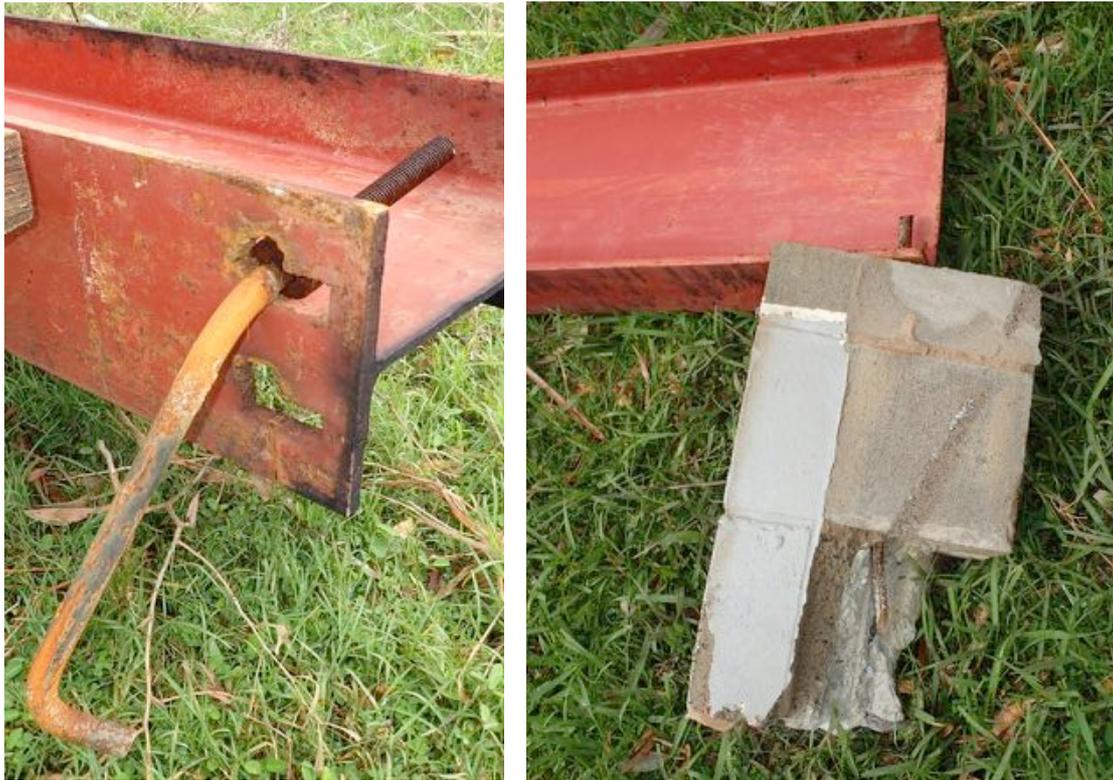
For example, Figure 4.20 shows details from a building in an exposed location with large semi-enclosed verandahs where the tie-down of the steel verandah beam to the concrete blockwork failed.

Figure 4.20 Failure of verandah beam to concrete block connection

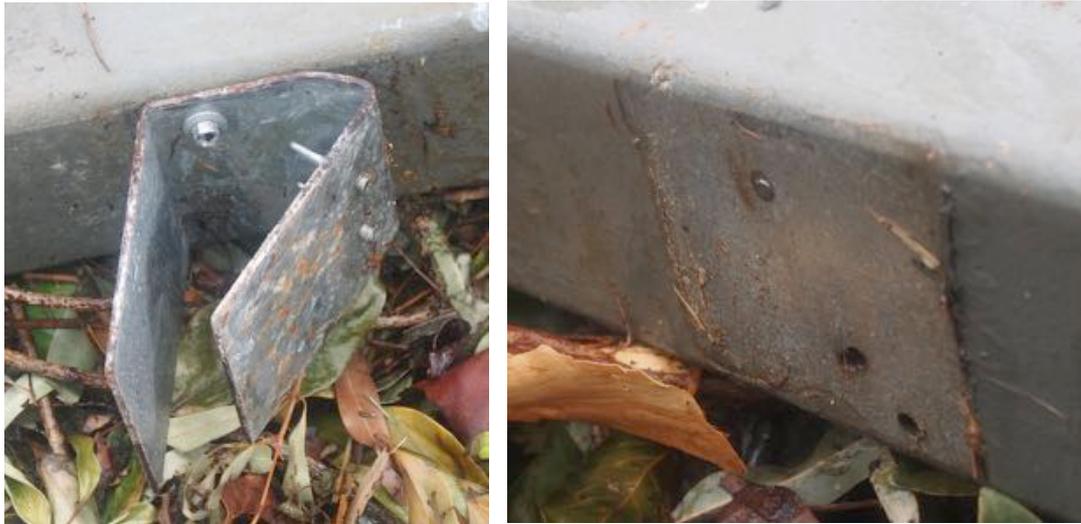
Figure 4.21 shows a verandah beam to post failure. In this case the SHS verandah beams had been connected to SHS verandah posts with two concealed tek screws. Figure 4.21 also shows that a tack weld had been used on one of the two connections to connect the SHS sections directly. However, the weld was very small, of poor quality and failed.

Figure 4.21 Tek screwed connection between SHS sections

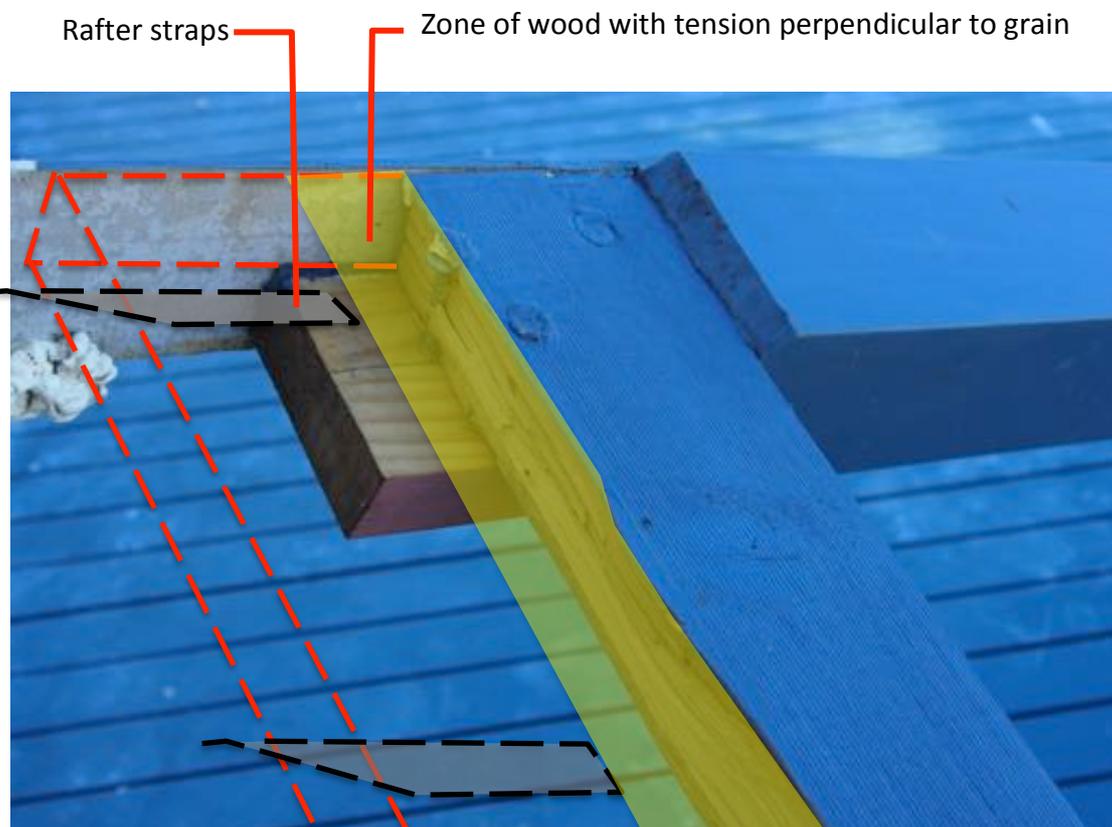
The straps shown in Figure 4.17 were nailed down the full length of the verandah beam and the failure was by tearing of the straps. A similar detail on a different contemporary house had a different failure mode as the straps were nailed to only the upper part of the verandah beam. The bolts to its verandah posts were fixed into the lower part of the verandah beam as shown in Figure 4.22. In this case, the failure was by splitting along the length of the verandah beam as there was a zone down the centre of the verandah beam that had substantial tension perpendicular to the grain.

Figure 4.22 Failure due to tension perpendicular to grain in a verandah beam

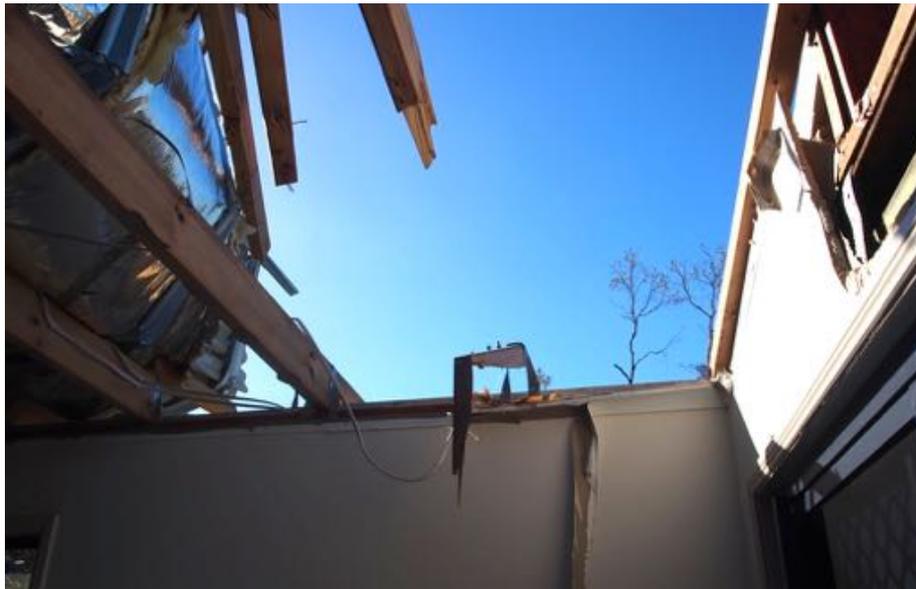
Unfortunately, the verandah was a continuation of the main roof line, so loss of the verandah led to failure of part of the main house roof as shown in Figure 4.23.

Figure 4.23 Loss of verandah leading to the main roof peeling back

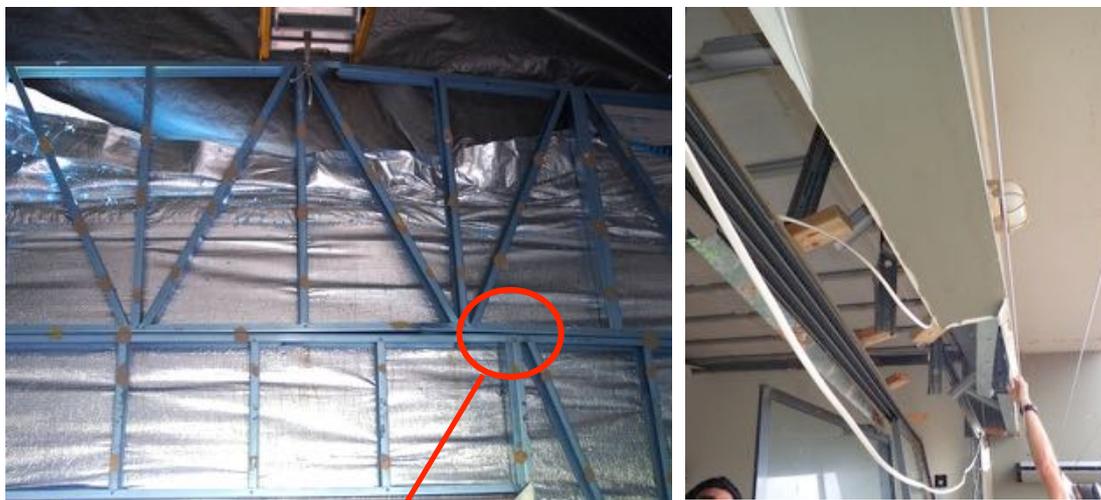
Figure 4.24 Out-of-plane failures in light gauge walls at lintel – windward walls

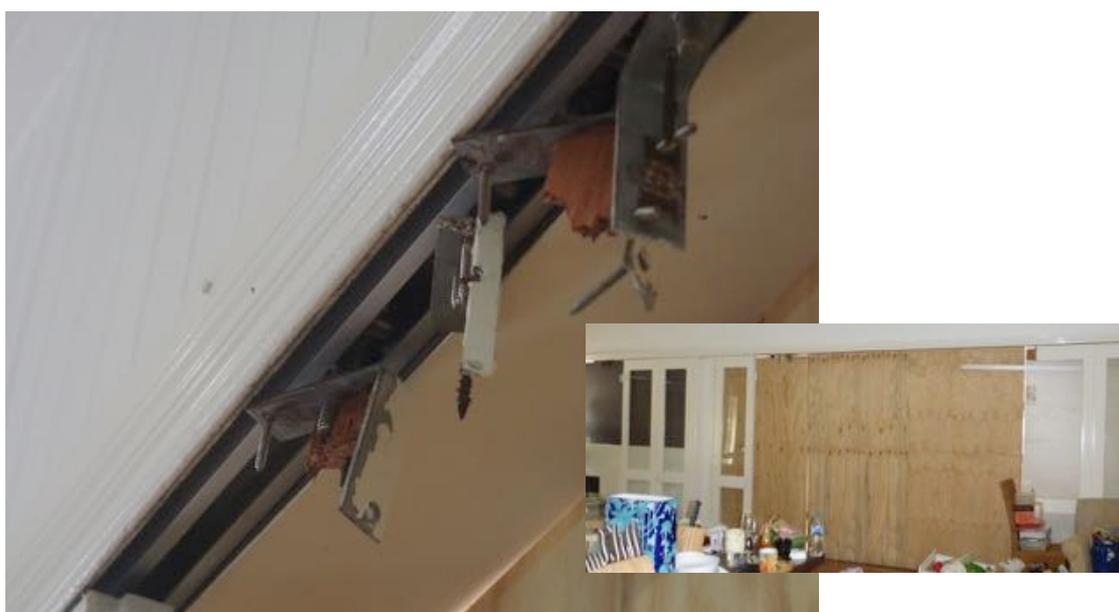
For example, Figure 4.31 illustrates failure of hinges and latches in timber bi-fold doors. The inset shows plywood over the gap where the doors had been, and similar sets of undamaged doors can be seen on either side of the broken set. The house was not occupied at the time, but it is highly likely that the latches may have worked their way undone due to the shaking of the doors during the cyclone and the uncontrolled swinging of the doors may have destroyed the hinges.

Figure 4.31 Broken hardware on timber bi-fold doors

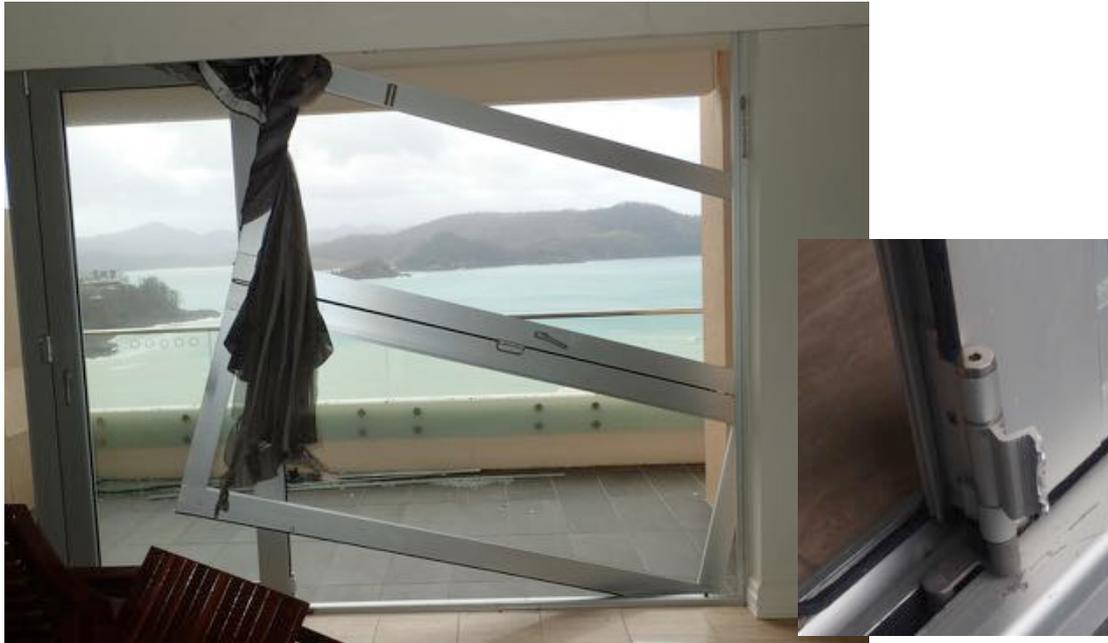
Figure 4.32 also shows broken hinges on aluminium bi-fold doors. All hinges on one fold had broken as shown in the inset photo. It is likely that the failure of these hinges was caused by bolts working free and allowing the door to repeatedly swing open and closed. Similar doors in a similar exposure also had bolts that worked free, and slammed repeatedly during the rest of the cyclone, but had not failed; the hinges on those doors were more robust and there were twice as many hinges than on the doors shown in Figure 4.32.

Figure 4.32 Failure of hinges on aluminium bi-fold doors

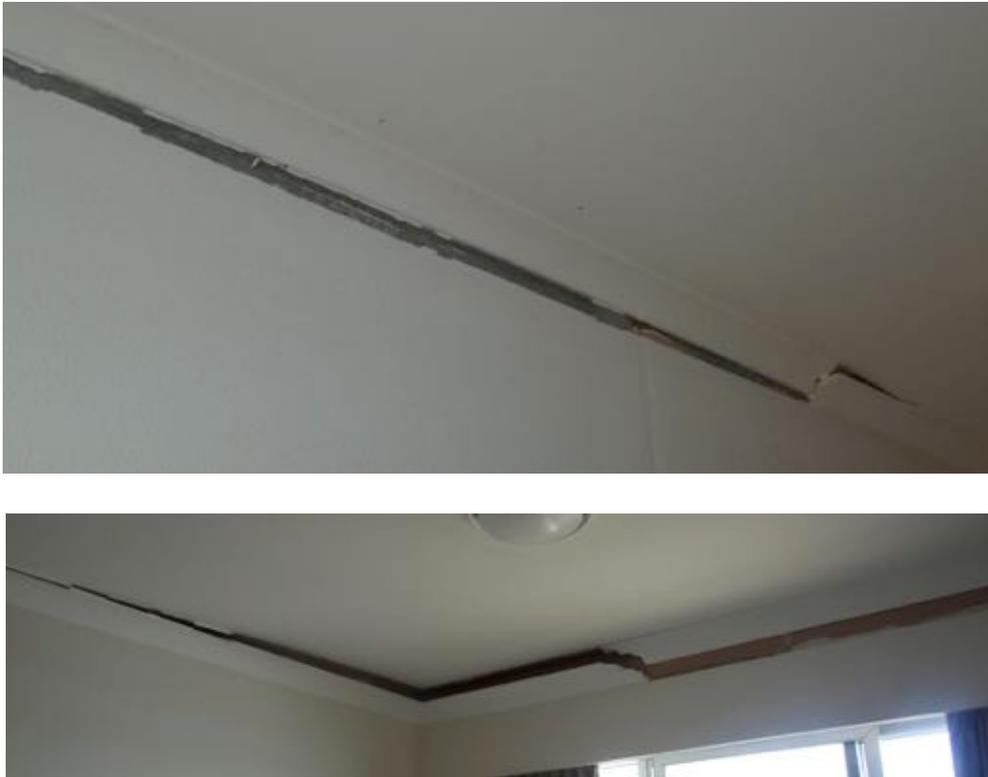
Creation of openings on the windward wall increased the internal pressure in apartments and houses. In a number of cases, the internal pressure was able to lift suspended ceilings. Figure 4.35 shows two different apartment buildings in which internal pressures forced ceilings upwards.

Figure 4.35 Positive internal pressures caused suspended ceilings to lift

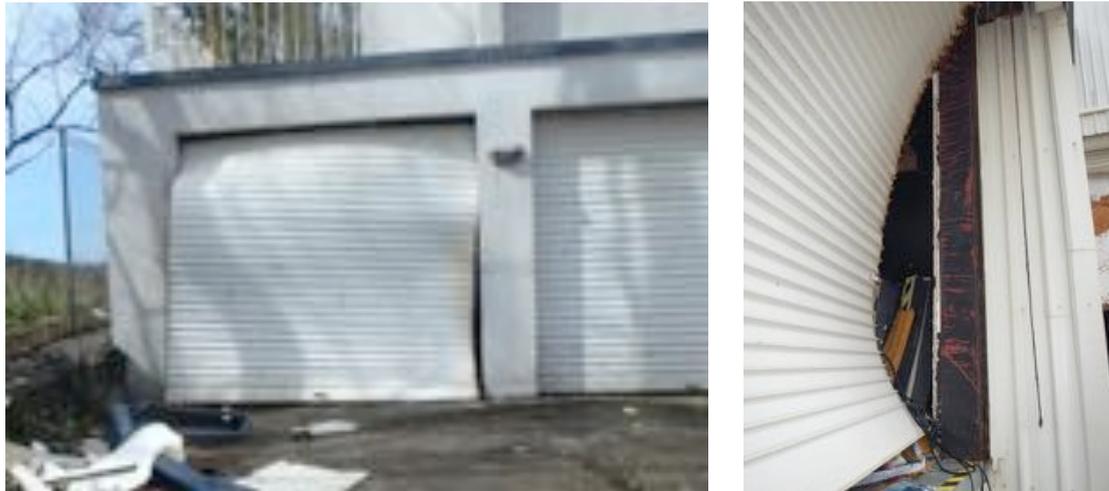
The most common failure mechanism for roller doors installed before 2012 was disengagement of the door from its tracks as shown in Figure 4.40(a). Without wind locks, the flexible door curtain bowed under either positive or negative wind pressures, which allowed it to disengage from its tracks. The door was then free to flap in the opening, and in some cases, caused more damage to interior items and the structure, and in others was ripped from the drum. Figure 4.40(b) shows roller doors that had damaged the building as they flapped against the cladding. In some cases, parts of roller doors became wind-borne debris and where they had separated from the drum, the whole door became wind-borne debris. Figure 4.40(c) shows a door that lost part of the curtain and a building where all of the roller doors separated from the drum.

(a) Curtain out of track

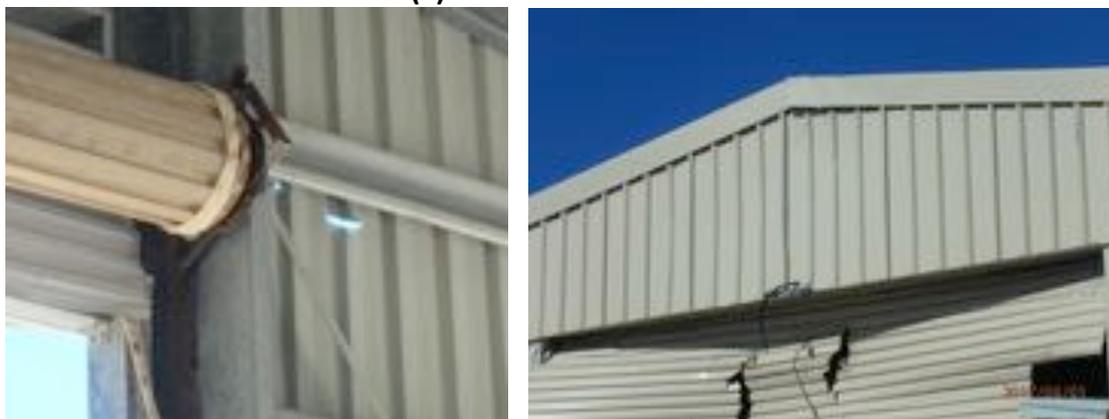
(b) Damage to cladding after roller door failure

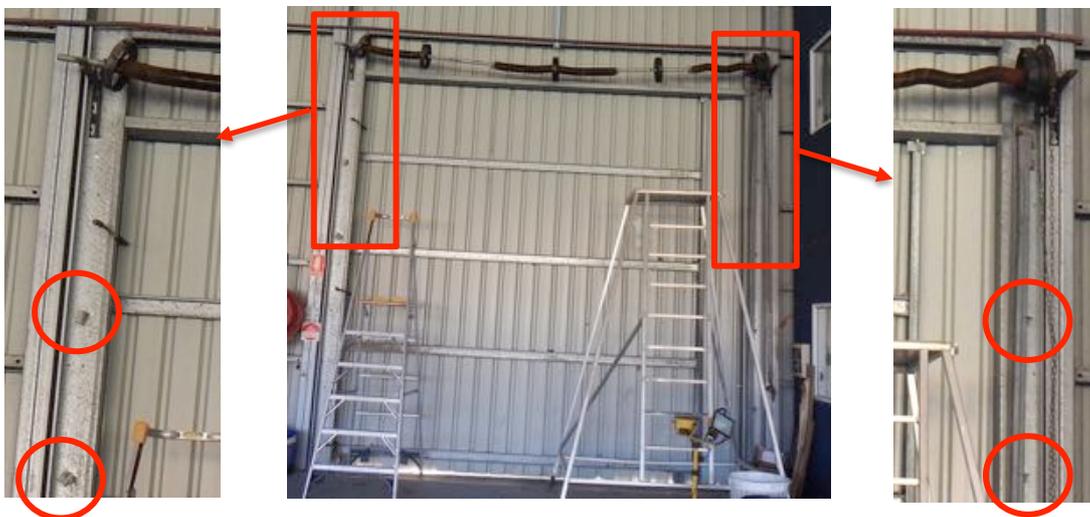
No failures of roller door curtains with wind locks were observed in this investigation. Wind locks prevented the main failure mode of roller doors – disengagement from the guides. However, one roller door with wind locks tore the left guide from the building (left photo in Figure 4.41) because the connections to the structure (circled) were inadequate to resist the catenary forces. The right guide is still attached to the frame (right photo in Figure 4.41) and a temporary panel has been placed over the opening as shown in the centre photo in Figure 4.41.

Figure 4.41 Failure of connections between guide and building

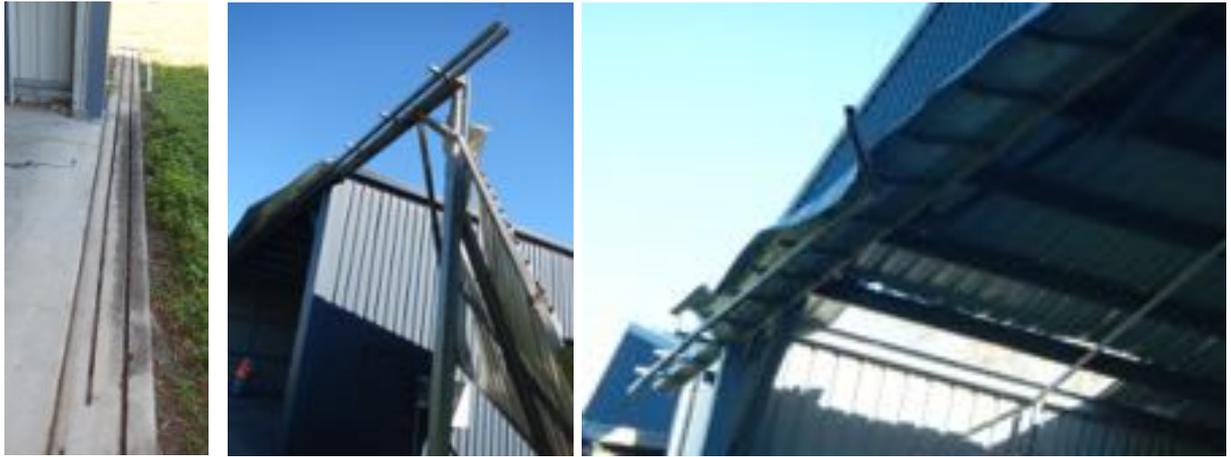
(a) Guides at base (b) Sliding door failure (c) Failure of track
Figure 4.42 Damage to large sliding doors

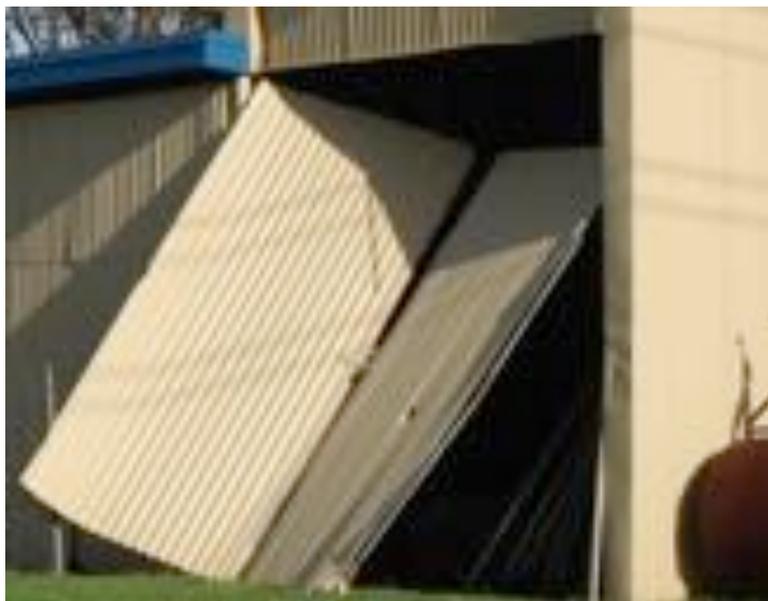
Figure 4.43 Damage to hinges on large swinging doors

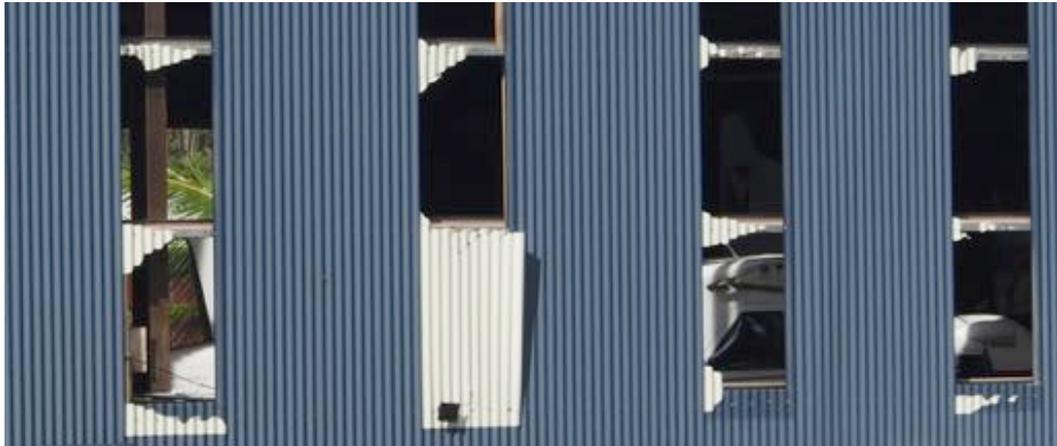
Figure 4.48 Loss of polycarbonate sheeting

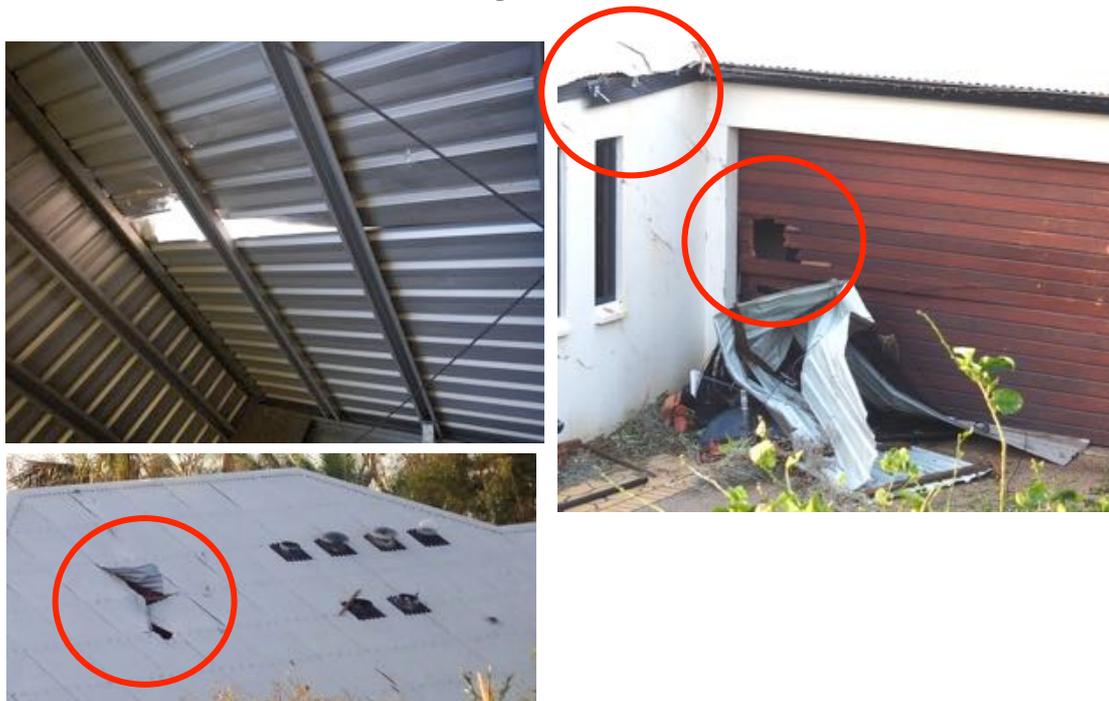
Figure 4.50 Debris damage to cladding elements

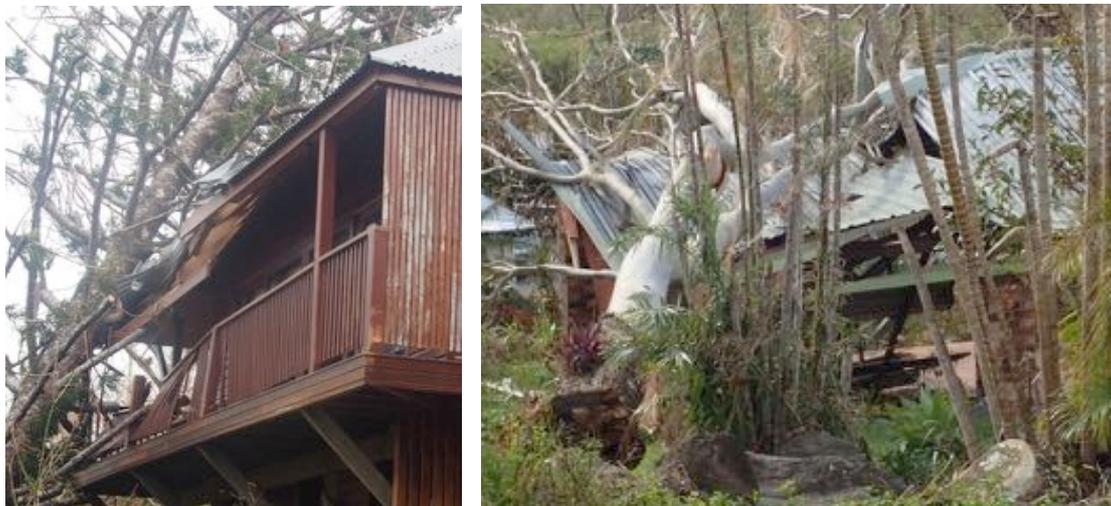
Figure 4.53 Damage to buildings by fallen trees

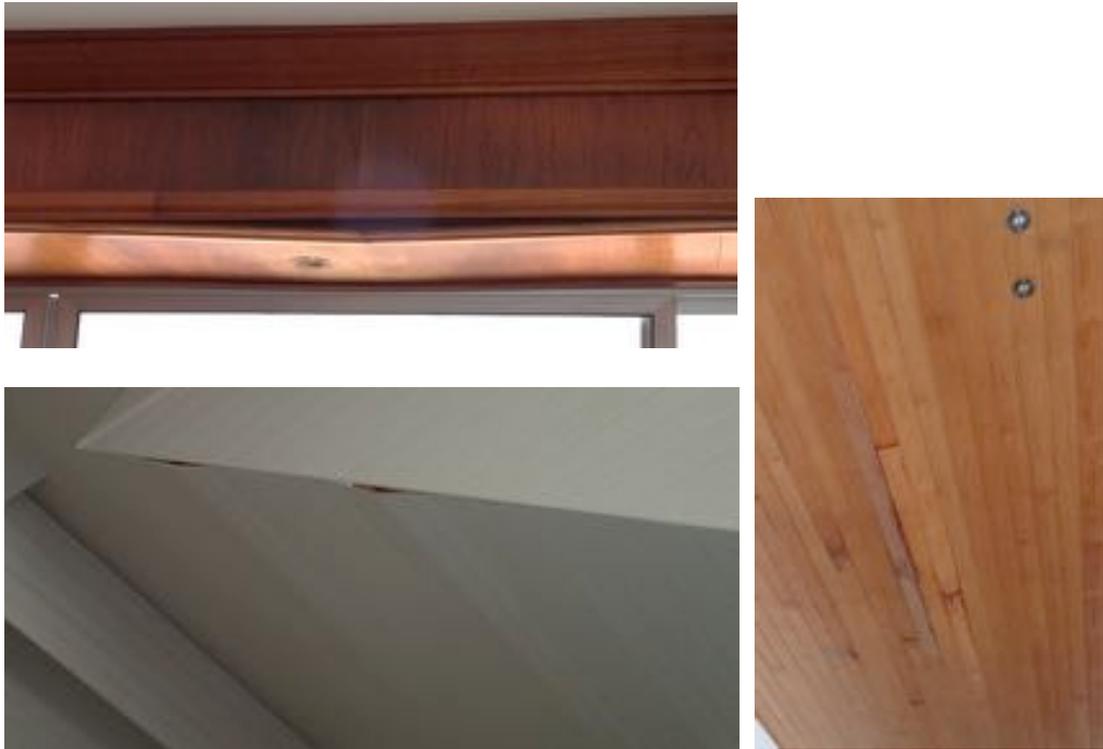
Figure 5.4 Examples of damage to timber-lined ceilings

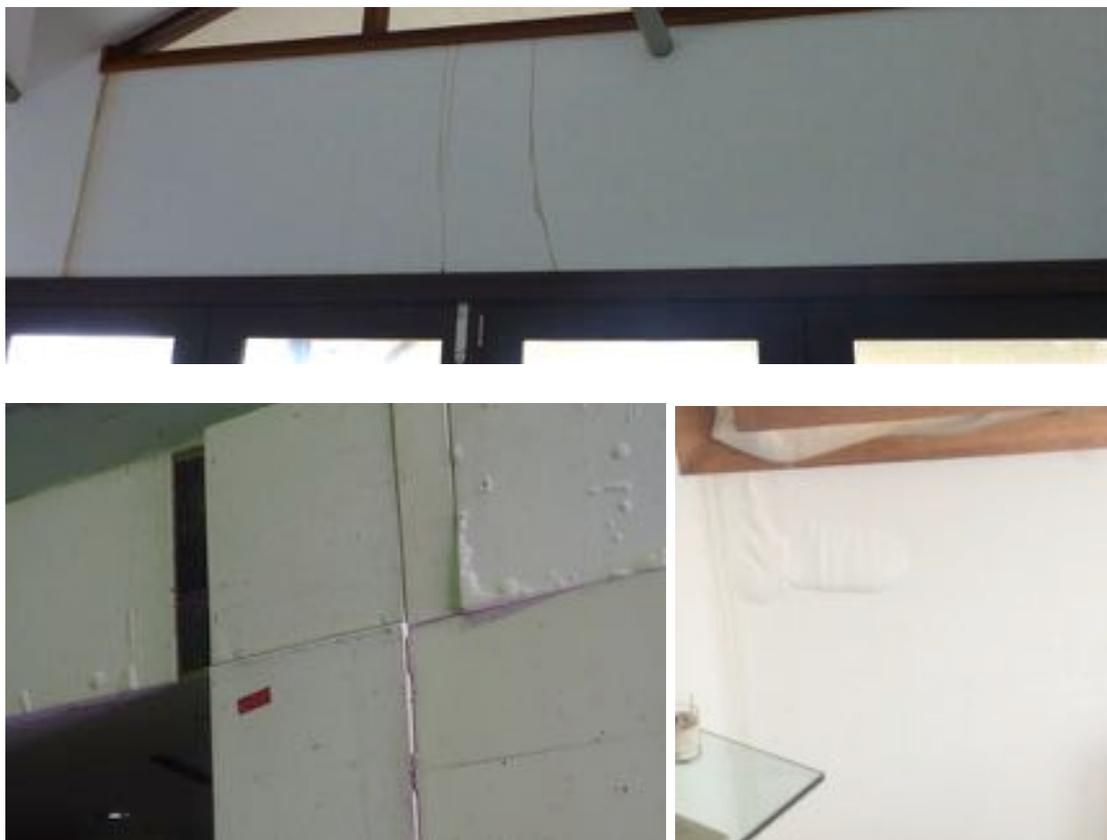
Figure 5.6 Early signs of damage to plasterboard wall linings

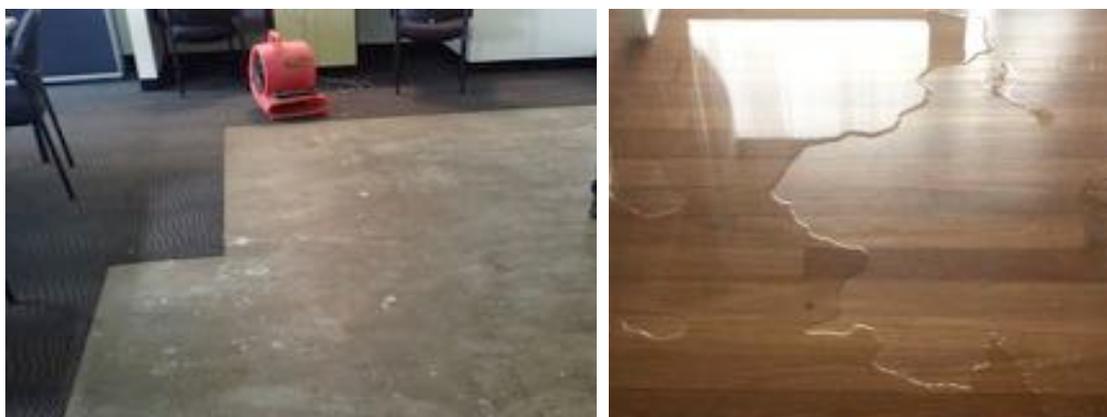
Figure 5.7 Damage to carpet and timber floors

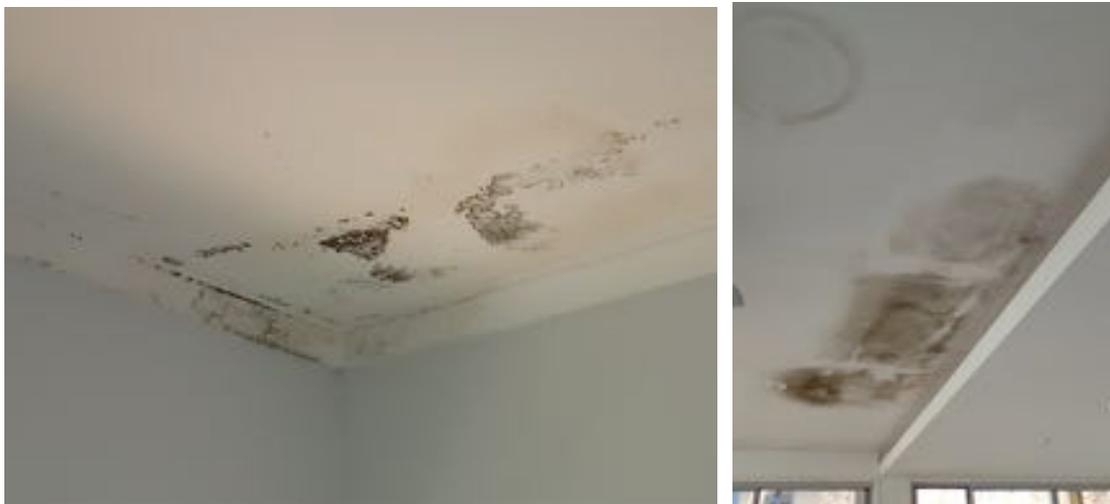
Figure 5.11 Mould in ceilings affected by water entering under failed flashings

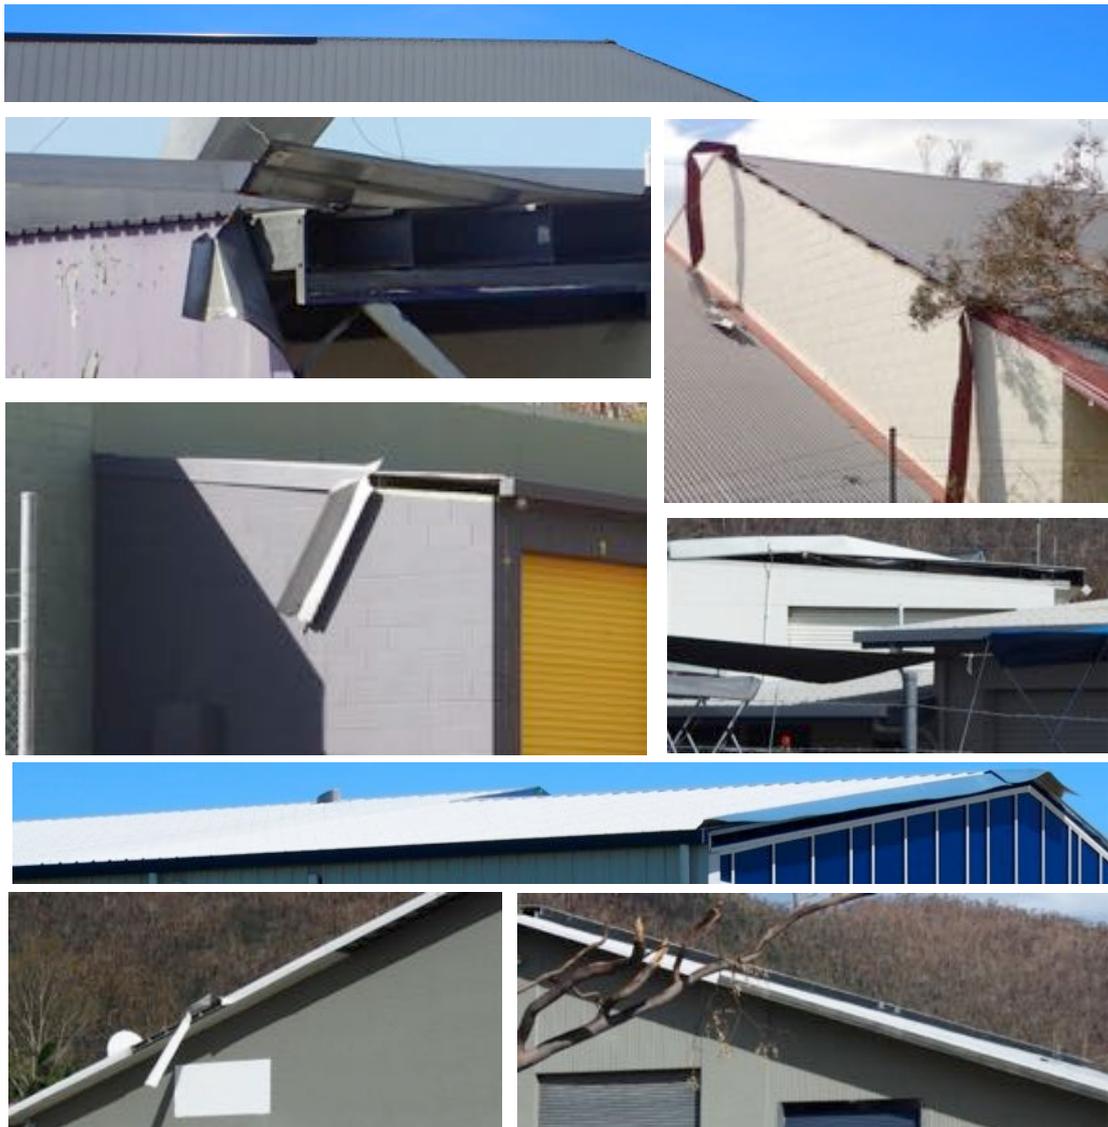
Figure 5.12 Examples of failure of flashings on larger industrial buildings

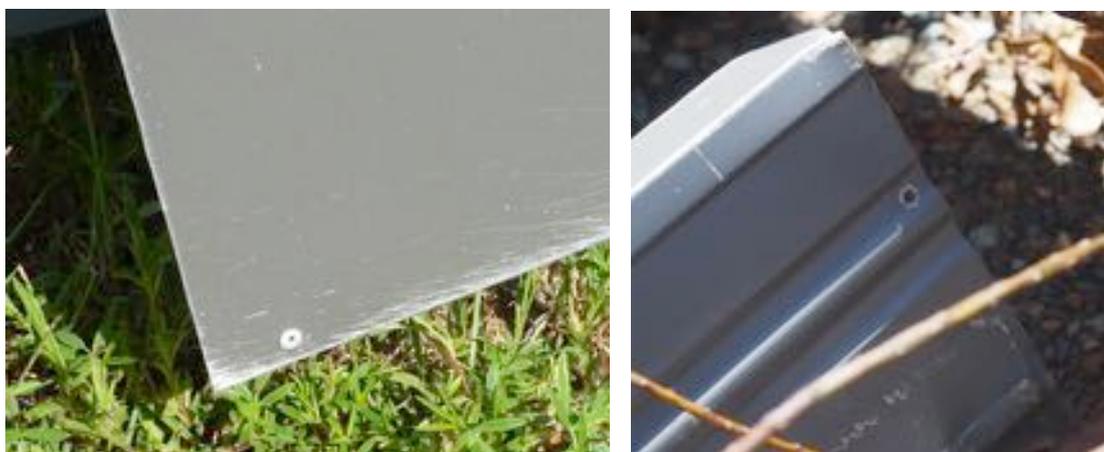
Figure 5.14 Examples of flashings that had been fixed with pop rivets

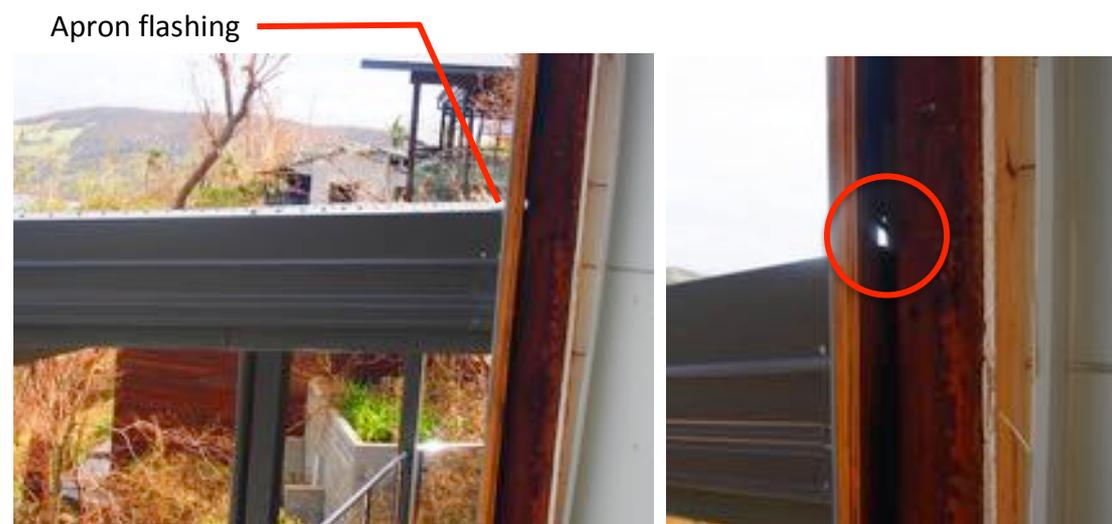
(a) Apron flashing on verandah (b) Gap in apron flashing
Figure 5.16 Gap in apron flashing
