Tropical Cyclone Debbie Damage to buildings in the Whitsunday Region

CTS Technical Report No 63

This edition: 03 June 2017

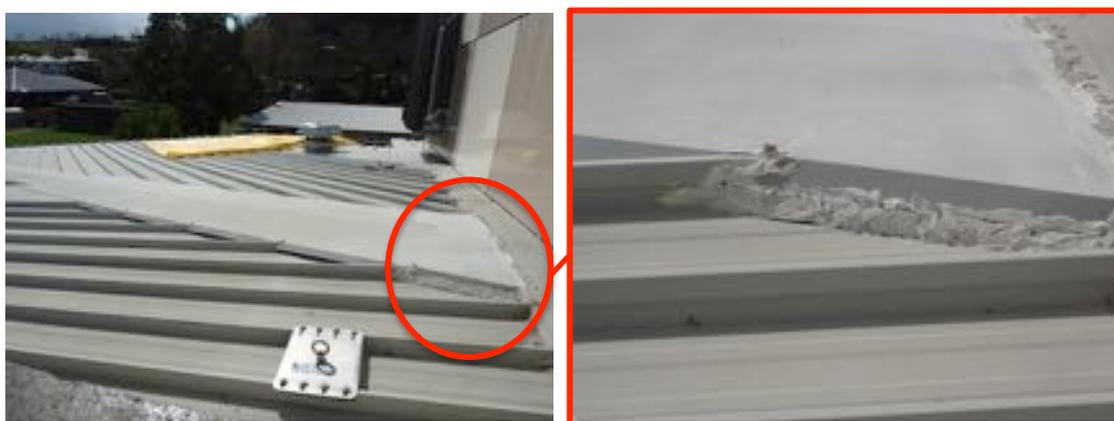
Figure 5.19 Roof of building that had significant damage to ceilings with silicon sealant near apron flashing

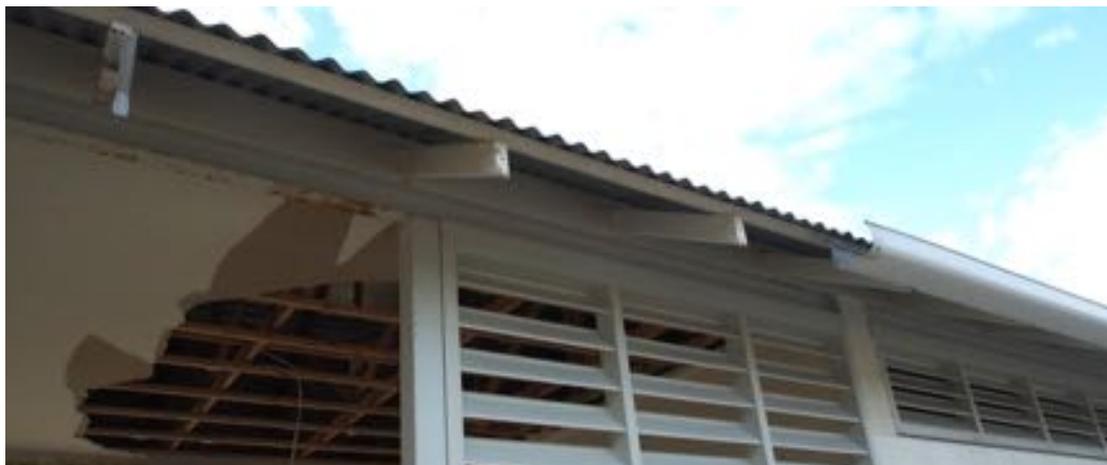
Figure 5.22 Damage to ceiling in a building with missing gutters

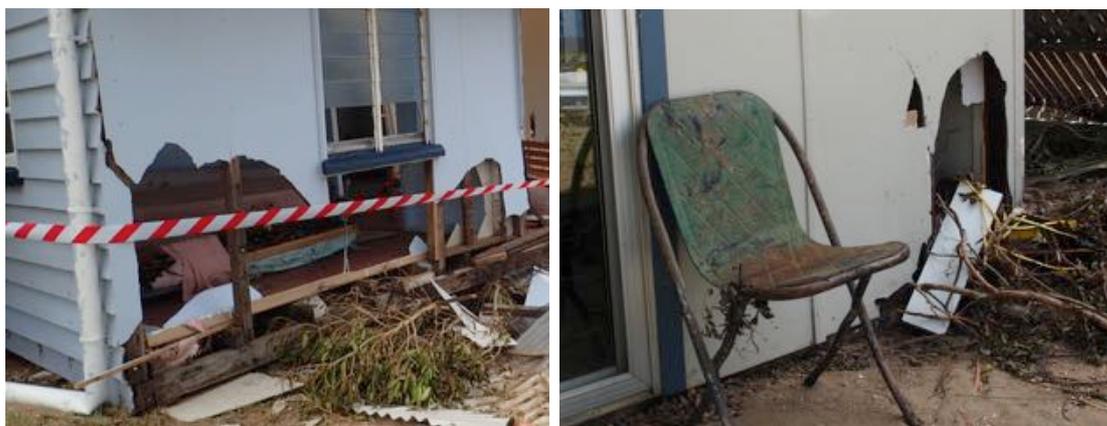
Figure 6.13 Damage to thin fibre cement sheeting

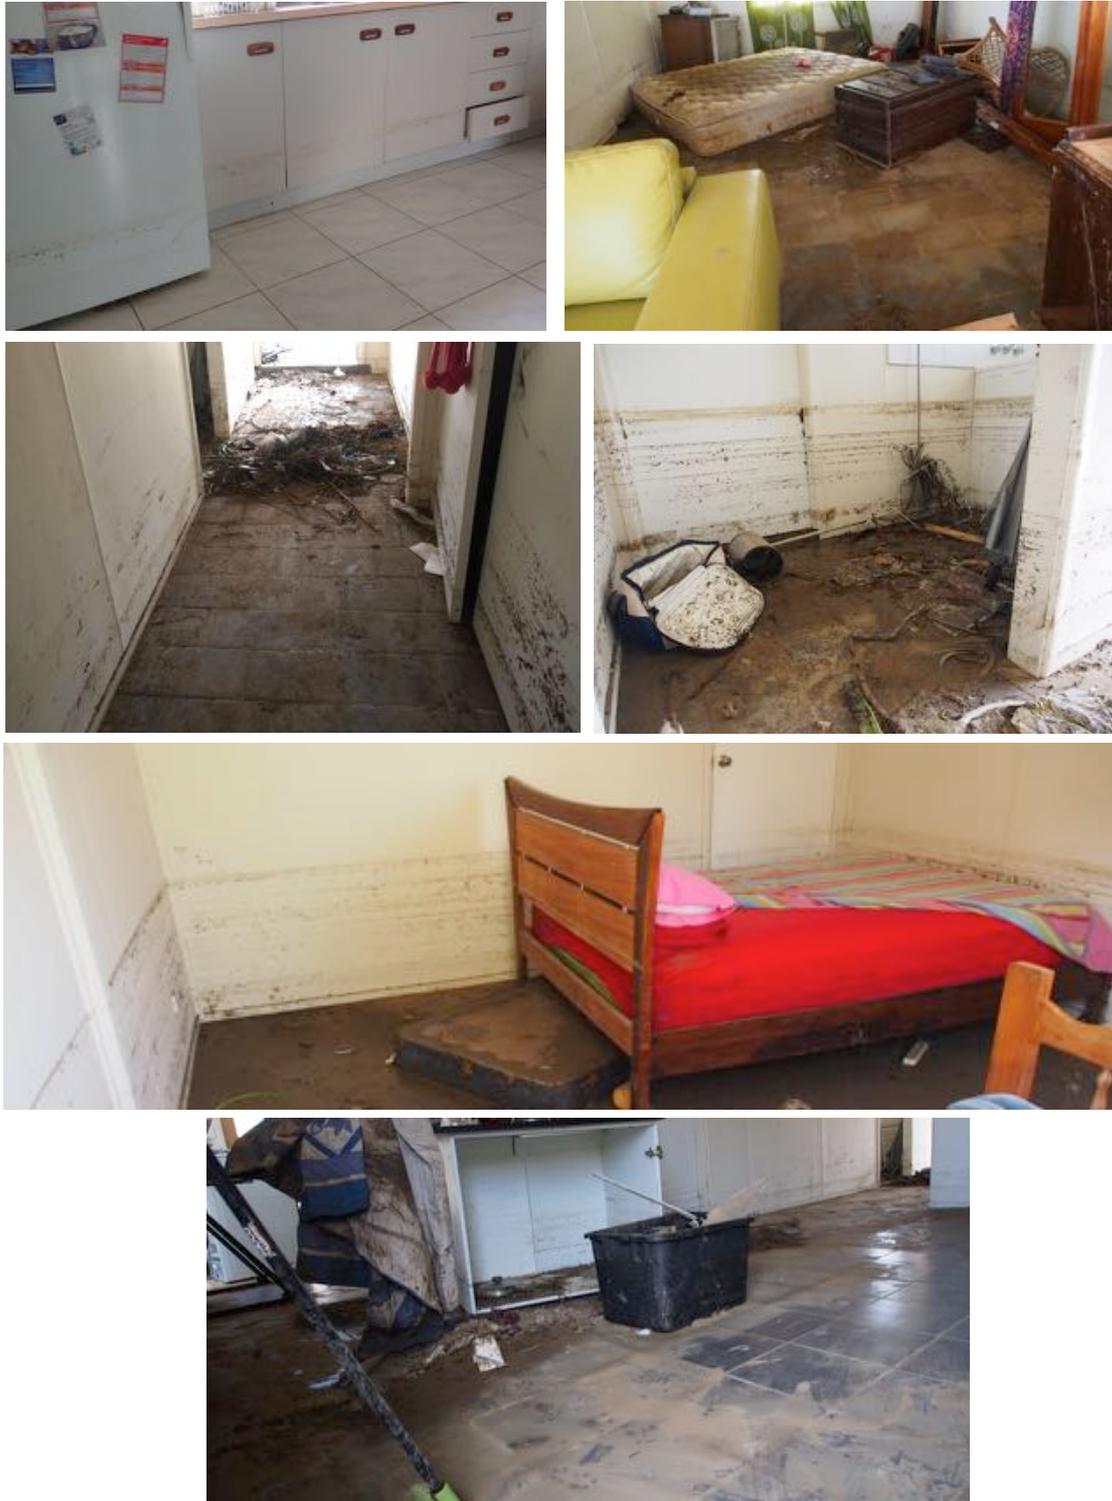
Figure 6.14 Damage to internal building elements and contents

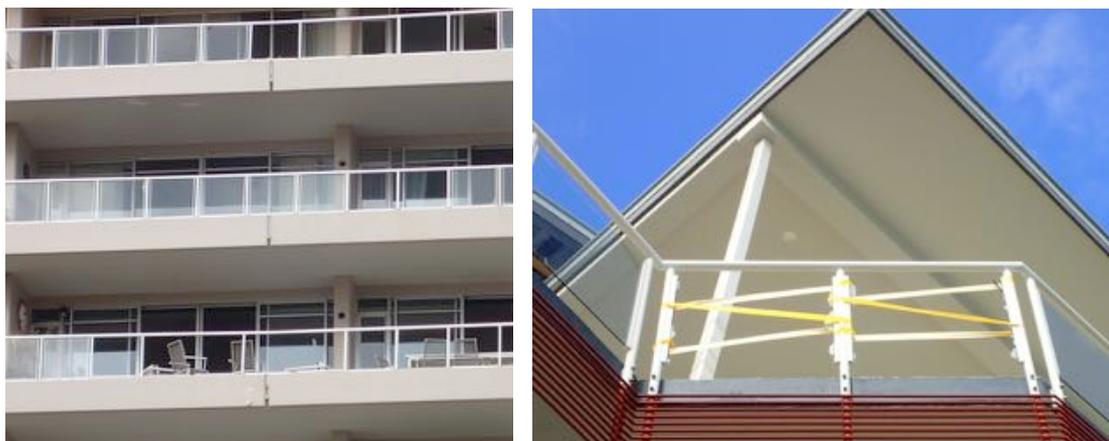
Figure 7.6 Failure of framed glass balcony balustrades

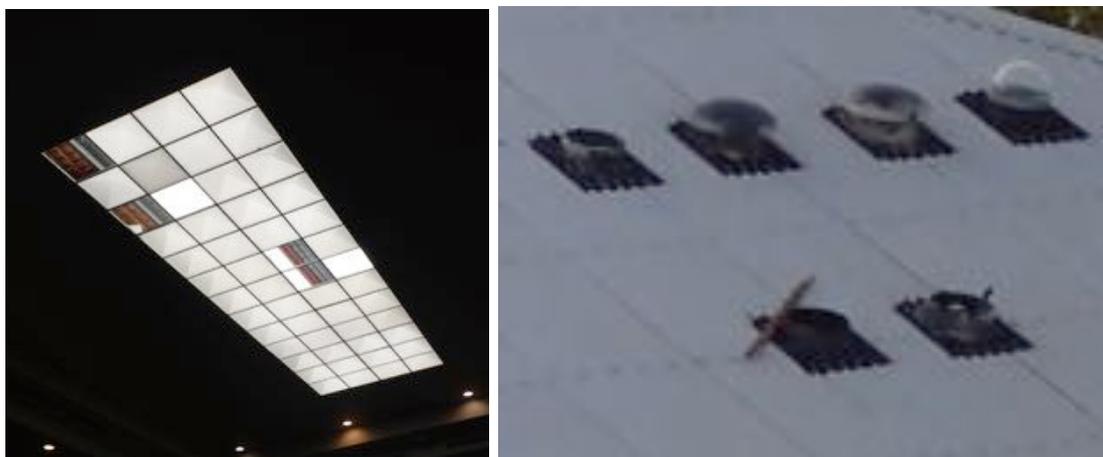
(a) Skylights broken by wind pressure (b) Skylights damaged by debris
Figure 7.17 Damage to skylights

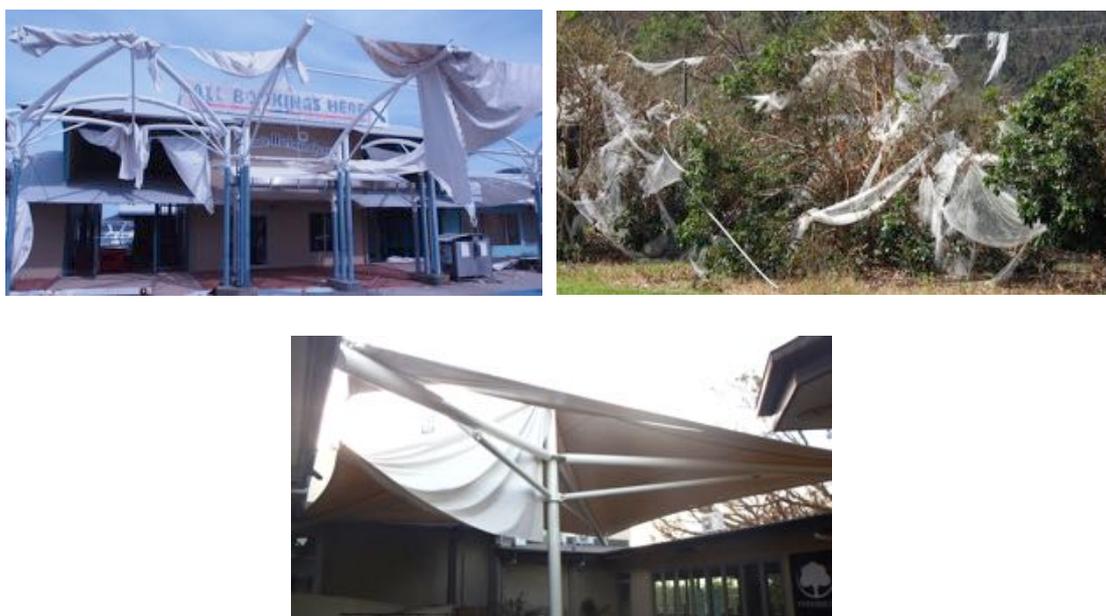
Figure 7.18 Examples of damage to sail and shade cloth structures

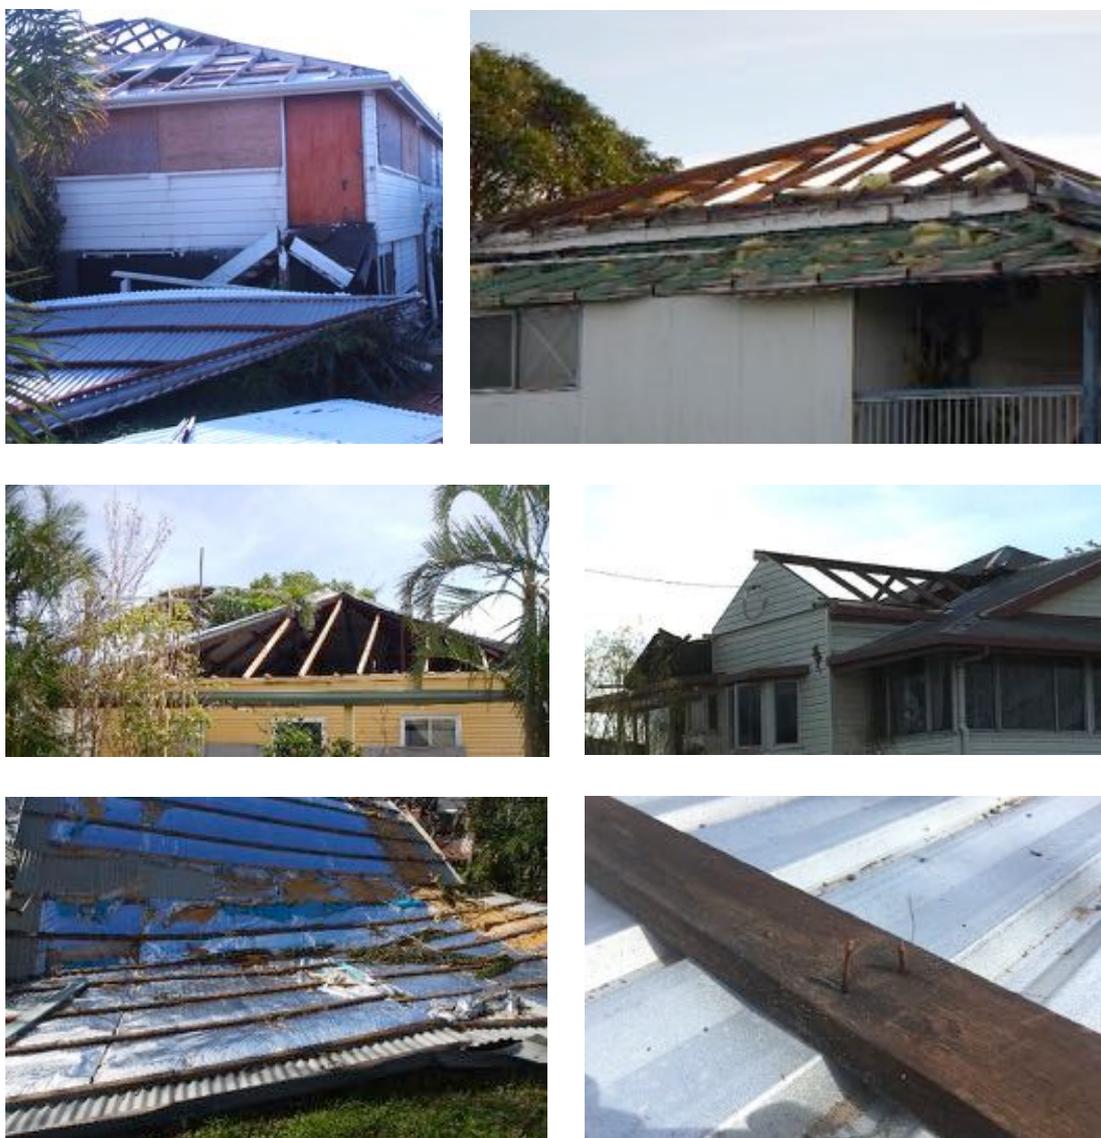
Figure 8.2 Batten-to-rafter failures in buildings built before 1985
