## TC Zelia, East Pilbara, WA Damage to Structures

### CTS Technical Report No 69

7 March 2025

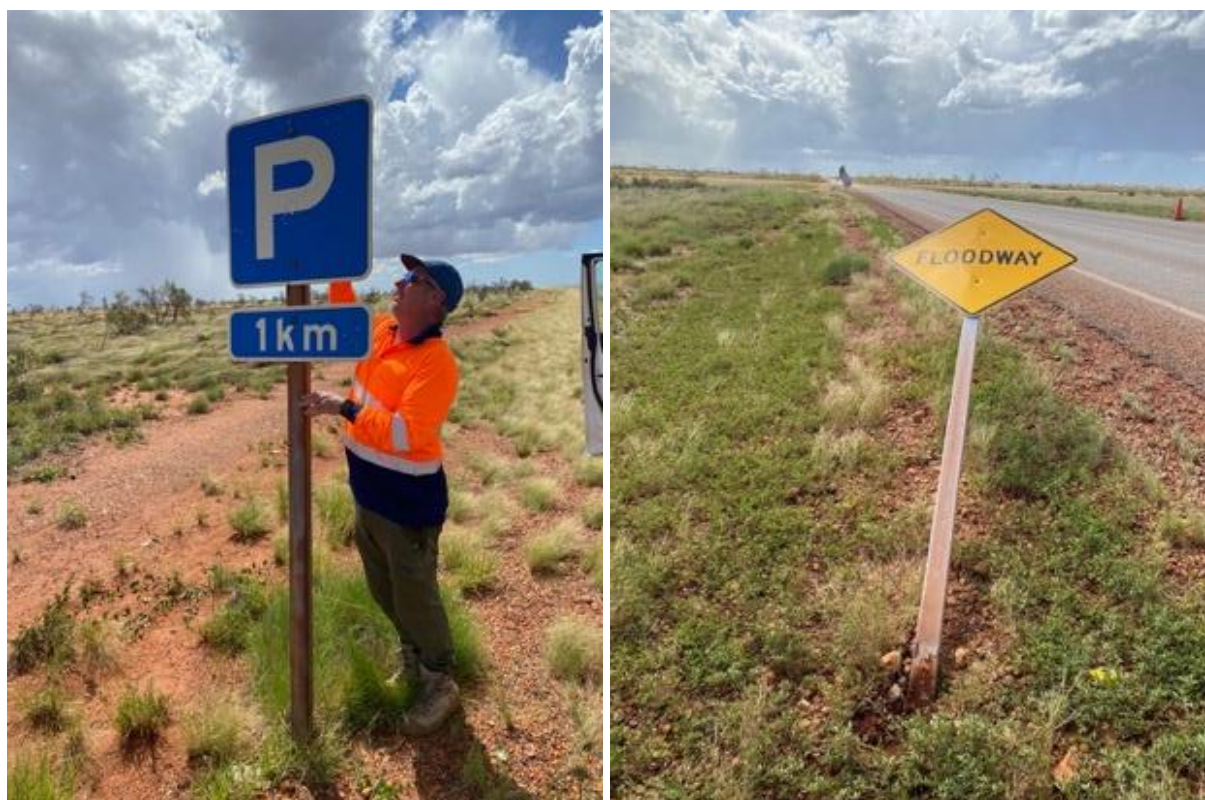
Figure 2-3 shows two of the road signs that was used to estimate the wind speeds associated with the tropical cyclone. The left photo shows a sign that was still vertical. The wind forces had not been enough to cause a plastic hinge in the pole, so by calculating the speed required to cause a hinge, an upper bound of the wind at the location could be found. The right photo shows a sign that had developed a plastic hinge in the pole, so the same calculations on this sign gave a lower bound of the wind speed at the location.

Figure 2-3 Road sign used to estimate wind speed.

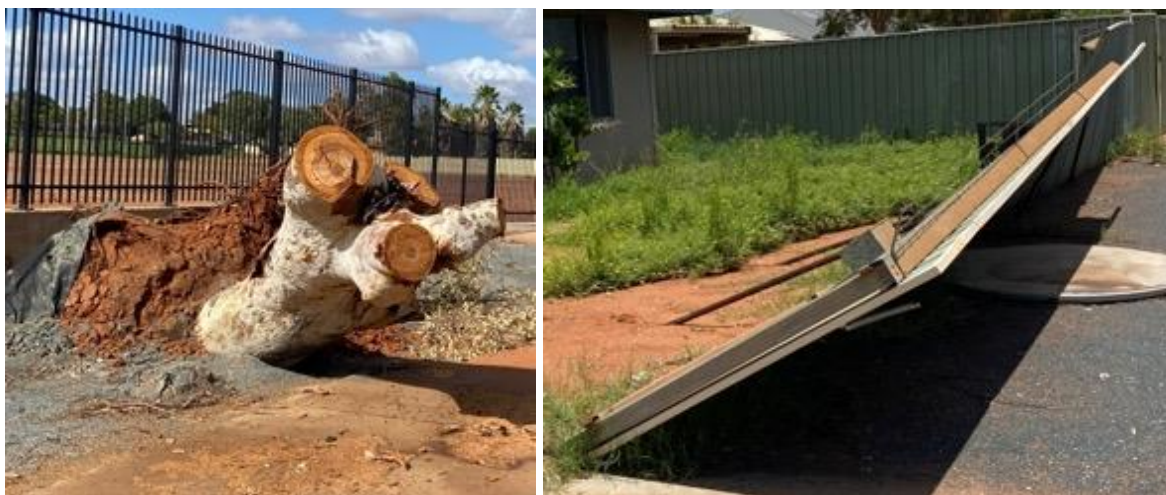
As indicated in Section 2.3, recorded wind speeds in the Port Hedland area were significantly lower than the regional design wind speed for importance level 2 structures in wind region D. Figure 3-1 shows a large tree that had been blown over in Port Hedland and a fence that had been blown over in South Hedland. (The photo of the tree was taken after it had been cut up by SES.)

Figure 3-1 Minor damage in Port Hedland area.

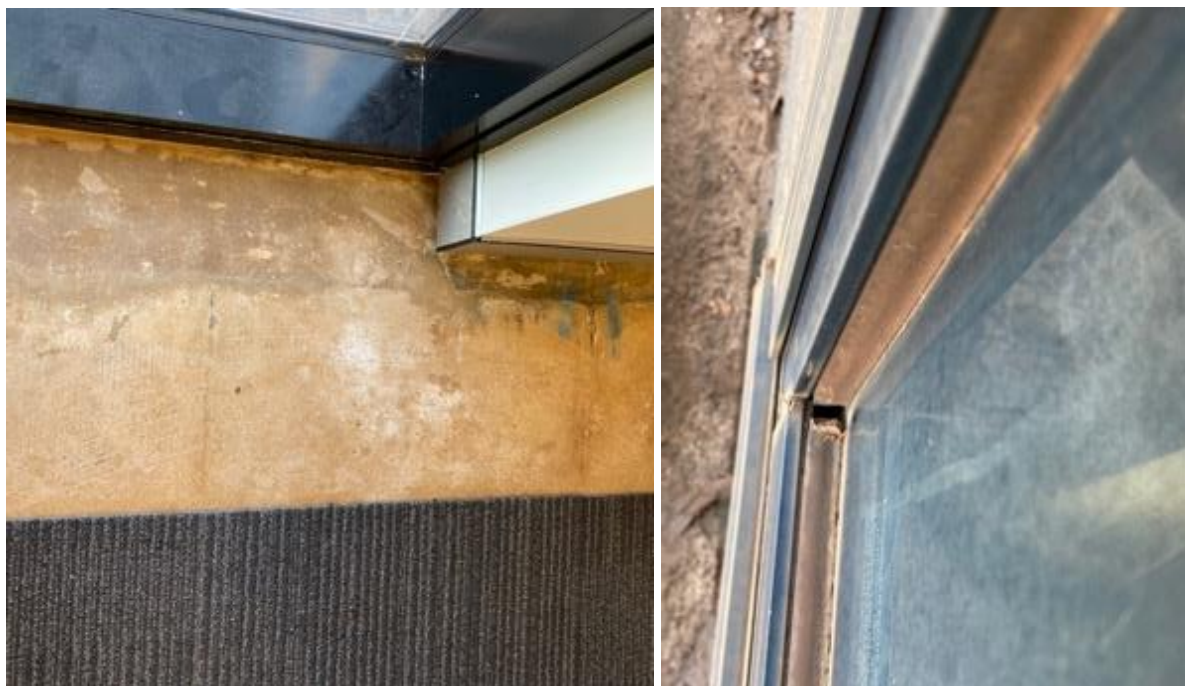
Some occupiers had reported wind driven rain entering their premises and Figure 3-2 shows some water damaged carpet and a gap in a window seal at the corner of the window that allowed water to enter the building.

Figure 3-2 Water ingress through windows.

The wind speed in Port Hedland was lower than the serviceability wind speed for structures but higher than a speed that would give the water penetration test pressure for windows.

Check and maintain seals on windows to minimise the chance of water penetration during even low winds associated with storms or nearby tropical cyclones.

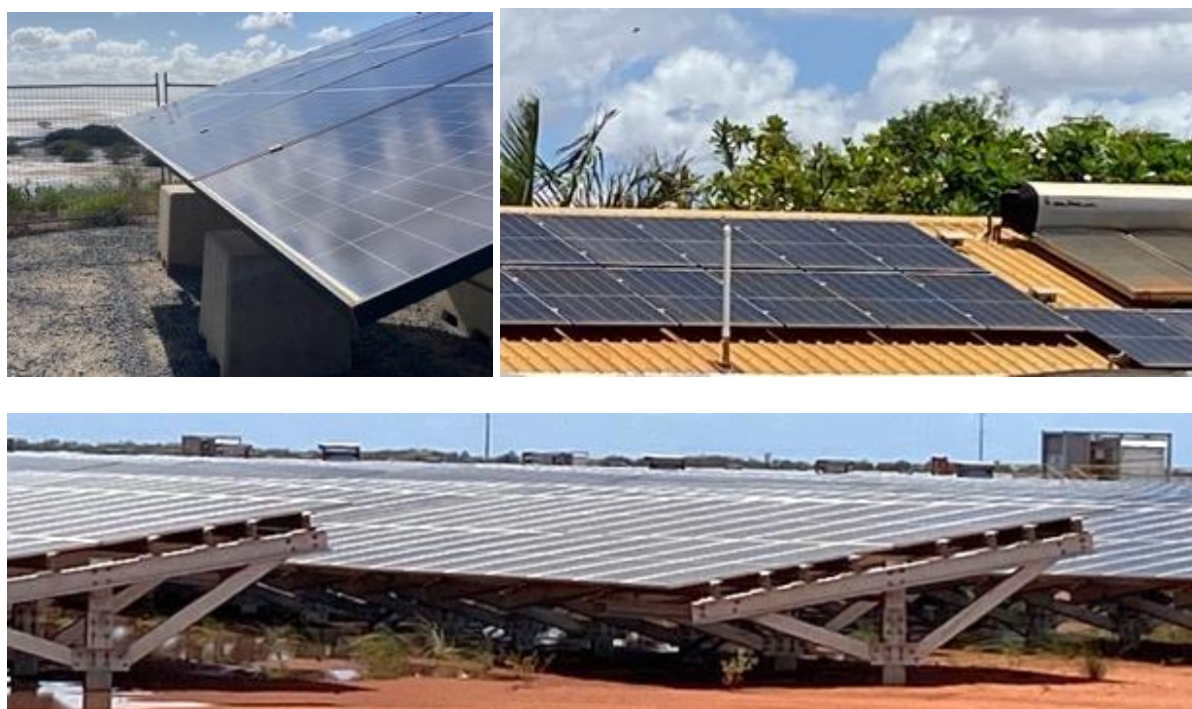
At the wind speeds experienced in the Port Hedland area, both ground-mounted and roof mounted solar panels performed well, as shown in the photos in Figure 3-3. This was expected as the wind speed was 45% of the design wind speed in the port Hedland area. As the wind pressures are calculated from the square of the wind velocity, this meant that the wind loads were around 20% of the wind loads for which the facilities had been designed.

Figure 3-3 Good performance of solar panels in the Port Hedland area.

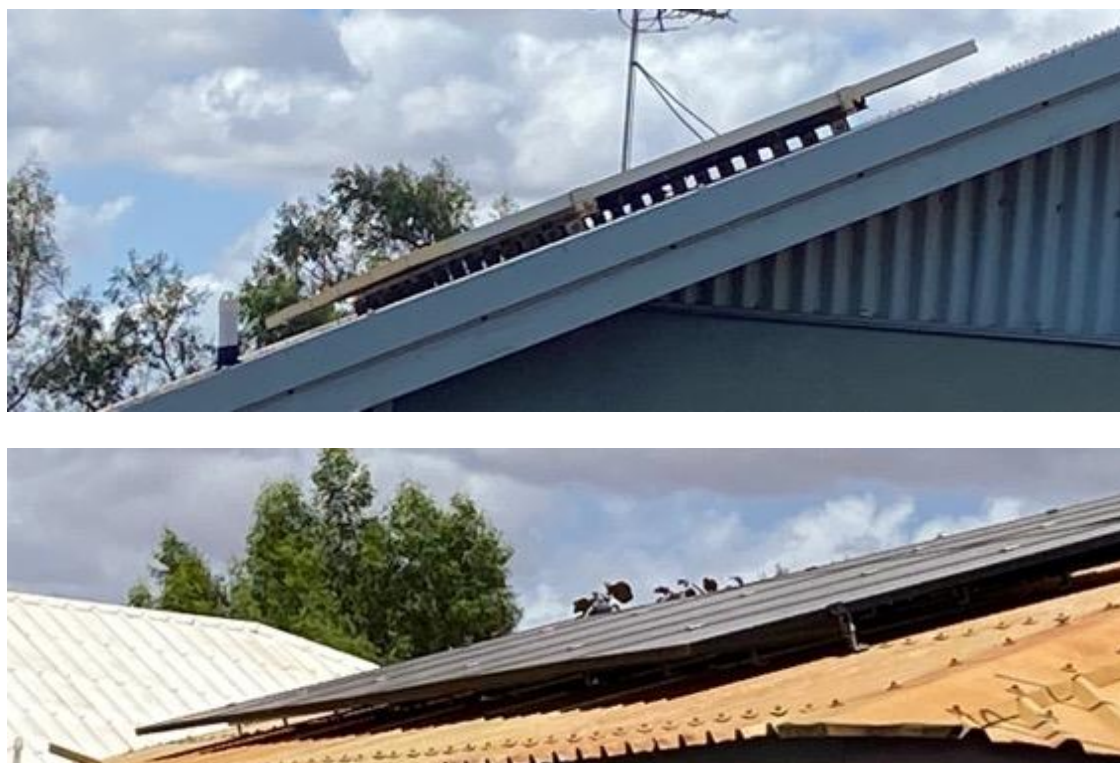
The fixing systems varied. In the lower photo in Figure 3-3 each panel was clamped to four rails using a total of 8 clamps per panel, whereas in the top left photo in Figure 3-3 each panel was clamped to only two rails using a total of 4 clamps per panel. Likewise in the roof-mounted systems, some rails were supported on L-foot brackets at around 160 mm centres in the roof cladding as shown in the upper photo in Figure 3-4 and others at around 900 mm centres as shown in the lower photo of Figure 3-4. In this case, the winds were not strong enough to cause damage to the systems that had fewer rails or lower frequency of L-foot brackets. In previous investigations in this area and in locations that experienced wind speeds in excess of 73 m/s, there were cases in which the L-foot brackets had pulled screws out of metal battens or purlins where their spacing was high and the tributary area per L-foot bracket was large.

Figure 3-4 Varying frequency of L-foot brackets in roof-mounted solar panel systems.

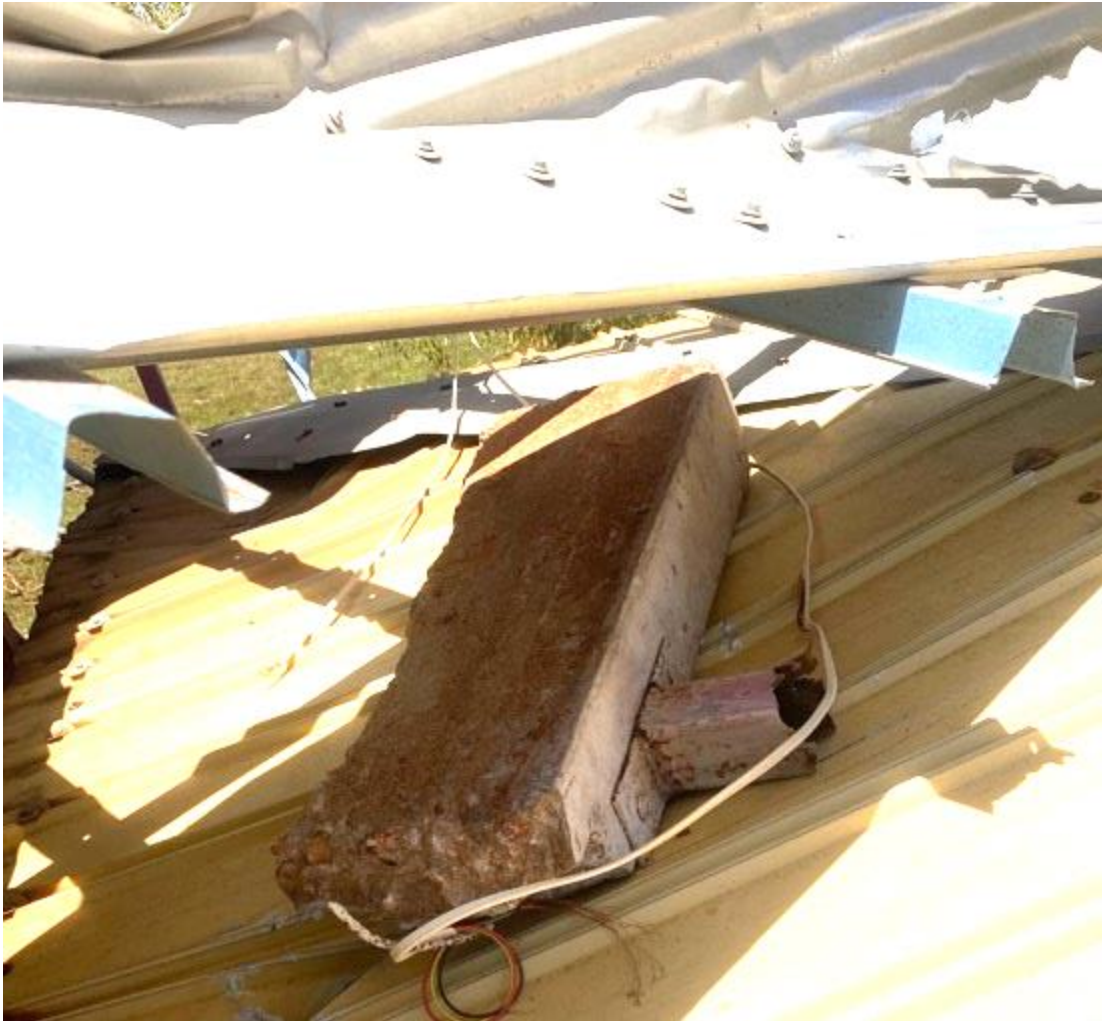
A veranda on a house failed under wind uplift. In this case, the failure was in the footings. Footings were removed still attached to the base of the veranda posts as shown in Figure 3-5. The edge of the concrete slab of the veranda was used as the footings for the post and each post was bolted to the slab edge with three bolts. Figure 3-5 presents a photo taken on the roof of a nearby building where part of the veranda had been deposited by the wind.

- The slab edge is shown in the centre of the photo in Figure 3-5. The base of the veranda post is still attached and two of the masonry anchors at the base of the post are visible. (The third is under the concrete but was also intact.)
- The veranda post had broken about 200 mm above the base plate after the post had been lifted to its current location. The upper part of the post remained attached to part of the veranda and blew further away. There had been some corrosion inside the post that facilitated the break once the column had been removed, but the corrosion was not a contributor to the original failure of the footing.
- The roofing above the base of the veranda post is part of the veranda roof. The blue battens visible in the upper half of the photo are battens from the veranda.

Figure 3-5 Footings still attached to the base of the veranda post after failure.

The veranda had been added to the house relatively recently, and while many aspects of the veranda were able to carry the wind loads, the footing had not been upgraded at the time of the veranda construction. The consequential water damage meant that the house had to be emptied of contents and could no longer be used as a house. This case study underlines the potential for premature failure of a structure attached to a house to render the house unfit for habitation. In order for additional structures not to be a liability for the main house, they must be designed and constructed to the same design criteria as the main house.

Ensure that structures attached to houses and other buildings are built to the same design criteria as the main building.

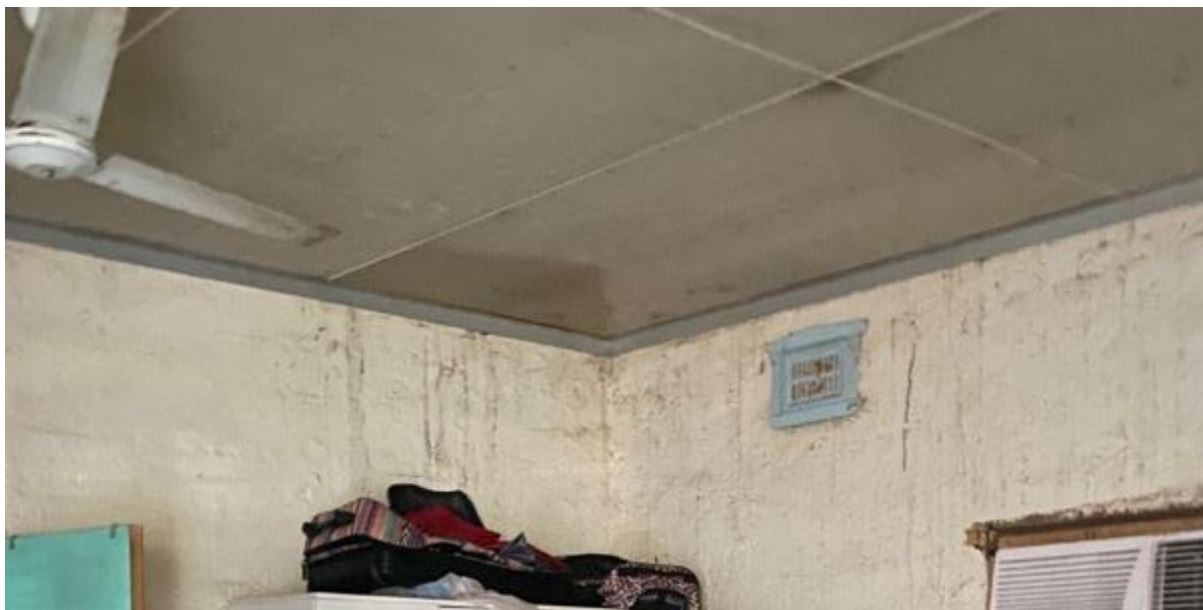
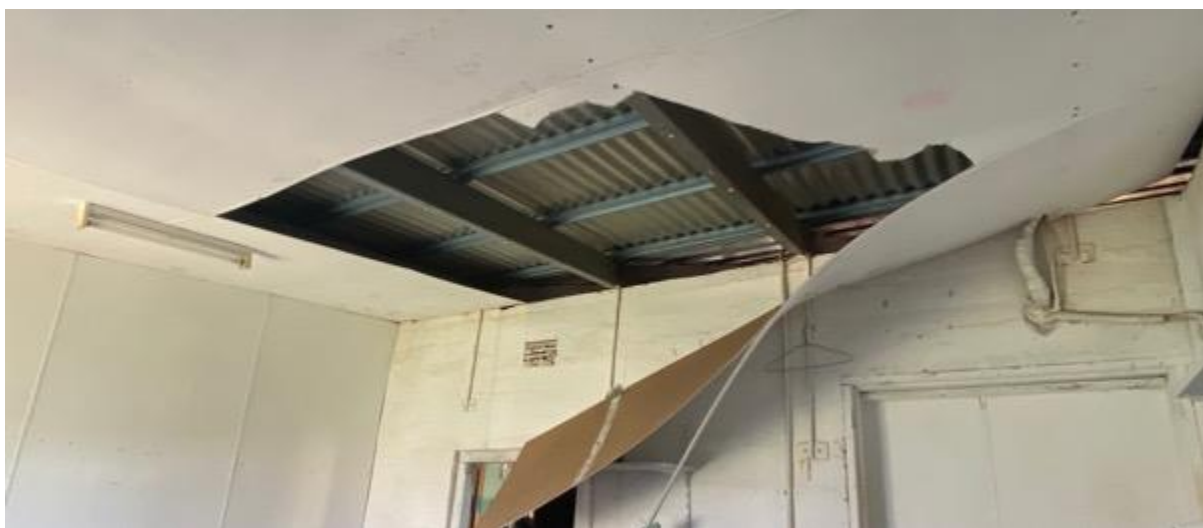
Once the veranda shown in Figure 3-5 had failed it exposed the roof edge to which the veranda had been attached to wind-driven rain. This allowed rain into the roof space and caused damage to linings and contents throughout the house as shown in Figure 3-6.

Figure 3-6 Water damage as a consequence of veranda loss.

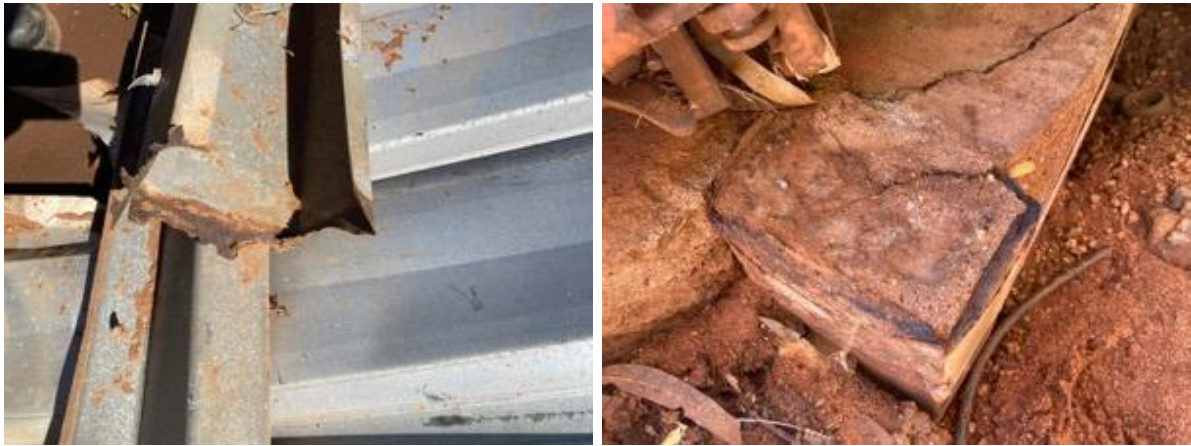
A shed was significantly damaged and caused damage to the contents of the shed which included some farm equipment and expensive vehicles. The first failure was at the base of the posts. In this case, corrosion in the cold-formed steel posts where they had been cast into concrete had caused the posts to break at the surface of the concrete slab as shown in Figure 3-7. This figure shows the base of the shed post on the left and the footing with the rusted shed post cast in on the right.

Figure 3-7 Corrosion at the base of the steel posts.

The damage to this structure highlights the importance of specifying details that minimise the effects of deterioration in important structural members. It is particularly necessary to regularly inspect and maintain thin steel structural members to ensure that they have not been compromised by corrosion.

Use details that minimise the effects of corrosion in the design and construction of all buildings. Check and maintain buildings to minimise the effects of deterioration.

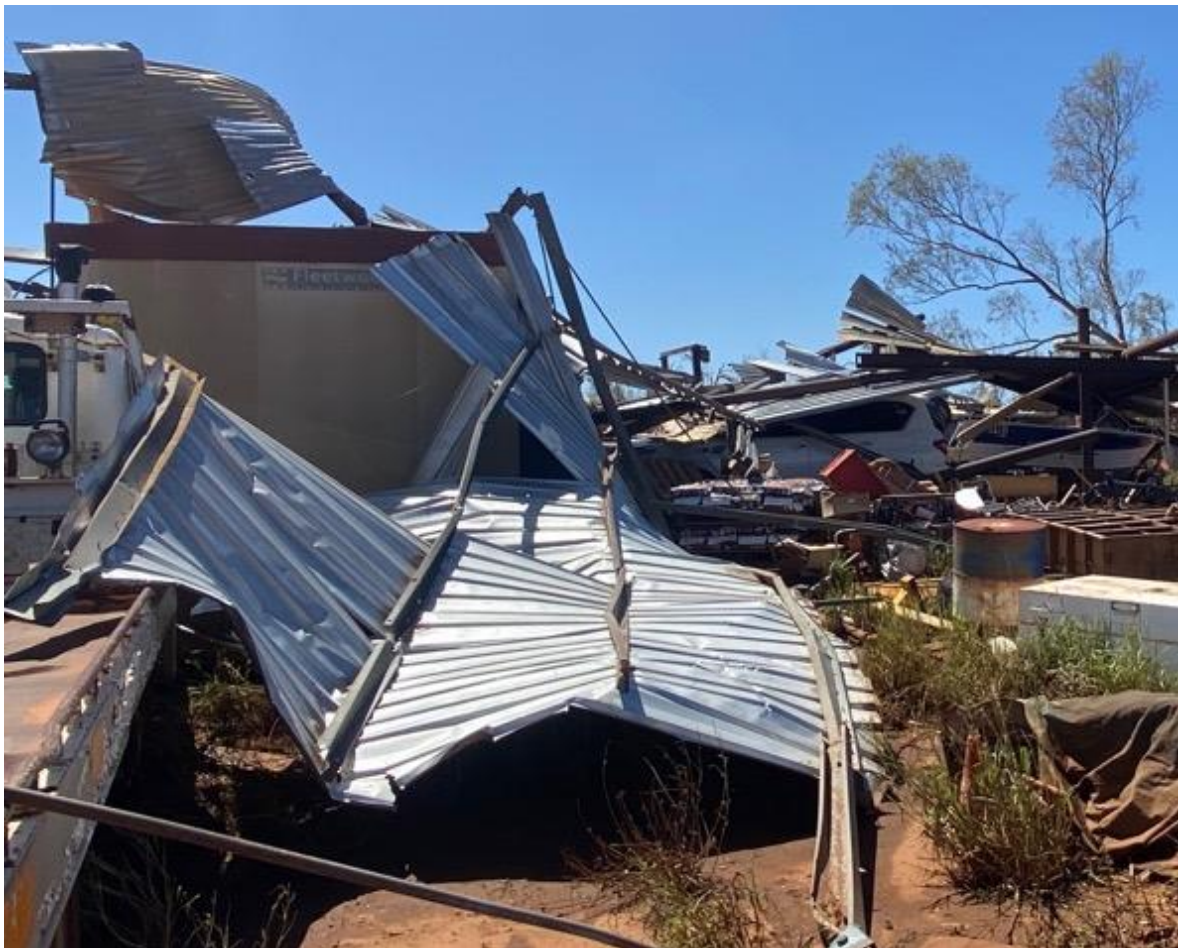
Once the post at the front of the shed was no longer connected to the slab, it allowed the wall to lift off the slab and allowed the sliding doors on the front of the shed to blow in and the roof with walls attached to fold back. As there was an accommodation block behind the shed, the roof and part of the walls became wrapped around the accommodation and compromised its use as well. In Figure 3-8 the original position of the shed was on the right side of the photo, and the roof of the shed can be seen wrapped over a mobile accommodation block

(donga) on the left of the photo. The panel at the bottom of the photo is a side wall that rotated about the back post of the shed after the front posts had failed.

Figure 3-8 Roof of shed over accommodation block.

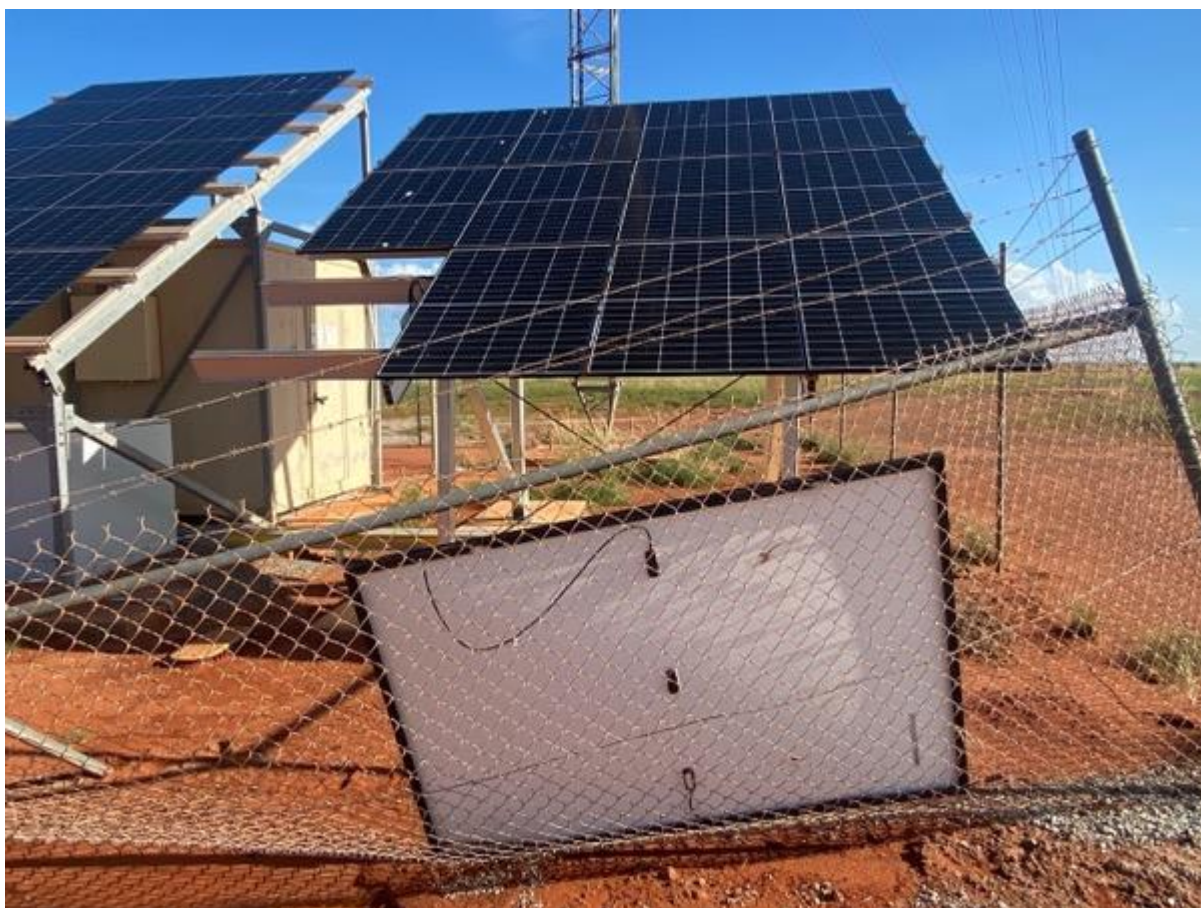
The 0.2 sec wind speed at the location of some ground-mounted solar panels shown in Figure 3-9, was estimated at around 65 m/s – around 76% of the regional design velocity for this location. A few panels had failed by detachment of the panel chassis at the clips that held them to the rails. Some panels at this facility had experienced very similar failures in a previous cyclone that caused around the same wind speed at this location (Boughton et al, 2023).

Figure 3-9 shows a missing panel from one array of panels. There were four arrays at this location and each had at least one panel missing. The wind direction at this location was from behind the array. (The photo is taken looking into the wind direction that caused this damage.)

Figure 3-9 Failure of anchorage on ground mounted solar panels.

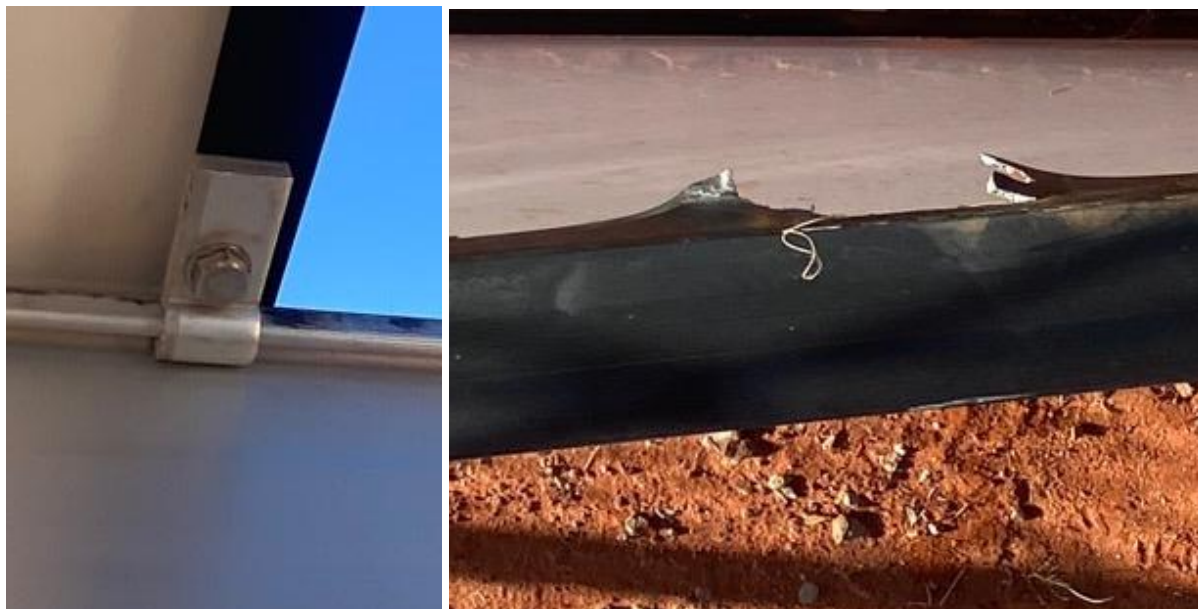
The panels had clamps bolted to the back of the chassis that tightened onto a ridge on the rails under the panel. The metal of the chassis had torn around the bolt to the clamp. It is likely that low cycle fatigue may have contributed to the failure. The fatigue failures in the chasses may have been affected by the prior cycling in the previous tropical cyclone.

The left photo in Figure 3-10 shows an anchorage clip on a panel that had not failed adjacent to the panel that had failed. The chassis of the panel is coloured black, and the clamp was bolted directly to it with the bolt visible on the underside of the clamp. The right photo shows the tear in the back of the chassis of the panel that became separated. The torn failure surface can be seen in the photo, and it appeared to involve progressive tearing.

Figure 3-10 Detail of the chassis failure.

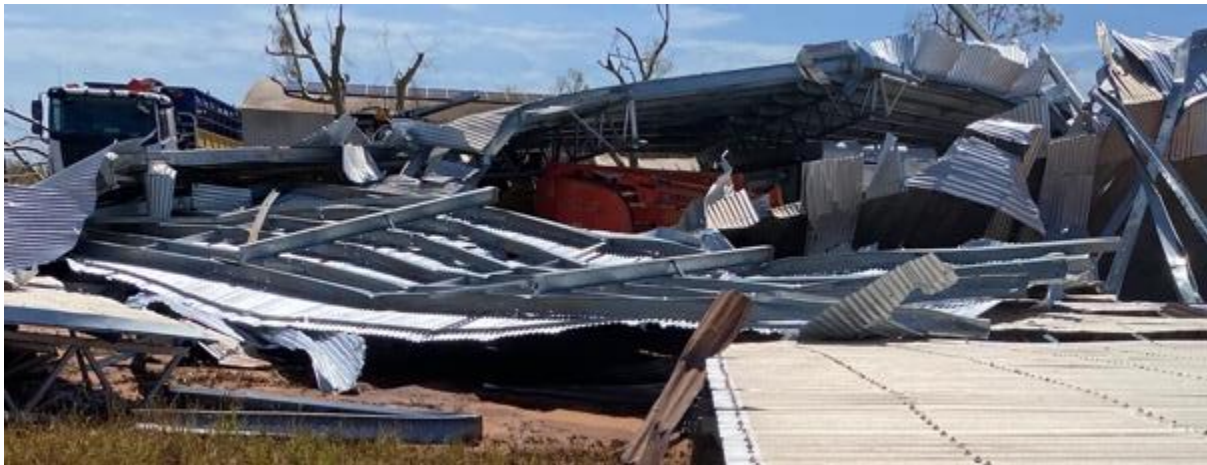
A shed that was around a year old was significantly damaged. The shed was an open shed with one whole side open. The failure occurred when the wind was blowing towards the opening. There was no evidence of failures of cladding separating from the purlins or of purlins failing under wind uplift which indicates that the shed had been appropriately designed for internal pressure.

Figure 3-11 shows a view of the shed which lost approximately  $\frac{3}{4}$  of its roof, one end wall and nearly all of the back wall. The parts of the shed that remained were badly twisted and the contents of the shed (mainly vehicles) had been damaged in the collapse.

- In the right foreground of Figure 3-11 is a part of the roof with the ridge line on the left of the panel. This panel was the downwind section of roof at the time of the shed failure
- Lying on top of that panel is the badly damaged end wall.
- The very left of the photo shows the back or leeward wall of the shed protruding from under the end wall.
- The top of the photo shows the half of the upwind roof panel that remained attached, having collapsed on the contents of the shed. The truck in the top right of the photo has not been moved since the cyclone, and was stored completely within the shed.

Some security video footage showed that the roof failure started at the ridge of the shed near the end wall shown in Figure 3-11. The roof panel in the foreground was the part of the roof close to the failure point. It showed that the roof truss had fractured at the ridge.

Figure 3-11 Failure of a recently constructed shed.

Once the top chord of the end truss had failed at the ridge, the wind could lift the end of the roof, progressively failing each truss at the ridge. The back half of the roof would have been lifted off the building which would have enabled the back wall of the shed to be folded out of the building by the lateral wind pressure. Likewise the top of the end wall was also unsupported and was blown out of the building.

Truss members in structures should be sized so that the cross section can resist local stresses near welds under all actions associated with wind uplift. This includes the combination of stresses at weld cleats and cleats for bracing members combined with tension in the truss chords.

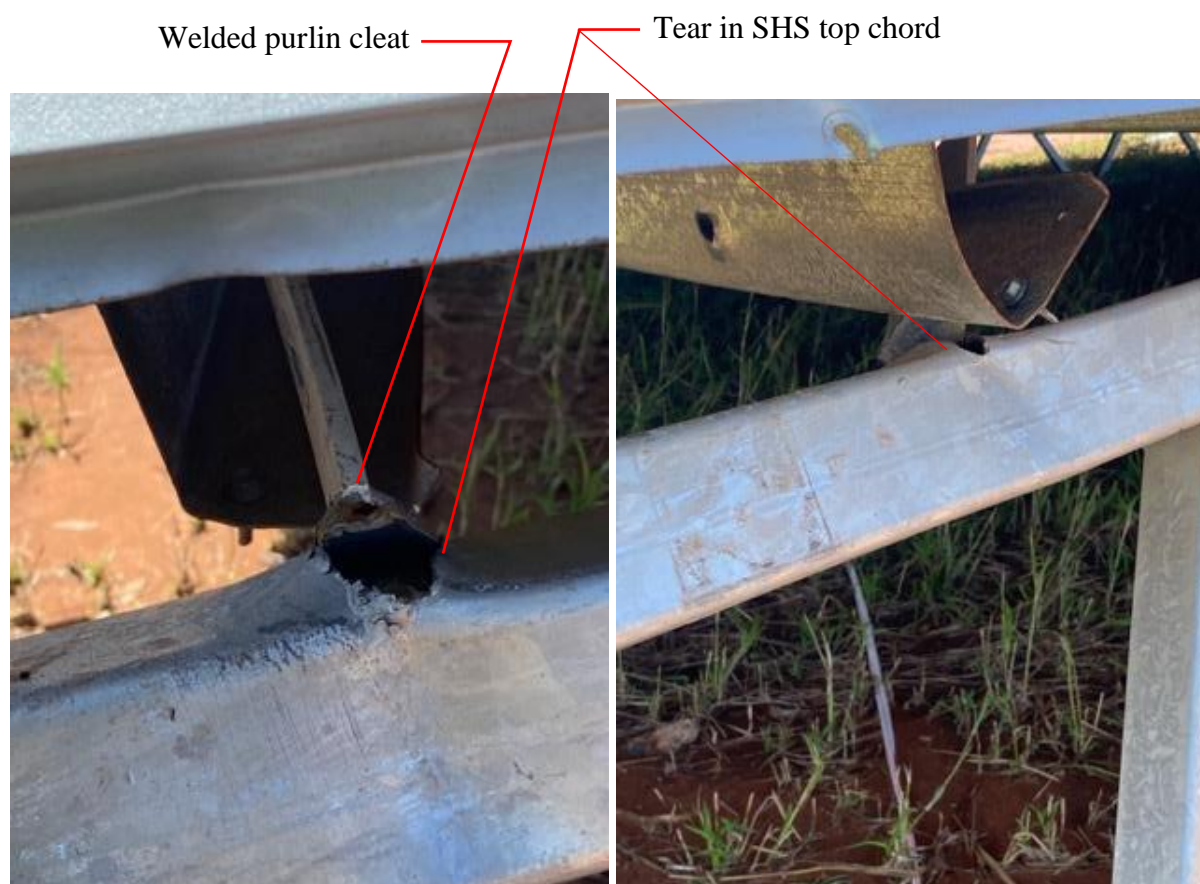
The top chord of the truss was a Square Hollow Section (SHS) in tension during the wind uplift during TC Zelia. Examination of the length of the truss showed that some of the cleat plates had torn the top face of the top chord at the weld of the purlin cleat as shown in Figure 3-12. This type of tear in the top chord changed the stress distribution in the top chord as the top face could not carry tension through the tear. The resulting higher stresses on the other three sides of the SHS caused it to fail at the weld with the bolted ridge plates.

Figure 3-12 Torn SHS top chord at cleat plates.

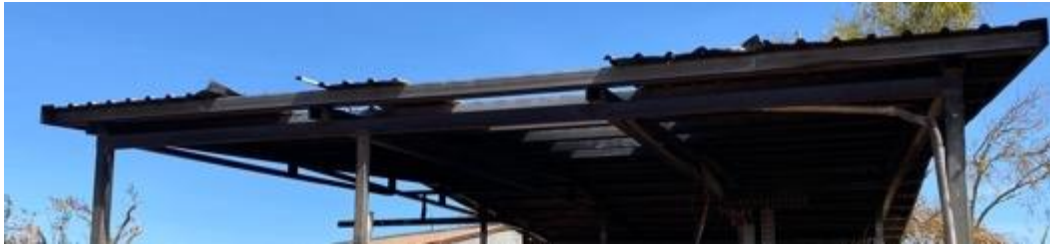
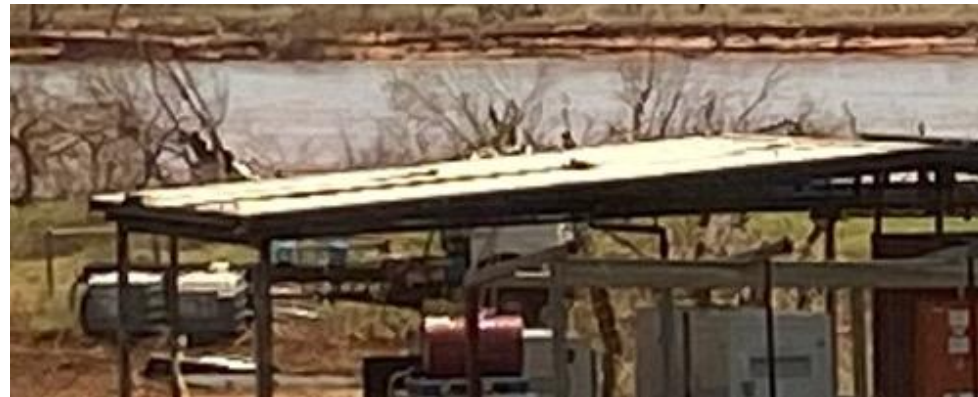
A number of buildings in this area had roof-mounted solar panels. On one building, the forces on the L-foot brackets removed the roof screws from the purlins. Panels, clamps and rails were lifted from the roof by the wind forces on the solar panels. In parts of the roof, sheeting was lost because of the missing screws. Figure 3-13 shows the building with no rails left. The screws that were removed were roofing screws that were holding down the L-foot brackets and the roofing.

In the centre part of the roof, the missing screws also led to the loss of some roof sheeting. Depending on the spacing of the L-foot brackets, the loads on the individual screws can be increased substantially by the wind actions on the panel itself. (Where there are only two rails per panel and one L-foot bracket on a rail under each panel, the tributary area of each L-foot bracket is around half the area of the panel – considerably higher than the tributary area of roofing for each screw before the panels were installed.

Figure 3-13 Forces on L-foot brackets removed roofing screws and rails from roof.

Loads on roofing screws can be reduced by using more L-foot brackets on each rail as shown in the upper photo in Figure 3-4.

Solar panels mounted on buildings should have all components in their fastening system rated for wind actions calculated for the location using an importance level appropriate for the buildings on which they are located.

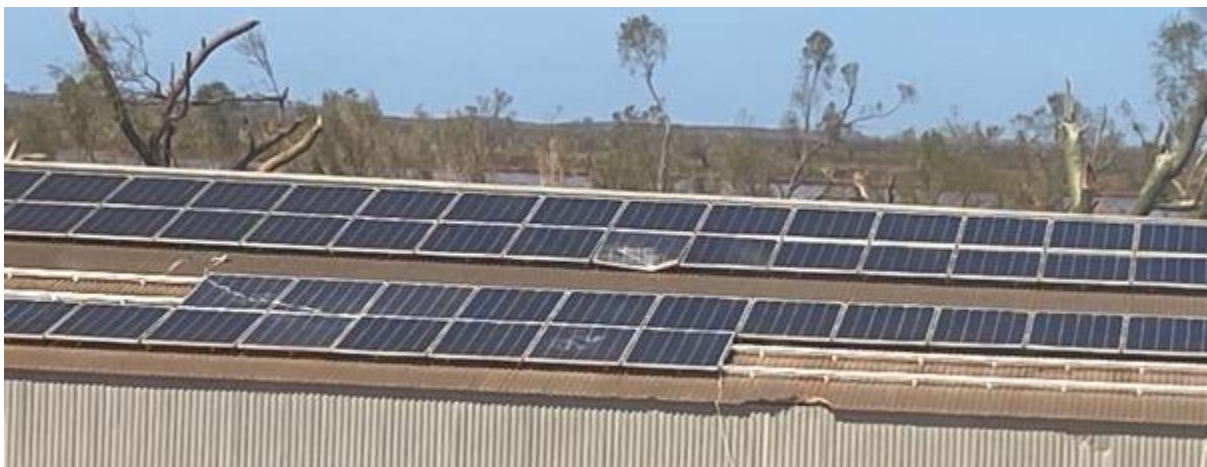
Figure 3-14 shows a building with some panels that are missing because clamps failed or moved. The photo also shows that there were several panels in this roof that had sustained debris damage. The panels that were released became wind borne debris that may have impacted other buildings. Some wind-borne panels were captured on security cameras though few of them were found.

Figure 3-14 Missing roof-mounted panels due to clamp failure.

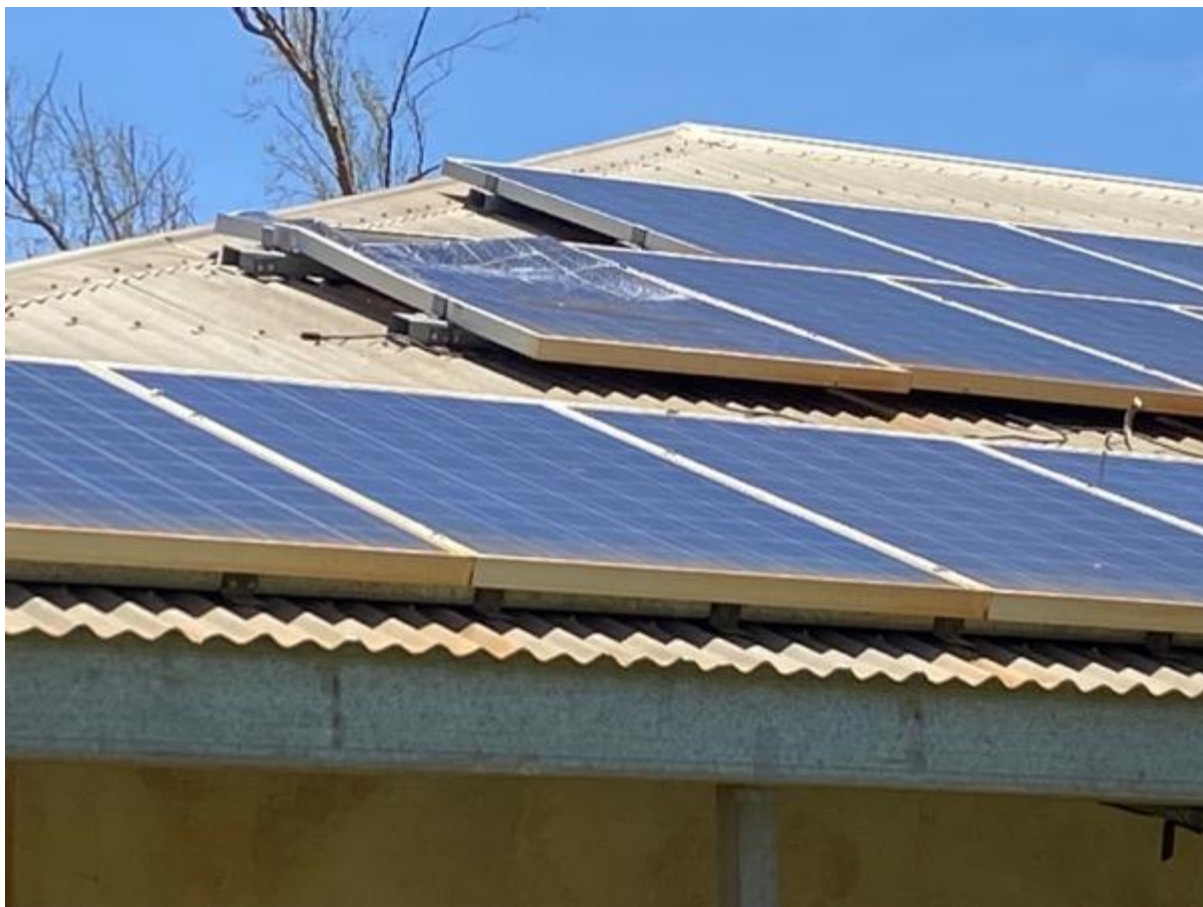
Figure 3-15 shows panels on a roof where debris had damaged a number of panels, but they hadn't become detached from the roof. Some panels on this roof had moved under the clamps, but none had become detached.

Figure 3-15 Debris damage to roof-mounted solar panels.

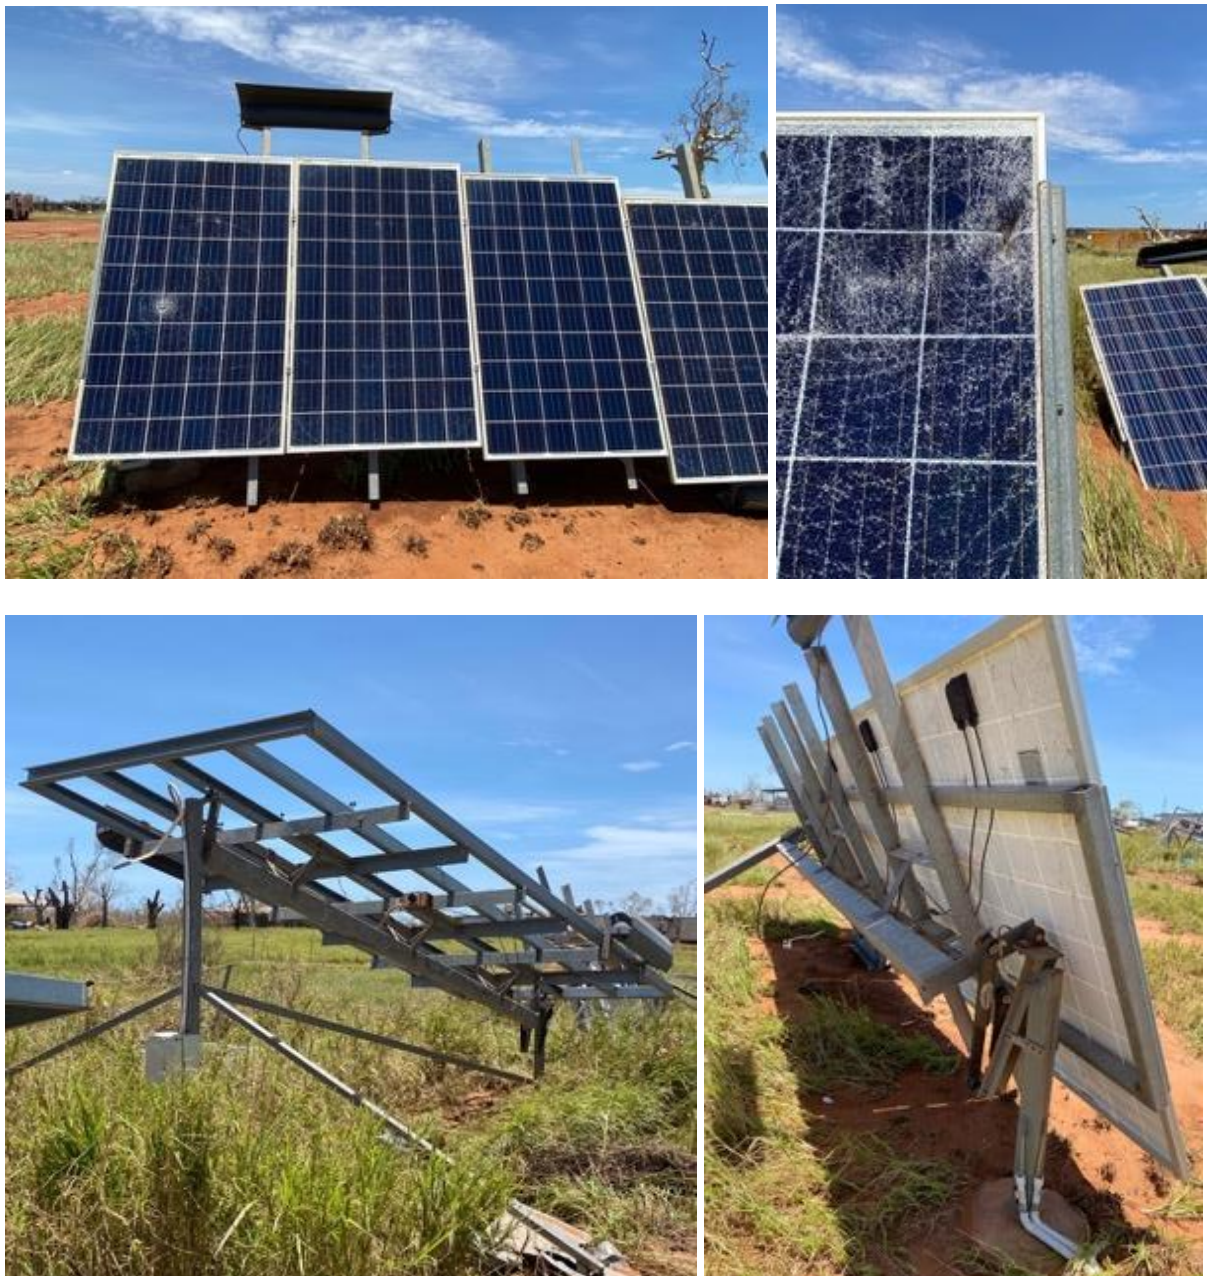
A number of arrays of tracking ground mounted panels were observed in the area that experienced winds estimated at 0.2 s gusts around 75 m/s. As the tracking systems had stopped working a number of years ago, the tracking mechanism had been locked in position so that each panel was horizontal. Each array consisted of 5 panels and there were 16 arrays installed in two rows. Most arrays had been damaged, either by loss of panels, failure of the framing or by debris impact. Figure 3-16 shows a selection of photos illustrating the damage to these systems.

- These panels had been directly screwed to the framing rather than utilising a clamp, but the principle was the same, it relied on friction between the panel and the frame to hold it in position and sliding of some panels indicated that this mechanism was not sufficient.
- Some panels had concentric fracture rings consistent with debris impact damage, and others had uniformly crazed cracking across the whole panel, more consistent with glass failure under pressure loads.
- Most panels had moved from an inclination of around 0° (horizontal) to the range of the mechanism (near vertical). The final angle was not consistent.

Figure 3-16 Damaged ground-mounted solar panels.

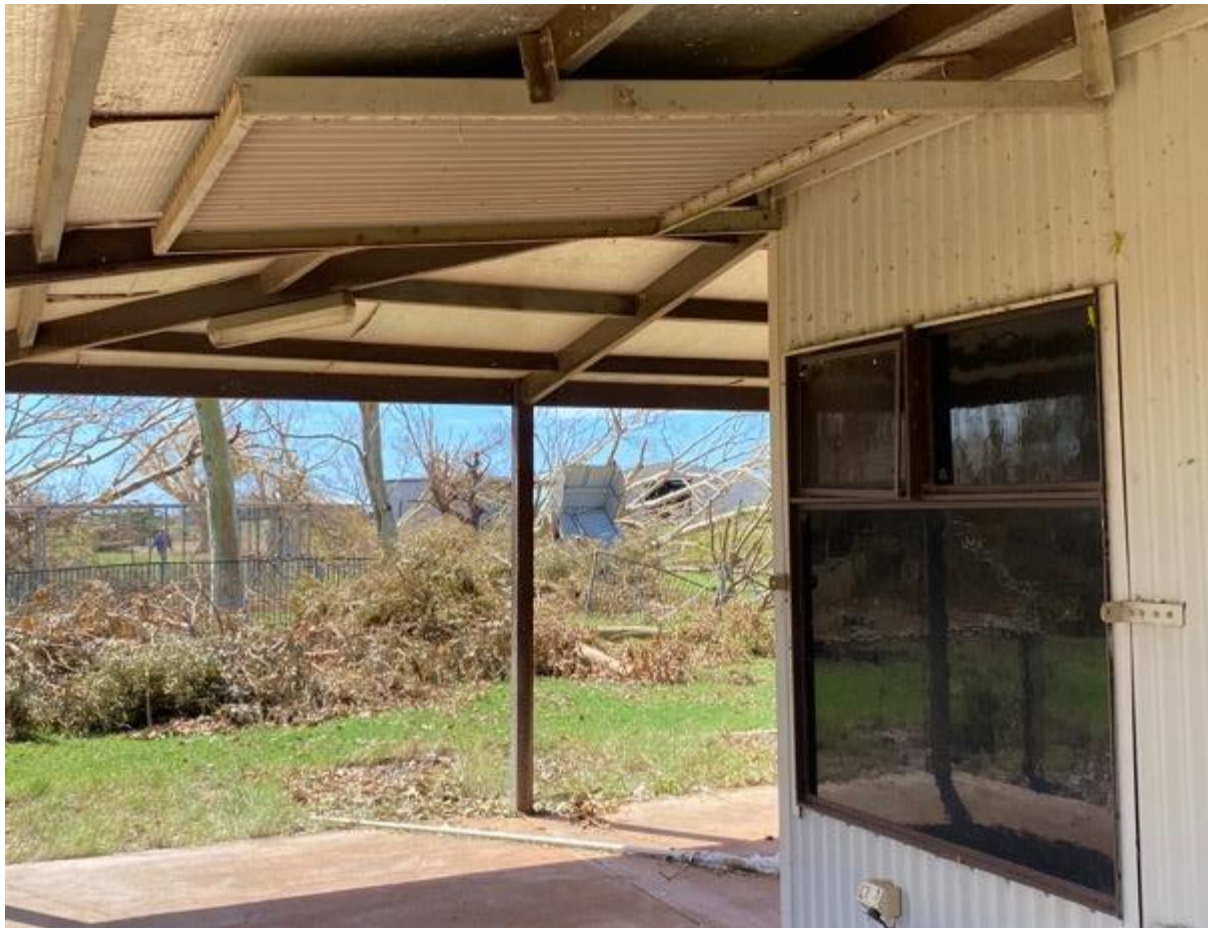
The screens used roofing sheets screwed to a light steel frame and had a bolted hinge at the top and bolts near the bottom to secure them. They are illustrated in Figure 3-17.

These systems had not been tested using simulated wind-borne debris projected with the energy defined in AS/NZS 1170.2, but there were no cases of windows breaking where they had been protected by the screens. On one building, two of the screens had been blown away by wind actions.

Figure 3-17 Fold-down debris screens.
