INVESTIGATION of DAMAGE to STRUCTURES FOLLOWING CYCLONE CONNIE

TECHNICAL REPORT No. 30

May 1987

G.N. Boughton

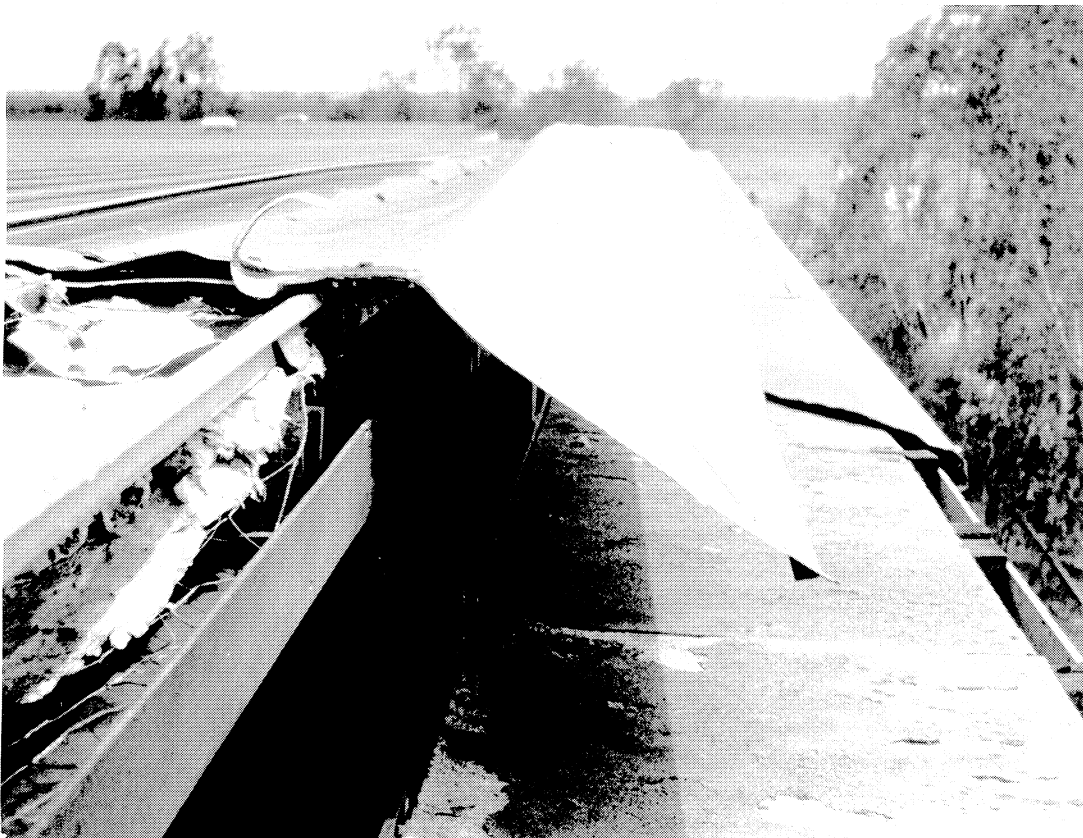
Figure 6. Photograph of Flashing Damage
Hedland Senior High School

The roof flashing on the eastern side of this block had been removed for a distance of approximately 12 metres. A portion of the damaged flashing is shown in the photograph in Figure 6.

were installed within 25mm of the top of the stud. These screws had pulled out of the stud without tearing the aluminium of the flashing. Some of the screws may have been worked out in previous cyclones, as there were other places where the screws were missing although the flashing had remained in place in spite of their loss. Calculation of the wind load applied to each fastener by the peak gust recorded in cyclone Connie, shows that approximately 50 N had to be resisted in shear. AS1720 (1975) indicated that fixed with appropriate end distances, the screws should have had a permissible working load of nearly twenty times that load. Clearly, the deterioration in the timber associated with the splitting due to low end distances has resulted in a very significant reduction in the strength of the connection.

Once the wind had lifted the front of the flashing, the screws pulled out of the particle board (shown as (ii) in Figure 8). The particle board had deteriorated due to water damage in the past, and in many places had disintegrated leaving holes as shown in the photograph in Figure 9.

Having lifted the entire lower portion of the flashing, the large loose flapping piece of flashing caused rapid failure of the top flashing. The screws on the joint between the two pieces ensured that the freed lower portion of flashing remained attached to the upper portion, and could assist in its removal.

At the corner of the roof, the flashing had remained attached to the aluminium roof sheeting and had caused it to lift, breaking a number of secret fixings. The lifting of the roof sheeting may have also been assisted by positive pressure on the underside of the roofing. The internal pressure was due to the opening created by the removal of the flashing.

The following recommendations were made that in replacing the damaged flashings:

The sketch in Figure 10 illustrates the recommendations.

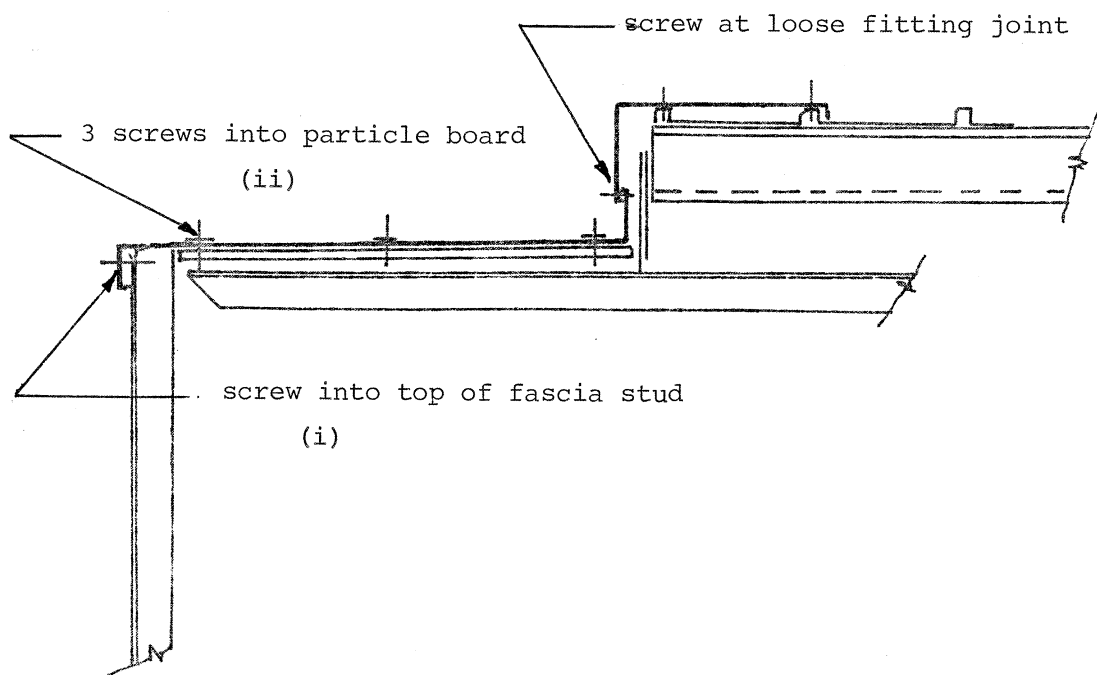
Figure 8 Sketch of flashing and attachment as constructed

The detail shown in Figure 7 was taken from the design drawings, but a few minor differences between the detail as installed and that shown on the drawings may have contributed to the failure of the flashing.

A sketch showing the 'as constructed' flashing is shown in Figure 8.

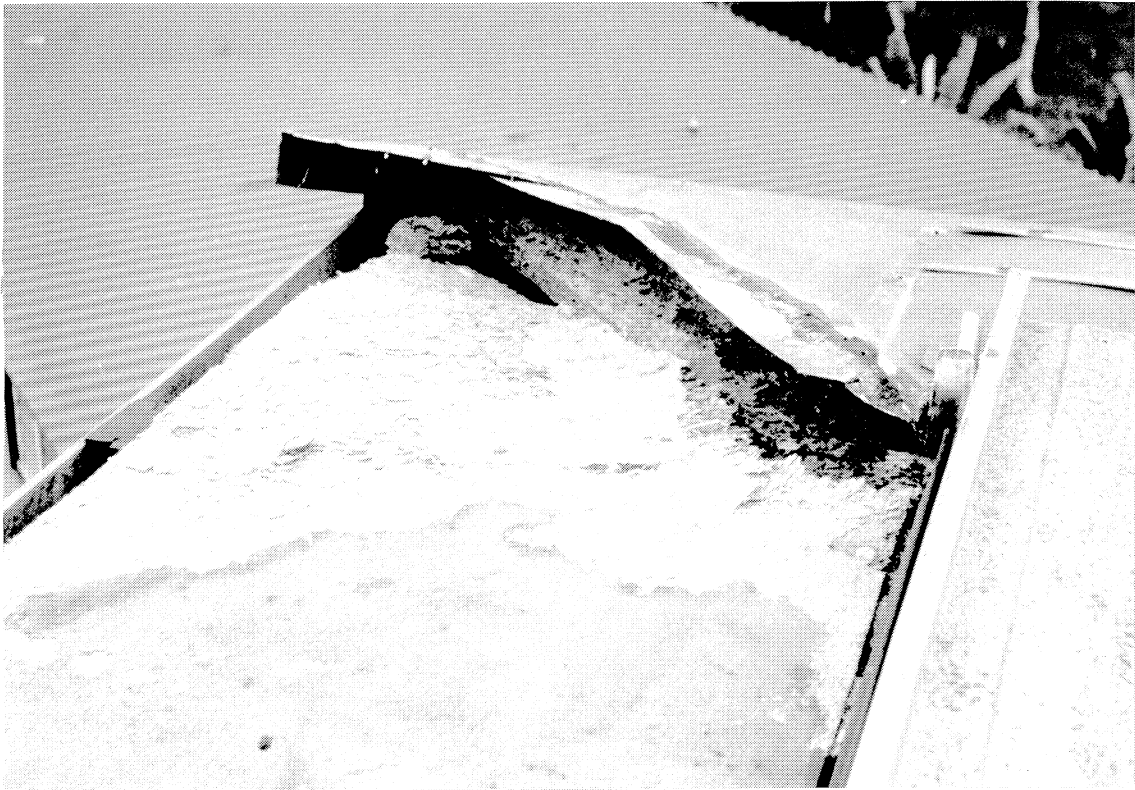
**Figure 9. Deterioration of Particle board under the
Flashing**

The damage indicated above, occurred during the early part of the passage of the cyclone when the wind was blowing mainly from the east. An 8 metre section of similar flashing on a different roof was removed during the second portion of the cyclone when the wind was blowing from the north-west. For this flashing the failure mechanism was similar, but the flashing was screwed to plywood rather than to particle board. The screws had also withdrawn from the plywood.

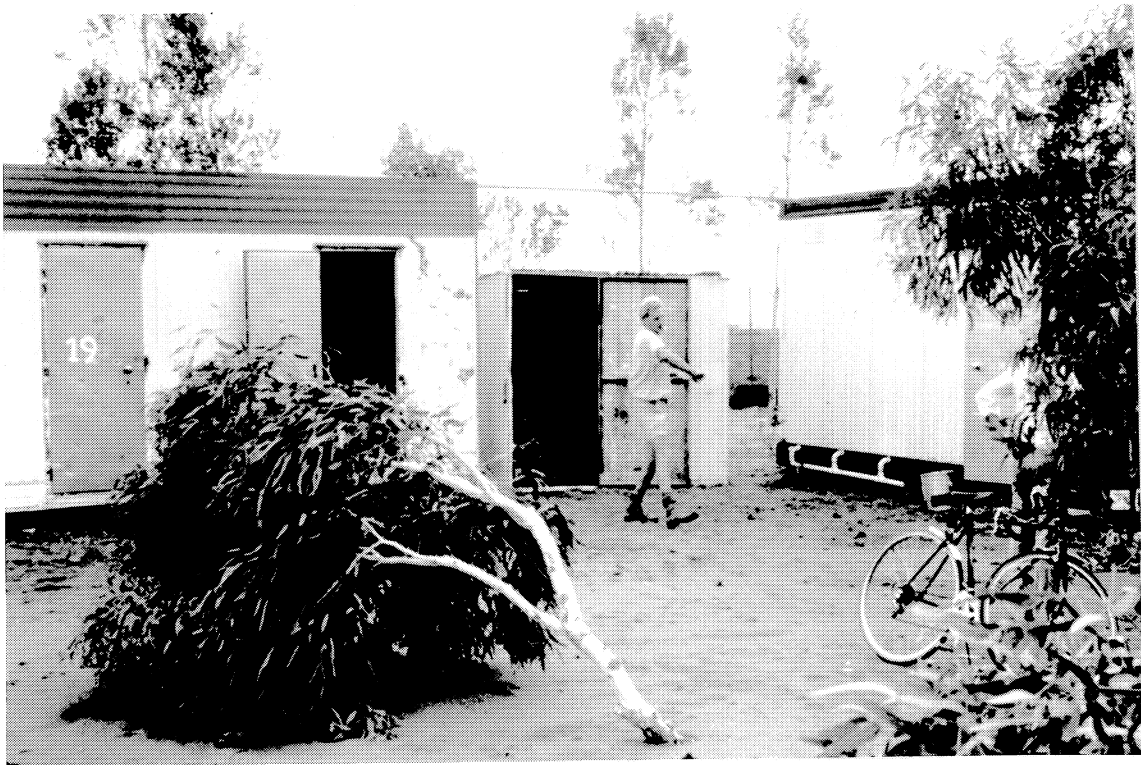
Figure 11. Temporary Builder's Huts - Hedland Senior High School

These temporary buildings, shown in Figure 11, consisted of an office and amenities wing, (shown to the left of the picture) a small storage shed, (with door open in the centre of the picture,) and an ablution wing (to the right of the picture). The easterly winds during the early part of the cyclone would have blown normal to the office wing and small tool store, but protection may have been afforded by the permanent school buildings. During the later part of the cyclone, the wind was normal to the ablution wing and passed over essentially open playing areas immediately up-wind of the building.

Under the conditions estimated to be prevailing during the maximum recorded gust, the ablution wing experienced an overturning moment of approximately 100 kNm using the coefficients presented in AS1170-II (1983). This overturning moment could have been resisted by weight forces alone if the total mass of the ablution block was in excess of 7.2 tonnes. Estimates of the mass of the block returned values marginally less than that. The theoretical calculations showed that overturning of the building should have been initiated.

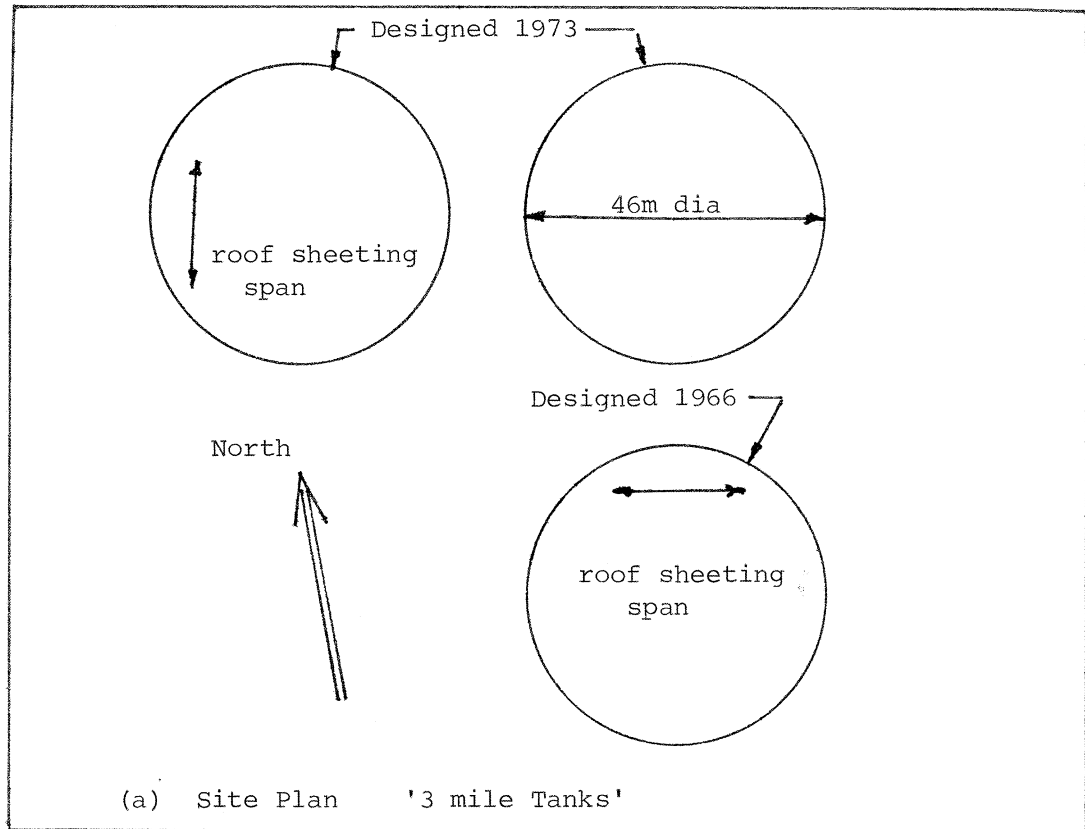
Figure 12. Site Plan and Damage Location
3 Mile water tanks.

The Water Authority of Western Australia has constructed three two million gallon ground level water tanks at the location called 'the Three Mile'. Roof damage was sustained by two of these tanks. The two damaged tanks were constructed six years apart, but used essentially similar designs. They were sited in an environment that had terrain category 2 approach terrain to the east and to the north-west. A site plan is shown in Figure 12.

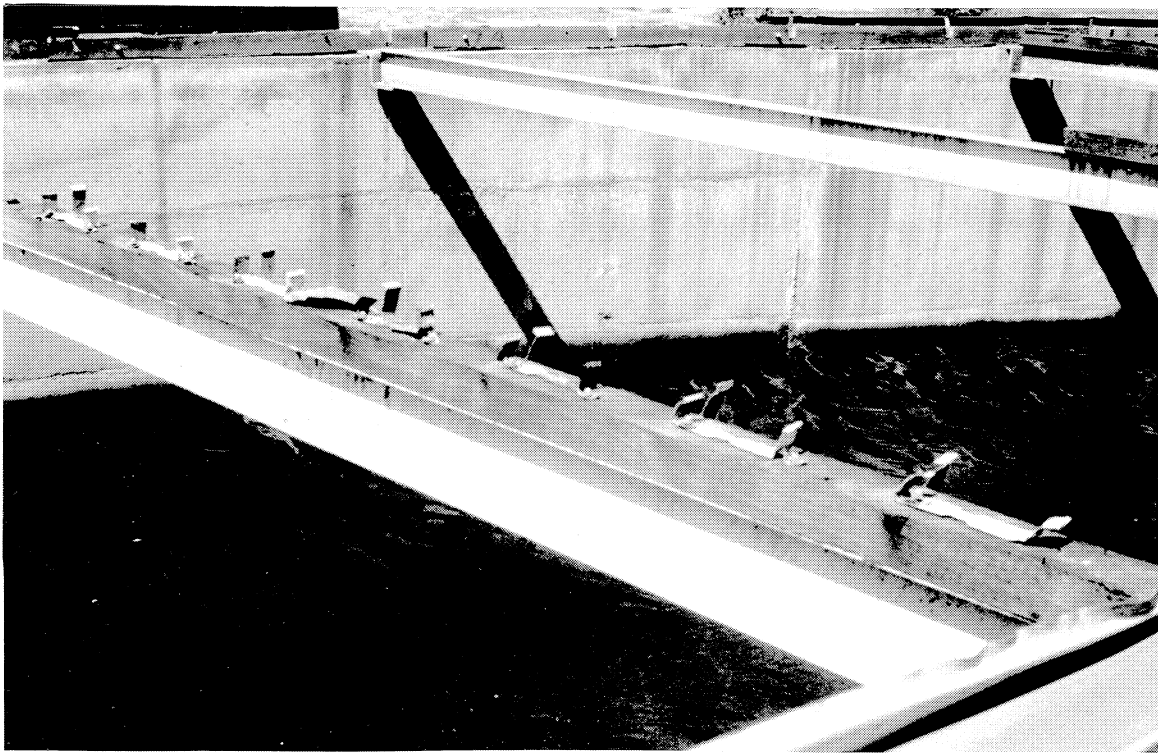
Figure 14. Photograph of Roof Fixing System - Tanks

The photograph in Figure 14 shows the roof sheeting, fixing clips, nailing piece and RSJ. No washers were observed under the head of the bolts in the timber.

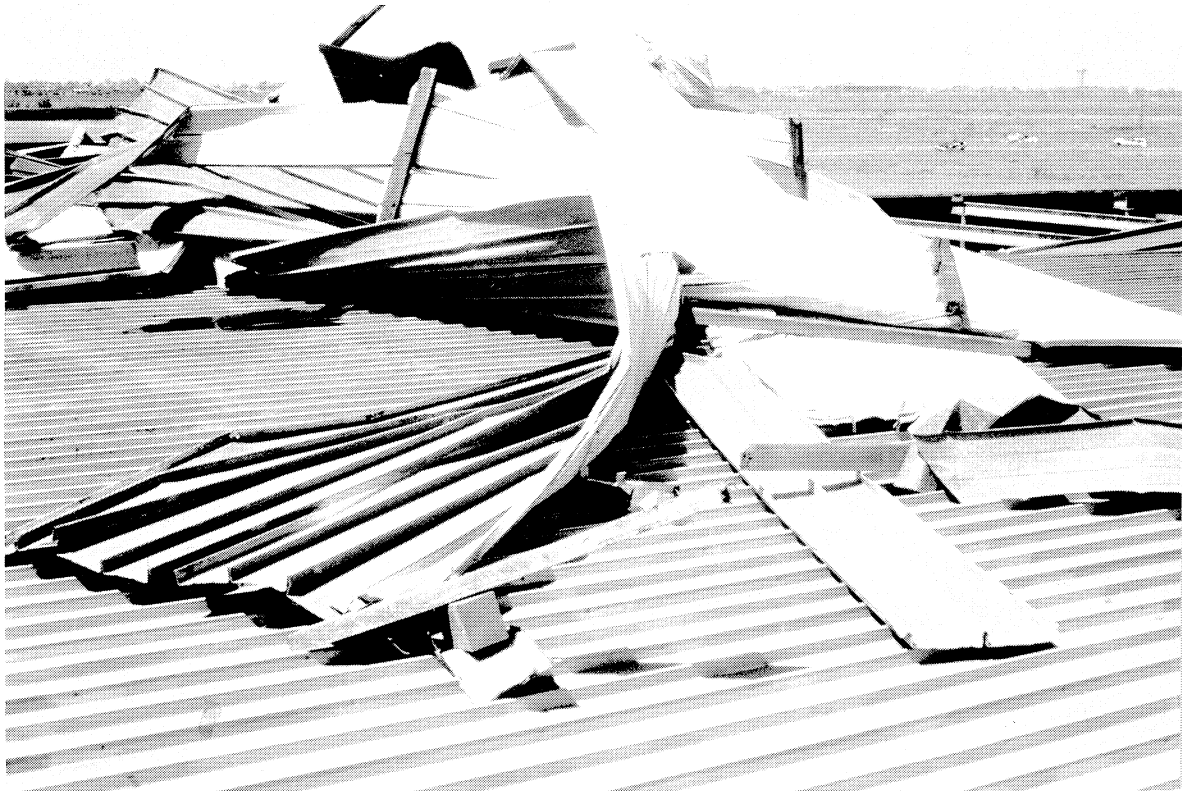
Figure 15. Roof Sheetting from eastern edge of older tank

Figure 15 shows the roofing from the eastern edge of the tank folded back onto the roof by easterly winds and subsequently pushed into an untidy heap by the later north-westerly winds.

It is postulated that the damage to the older tank was caused by two factors, the effects of which were impossible to separate.

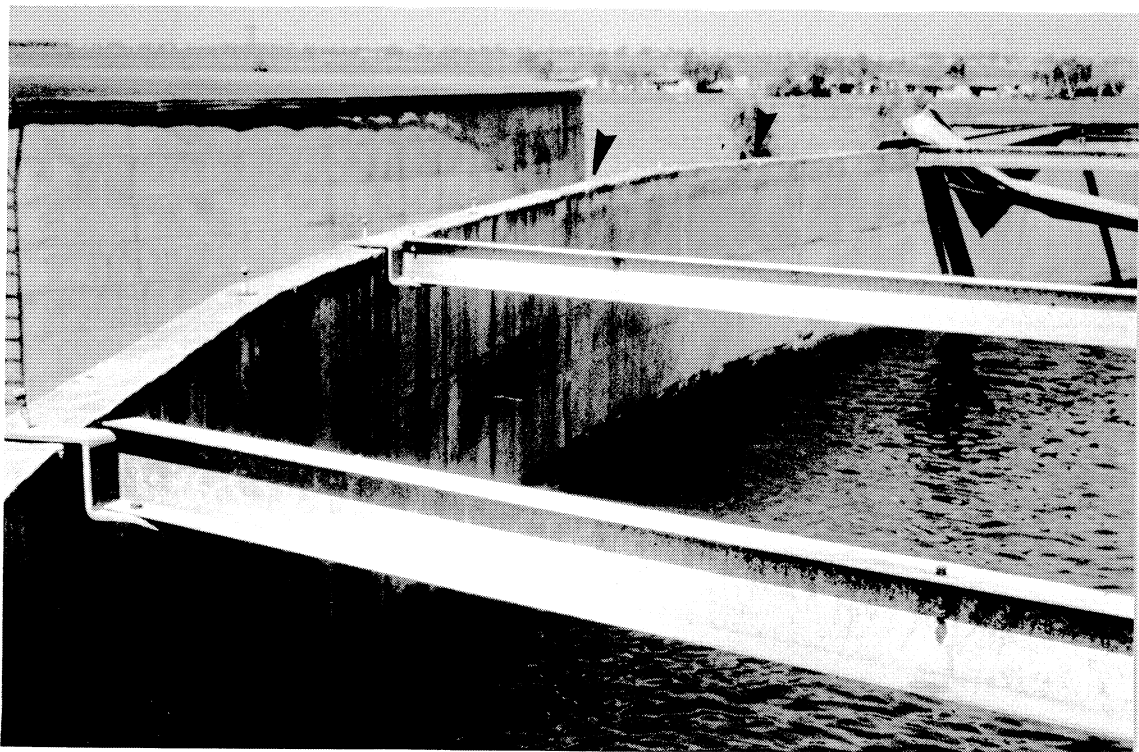
Figure 16. Missing Sheeting and Purlins
- Northern Edge older tank

Figure 16 shows the northern edge of the older tank. One bolt that had secured the timber nailing piece can be seen remaining in the closest steel purlin. In some cases where the bolts had sufficient strength, the nailing piece was dragged over the bolt head, leaving a hexagonal shaped hole in the timber. The use of a washer under the bolt head would have prevented such a failure. Two purlins were missing from this part of the tank (locations arrowed). The third purlin from the camera was removed by withdrawal of the holding down bolt from the concrete, and the fourth by fracturing the metal of the Z shaped bracket.

For this portion of the roof, it is highly likely that both the withdrawal of the bolt from the concrete and the failure of the Z bracket were initiated in previous cyclone events.

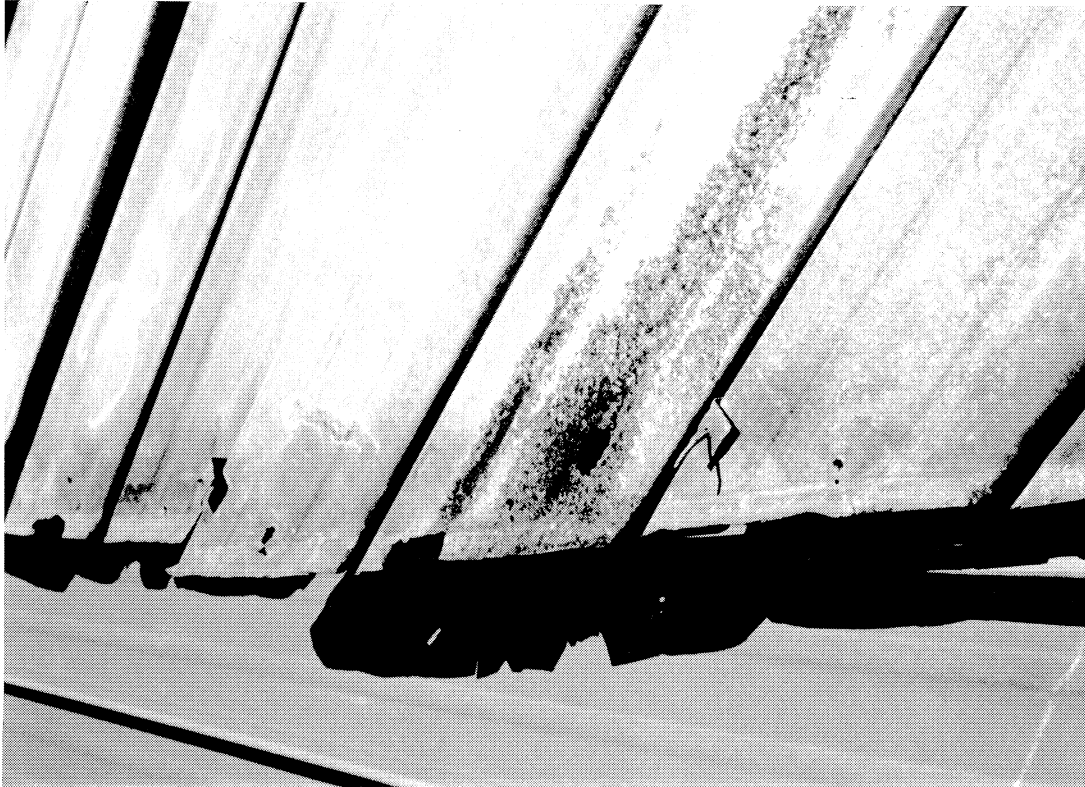
Figure 17. Corrosion of Sheetting – Newer Tank

The failure of this 13 year old roof was initiated at the edges. The roofing over the edge nailing piece was observed to be very severely corroded. Figure 17 shows the advanced state of corrosion at the edge of this tank. This allowed the separation of the roof sheeting from the fixings at the edge. The extra load attracted by the next purlin following the release of the edge of the roof caused failure of the nailing piece bolts over the purlins. The bolts on this tank were observed to be corroded to a similar extent as those on the older tank.

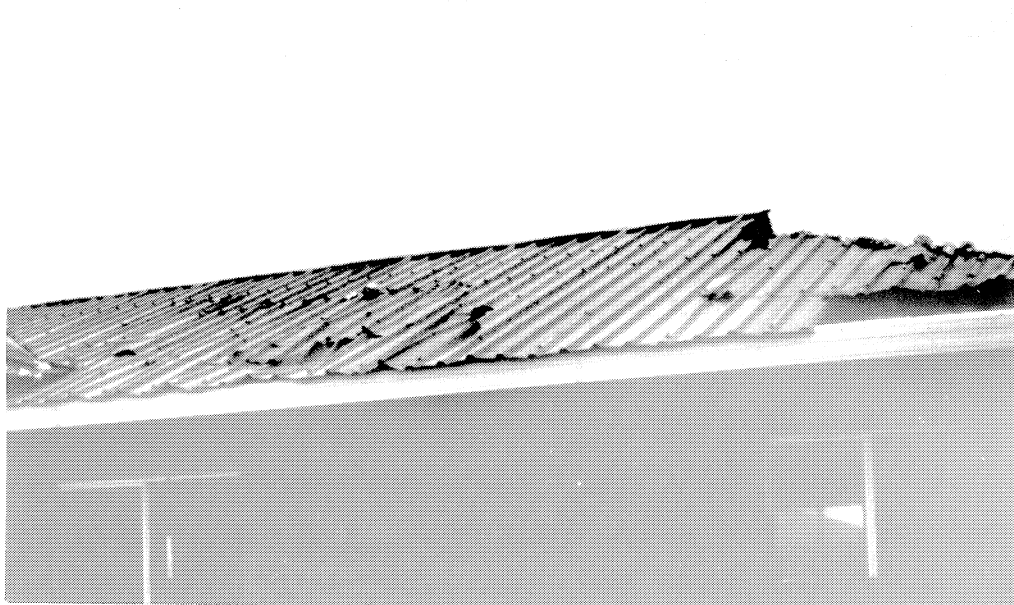
Figure 18. Damaged Roofing On A House Under Construction

A house in South Hedland had the roof sheeting partially fixed prior to the high winds and it therefore sustained damage to a portion of the roof sheeting. Figure 18 shows the house after the damaged sheeting had been bent back and screwed into place as a temporary measure to keep rain water out of the ceiling space. The damaged roofing was in the centre and on the right hand side of the picture.

The damaged part of the house had a terrain category 2 exposure to the easterly winds. The recommended fastening method for terrain category 2 is one fastener at every Trimdek crest with batten spacing at a maximum of 970 mm (Lysaght, 1986). The battens had been installed in accordance with those recommendations, but all the screws had not been installed. There was a large area on the eastern slope of the roof that appeared to have been fastened by one fastener every fourth crest.

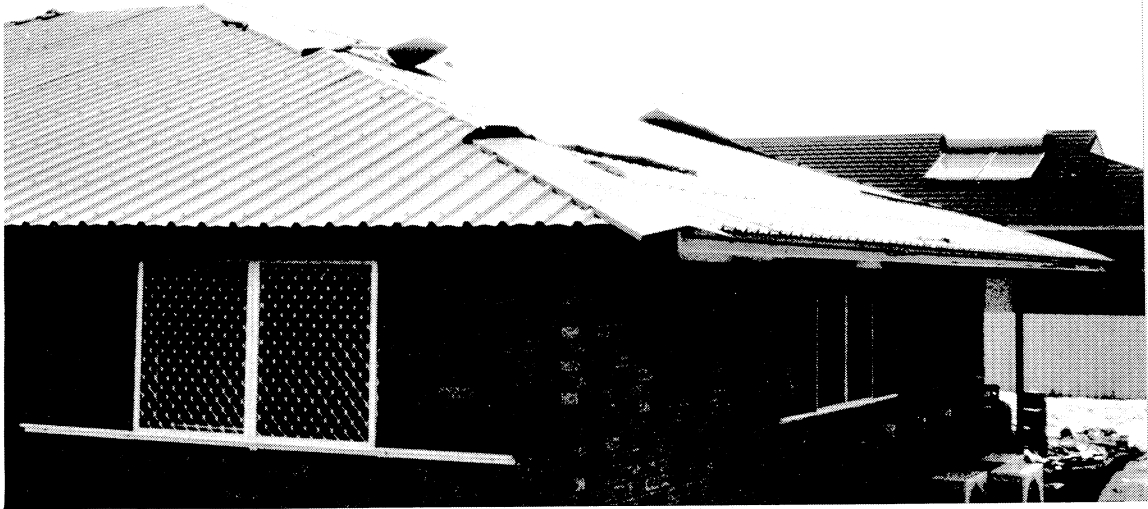
Figure 19. Ridge Capping Damage

Ridge capping damage was observed on three houses that were under construction. In each case insufficient fasteners had been installed. Figure 19 shows typical damage of this type, where the roof sheeting had been installed in accordance with the manufacturer's recommendations but the ridge capping had been fastened with only six fasteners per length. The good performance of some of the ridge capping fixed in this very nominal fashion was surprising.

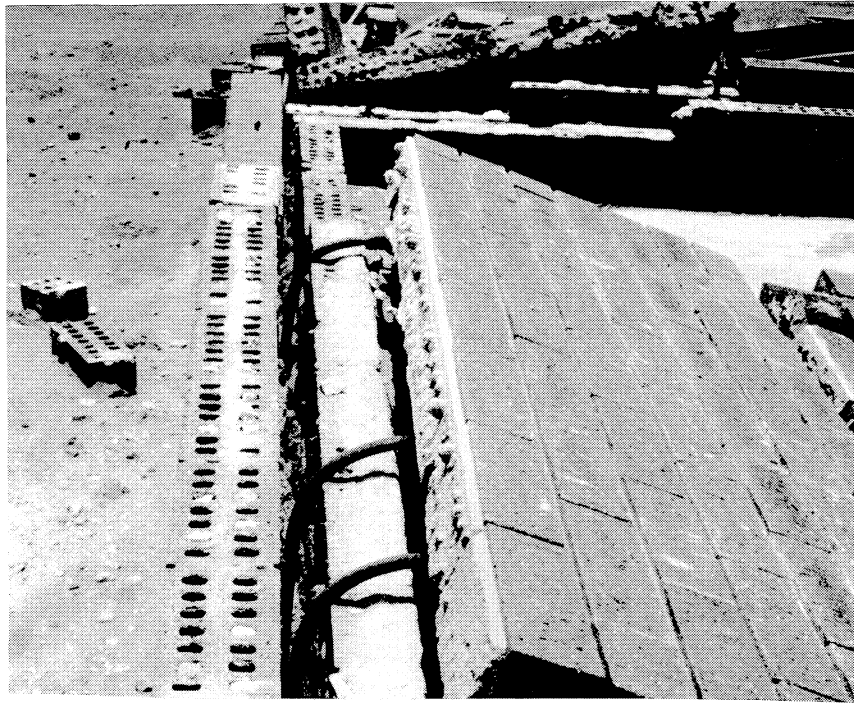
Figure 20. Damaged Brickwork On A House Under Construction

This low factor of safety would indicate that additional structural provisions to carry loads away from the large window in that wall were warranted. Figure 20 shows the base of the damaged brick wall.

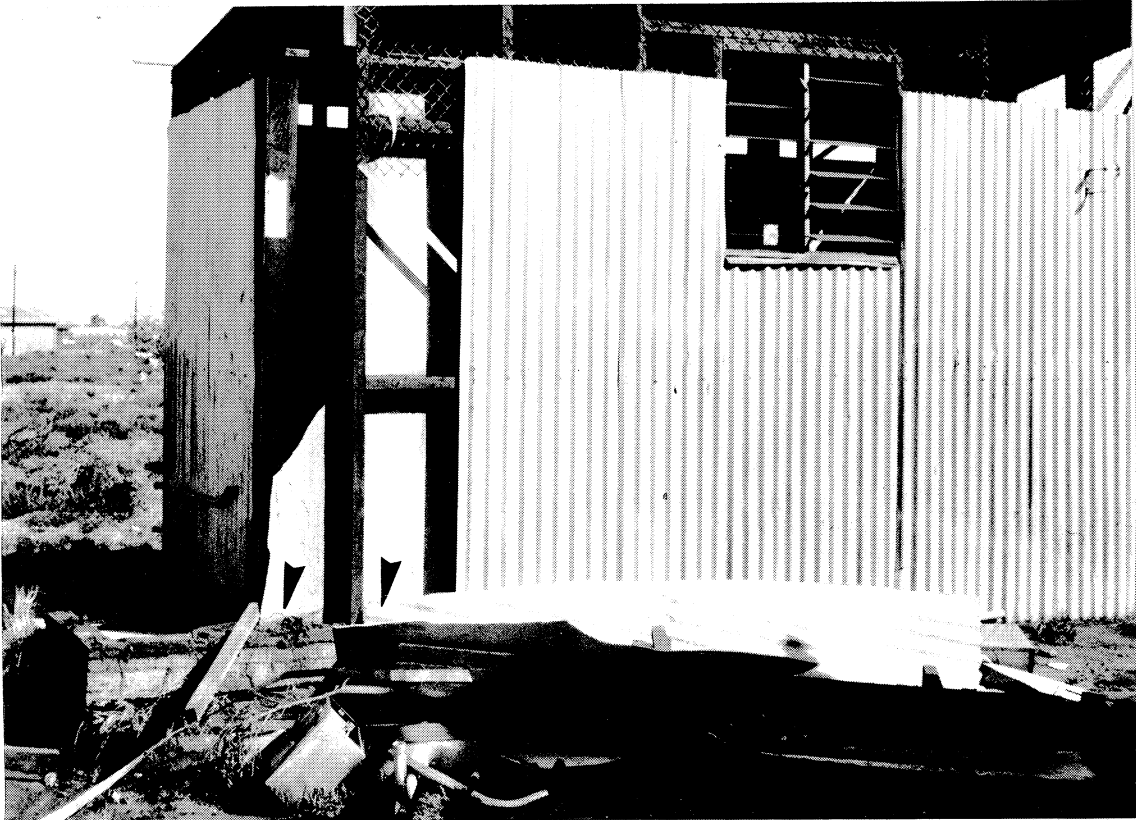
Figure 22. Toilet/Shower Block in Wedgefield Industrial Area

This building, pictured in Figure 22, lost the privacy screen at the entrance to the door in the right-hand side of the building (arrowed). The position of the damaged screen, lying in front of the building, indicated that the damage occurred when the wind was blowing from the north-east. This quarter corresponded to the highest velocity winds recorded during the cyclone.

The cladding of the structure had demonstrated that it was capable of withstanding the maximum wind, and there was no sign of racking failure of the screen. However, examination of the timber frame of the building showed that there had been deterioration due to insect or termite attack. This had resulted in loss of strength of the timber frame. Tensile failure of the weakened wood had caused overturning of the privacy screen. Figure 23 shows a detail of the timber in the vicinity of the primary failure (arrowed).

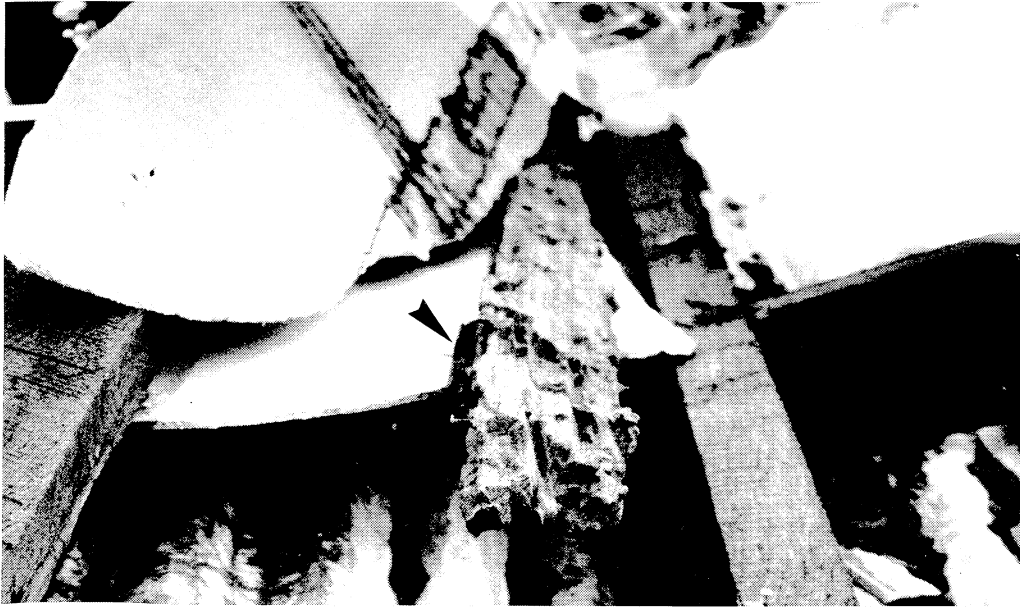
Figure 23. Termite Attack in Frame Timber

Other timber in the building also showed signs of deterioration, but the timber in the screen carried more than twice as much tension as any other frame member.

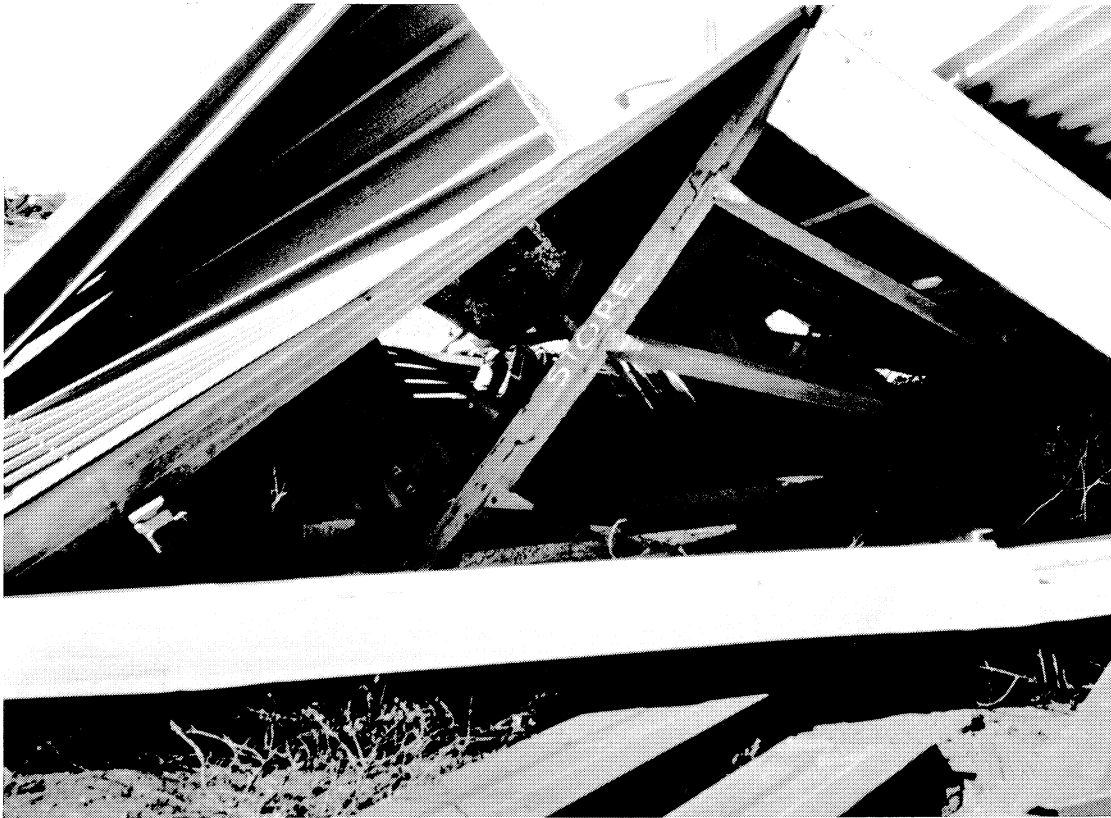
Figure 24. Damaged Shed

Figure 24 shows the remains of the shed lying on its side. The panel facing the camera was an unbraced wall which had been damaged by the Trimdek lying in the foreground. These unused sheets had been stacked nearby prior to the passage of the cyclone but had become airborne debris during the strong northerly winds. The loss of racking strength of that wall caused a lateral failure of the shed by combined racking and twisting, once the wind had started to shift from the east to the north. This had caused lateral bending of the unbraced carport legs.

The damage incurred underlines the importance of ensuring that all materials that have potential to become airborne debris are stored in a manner that prevents them from damaging other structures.

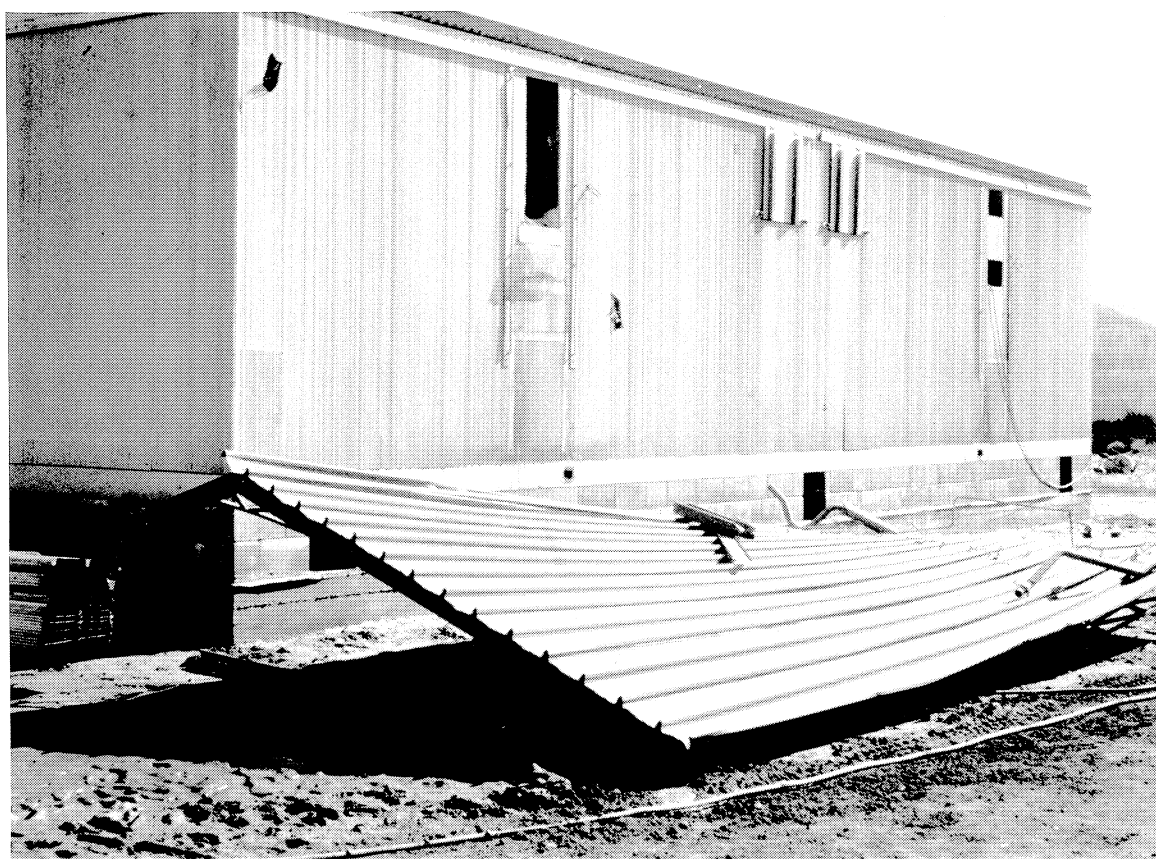
Figure 25. Detached Carport Roof

While it is impossible to state with certainty that the shed and carport would have remained unscathed had the debris not perforated the cladding, certainly the airborne debris was instrumental in the damage to the shed, and by implication, may have contributed to the damage of the parked car and a transportable building.

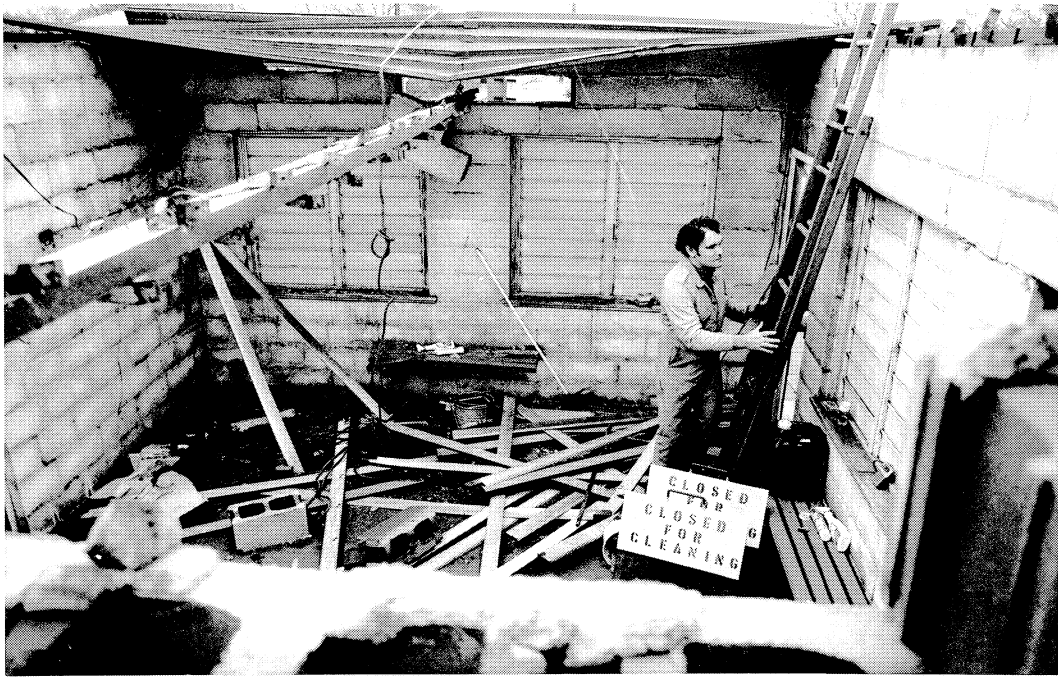
Figure 26. Damage To Roof Of Rest Room

This building was constructed with hollow concrete block walls and a flat secretly fixed roof. The building was unlined and had metal louvre windows protected by mesh shutters. The principal damage to the building was the removal of the roof sheeting as shown in Figure 26.

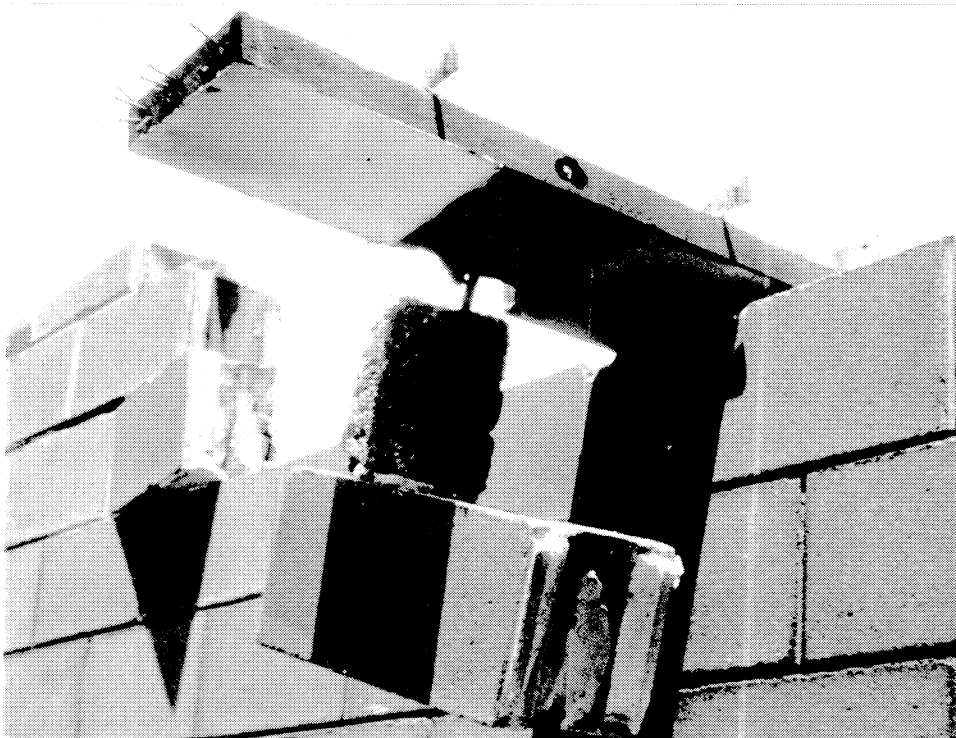
Figure 27. Inadequate Purlin Anchorage

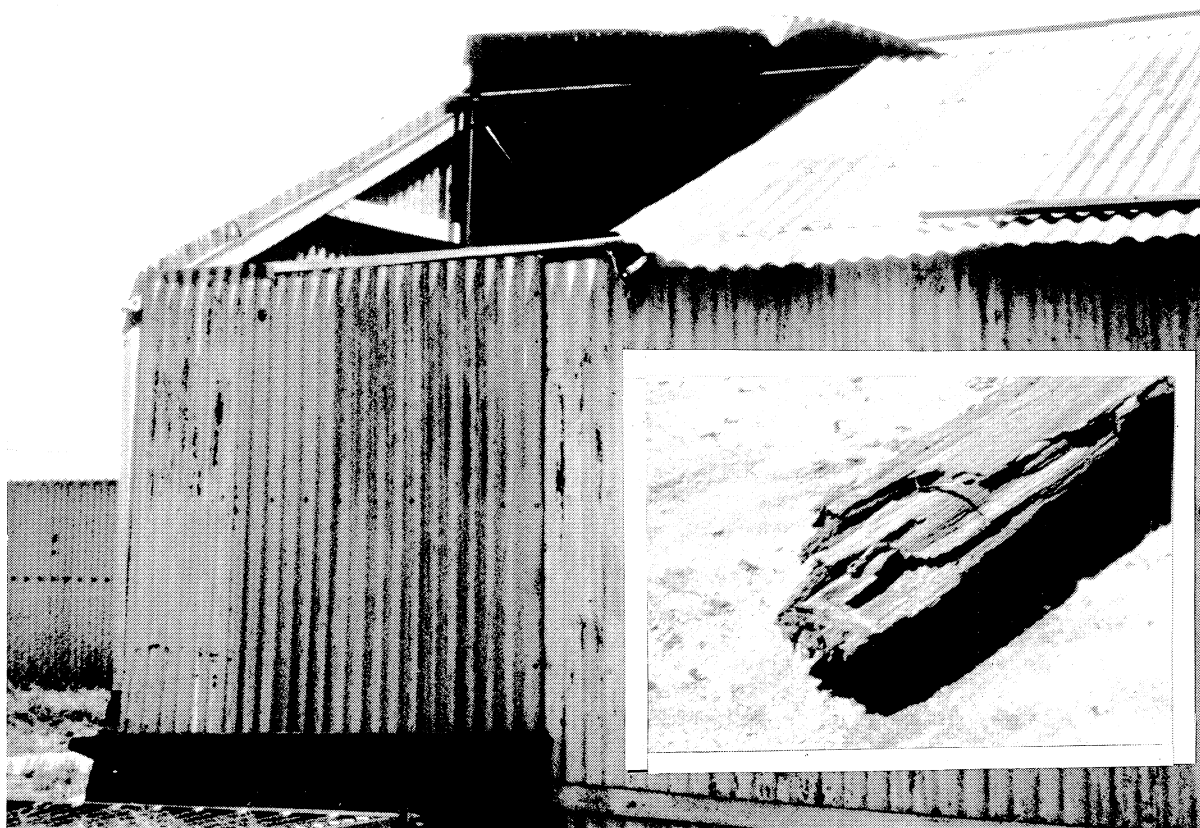
Alternatively, the wind load associated with previous cyclones may have caused damage to the timber which accumulated over the years and led to failure under the generally lower loads in cyclone Connie.

Figure 28. Roof Damage To An Old Timber Framed Shed
(Inset purlin deterioration at end)

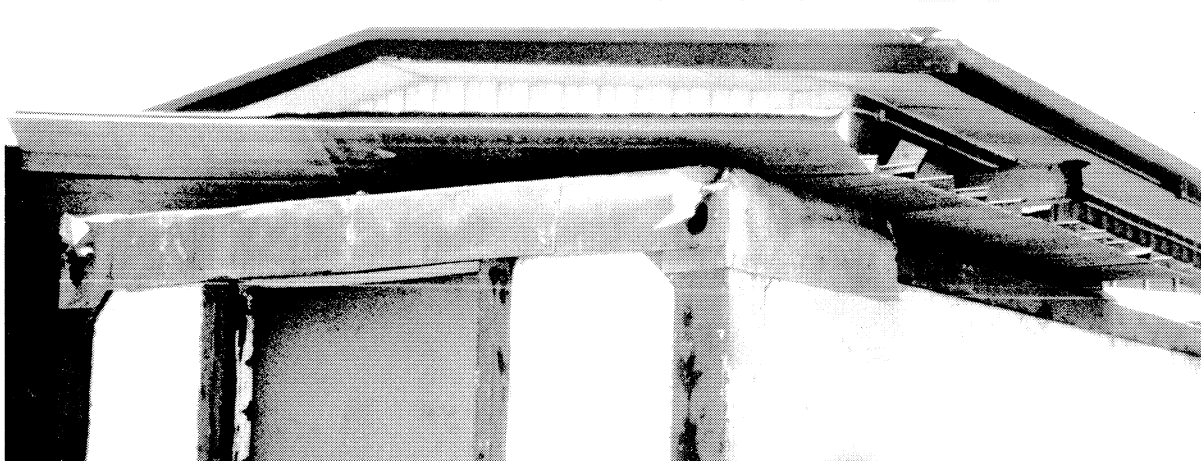
Figure 30. Small Temporary Building With Damaged Roof.

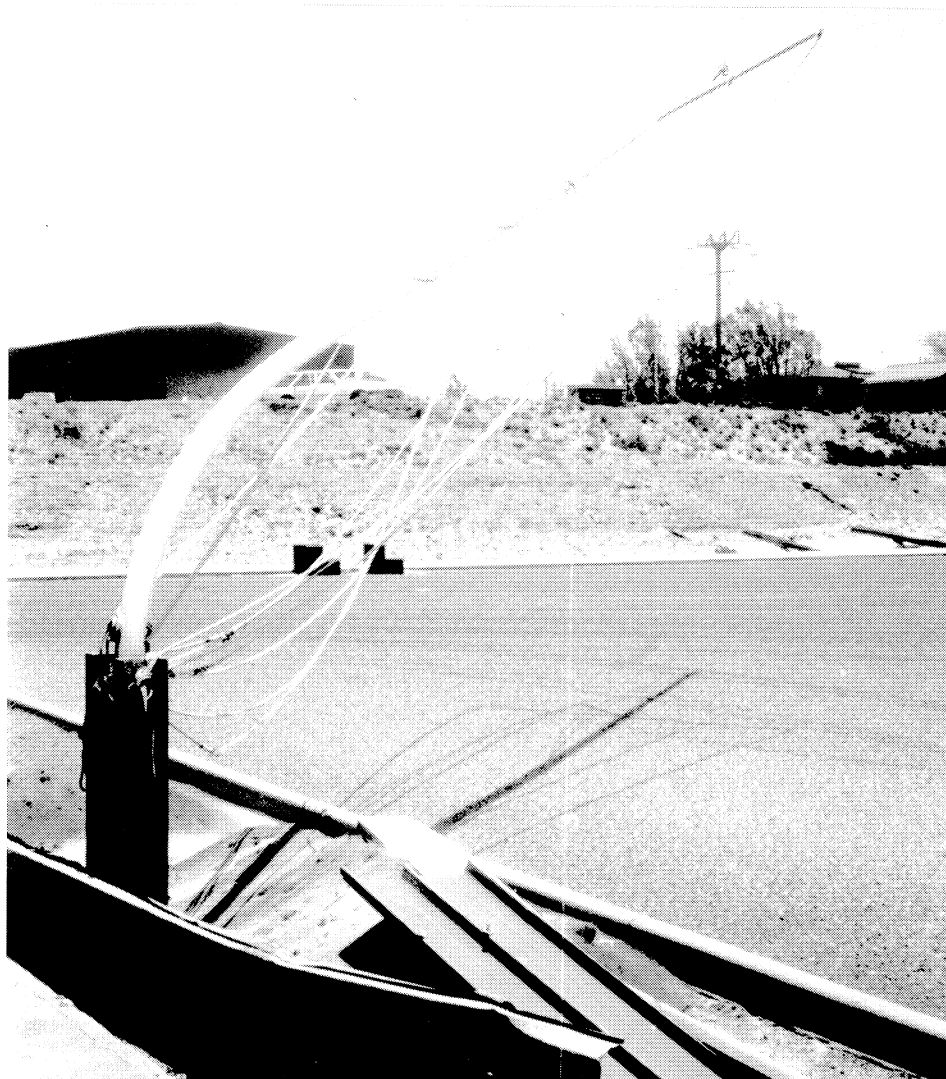
Figure 31. Damage To Permanent Mast By Dislodged Sheeting

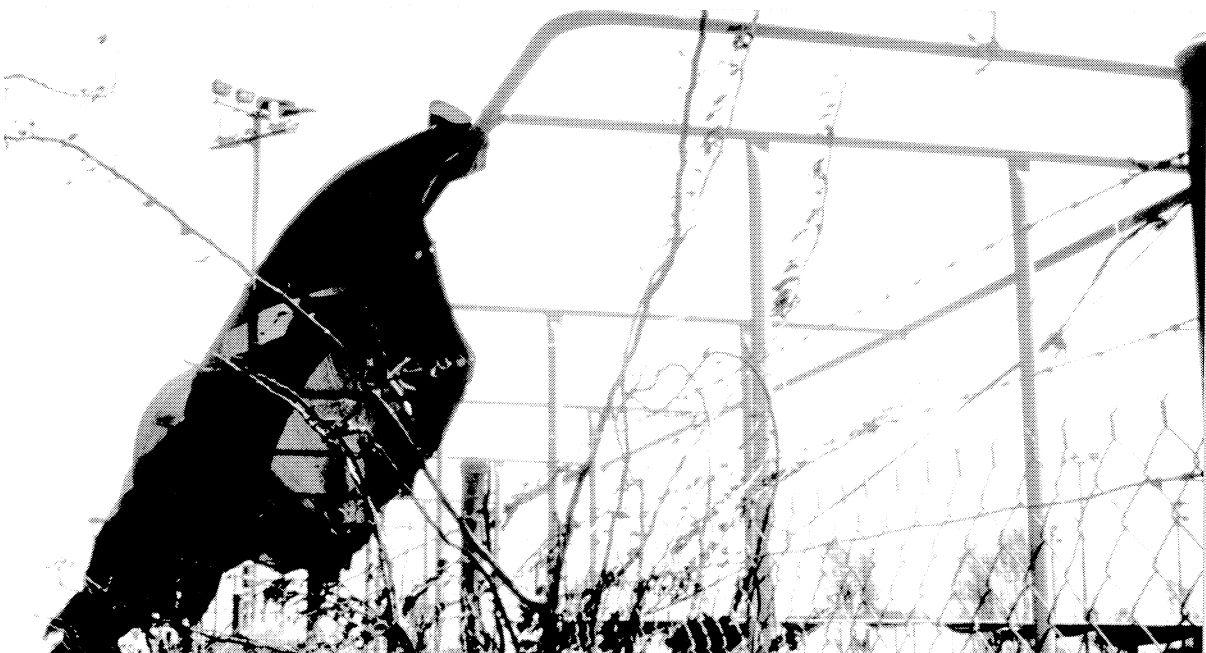
Reardon, Walker and Jancauskas (1986) discussed the performance of shade cloth structures and the generally high levels of damage they sustained in tropical cyclone 'Winifred' in north Queensland. Shades at the Pt Cooke Sporting Club were damaged by cyclone Connie as shown in Figure 32. Adjacent shades that were nominally identical sustained no damage which may indicate a sensitivity to age of material or tension of the fastening.

Figure 32. Damage to Shade Cloth

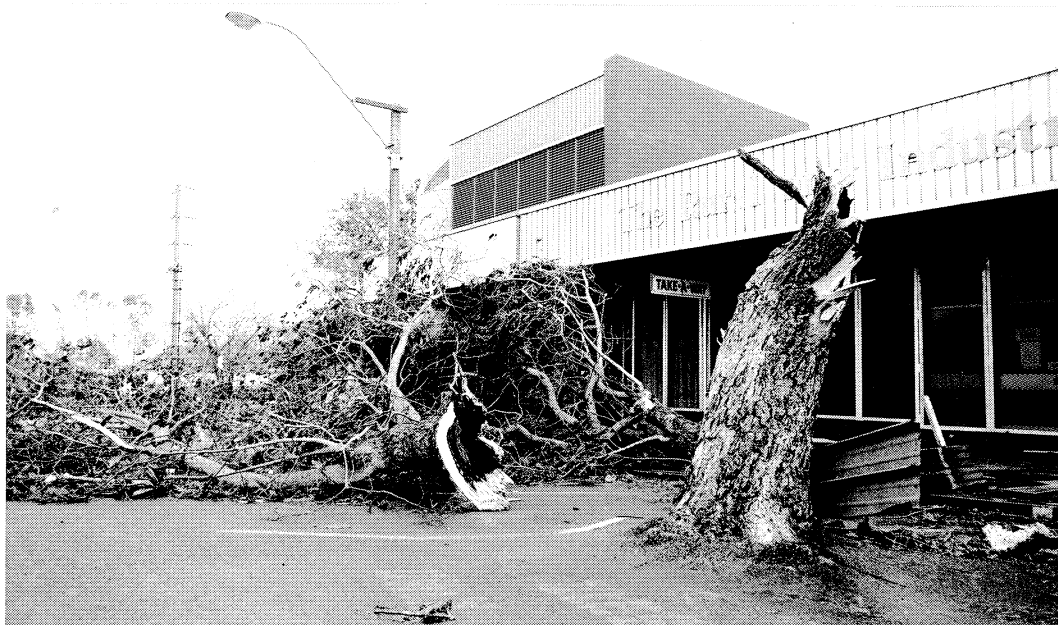
Such trees pose a particular threat where they are close to buildings.

Figure 33. Damage To Ageing Tree With Well Developed Rot
