## Tropical Cyclone Damien Damage to buildings in the Pilbara Region of WA

### CTS Technical Report No 65

## **Tropical Cyclone Damien Damage to buildings in the Pilbara Region of Western Australia**

This edition: 28 February 2020

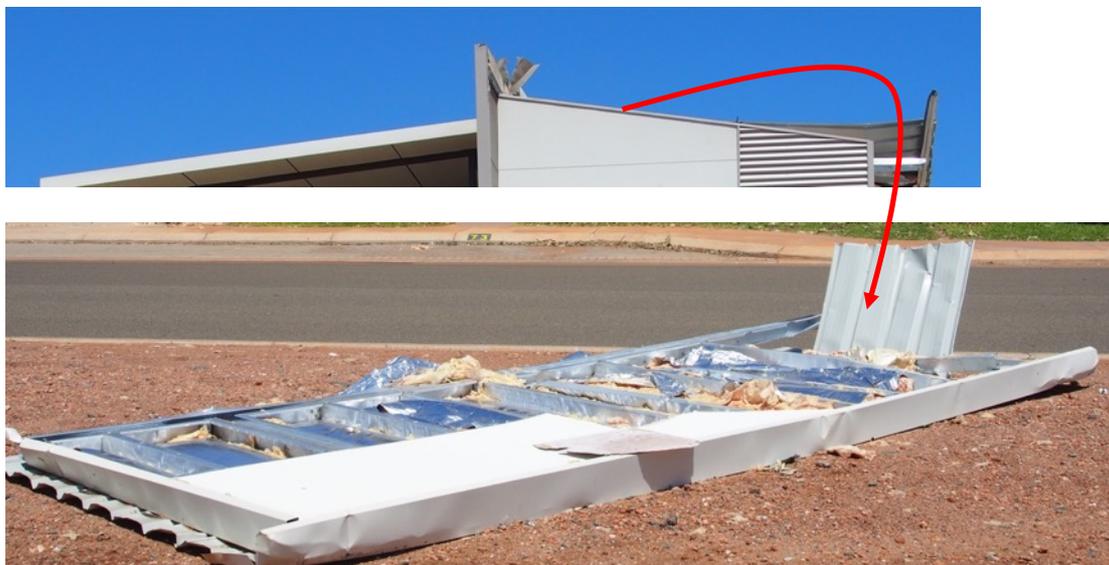
Wind around 70% of the design ultimate wind speed (producing 49% of the design wind load for houses) caused structural failures in some contemporary houses in Karratha. An example is shown in Figure 4.1. In most cases, the failures were caused by inadequate structural details; either poor design or installation. They are discussed in the following sections.

**Figure 4.1 Example of damage to a recently constructed house**

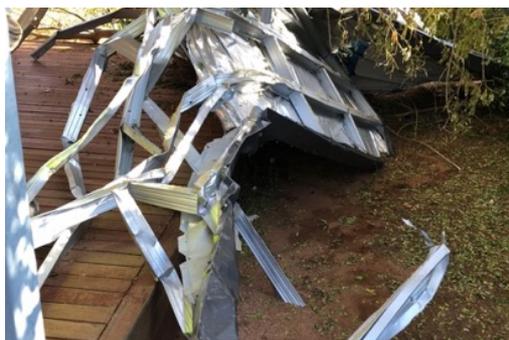
One of the inspected buildings that failed during TC Damien included non-standard structural system and a discontinuity was noted in the tie-down chain. Figure 4.4 shows the disconnected purlins after failure, and Figure 4.5 includes photos and a diagram of the back-to-back purlins used in a part of a roof that failed.

**Figure 4.4 Disconnected purlins in neighbour's property**

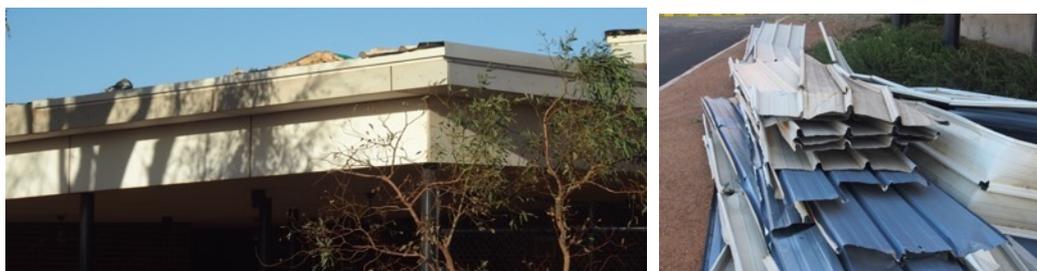
However, loss of some concealed-fixed cladding was observed in a recently constructed community building, shown in Figure 4.6. There was no evidence that the sheets had been fixed at the crests. There was no marking on the sheeting to identify the specific profile and it was not possible to access the roof to inspect the clip system.

**Figure 4.6 Failure of concealed-fixed roof cladding**

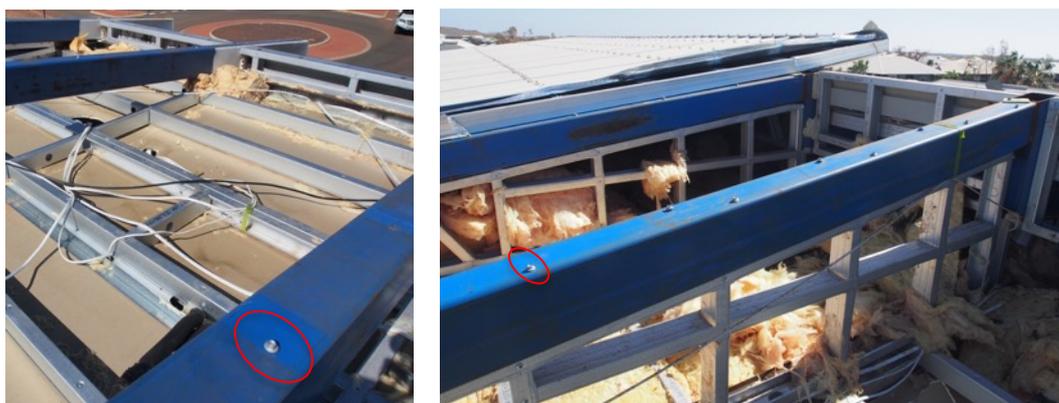
The investigators found one house where the purlins had separated from the rafters. The failure mode involved tearing of the purlins from around the screws, as highlighted in Figure 4.7.

**Figure 4.7 Failure of batten-to-rafter connections in a contemporary house**

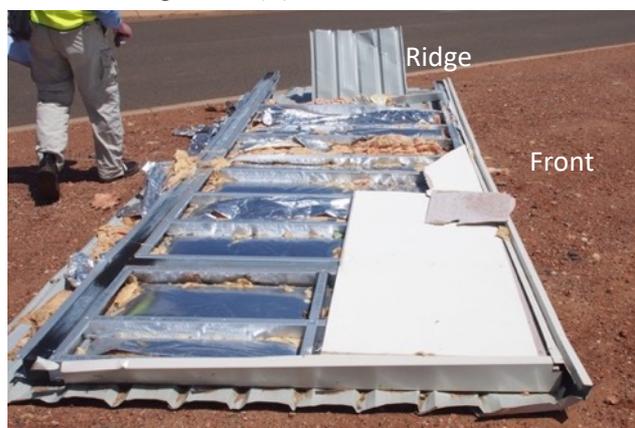
Four houses with the same type of skillion roof lost about 2 m width of the main roof associated with the two-way overhang. Figure 4.9(a) shows the detached portion of roofing with the SHS frame around the edge. The purlins were securely fixed to the SHS frame, but there was little evidence of tie-down between the SHS frame and the walls. Screw holes to connect the frame to another roof member were only found in one corner of the SHS frame as shown in Figure 4.9(b).

**(a) Photo of detached roofing**

**Figure 4.9 Failure of skillion roof**

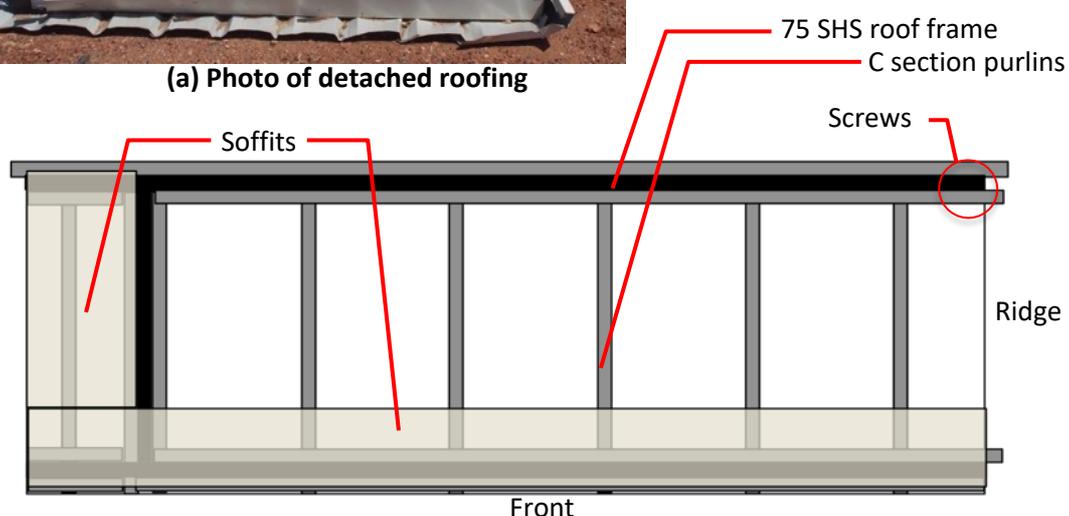
**(b) Diagram of fixings noted in detached roofing**

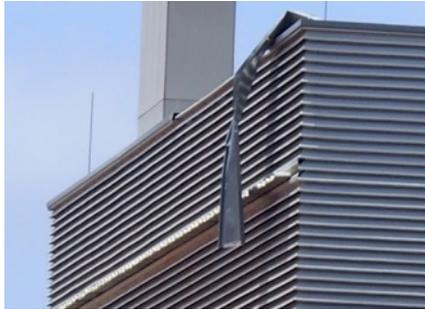
A significant number of buildings, including contemporary buildings had damage to flashings. Some lifted flashings are shown in Figure 4.10. In each case, the lifted flashing allowed significant water entry into the roof space causing water damage, as discussed in Section 5.

(a) Parapet flashing

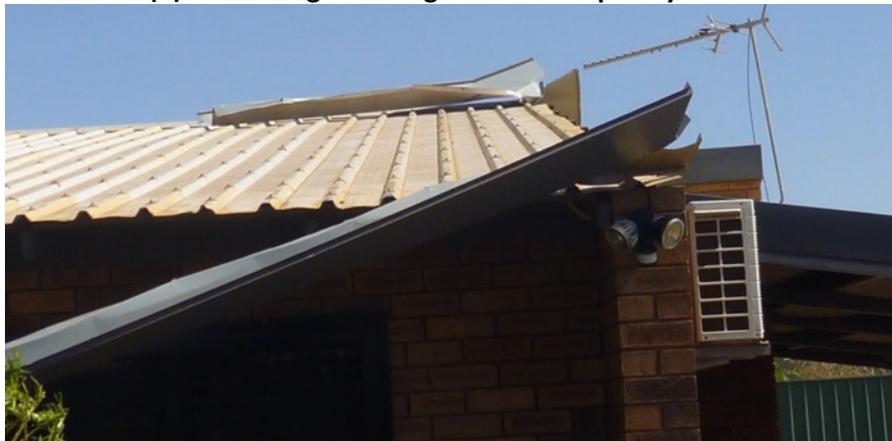
(e) Lifted barge flashing on an older house

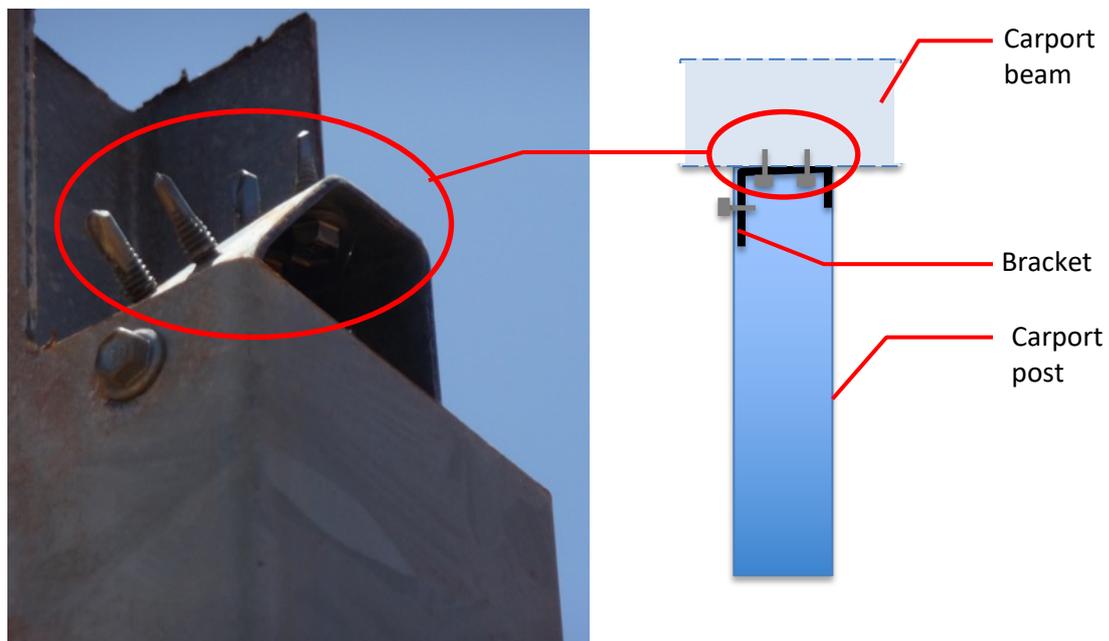
(b) Tek screws in tension on carport structure  
Figure 4.11 Failures of carport roofs in uplift

In the example shown in Figure 4.11, the carport roof was a continuation of the main house roof and the failure had not propagated into the house, though the loss of the carport roof gave a pathway for water ingress into the main house. Figure 4.12 shows a house from a similar construction period with similar construction details in the carport.

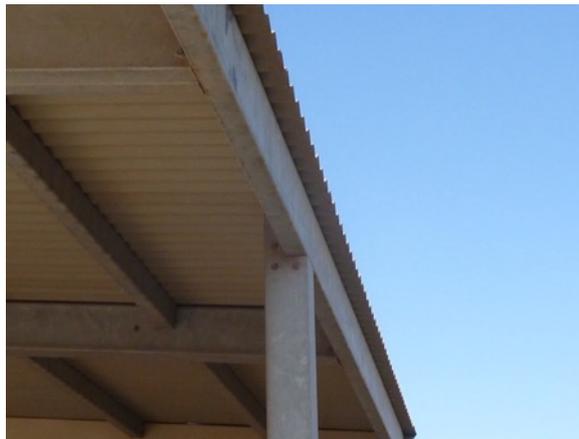
**Figure 4.12 Undamaged carport with similar construction details**

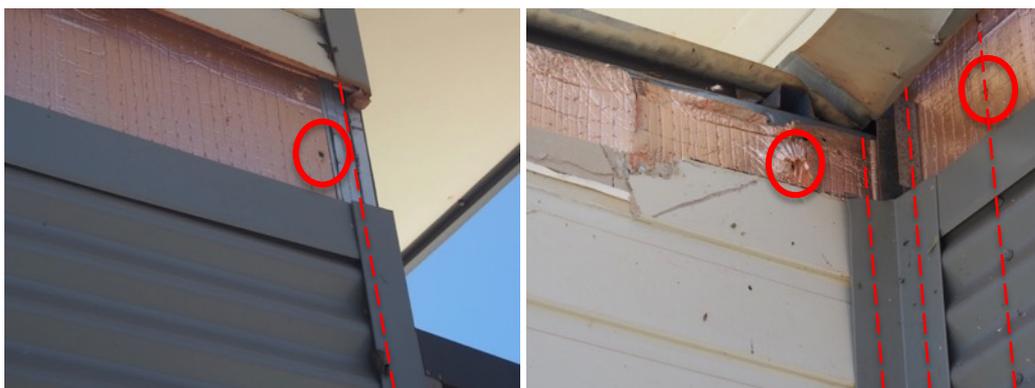
Figure 4.13 shows a missing carport where the carport roof line was completely separate from the house roof where the edge of the carport roof had been screwed into the house wall. However, a number of the screws did not align with the studs (shown as dashed lines in Figure 4.13) in the house wall, resulting in reduced tie-down capacity. The details at the top of the posts were the same as those illustrated in Figure 4.11.

**Figure 4.13 Damaged carport with connections not aligned with wall studs**

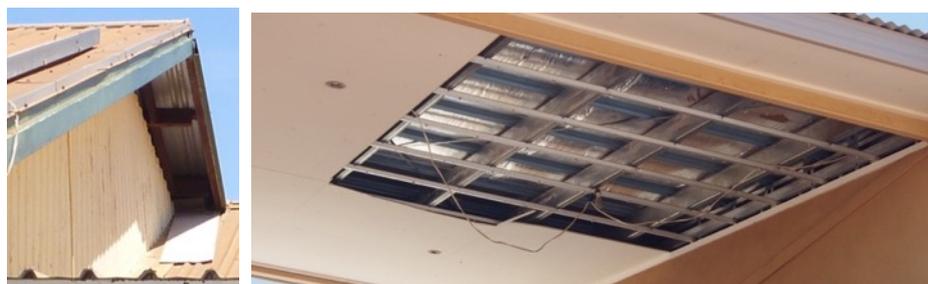
(a) Older house

Previous CTS reports on damage to buildings following wind events (e.g. Henderson *et al*, 2006 and Boughton *et al*, 2011) have highlighted the high frequency of damage to soffits. Investigations following TC Damien reinforced those findings. Figure 4.14 shows an example of damage to soffits in both contemporary and older houses. In both these cases, the failures originated in the connections of the brittle material to the frame above. In addition, the end joints were not supported by framing, which is not in accordance with manufacturers' recommendations.

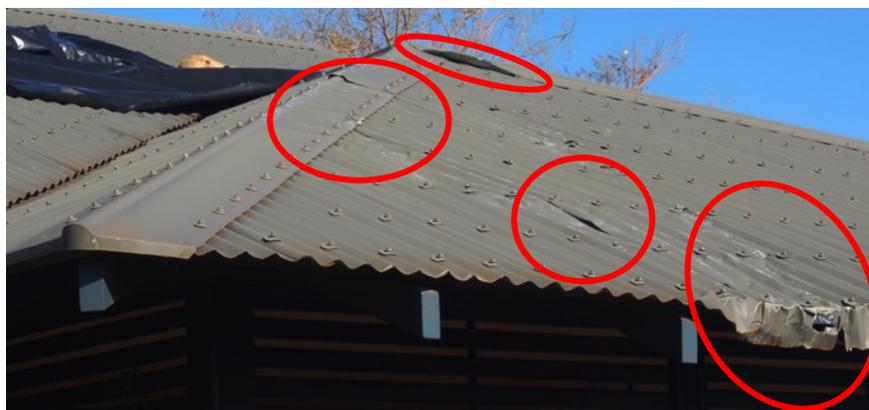
Figure 4.15 shows damage to roof cladding caused by a large section of roof structure detaching from another house.

Figure 4.15 Debris damage to cladding elements

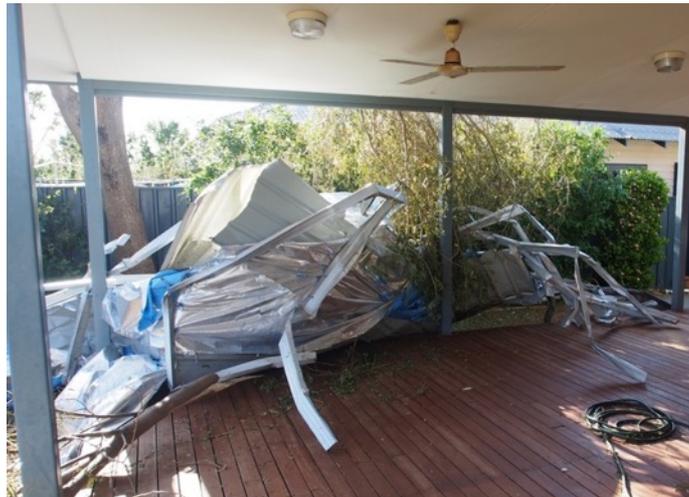
The failed section of the roof caused damage to several houses and cars before landing over 300 metres away in a neighbour's outdoor area (Figure 4.16).

**Figure 4.16 Failed roof structure in neighbouring property**

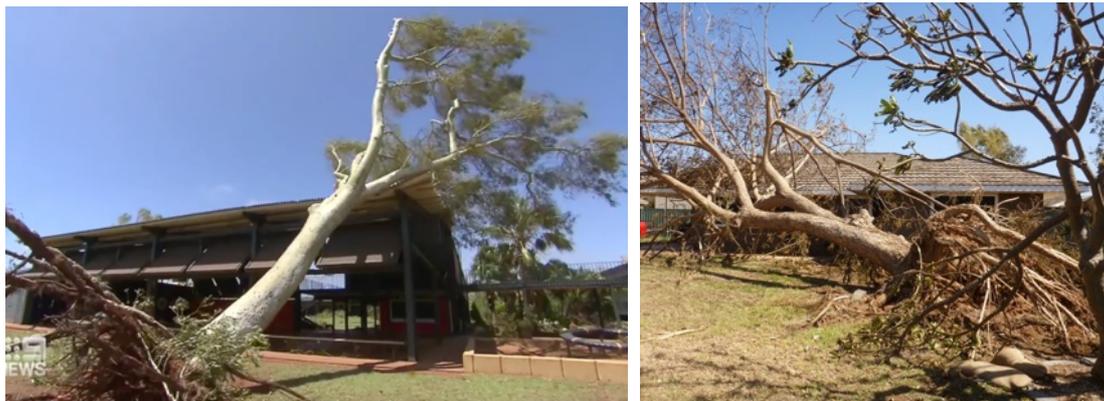
Figure 4.17 shows examples buildings that were struck by fallen trees.

**Figure 4.17 Damage from fallen trees**

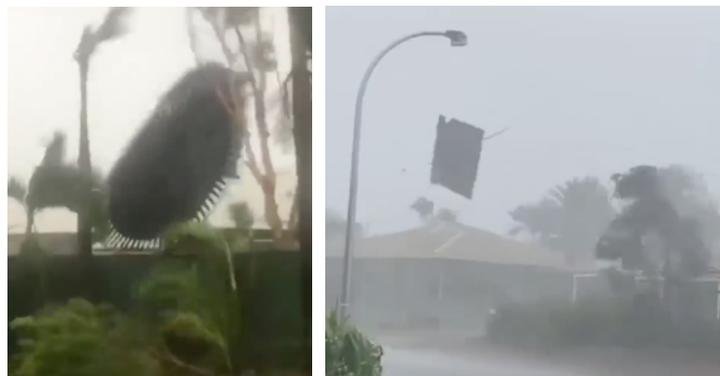
Figure 4.18 shows an unsecured trampoline and a section of roof that became airborne during TC Damien. The loose trampoline illustrates the need to clean up properties and secure items as part of the preparation for a cyclone, and the risk to life and safety created by wind-borne debris.

**Figure 4.18 Wind-borne debris (Photos – Channel 9 Perth)**

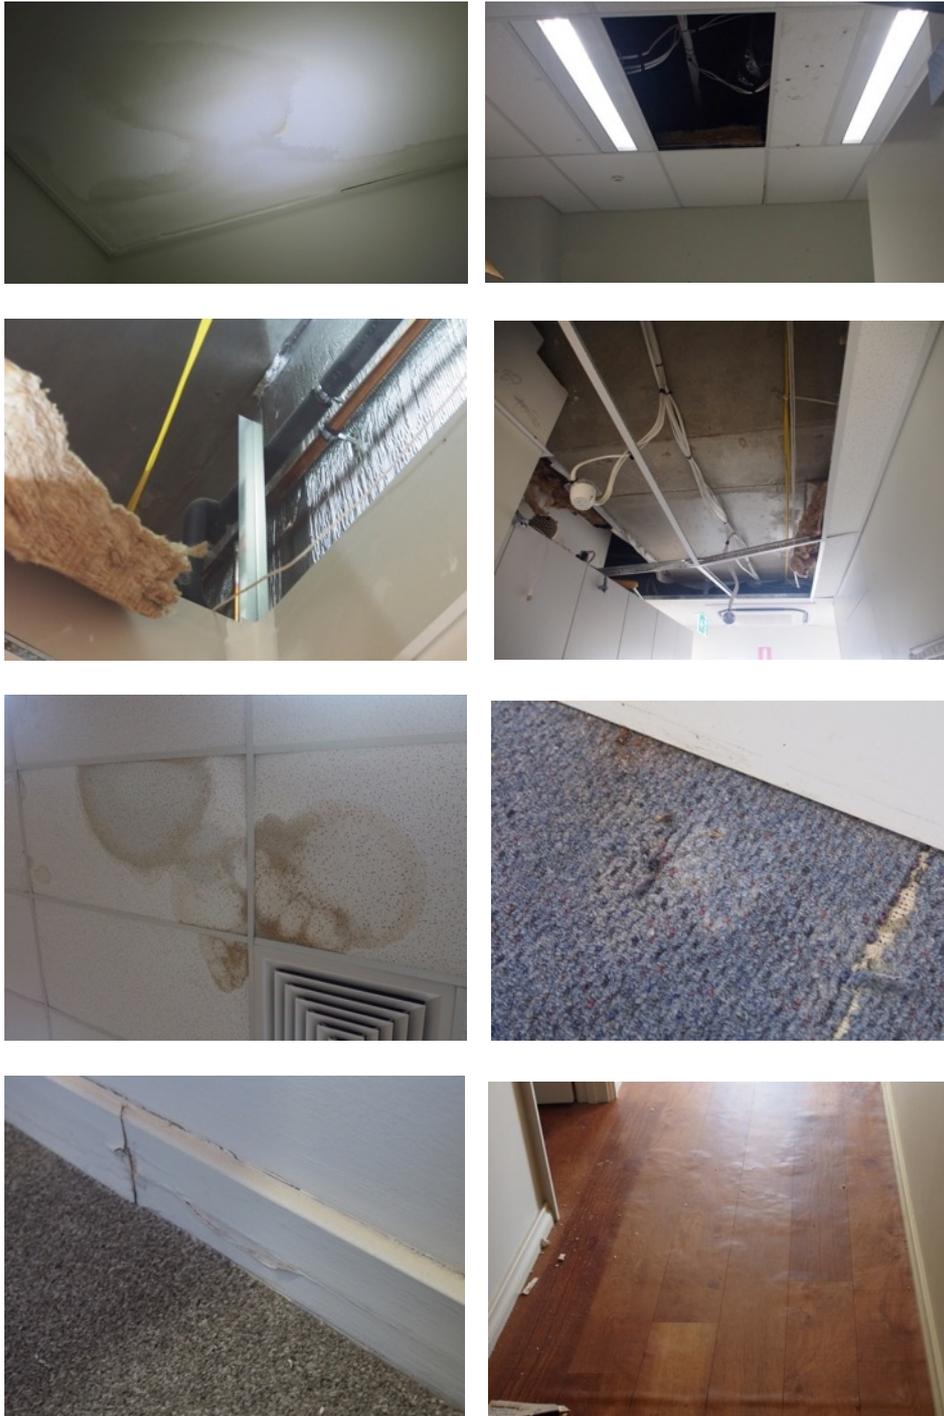
Figure 5.2 shows examples of damage caused by wind-driven rain entering buildings.

**Figure 5.2 Damage from wind driven rain entering buildings**

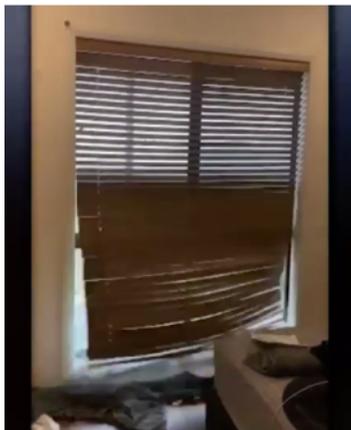
As noted in previous reports (Boughton *et al*, 2017), people stood in front of windward windows and glass doors to take videos of the cyclone or mop up rainwater. They risked serious injury if the windows or doors had been broken by debris, or if they had slipped on the wet floors. In fact, one person was filming as a window on the front of their building broke, sending shattered glass, broken bits of blind and large volumes of rainwater into the room (Figure 5.3).

**Figure 5.3 The moment a windward wall window broke**  
(Still photo from video on Channel 9 news website)

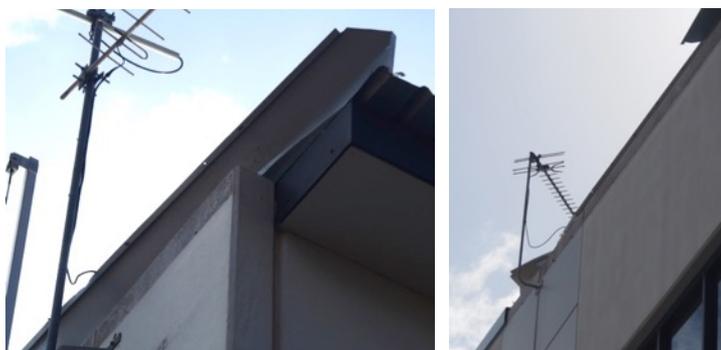
Figures 5.4 and 5.5 show a selection of relatively recently constructed buildings that had lost sections of flashing.

**Figure 5.4 Examples of failure of flashings on a commercial building**

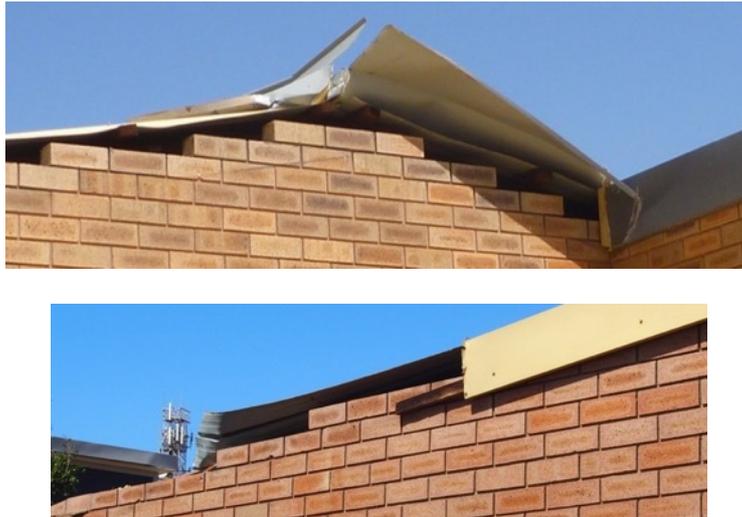
**Figure 5.5 Examples of failure of flashings on houses**

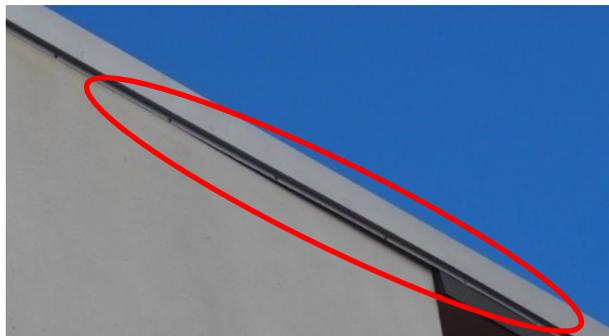
Flashings that don't fit properly can allow rainwater to be driven up the external wall, behind the flashing and into the roof space, causing damage to or collapse of ceilings. Figure 5.6 shows an example of a flashing that was poorly installed.

**Figure 5.6 Example of a poorly installed flashing**

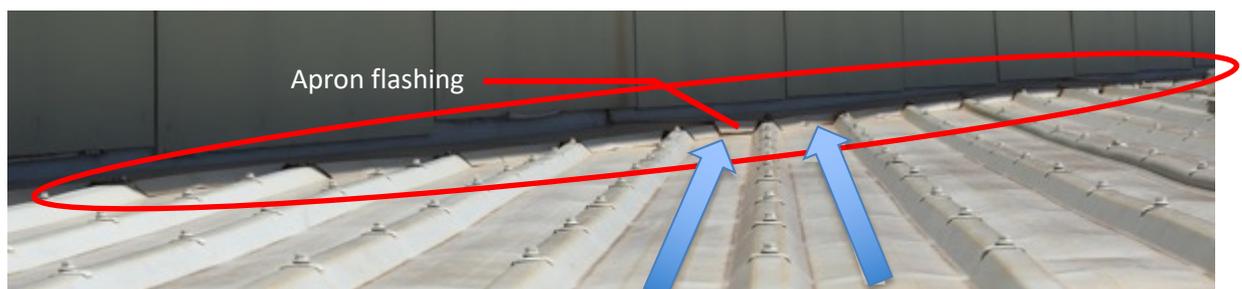
A relatively complex roof shape on a public building (involving a number of apron flashings) led to water being forced up the roof sheeting and under the apron flashing, as shown in Figure 5.7. This caused extensive damage to ceilings and carpets. Complex roof configurations can be difficult to seal against wind-driven rain.

**Figure 5.7 Point of entry of wind-driven rain**

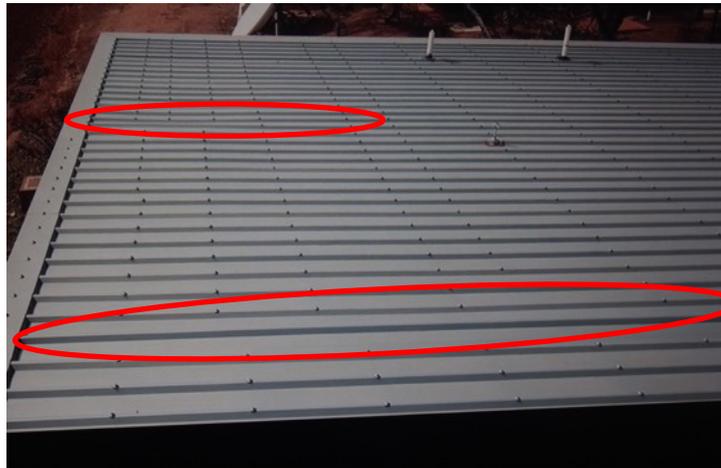
Figure 5.8 shows an example of a building where roof sheeting laps had lifted. There were no fasteners along a significant length of the ribs that had lifted.

**Figure 5.8 Roof with ribs without fasteners (highlighted)**

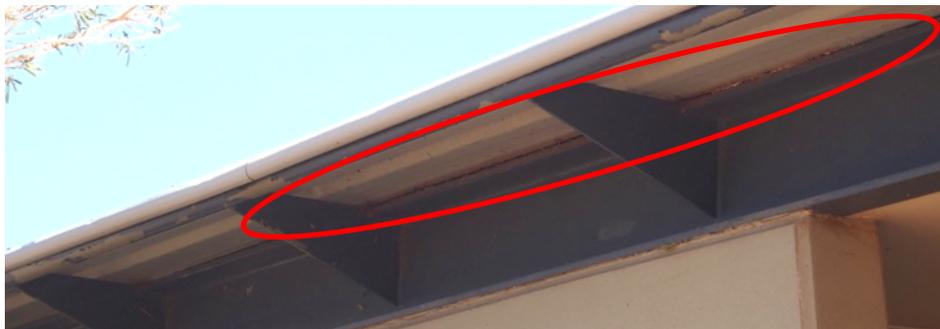
Figure 5.9 shows a building in which the roof sheeting had been sealed to a rigid structural system using a flexible sealant. During TC Damien when the wall shown was on the windward side, the roof sheeting flexed enough to break the sealant and allow significant volumes of wind-driven rain to be channelled into the building through the crack. Sealant shouldn't be the primary flashing element.

**Figure 5.9 Inadequate waterproofing at junction of the roof and walls**

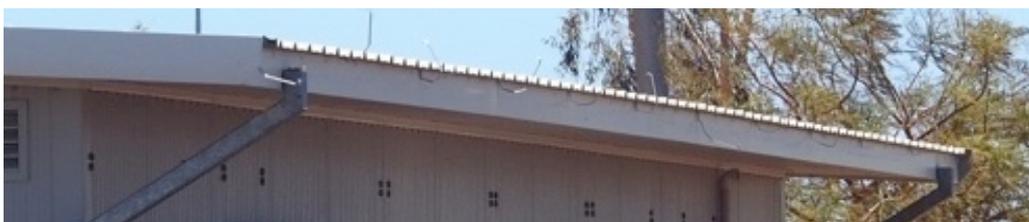
Many buildings in Karratha did not have gutters. On some buildings with gutters, rainwater entered when gutters were damaged or lost. Some gutters were attached to fascia with clips or fixings that did not have the capacity to resist the wind forces during TC Damien, as shown in Figure 5.10.

**Figure 5.10 Loss of gutters**

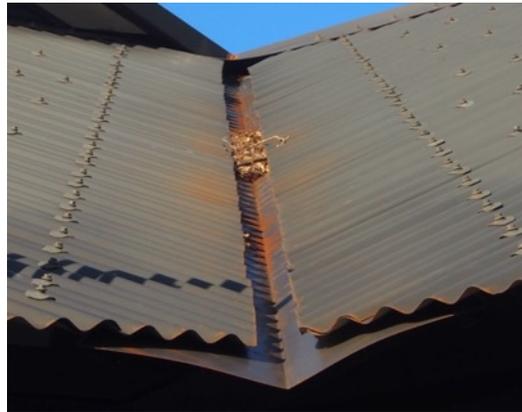
Figure 5.11 shows a valley gutter that became blocked during TC Damien causing water to overflow into the ceiling space and damage the ceiling underneath.

**Figure 5.11 Example of a blocked valley gutter**

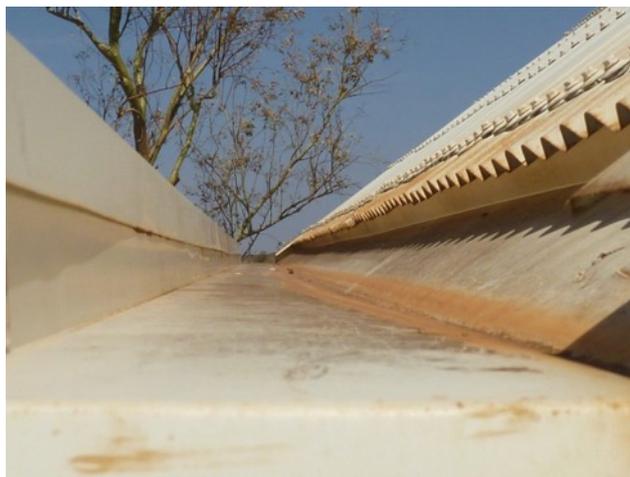
In previous damage investigations (Boughton *et al*, 2017, Boughton *et al*, 2011), the CTS team found that rainwater was driven over the edge of box gutters during high wind events. Box gutters usually only have a drain at one end. Strong winds can drive water pooled in the gutter to the opposite end to the drain where it piles up and overflows into the ceiling space. However, Figure 5.12 shows a box gutter completely open at both ends. Rainwater was still blown over the right edge of the box gutter and into the roof space. Therefore, most configurations of box gutters are likely to allow water into a building during high wind events.

**Figure 5.12 Box gutter open at both ends**

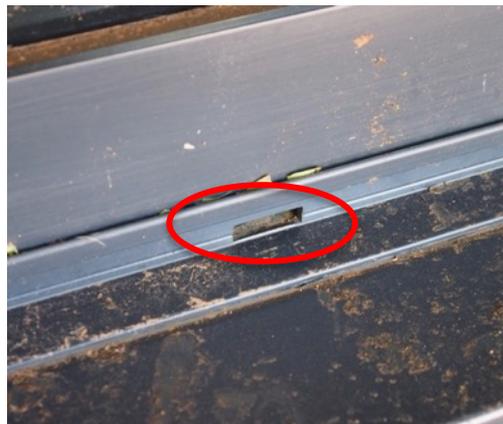
In addition, many windows in commercial buildings and apartments investigated after TC Damien are non-opening (fixed). Even these windows leaked around the window frame, as shown in Figure 5.13.

(a) Uncovered weep hole in a fixed window on the outside of a building

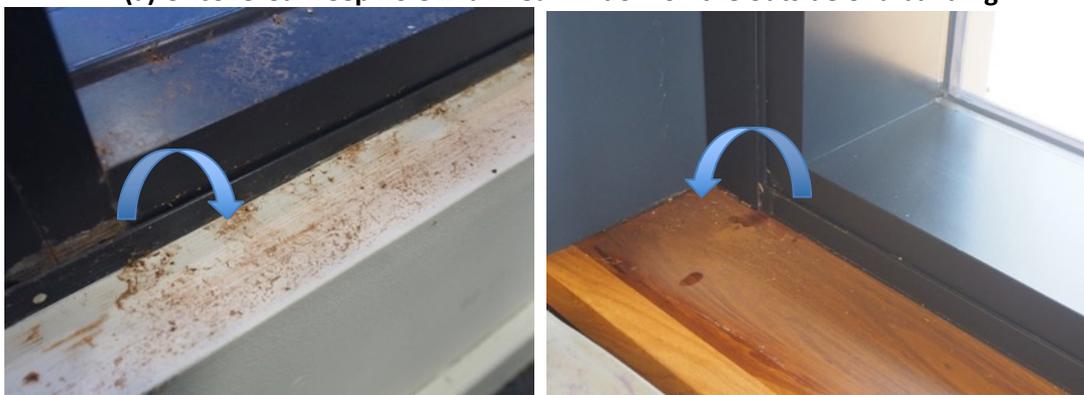
(b) Staining on inside of window sill from leakage

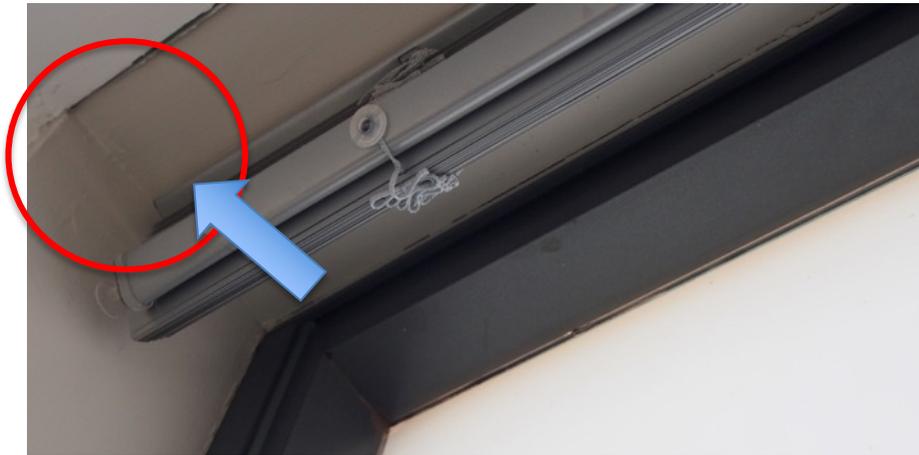
A number of windows also showed signs of leakage around the window head. (Figure 5.14). the highlighted area indicates where the plaster has started to soften as a result of water through the gap at the window head.

**Figure 5.14 Example of leakage around a window head**

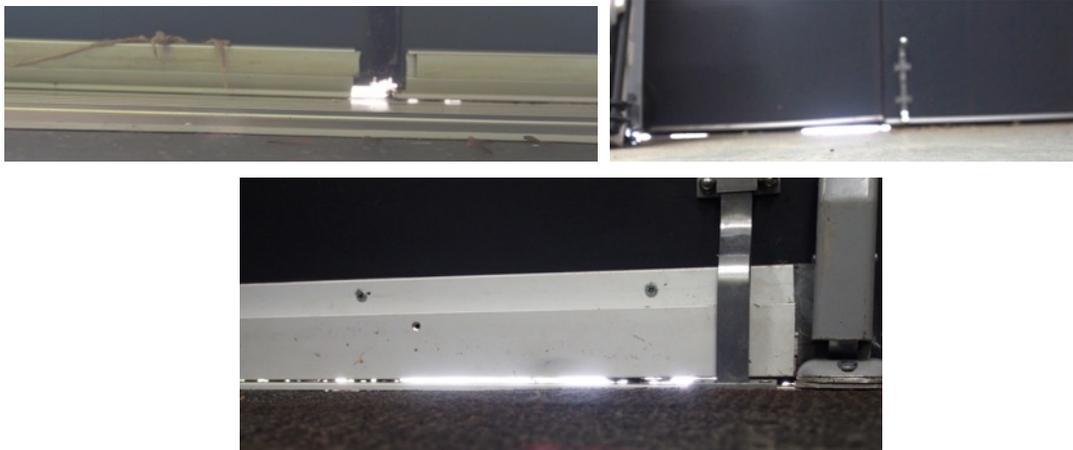
During TC Damien, significant amounts of rainwater were driven under some swinging doors. In the majority of cases where water entered through swinging doors on windward walls, there was no sill and water was driven through the gap under the door, even though there was a weather seal. Figure 5.15 shows some examples of gaps under doors where wind driven rain entered buildings.

**Figure 5.15 Gaps under swinging doors with weather seals**

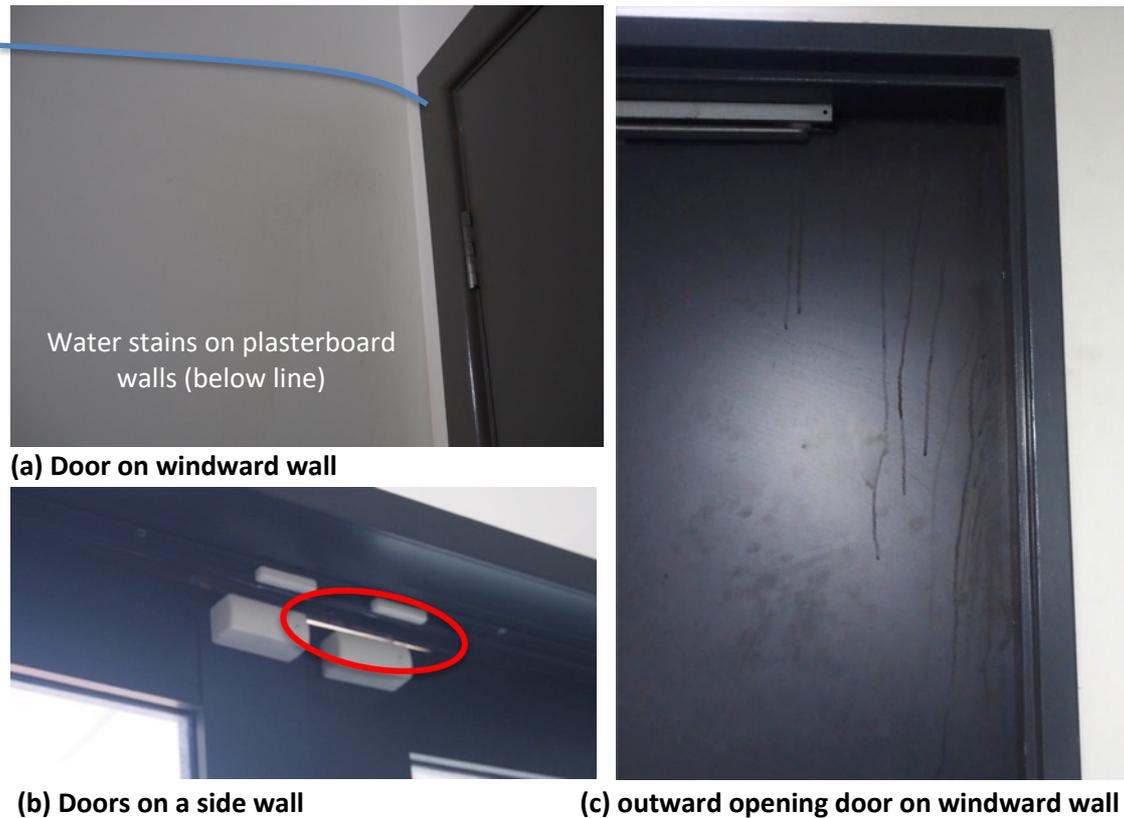
Figure 5.16(c) shows that even outward opening doors on the windward wall will let some water in around the edge of the door where there are no seals.

Figure 5.16 Examples of doors that flexed under wind loads

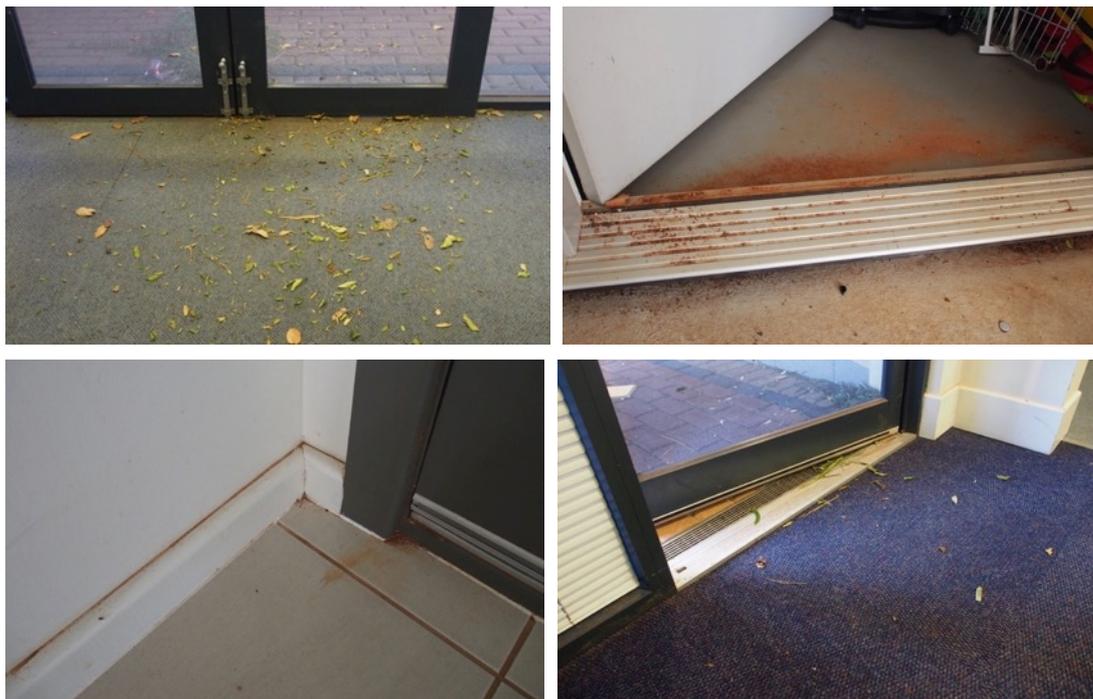
Figure 5.17 shows some examples of how far rain and leaf litter were driven into buildings under or around doors. Many commercial buildings had carpets on the floors and these sustained quite a lot of water damage.

Figure 5.17 Examples of rainwater entry under or around swinging doors

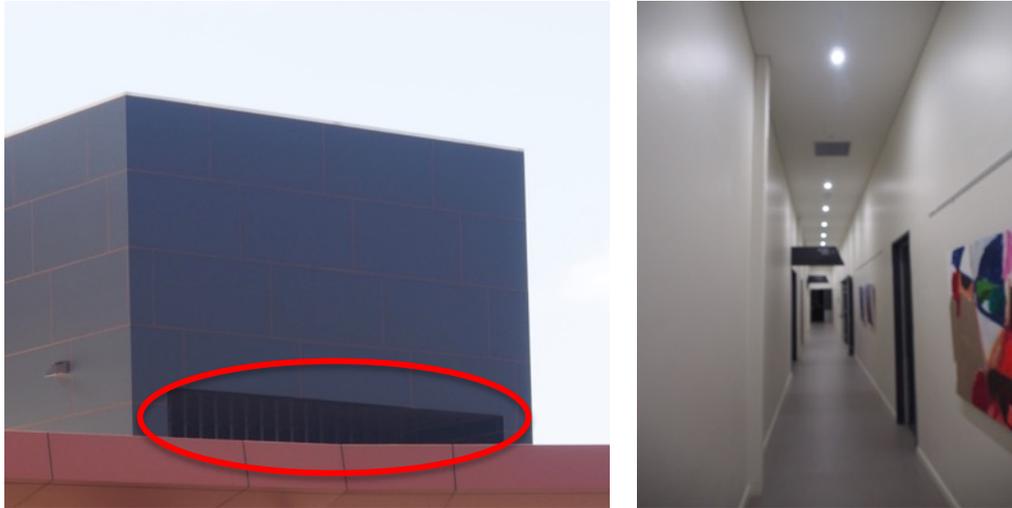
Wind driven rainwater can enter buildings through any openings in the building envelope including vents and machinery rooms. During TC Damien, rainwater was driven through the air intake for the HVAC of a large building in Karratha and entered rooms in the centre of the building through the air conditioning ducts. Figure 5.18 shows the single stage louvres on the machinery room for the building, and the ground floor corridor that was flooded.

**Figure 5.18 Large building in Karratha – Machinery room louvres and ground floor corridor in the centre of the building**

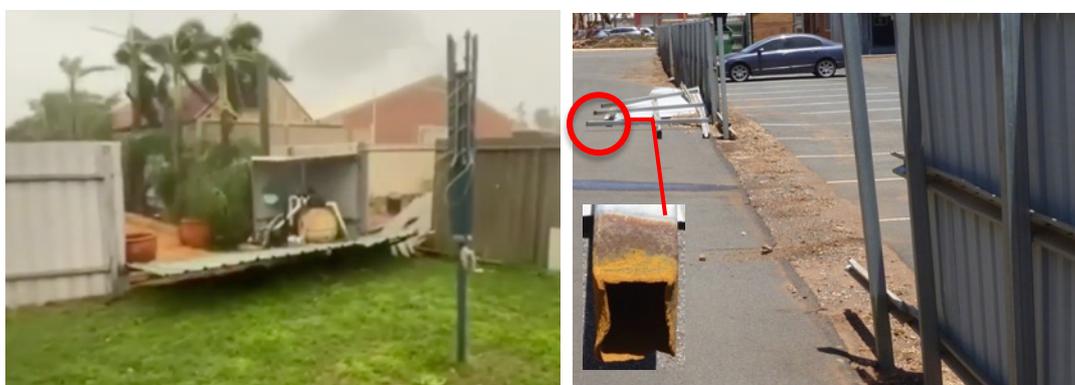
(a) The moment of failure (*Photo – Channel 9*)

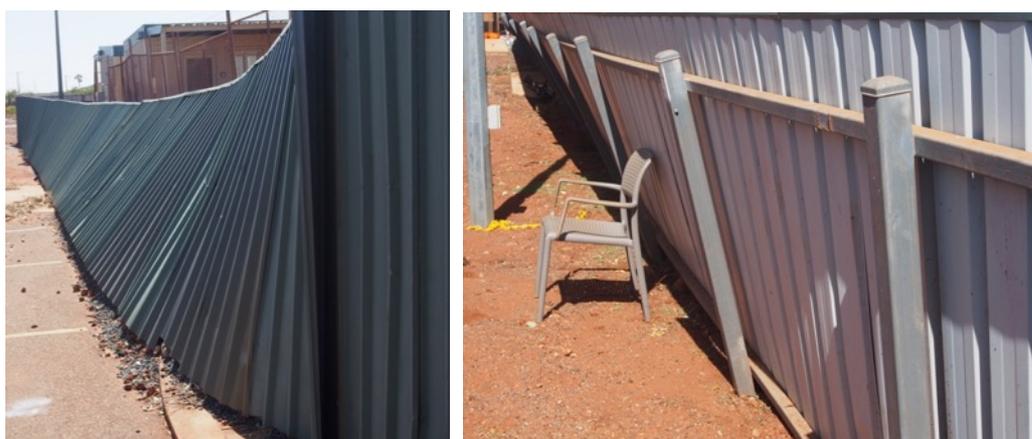
Figure 7.2 Failure of ground around posts

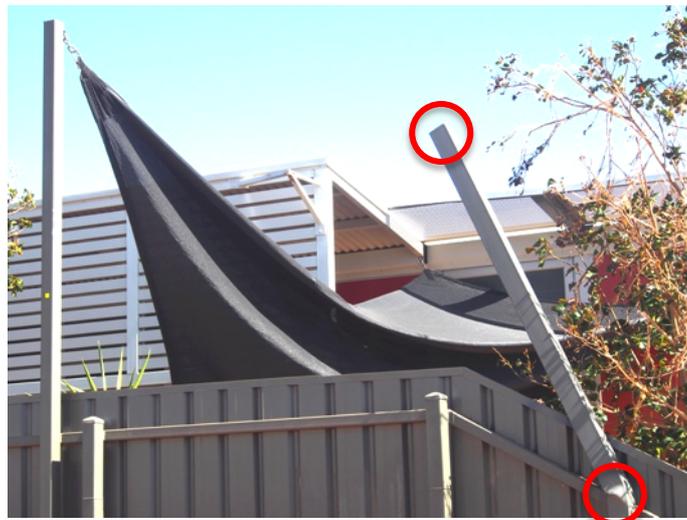
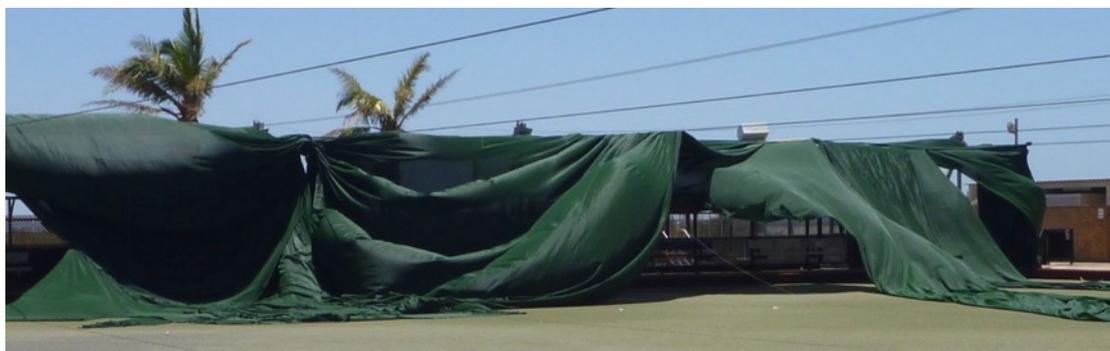
Figure 7.4 Examples of damage to sail and shade cloth structures

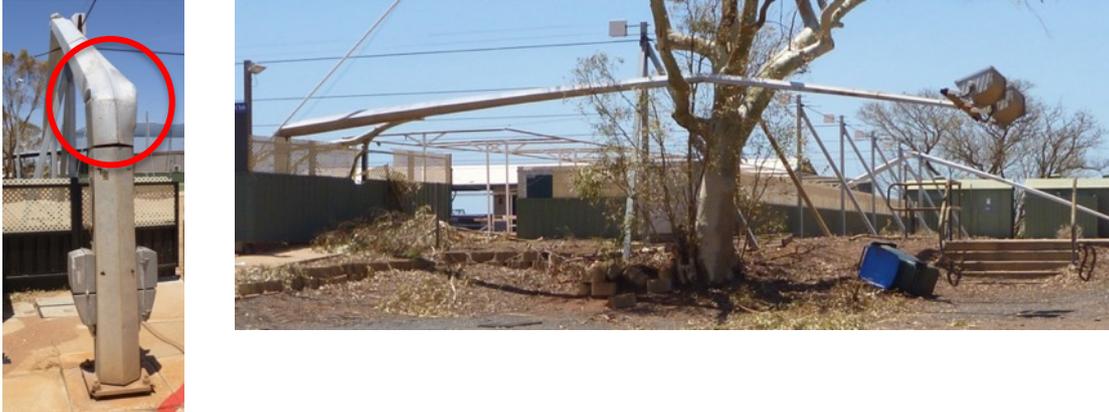
**Figure 7.5 Damage to lighting towers**

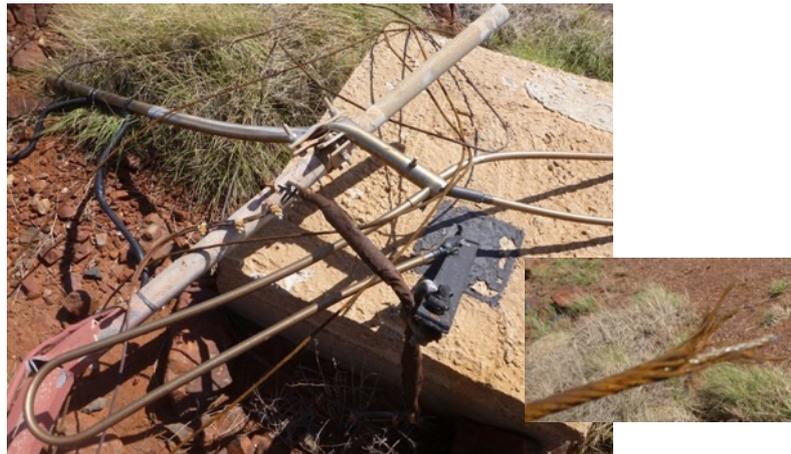
**(a) Broken stays near top of the tower (inset – broken stay)**

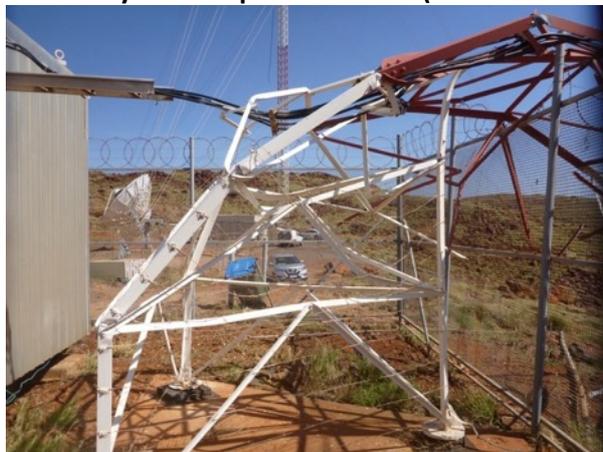
**(b) Buckling of compression leg at the base of the tower**  
**Figure 7.6 Damage to Karratha TV tower**

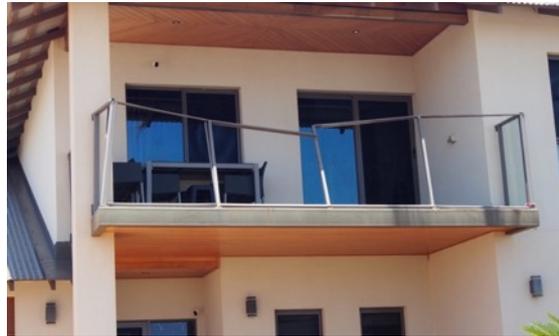
**Figure 7.7 Failure of framed glass balcony balustrades**

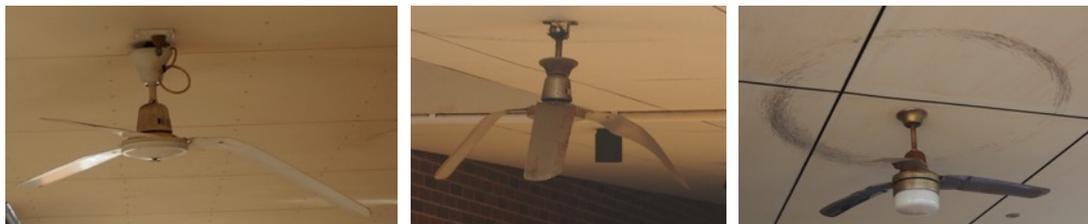
**Figure 7.9 Examples of damage to outdoor ceiling fans**

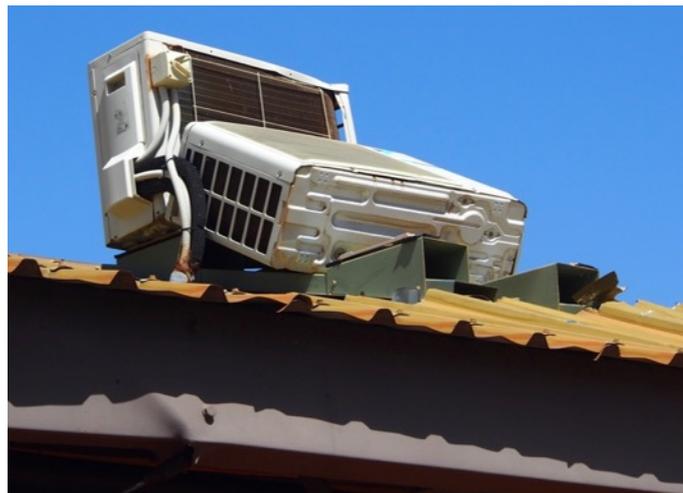
**(a) Failure of attachment on the A/C external unit**

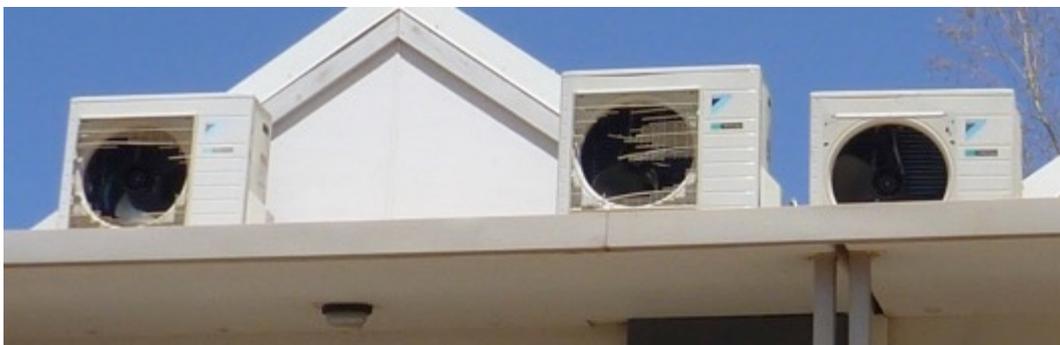
**(b) Damage to fans in external units**

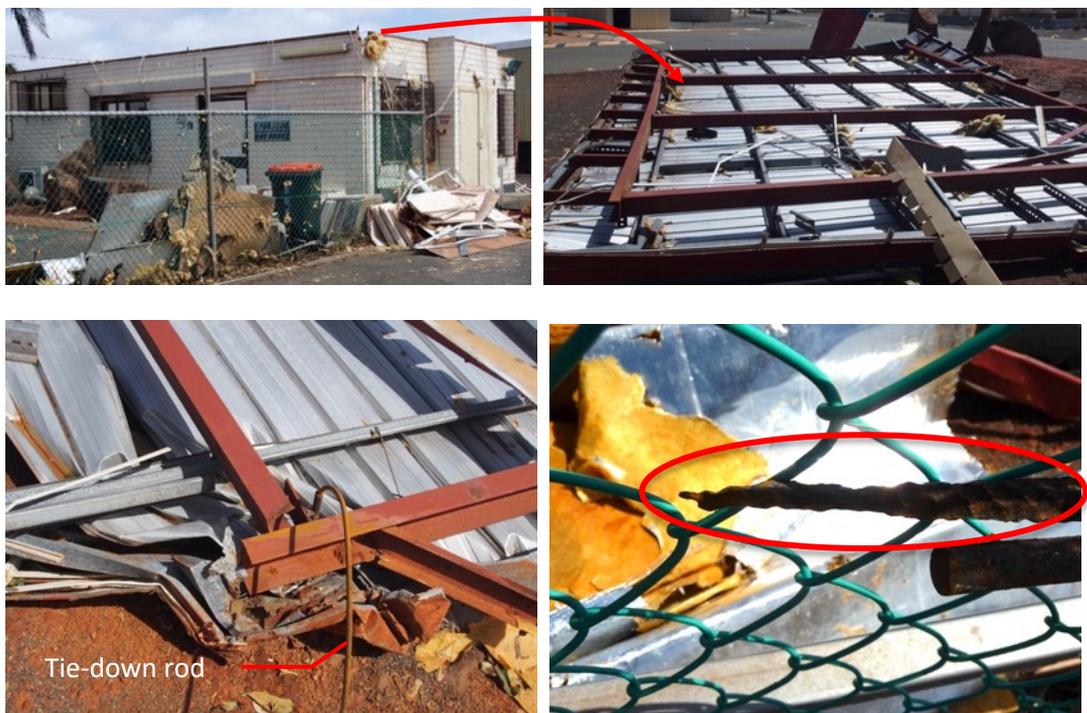
Figure 8.1 Corrosion in tie-down rod that led to loss of steel framed roof

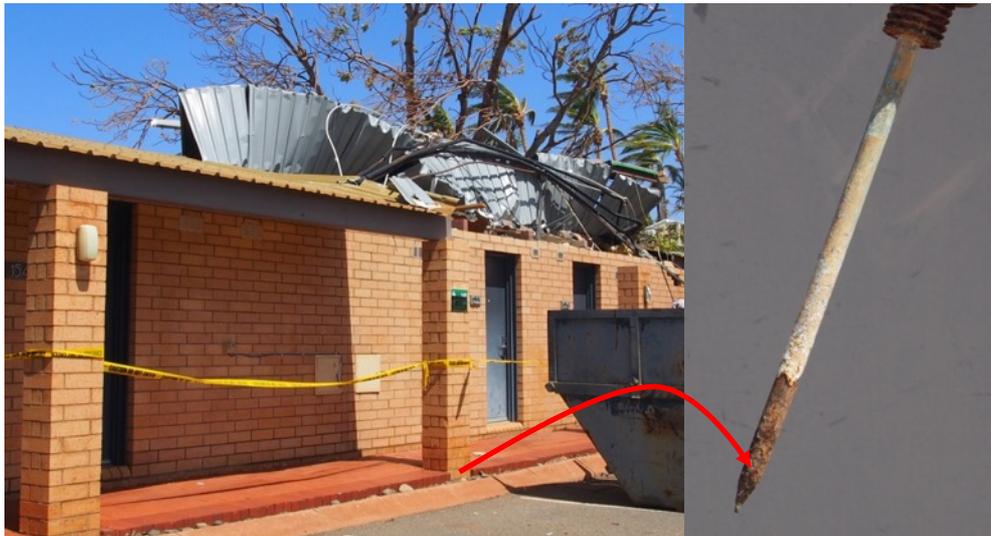
**Figure 8.2 Corrosion in tie-down rod that led to loss of timber framed roof**

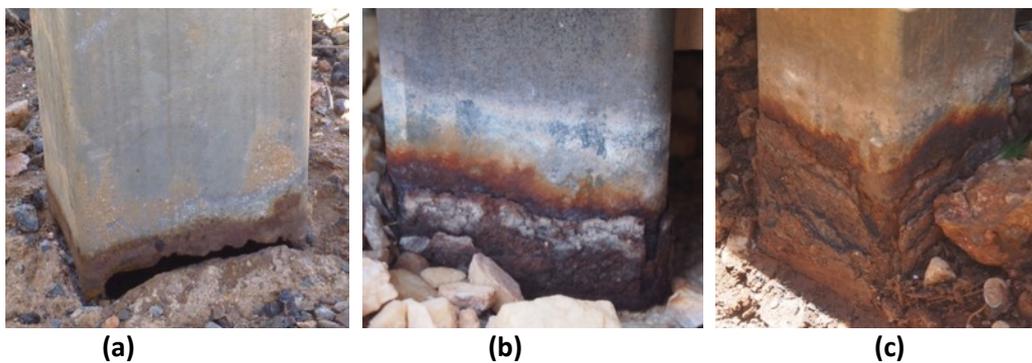
**Figure 8.3 Corrosion in SHS posts**

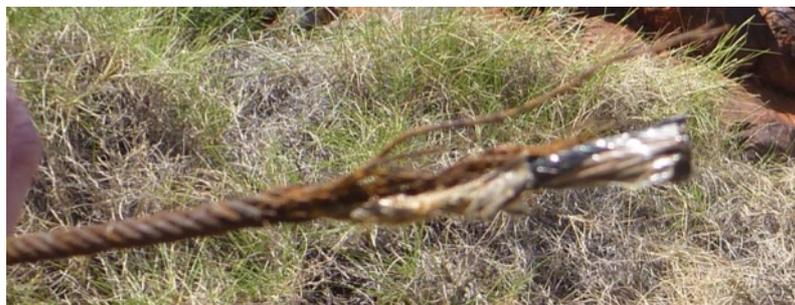
**Figure 8.4 Corrosion in TV tower stay**
