## Tropical Cyclone Damien Damage to buildings in the Pilbara Region of WA

### CTS Technical Report No 65

## **Tropical Cyclone Damien Damage to buildings in the Pilbara Region of Western Australia**

This edition: 28 February 2020

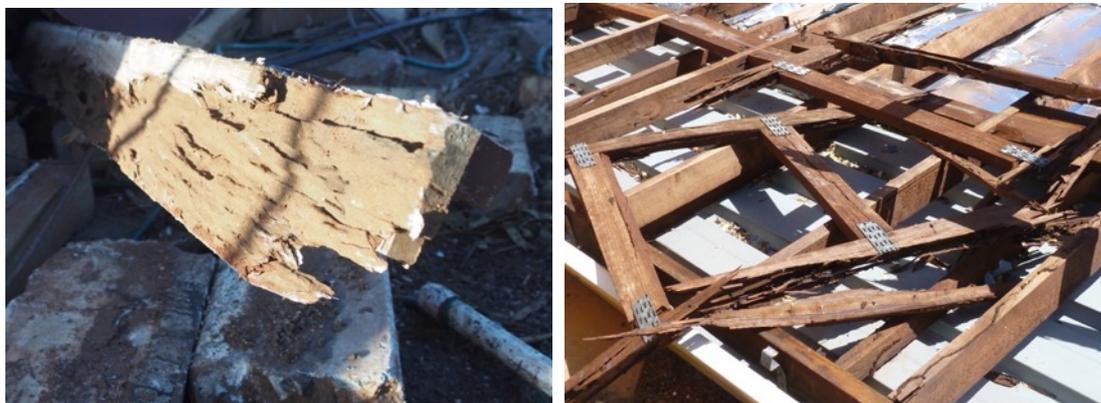
**Figure 8.5 Failures due to termite activity**

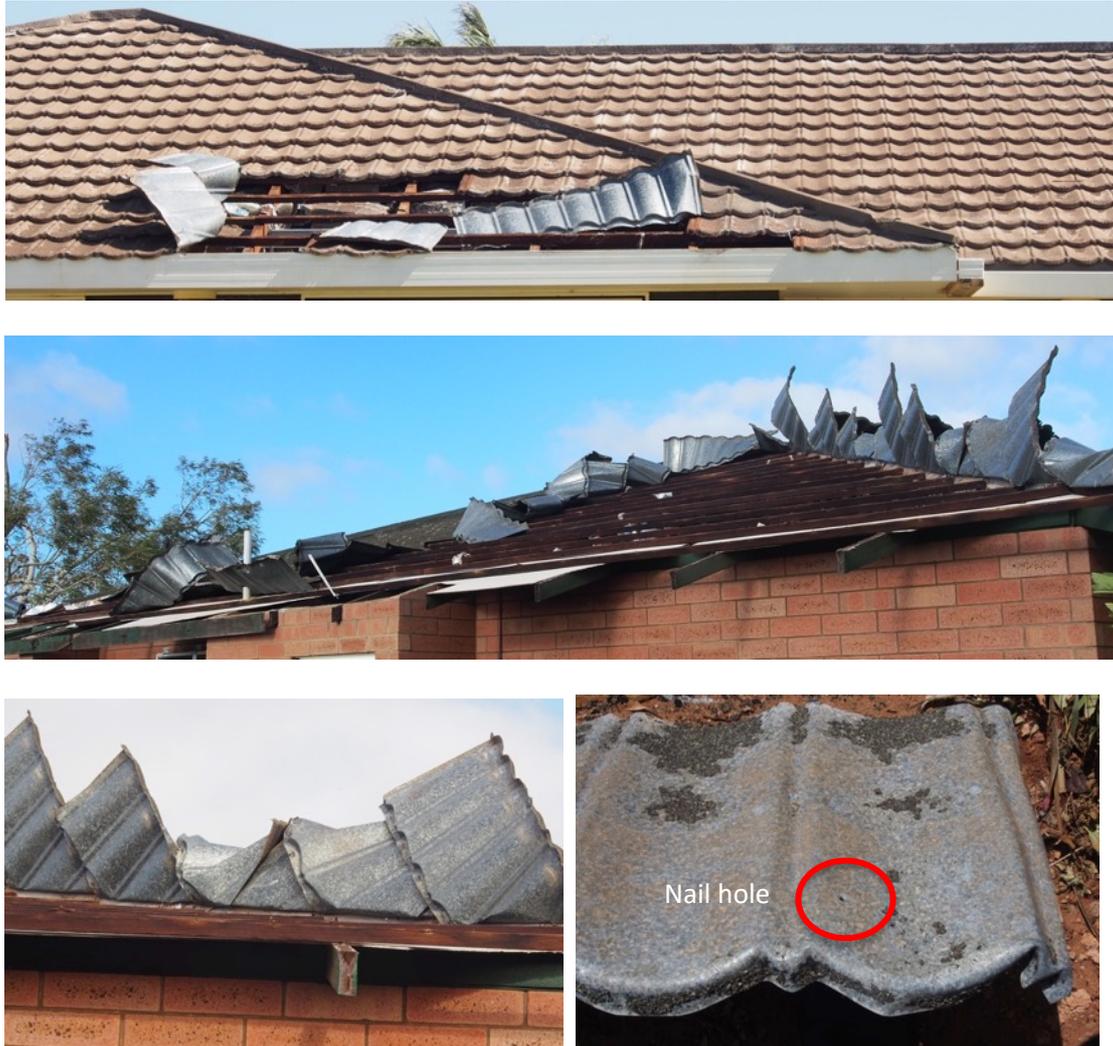
**Figure 8.6 Loss and damage to metal roof tiles**

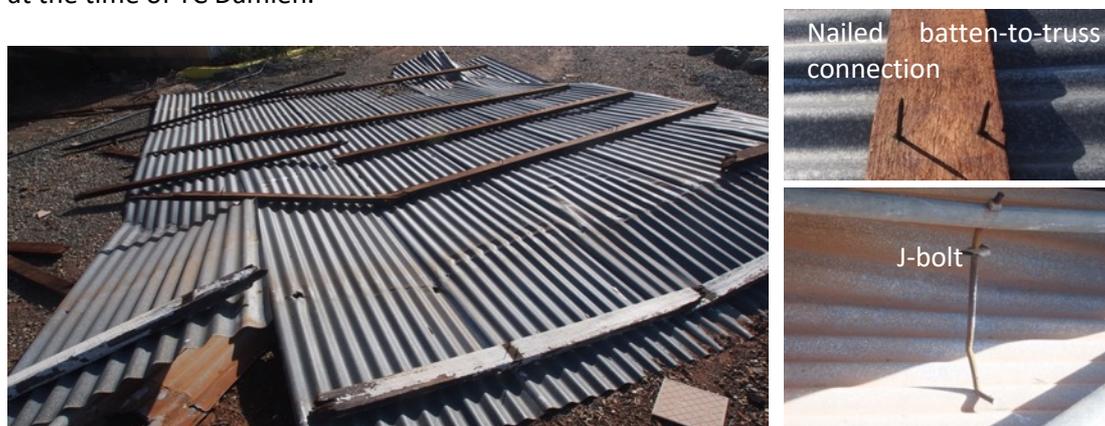
**Figure 8.7 Loss of roof sheeting and battens at batten-to-truss nailed connections**

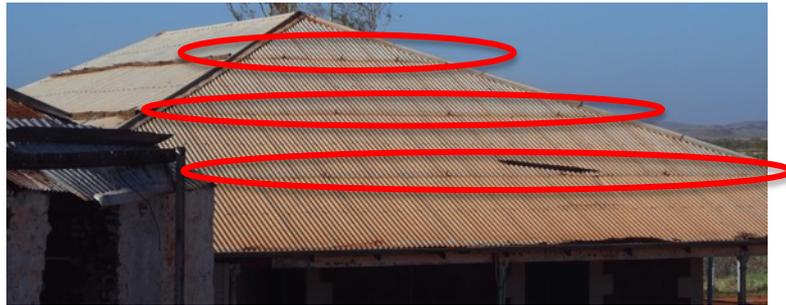
**Figure 8.8 Deterioration of overbattens on a heritage building**
