Tropical Cyclone George
Wind penetration inland

Report: TR53
February 2009

Cyclone Testing Station
School of Engineering
James Cook University
Queensland, 4811

TECHNICAL REPORT NO. 53

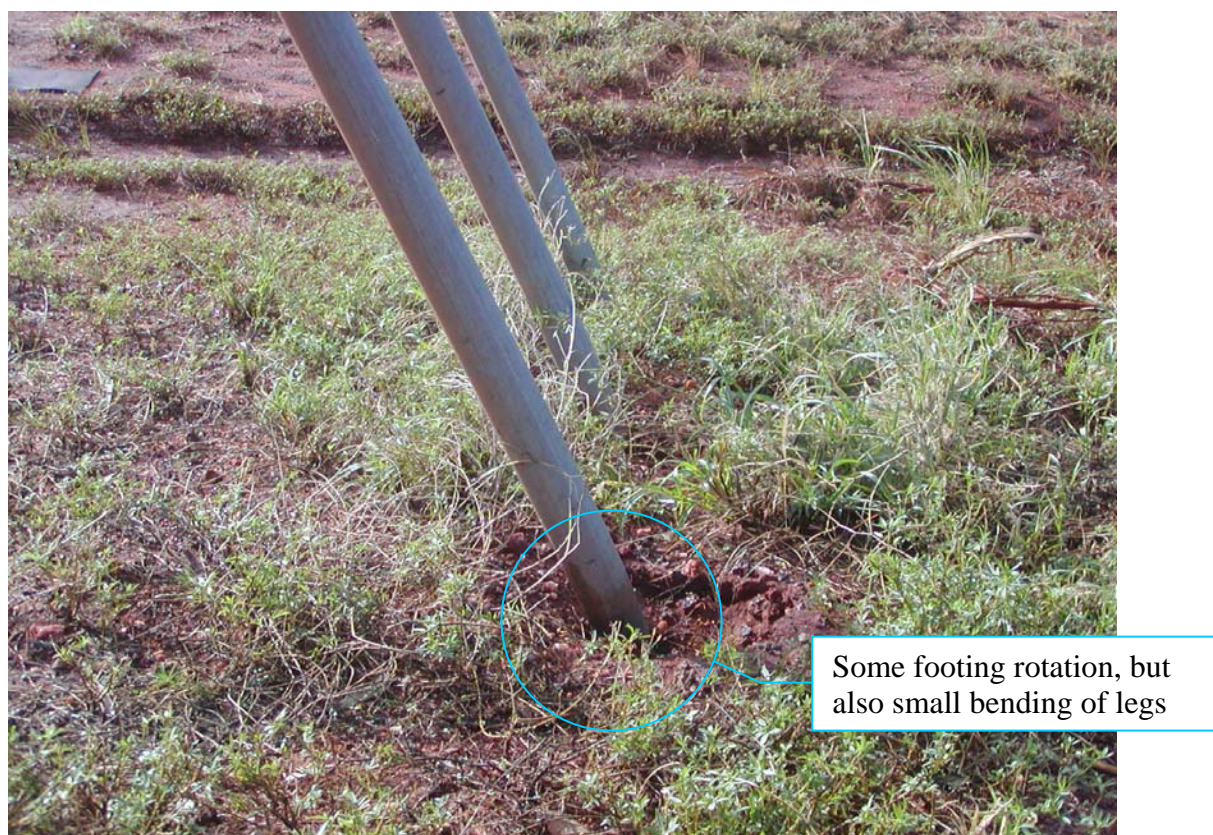
Wind speeds in Greater Port Hedland were estimated at approximately 200 kph or 55 m/s in Technical Report 52 [1]. A number of road signs were measured and a lower bound estimate on a sign that had only just developed plastic hinges at the base of the poles was used for this estimate. It is shown in Figure 3.1. The reliability of the simple structure, and the fact that plastic hinges had only just started to form gave this estimate a reasonably high level of reliability. It has an estimated range of +/- 5%.

As well for this area, the range between lower and upper bounds of wind speed was quite small. The indicated wind speed was greater than 200 kph and less than 230 kph. The plastic hinges in the sign that gave the lower bound (shown in Figure 3.1) were only just deformed indicating that the wind speed was very close to the speed required to generate the plastic hinges.

Figure 3.1: slight bend in posts of lower bound sign in Port Hedland

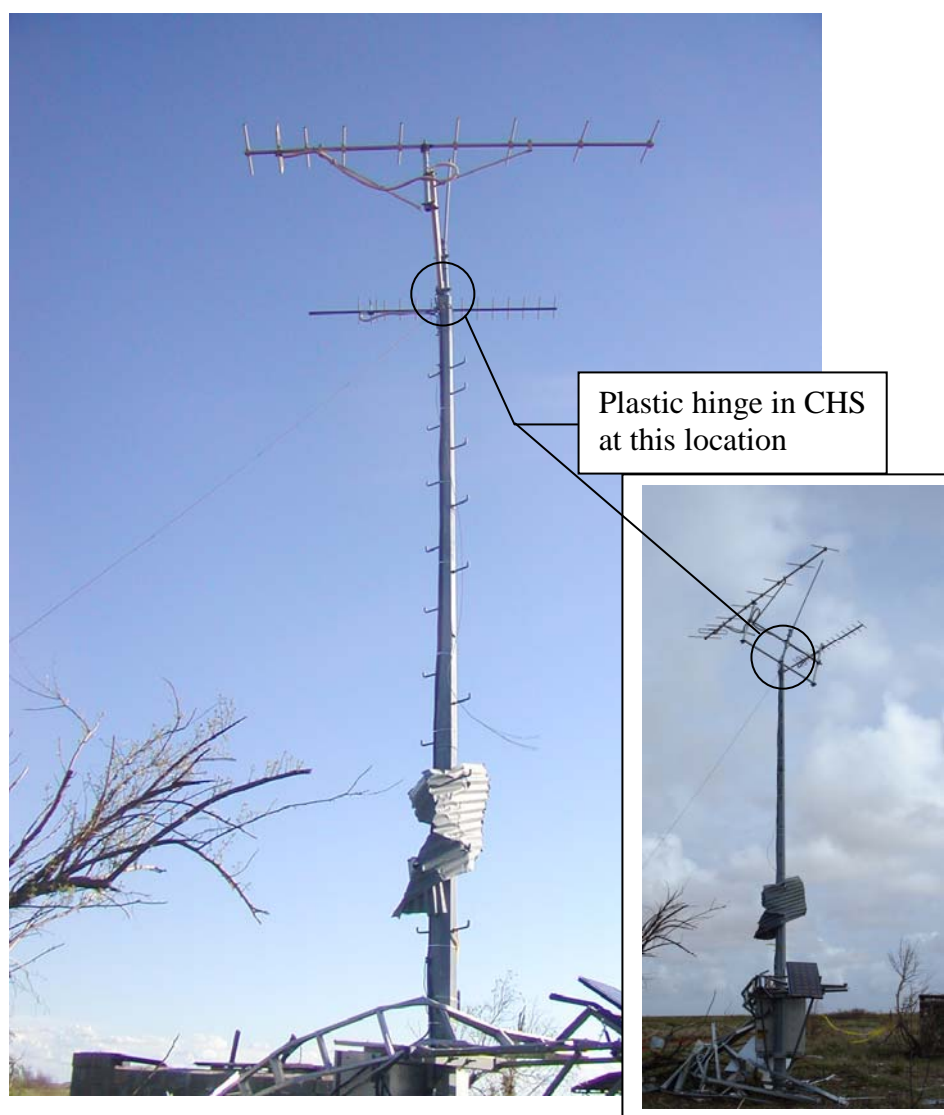
A radio mast at Strelley station was damaged by wind pressures and the plastic hinge gave an estimation of the gust wind speed. The mast is shown in Figure 3.2. It appeared to have been damaged by North-Easterly winds. While there was some debris wrapped around the base of the mast, this was below the level of the plastic hinge (as shown in Figure 3.2). The smaller members in the antenna would almost certainly have been bent by debris if it had impacted the aerial above the level of the hinge.

The dimensions of the mast were used to estimate a lower bound for the wind speed that caused the bending of the Circular Hollow Sections (CHS). At 10 m above terrain category 2, the lower bound of the wind speed was estimated at between 230 kph and 280 kph. This range is based on the range of sizes and dimensions estimated from ground level, the errors in pressure coefficients for the aerial, and sensitivities to the wind direction at the time the failure hinge was formed.

Figure 3.2: small plastic hinge in radio mast at Strelley community

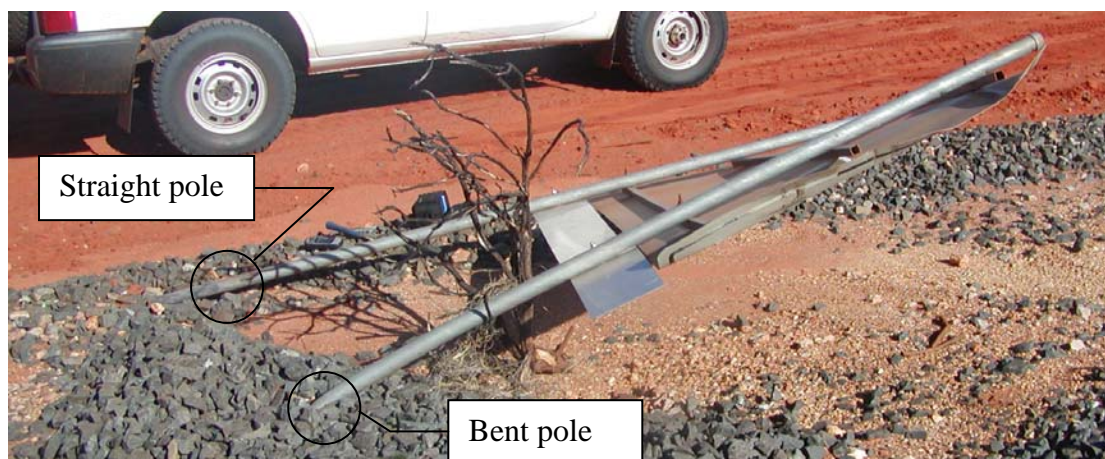
There are a large number of road signs along this road, but they are not concreted into the ground. Many of them had been blown over, but the failure was by rotation in the ground rather than formation of a plastic hinge in the poles. However, one sign did exhibit a plastic hinge in one of the two poles supporting it. The lower bound wind speed to cause failure of that sign could therefore be calculated.

The analysis of this sign was complicated by the fact that only one plastic hinge had formed in the legs. However, it is reasoned that the foundation failure of the straight leg occurred at the same time or after the formation of the hinge:

Figure 3.3: sign on rail access road

The sign fell as a result of winds in the quarter from South East to South West, compatible with the wind directions in the passage of the cyclone eye wall at this location. The analysis of the sign yielded a lower bound of the wind speed (standardised to 10 m height and terrain category 2) of 200 kph. Thus at the point where the eye wall crossed the road (around 40 km south of South Hedland) the Southerly winds would have been in excess of 200 kph.

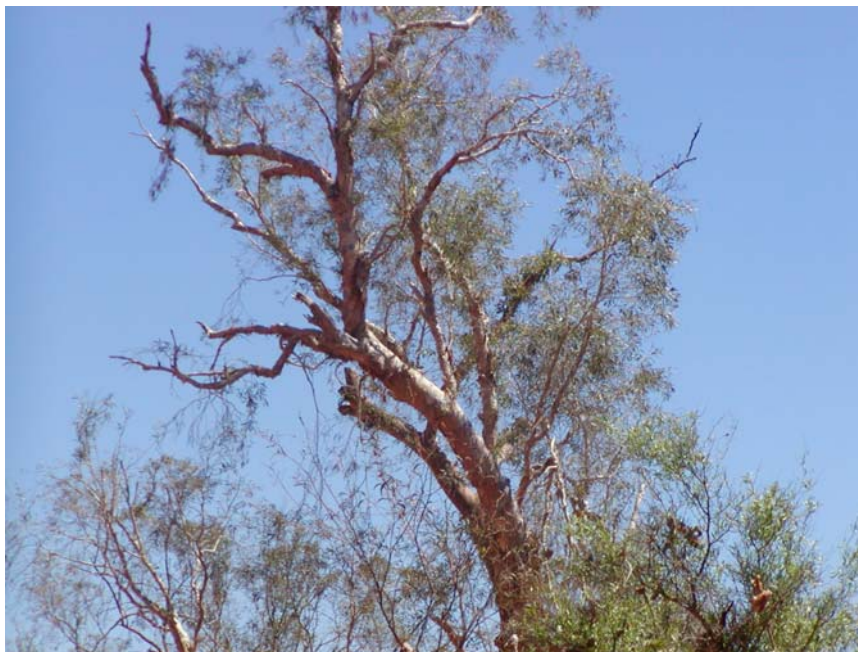
Damage to river gums at this location indicated wind speeds of around 220 kph. The extent of defoliation and the damage to branches of about 50 mm diameter or more were similar to the type of damage to this species observed in locations where road signs had indicated wind speeds of around 220 kph. The tree damage at this location was greater than that observed in greater Port Hedland where wind speed was estimated at 200 kph, and less than that observed in the Tabba Tabba River near Strelley with estimated wind speeds of up to 270 kph. At Strelley, the extent of the defoliation was similar, but larger branches (up to 75 mm) had been broken.

Figure 3.4: Damage to river gums East Turner River
(near eye wall south of Port Hedland)

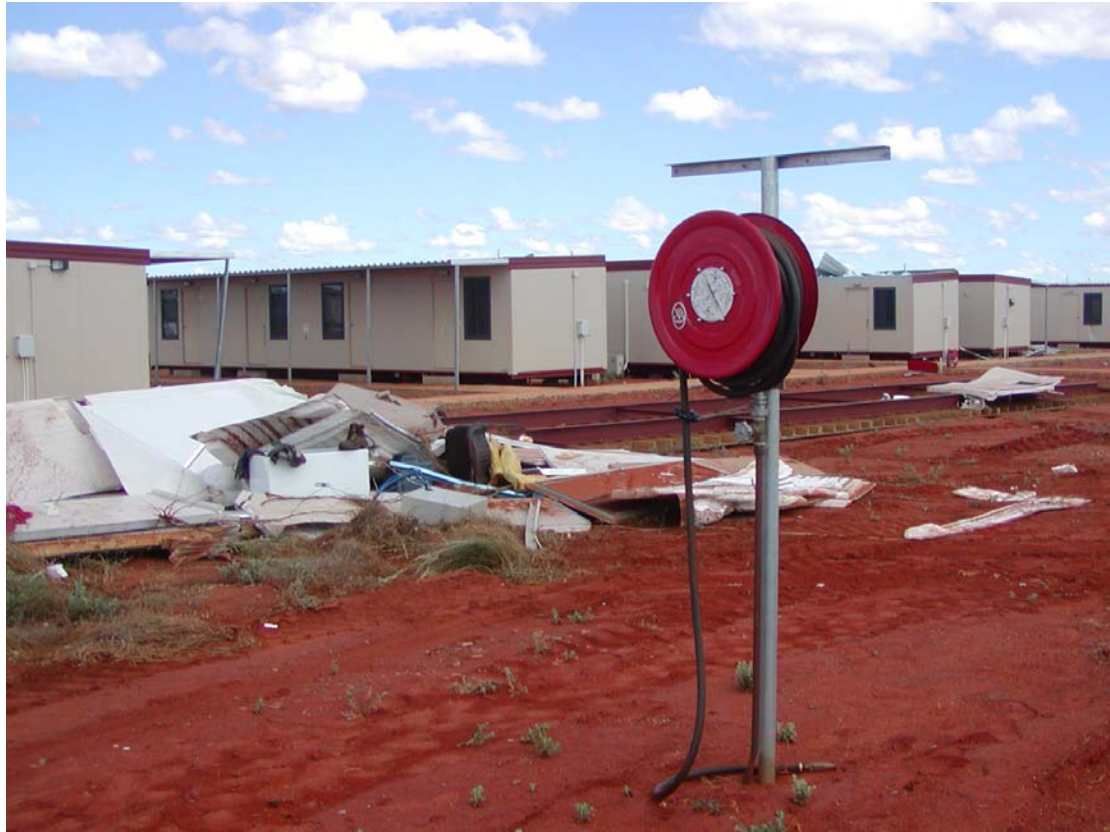
Figure 3.5 shows a hose reel that was completely undamaged in the middle of the camp. At the commencement of the cyclone, it may have had considerable shielding from surrounding buildings, but by the time the winds reached their maximum, the sheltering buildings had all been moved or removed. (Two substantially damaged buildings are shown behind the reel in Figure 3.5.)

Figure 3.5 shows that the face of the reel was free of scratches from debris impact. It also faced directly into the winds that seemed to inflict the most damage on the camp.

Figure 3.5: Hose reel at Rail Camp 1

The hose reel itself was a simple structure suitable for consideration as a “windicator” [3] and its undamaged condition made it possible to estimate the upper bound wind speed. However, the rigidity of this structure simply indicated that the wind had a velocity of less than 300 kph.

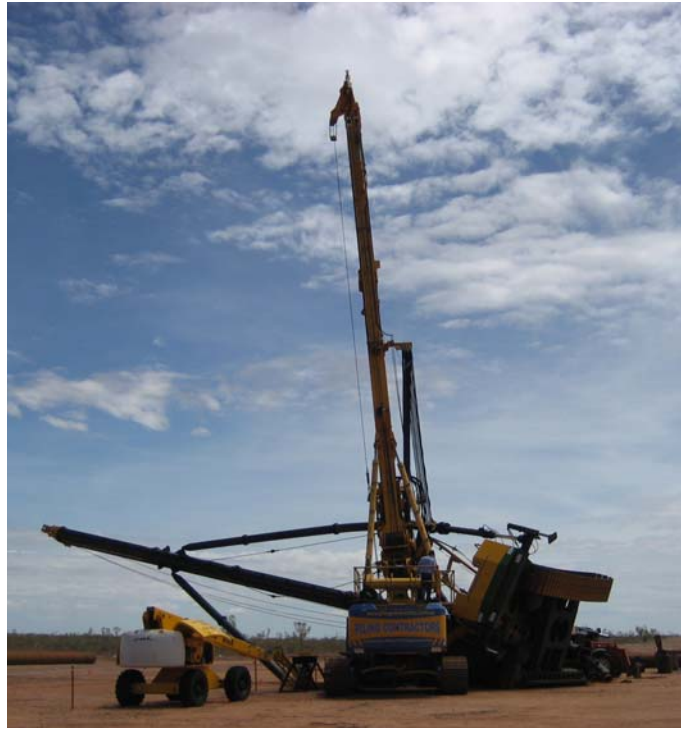
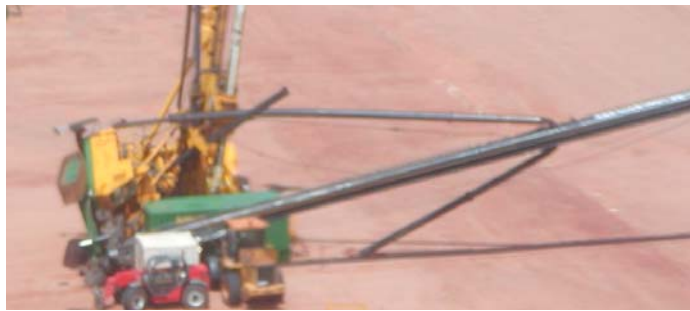
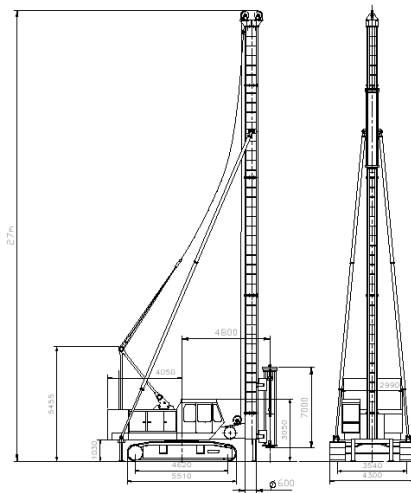
Figure 3.6 Pile Driving Rig
(Drawing from FMG Group)

A 27 m high pile driving rig at the Turner River was blown over during the passage of the tropical cyclone. The rig was approximately 5 km North of FMG Rail Camp 1. Photographs of the toppled rig and a drawing of the rig is shown in Figure 3.6.

While the aerodynamic drag on of the rig can be evaluated from the drag coefficients for cylinders and the drag on the body, the forces required to topple the rig are complicated by the softness of the ground under the leeward track.

A deformation of the soil of 88 mm under the very outer edge of the track corresponds to a change of angle of around 1.3 degrees, and represents 1 mm deformation per tonne. It is likely to be a lower limit to the deformation. 200 mm under the edge of the track is more likely. This range of deformations gives a lower bound wind speed of between 176 and 189 kph.

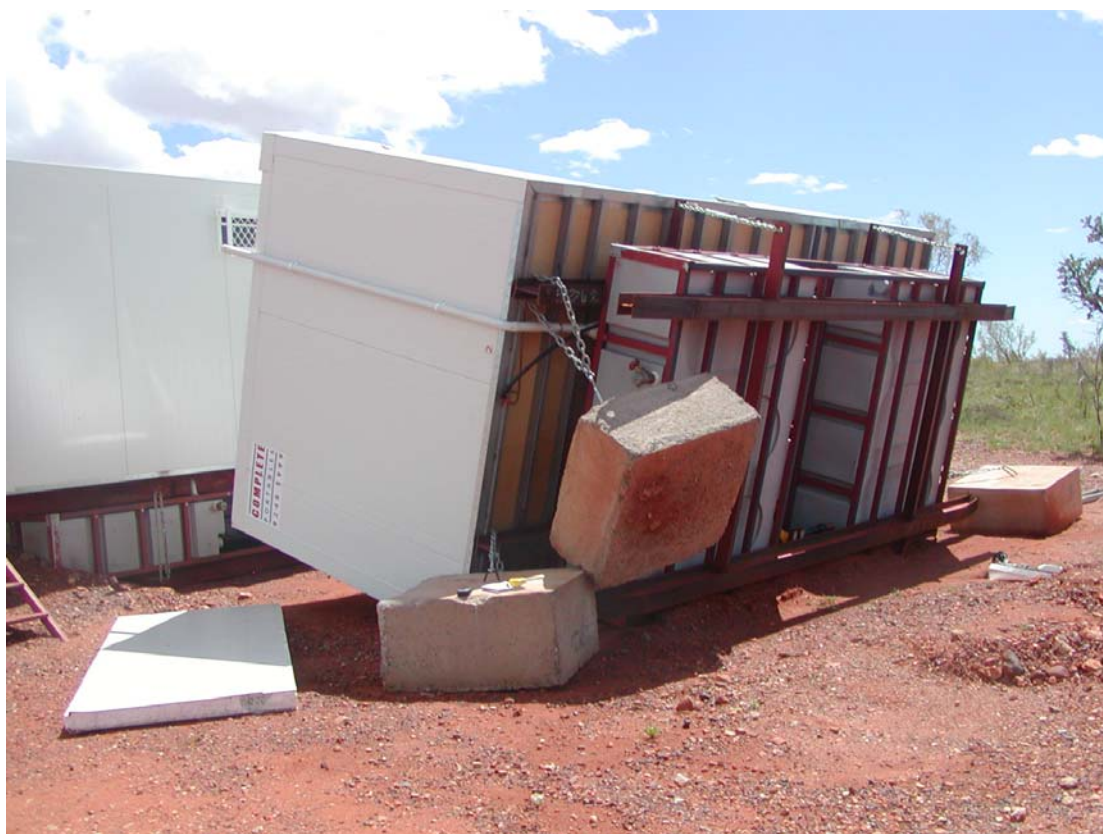
A transportable toilet block near the Turner River (around 4 km North of FMG Rail Camp 1) was overturned by the winds. Figure 3.7 shows a photograph of the overturned building with the large concrete block used to secure it.

Figure 3.7 Overturned toilet block North of Rail Camp 1

The toilet block had heavy concrete blocks on 3 corners, but in the direction from which the wind was blowing there was only one concrete block which could counter the wind forces. It had lifted off the ground.

Fortunately, Table 3.2 shows that the estimated lower bound wind speed is not highly dependent on the volume of fluid in the tank. Also measurements of the length of the chain securing the concrete block indicates that the slack would be close to 0.3 metres. This indicates a lower bound wind speed of around 180 kph.

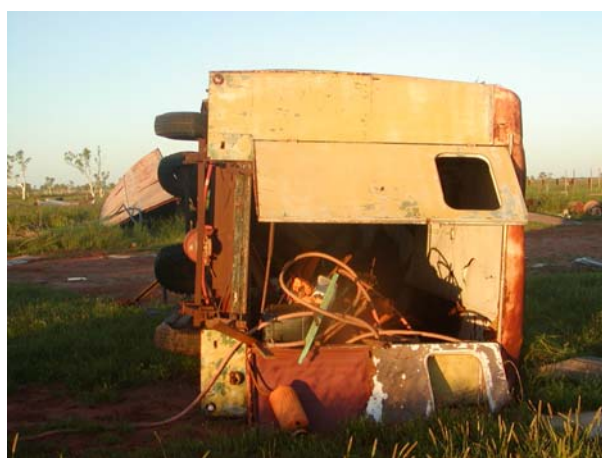
These vehicles are illustrated in Figure 3.8. Attempts to use them as “windicators” [3] were unsuccessful as the flexibility of the tyres and suspension was unknown, and proved critical in the calculations. As well the drag on the cattle trailer was difficult to determine due to the porosity of the sides.

Best estimates at the calculation yielded lower bound wind speeds of around 145 kph. The other damage at De Grey station was commensurate with wind speeds well in excess of this value.

(a) overturned bus

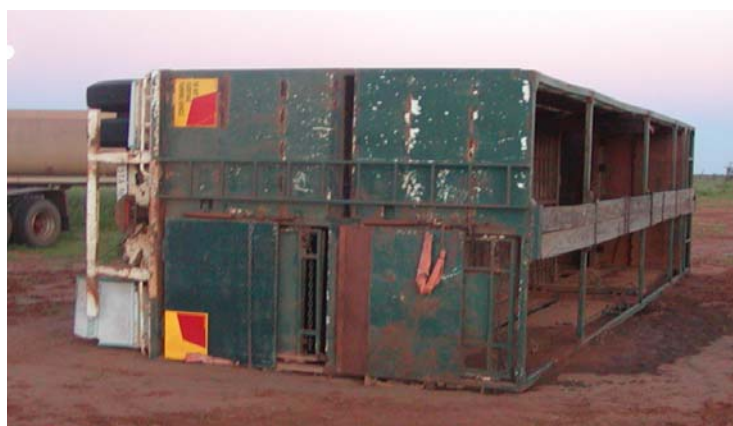
(b) overturned empty cattle trailer
