Tropical Cyclone Larry

Tropical Cyclone Larry crossed the North Queensland coast in the early morning of Monday 20th March 2006 and caused severe damage to infrastructure and crops in the Innisfail region. Wind damage was reported by the media well into the Atherton Tablelands and flooding was reported in the Innisfail area, the Tablelands and into the Gulf country.

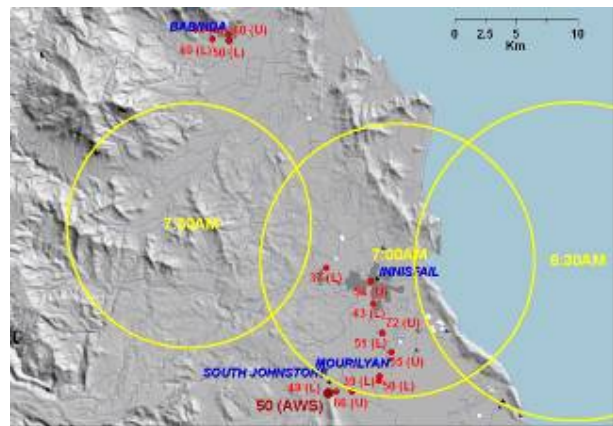
Simple structures (e.g. road-signs) were used to estimate upper and lower bounds of peak gust wind speeds at different locations in the study area. Undamaged sign posts give an upper bound to the wind speed as the signs resisted the wind loads, while bent posts give a lower bound to wind speed as they failed during the event.

The maximum gust wind speeds (referenced to flat open country at a height of 10 m) across the study area were estimated to range from 50 m/s to 65 m/s.

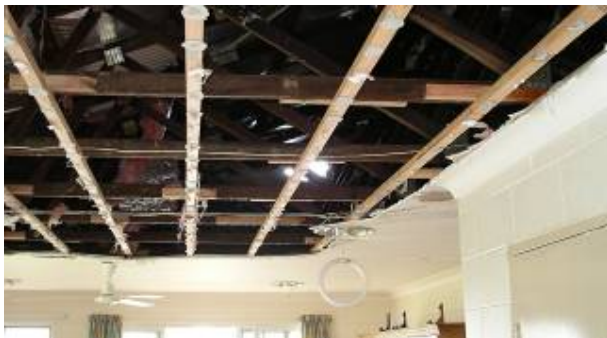
Housing constructed since the mid 1980s performed well, structurally. This is to be expected due to the contemporary housing having a regional design wind speed greater than the event wind speed. The main source of structural damage to newer construction was from wind driven debris. For a small number of cases, poor detailing led to loss of structural elements. In general, garage doors performed poorly leading to water ingress, internal pressurization and subsequent damage. The loss of flashings, guttering vents and soffits also contributed to water ingress, which on occasion resulted in the collapse of the ceiling. Such collapse could lead to structural problems if the ceiling is relied upon to provide diaphragm action to link bracing walls.

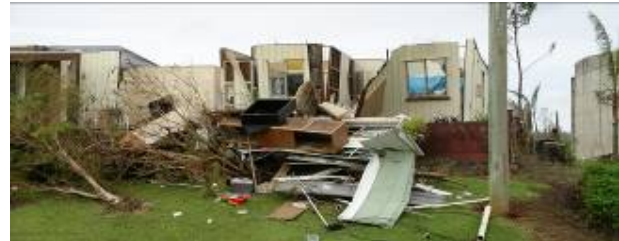
Increase in wind speeds due to speed up over steep topography did cause increase in damage to buildings. This was more apparent in the older housing. However there were a few cases of damage to contemporary houses, where the construction details were inadequate for the site topography. This highlights the need for each building site to have the topographic wind speed modifiers (AS/NZS1170.2, or AS4055) correctly specified.

Also, in assessing the topographic and terrain effects in tropical cyclone areas, the sheltering effects of vegetation should be ignored. This is because it invariably is denuded by winds less than the design wind velocity.

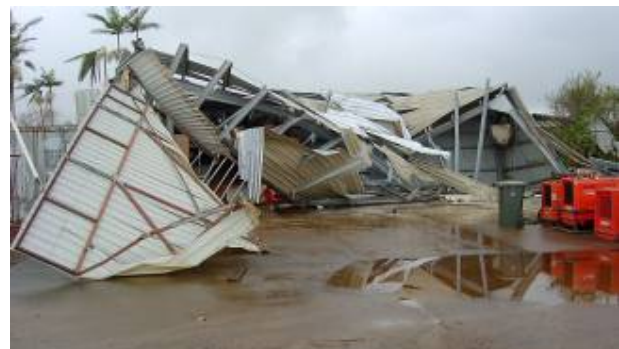
Most commercial and light industrial buildings surveyed had some form of damage including water ingress, loss of flashings, roller door failures, cladding loss, and in some cases, structural frame failure. Apparent poor detailing of structural connections contributed to failure of some structures. A street side assessment of cold formed industrial sheds showed that approximately 30% of these engineered structures suffered loss of cladding through to complete collapse. This is at wind loads less than the region's design wind speed where structural failures should not be expected. For 60% of industrial sheds surveyed, that had roller doors were fitted, the roller doors had failed. Designers need to assume that a dominant opening (such as roller door failure) will occur, causing a large internal pressure. Poor construction practice and minimal maintenance lead to failure from corrosion of cladding and frame elements. The failure of such engineered structures, at wind speeds less than the regions design wind speed is a cause for concern.

- A significant number of sheds suffered structural damage. The failure of engineered structures, at wind speeds less than the regions design wind speed is a cause for concern. Continuing education of designers and manufacturers in wind loading details is required.
