# Tropical Cyclone Yasi Structural damage to buildings

**CTS Technical Report No 57**

April, 2011

Cyclone Testing Station  
School of Engineering and Physical Sciences  
James Cook University  
Queensland, 4811, Australia

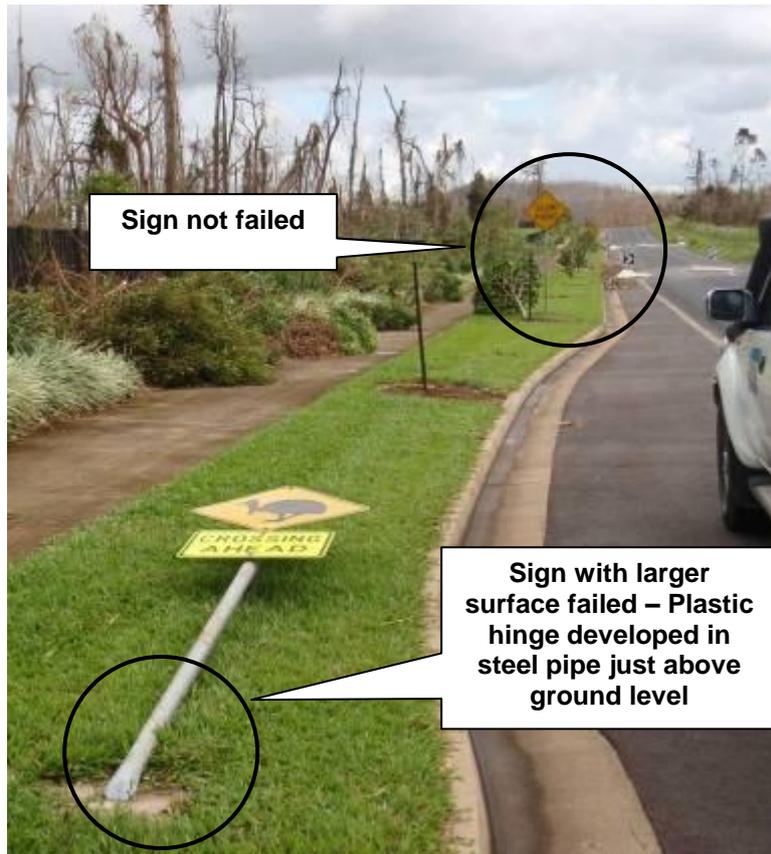
Over a 100 failed road signs were inspected during the course of the field investigation. Many of these were found to have failed as a result of a footing failure and were ignored. Detailed dimensions were obtained from those that had shown a permanent deformation resulting from generation of a plastic moment at, or near, ground level. In those cases, a suitable non-failed sign was sought in the general vicinity, although this was not always possible. In this way, lower and upper limits of gust wind speed were derived.

**Figure 2.1 Failed road sign with increased signage area compared to upright sign in background**

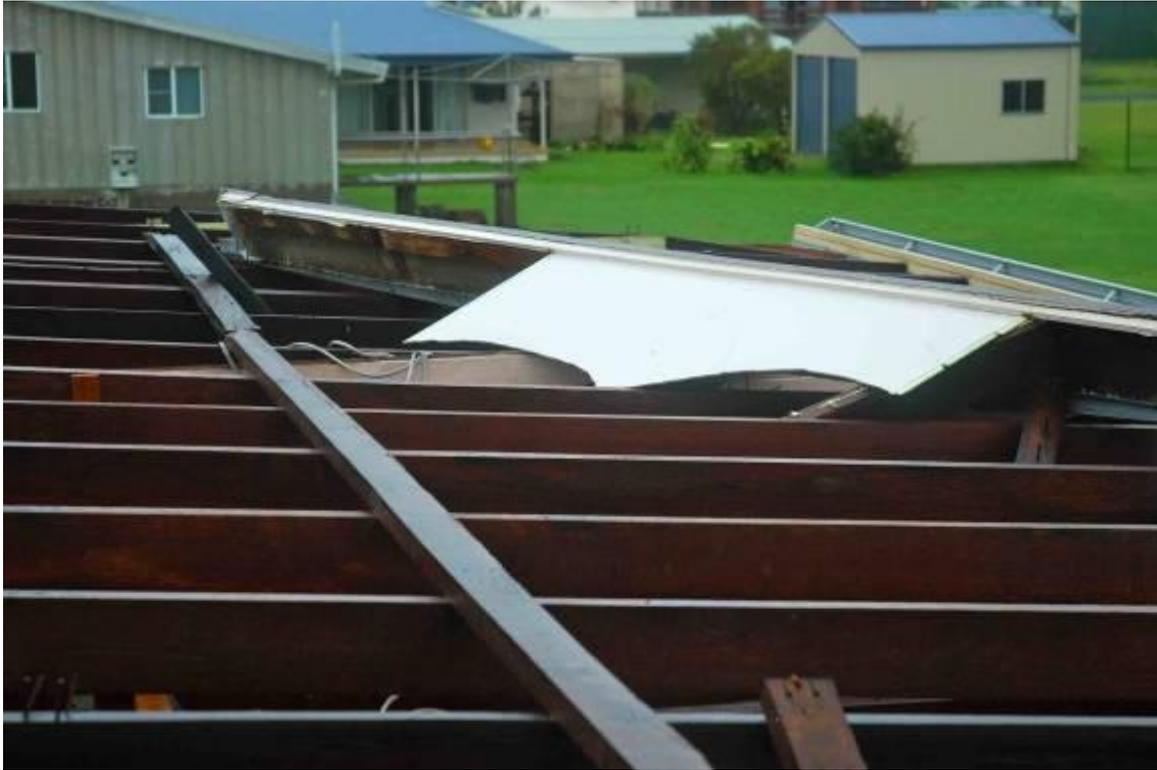
- Replaced buildings had a 2 in 4 success rate from the small sample, and
- Repairs had a lower success rate of 1 in 3 from the small sample.

**Figure 3.7 Roof and batten loss for a second time**

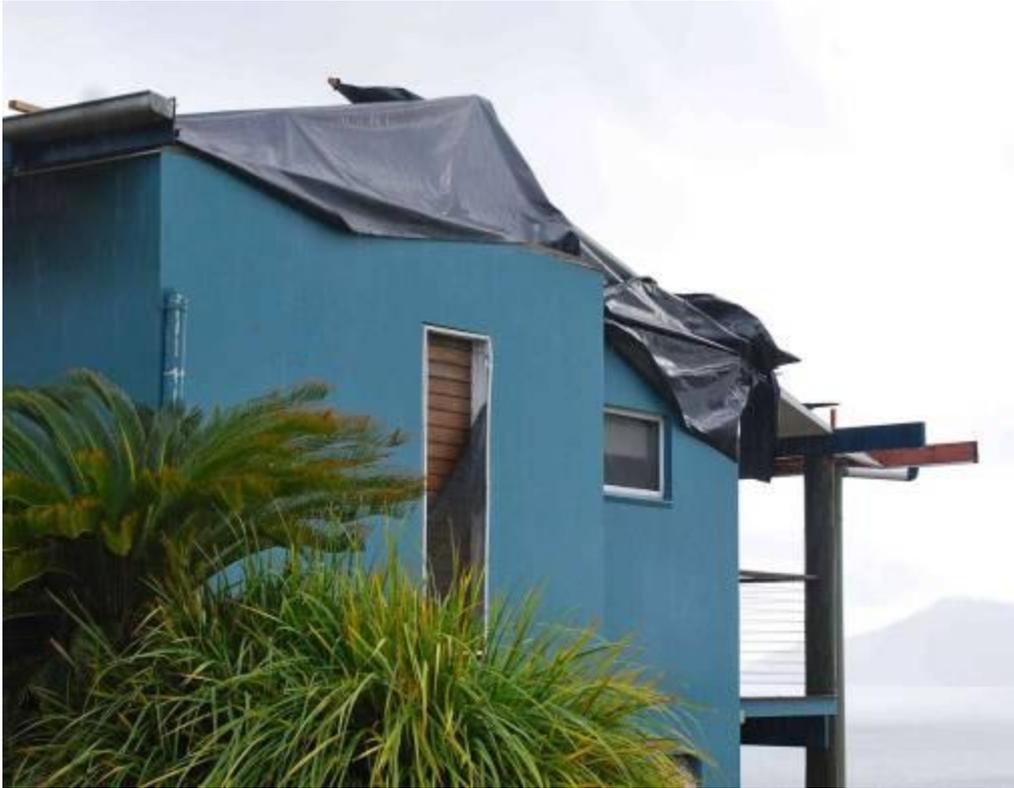
While no formal attempt was made to examine the repairs to buildings damaged in TC Larry in other areas, in four other cases, when discussing damage to a house with the owner or a friend of the owner, the CTS inspectors were made aware that the damage sustained in TC Yasi was similar to the damage in TC Larry.

**Figure 3.8 Same gable lost in TC Larry and TC Yasi**

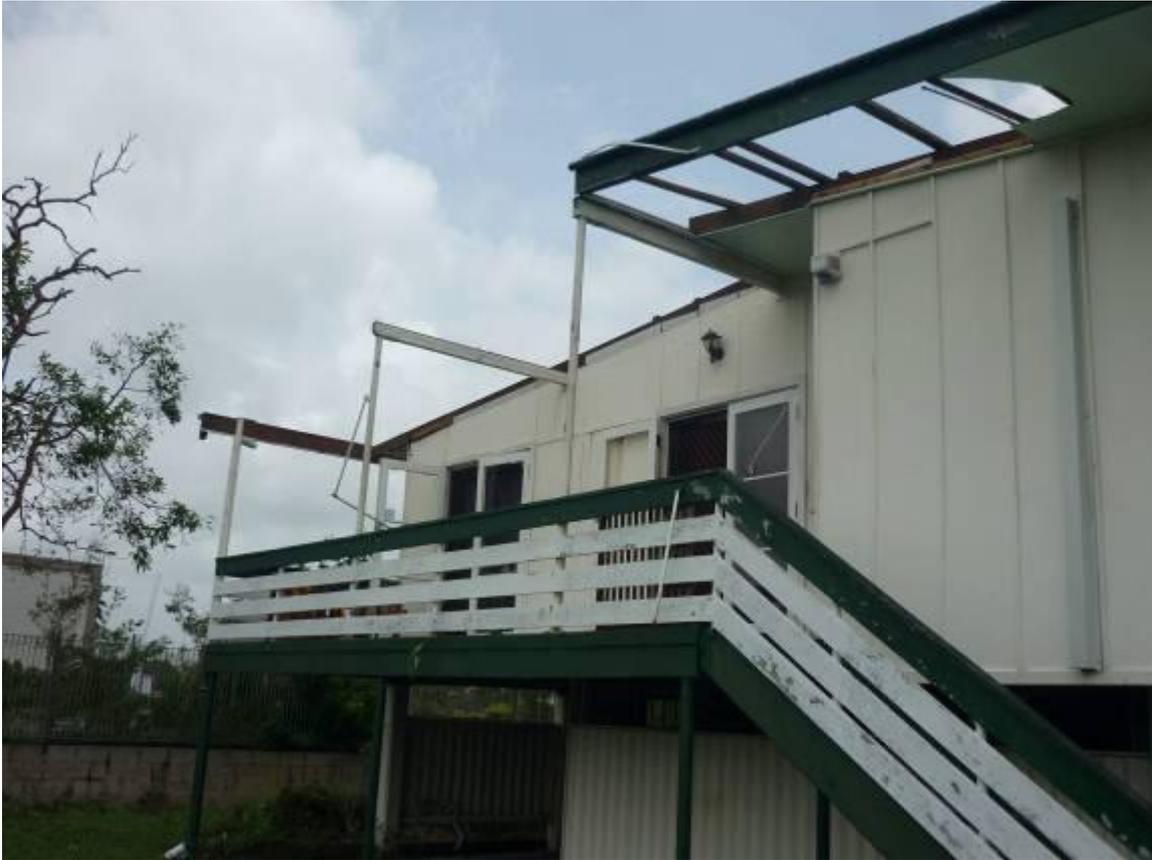
Figure 3.9 shows a high-set fibre-cement 12 m x 8 m house in Townsville where peak gust wind speeds were estimated as 55% of the  $V_{500}$  wind in AS/NZS1170.2:2002, with a low slope corrugated steel roof cladding fixed every 4<sup>th</sup> corrugation with one 75 mm nail to 75 x 40 mm battens spaced 900 mm apart. These battens were nailed with two 75 nails to 125 x 50 mm rafters spaced 1100 mm apart. The failure of a glass pane created large positive internal pressure pushing-in the ceiling access-hole and lifting all the battens with the cladding attached and depositing it approximately 25 m downwind. The member sizes and spacings were appropriate for the estimated wind loads, but the connections were not.

**Figure 3.9 Batten to rafter failure at 55% design wind speed**

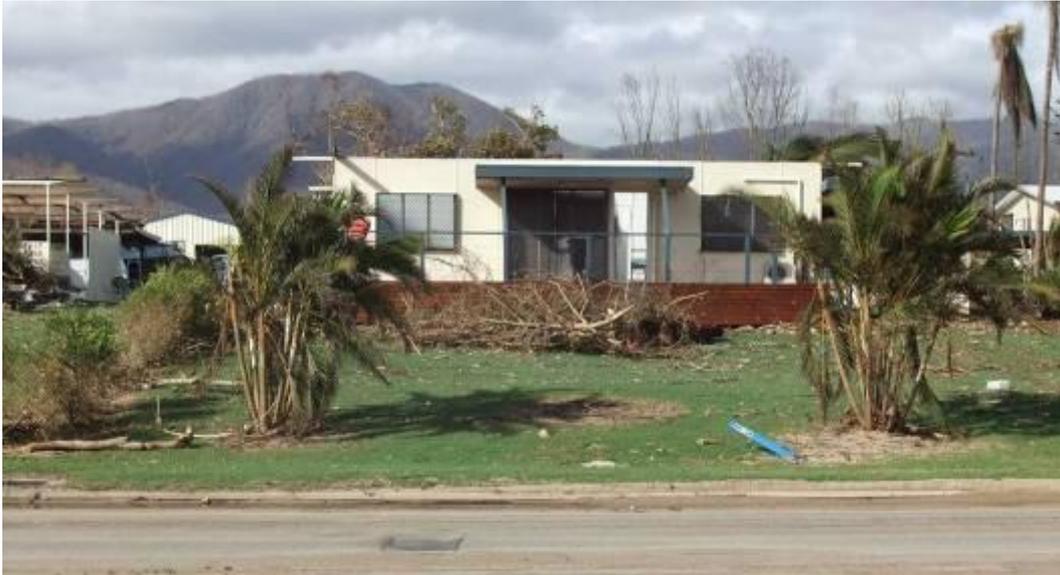
The roof structure suffered significant damage. The failure of the door lock for winds normal to that wall created a dominant windward opening and generated large internal pressure which contributed to the failure of the entire roof. A significant part of the roof travelled a distance of about 100 m downwind over neighbouring houses and impacted a 2-storey recently constructed house damaging its envelope. Figure 3.11 shows parts of the roofing with battens still attached that impacted the new house. As for the house in Figure 3.9, the weaknesses in this house were the connections. Member sizes were adequate, so had the connections been upgraded, the roof structure would have been sufficient to resist the estimated wind loads. This house had metal screens over the windows, but still was exposed to internal pressures from dominant openings because of failure in door furniture.

**Figure 3.10 Roof loss after door failure**

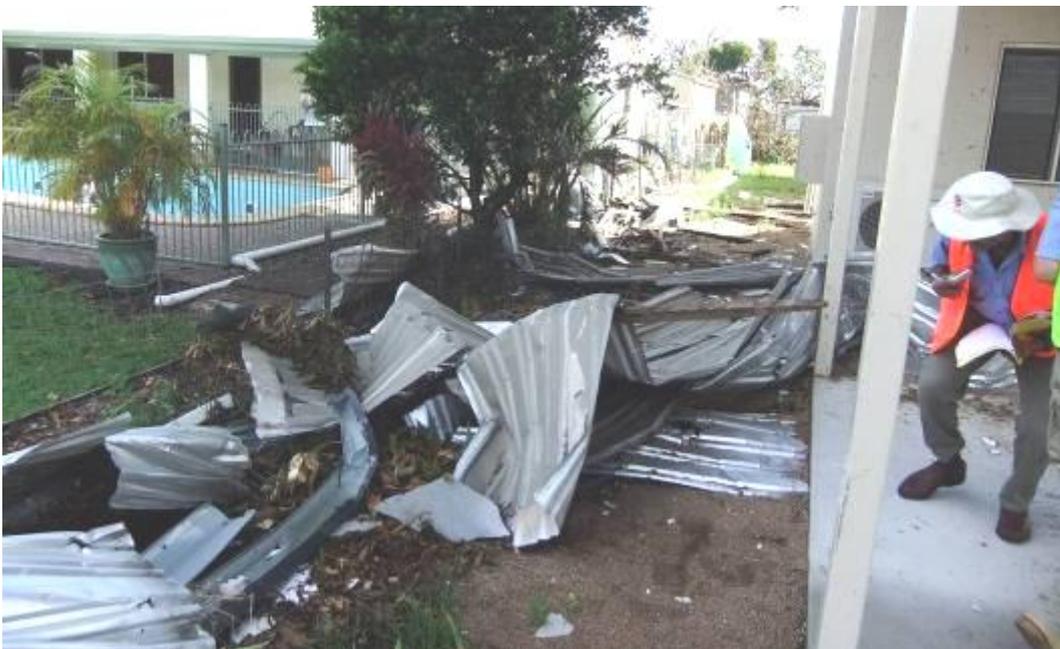
**Figure 3.11 Roofing with battens attached from house shown in Figure 3.10**

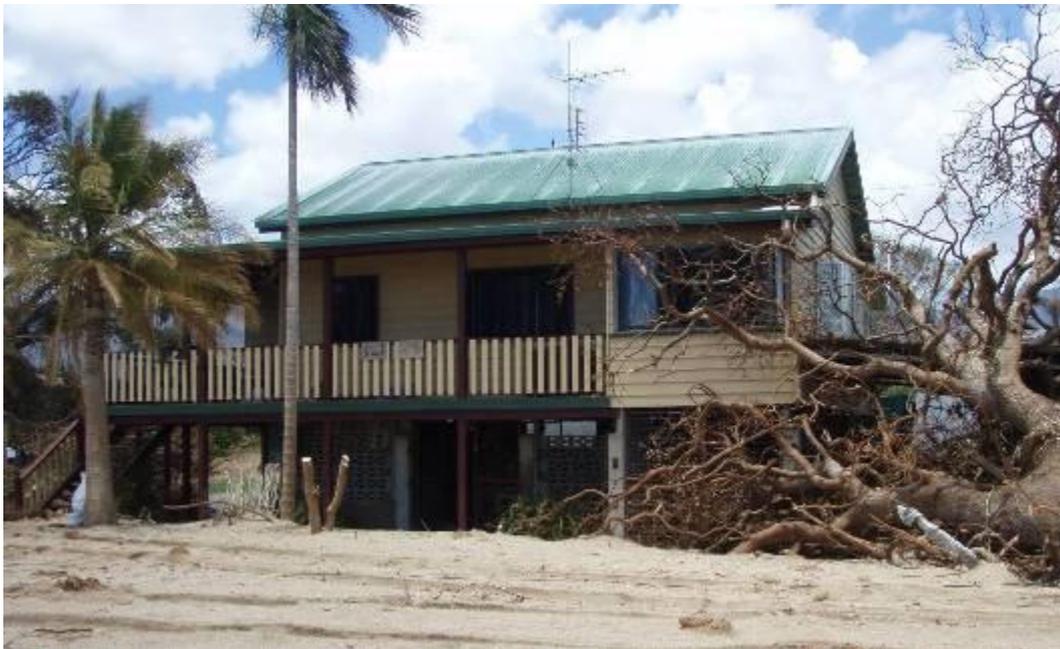
**Figure 3.13 High exposure site with minimal damage to Pre-80s house**

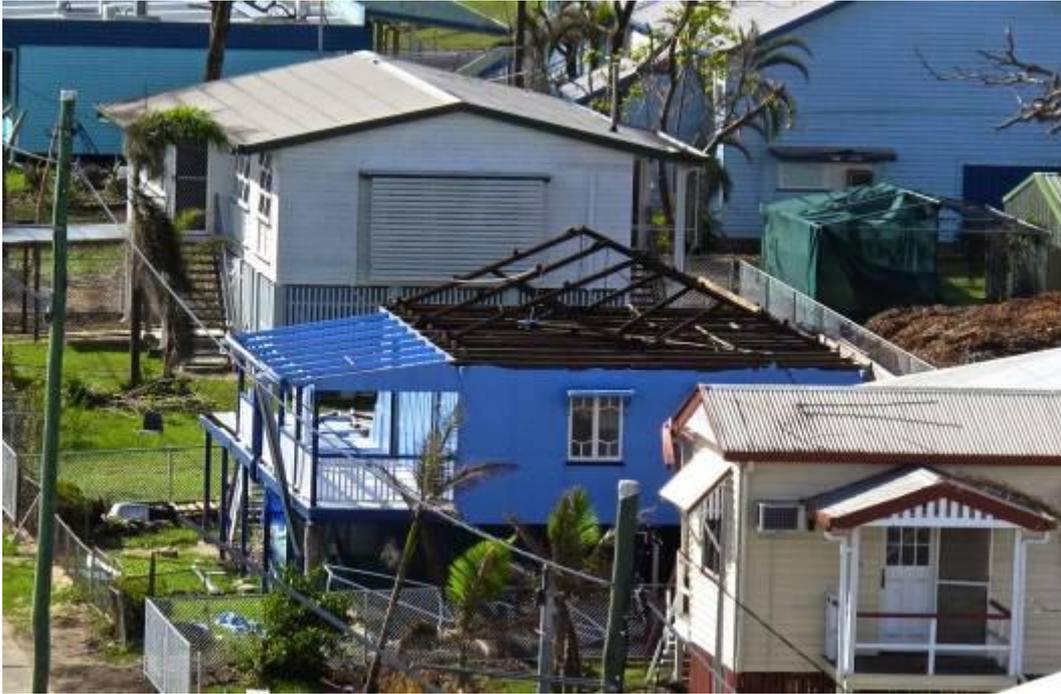
**Figure 3.14 mixed performance of Pre-80s housing**

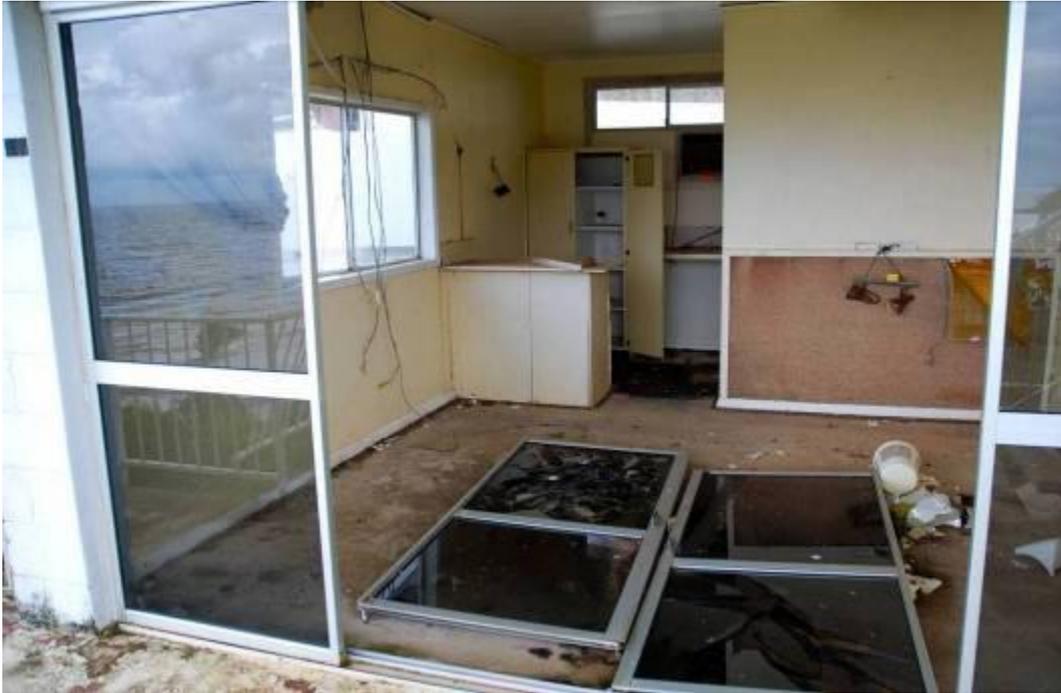
In both of these cases, there was no sign of any debris impact. Both types of failures had been caused by differential air pressure.

**Figure 3.16 Sliding door and window glass failures**

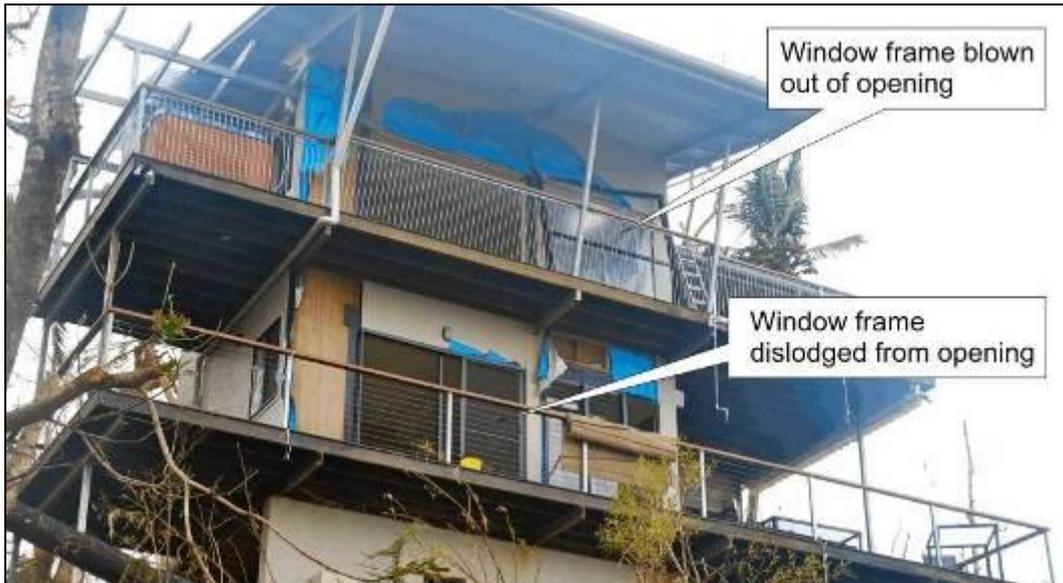
Figure 3.17 shows a modern house in an exposed location in which a number of window frames on the side wall (aerodynamically) of the building were sucked out of the building. A failure of some window glass under wind pressure on the windward wall allowed internal pressurization of the building that contributed to the failure of the large frames. This house was in a very exposed location and the frames should have been anchored against the required higher pressures.

**Figure 3.17 Loss of window frames under differential pressure**

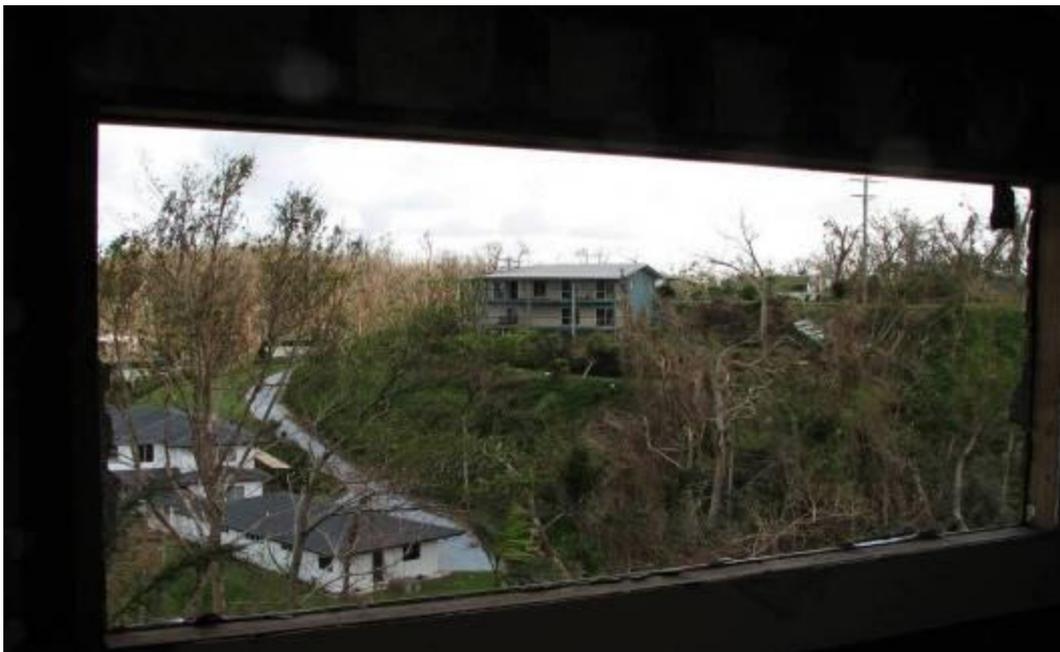
Two complete timber casement window frames detached from the supporting frame and were blown in on a Post-80s house as shown in Figure 3.18. The connection between the timber window frame and the timber house frame was inadequate. The failure of the windows resulted in significant water ingress.

**Figure 3.18 Window frame failure due to inadequate anchorage**

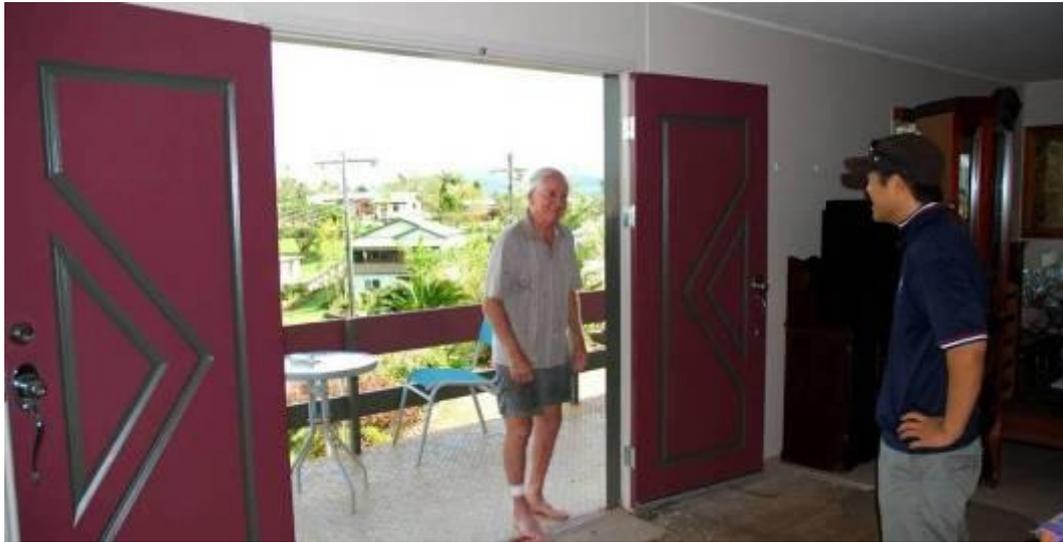
securing the keepers for these bolts all failed (see Figure 3.6) and allowed the doors to swing inwards. In this case the load on the doors was substantially less than the design loads on the house. Significant water damage followed the failure of the door latch.

**Figure 3.19 Door furniture failure**

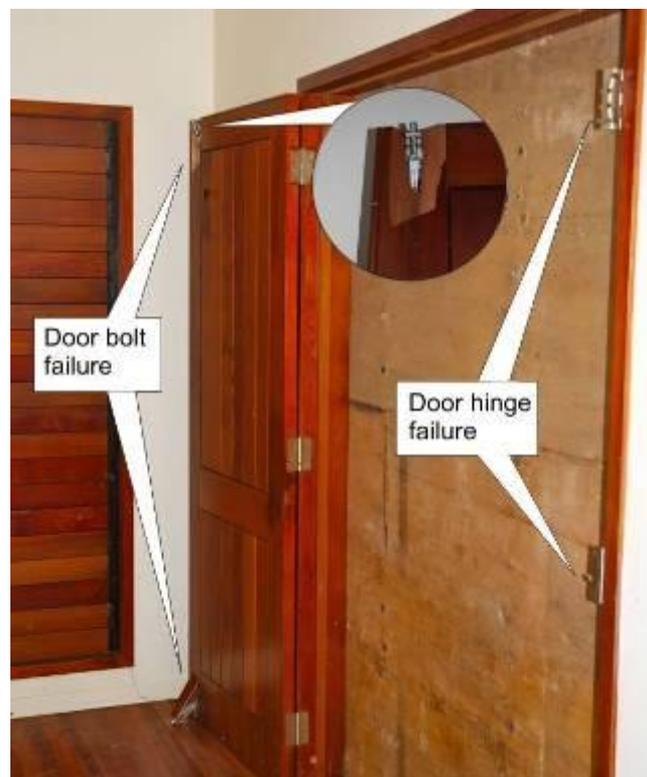
While this detail was very simple, a similar sized opening with semi concealed barrel bolts in a pair of solid doors failed because the bolts broke out of the door under lateral loading as shown in Figure 3.20. There did not appear to be any contributing impact damage on the doors. The swinging of the now unrestrained doors contributed to one the doors tearing off its hinges. In both of these cases, the failure of the furniture contributed to a dominant opening in the building envelope.

**Figure 3.20 Door bolt and hinge failure**

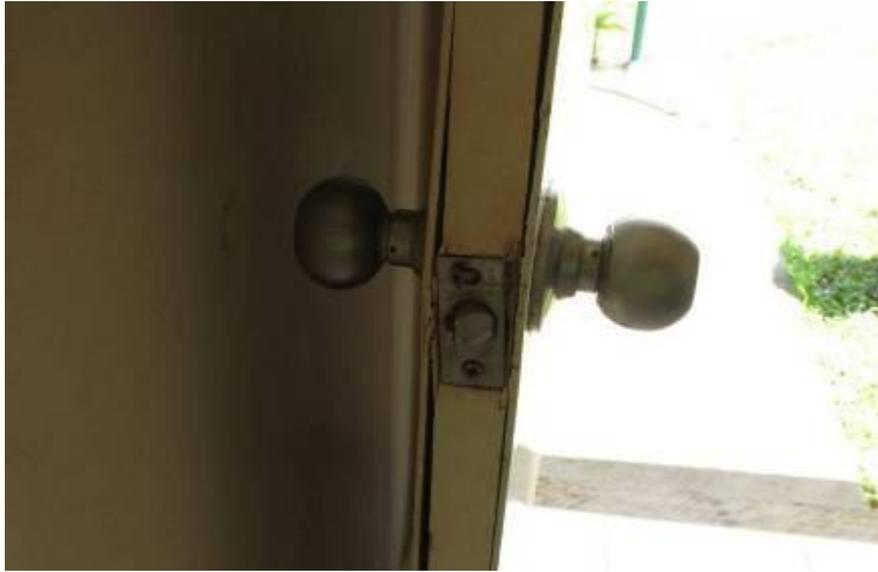
Figure 3.21 shows a door furniture failure that caused damage to the entire hollow core door. Here the forces on the lock had pried the inner and outer faces away from the frame.

**Figure 3.21 Failure of door around the lock**

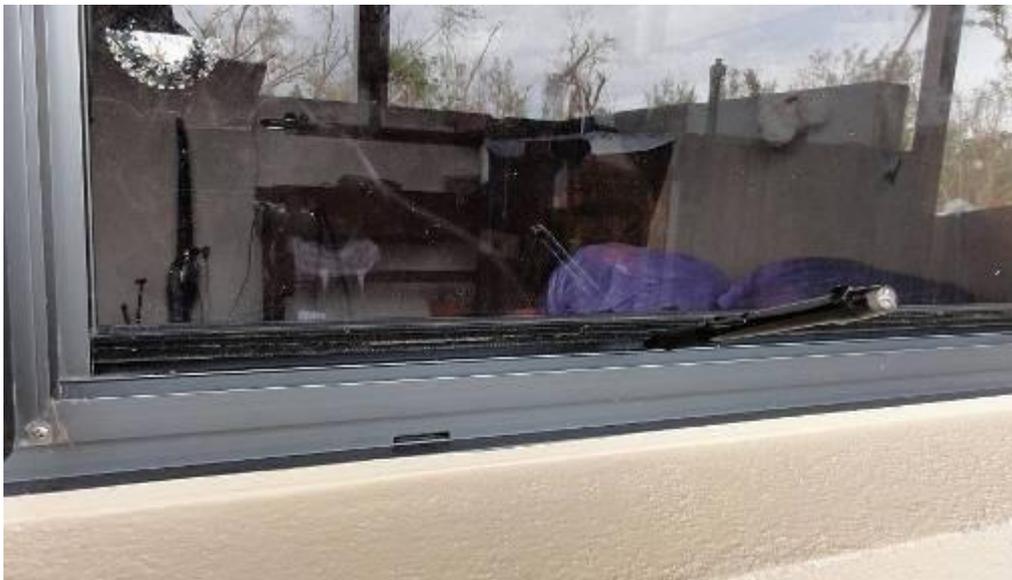
The investigation also found window furniture failure associated with locks and movement of windows within frames. Figure 3.22 shows a sliding window that had been lifted by the applied wind pressure, causing it to become jammed in the opening. While it did not create a large opening, a narrow opening (highlighted by the pen) will contribute to water ingress.

**Figure 3.22 Jamming of window in the frame**

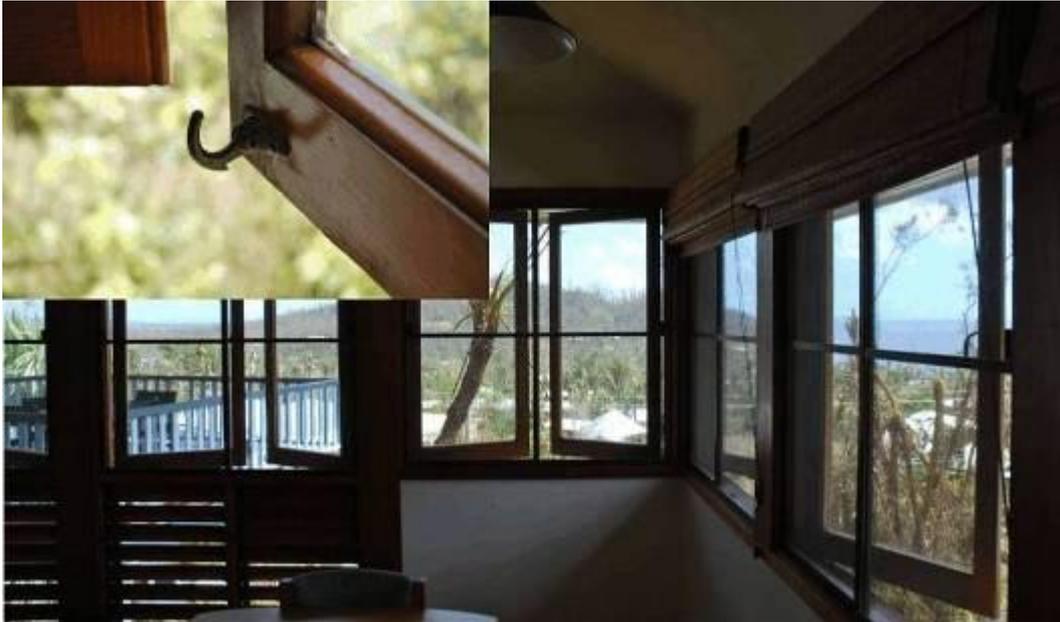
Figure 3.23 shows some catches that opened during the maximum winds without causing any permanent damage to the latch, the window or frame. The latch may have opened due to flexing of the Western Red Cedar timber frame. On some larger Western Red Cedar doors, the flexing had cracked the glass.

**Figure 3.23 Window latch disengagement**

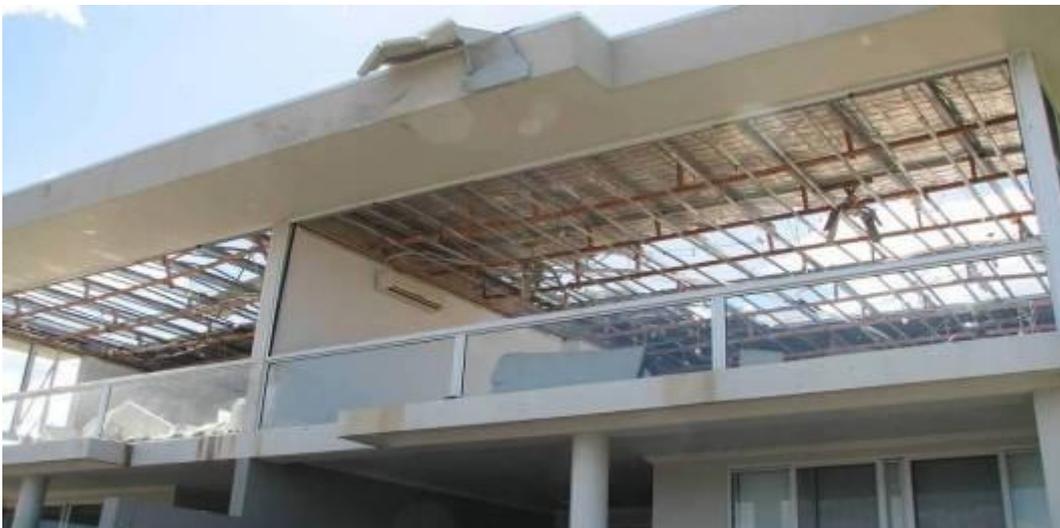
Damage to window and doors during cyclones can create a dominant opening and allow large internal pressures that may lead to the failure of the roof system. Figure 3.24 shows a building in which windows 7.7m wide were blown in. The loss of windows allowed the wind to internally pressurise the units causing loss of the roof cladding and failure of the first internal beam connection to the wall.

**Figure 3.24 Consequences of window failure**

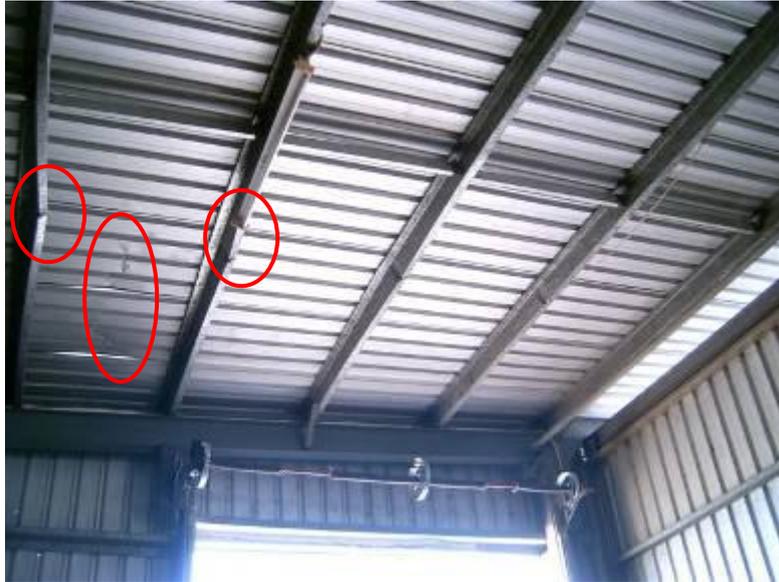
Many roller door failures were observed in which the door had become first disengaged from the guides, then detached from the drum and become wind-borne debris. Figure 3.27 shows a door that has damaged the roof of the shed (highlighted with the red ellipses) after becoming disengaged from the guides and then detaching from the drum.

**Figure 3.27 Roller door detachment from drum**

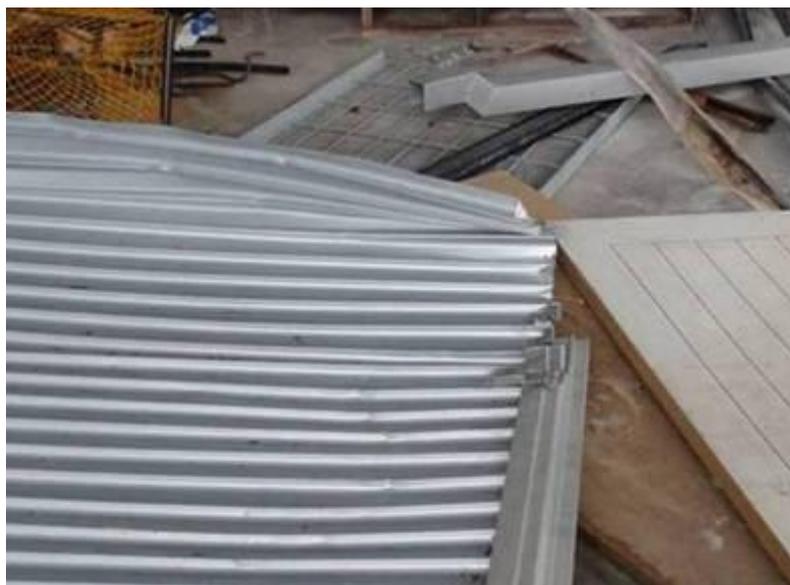
Wind locks anchor the edges of the door curtain to the guides and enable the deflected door to develop in-plane tensions. The deflected door uses bending and catenary action to carry the wind forces to the sides of the opening. The tension force develops secondary forces in the guides that must be successfully transitioned to the rest of the structure and safely carried to the ground. Where wind locks are used, it is essential that the guides and the supporting structure are designed to accept the large lateral forces (forces in the plane of the door) than can occur in a severe wind event.

**Figure 3.28 Roller door guide failure**

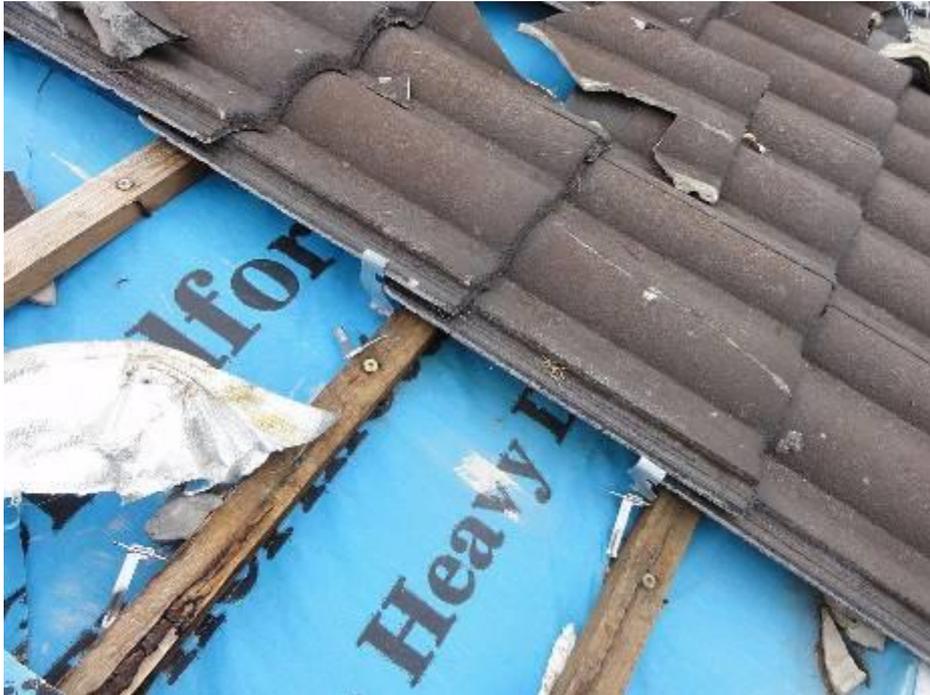
the battens next to the heavier gauge galvanized clips installed for the re-roof after Cyclone Larry. A neighbouring tiled roof house also suffered loss of tiles.

**Figure 3.32 Failed tile roof with clips from initial installation and an upgrade**

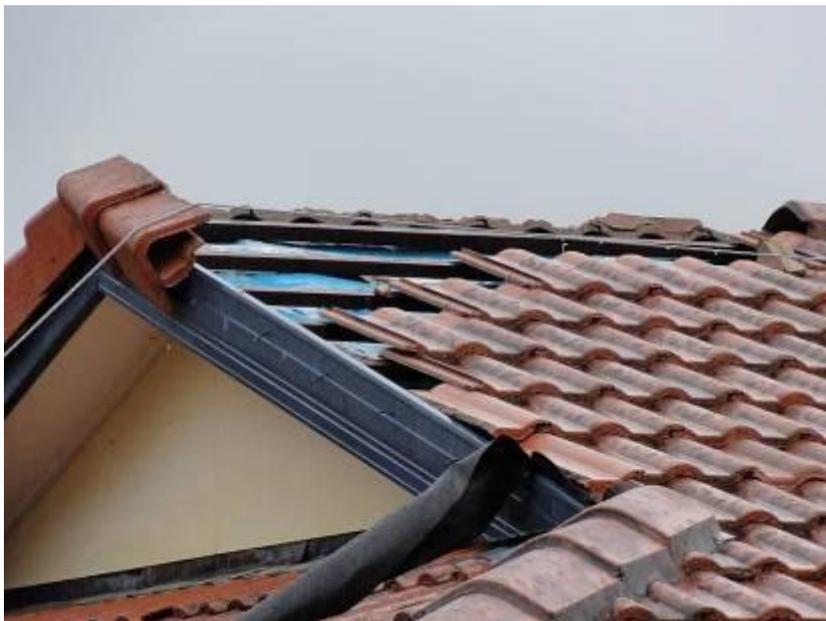
A number of damaged tile roofs had lost ridge (both apex and hip) capping. An example of a house in a C2 site is shown in Figure 3.33. On this house and on most that had lost ridge capping, no mechanical fixings such as clips or screws on the ridge tiles were observed. The fixing method appeared to be the flexible pointing adhesive. The dislodgement of the ridge or other tiles generally led to additional damage to the tile roof and to adjacent structures. The barge tile fixings can be seen still in the fascia.

**Figure 3.33 Failure of ridge capping**

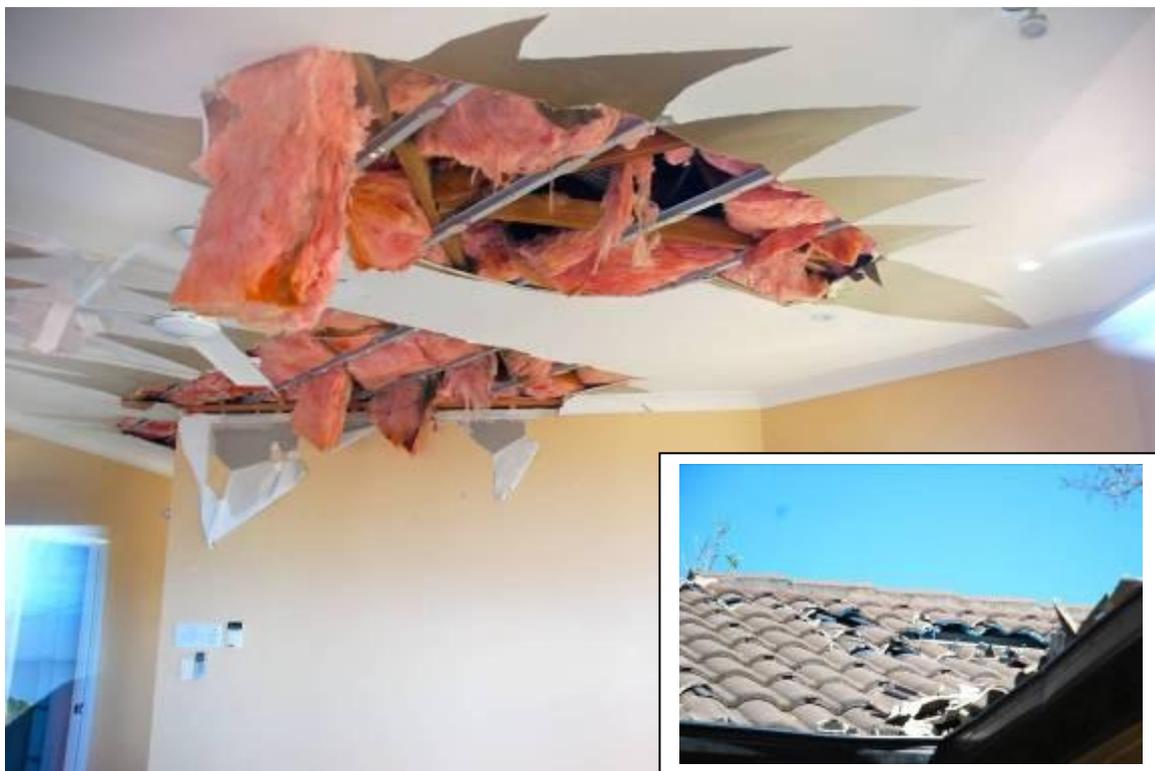
Loss of tiles causes debris damage to the same roof and this can put holes in the sarking and allow water to enter the ceiling space. Most houses with damaged tile roofs showed water damage to ceilings below the tile damage as illustrated in Figure 3.34. The inset shows the area above the ceiling damage on leeward side of roof where damage was caused by wind-borne tiles from the same roof.

**Figure 3.34 Ceiling damage under tile damage**

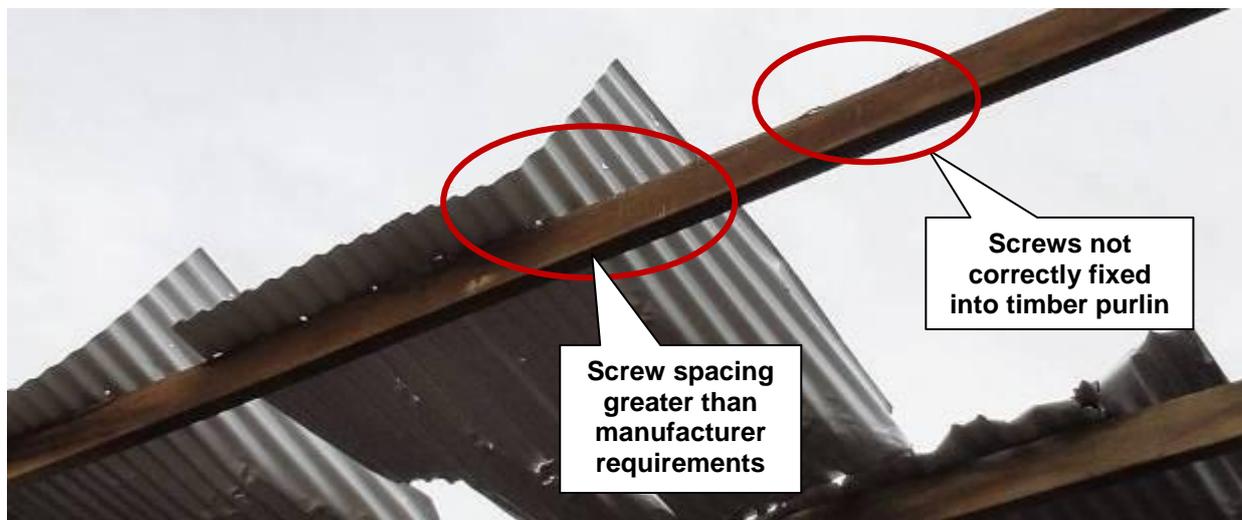
Figure 3.35 also shows that some fasteners have broken out of the side of the timber purlin. With only partial embedment, these fasteners did not have the necessary holding strength as and would have caused the adjacent fasteners to be overloaded.

**Figure 3.35 Large fastener spacings led to fatigue failures of sheeting**

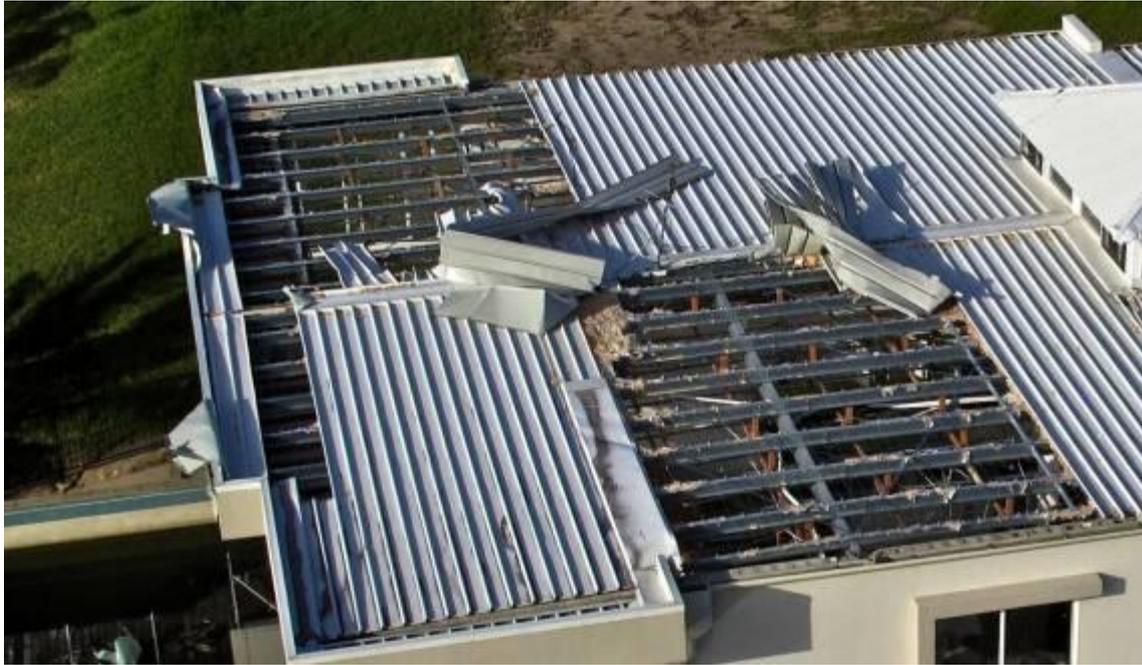
As for pierced fixed metal cladding, the failures observed involved systems that were not installed to specifications and in some cases flashing damage may have influenced the outcome.

**Figure 3.37 Failure of secret fixed roofing.**

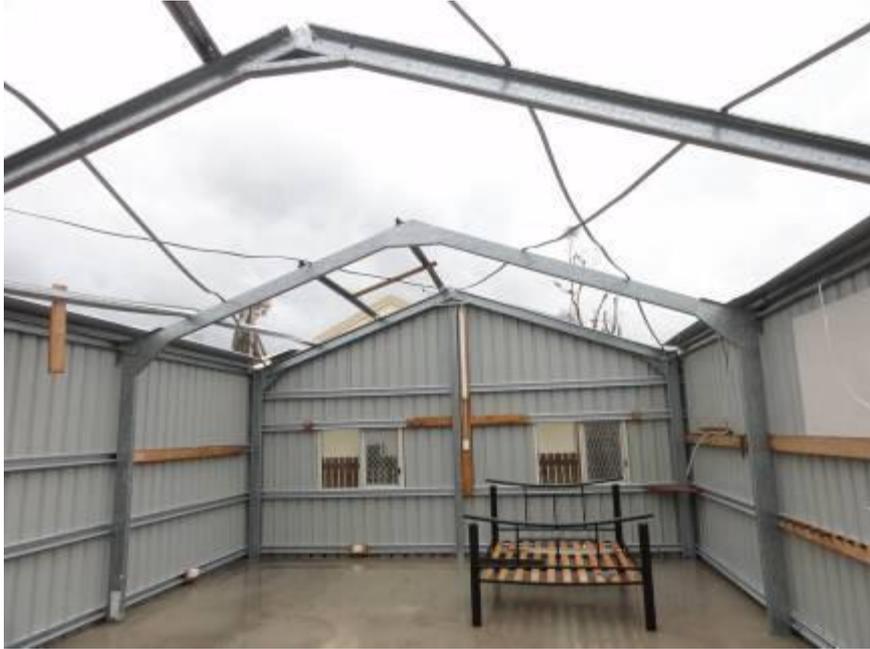
**Figure 3.38 Loss of roofing envelope after purlins buckled**

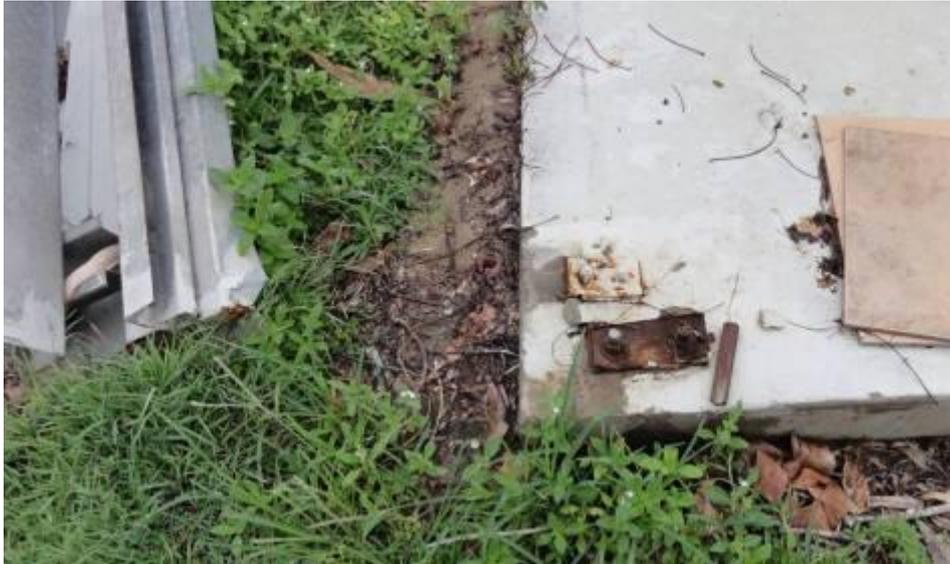
**Figure 3.42 corrosion of base plate previously welded to cold formed column**

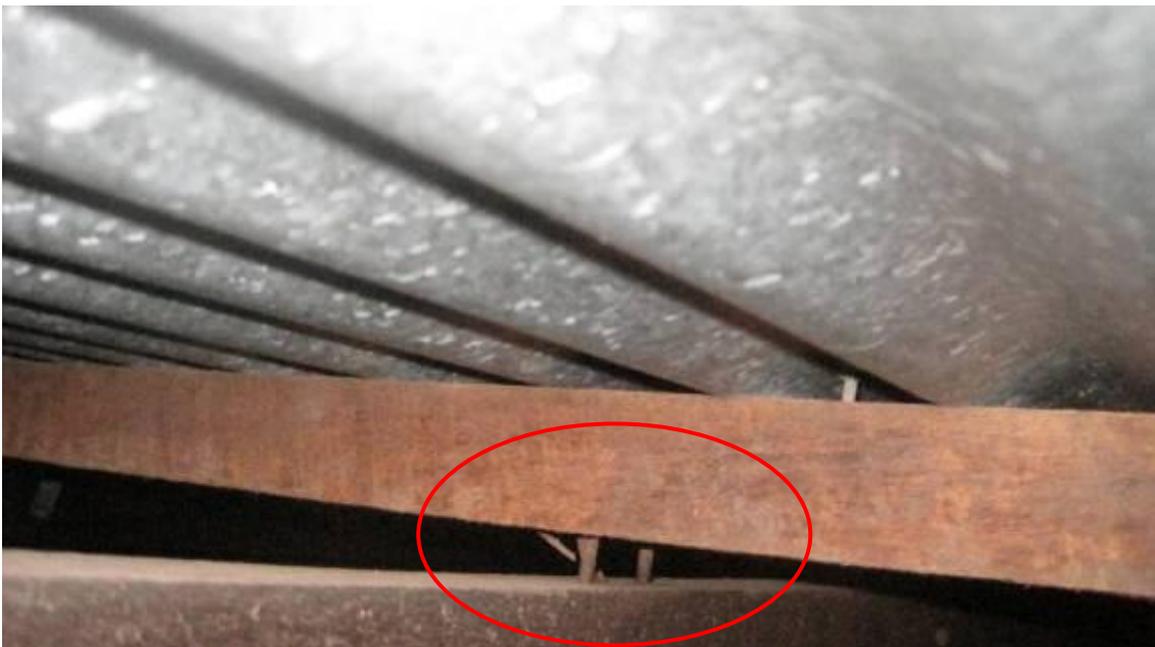
**Figure 3.43 Partial withdrawal of nails in batten to rafter connection**

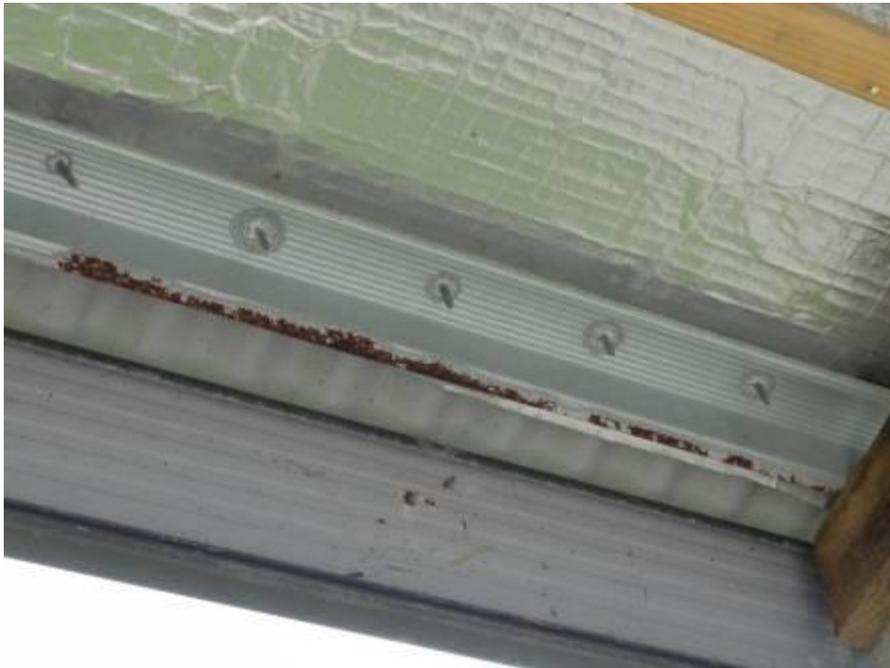
**Figure 3.44 Corrosion of eaves top hat section in beach-front house**

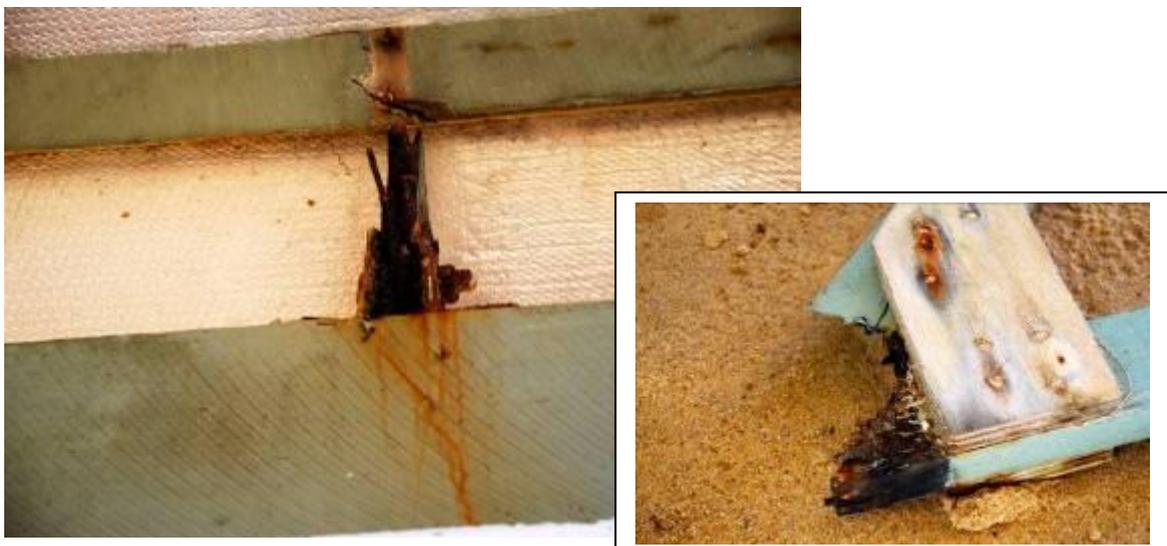
**Figure 3.45 Corrosion of nail plates and anchorages on a truss adjacent to the beach**

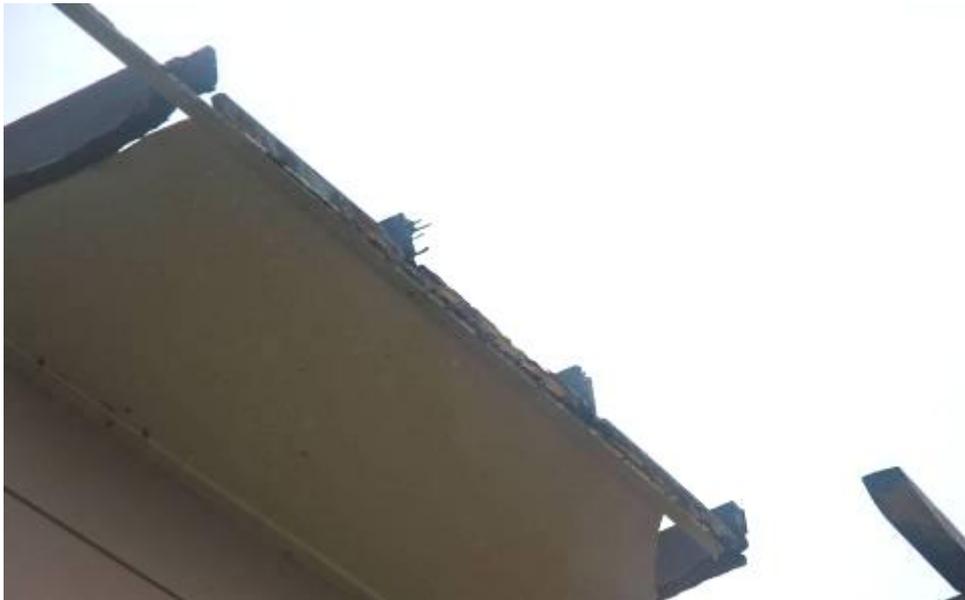
**Figure 3.46 Deterioration of timber at the very edge of a roof**

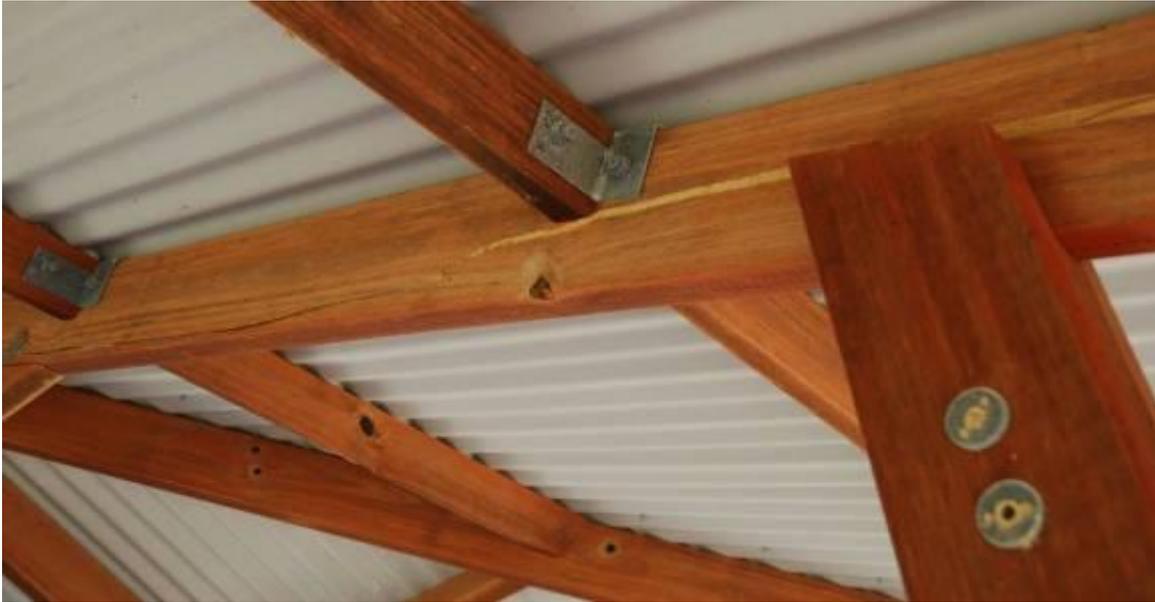
**Figure 3.47 Tension perpendicular to grain failure in rafter**
