# Tropical Cyclone Yasi Structural damage to buildings

**CTS Technical Report No 57**

April, 2011

Cyclone Testing Station  
School of Engineering and Physical Sciences  
James Cook University  
Queensland, 4811, Australia

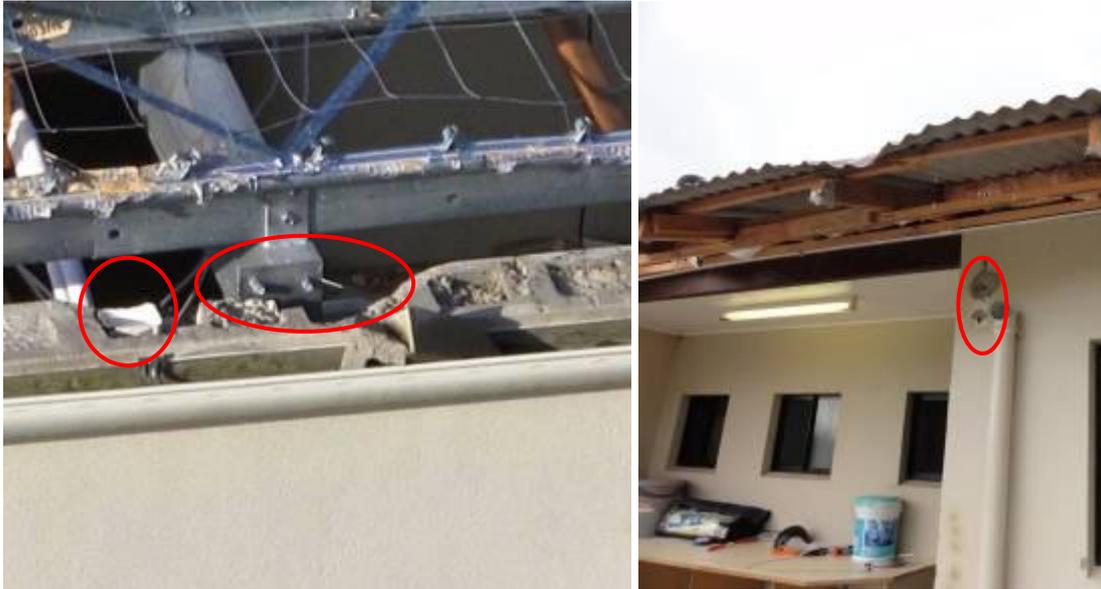
(a) between steel rafter and bond beam

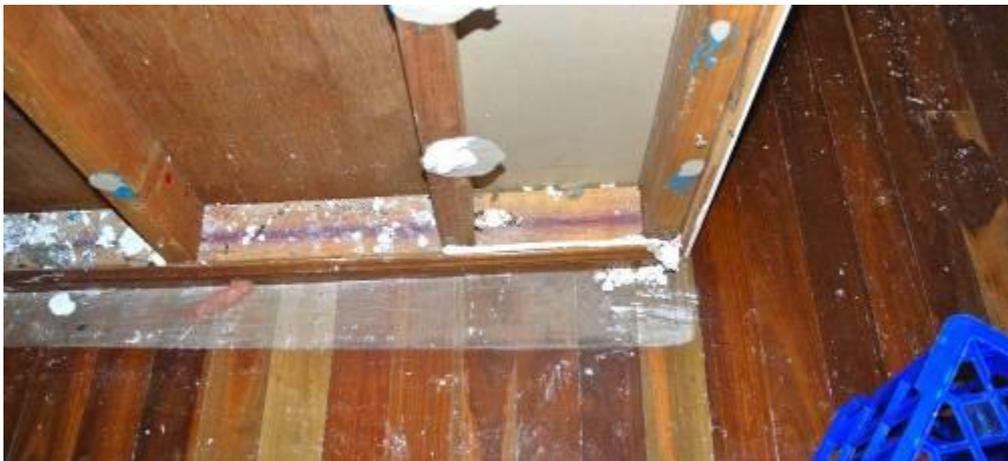
**Figure 3.49 Internal wall moved by differential air pressure**

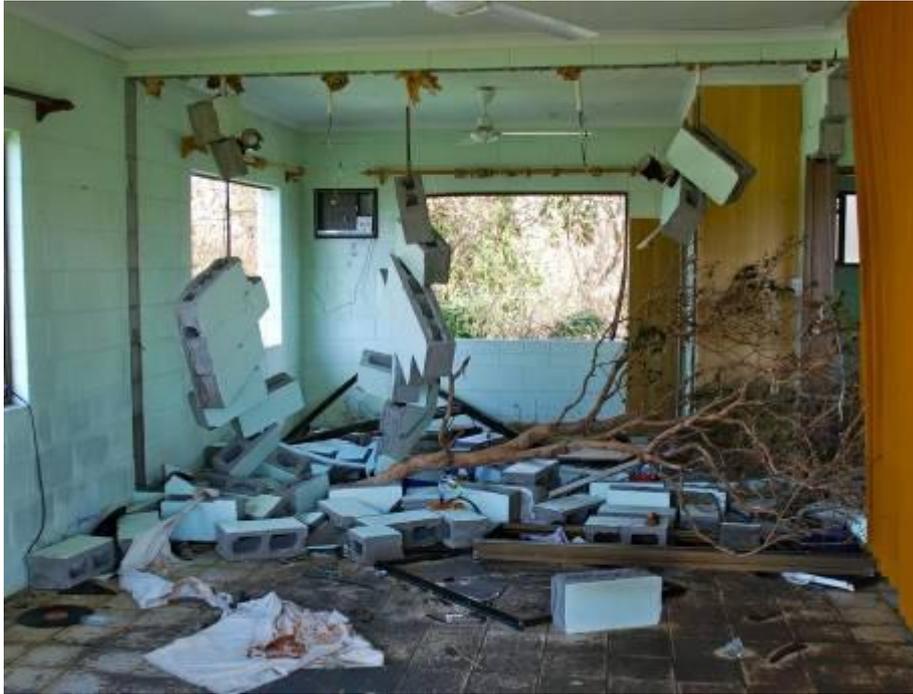
**Figure 3.50 Internal unreinforced blockwork under storm surge loading**

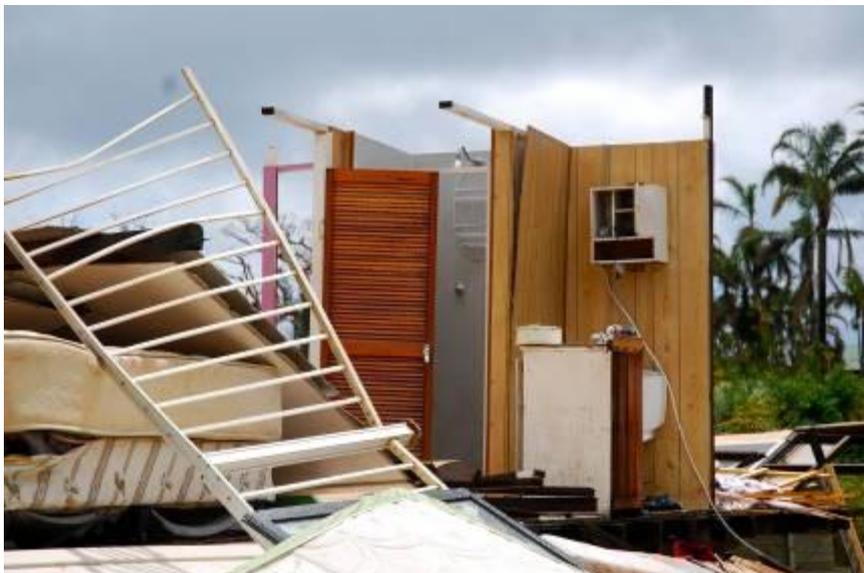
**Figure 3.51 Small rooms remaining after extreme wind damage**

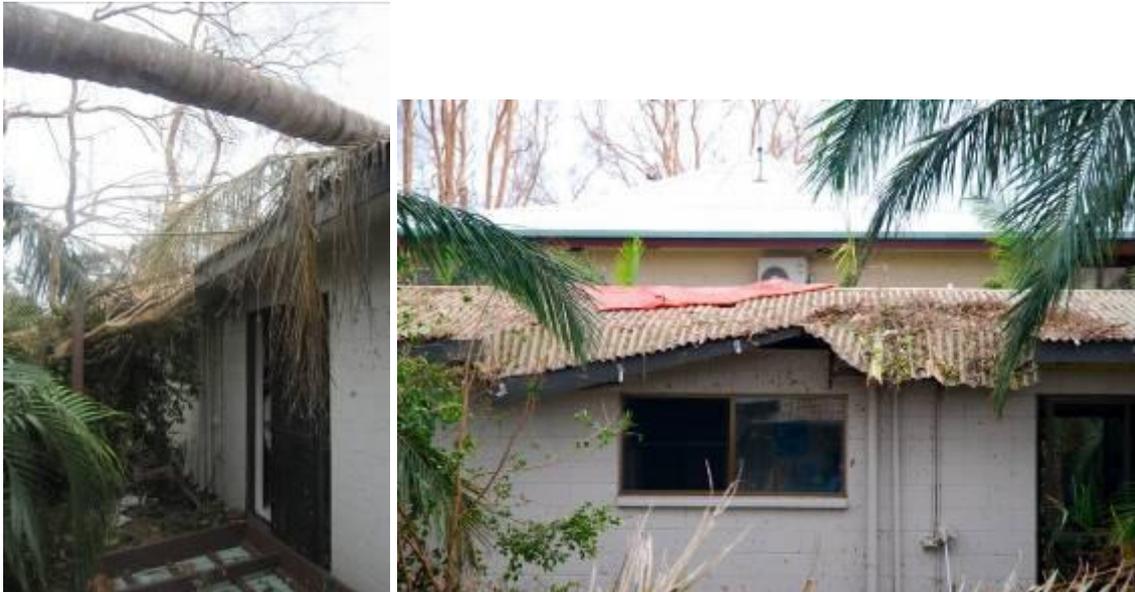
Figure 3.52(a) Tree damage to housing

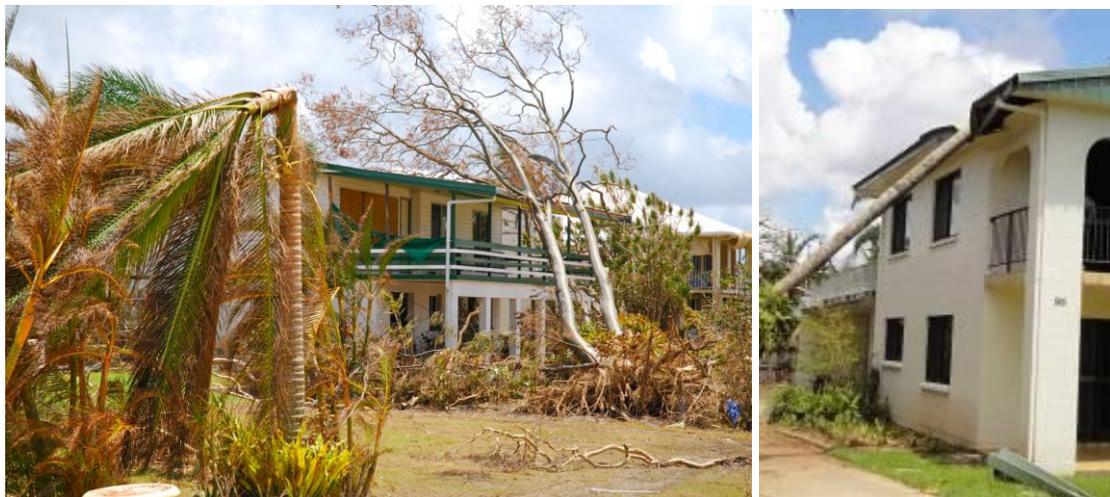
Figure 3.52(b) Tree damage to housing

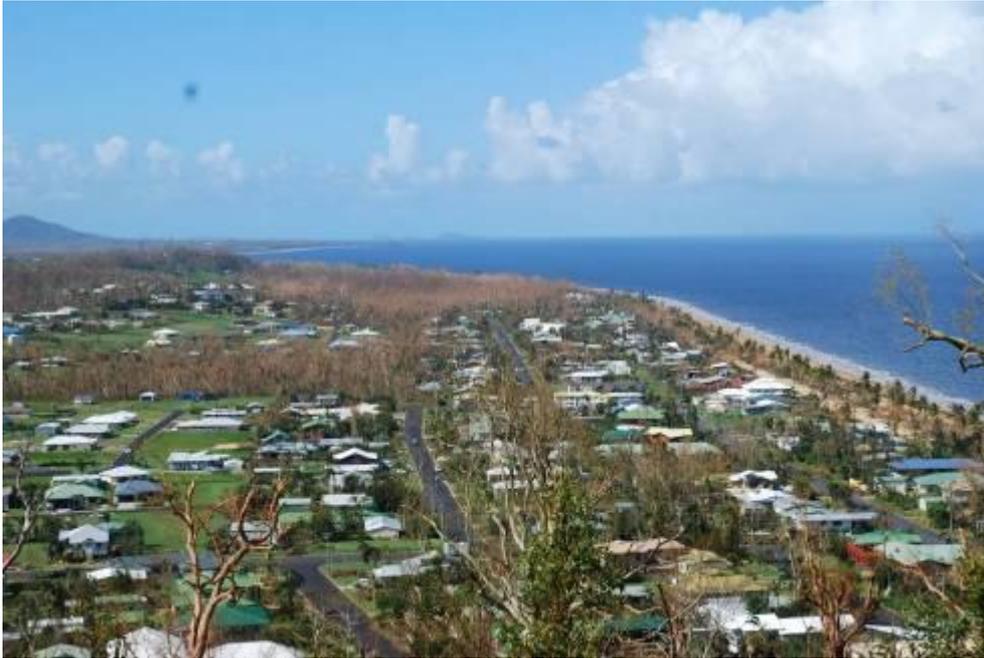
**Figure 3.53 View from ridge with T2 classification in AS 4055 but more severe wind loads**

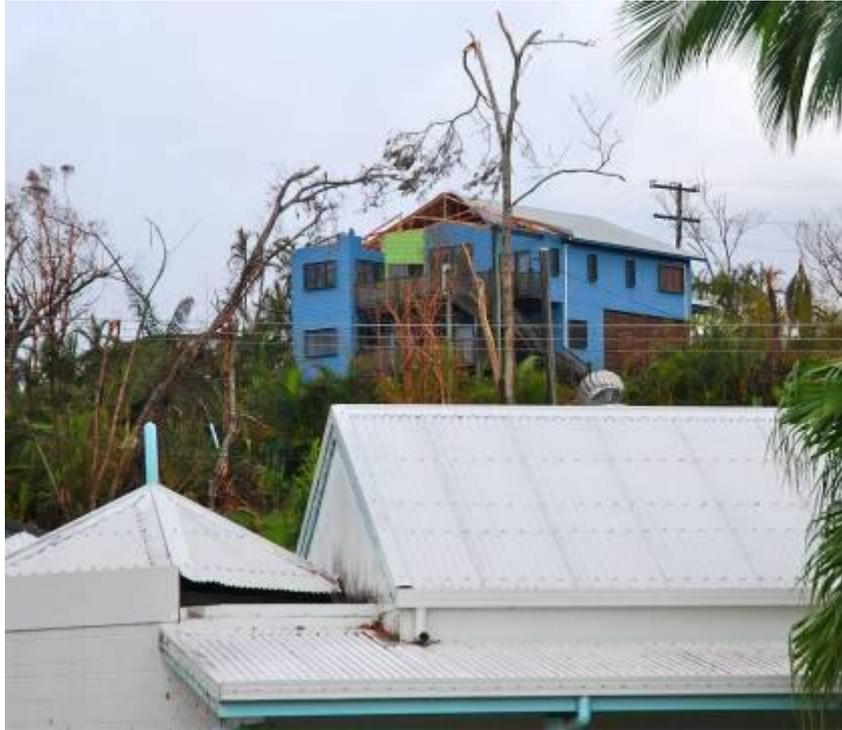
**Figure 3.54 Damage to hill-top houses.**

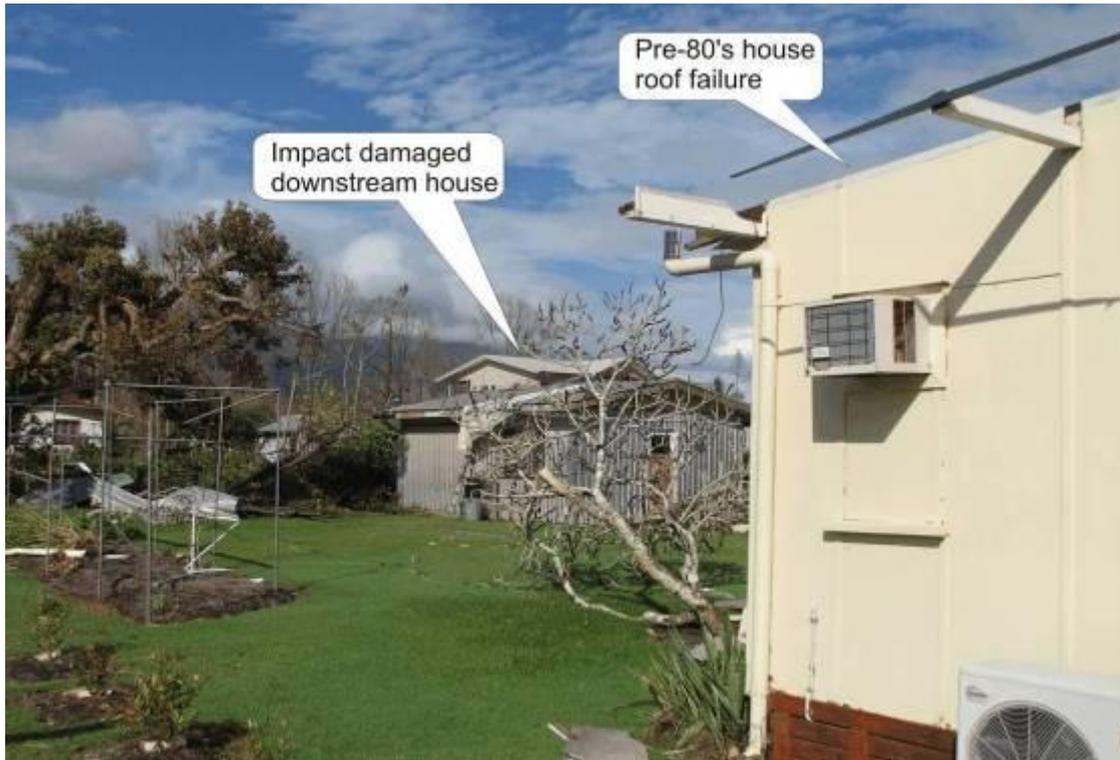
**Figure 3.55 Roof as wind-borne debris**

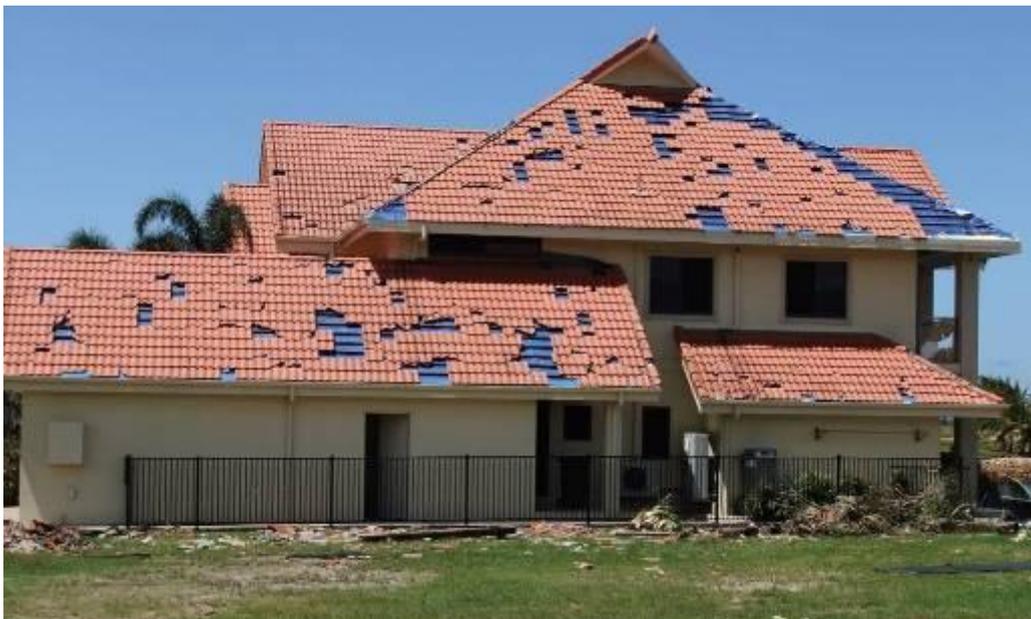
**Figure 3.56 Damaged tiled roof, each lost tile being a potential missile**

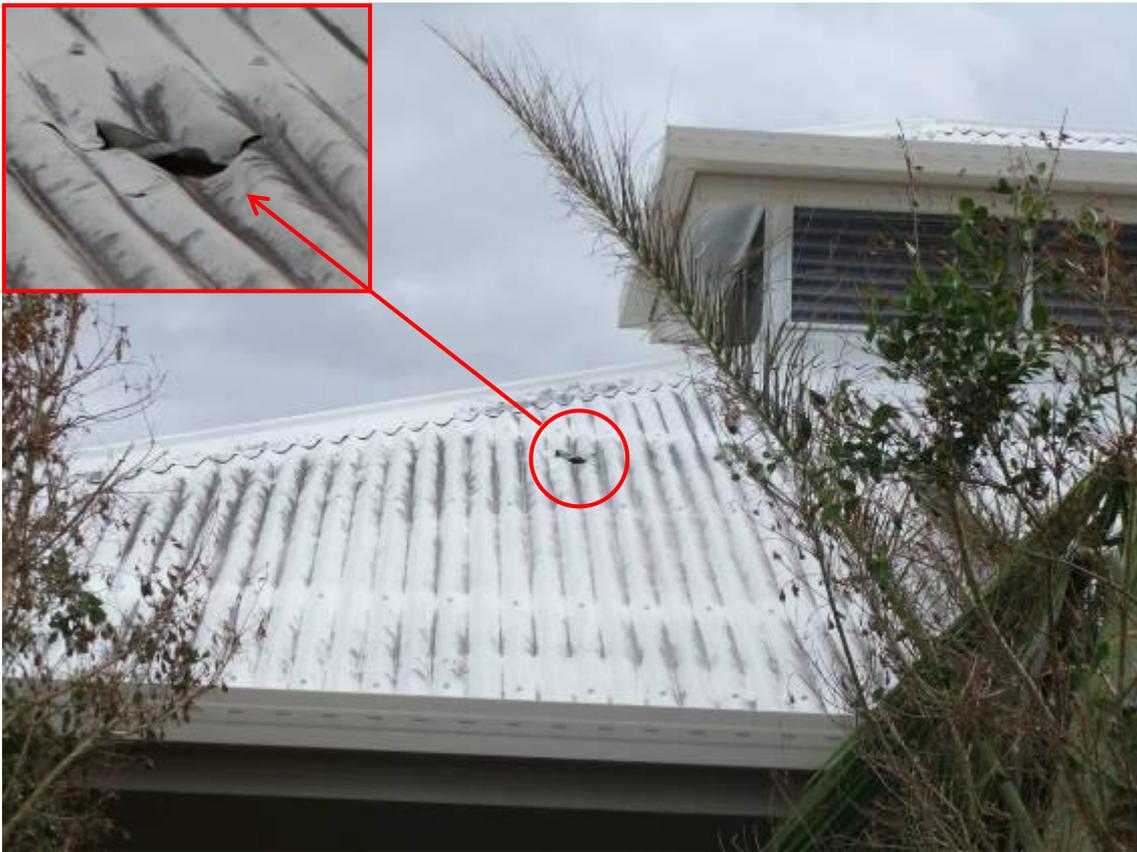
**Figure 3.57 Metal roof damaged by dislodged roof tile**

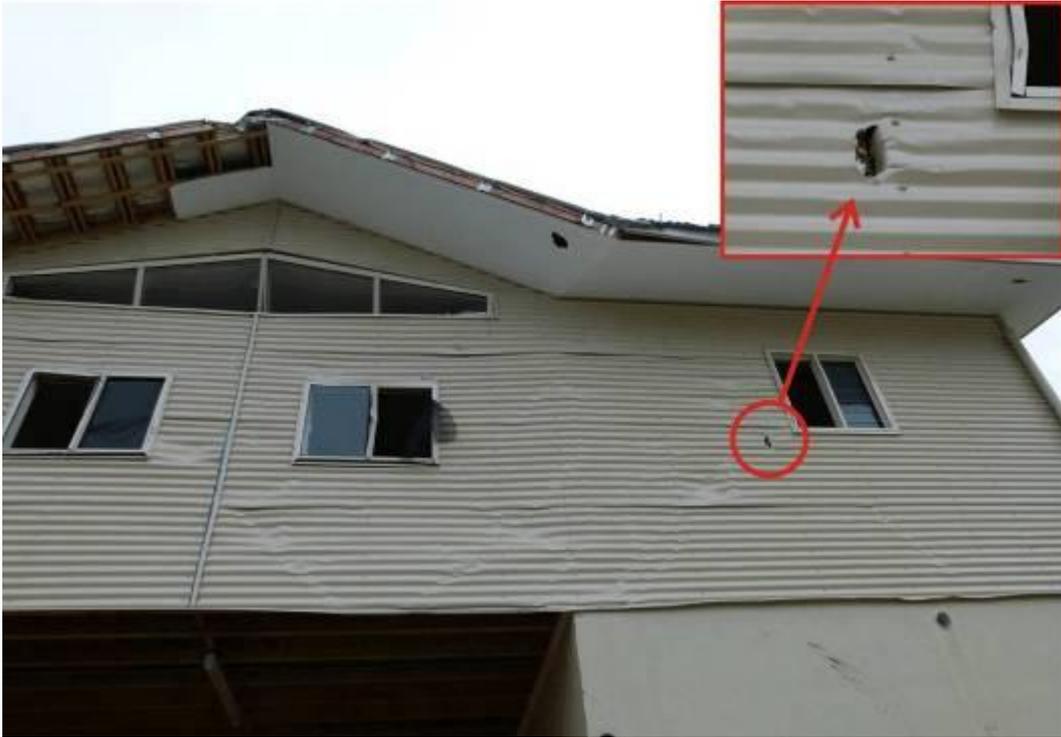
**Figure 3.58 Impact damage on metal cladding without complete missile penetration**

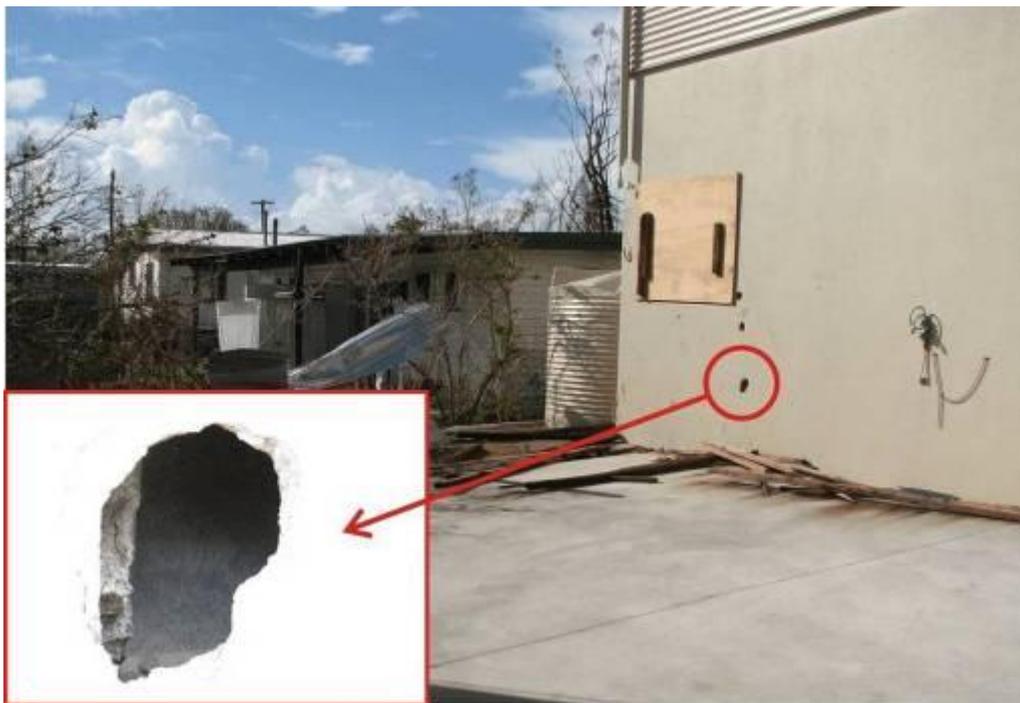
**Figure 3.59: Impact damage on concrete block wall without complete missile penetration**

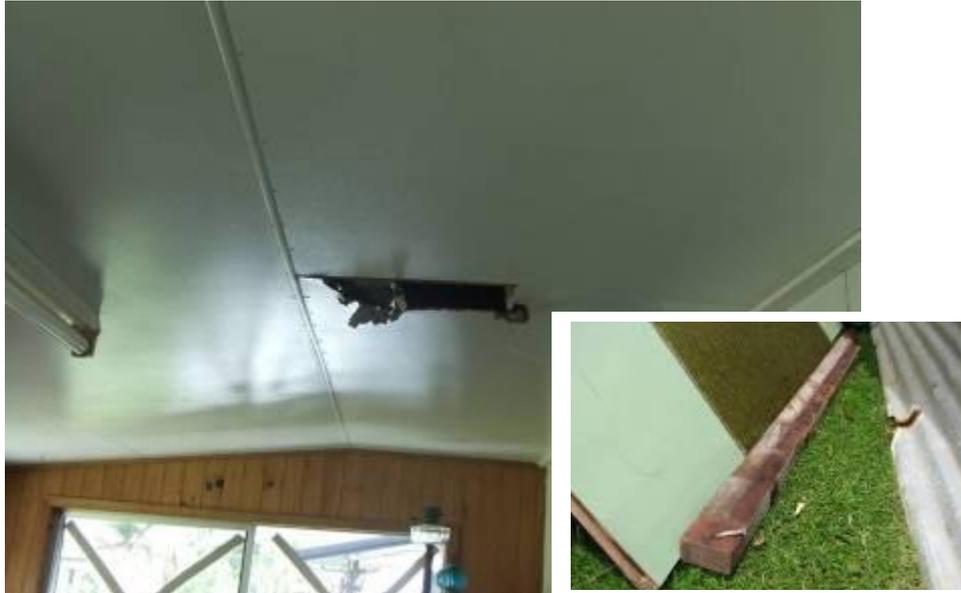
**Figure 3.60 Debris complete penetration through steel roof (inset shows missile)**

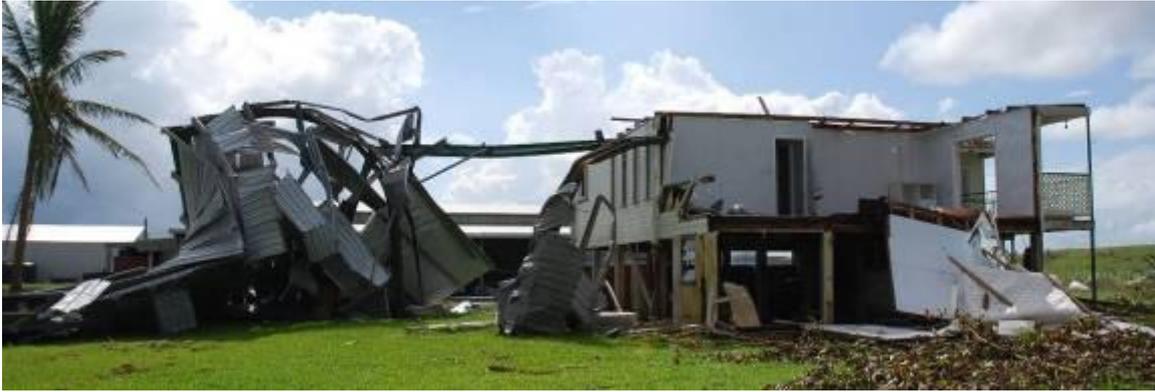
**Figure 3.62 Very large debris and the house it hit**

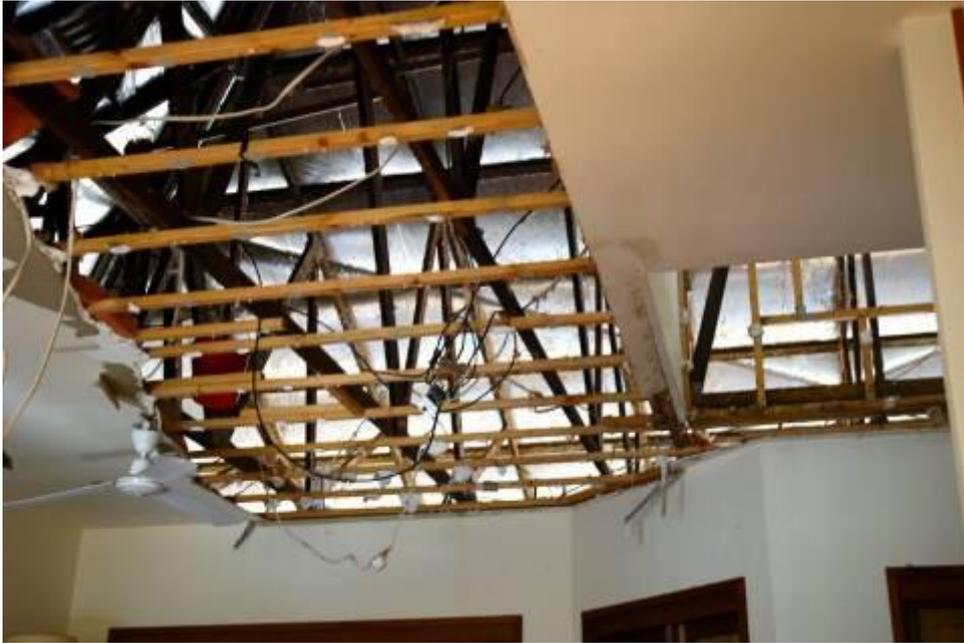
**Figure 3.64 Loss of ceiling under damaged roof**

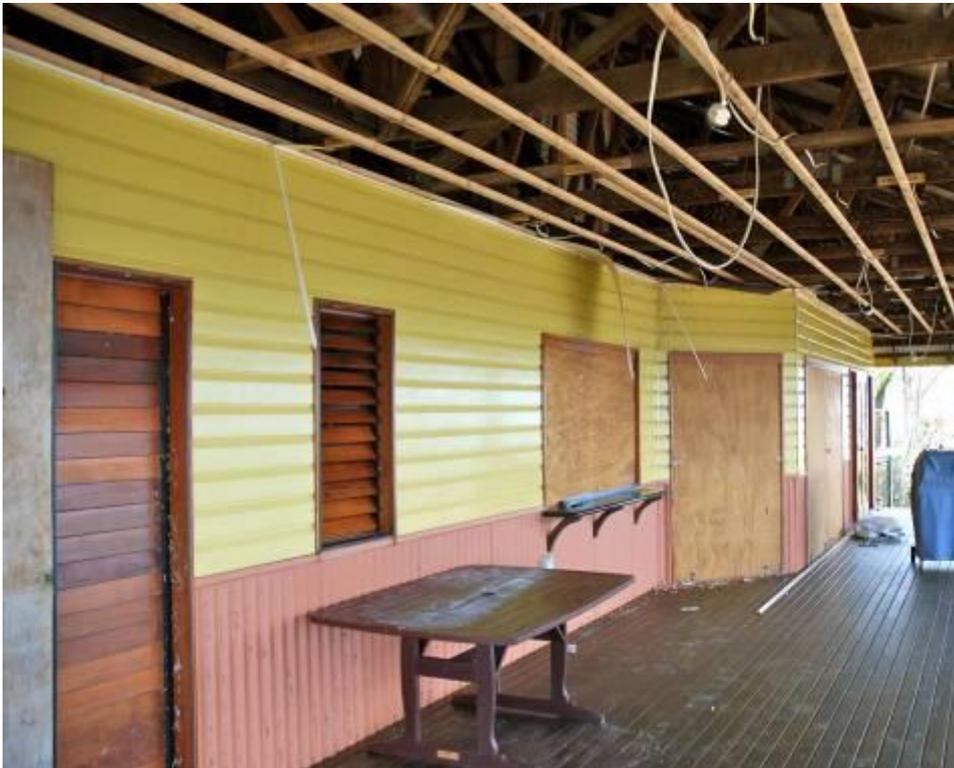
**Figure 3.65 Soffit failure under large outdoor entertainment area**

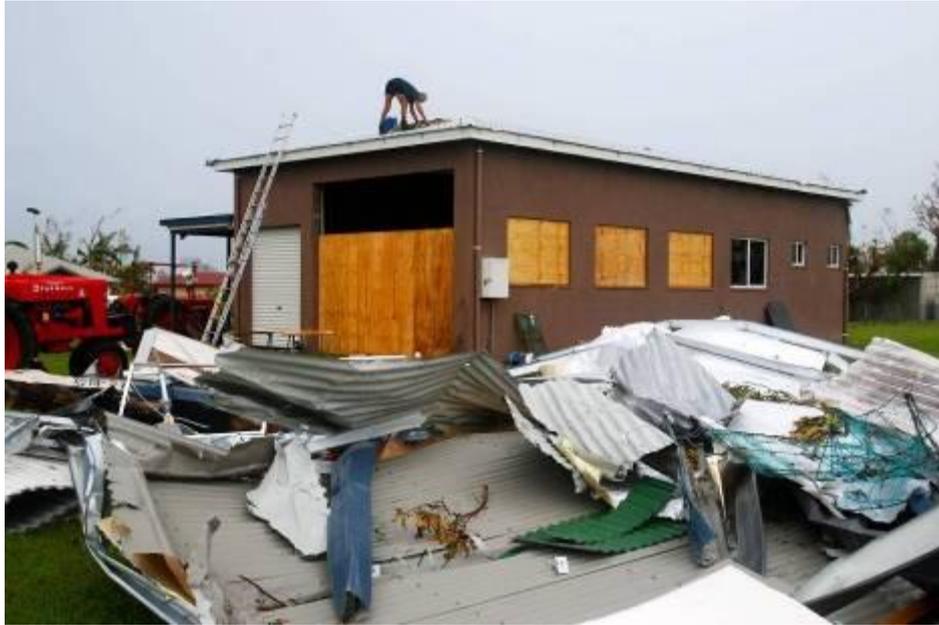
**Figure 3.67 Guttering loss**

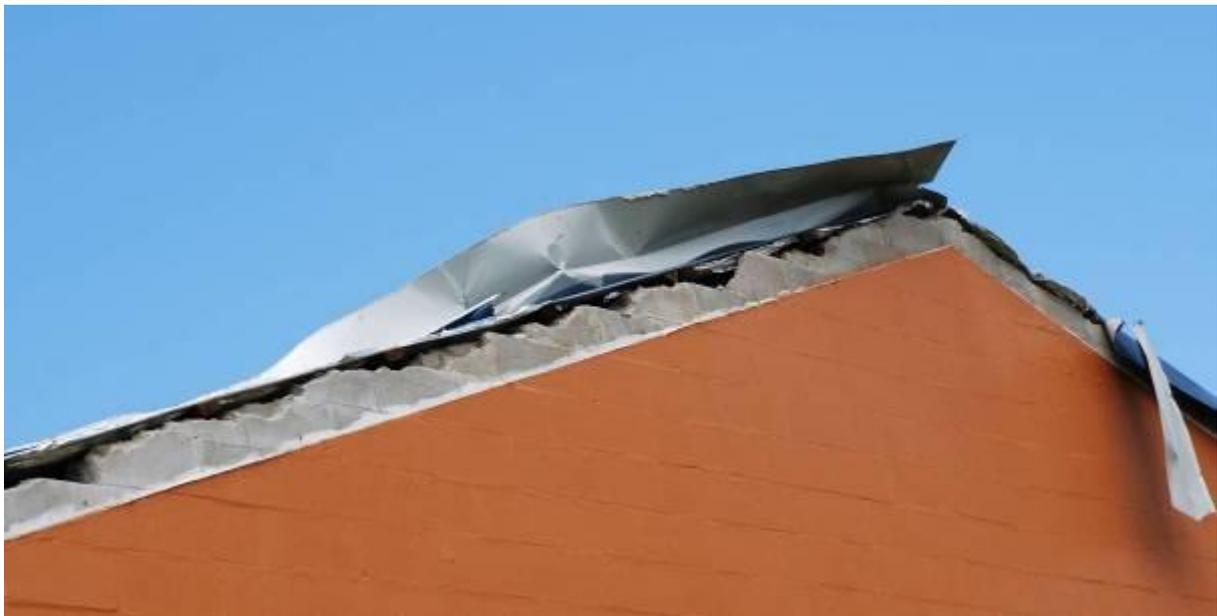
**Figure 3.68 Flashing loss**

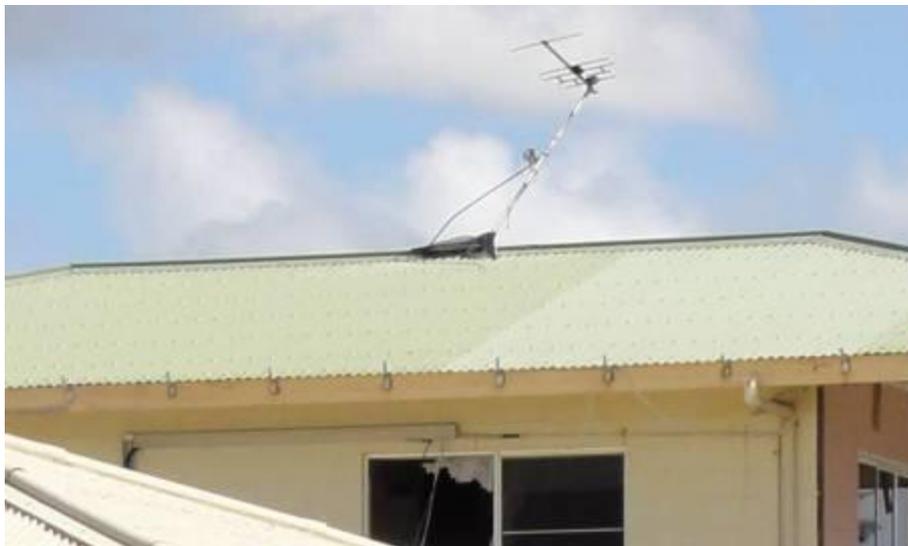
(b) damaged aerial and consequential roofing damage

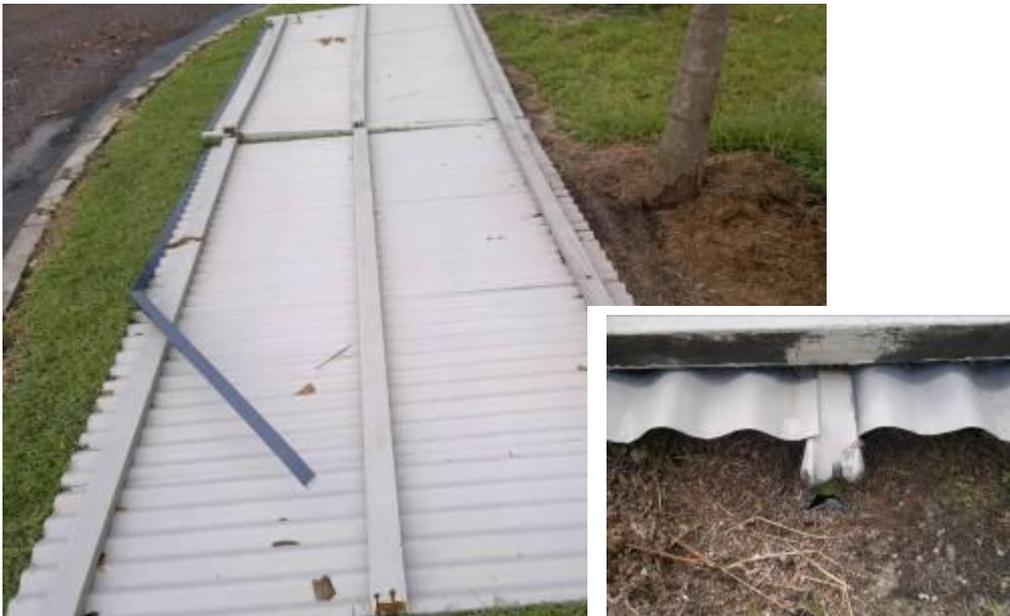
**Figure 3.76 Failed fence**

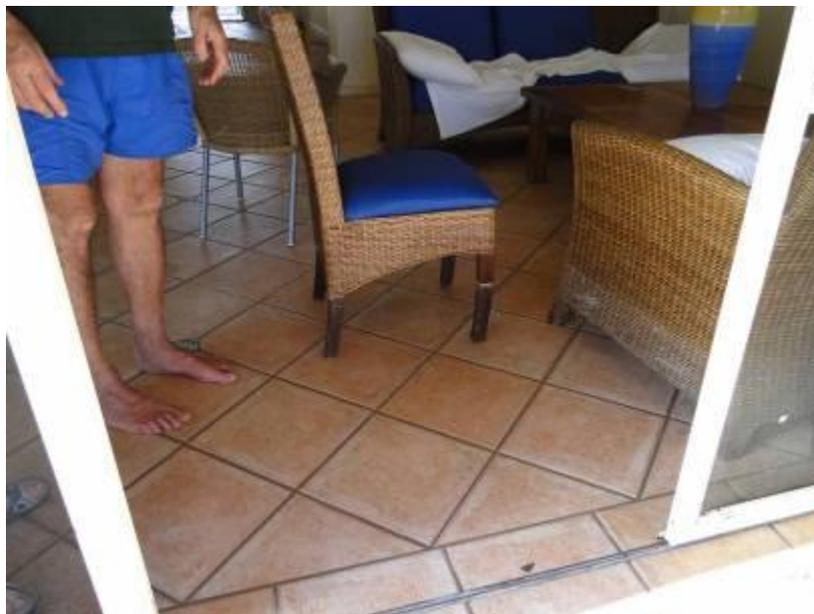
**Figure 4.8 Marks on chair leg and cane settee show depth of storm surge inundation at Port Hinchinbrook**

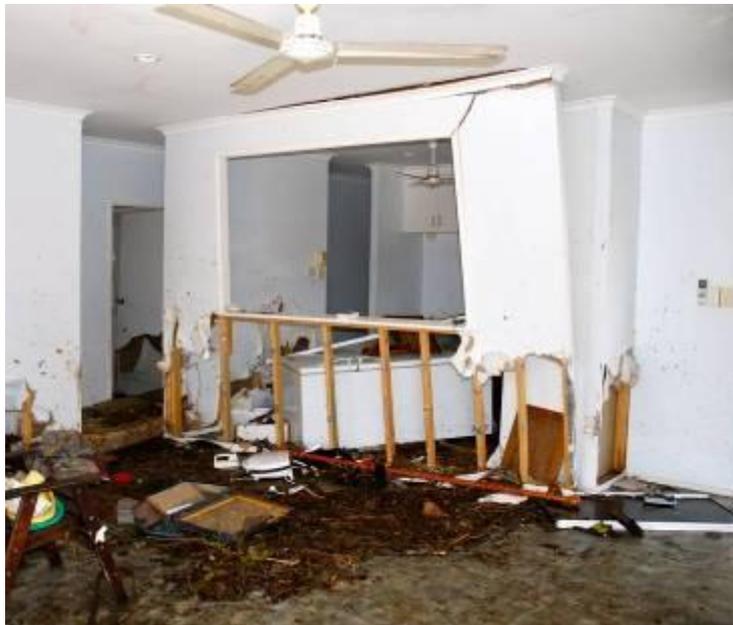
**Figure 4.10 Damage to internal linings and movement of internal walls**

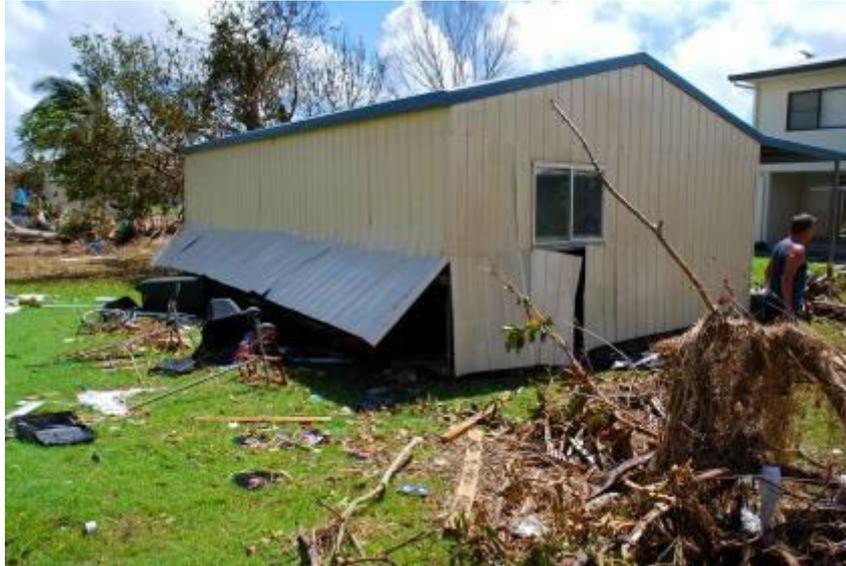
**Figure 4.11** Damage to external wall due to water flow through shed

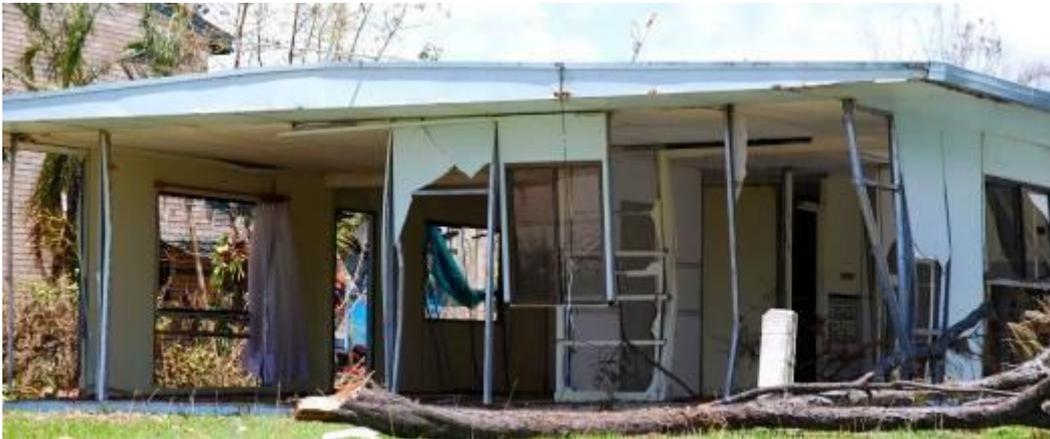
**Figure 4.12** Damage to external walls on the seaward side of a house

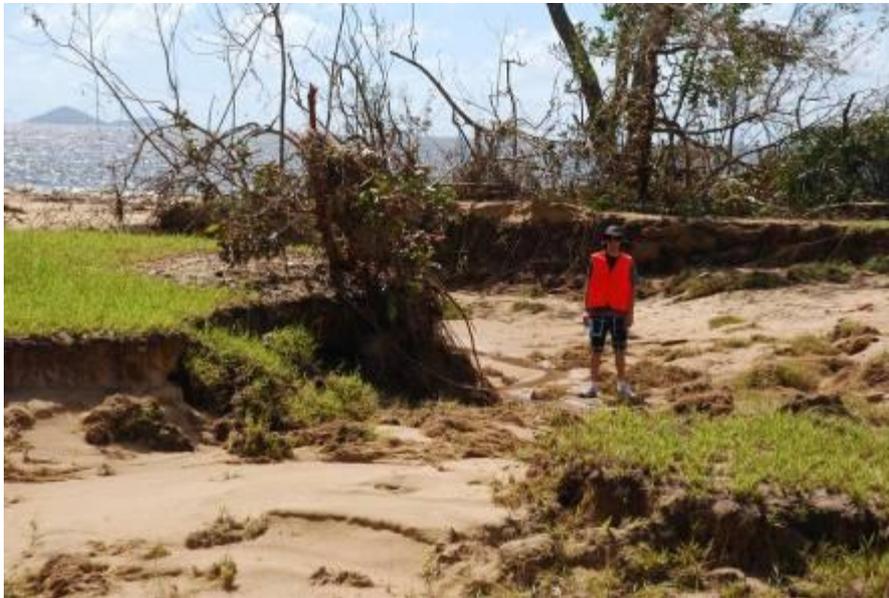
**Figure 4.13 Ebb channel cut by receding storm surge**
