TC Narelle, Queensland, NT, WA Damage to Structures

CTS Technical Report No 72

TC Narelle, Queensland, NT, WA Damage to structures

May 2026

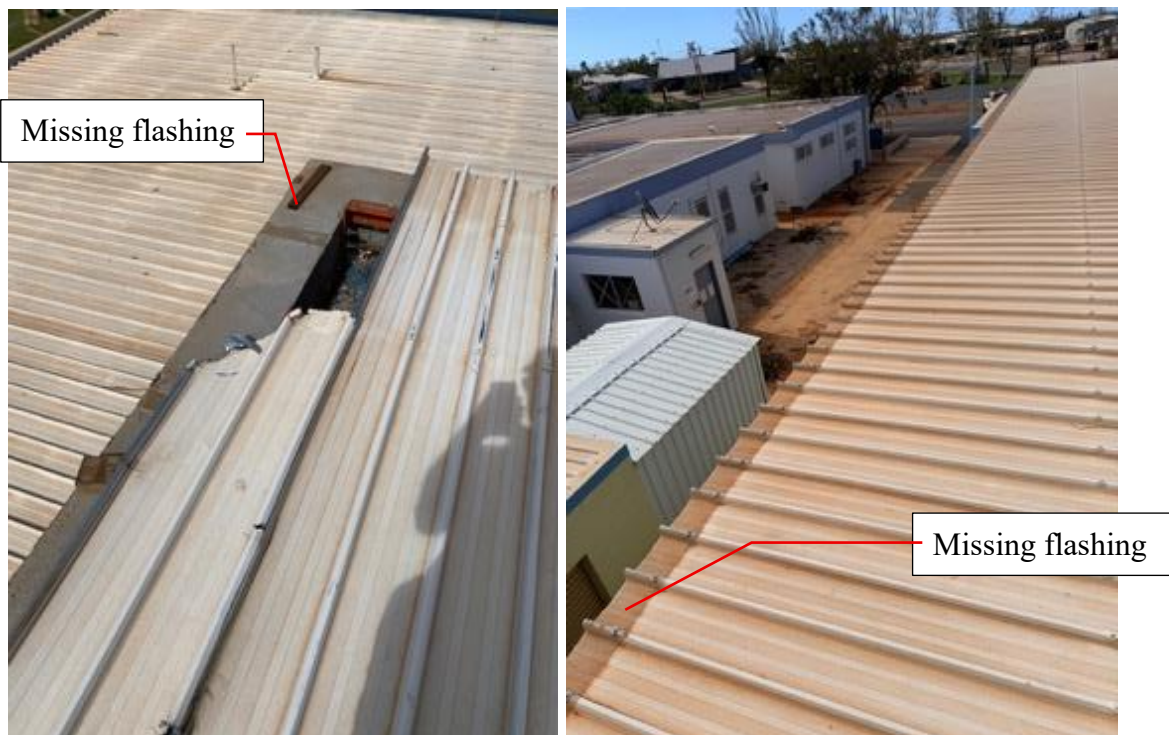
(a) Flashing parallel to ribs
Figure 6-1 Missing flashings

A similar failure (loud banging and water ingress) was experienced during TC Narelle. The barge flashing had come off many edges of the roof as shown in Figure 6-1. The loss of flashing in Figure 6-1 (a) happened prior to the loss of the roof sheeting. The flashing shown in Figure 6-1 (b) was new flashing fitted at the time of the refurbishment. Holes in the roofing at that edge showed that the previous flashing had been screwed to the sheeting at every second rib, but the new flashing was fastened with pop rivets every fourth rib. Widespread flashing failure on this building was due to the inadequacy of the fixing methods.

The failure of the flashing shown in Figure 6-1 (a) allowed the wind to get under the edge of the sheet on the left side of the photo and it would have started to flap. (The wind at that stage was coming from left to right in the photo.) However, the reason for the roof failure was that three of the four screws that held the lap joint of the edge sheet had broken years ago. It is likely that the screws broke on installation into the hot rolled purlins, but were held tight by the double layer of sheeting at the lap. One of these screws was removed by hand and is shown in Figure 6-2. Figure 6-2 also shows the purlins with the very badly rusted small gauge screws that held the initially installed clips and corroded failure surfaces on the new screws associated with failure at the time of installation.

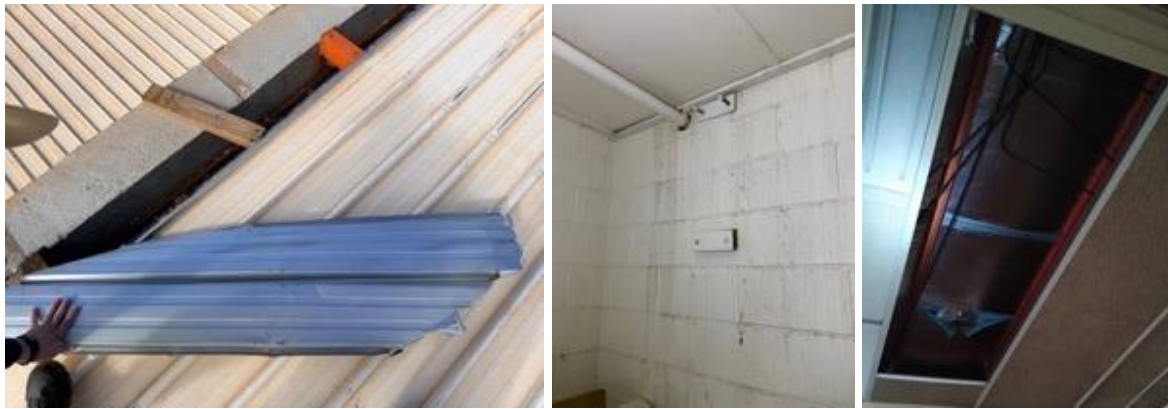
The roofing had detached except for one end and had folded back as shown in Figure 6-3 (a). The detached portion of roofing had flapped across the top of the roof and eventually broken the end of the sheet off, leaving the gap shown in Figure 6-1 (a). Water was blown in through this gap and under the missing flashing on that edge. It caused water damage to the ceiling underneath as shown in Figure 6-3 (b).

(a) Damaged roofing

(b) Internal water damage including ceiling loss

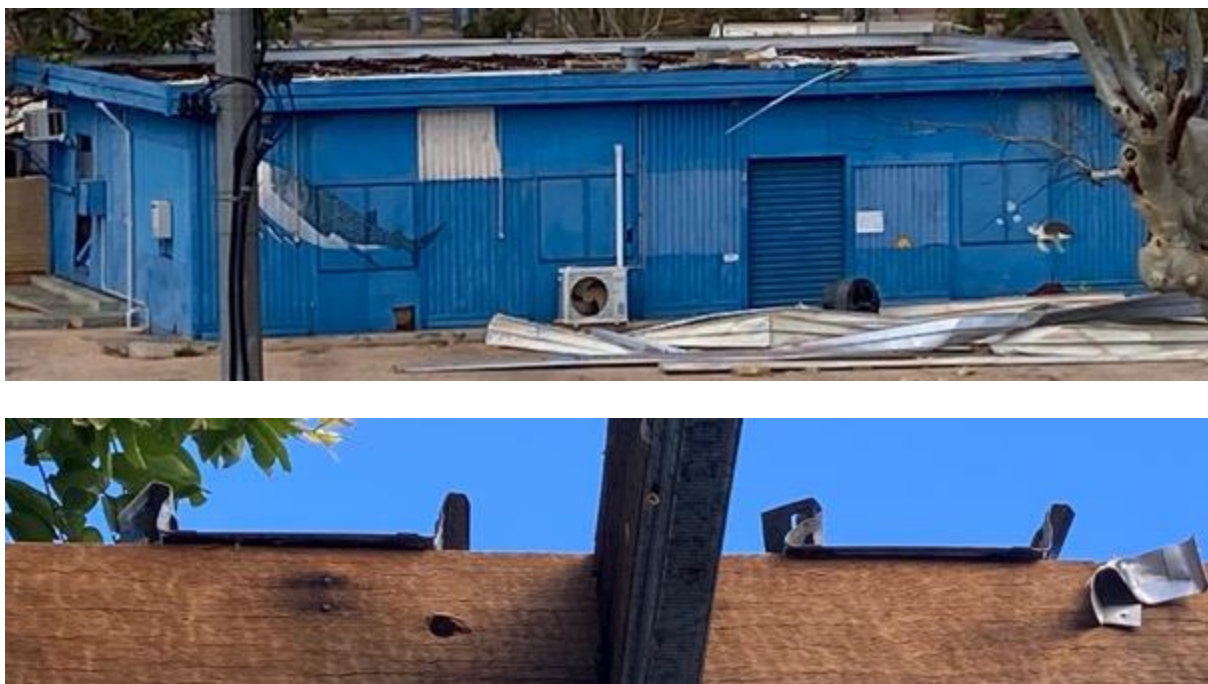
Figure 6-4 Loss of older concealed fixed roofing

The roof is shown in Figure 6-4 together with a photo showing a normal clip on the left and a bent clip on the right.

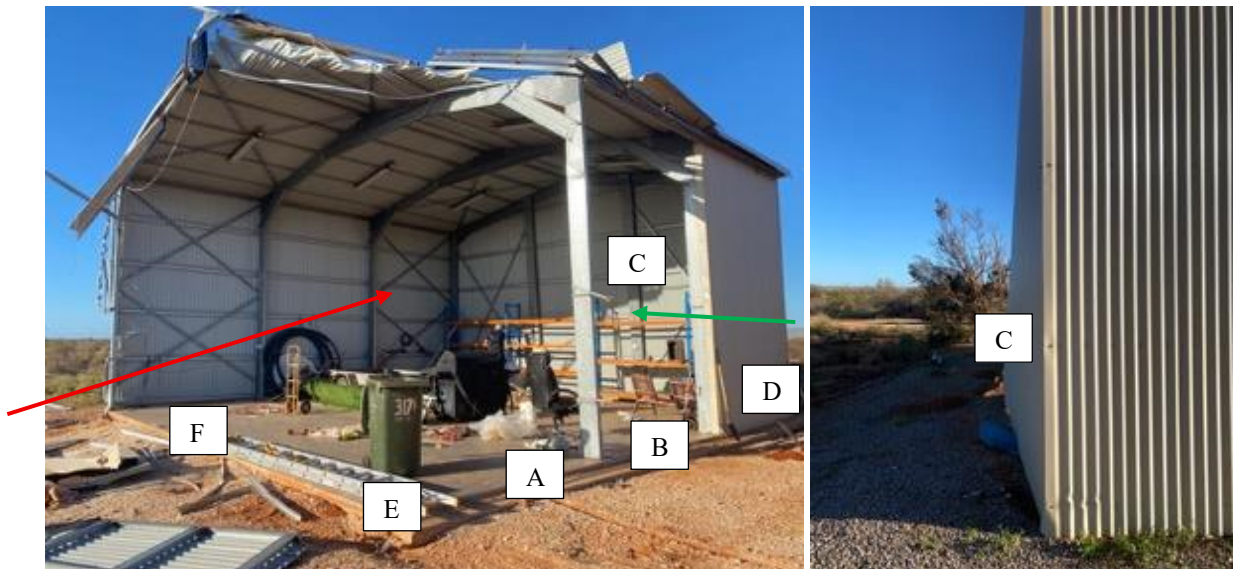
Figure 6-6 Shed failures

Figure 6-6 shows a shed that had experienced multiple failures:

- The doors on the right side of the shed had blown off (A and B).
- One end wall had bowed outward (C).
- The base of one portal had lifted around 250 mm (D) – also shown in Figure 6-7.
- A different portal leg had broken away from the footing folded back onto the roof (E)
- The other end wall had blown out of the building (F)

The red arrow indicates the wind direction when doors came off. The green arrow indicates the wind direction for the maximum winds.

As at least one of the end posts had been compromised and the support for the girts at one end removed, the end wall (F) was blown out of the building. The wind speeds that caused this damage were around 70% of the design wind speed for importance level 2 structures. The wind loads on this shed were around 50% of the region's design wind loads.

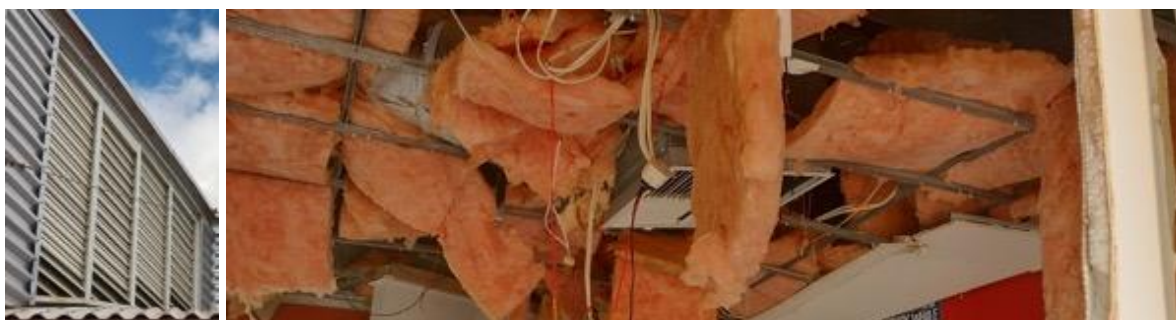
Figure 6-8 (a) shows the redundant air conditioning vents that allowed pressurisation of the ceiling space in the building. Where the ceiling had been blown into the building under the vents, the insulation was obviously wet, but Figure 6-8 (b) shows ceiling collapse some distance from the vents where the insulation remained dry. These failures could have been avoided by replacing the redundant vents with sealed wall cladding.

(a) Redundant vents (b) collapse of dry ceiling

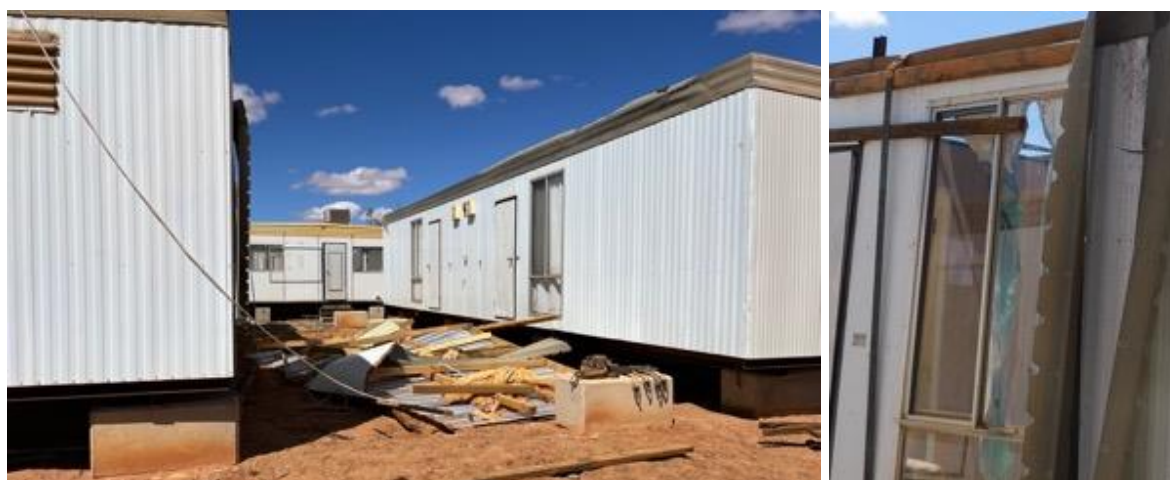
Figure 6-9 Roof loss in one donga that had damage to a windward window

contributed to the failures, but where there were similar buildings side-by-side it was only the ones that had windward wall failures that had significant roof damage. Figure 6-9 shows a transportable building (donga) that had been well tied down to concrete blocks, but where windward wall windows had broken, the internal pressure had caused roof loss, while neighbouring dongas without window damage retained their roofs. While these buildings were in region A and were not required to be designed for internal pressure, the failure of the roof associated with a windward wall window breaking, confirmed that internal pressure can arise in any wind region.

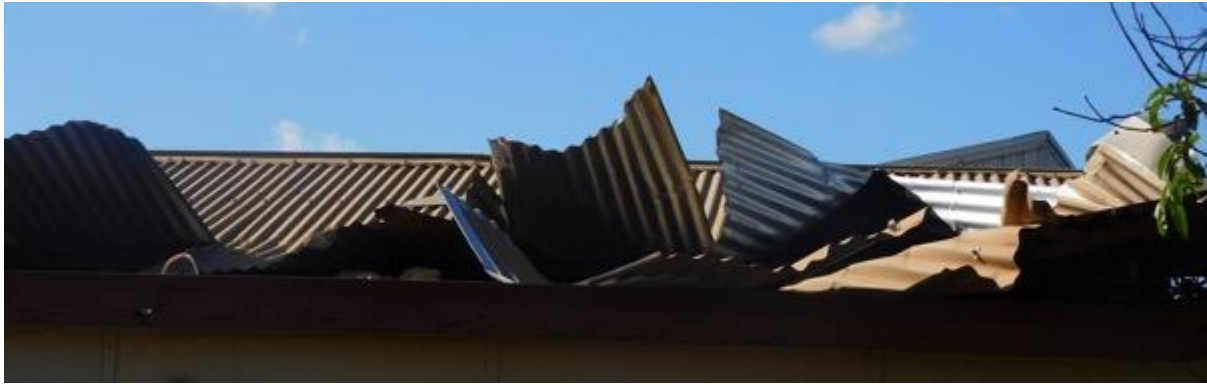
(a) Partial roof failure due to deterioration of roofing fasteners

Coastal environments require more frequent maintenance or specification of cladding fasteners with higher levels of protection.

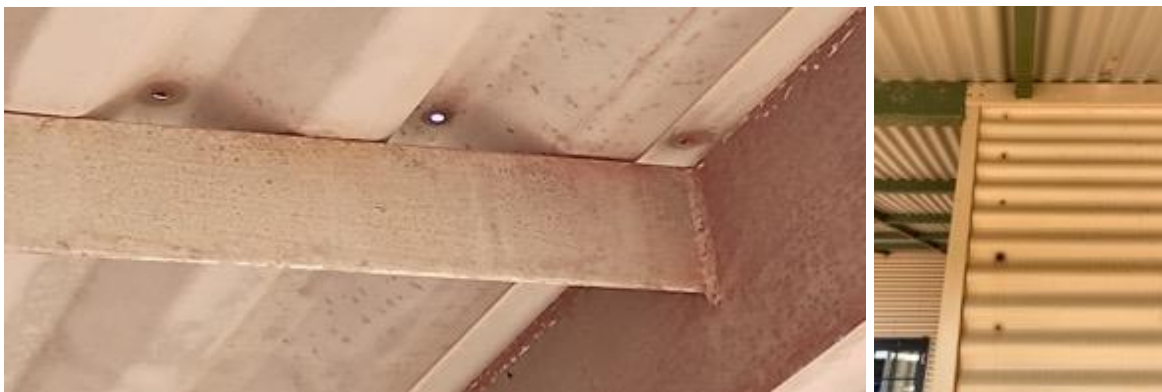
(b) Corrosion of cladding fasteners leading to fastener failure

(c) Corroded wall sheeting fasteners

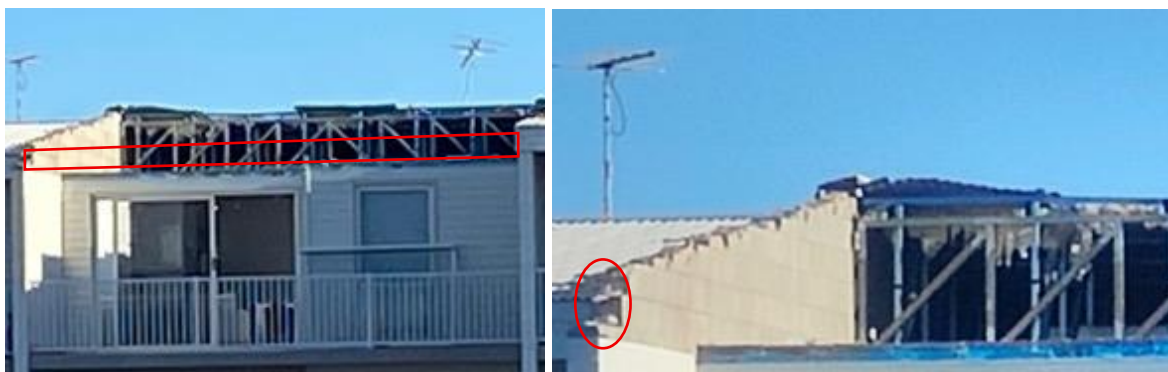
A recently constructed building lost a complete section of roof due to connection failure between the roof and the walls. The walls were reinforced blockwork with filled cores. Figure 6-12 (a) shows that the roof from the veranda beam to the ridge line is missing. The original position of the veranda beam is indicated by the red rectangle and missing blocks at the end connection are highlighted by the oval. At the other end of the veranda beam masonry anchors had pulled out of the reinforced cores as shown in Figure 6-12 (b). At this end, the reinforcement could be seen in the cores, but there was no sign of it at other end.

(a) Roof loss

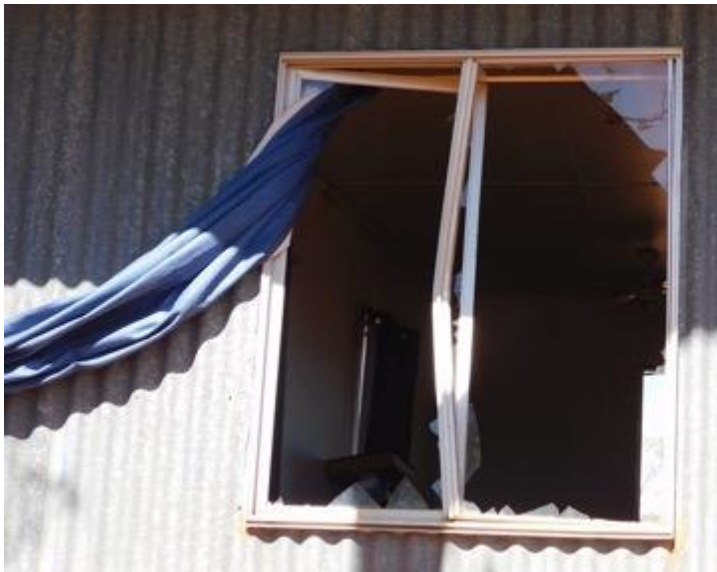
Figure 6-13 Glass failures

Some windows were broken by either wind-borne debris or by wind pressure. Figure 6-13 (a) shows a float glass window that failed by differential pressure from the inside of the building to the side wall. The glass failure created a hole in the building envelope and spread large pieces of sharp broken glass nearby. Figure 6-13 (b) shows some debris damage to a laminated glass sliding door. Though the glass had broken, it remained in place and had not caused an opening in the building and had not spread broken glass.

(a) Float glass

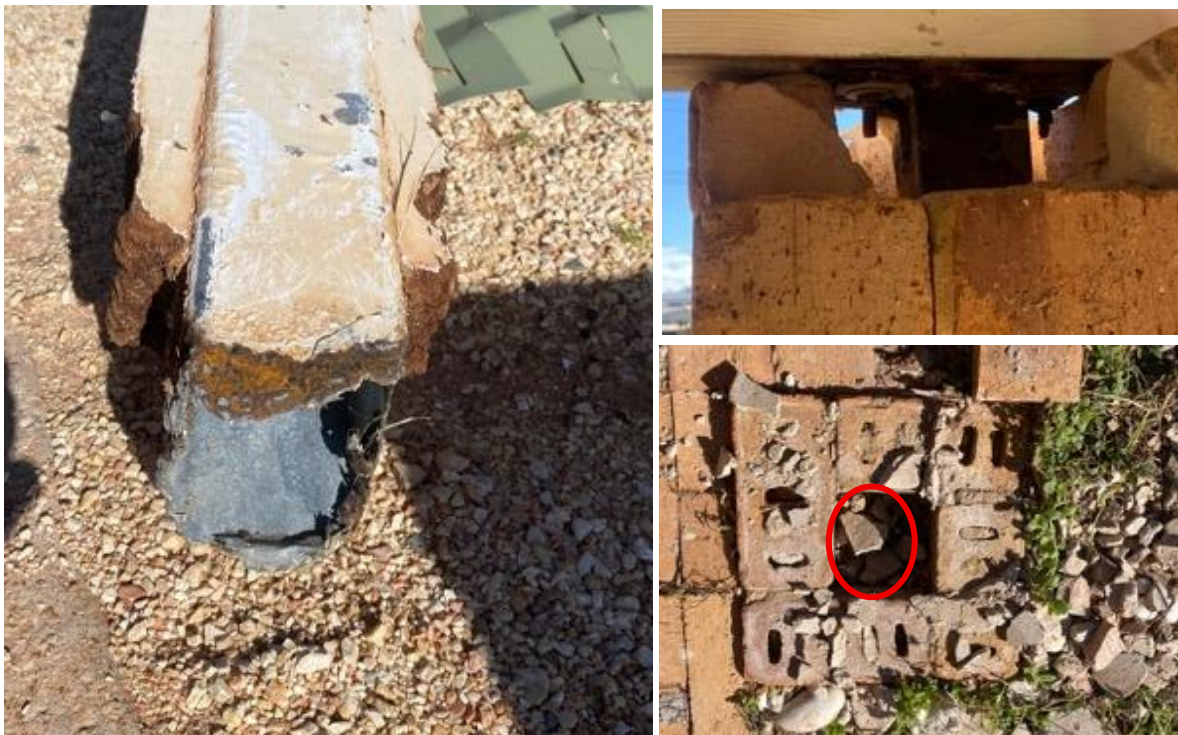
Figure 6-15 (a) shows a veranda post that had broken off at the ground level. Here the corrosion had almost completely eroded the thickness of the steel walls of the post. Figure 6-15 (b) shows a brick column supporting the veranda roof that had a steel post embedded in the column. There were signs of rust up the full height of the column, but at the base, the post was completely corroded with only a small portion of one side of the SHS visible. (See the red ellipse.) In both of these cases, because most of the veranda posts were in this condition, the posts had failed causing the whole veranda to lift. As they tore away from the structure, they damaged the edge of the roof causing water ingress to the main building. The veranda also became wind-borne debris that caused damage to other parts of the roof and neighbouring properties.

(a) Steel veranda post

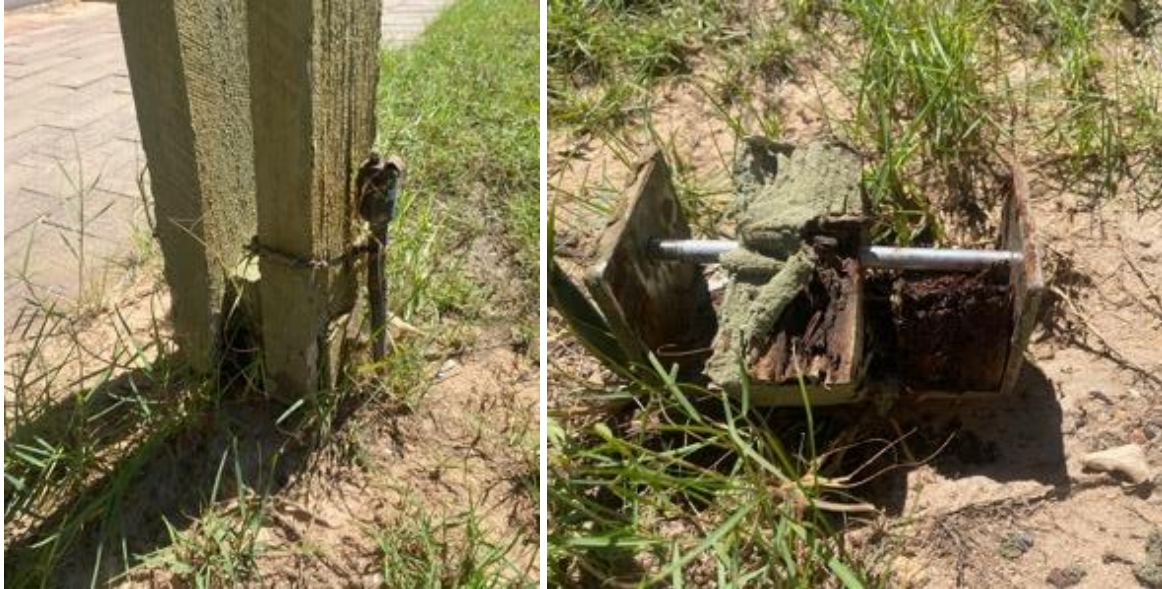
Figure 6-16 Rotten veranda posts

Figure 6-16 shows some timber veranda posts with significant rot near the ground line. There was evidence that the steel bolts from posts to the stirrups had corroded and been recently replaced with new steel bolts and the posts had been recently repainted. However, as the timber had rotted at the base of the veranda post, most of the posts failed in spite of the maintenance work.

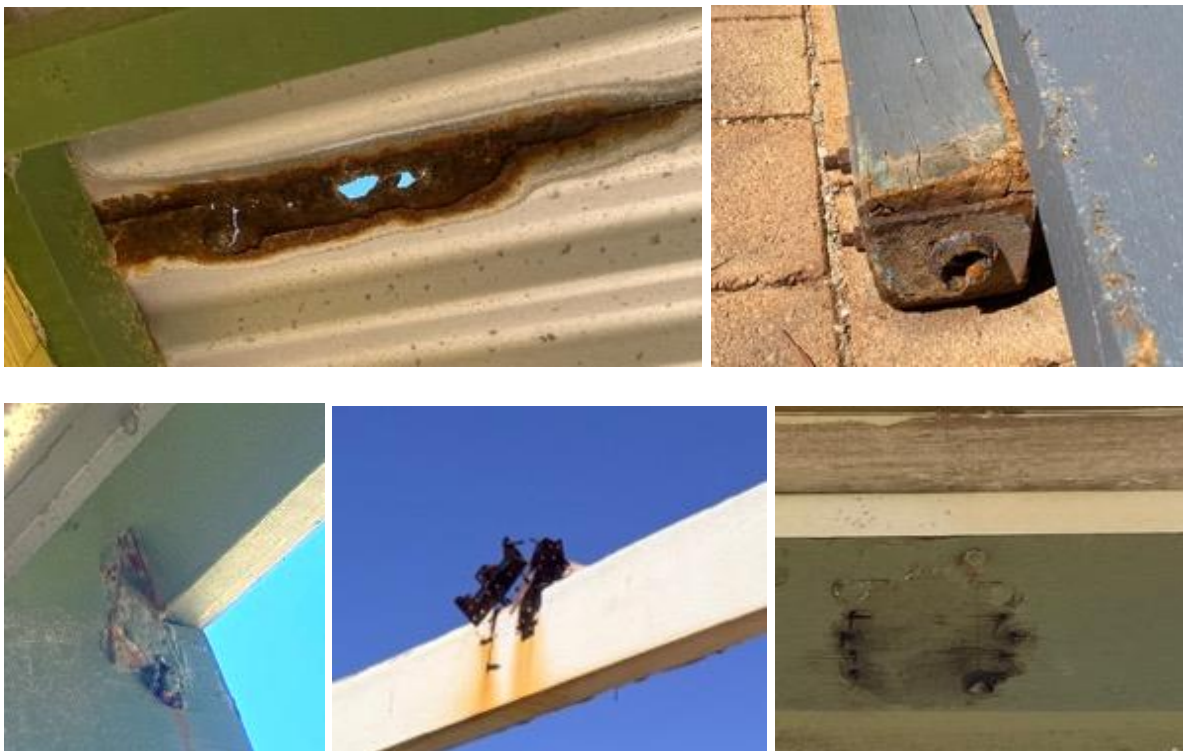
Figure 6-17 Corrosion in steel elements of verandas

Some verandas had corroded roofing, and others had corroded steel stirrups, nails and nailplates as shown in Figure 6-17.

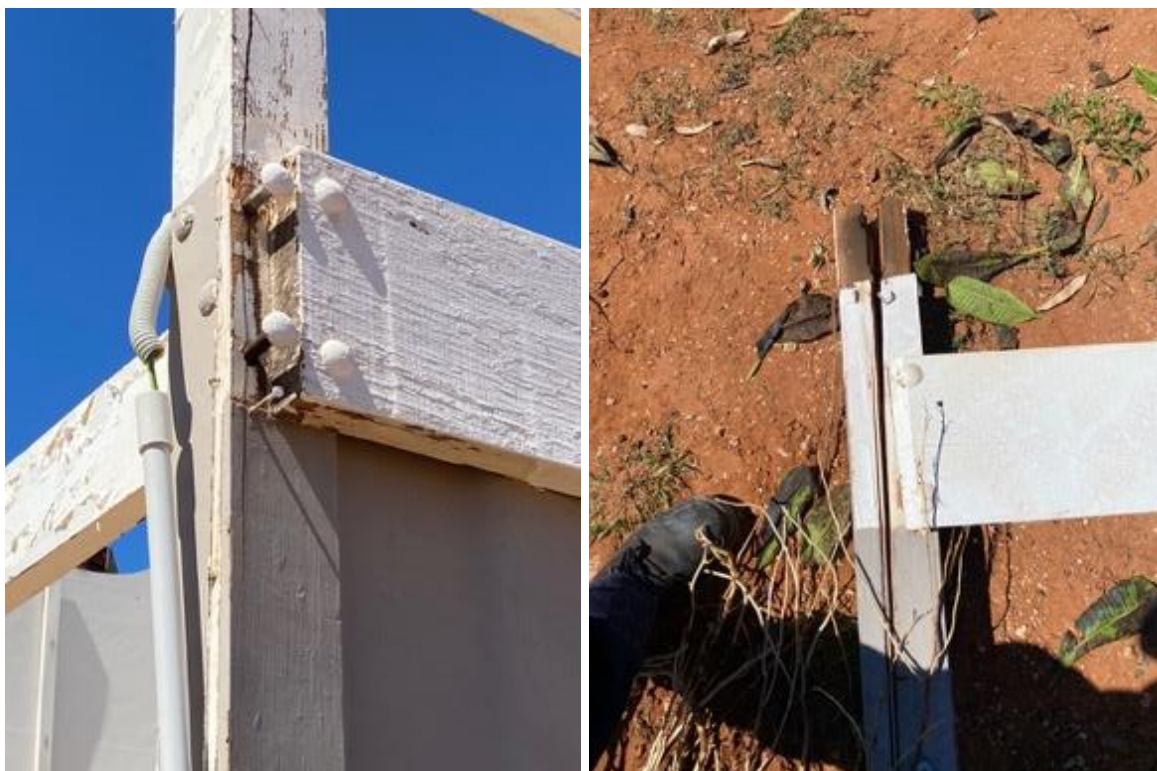
Figure 6-18 Insufficient end distance for bolts on veranda beams

In some cases, details on the veranda itself can cause premature failure. Figure 6-18 shows some bolts in veranda beams that do not comply with the end distances in AS 1720.1. These details failed and caused loss of both a veranda and part of the house roof.

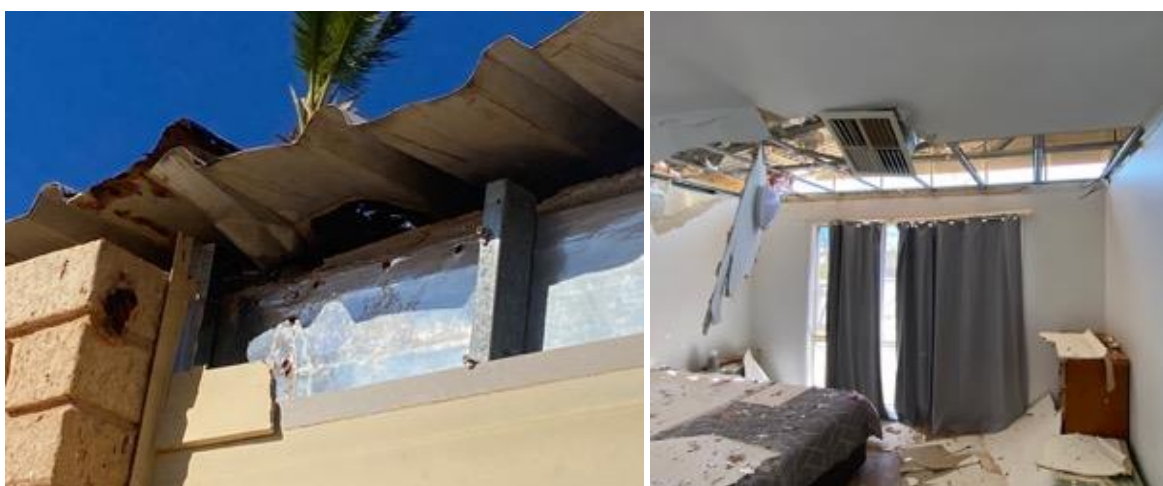
Figure 6-19 Water entry following veranda loss

Where verandas lift off, they can damage the house roof and/or the wall at the point of attachment of the veranda and this allows water in. This is illustrated in Figure 6-19. The veranda loss has created an opening at the top of the wall. It is generally above ceiling level, so wind-driven rainwater wets the ceiling which collapses. All of the cases of veranda failure illustrated in this report resulted in ceiling loss inside the house.

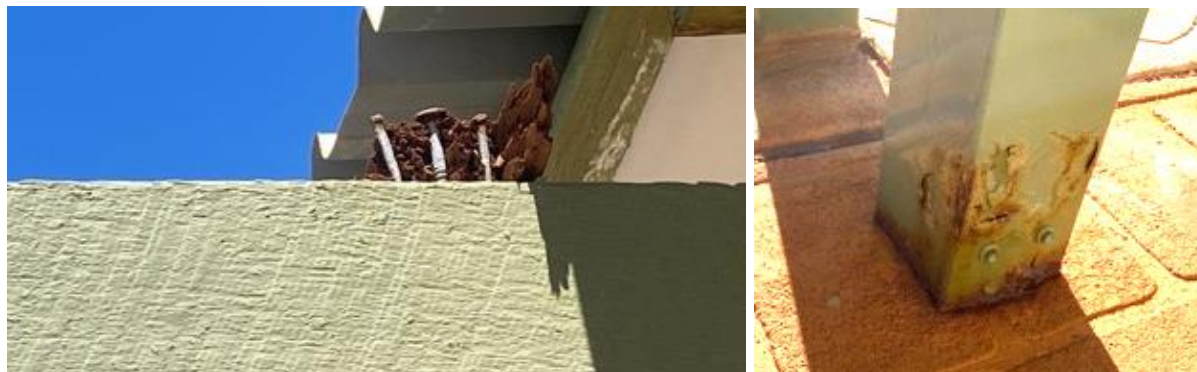
Figure 6-20 (b) shows corrosion in a steel veranda post that was only 6 years old. It hadn't failed during TC Narelle, but if left unchecked, it may fail in a future tropical cyclone.

(a) Rot in batten

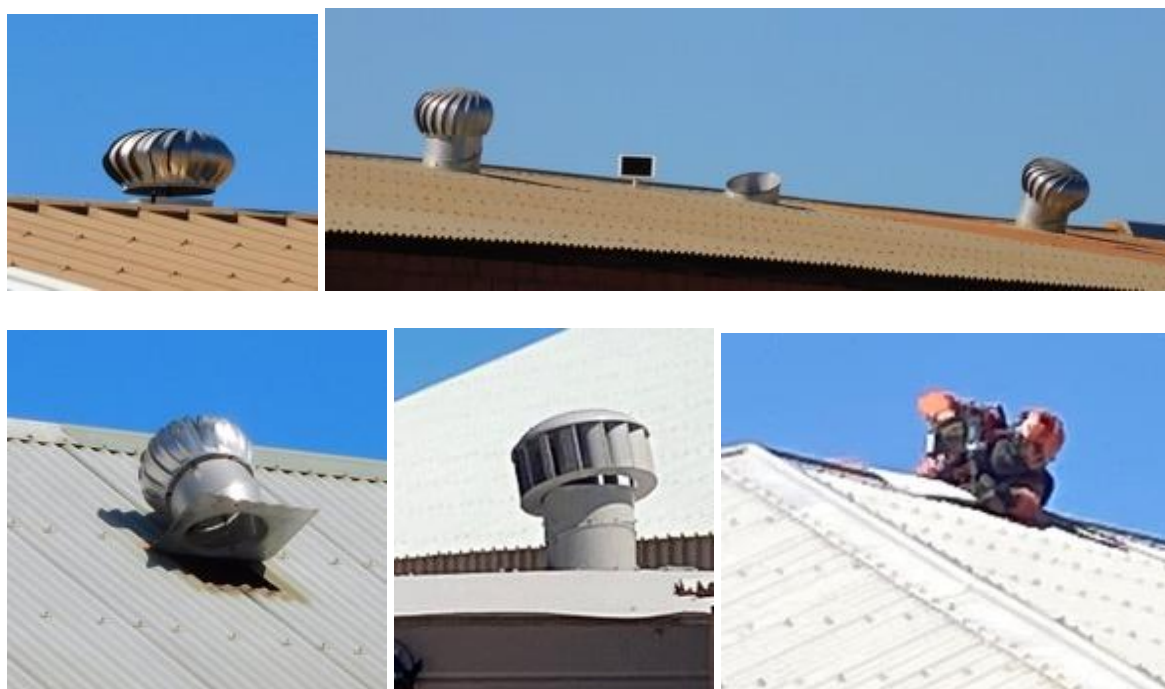
Figure 6-21 Damage to rooftop ventilators

Figure 6-21 shows damage to roof top ventilators. An SES volunteer is putting a temporary patch on the roof where a ventilator had come off completely and left a hole that was allowing water in.

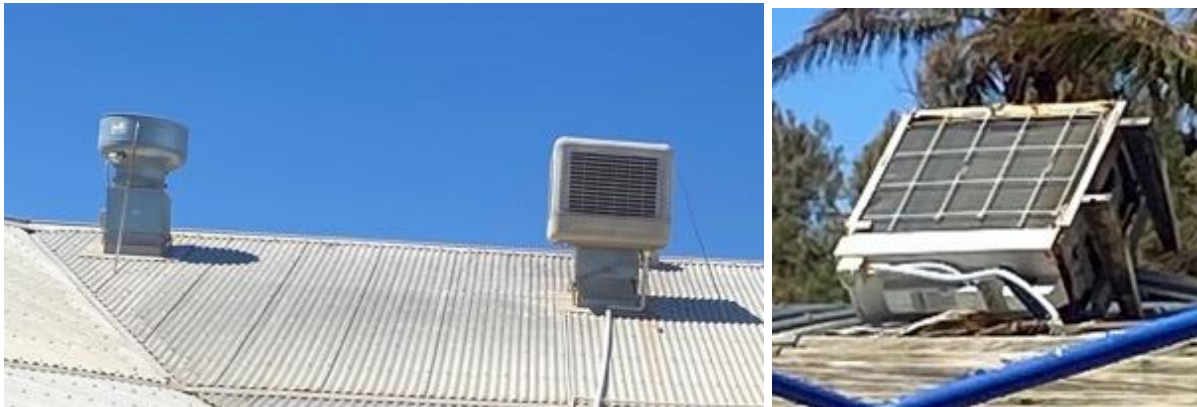
Figure 6-22 Roof-top air conditioners and kitchen extractors

- A kitchen extractor where the top cover has blown off. The loss of this cover has allowed water into the building and compromised the extractor.
- An evaporative cooler. Many evaporative coolers lost panels of fill. This allowed water to be blown into the unit and in some cases, find its way through the ducting into rooms below.
- An external condenser unit for a split system air conditioner that had broken its mounting. Not only was the system damaged, but it had created holes in the roof that had allowed water in.

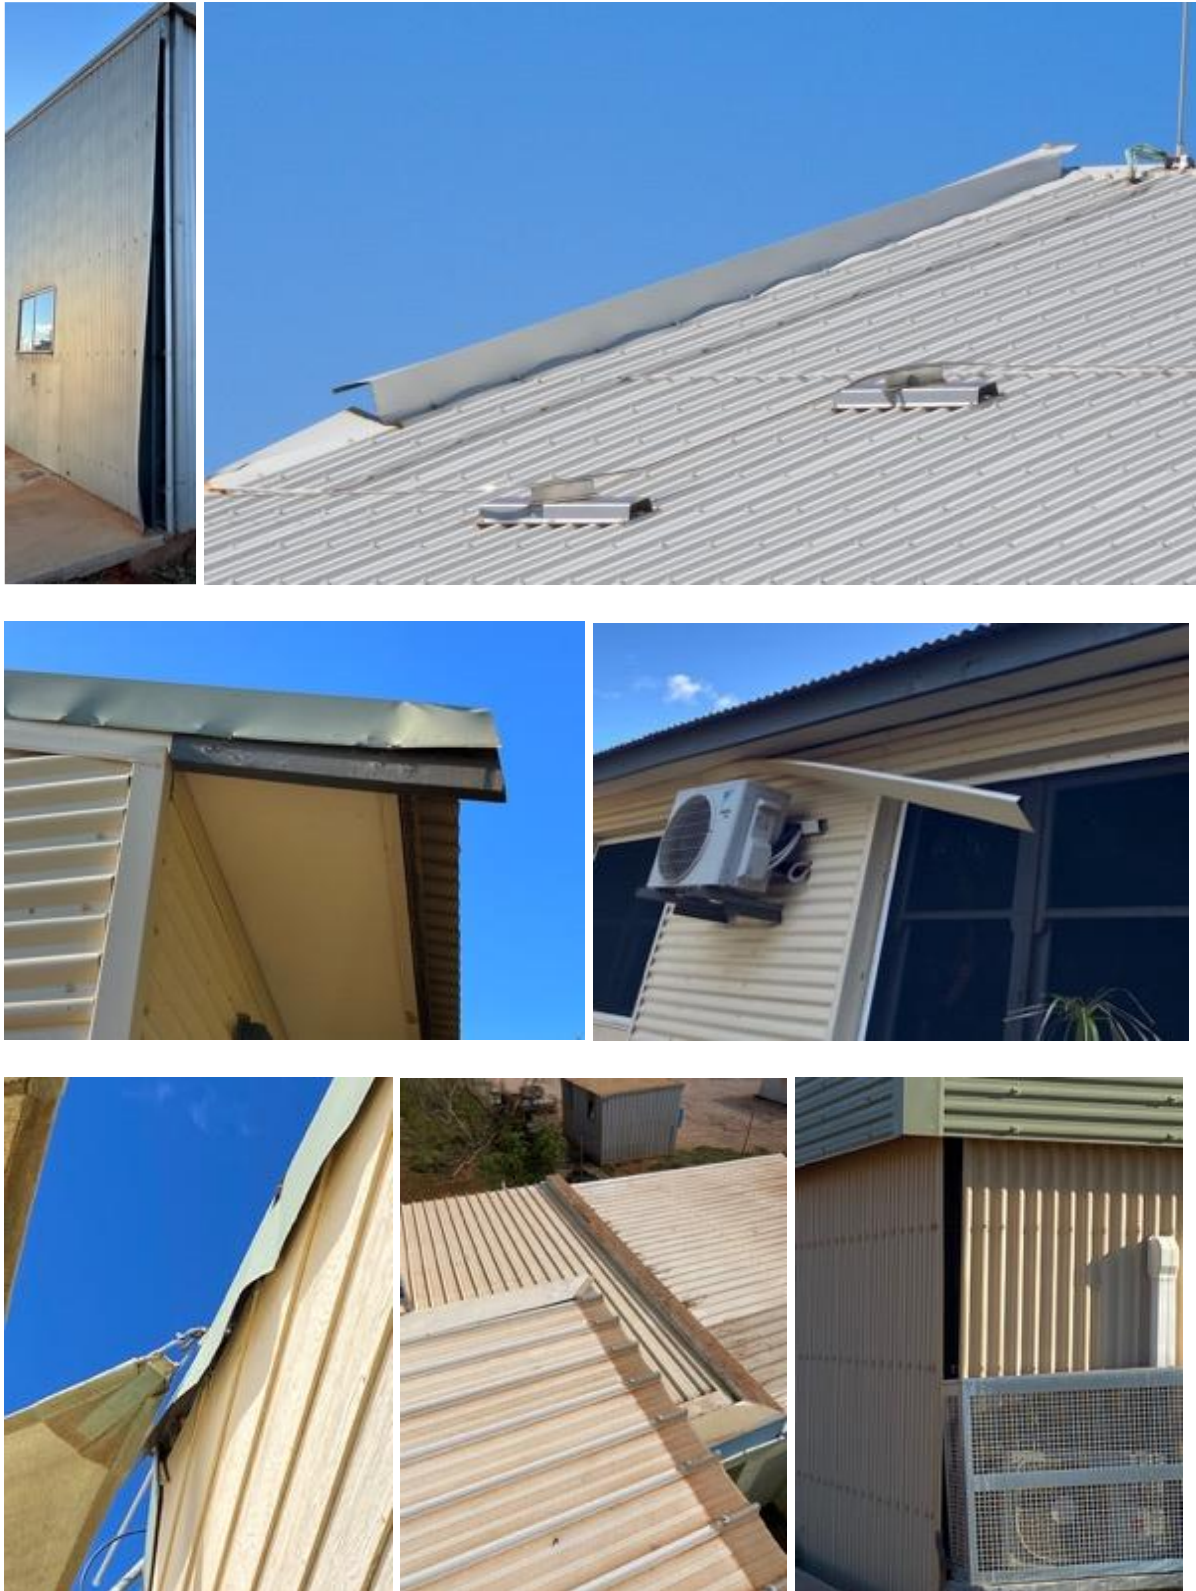
Figure 6-23 A collage of damaged flashings from TC Narelle

Failure of apron flashings between either a wall and an eaves or a second storey wall and a first storey roof allowed water direct access to a ceiling and wall linings.

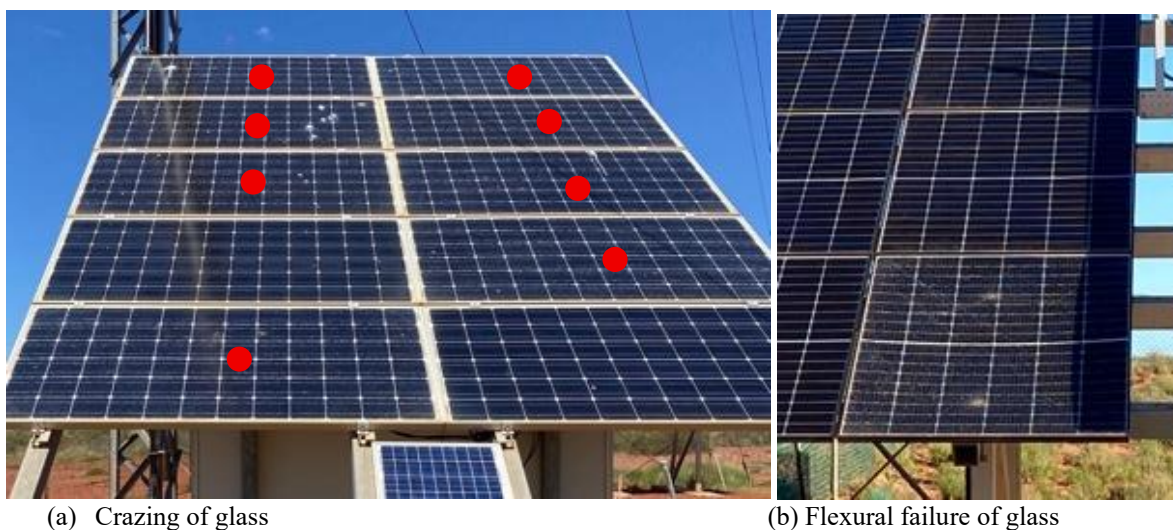
Figure 6-24 Glass failures in ground mounted solar panels

Figure 6-24 (a) shows some ground-mounted panels where crazed glass was evident. (Panels with crazed glass are shown with dots). Figure 6-24 (b) shows that one panel failed by bending. Wind tunnel testing shows that the lower panels have the highest positive net wind pressures pushing on the upper surface of the panel and it was a lower corner panel that failed consistent with the wind tunnel results.

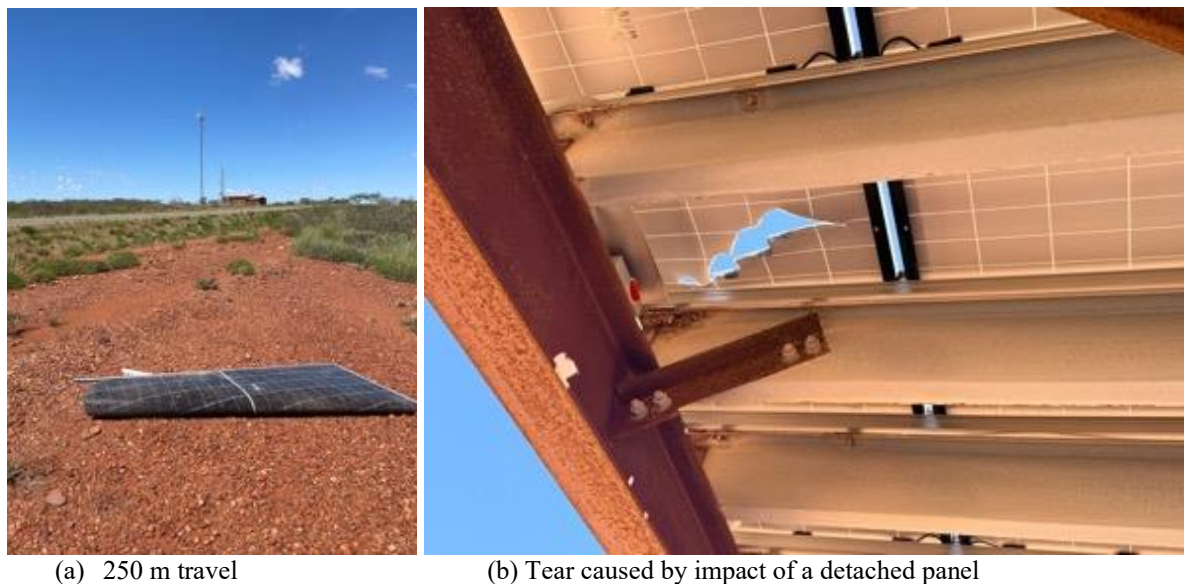
Figure 6-26 Panels lost from ground mounted arrays and damage from windborne panels

Figure 6-26 (b) shows debris damage from a solar panel that had only travelled 3 metres from its point of detachment prior to bouncing off this panel. We could not find the panel that caused this debris damage.

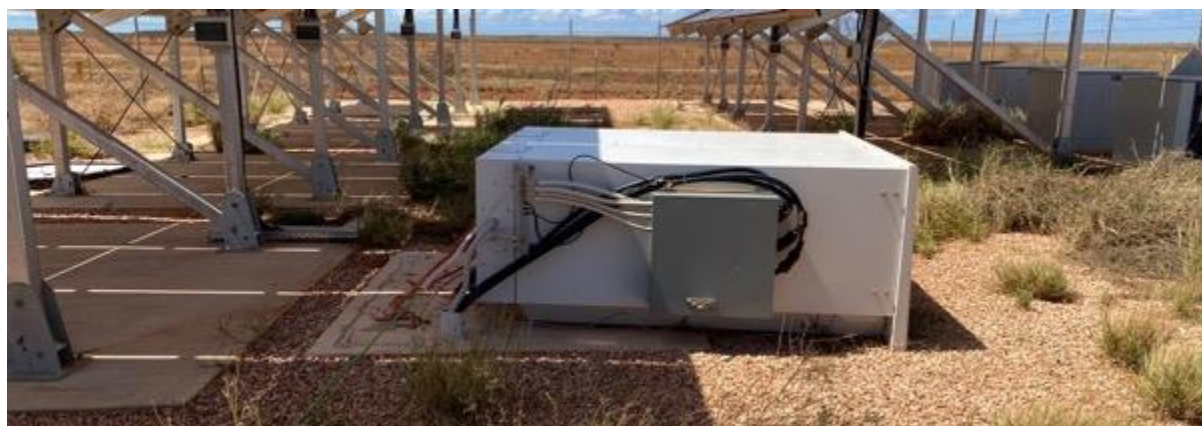
Figure 6-27 Damage to ground mounted cabinets

Wind causes lateral loads on cabinets associated with the solar panels. Figure 6-27 shows a cabinet that was blown over. In this case, the failure would have allowed wind-driven rain (from left to right in the photo) into the base of the cabinet and may have damaged circuitry inside even if it had survived the fall.

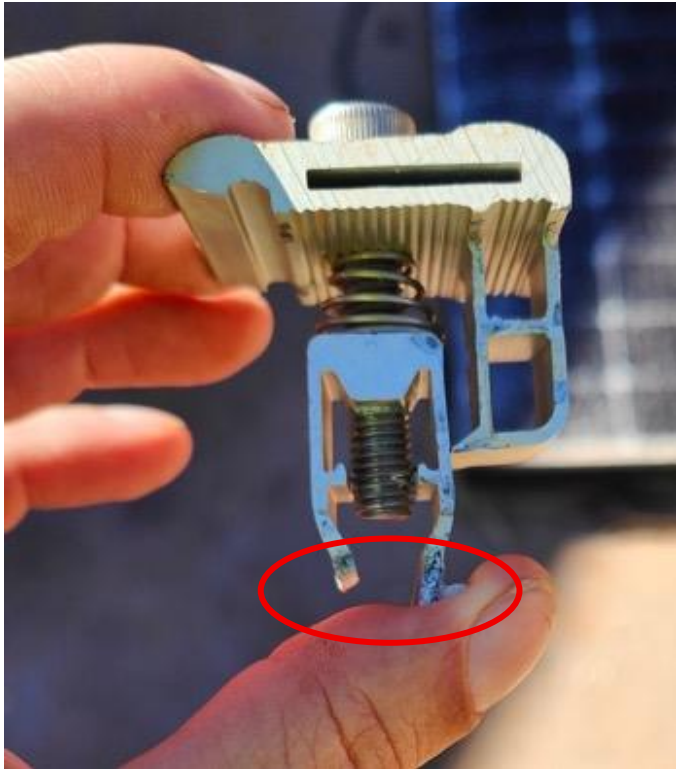
Figure 6-29 Clamp failure

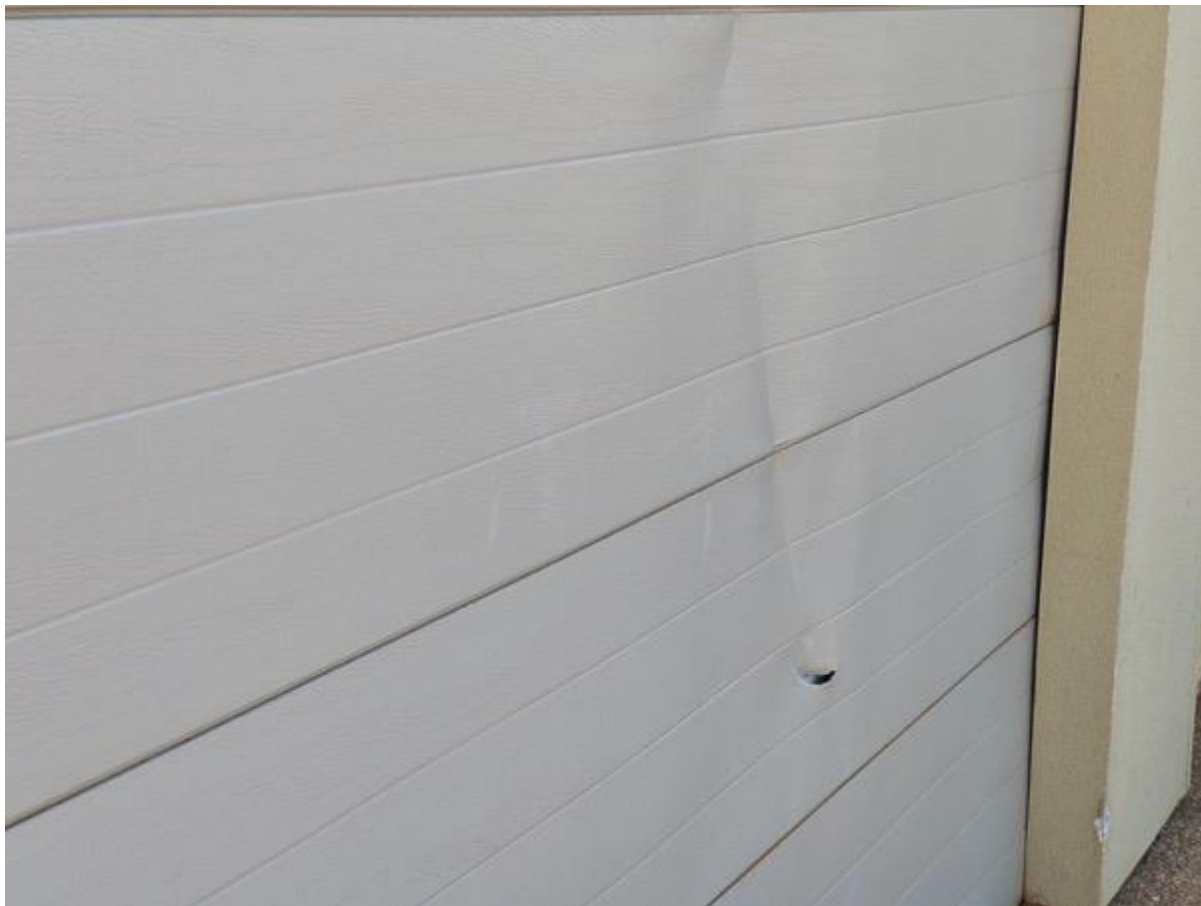
Figure 6-31 Debris damage on a garage door from an impact by a solar panel

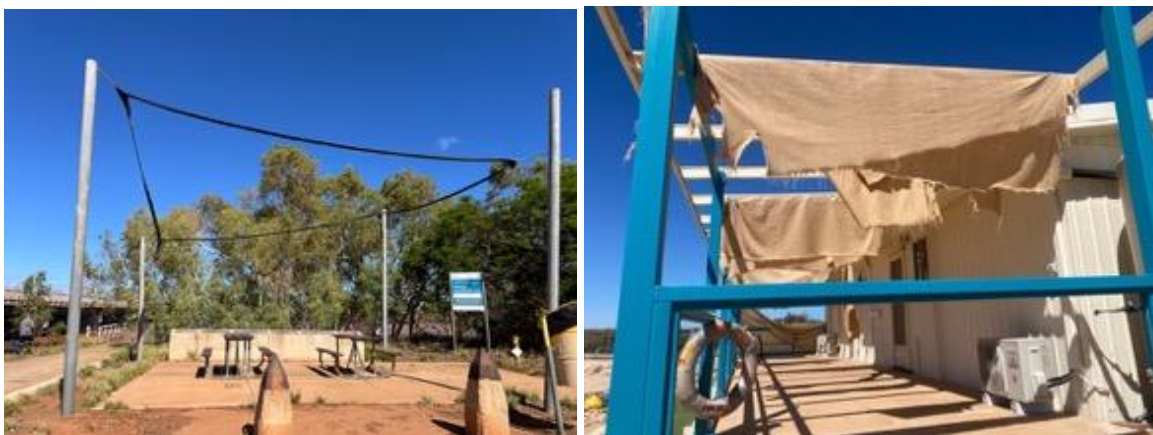
Figure 6-35 Damaged shade sails that had not been taken down in preparation for the cyclone

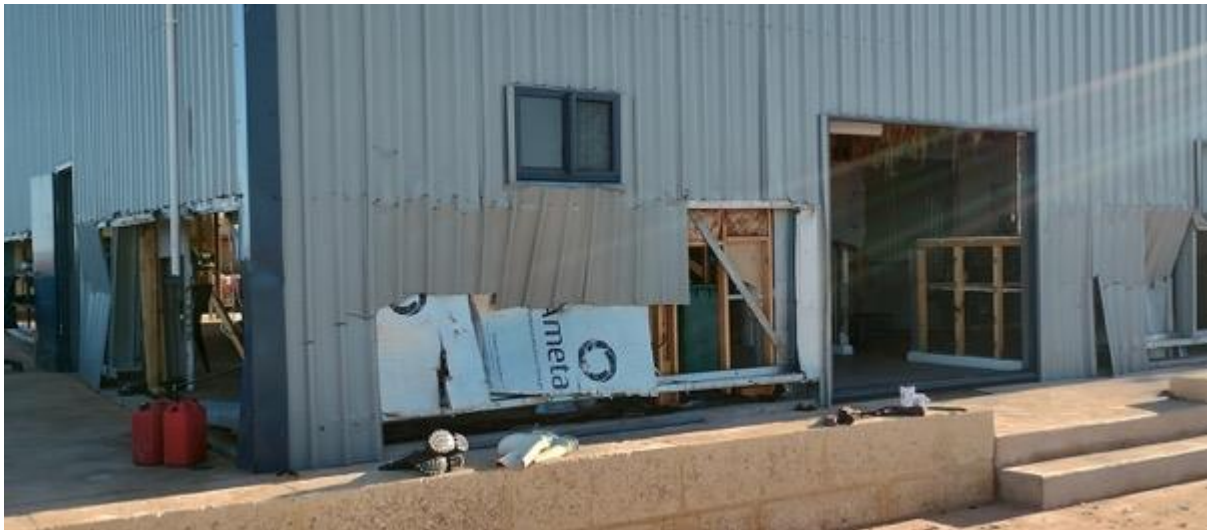
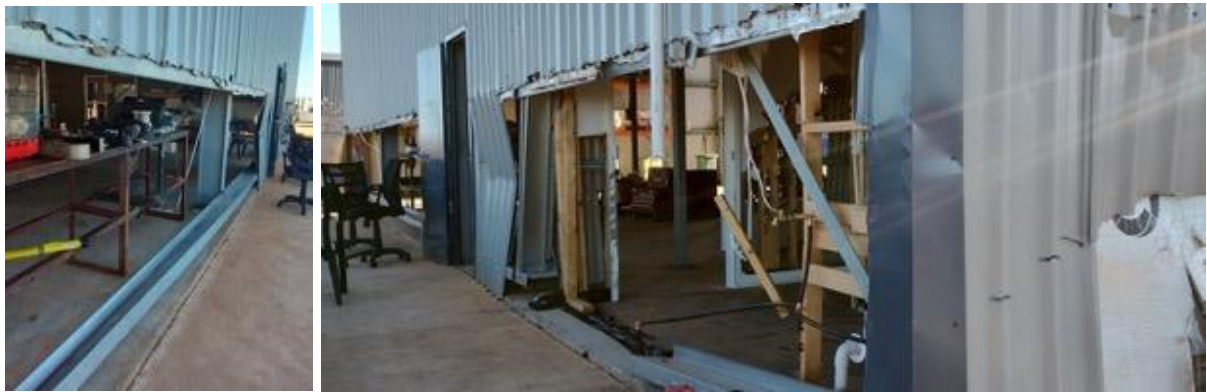
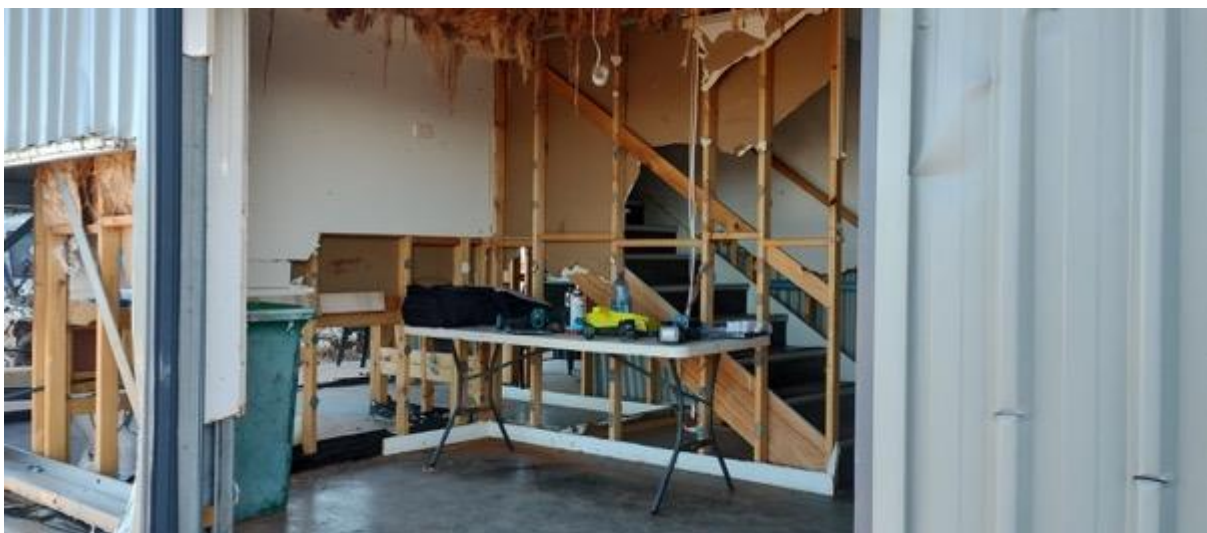
Figure 7-6 Wave damage to office warehouse, Exmouth

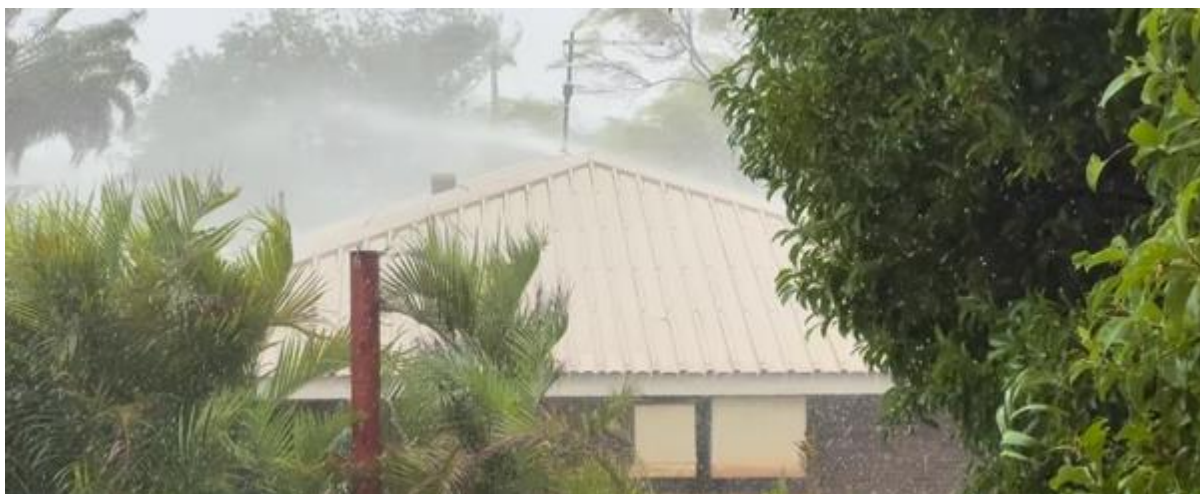
Figure 8-2 Water driven up a roof slope in TC Narelle
