TC Narelle, Queensland, NT, WA Damage to Structures

CTS Technical Report No 72

TC Narelle, Queensland, NT, WA Damage to structures

May 2026

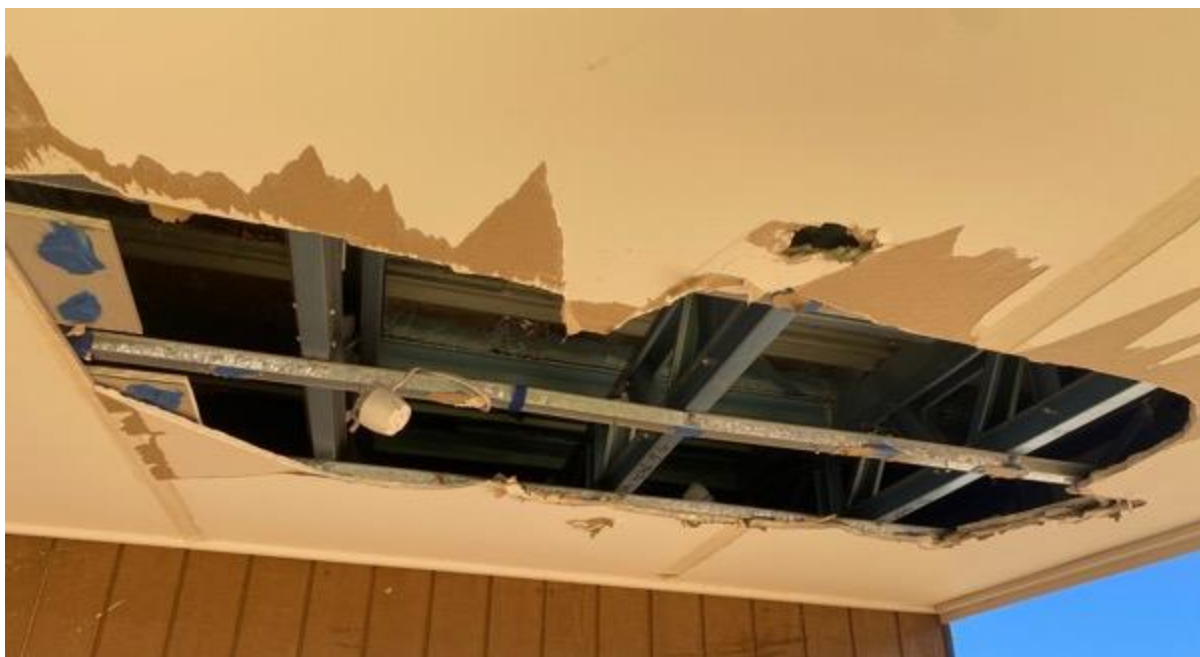
Figure 8-3 Water damage of external plasterboard ceilings

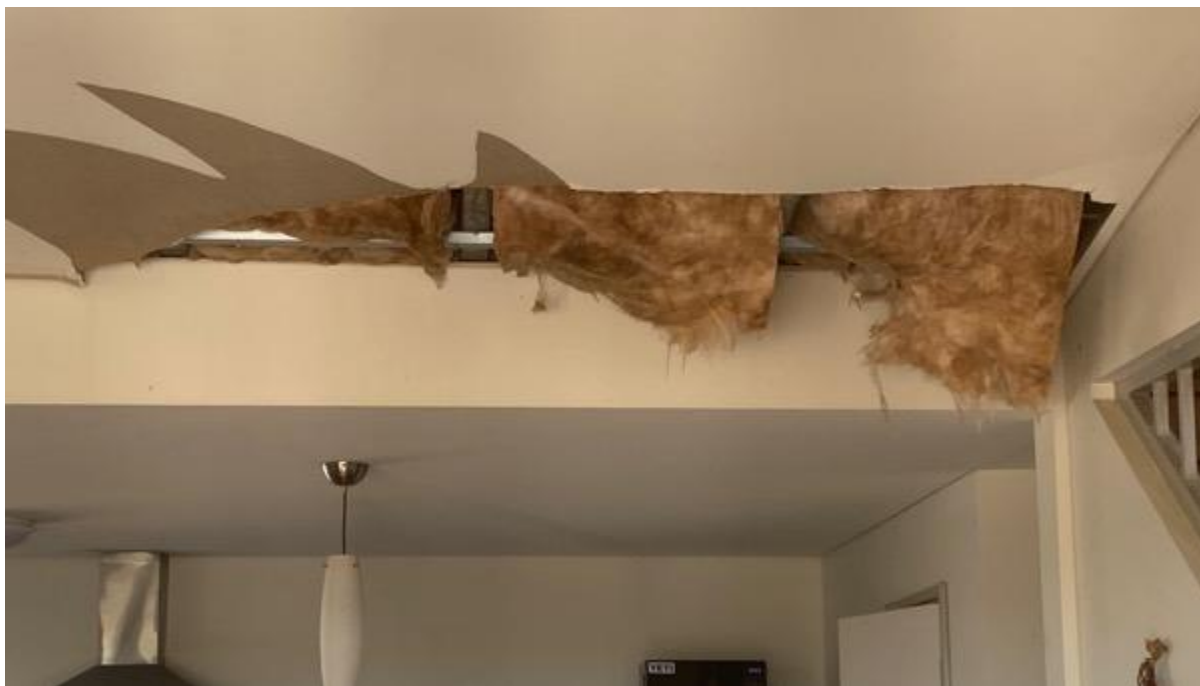
Figure 8-4 Ceiling damage under a box gutter in a house

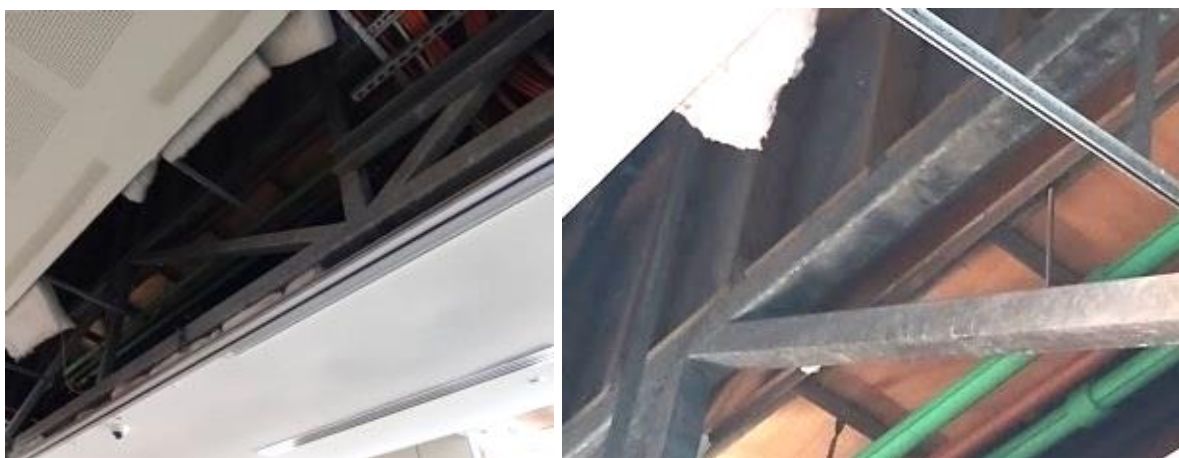
Figure 8-5 Ceiling damage under a box gutter in a commercial building

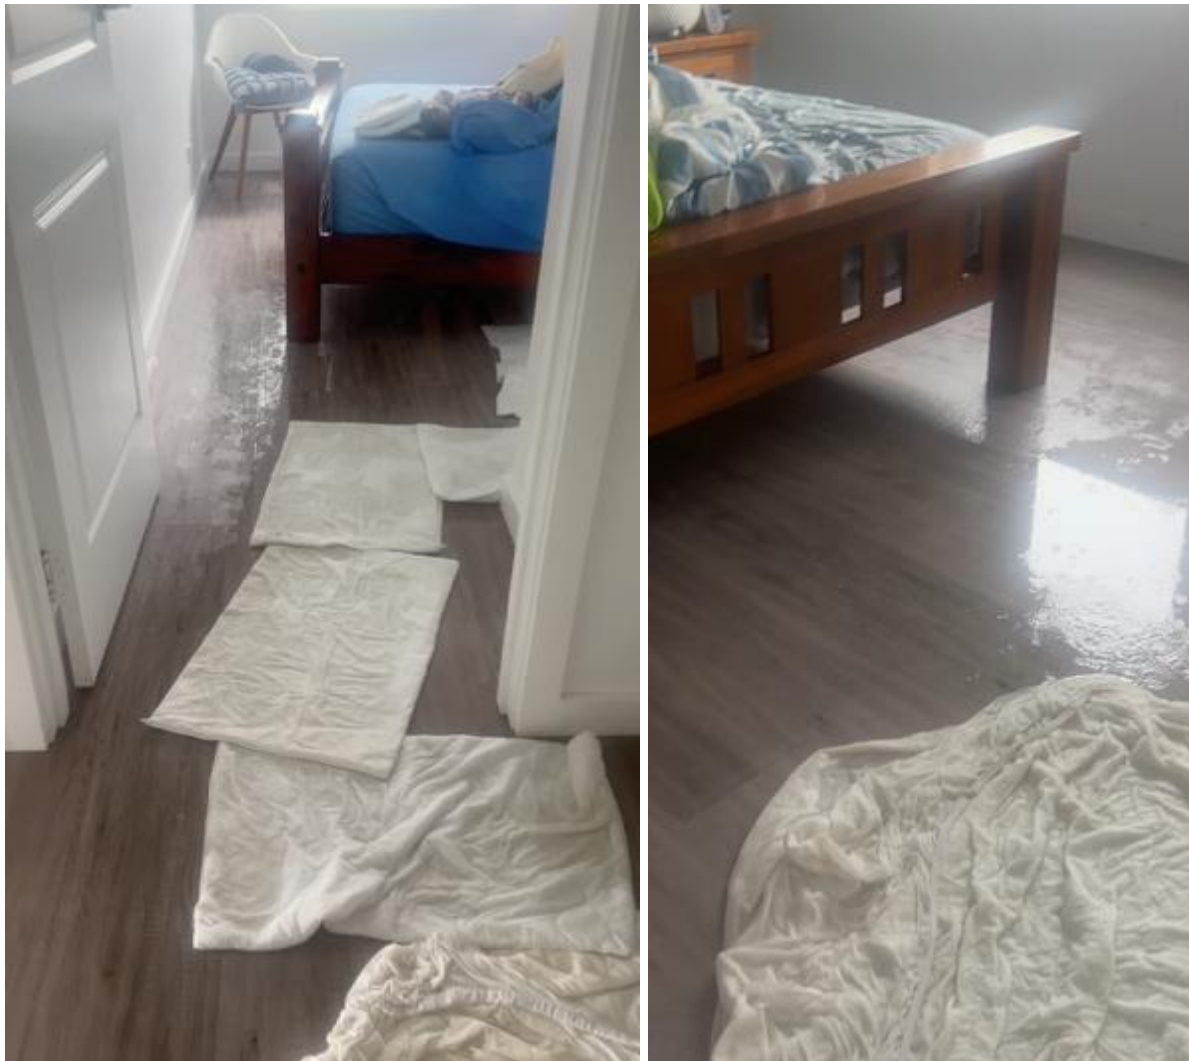
Figure 8-6 Water falling from the ceiling under valley gutters during TC Narelle

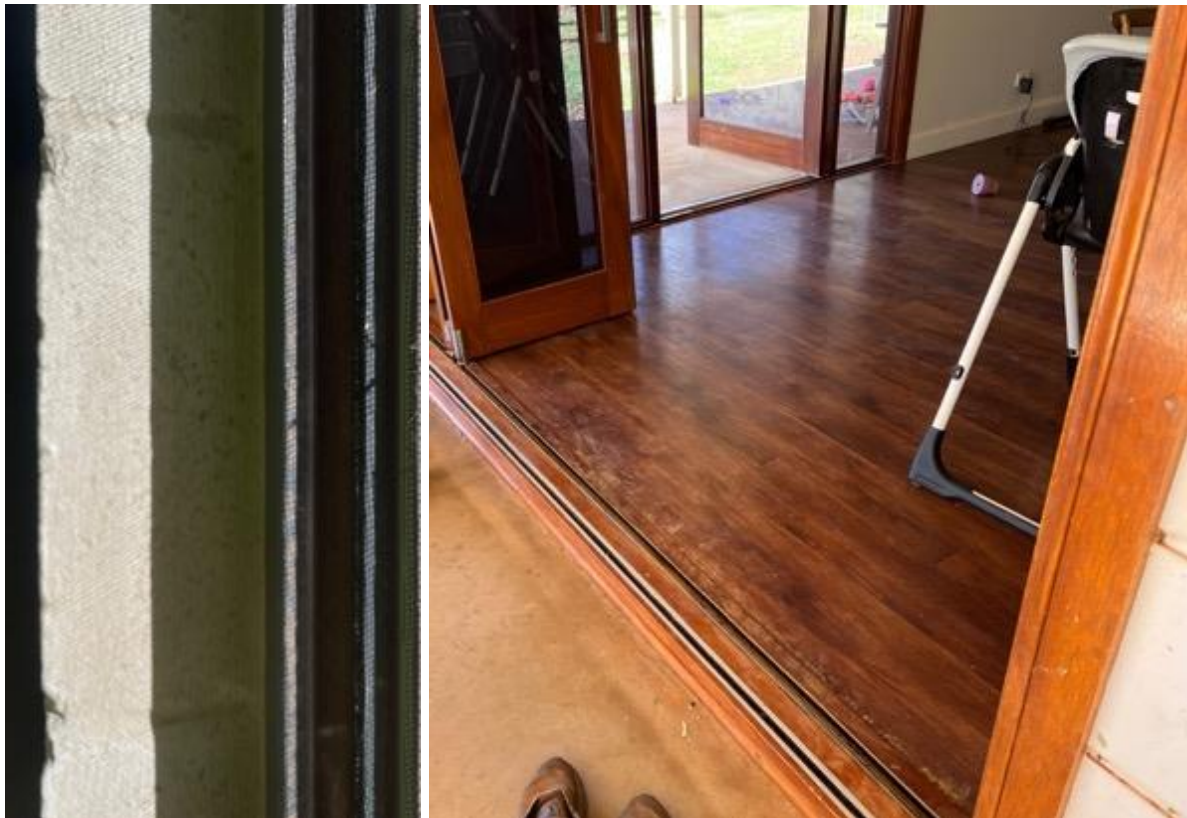
(a) Water between window and blockwork (b) Water under bifold doors

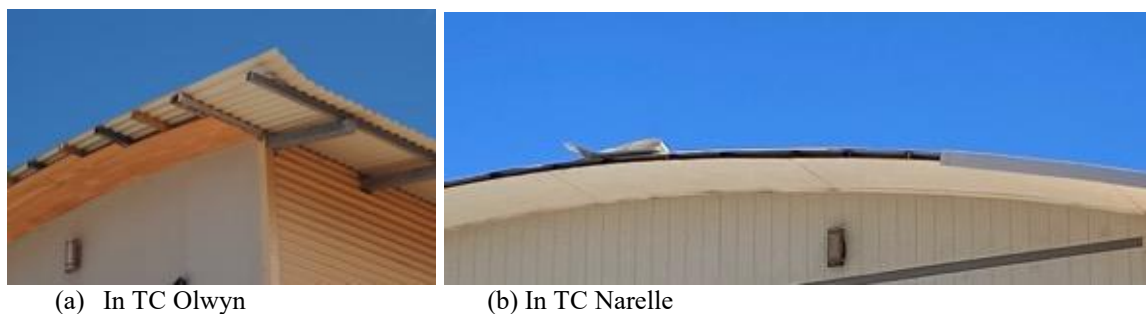
(a) In TC Olwyn
Figure 8-9 Damage to roof flashing

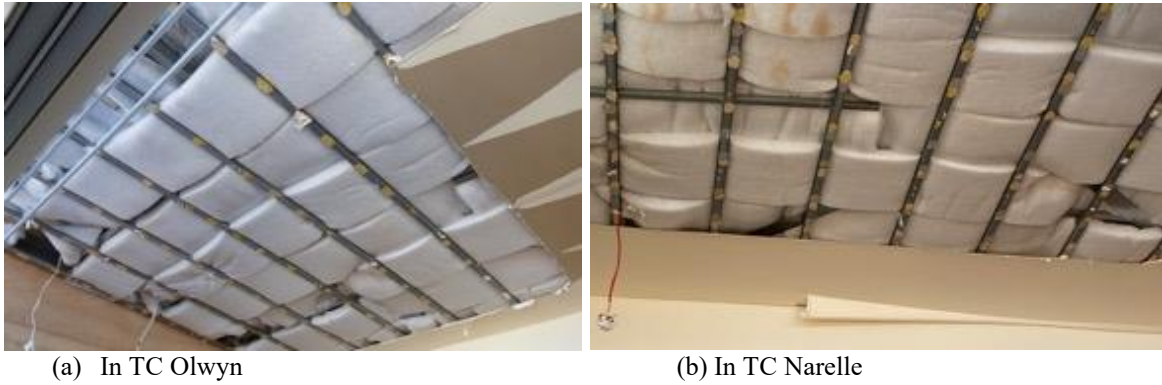
(a) In TC Olwyn
Figure 8-11 Ceiling loss under a leaking apron detail

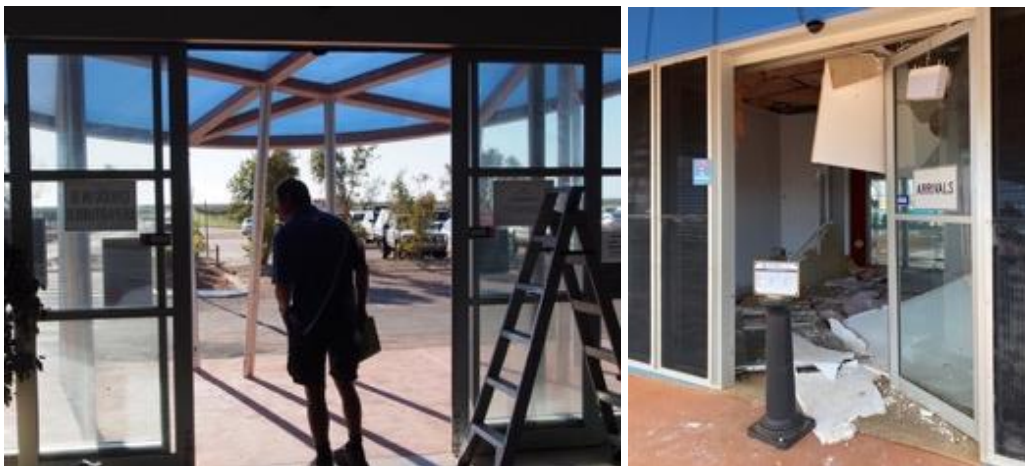
(a) In TC Olwyn
Figure 8-12 Failure of automatic sliding glass doors
