ASBESTOS MATERIALS REPORT AND REGISTER

St Mark's College,
James Cook University
DOUGLAS QLD 4811

Inspection Date: 23/11/2016 9:00:00 AM

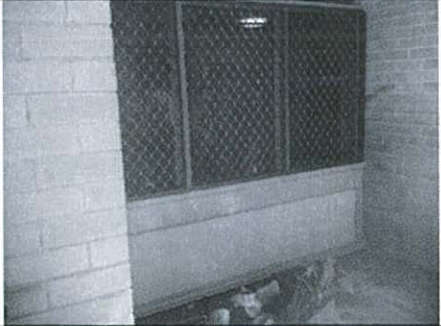
Building	Floor Level	Room	Asbestos in Room	Type	Condition	Priority	Sample No.	Result	Photo
Administration Building	GL	External / Internal	Asbestos cement sheeting to panels under windows with some above windows and doors generally throughout the building.	NF	N	L	E3189	AA	
25/11/2016		No change in the condition of this item.			N	L

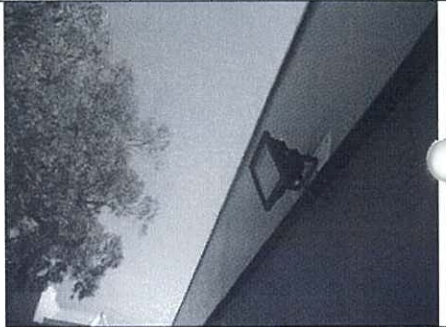
Administration Building	GL	External	Asbestos cement sheeting to fascias generally.	NF	N	L	E3189	CH

Building	Floor Level	Room	Asbestos in Room	Type	Condition	Priority	Sample No.	Result	Photo
25/11/2016			No change in the condition of this item.		N	L

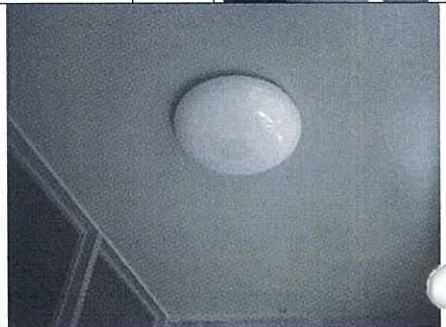
Administration Building	GL	External	Asbestos cement sheeting to soffits generally throughout, including any bulkheads.	NF	N	L	E3189	CH

25/11/2016			No change in the condition of this item.		N	L

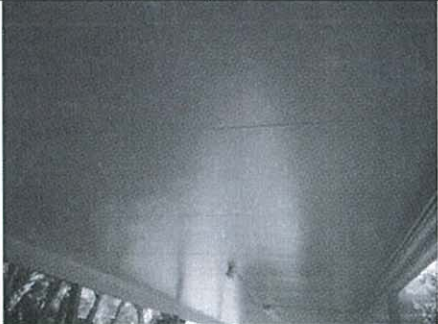
Building	Floor Level	Room	Asbestos in Room	Type	Condition	Priority	Sample No.	Result	Photo
Administration Building	GL	Covered walkway to dining room	Asbestos cement sheeting to ceiling.	NF	N	L	E3193	CH, A

25/11/2016		No change in the condition of this item.			N	L

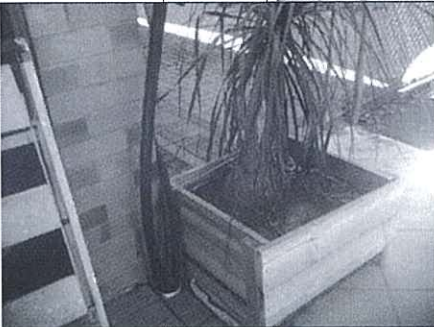
Building	Floor Level	Room	Asbestos In Room	Type	Condition	Priority	Sample No.	Result	Photo
Kitchen / Dining Hall	GL	External - Main entrance	Asbestos to lining to cable pit.	NF	N	L	E0	CH, A

25/11/2016		No change in the condition of this item.			N	L

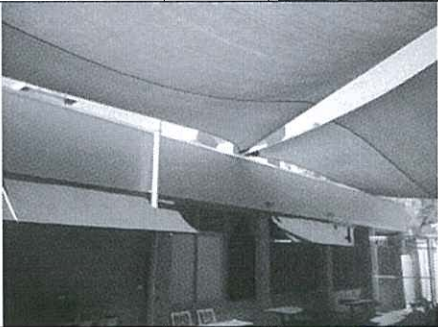
Building	Floor Level	Room	Asbestos in Room	Type	Condition	Priority	Sample No.	Result	Photo
Kitchen / Dining Hall	GL	External	Asbestos cement sheeting to fascias.	NF	N	L	E3196	CH

25/11/2016		No change in the condition of this item.			N	L

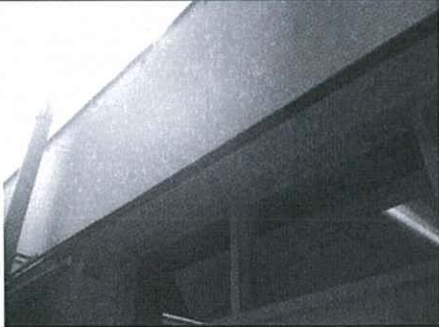
Kitchen / Dining Hall	GL	External	Asbestos cement sheeting to soffits including bulkheads.	NF	N	L	E3196	CH

Building	Floor Level	Room	Asbestos in Room	Type	Condition	Priority	Sample No.	Result	Photo
25/11/2016			No change in the condition of this item.		N	L

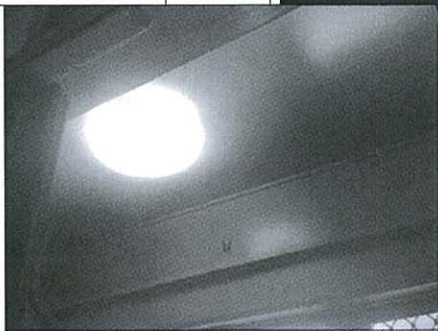
Kitchen / Dining Hall	GL	Main entrance Alcove	Asbestos cement sheeting to ceiling and wall panel.	NF	N	L	E3198	CH

25/11/2016			No change in the condition of this item.		N	L

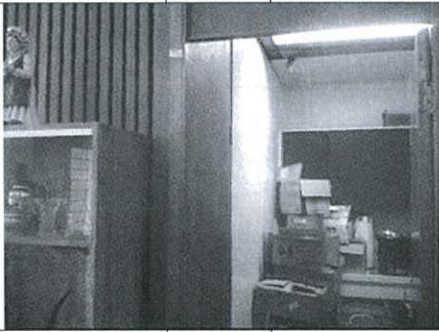
Building	Floor Level	Room	Asbestos In Room	Type	Condition	Priority	Sample No.	Result	Photo
Kitchen / Dining Hall	GL	Store room next to PABX room	Asbestos cement sheeting to walls	NF	N	L	E3198	CH	
/11/2016		No change in the condition of this item.			N	L

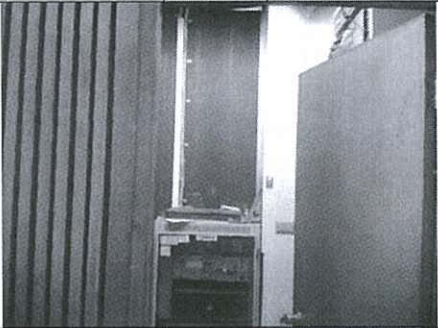
Kitchen / Dining Hall	GL	Server room next to PABX room	Asbestos cement sheeting to walls	NF	N	L	E3198	CH

Building	Floor Level	Room	Asbestos in Room	Type	Condition	Priority	Sample No.	Result	Photo
25/11/2016			No change in the condition of this item.		N	L

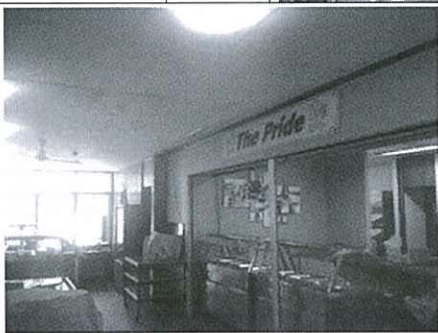
Kitchen / Dining Hall	GL	Dining hall	Asbestos cement sheeting to walls (to service area internally and externally).	NF	N	L	E3198	CH

25/11/2016			No change in the condition of this item.		N	L

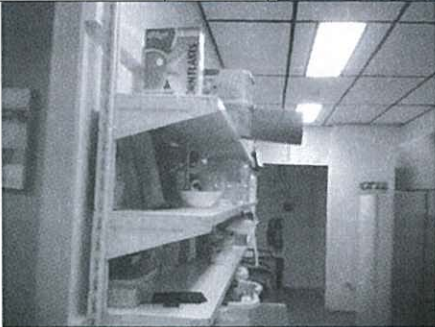
Building	Floor Level	Room	Asbestos in Room	Type	Condition	Priority	Sample No.	Result	Photo
Kitchen / Dining Hall	GL	Kitchen	Asbestos cement sheeting to walls to rear corridor.	NF	N	L	E3197	CH, A

11/11/2016		No change in the condition of this item.			N	L

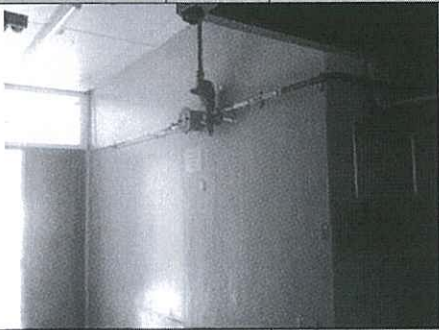
Kitchen / Dining Hall	GL	Rear stores to kitchen	Asbestos cement sheeting to walls externally and internally.	NF	N	L	E3202	CH

Building	Floor Level	Room	Asbestos in Room	Type	Condition	Priority	Sample No.	Result	Photo
25/11/2016			No change in the condition of this item.		N	L

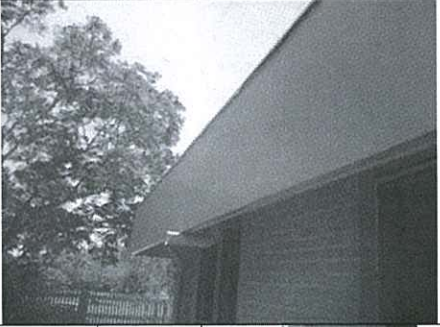
Building	Floor Level	Room	Asbestos in Room	Type	Condition	Priority	Sample No.	Result	Photo
Cottage	GL	External	Asbestos cement sheeting to fascias generally.	NF	N	L	E3204	CH, A

25/11/2016		No change in the condition of this item.			N	L

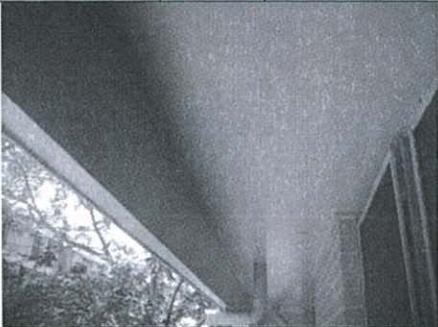
Cottage	GL	External	Asbestos cement sheeting to soffits generally.	NF	G	L	E3204	CH, A

Building	Floor Level	Room	Asbestos in Room	Type	Condition	Priority	Sample No.	Result	Photo
25/11/2016			No change in the condition of this item.		G	L

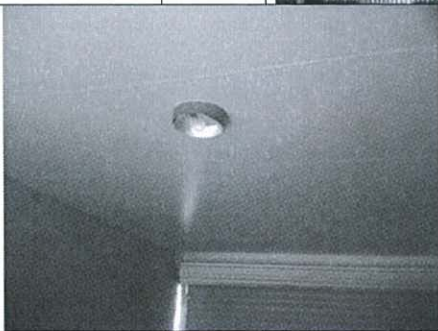
Cottage	GL	Garage	Asbestos cement sheeting to ceiling.	NF	G	L	E3203	CH

25/11/2016			No change in the condition of this item.		G	L

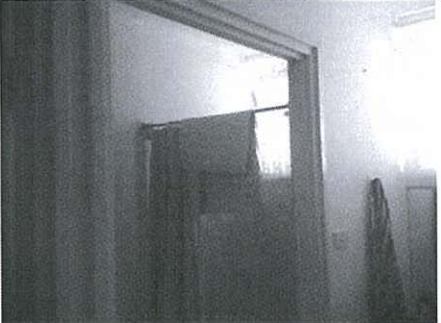
Cottage	GL	Bathroom	Asbestos cement sheeting to walls	NF	G	L	AA	AA

Building	Floor Level	Room	Asbestos in Room	Type	Condition	Priority	Sample No.	Result	Photo
25/11/2016			No change in the condition of this item.		G	L

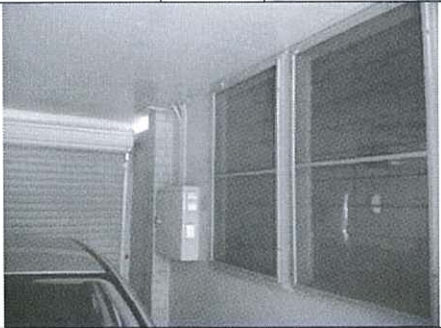
Cottage	GL	Garage	Asbestos cement sheeting to external walls to house.	NF	G	L	E3203	CH

25/11/2016			No change in the condition of this item.		G	L

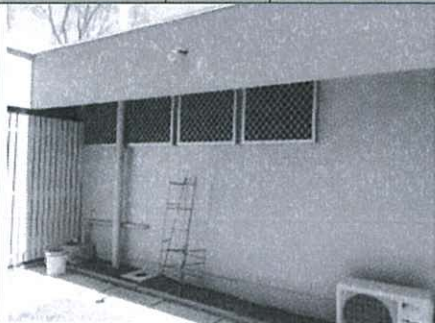
Cottage	GL	External	Asbestos cement sheeting to non brick external walls.	NF	G	L	AA	AA

Building	Floor Level	Room	Asbestos In Room	Type	Condition	Priority	Sample No.	Result	Photo
25/11/2016			No change in the condition of this item.		G	L

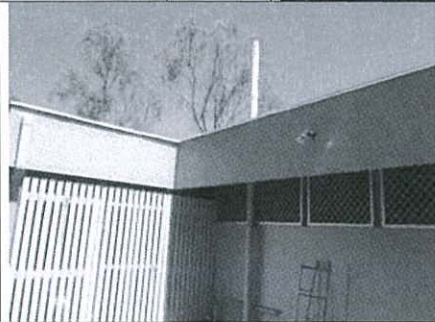
Cottage	GL	External	Assumed Asbestos cement vent pipe.	NF	G	L	AA	AA

25/11/2016			No change in the condition of this item.		G	L

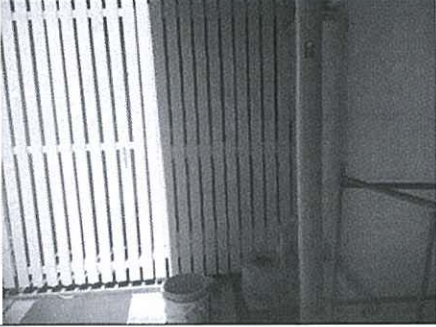
Cottage	GL	External	DT Surround.	NF	G	L	AA	AA

Building	Floor Level	Room	Asbestos in Room	Type	Condition	Priority	Sample No.	Result	Photo
25/11/2016			No change in the condition of this item.		G	L
