Tropical Cyclone Damien Damage to buildings in the Pilbara Region of WA

CTS Technical Report No 65

Tropical Cyclone Damien Damage to buildings in the Pilbara Region of Western Australia

This edition: 28 February 2020

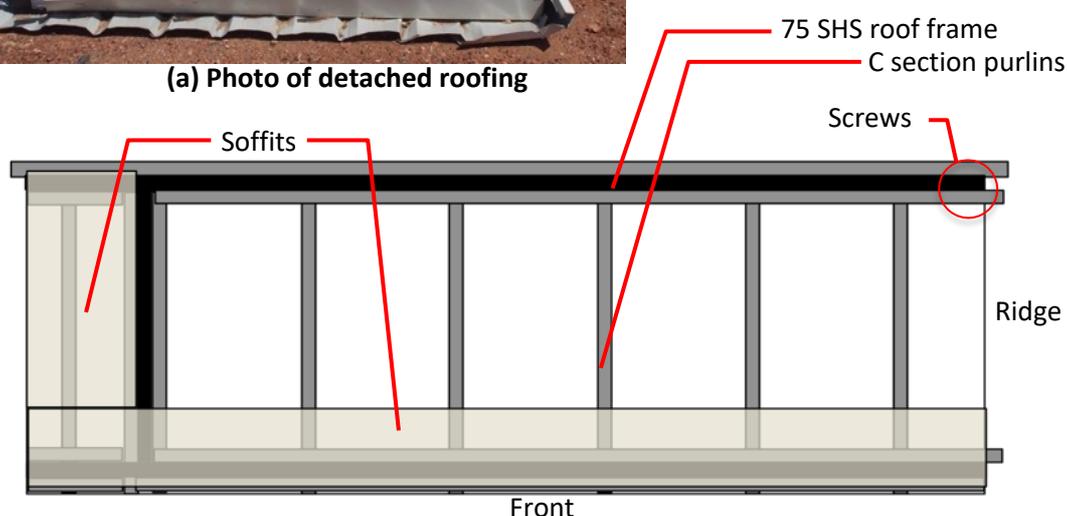
(b) Diagram of fixings noted in detached roofing

Figure 4.9 Failure of skillion roof

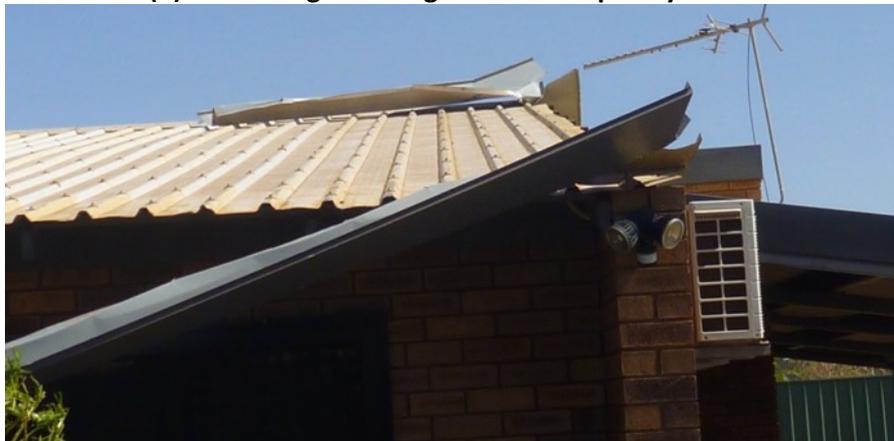
(e) Lifted barge flashing on an older house

Figure 4.10 Failures of flashings

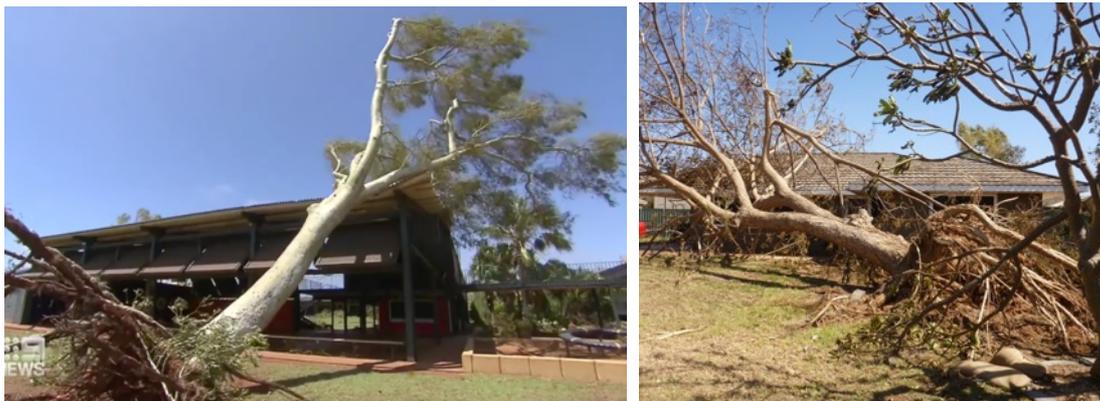
Figure 4.17 Damage from fallen trees

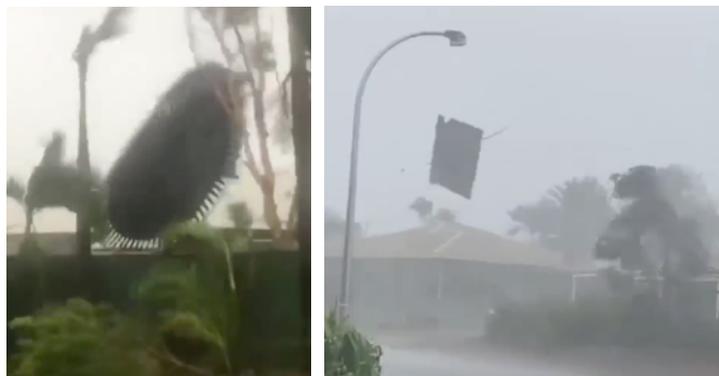
Figure 4.18 shows an unsecured trampoline and a section of roof that became airborne during TC Damien. The loose trampoline illustrates the need to clean up properties and secure items as part of the preparation for a cyclone, and the risk to life and safety created by wind-borne debris.

Figure 4.18 Wind-borne debris (Photos – Channel 9 Perth)

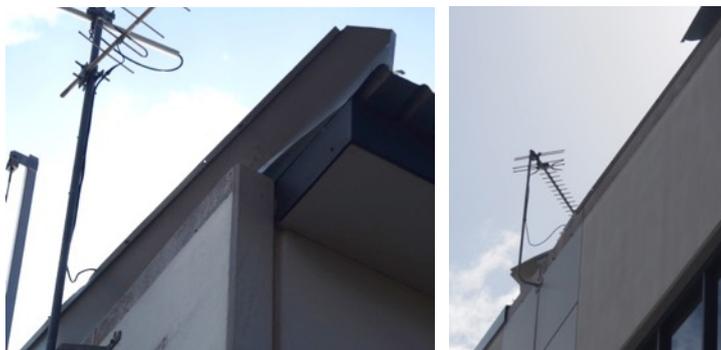
Figure 5.4 Examples of failure of flashings on a commercial building

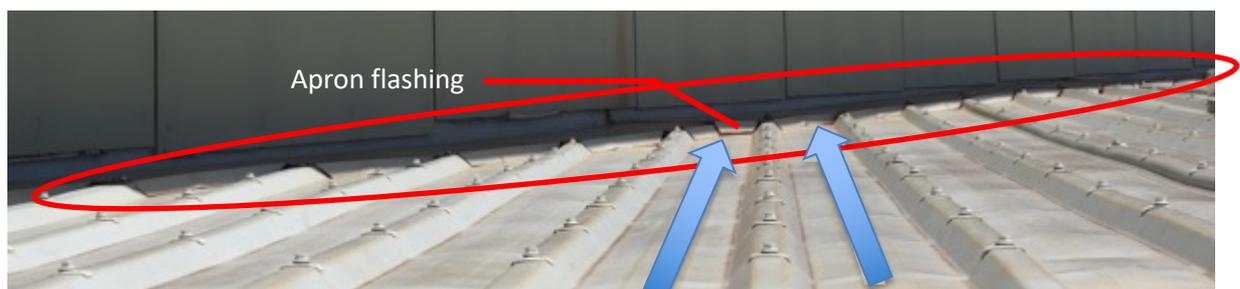
A relatively complex roof shape on a public building (involving a number of apron flashings) led to water being forced up the roof sheeting and under the apron flashing, as shown in Figure 5.7. This caused extensive damage to ceilings and carpets. Complex roof configurations can be difficult to seal against wind-driven rain.

Figure 5.7 Point of entry of wind-driven rain

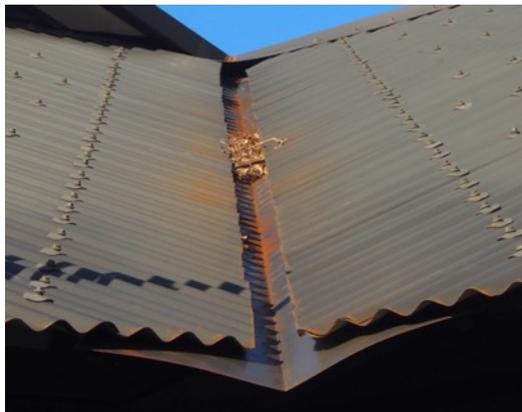
Figure 5.11 shows a valley gutter that became blocked during TC Damien causing water to overflow into the ceiling space and damage the ceiling underneath.

Figure 5.11 Example of a blocked valley gutter

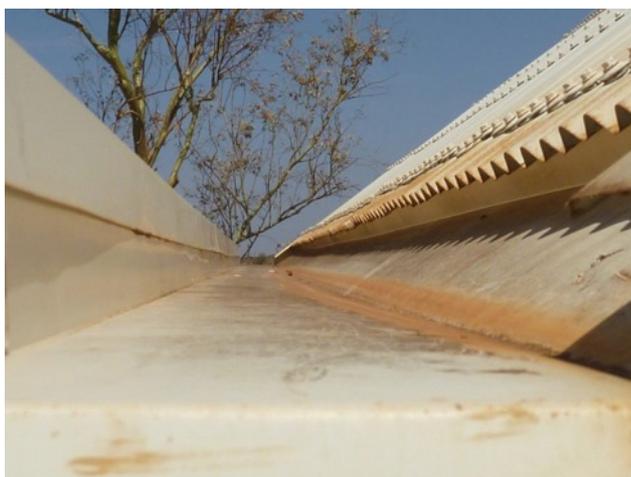
In previous damage investigations (Boughton *et al*, 2017, Boughton *et al*, 2011), the CTS team found that rainwater was driven over the edge of box gutters during high wind events. Box gutters usually only have a drain at one end. Strong winds can drive water pooled in the gutter to the opposite end to the drain where it piles up and overflows into the ceiling space. However, Figure 5.12 shows a box gutter completely open at both ends. Rainwater was still blown over the right edge of the box gutter and into the roof space. Therefore, most configurations of box gutters are likely to allow water into a building during high wind events.

Figure 5.12 Box gutter open at both ends

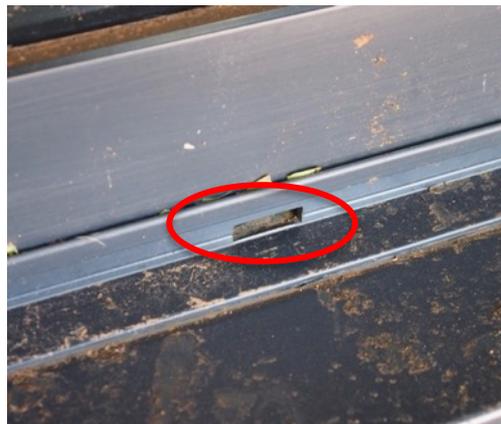
In addition, many windows in commercial buildings and apartments investigated after TC Damien are non-opening (fixed). Even these windows leaked around the window frame, as shown in Figure 5.13.

(a) Uncovered weep hole in a fixed window on the outside of a building

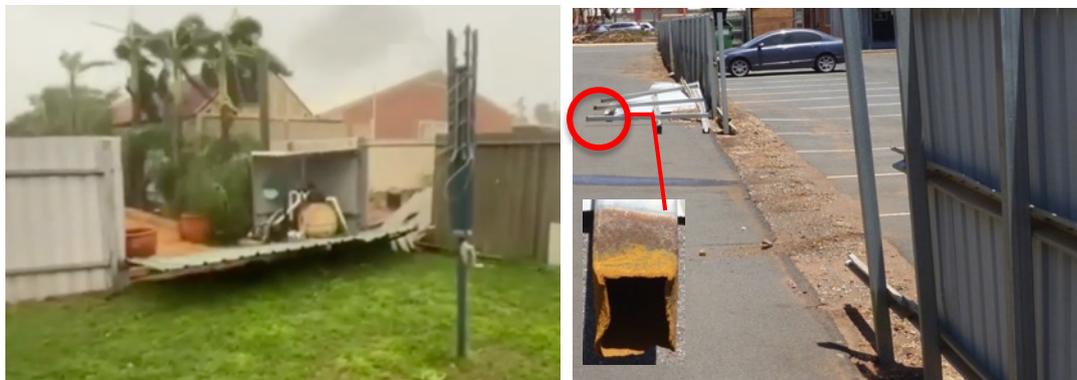
During TC Damien, high winds and falling trees damaged some boundary fences. Figure 7.1 shows two examples where fence posts failed under wind loads.

(a) The moment of failure (*Photo – Channel 9*) (b) Corroded posts
Figure 7.1 Fence post failures

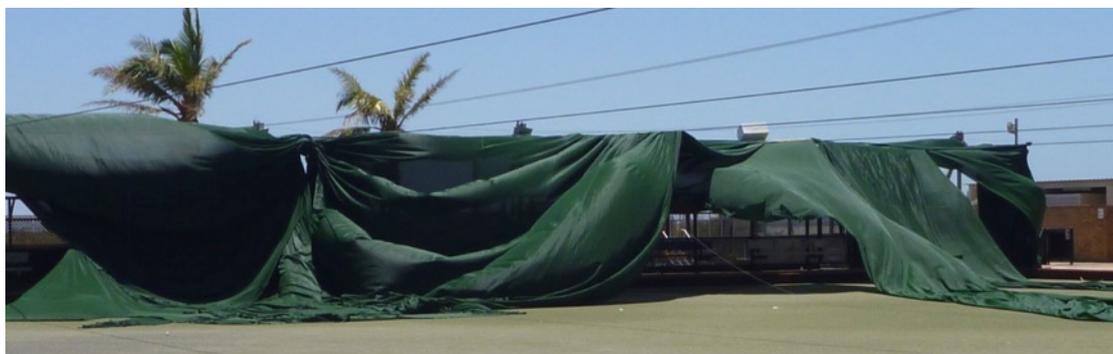
Figure 7.4 Examples of damage to sail and shade cloth structures

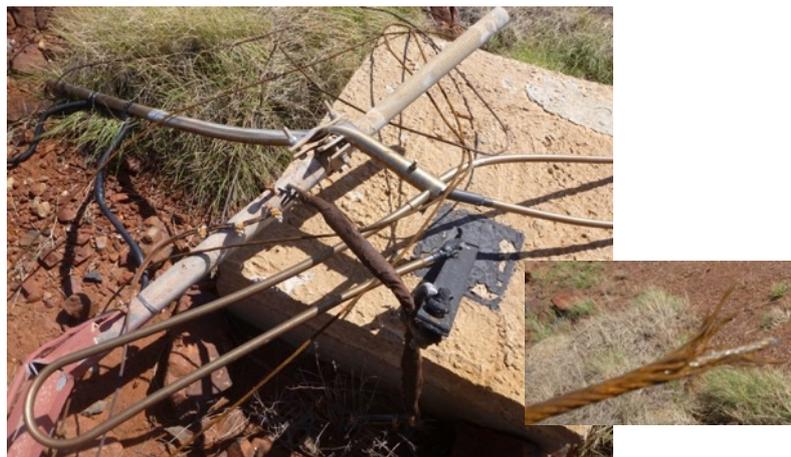
(a) Broken stays near top of the tower (inset – broken stay)

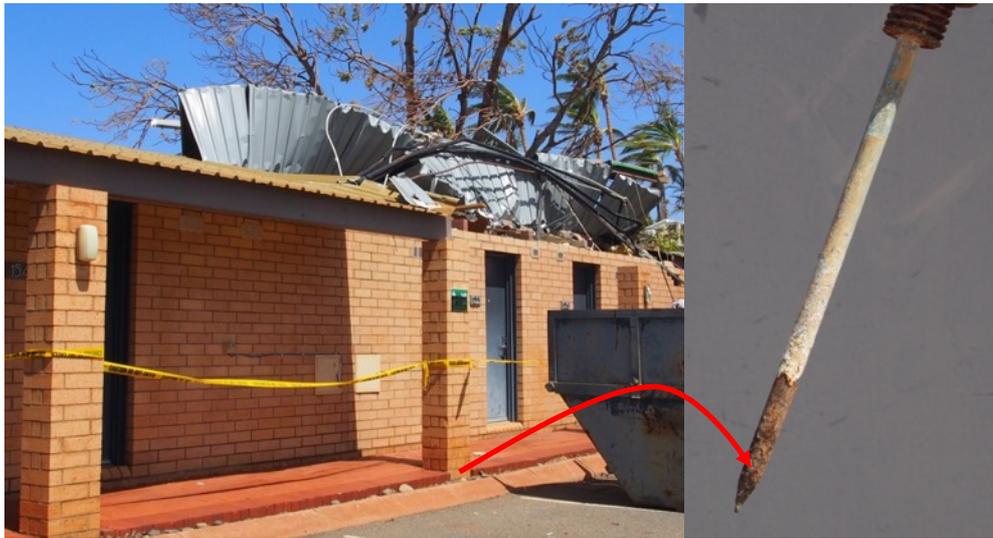
Figure 8.2 Corrosion in tie-down rod that led to loss of timber framed roof

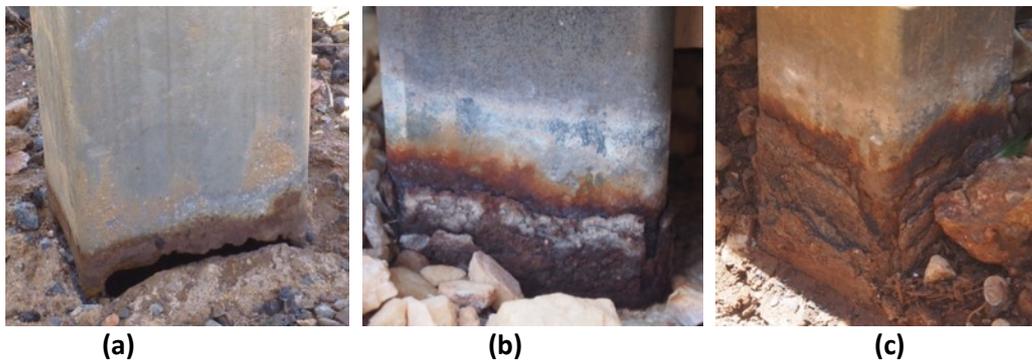
Figure 8.3 Corrosion in SHS posts

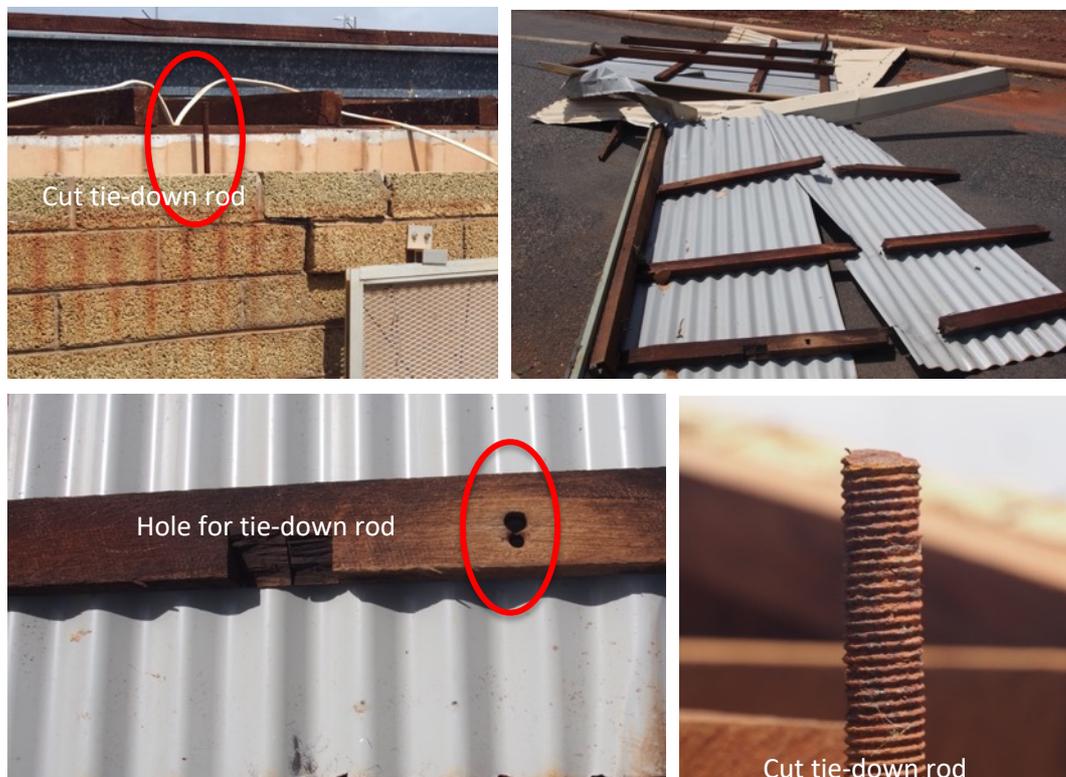
Figure 8.9 Building where overbattens were removed during re-roofing
