2024 Severe storms in Bunbury, WA Damage to Houses

CTS Technical Report No 68

TECHNICAL REPORT NO. 68

2024 Severe Storms in Bunbury, WA

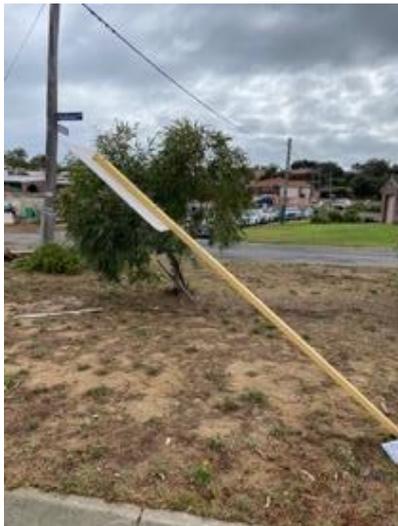
Figure 2-2 A road sign used to estimate wind speed.

- Lower-bound signs were those which had failed by bending the posts (forming ‘plastic hinges’). The wind speed to cause the damage was higher than the wind speed that would have created enough load to fail the post, and this is shown in the photo of Figure 2-2.
- Upper-bound signs had not failed by forming plastic hinges in the posts and remained upright. The wind speed cannot have exceeded the speed that would have created enough load to fail the post. This is shown in Figure 3-2.
- Where the pole had just started to fail but hadn’t developed a full plastic hinge, the lower-bound wind speed was likely close to the actual wind speed. This is the case for the sign in Figure 2-2.

The wind speed calculated from the measurements of the sign was estimated to be close to the actual wind speed as it was a lower bound sign that had just started to fail. The calculations gave a wind speed corrected for standard conditions (0.2 sec gust, 10 m height over flat, relatively smooth terrain) of 47 m/s. Within the calculation tolerances, this is about the same as the design wind speed (V_{500}) for wind region A (45 m/s) in which Bunbury is situated.

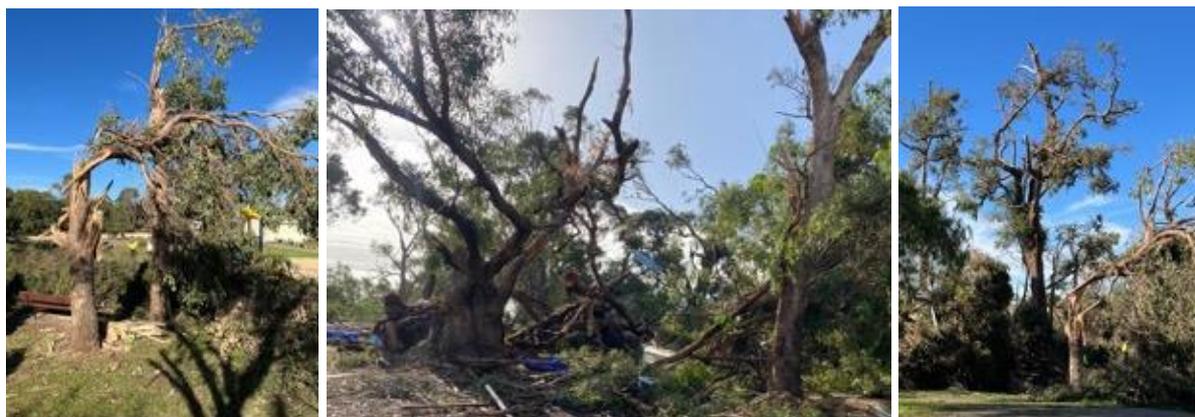
Figure 2-3 Peak damage to vegetation along the track of the tornado.

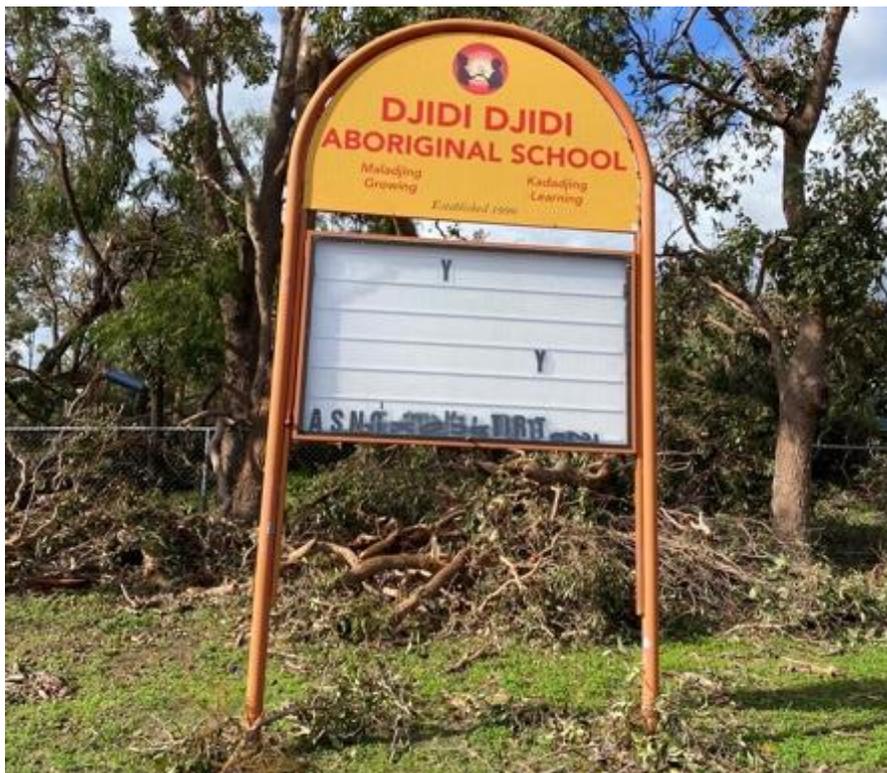
Figure 3-2 Sign at Glen Iris used to estimate an upper bound for the wind speed

Because this sign had not started to develop a plastic hinge in the posts, the sign could be used to calculate an upper bound to the wind speed at that location. The calculations showed an upper bound to the wind speed of 120 km/h or 34 m/s as a 0.2 sec gust which was around 75% of the design wind speed for importance level 2 buildings in Bunbury.

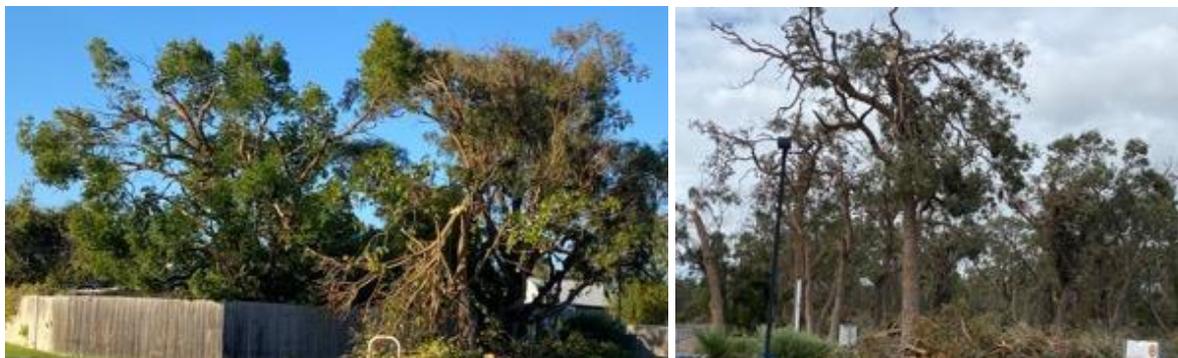
Figure 3-3 shows the extent of tree damage along the path of the downburst. It is not as significant as the damage to the same tree species in the tornado and illustrated in Figure 2-3.

Figure 3-3 Tree damage along the path of the downburst

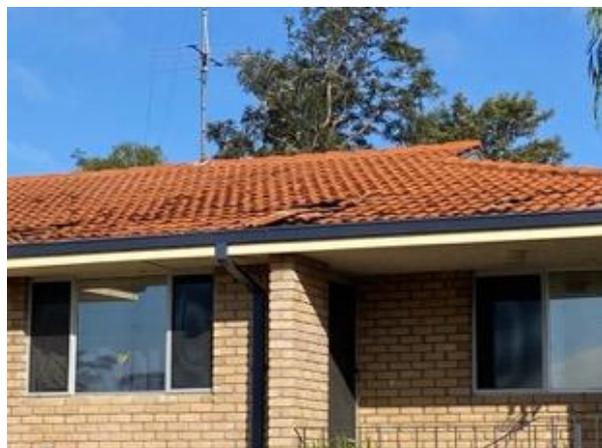
(a) Slight damage

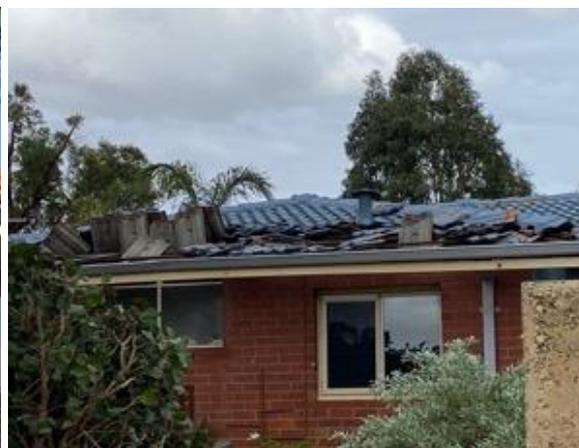
(b) Moderate damage

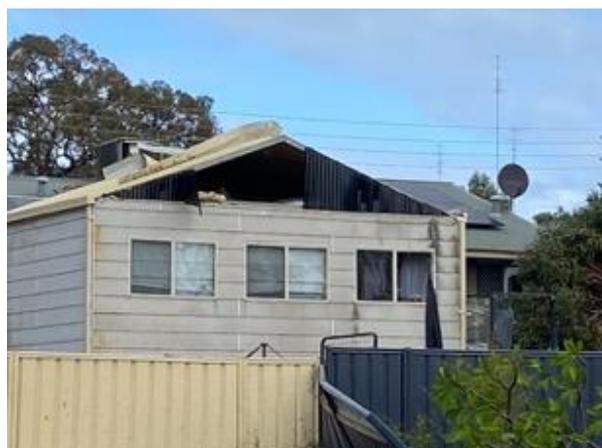
(c) Severe damage

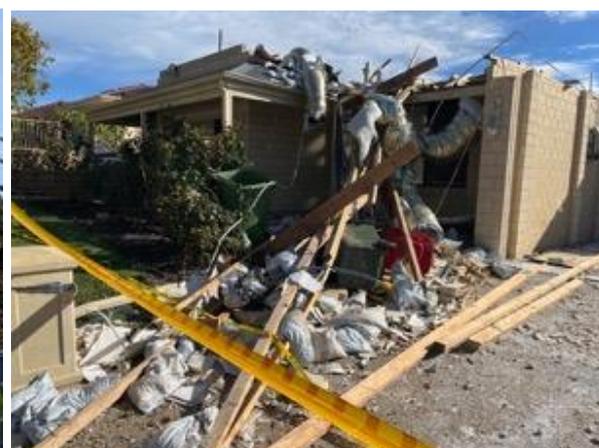
(d) Total damage

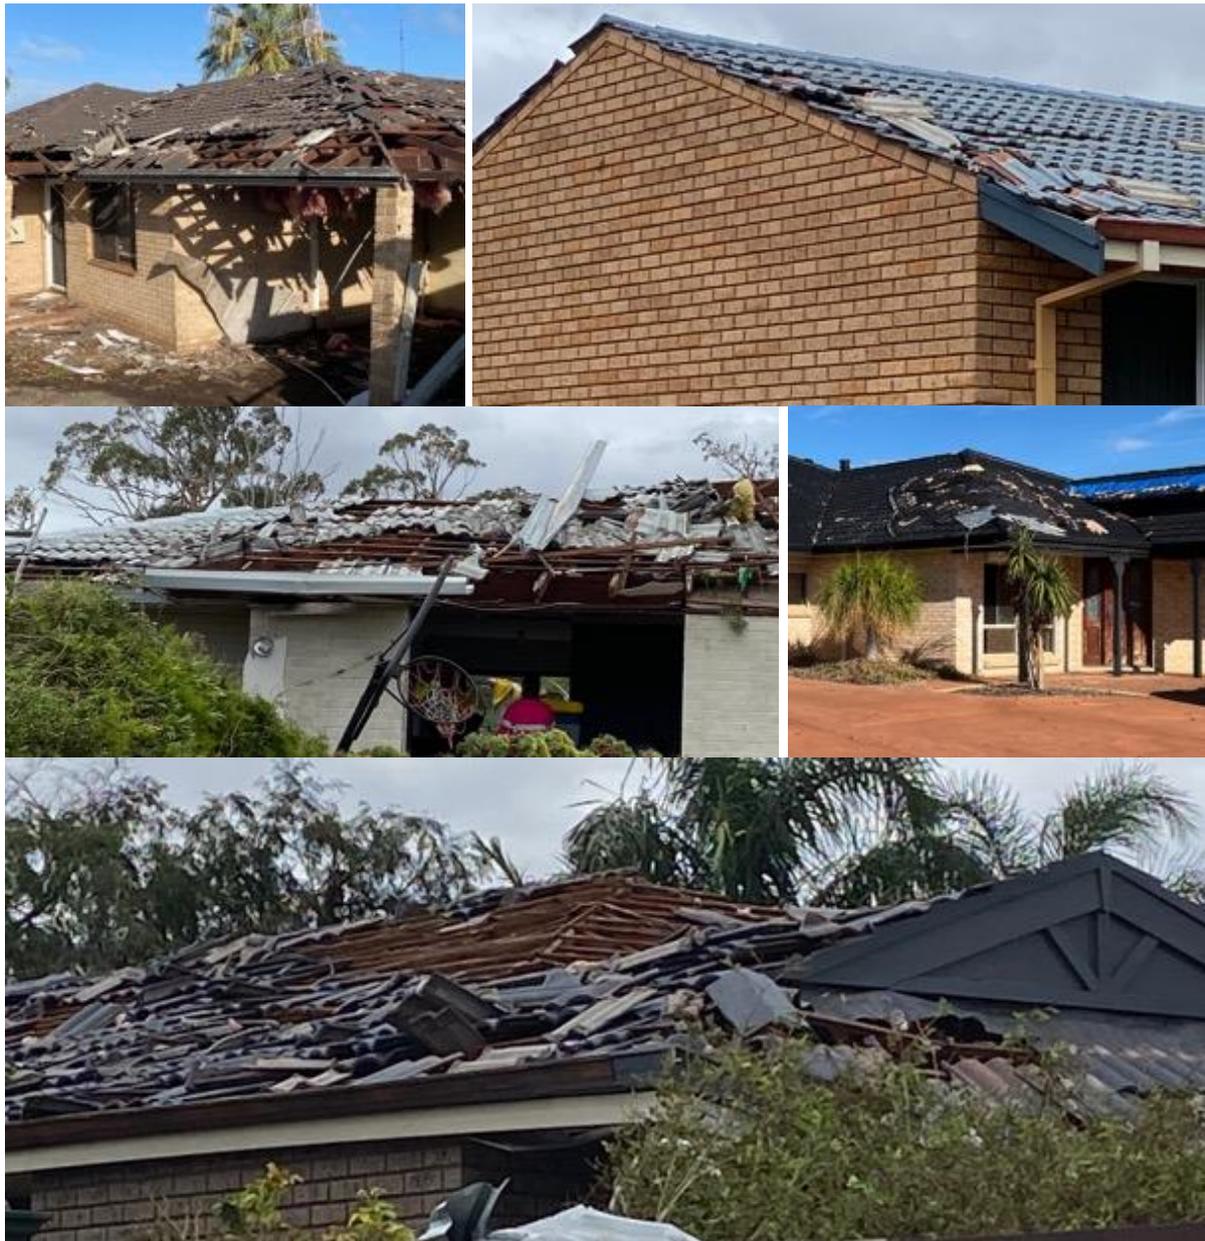
Figure 4-4 Damage to tile roofs.

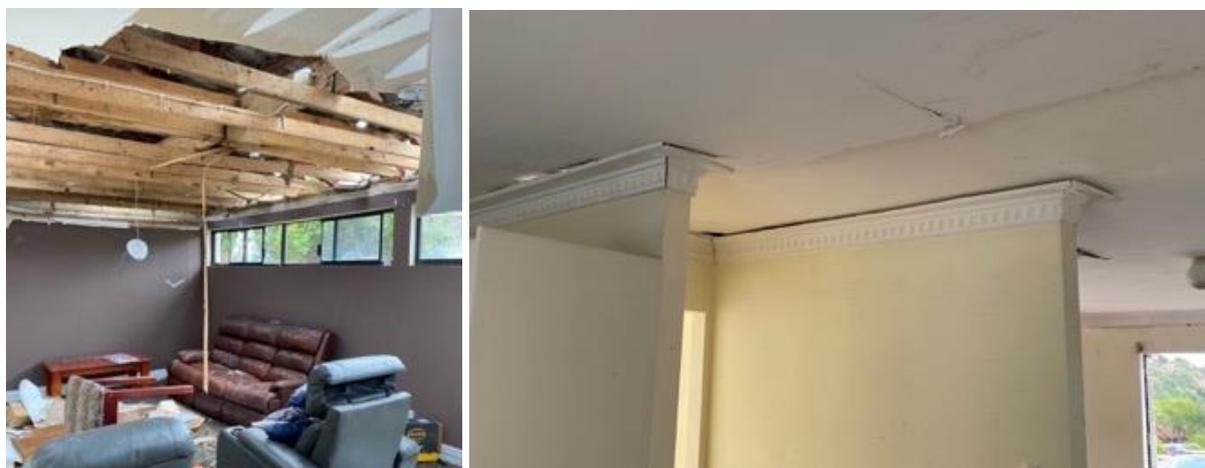
In each of these cases, the dislodged tiles had also damaged the ceiling, and water ingress through the tile damage had also caused loss of ceilings and damage to contents, as shown in Figure 4-5(a). In some cases, the entire tile roof had lifted off the walls, as shown in Figure 4-5(b).

(a) Ceiling loss (b) complete tile roof structure lifted

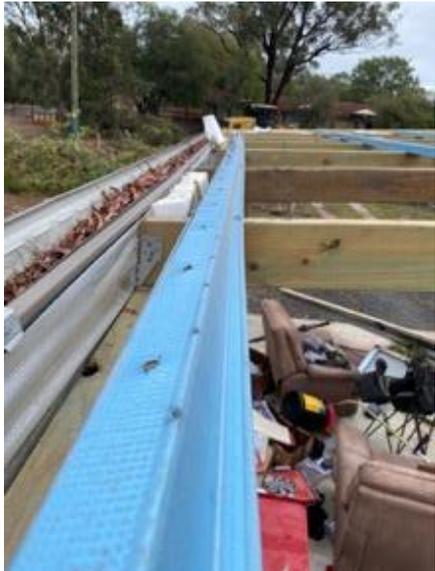
(a) Roofing screw failure

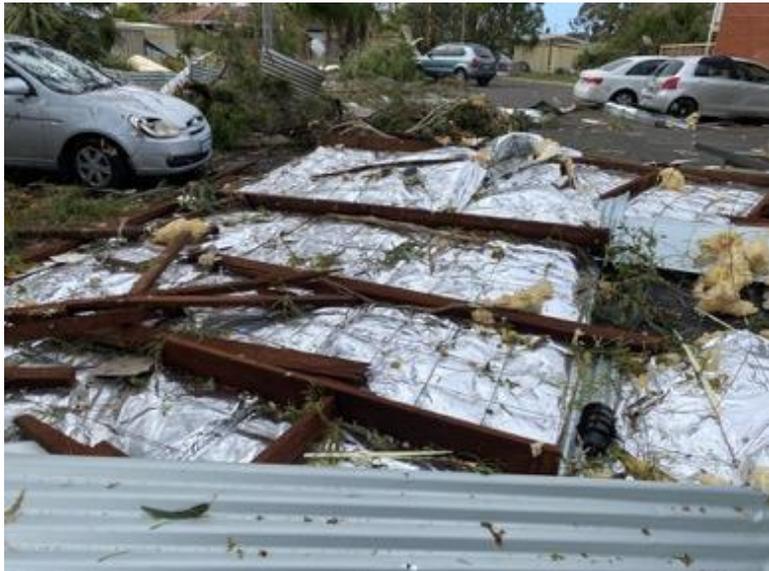
(b) Batten fastener failure

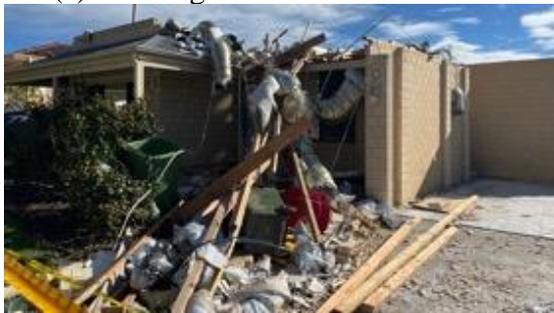
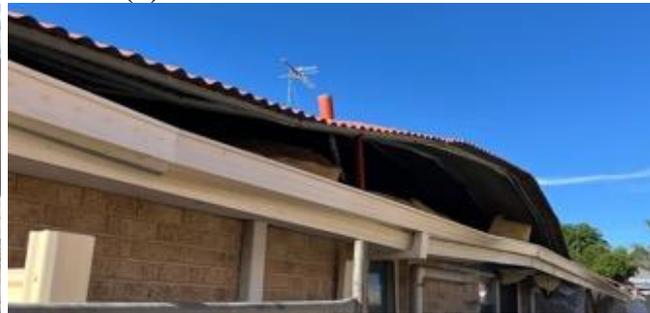
(c) Failures of roof to wall connections

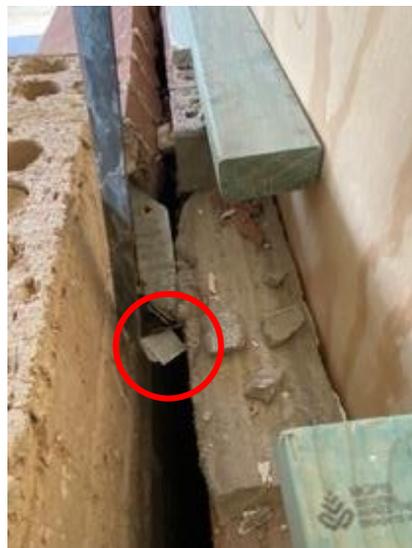
Figure 4-6(d) shows the detail of a failure at the base of a roof tie down strap commonly used for anchoring framed roofs to double brickwork walls. In this case, the roof was a steel-framed structure, but the strap pulled out of the internal leaf of brickwork. In pulling out, it broke the internal leaf at the bed joint into which the straps had been embedded. AS 4773.1 presents these straps as having a capacity of 6.5 kN (Standards Australia, 2015), but testing of the embedment of the strap into brickwork has shown a characteristic capacity around 3.5 kN (Tolentino, 2022). Failure of the straps in this and other houses in this event supports the limiting capacity of 3.5 kN.

(d) Failure of strap/brickwork connection

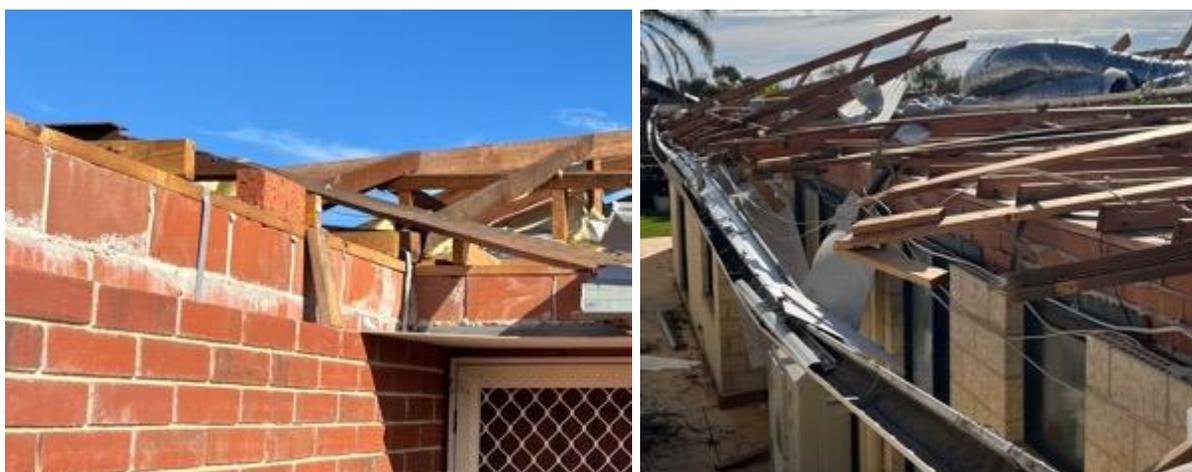
- Figure 4-7(a) shows a roof in which the tie-down straps secured the top plate, but the rafters had only been skew nailed to the top plates. This connection did not have enough capacity to resist the net uplift loads.
- Figure 4-7(b) shows a roof where the straps were fastened to the rafters and the failure was a mixture of straps pulling out of the brickwork within the cavity of the wall and nails pulling out of the roof structure. It is likely that the failure was precipitated by strap withdrawal from the brickwork and overloading of adjacent straps caused the nail withdrawal.

(a) Connection of brickwork to top plate

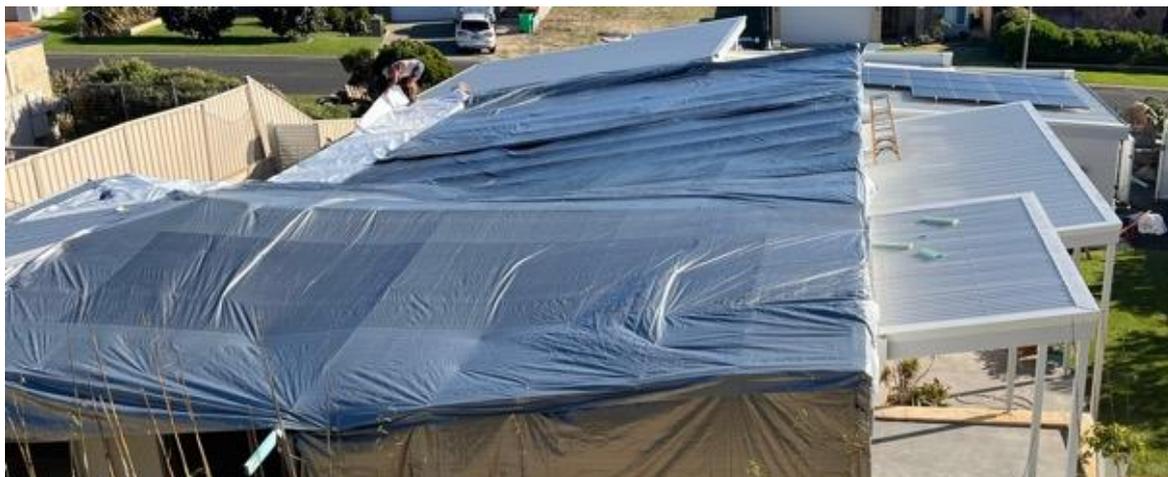
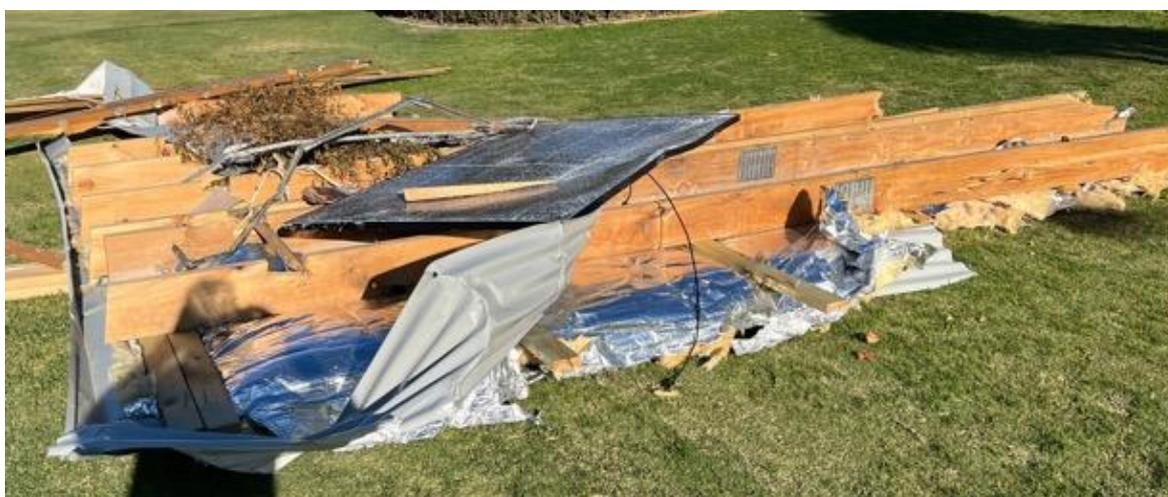
Figure 4-8 Failure of a skillion (monoslope) roof.

Check the external pressure coefficients for skillion or monoslope roofs in AS/NZS 1170.2. AS 4055 should also reflect the pressures on skillion or monoslope roofs used in AS/NZS 1170.2.

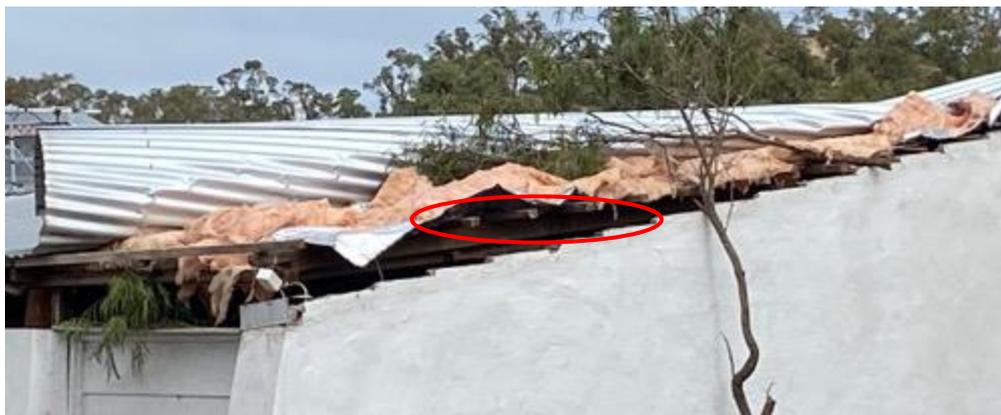
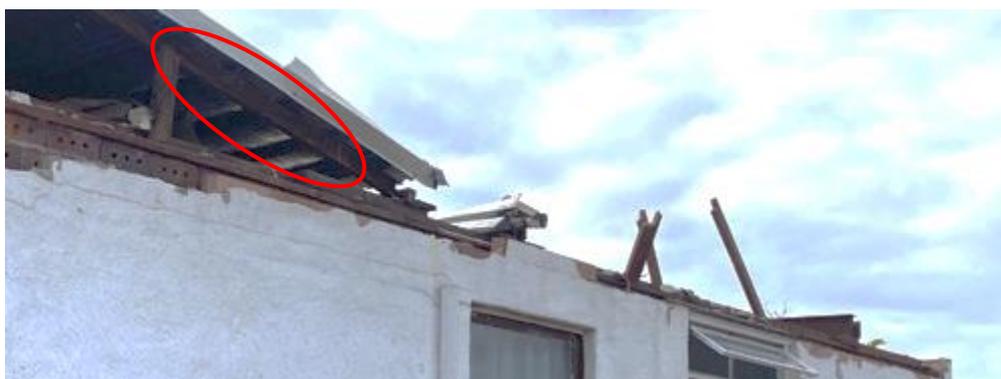
Figure 4-9 shows a roof where the original tile battens were still visible under the damaged sheet roof (highlighted by the red ellipses). In this case, the capacity of the roof to wall connections originally installed with the tile roof was lower than the net uplift causing separation of the roof from the walls.

Figure 4-9 Failure of a sheet roof that had replaced a tile roof.

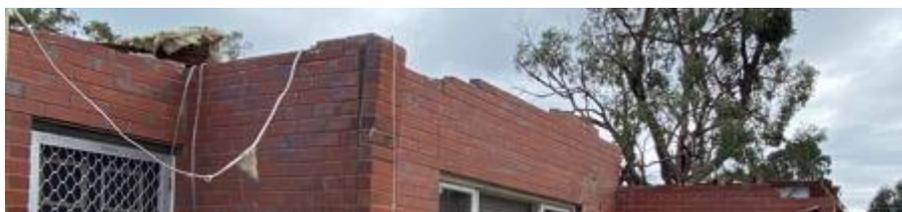
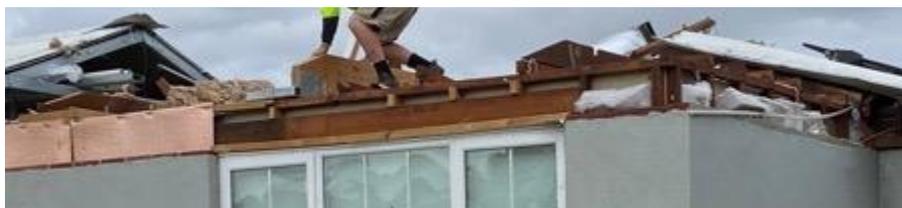
This type of failure is also shown in the total loss of the sheet roofs in Figure 4-10. In both of these houses, there was no sign of improved tiedown of the roof to the brick walls.

Figure 4-10 Total loss of a sheet roof that had replaced a tile roof.

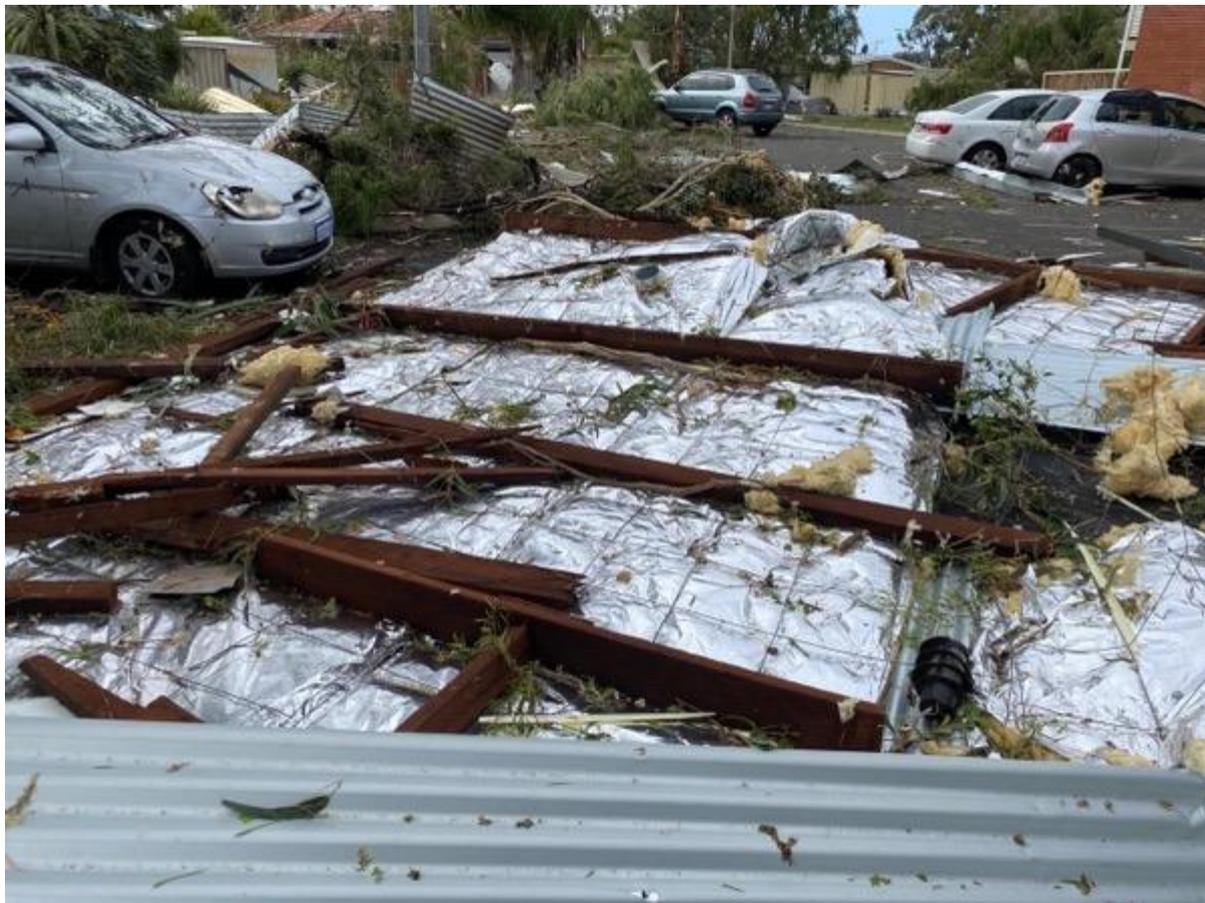
Figure 4-11 Loss of a sheet roof that had replaced a tile roof – failure at batten to rafter connection.

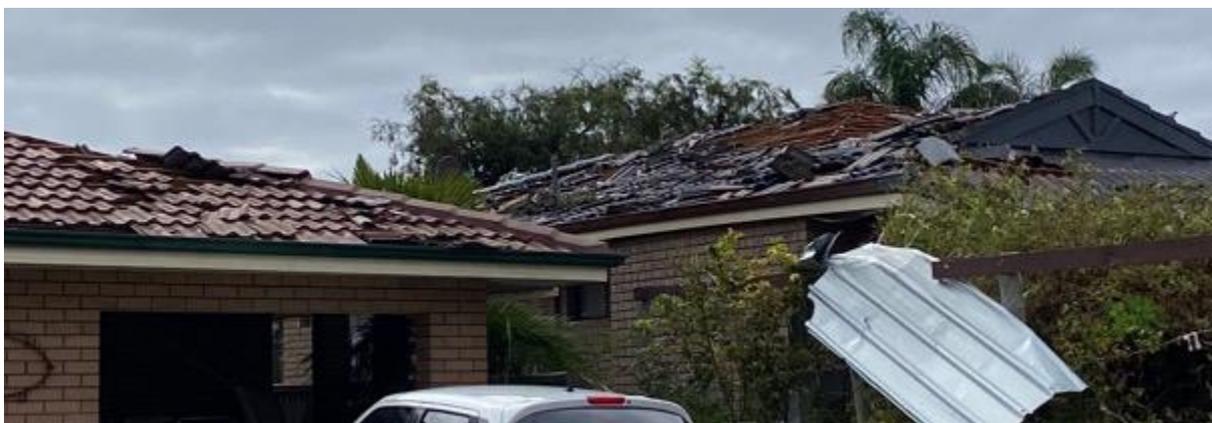
The internal pressure on the house on the right in Figure 4-13 significantly increased the level of damage to the tiles, compared with the damage to tiles on the house on the left.

Figure 4-13 Tile roof damage affected by internal pressure.

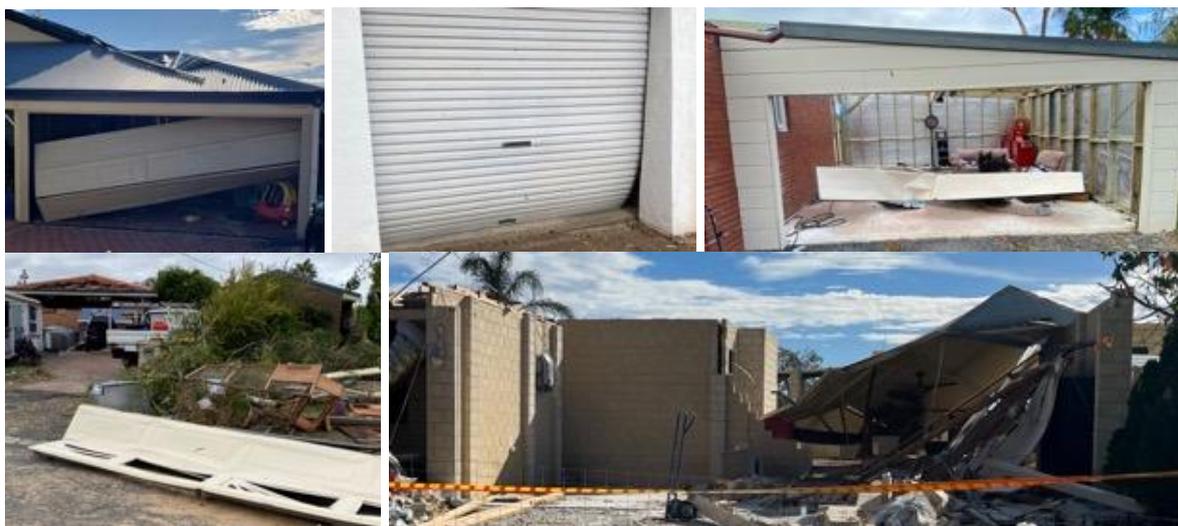
- Figure 4-14 shows a collage of photos of garage door failures. In each case, the loss of the garage door caused an increase in the damage to the roof in the area that was affected by the increased internal pressure. In the lower right photo, the damage to the garage door caused not only failure of the whole roof structure above the garage, but also an outward failure of the single leaf brick wall on the outside of the garage.
- Figure 4-15 shows photos of broken windows. Some of these were initiated by wind-borne debris, but others were caused by wind pressure. In the lower right photo, the force of the wind-borne debris broke the window frame out of the internal leaf of brickwork and blew the internal door out.

Figure 4-14 Failure of garage doors in 10/5/2024 tornado.

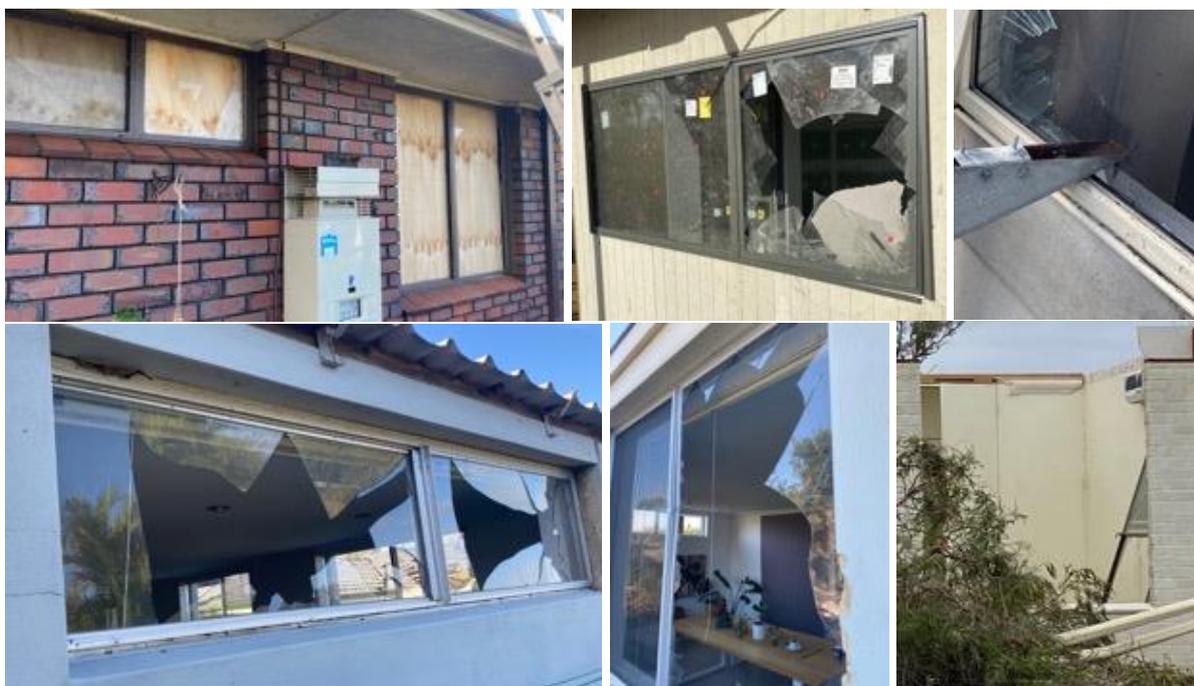
Figure 4-15 Window failures in 10/5/2024 tornado.

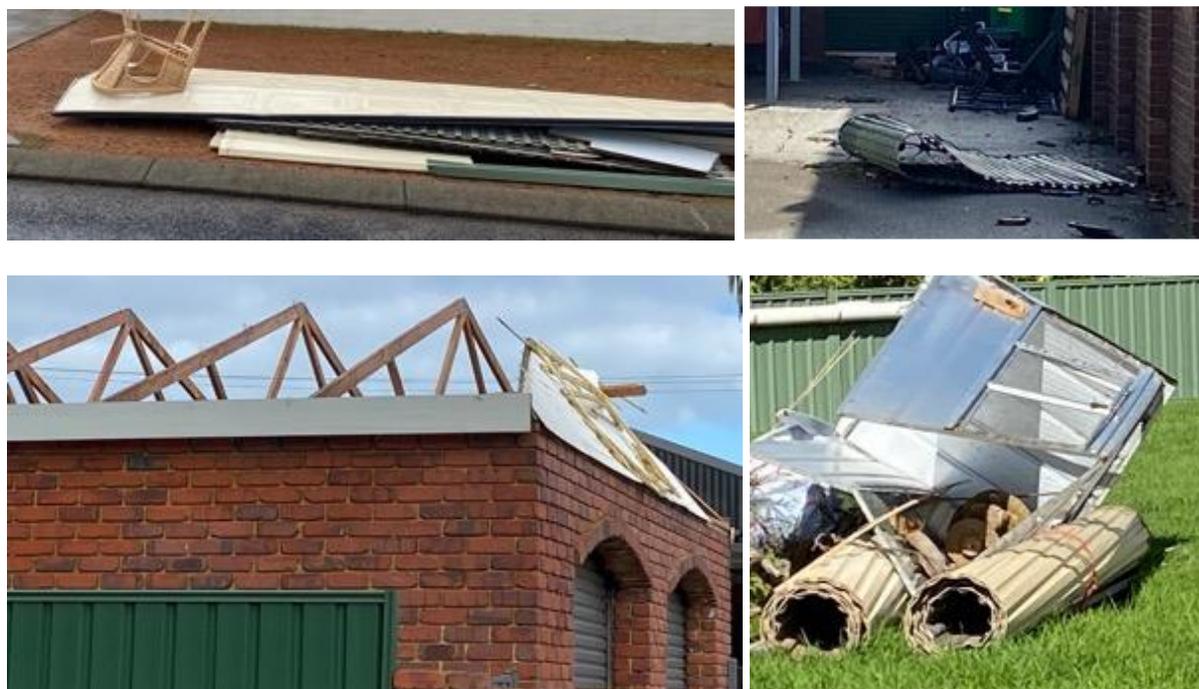
Figure 4-16 shows several garage doors that failed in the 1/6/2024 downburst and caused internal pressures that led to other structural failures in the house. In the lower left photo, the owner had been able to push the garage doors back into the guides, but both of them had blown in during the downburst. These garage doors all failed at loads just over 50% of the design wind loads and the internal pressure that resulted from the door failures increased the level of damage to the roof structure.

Figure 4-16 Failure of garage doors in 1/6/2024 downburst.

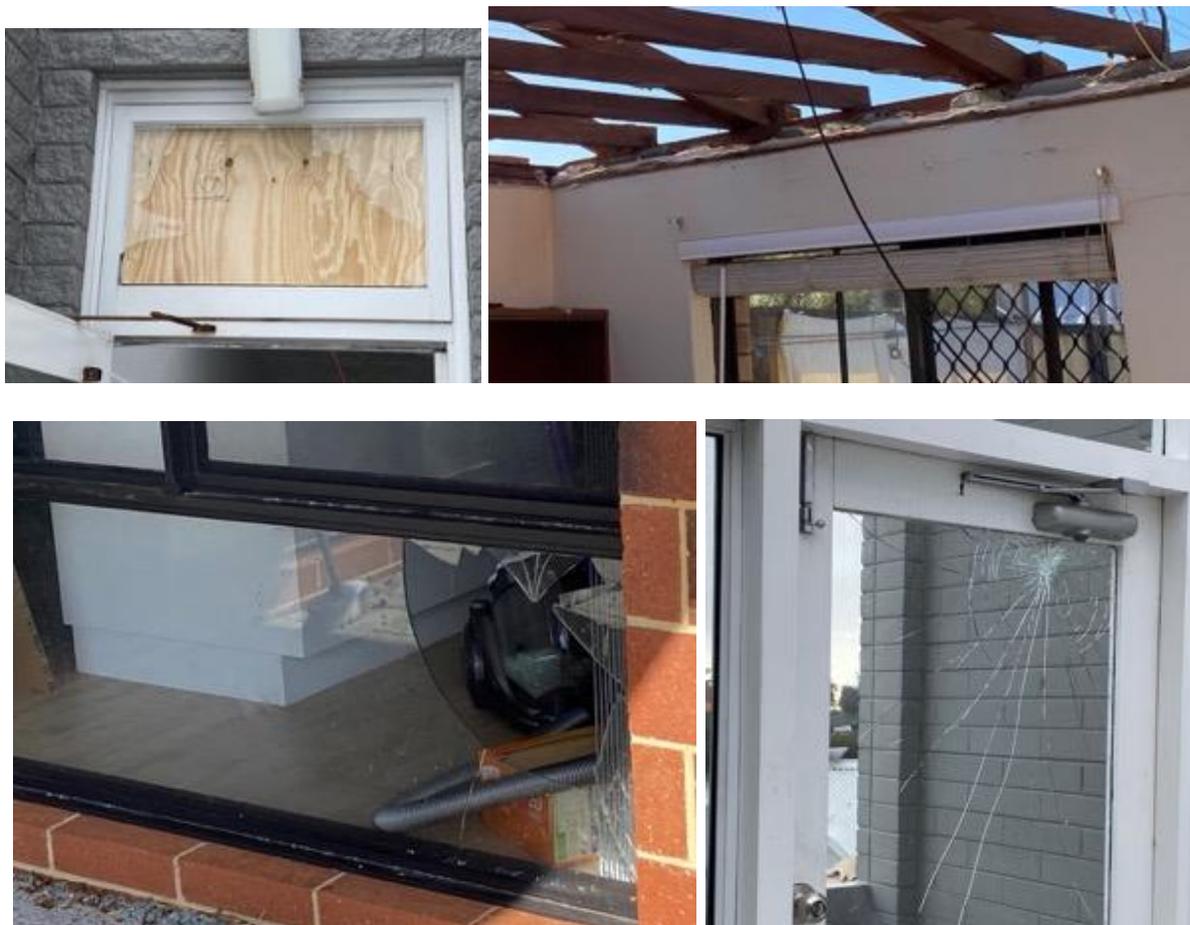
was float glass had contributed to the internal pressure that was instrumental in partial roof loss of the building.)

Figure 4-17 Window failures in 1/6/2024 downburst.

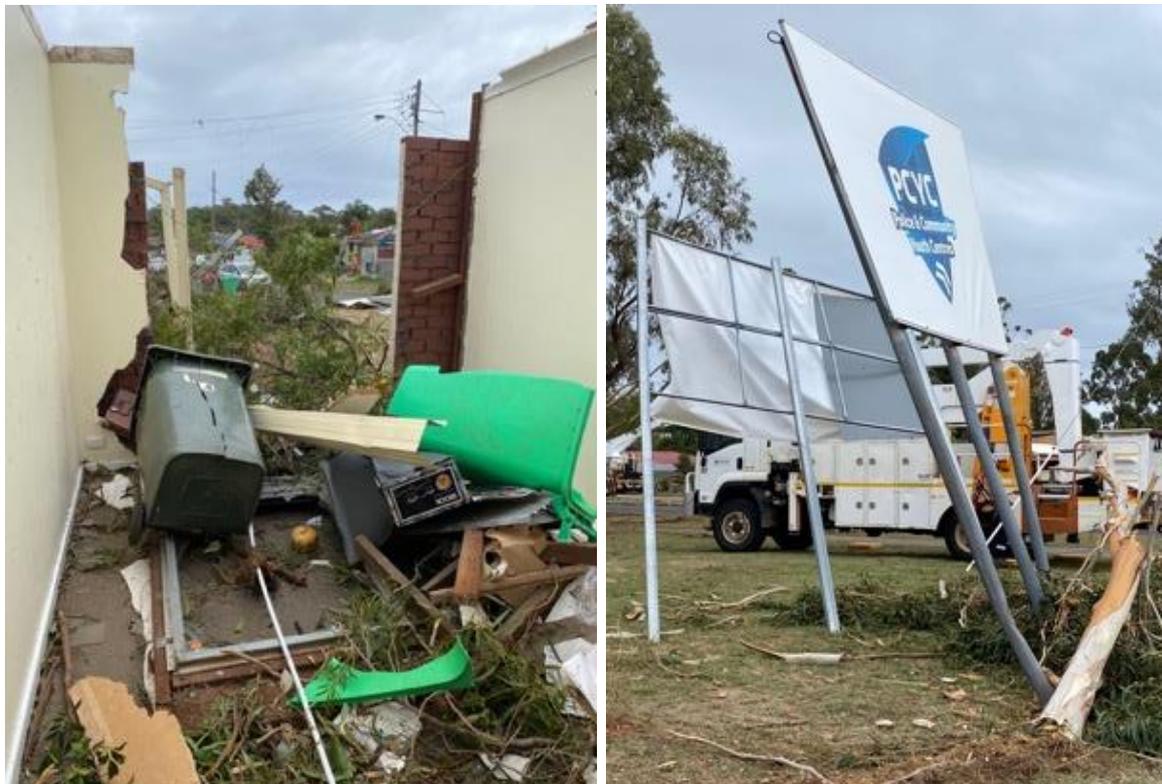
Figure 4-18 shows some large wind-borne debris. The left-hand photo is from the inside of a house and shows that two rubbish bins pushed the entire window frame inwards. It broke out the internal leaf of brickwork up to the internal abutting wall on one side and one to two brick lengths beyond the opening on the other side. The high internal pressure contributed to the significant net uplift forces that led to the loss of the complete roof structure.

Figure 4-18 Rubbish bins and large branches as wind-borne debris.

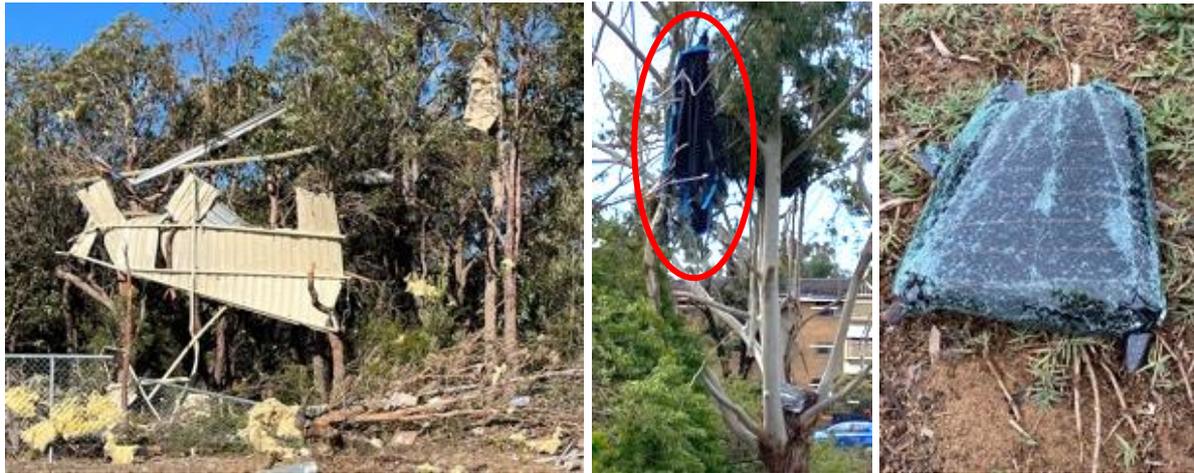
Figure 4-19 A light weight roofed patio, a trampoline and part of a solar panel as wind-borne debris.

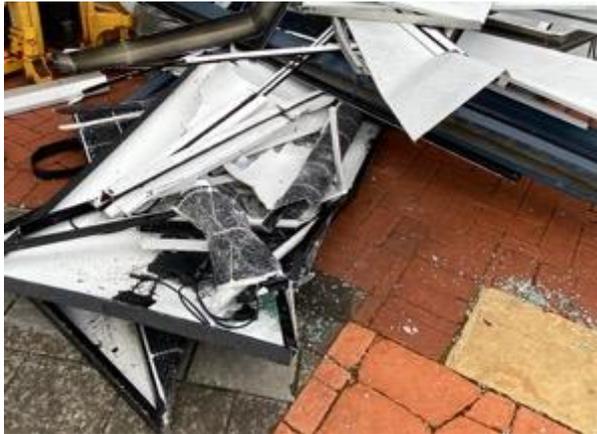
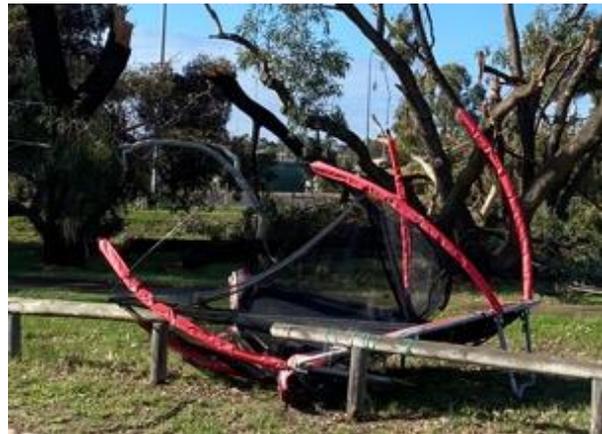
(a) Solar panels and trampolines

Revise the internal pressures for houses in wind regions A and B1 to give housing more resilience in cases where doors or windows are open at the time of the extreme winds or openings are created by wind-borne debris.

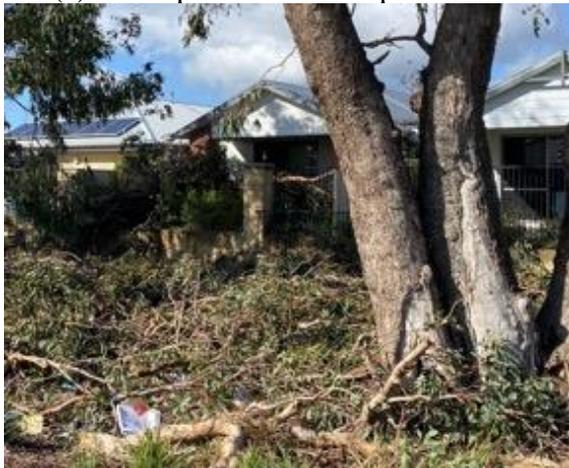
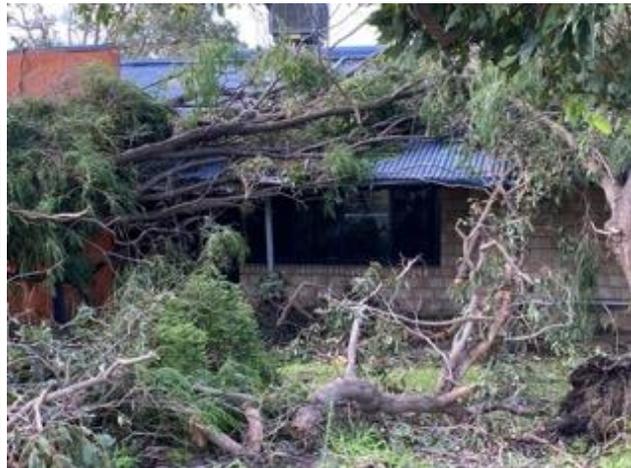
(b) Trees and tree branches

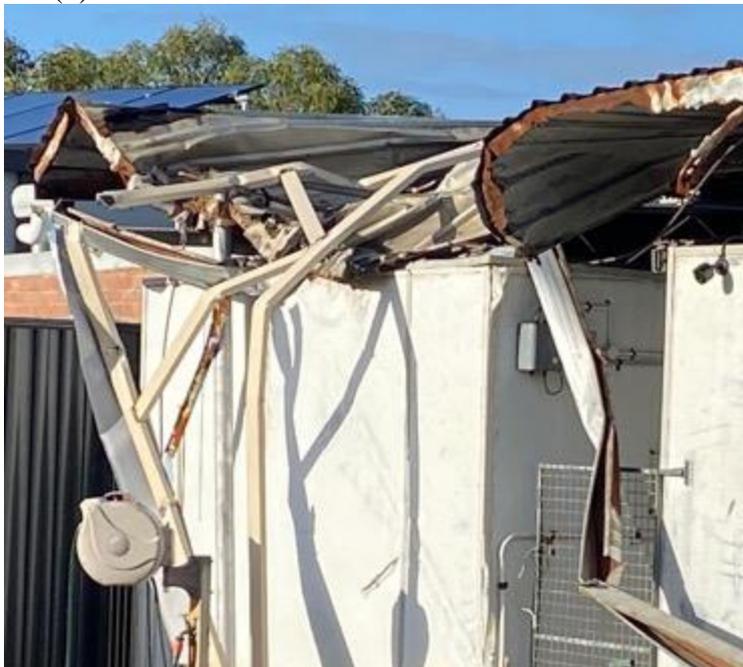
(c) Lightweight patio (cream coloured framing embedded in the roof)

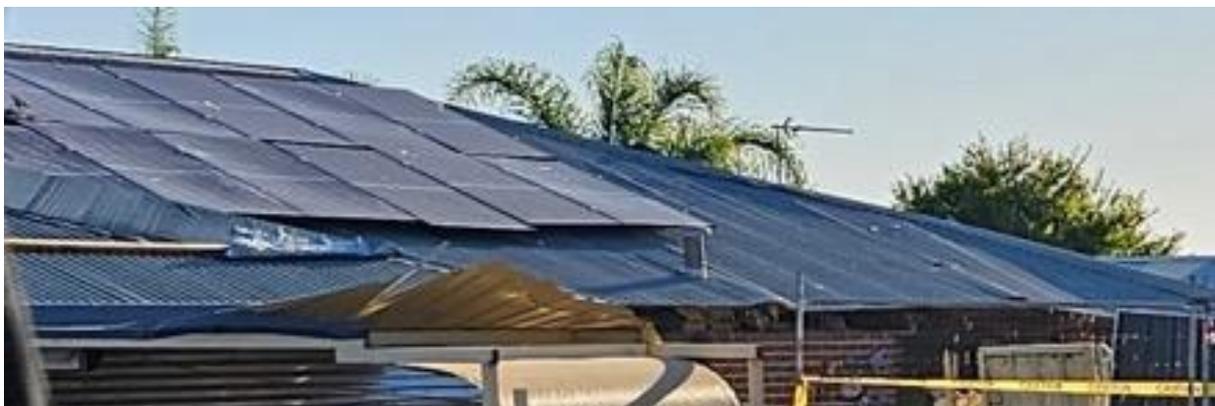
Figure 4-21 shows some roof mounted solar panels that were in the path of the tornado. It shows that four of the panels in the array of 10 panels bowed downwards under pressure loading.

Figure 4-21 Pressure failure of roof-mounted solar panels.

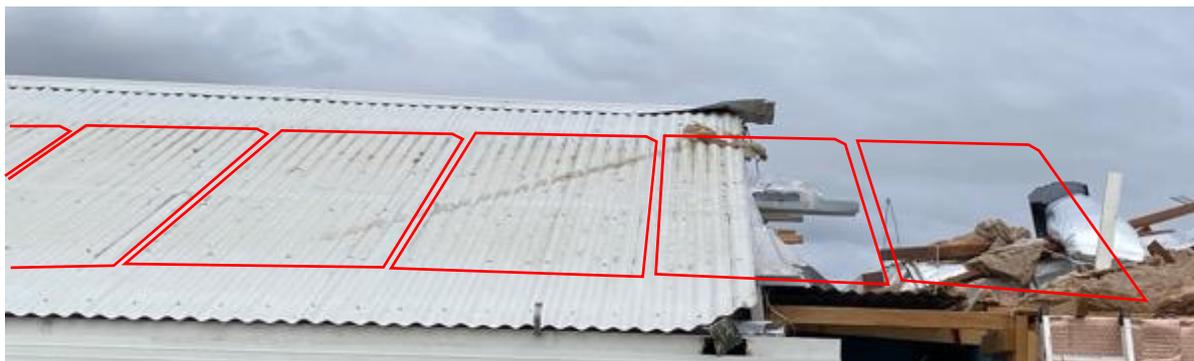
- On the left of Figure 4-22(a), the roof was a more recent addition with lightweight steel trusses and steel top hat battens – the screws pulled out of the battens and remained in the brackets. The screws are missing from the roof, but are still in the brackets, as shown by the red circles in the lower photo.
- On the right of Figure 4-22(a), the missing portion of roof is a re-roofed part of the original house with hardwood battens that remained attached to the sheeting. In the original house, the only part of the roof that was lost was the part under the solar panels. The aerodynamic wind actions across the roof and panels may have been increased by the presence of the panels.

(a) Missing solar panels over two different types of roof structure

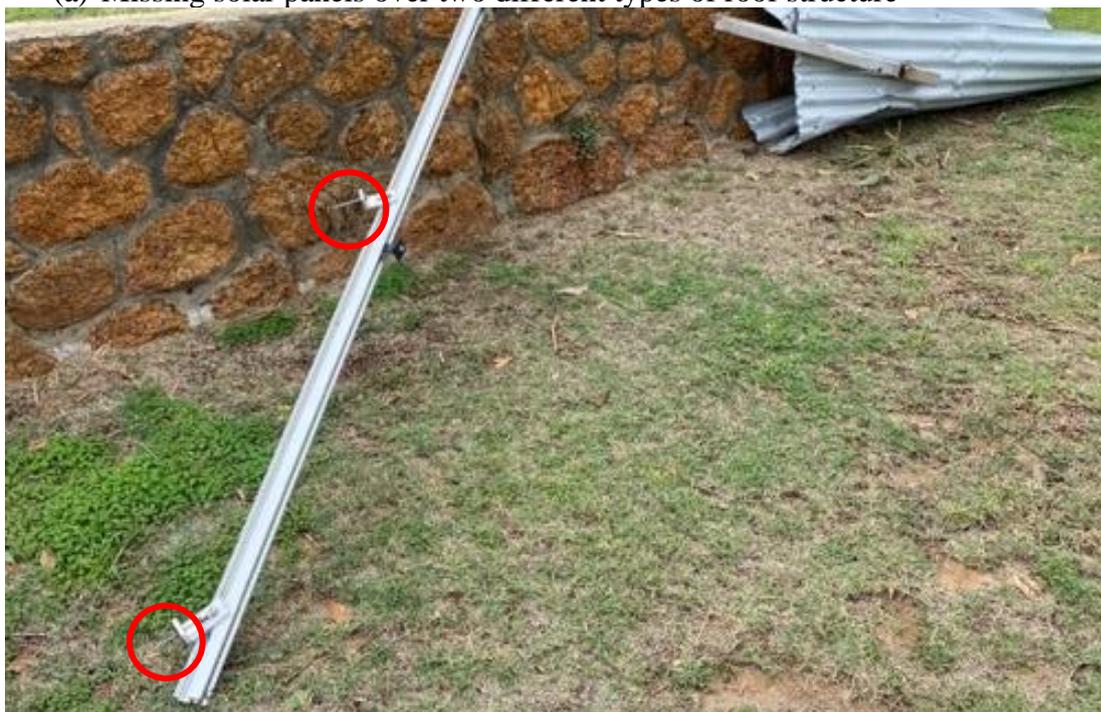
(b) Detached solar panel rail

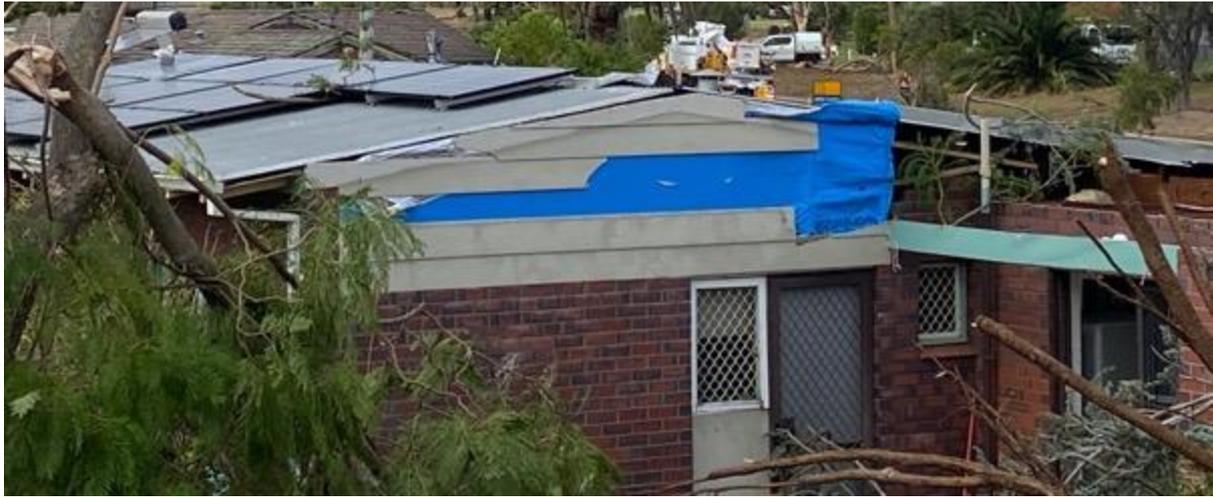
Some solar panels were directly in the path of the event but did not fail as shown in Figure 4-23. This house was in the path of the tornado, and was damaged in part, but most of the solar panels were undamaged by the wind and neither was the roof underneath the solar panels. In this case, nearly the whole roof panel was covered by solar panels, whereas many of the installations that were damaged had smaller portions of the roof covered by panels.

Figure 4-23 Good performance of solar panels on a damaged house.

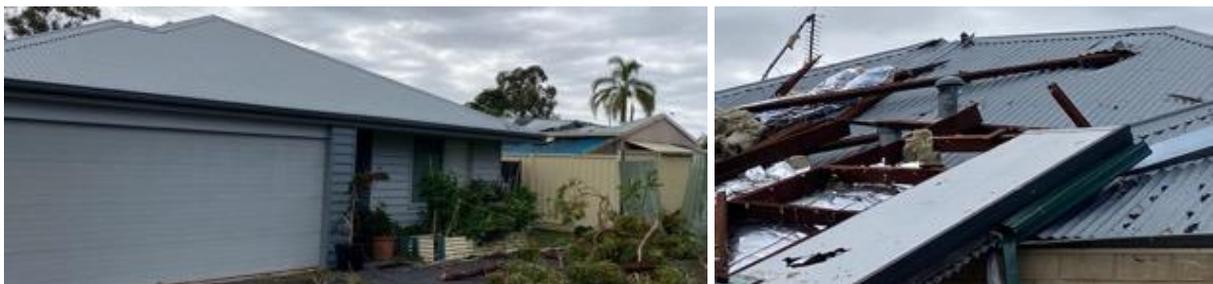
Some relatively recent construction (built in the last 15 or so years), performed poorly in the 10/5/2024 tornado, as illustrated in Figure 4-6(c) and Figure 4-8. However, there were at least 3 new houses or recently renovated houses that were in the path of the tornado that performed well. Figure 4-24 shows a house between two older houses that were badly damaged, but the only damage to the newer house was debris damage to the roof from one of the neighbouring houses. The debris still lying on the roof is shown in the right-hand photo in Figure 4-24.

Figure 4-24 Good performance of a new house in the 10/5/2024 tornado.

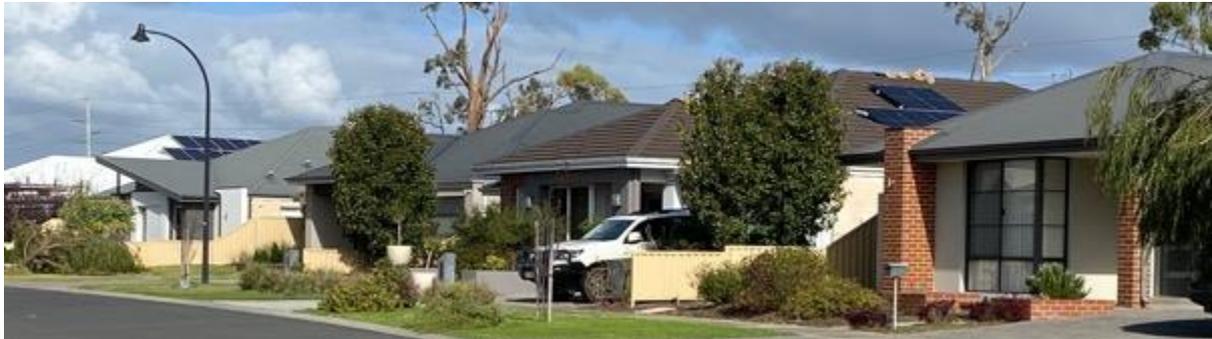
Figure 4-25 shows a street of relatively new houses with a mixture of roofing materials. Some ridge tiles had been damaged, but most of the sheet roofs were undamaged by the event. While the roof loads were approximately 50% of the design wind loads, this good performance cannot be taken as demonstration that modern construction is adequate; it shows that in areas affected by the downburst, some modern construction remained undamaged.

Figure 4-25 Good performance of new houses in the 1/6/2024 downburst.
