2024 Severe storms in Bunbury, WA Damage to Houses

CTS Technical Report No 68

TECHNICAL REPORT NO. 68

2024 Severe Storms in Bunbury, WA

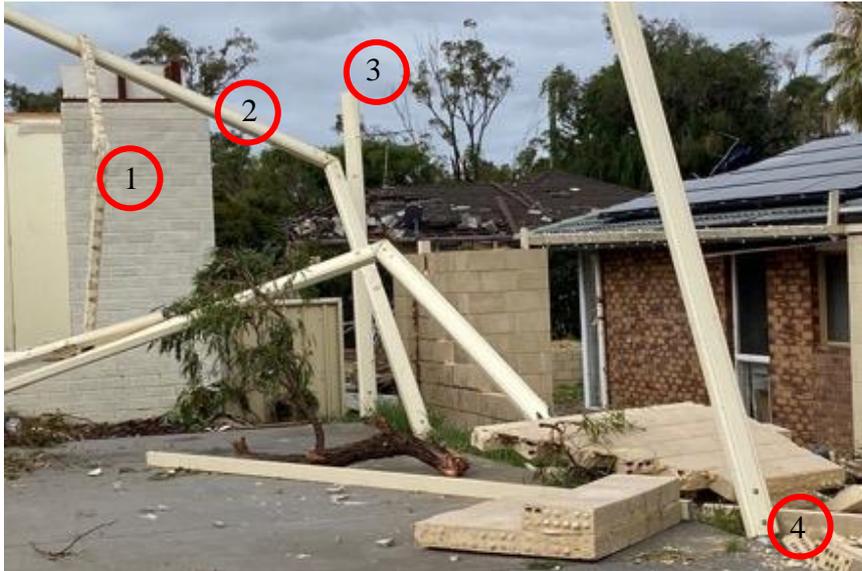
- One batten was left on the rafters and the cladding fasteners had withdrawn from this batten. (1)
- The roofing and battens separated from the rest of the structure and were blown more than 50 metres. The single large piece of roof caused damage to at least two other houses in its path. (2)
- Some of the rafters separated from the top of the posts. (3)
- Most of the posts developed a hinge at ground level and bent over. Lateral bracing is rarely designed for these types of structures. (4)

Figure 5-1 Failure of a lightweight carport during the 10/5/2024 tornado.

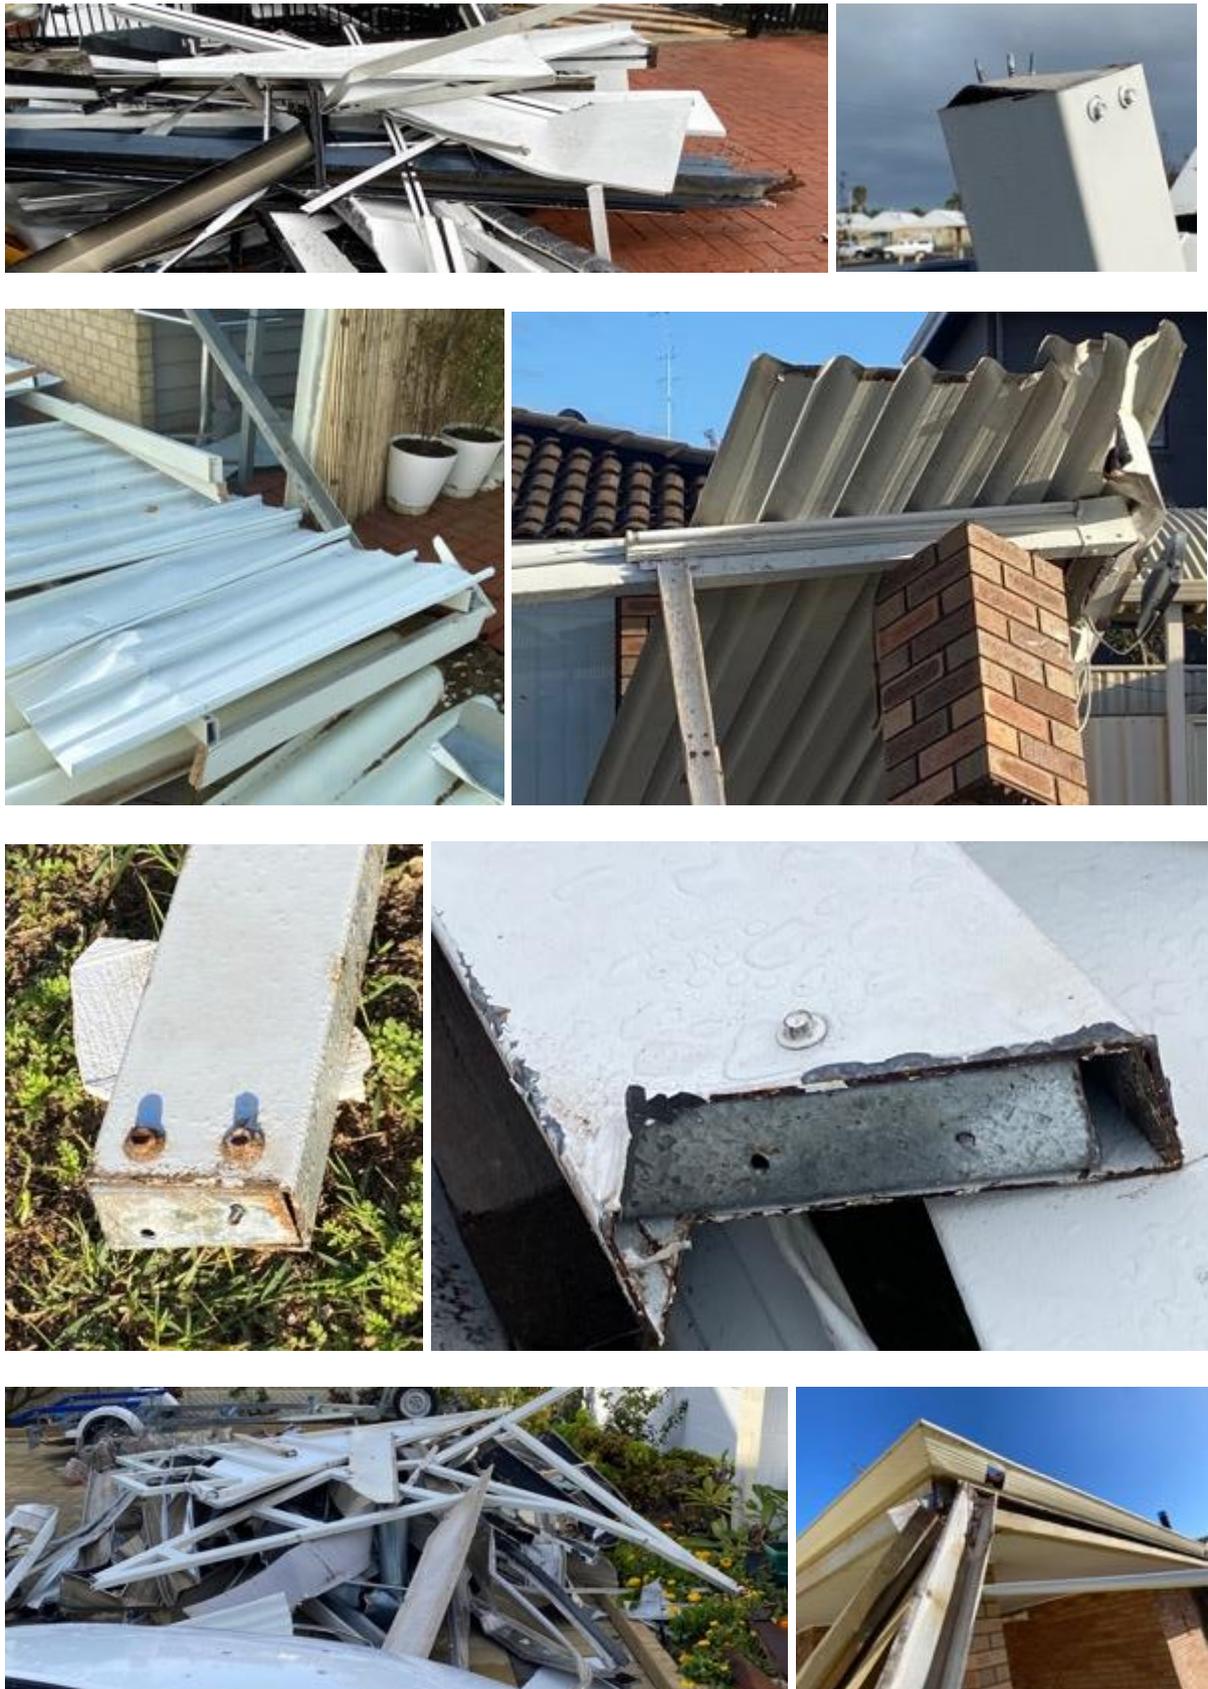
Similar details that had three tek screws in the underside of the rafter (top right hand photo in Figure 5-2) did not have sufficient capacity for the lower wind loads during the 1/6/2024 downburst.

Figure 5-2 Failure of lightweight carports and patio roofs during the 1/6/2024 downburst

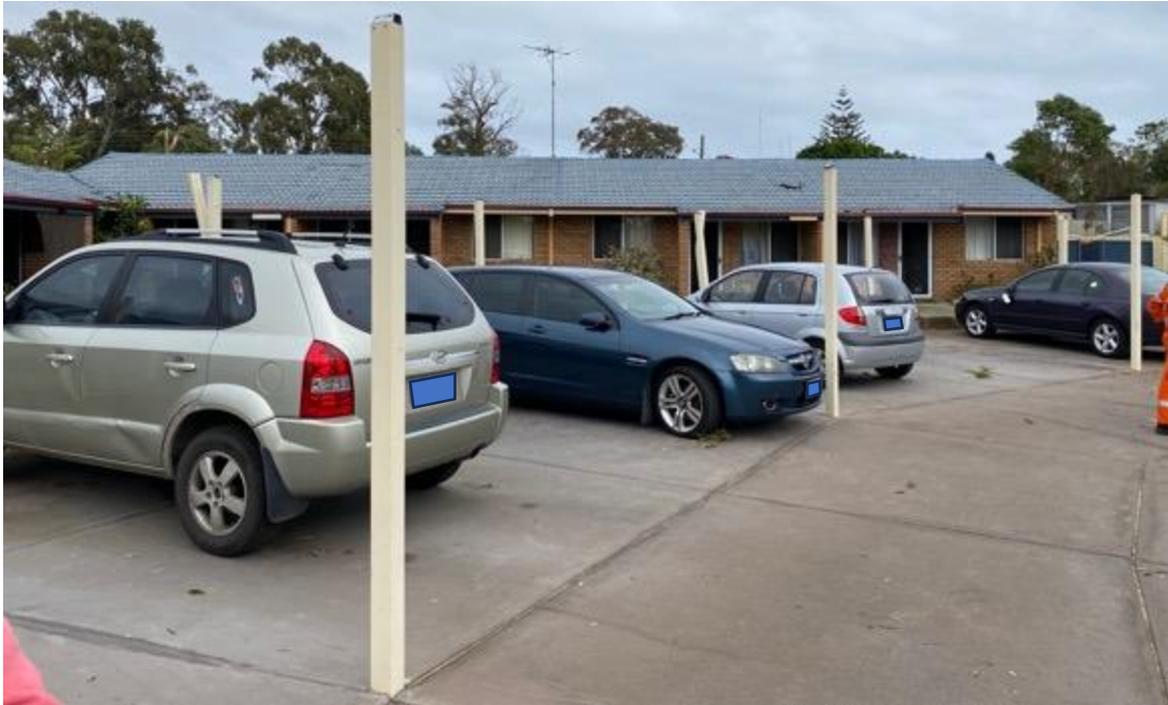
A number of the connections that failed during the 1/6/2024 downburst and were shown in Figure 5-2 had similar characteristics as the ones shown in Figure 5-3. This indicates that many of these lightweight structures did not have enough capacity to resist the lower wind loads (around 50% of the design wind actions) in the 1/6/2024 downburst.

Figure 5-3 Missing carport roof after 10/5/2024 tornado.

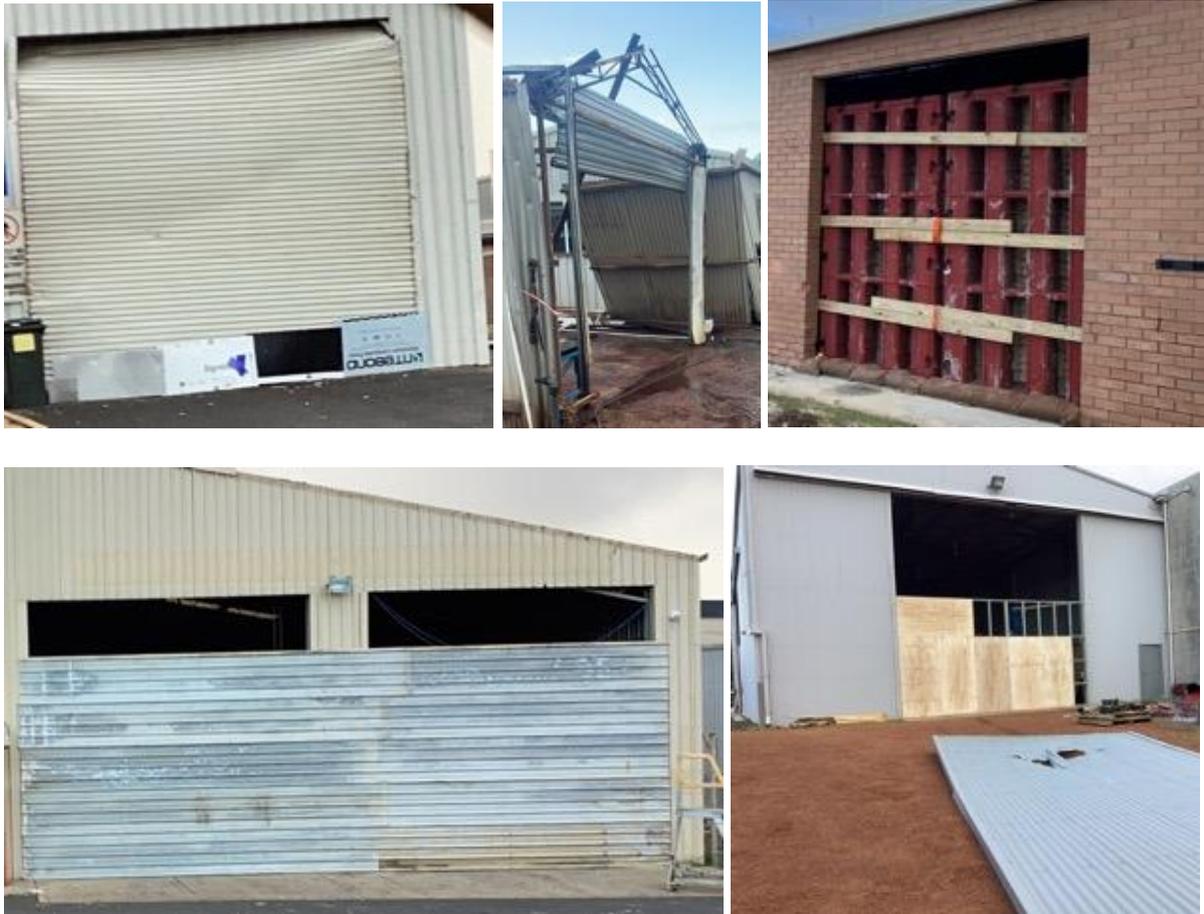
Figure 6-1 Damage to garage and large access doors on commercial buildings during the 1/6/2024 downburst

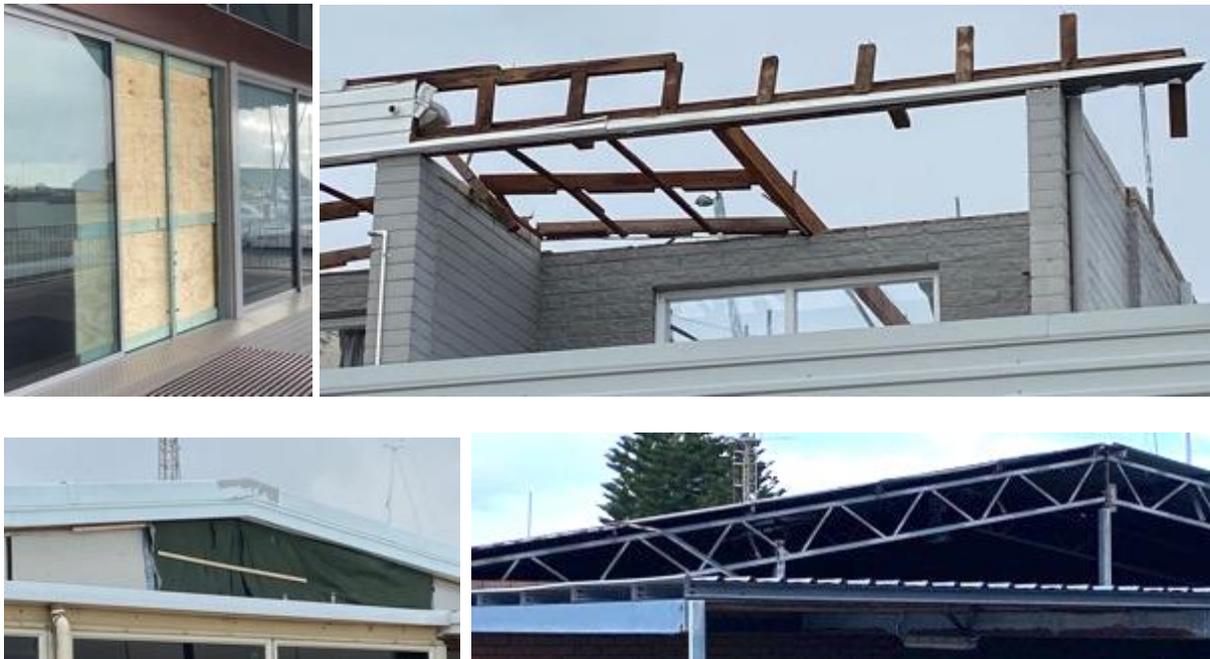
Figure 6-2 shows an automatic glass door that had failed and three commercial buildings with envelope damage that was the result of high internal pressures following the creation of an opening. Likewise, conclusions and recommendations made about internal pressure in houses also apply to commercial buildings.

Figure 6-2 Effects of internal pressure on commercial buildings in the 1/6/2024 downburst.
