## Cyclone Ingrid

Cyclone Ingrid was classified as an extremely destructive Category 5 cyclone, prior to crossing the coast at Croker Island. The CTS investigation focussed on the small community of Minjilang, located on Croker Island. The CTS team also inspected structures at Coburg Peninsula.

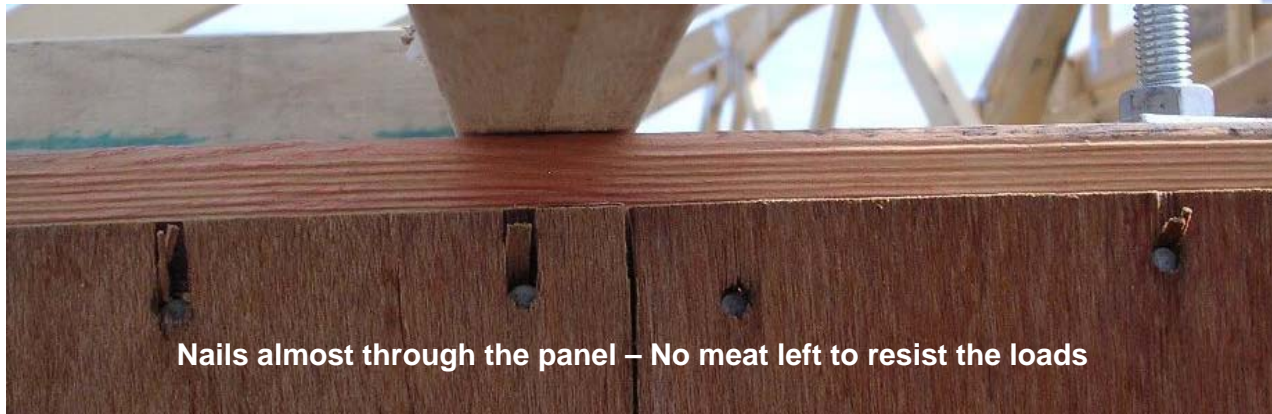
Nails almost through the panel – No meat left to resist the loads

Panel bracing works through diaphragm action, in that the bracing forces are transferred between the house frame and the panel via the nails. In resisting the wind loads, if some thickness of panel has been lost from crushing from overdriving, the panel ruptures with the nails bursting through the edge. Overdriving or not leaving enough edge distance will cause premature failure of the panel as there is not enough 'meat' left in the panel.

An apparent fix for not overdriving using a nail gun involves setting the gun's depth adjustment (or for some guns buying and using the add-on depth adjustment fitting).

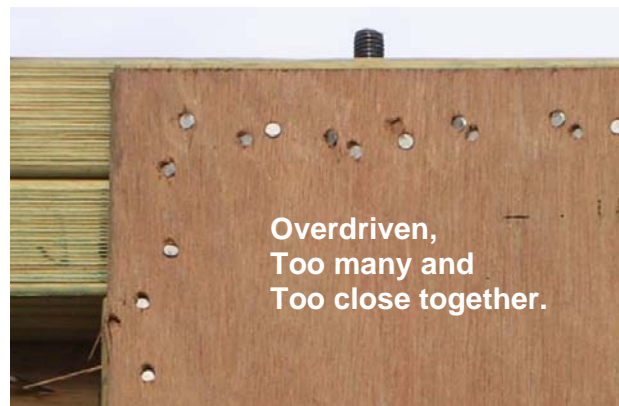
Overdriven,  
Too many and  
Too close together.

Please refer to the manufacturer's product data sheets for information on edge distances and correct fixing. **Remember a house is only as strong as its weakest link. Don't let it be you.**

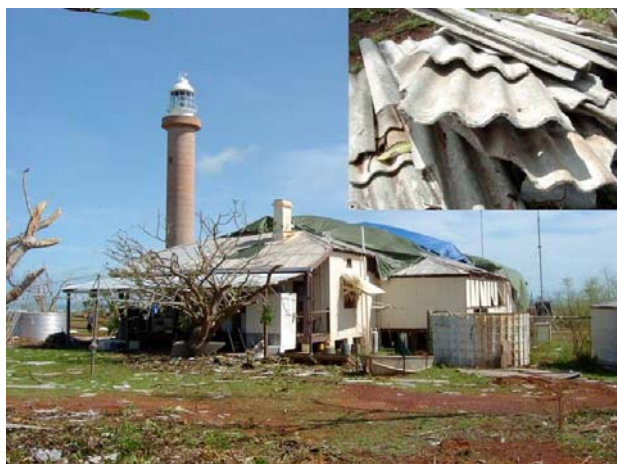
*Asbestos cement corrugated cladding scattered*

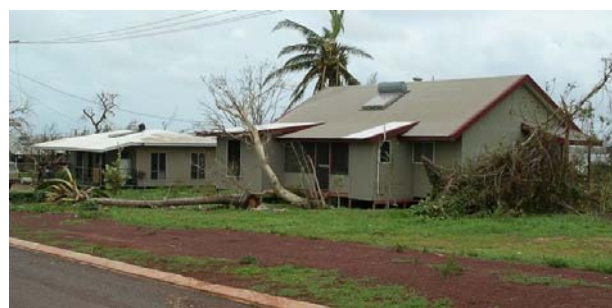
*Majority of housing resisted wind loads*

Typically housing that was constructed in the past several years survived with minimal structural damage from wind loads observed. Impact from wind driven debris, fallen trees, flashing loss and soffit loss was noted. One exception was a reinforced masonry block house that was built within the last couple of years.

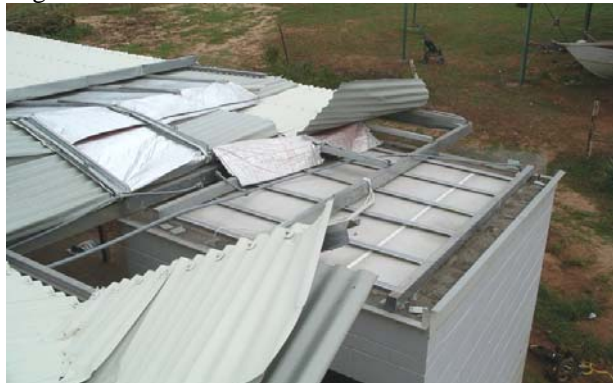
Part of the roof had peeled back from the windward edge where there was incorrect rafter tie down.

Many of the failures observed were initiated from elements suffering severe corrosion. Correct specification and installation of materials along with ongoing maintenance is required for structures in cyclonic regions as it may be many years until a severe cyclone impacts the building.

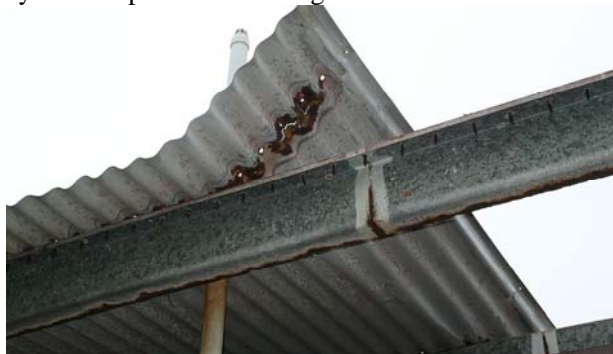
A highset fibro clad rectangular plan house suffered loss of roof cladding and battens. The battens to truss connections were; corroded, missing or inadequate (nailed). There was severe corrosion of the straps along the exposed eaves. A 3m x 3m section of the house's roofing with battens attached was found 200 m to the SE.

- Specify and use appropriate materials suitable for the site exposure conditions.
- Undertake regular inspection and maintenance of housing, especially the structural components.
- Ensure strength upgrades are completed on all structural components of the wind load resistance system. This includes the batten to truss/rafter connection.
- Use water resilient internal linings, if practical.
- Review (& upgrade strength if needed) storm resistance of Automatic Weather Stations.

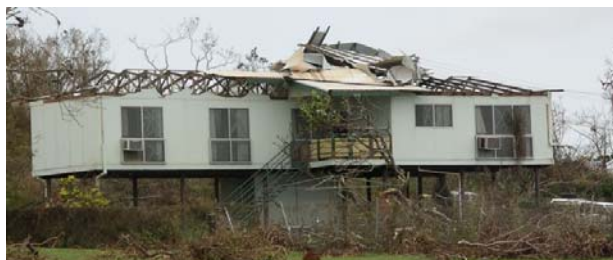
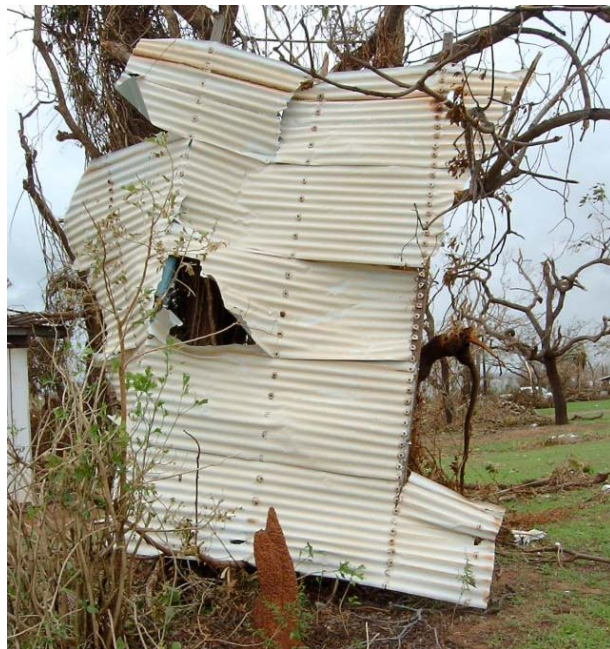
Even though observed damage levels were far lower than that from Cyclone Tracy, wind driven debris still posed a threat.

Roller door failures were noted. Along with damage to houses from attachments such as large awnings failing and smashing the house.
