Tropical Cyclone Seroja – Damage to buildings in the Mid-West Coastal Region of WA

CTS Technical Report No 66

**Tropical Cyclone Seroja
Damage to buildings in the
Mid-West Coastal Region of Western Australia**

Initial Release 28 May 2021
Revision released 3 June 2021

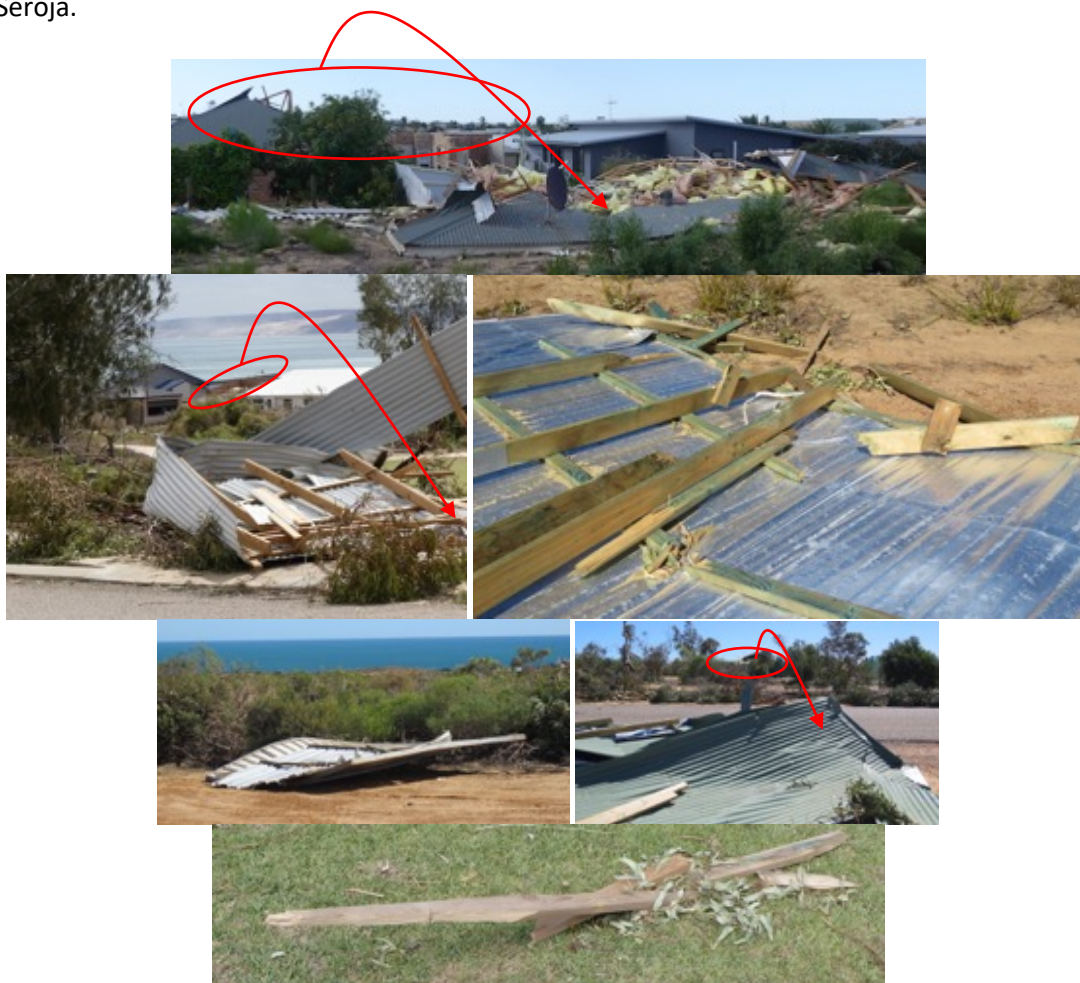
Figure 4-3 Examples of wind-borne debris

The wind-borne debris in this event included whole roofs, portions of roofs, verandas, and tree branches, similar to debris generated during cyclones in Wind Regions C and D. Parts of roof structures with sheeting attached were blown hundreds of metres. Some timber roofing elements speared into the ground or other houses. Figure 4-4 shows some of the damage caused to homes by wind-borne debris during TC Seroja. Many people were at risk of serious injury during this event.

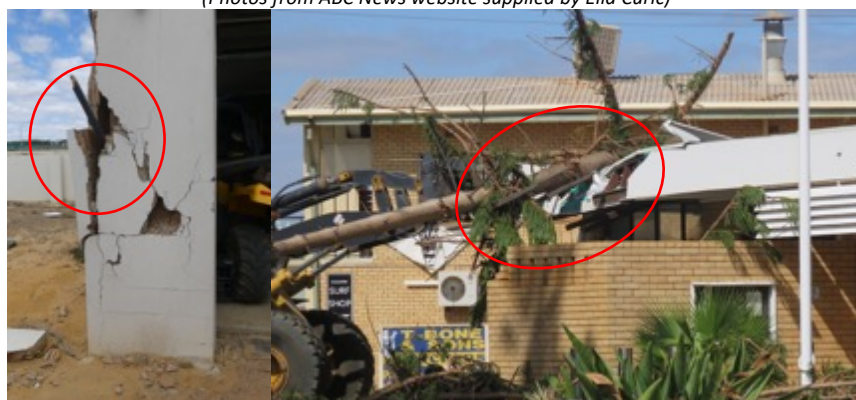
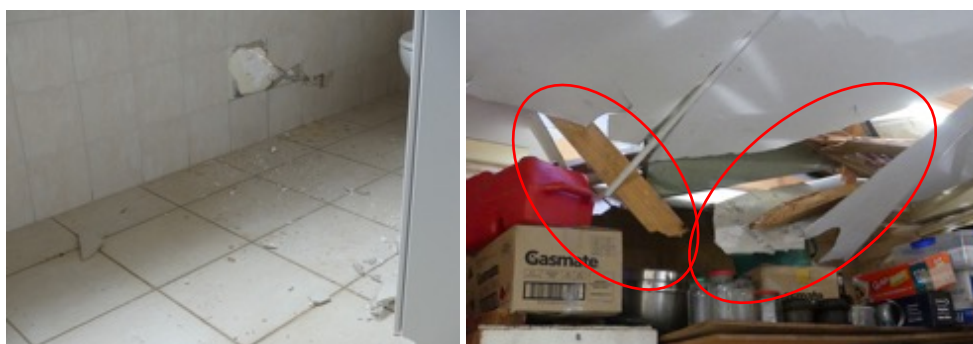
Figure 4-4 Examples of wind-borne debris damage to houses

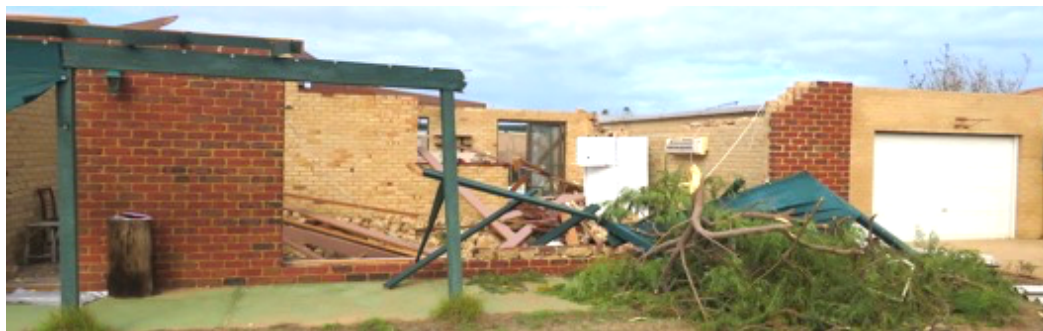
Figure 4-7 shows a house where the entire roof was lost, and brickwork on the windward wall collapsed into the lounge room after a door failed and increased the internal pressure inside the house.

Figure 4-7 Loss of timber-framed roof due to failure of tie-down straps in brickwork

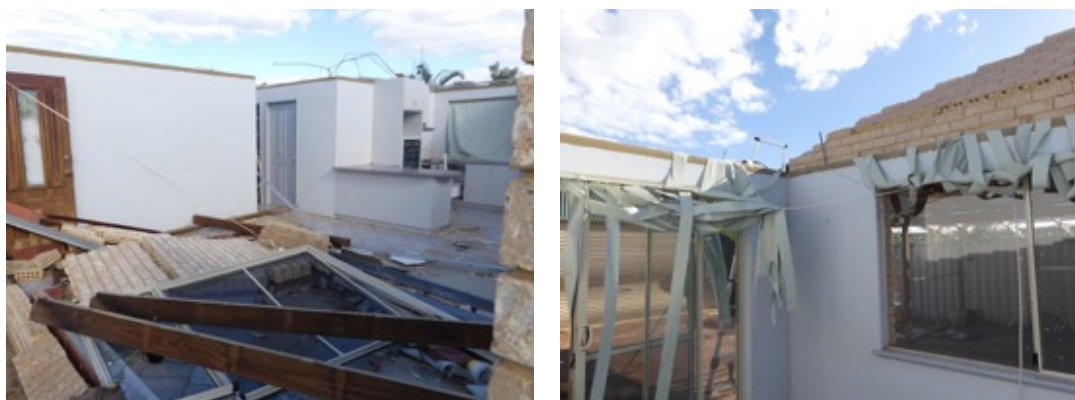
The tie-down straps on the windward wall of the house shown in Figure 4-8 were pulled out of the brickwork and cracked the wall at the level of embedment. The weight of the brickwork above the level of embedment was not enough to resist the net uplift load on the roof. There would have been sufficient weight if the tie-down straps had been embedded in the brickwork at the base of the wall. The tie-down straps in the wall under the gable end of the roof of this house hadn't been secured over the rafters. Although it is not required that tie-downs are installed in brickwork under the gable ends of roofs, it is recommended, as the highest uplift forces on the roof are at the gable if the gable wall is the windward wall.

Figure 4-8 Loss of roof structure due to the withdrawal of tie-down straps

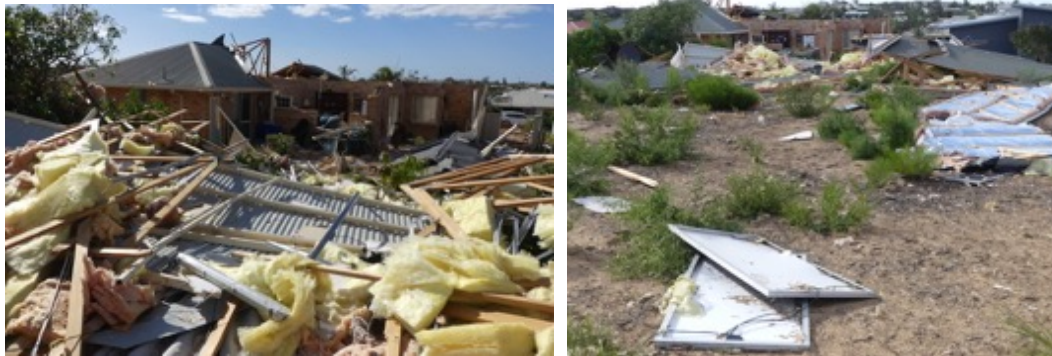
Failure of garage doors and the front door of the house shown in Figure 4-9 created high internal pressure under the roof. The roof over the garage was only around one-fifth of the floor area of the house, but the roof over more than 80% of the house was lost. The only parts of the roof that remained were over regions with bedrooms that stayed sealed from the rest of the house by closed internal doors.

Figure 4-9 Roof loss following the failure of garage doors

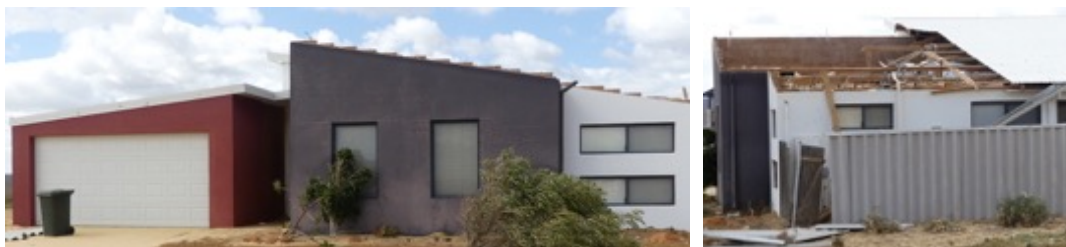
Figure 4-10 shows the loss of a skillion roof where the wind was perpendicular to the high edge of the skillion. The part of the roof with the large overhang failed at the roof to wall connection. The tie-downs did not have sufficient capacity to resist the high uplift forces (uplift forces are higher on the overhang region of skillion roofs than the uplift forces on other roof shapes). The roof from this house was found more than 200 metres away.

Figure 4-10 Failure of a skillion roof at the roof to wall connection

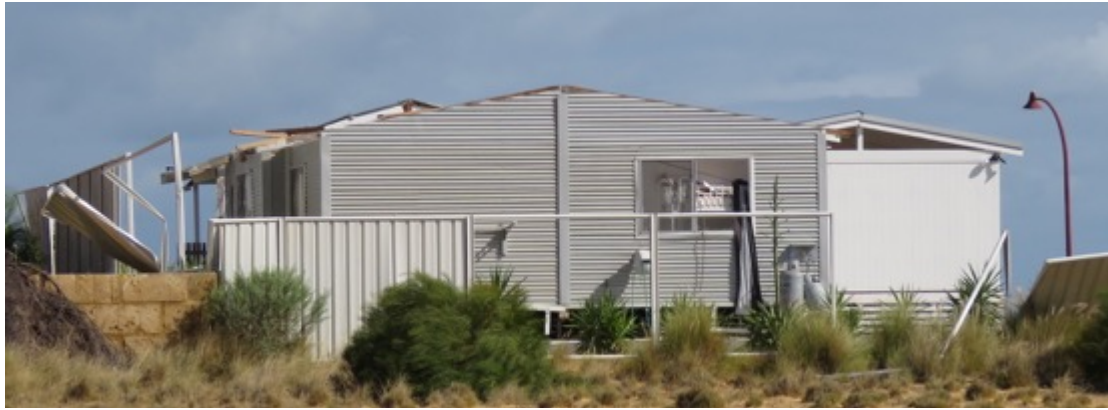
Figure 4-11(a) shows a transportable house that had been positioned on site, refurbished, and surrounded by a veranda. The house lost its roof, but the verandas remained intact. The verandas (Figure 4-11(b)) had been specifically designed for the site, but the wind design of the original transportable house was unknown. Although the building had been refurbished and the quality of the finishes was high, it appeared that the structural details in the roof were the original ones and may not have been appropriate for the wind classification for the site.

(a) Rear view of the transportable house

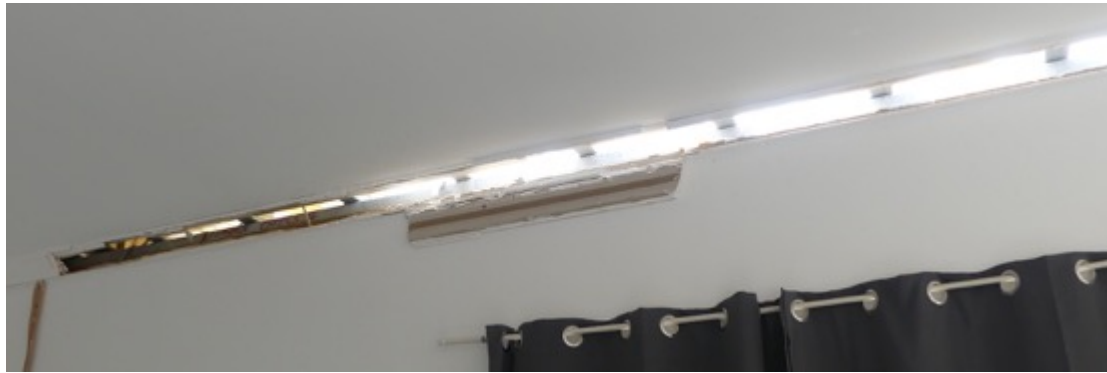
There were signs that the roofs of several houses had partially lifted off walls. An example is shown in Figure 4-12(a) and (b). These cases indicate that although the ultimate strength of the connections was sufficient, there was excessive deformation in the connections. In the house shown in Figure 4-12, the tiedown straps were angled to the outside of the building (highlighted by the red ellipse in Figure 4-12(c)), and they had cracked the outside upper courses of the external leaf when they straightened under uplift loads.

(a) Roof partially lifted off external walls

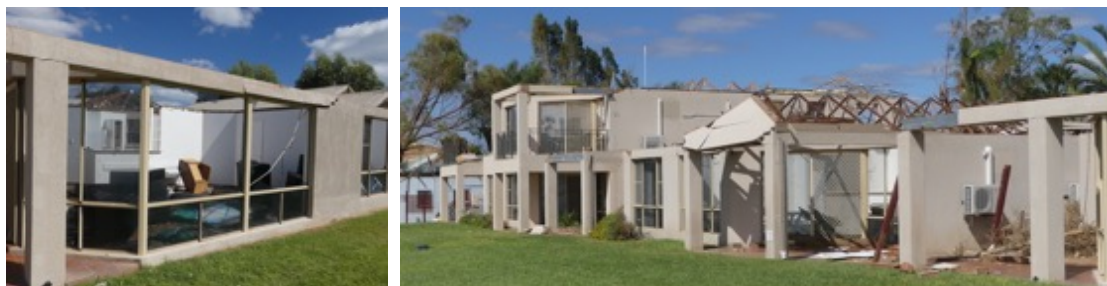
Failures of the roof to wall connections discussed in this section were often associated with window failures, as shown in Figure 4-13. The link between this type of failure and internal pressure was demonstrated in many new and refurbished residential buildings in Kalbarri.

Figure 4-13 Refurbished buildings with broken windows and substantial roof loss

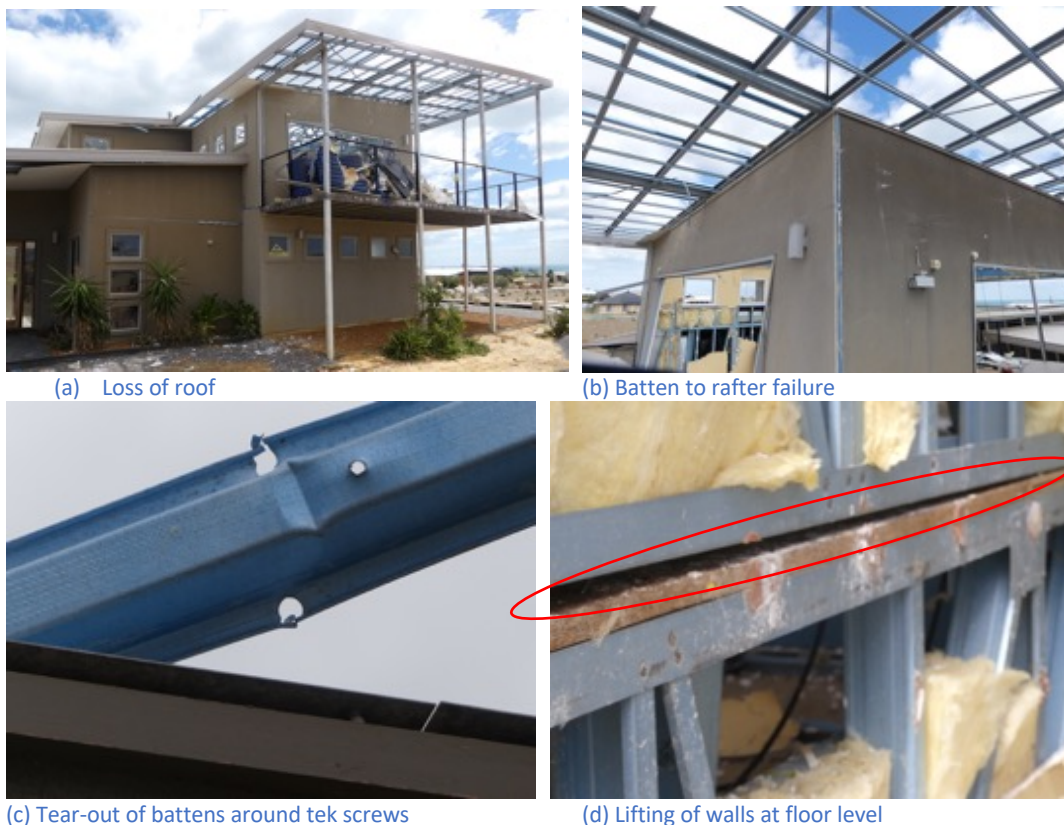
Figure 4-10 shows a skillion roof that lost the whole roof structure. The skillion roof in Figure 4-14 (a) and (b) also failed, but in this case, it was the batten to rafter connections that failed due to tear out around the tek screws shown in Figure 4-14(c). The loss of a large windward window increased the net uplift forces in this part of the house, and the overall uplift forces on the room were enough to lift the room at floor level, as shown in Figure 4-14(d).

(c) Tear-out of battens around tek screws

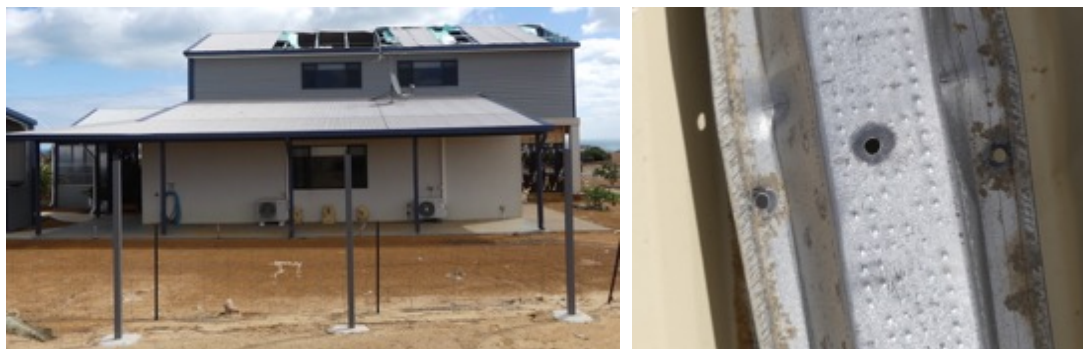
Damage to a steel-framed house shown in Figure 4-15 was caused by the failure of batten to rafter connections after a double front door blew in. In this case, the small tek screws used to fasten the top hat battens pulled out of the truss top chords. Several screws were still in the batten flanges. Use of batten and rafter systems with recommended tek screws justified by test results can avoid the type of damage illustrated in Figure 4-13 and Figure 4-14.

Figure 4-15 Failure of batten to rafter connection by the withdrawal of tek screws

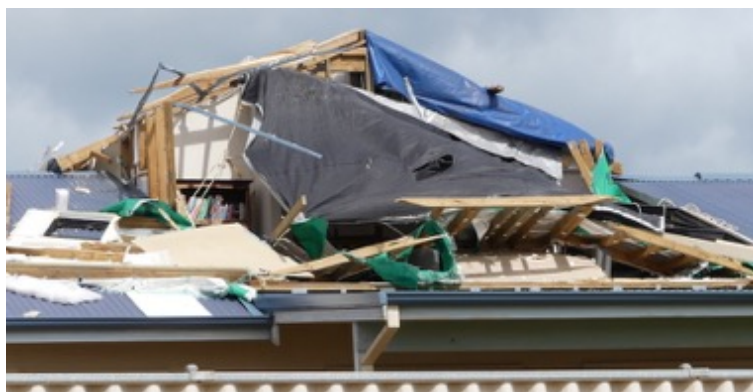
(a) Damage to roof

(b) Screws at base of rafter

Failure of timber in tension perpendicular to grain can be avoided by ensuring that the anchorage at each end of deep rafters (> 170 mm deep) attaches to the full height of the rafter.

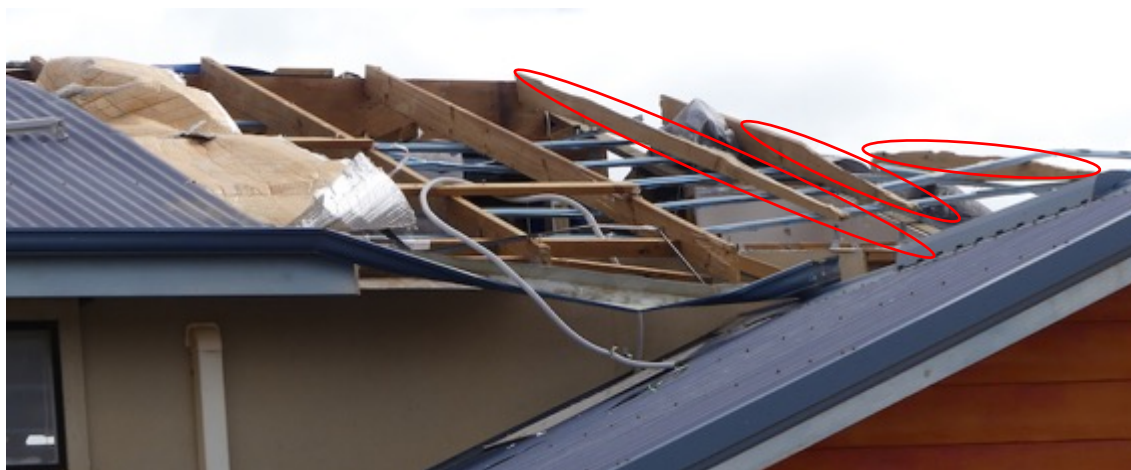
(c) Failure of rafters

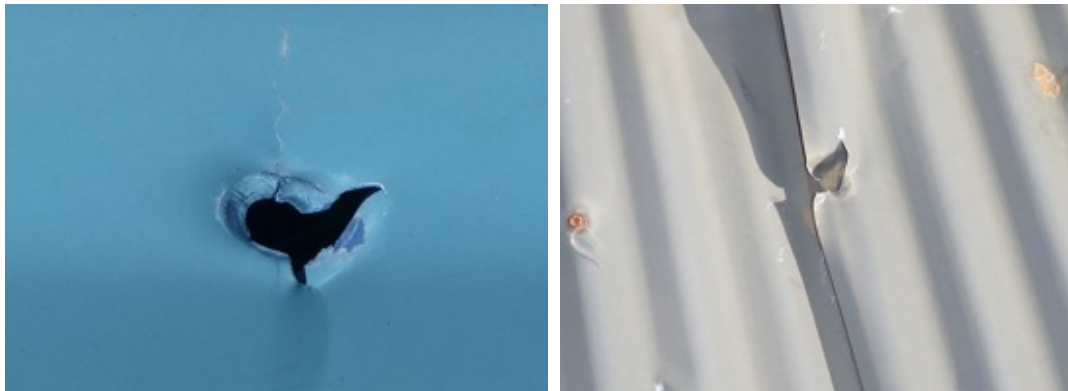
However, the investigation team noted signs of cracking in roof sheeting like that seen in damage caused by cyclones in Wind Region C. TC Seroja was a short duration cyclone. The damage shown in Figure 4-18(a) was probably caused by local plastic deformation (LPD) over a small number of cycles due to the large spacing between fixings. A low-high-low test of the roofing system would have identified this failure mode if the fixing pattern contributed to LPD. Figure 4-18 shows some examples of failures in roof sheeting where fasteners had pulled through the sheeting.

Figure 4-18 Failures in roof sheeting by fastener pull-through

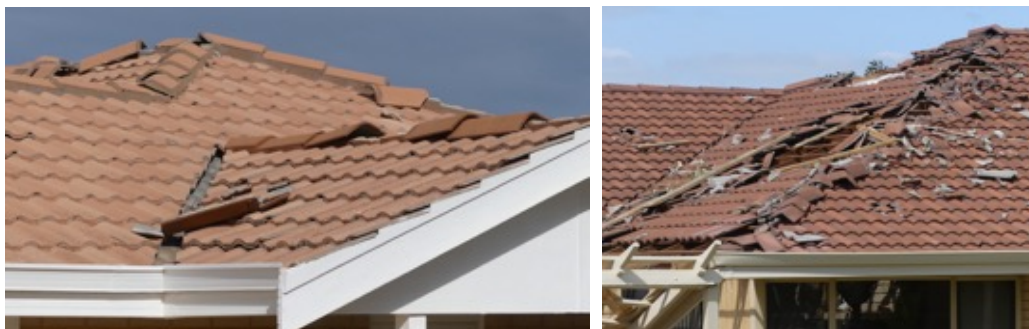
No tile roofs were lost entirely, but many tile roofs had damage to ridge and hip capping or had lost individual tiles. Some examples of ridge tile damage are shown in Figure 4-19. Capping is always located in zones of high local pressure factors. AS 2050 requires mechanical fixing of capping, but there was little evidence of mechanical fixing in the separated ridge tiles.

Figure 4-19 Examples of damage to ridges and hips on tile roofs

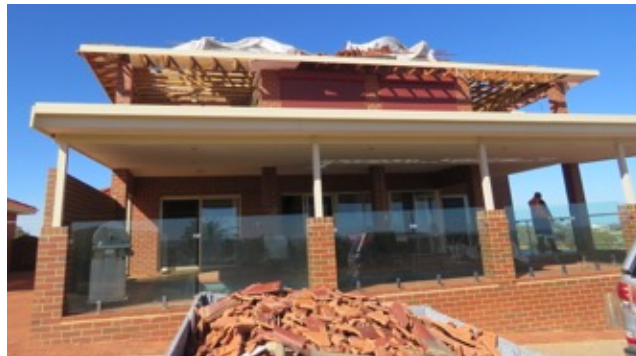
The adjacent garage had the same tiles fixed in the same way as the house, but the roof tiles were not damaged. The roller doors on the garage failed so that the roof would have experienced full internal pressure. The only noticeable difference between the garage and the house was that the garage had eaves gutters, and the house didn't.

Figure 4-20 Loss of tile battens and roof tiles

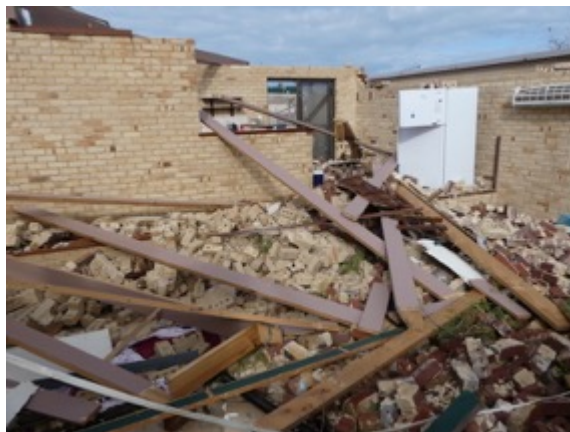
Many double brick walls in newer houses were damaged by wind or when roof structures were lifted from the walls during TC Seroja. Figure 4-22 shows an example of a windward wall that was blown into a lounge room. Windward walls that failed in this manner were generally external walls in open plan areas of the house and associated with large openings such as windows and doors. In the house shown in Figure 4-22, some of the roof timbers were on top of the wall debris, indicating that this wall may have failed before the roof loss.

Figure 4-22 Failure of a windward wall under wind actions.

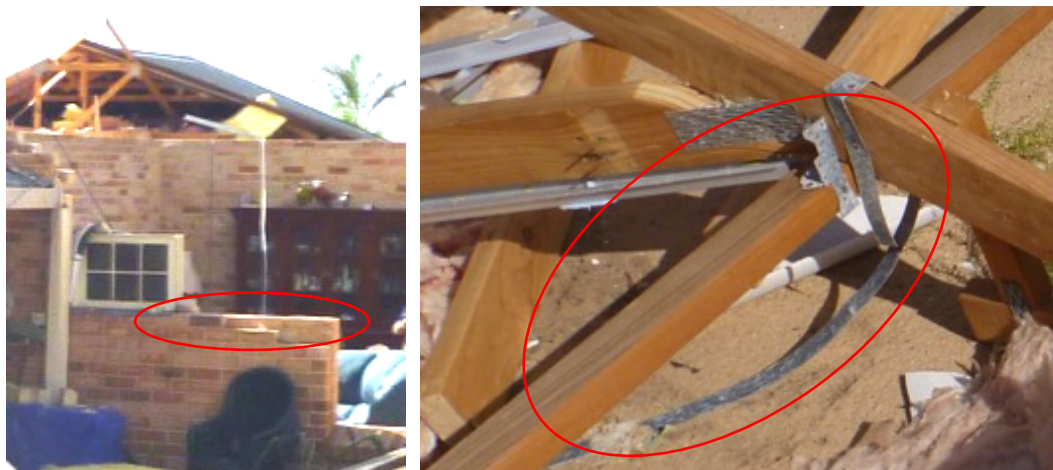
Figure 4-23 shows a house where the roof was lost at the same time as the walls collapsed. The tie-down straps between the roof and the wall were still firmly attached to the roof structure and had pulled out of the brickwork. The inner leaf of the brickwork had broken cleanly along the line of embedment of the brick straps (highlighted by an ellipse). The uplift force on the straps was higher than the weight of the inner leaf above the embedment line and cracked the brickwork leading to its failure along that line.

(a) Failure of brickwork at embedment depth (b) Tie-down strap attached to roof members

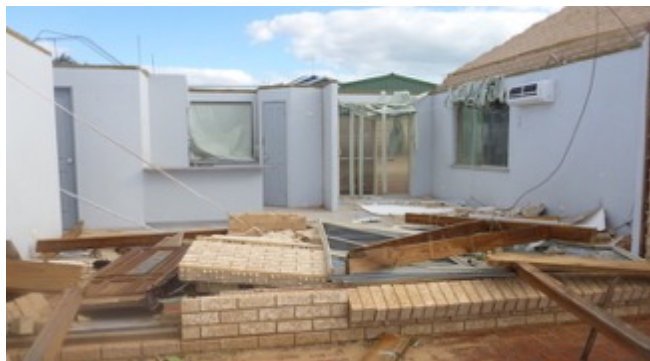
Figure 4-24 shows a wall that failed after the roof had lifted. The lintels across the large openings were still on the wall. The debris on the floor indicated that a door had broken, then the roof lifted, the windows broke, and the wall collapsed. Finally, the veranda timbers fell into the room. The large openings made it difficult for the tie-down straps in the brickwork to mobilise enough weight to counter the net uplift on the roof after a dominant opening had developed. It underlines the importance of designing appropriate tie-downs beside large openings.

Figure 4-24 Failure of a wall with large openings

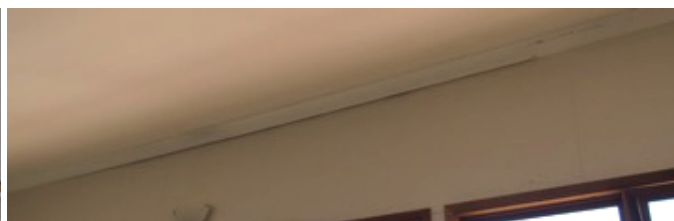
(b) Deflection at ceiling level

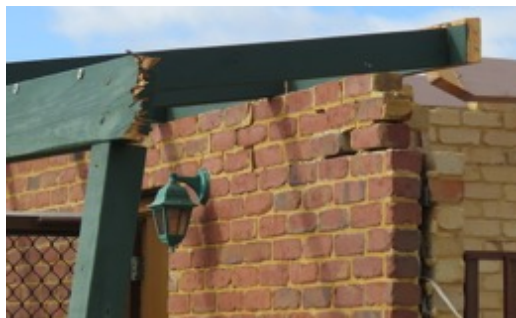
If the veranda roof was part of the main house roof, damage to the veranda roof led to the failure of the house roof. This is illustrated in Figure 4-27. In this case, failure at the base of the veranda posts caused the loss of the verandas and most of the house roof. This observation has also been made in investigations following cyclones in Wind Regions C and D. Where the roof sheeting on the veranda was separate from the sheeting on the house, the two structures could behave independently.

Figure 4-27 Veranda loss

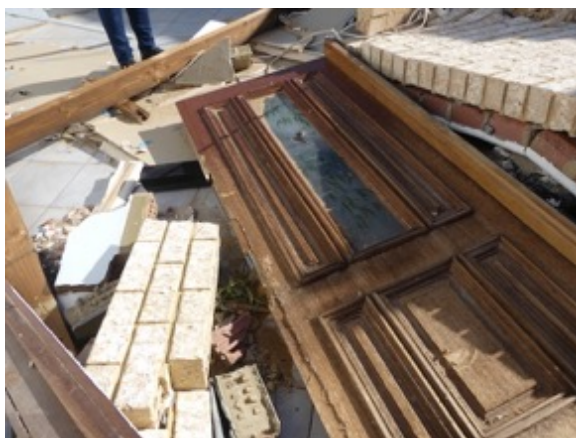
Figure 4-31(b) shows an example of a door latch that failed on a double entrance door, allowing full internal pressure into the house, causing failure of the roof. After the roof failed, the walls collapsed. The damage is also shown in Figure 4-8.

(a) Double door blew into house

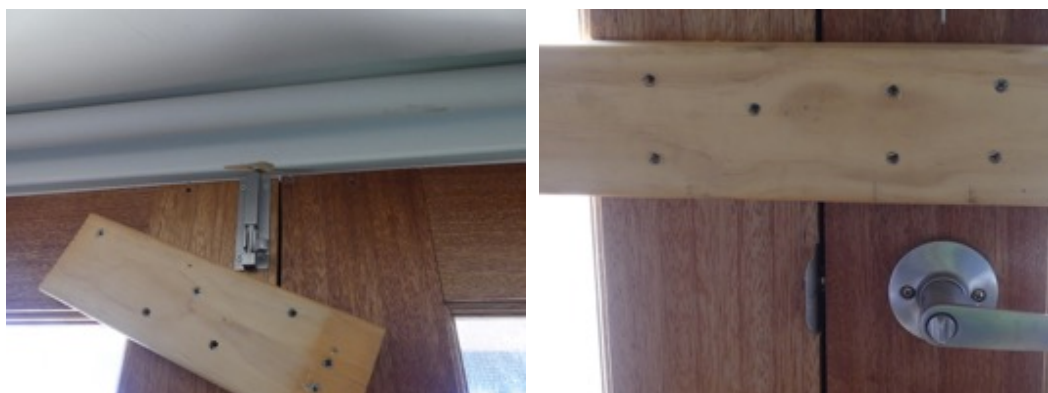
The latch on double front doors on a five-year-old house broke, and the bolt at the top of the door pulled out of the timber frame—the resulting increase in internal pressure caused loss of part of the roof. The owner was injured while making the temporary repairs to the doors during the cyclone. (The temporary repair to the doors is shown in Figure 4-32).

Figure 4-32 Temporary brace on the double front door

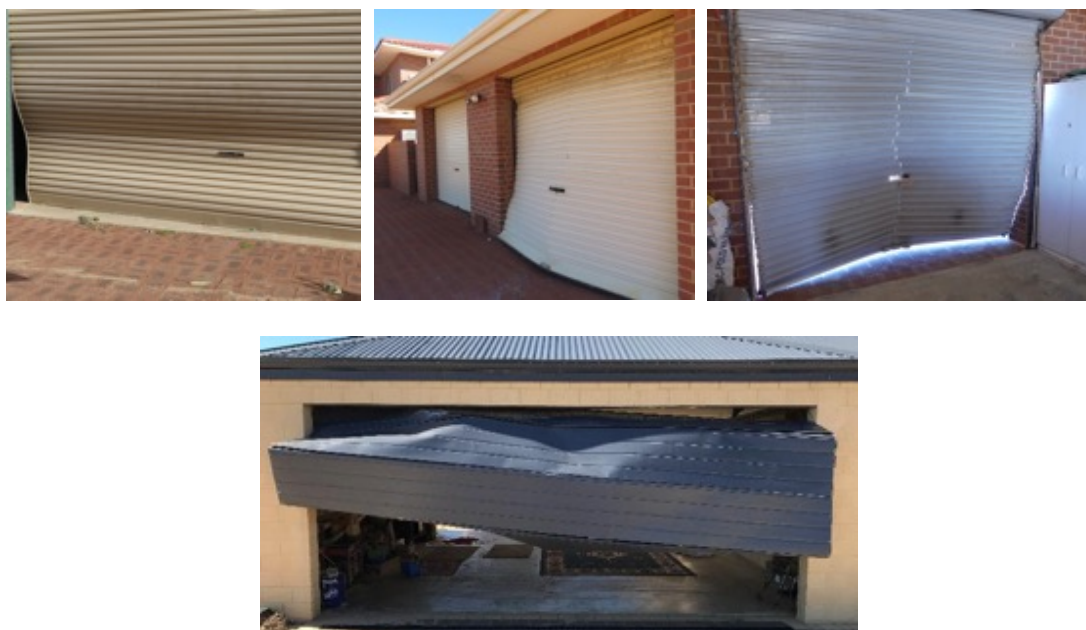
Figure 4-33 shows examples of damage to garage doors on residential garages.

Figure 4-33 Failure of garage doors in Kalbarri

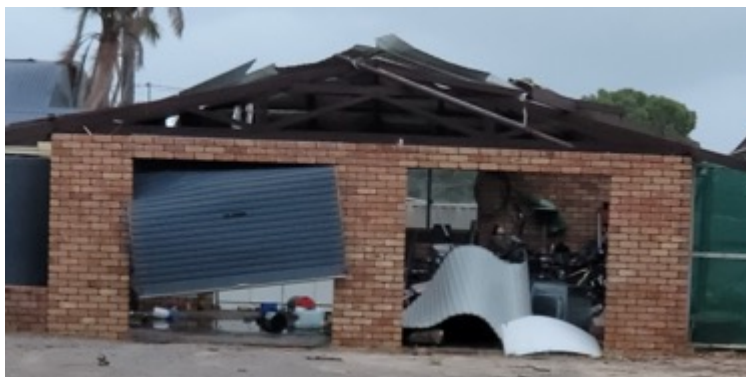
Figure 4-34 shows a house in Geraldton where the wind speeds during TC Seroja were lower than in Kalbarri. However, the damage to the garage doors initiated roof loss, even at wind speeds around 60% of the design wind speed.

Figure 4-34 Failure of garage doors in Geraldton

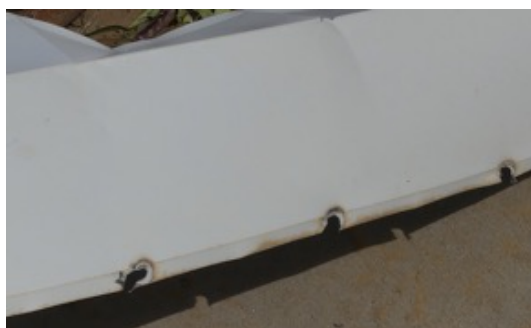
Flashings were damaged on a significant number of buildings, including contemporary buildings. Some lifted flashings are shown in Figure 4-35. In each case, the lifted flashing allowed significant water entry into the roof space causing water damage, as discussed in Section 6.

(a) Flashings fastened too close to the edge

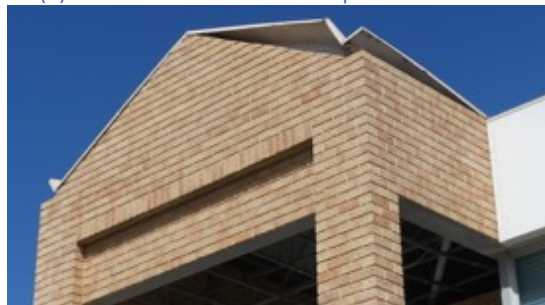
(d) Flashings not fastened

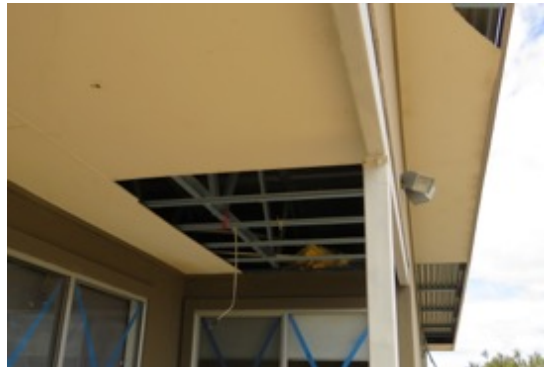
Previous CTS reports on damage to buildings following wind events (e.g. Henderson *et al.*, 2006 and Boughton *et al.*, 2011) highlighted the high frequency of damage to soffits. Figure 4-36 shows an example of damage to soffits during TC Seroja. Again, the character of the damage reflects previous observations of damage in tropical cyclones in other Wind Regions.

Figure 4-36 Damage to eaves linings

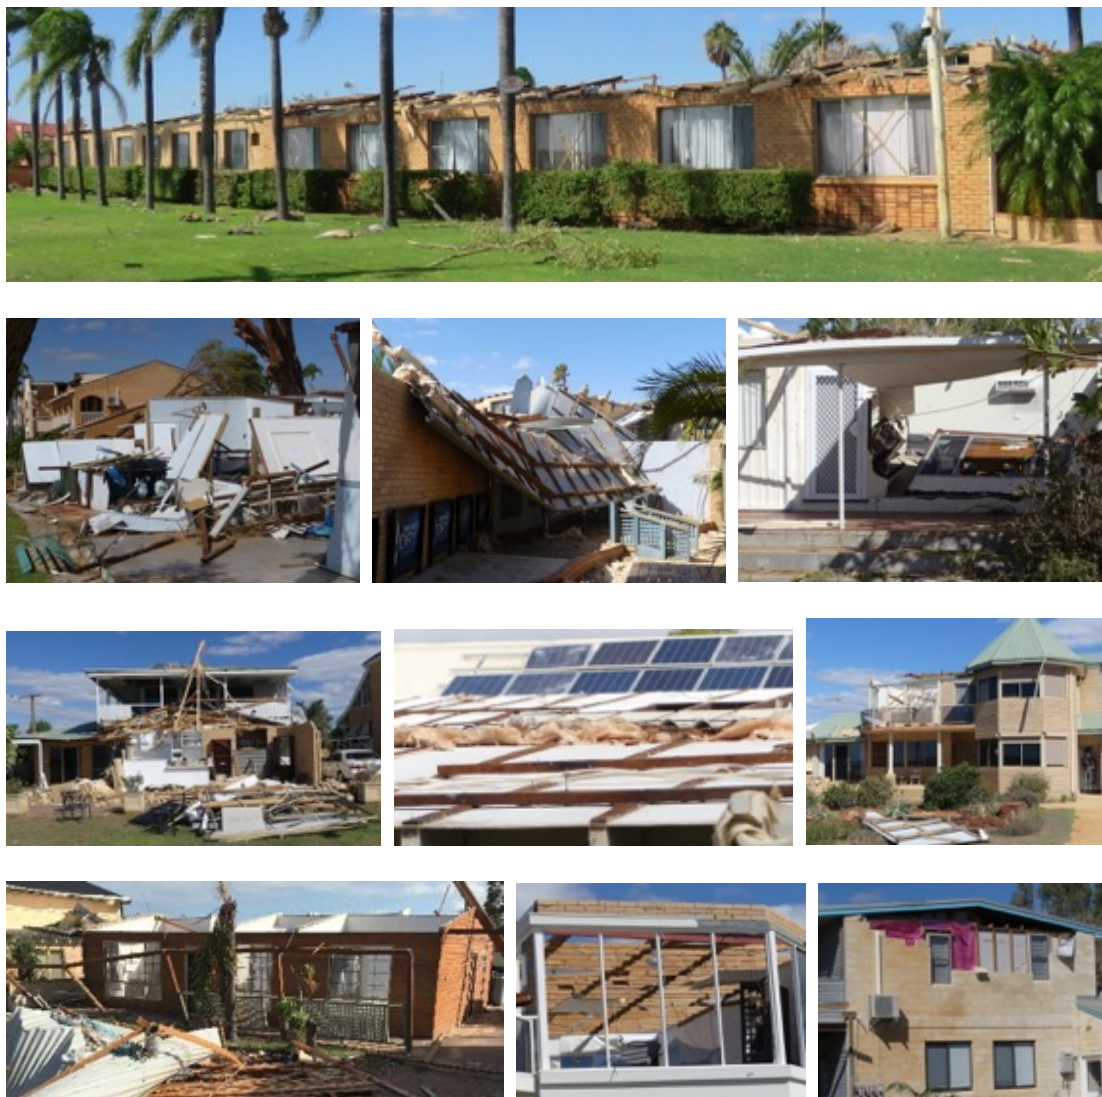
The investigation of damage to buildings after TC Seroja confirmed the findings of previous damage surveys (Boughton *et al.*, 2017, Boughton and Falck, 2015, Boughton *et al.*, 2011; Boughton and Falck 2007, Henderson *et al.*, 2006, and Reardon *et al.*, 1999); older buildings are usually damaged more frequently and severely than newer ones unless they have been adequately upgraded or retrofitted. Figure 5-1 shows some examples of wind and debris damage to older buildings in Kalbarri.

Figure 5-1 Damage to older buildings

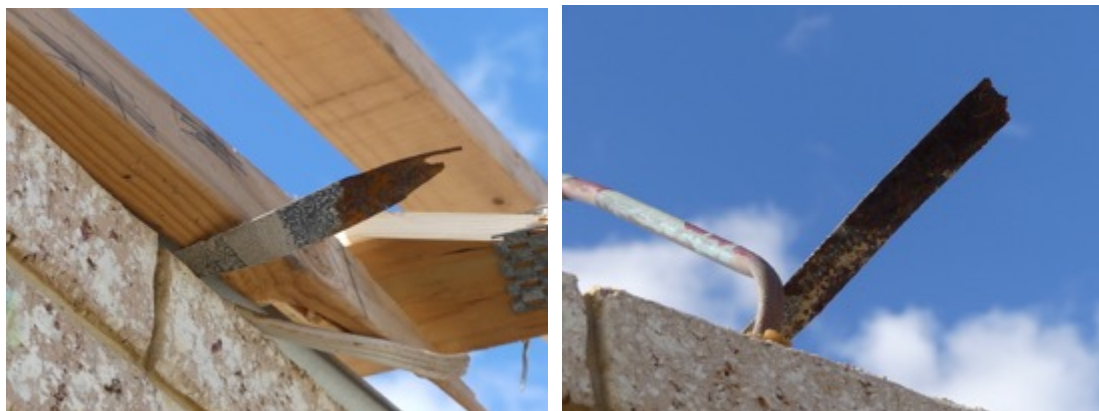
Figure 5-3 shows some examples of corroded tie-down straps that led to the loss of the roof structure.

Figure 5-3 Corrosion in tie-down straps that led to the loss of timber-framed roofs

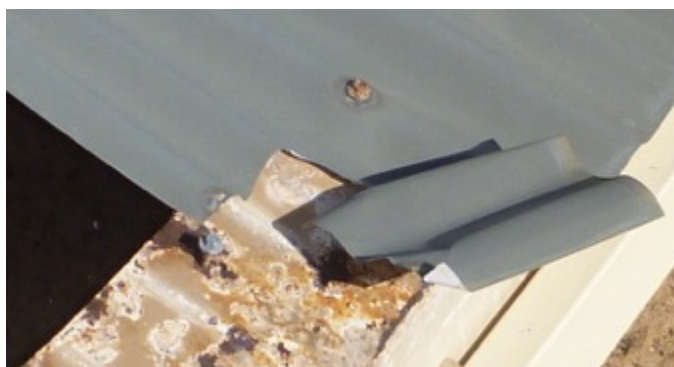
Figure 5-4 Corrosion of flashings and fasteners

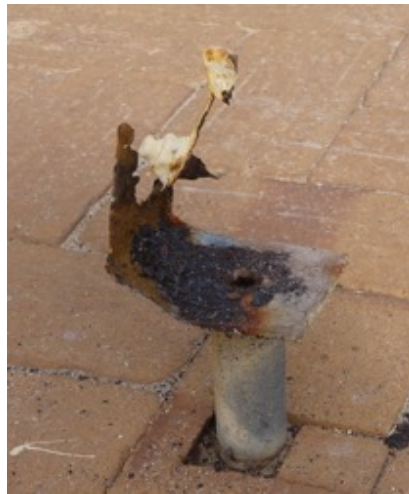
Figure 5-5 Corrosion in stirrups for veranda posts

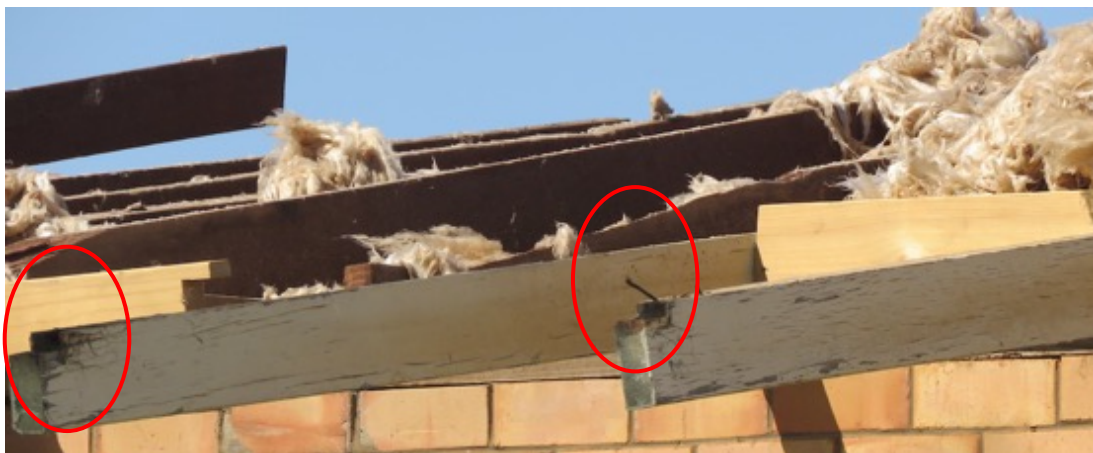
Figure 5-6 Rot in exposed rafter ends

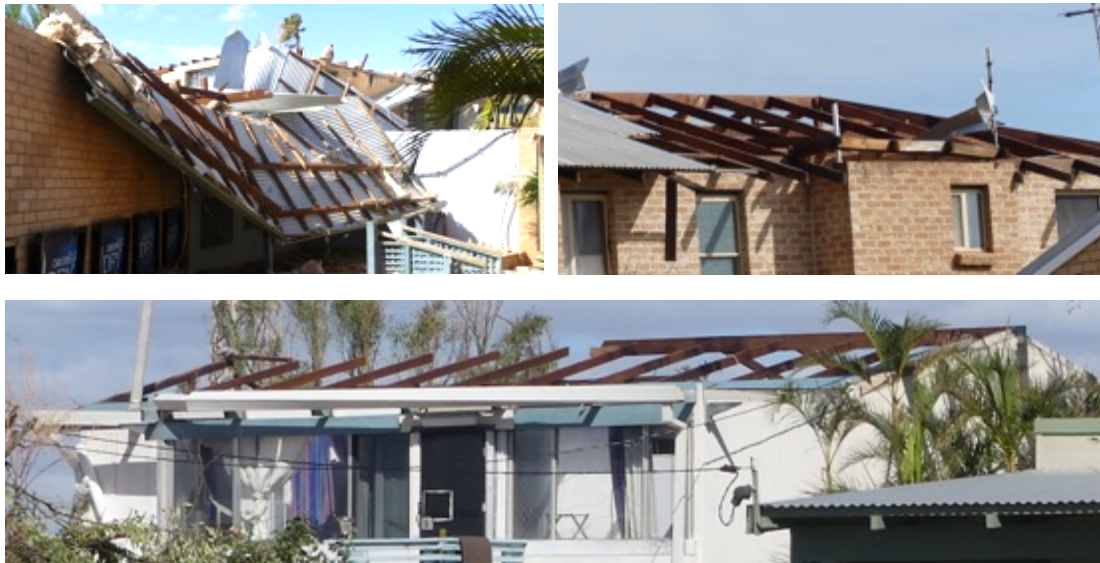
Figure 5-7 Failure of nailed batten to rafter connections or skew nailed rafter to wall connections

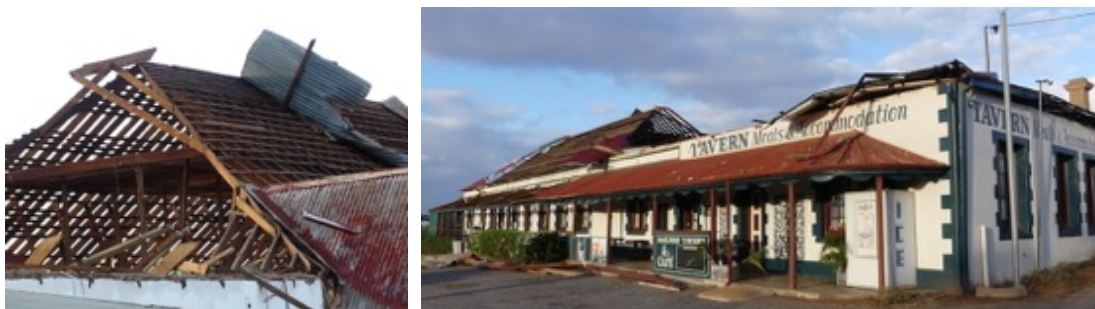
Figure 5-8 Damage to the roof of a heritage hotel in Northampton

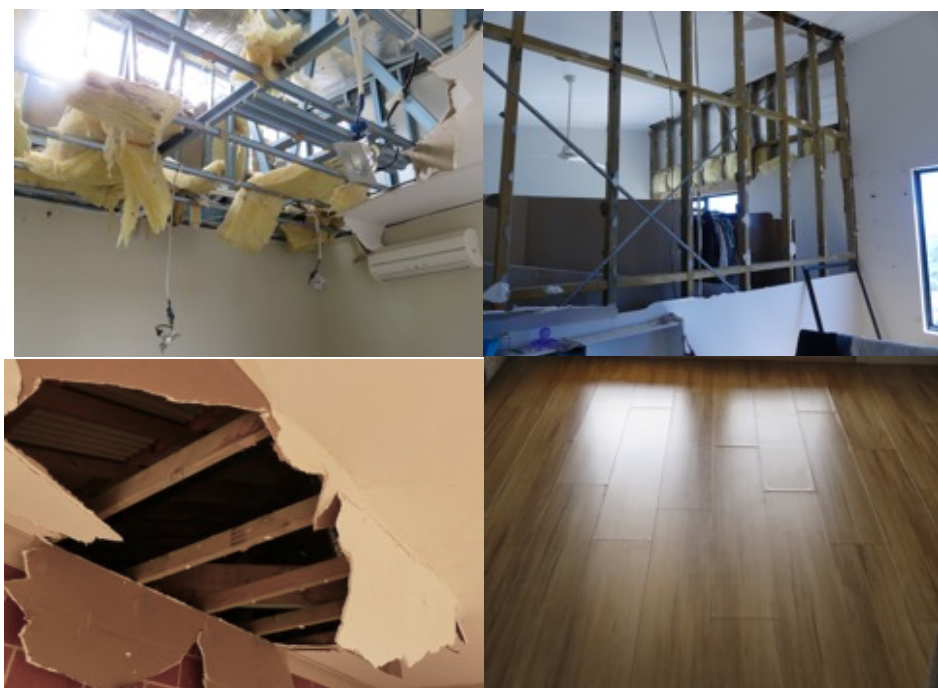
Figure 6-1 Damage to plasterboard wall and ceiling linings and timber floor

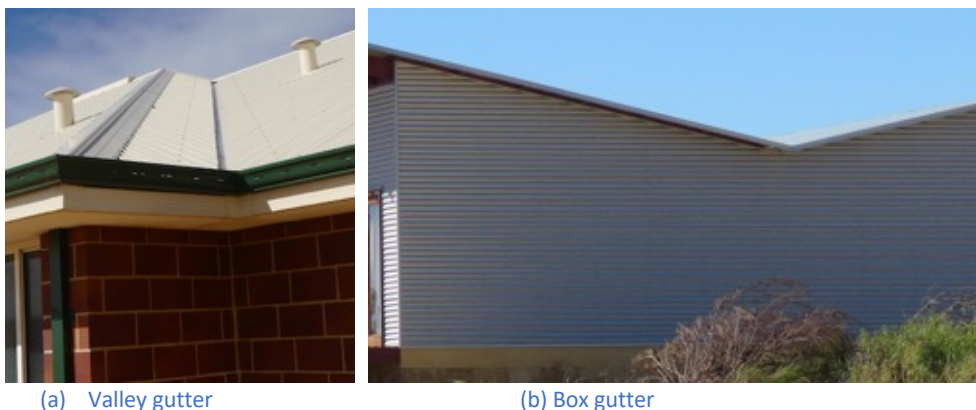
Figure 6-2 Wind-driven rain entered buildings with no structural damage

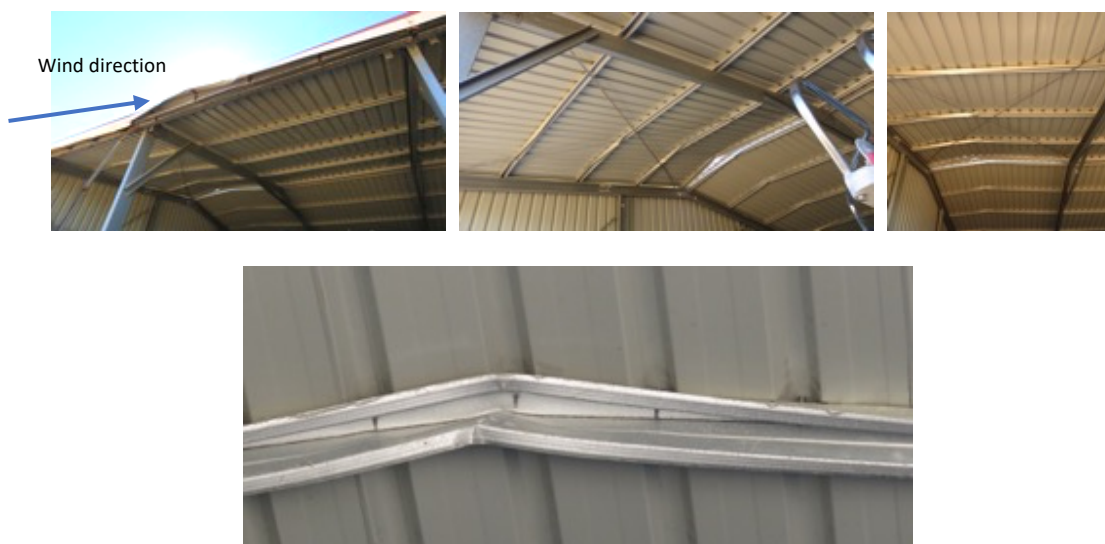
Figure 7-1 Damage to purlins in a large shed

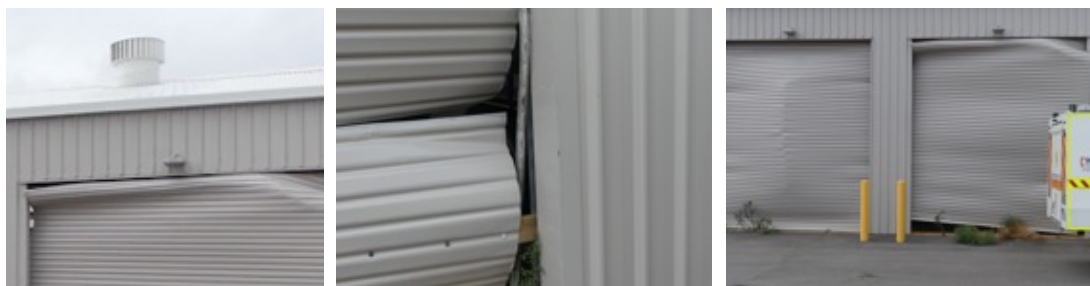
Figure 7-2 Damage to large access roller doors – View from outside the shed

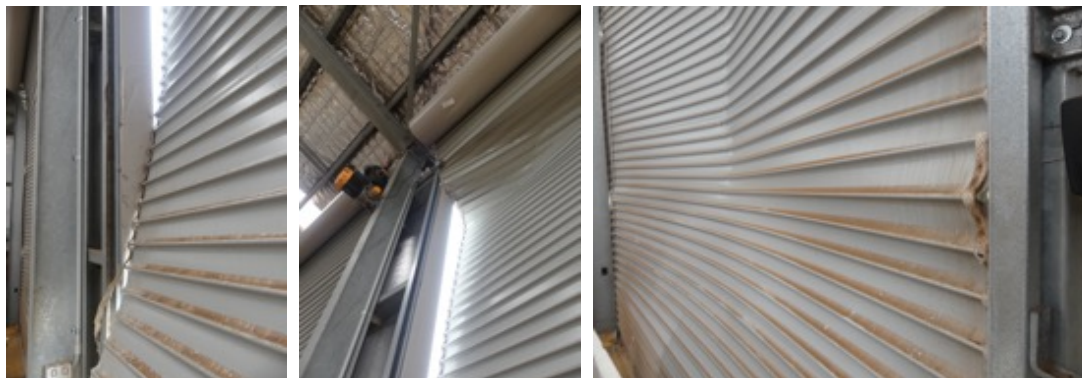
Figure 7-3 Damage to large access roller doors – View from inside shed

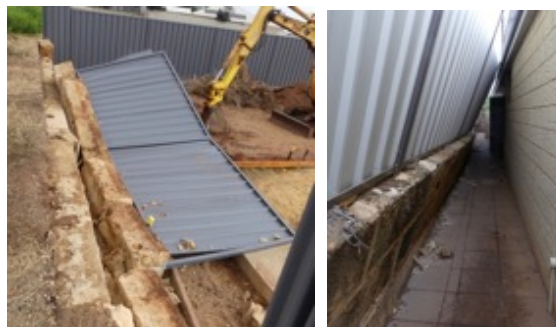
Figure 7-6 Damage to retaining walls caused by wind loads on attached fence panels

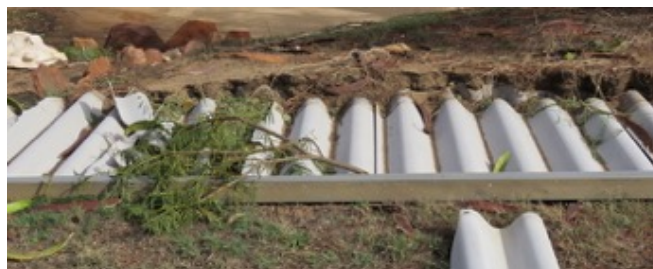
Figure 7-7 Damage to fibre cement fences

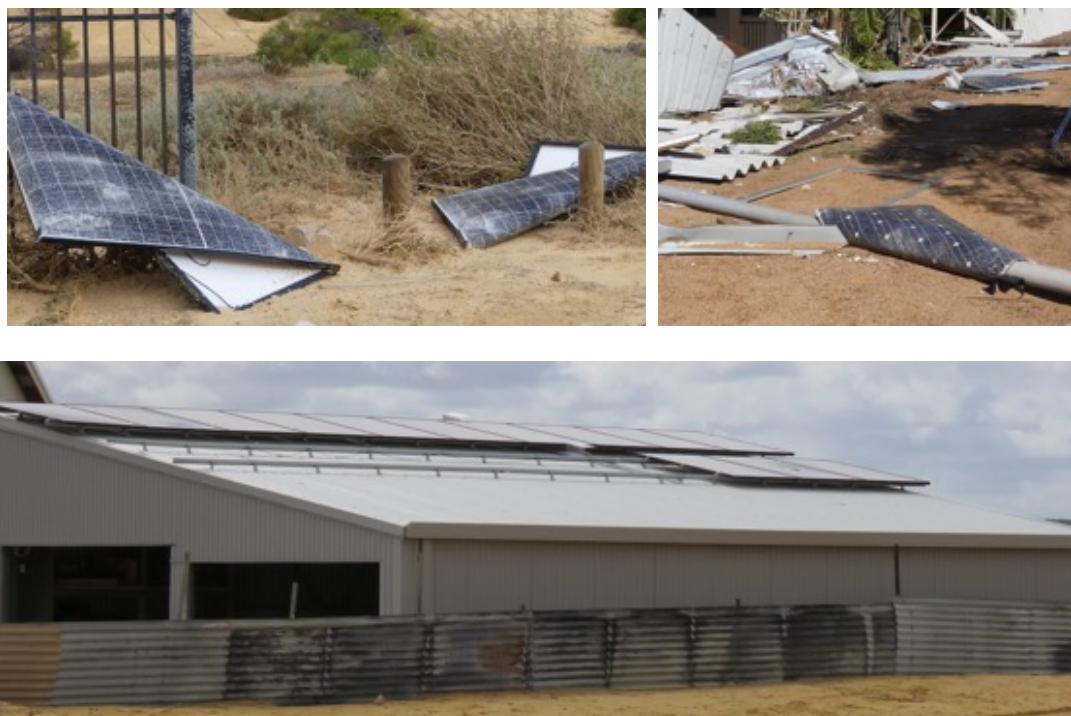
Figure 7-9 Damage to solar photovoltaic panels

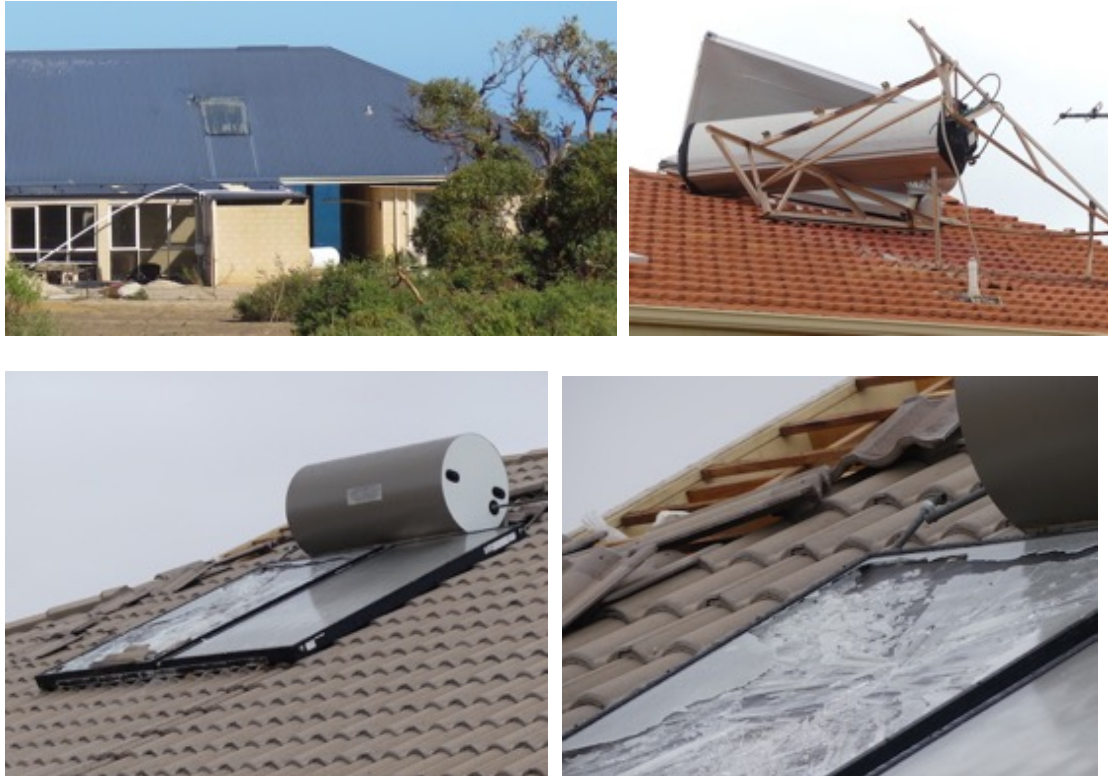
Figure 7-10 Damage to hot water systems

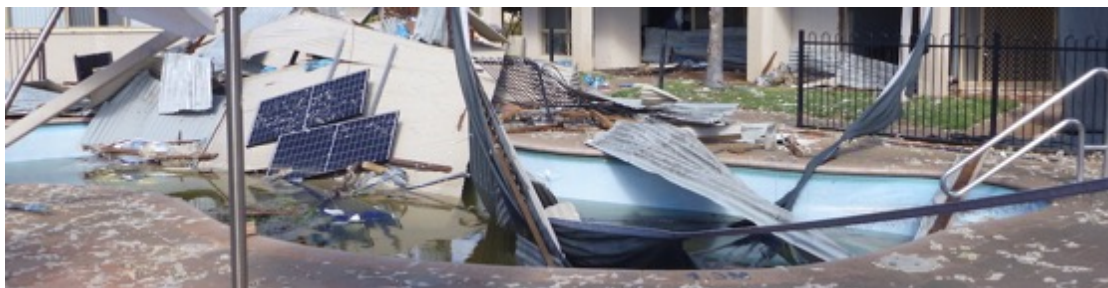
Figure 7-11 Debris in a swimming pool
