Tropical Cyclone Seroja – Damage to buildings in the Mid-West Coastal Region of WA

CTS Technical Report No 66

**Tropical Cyclone Seroja
Damage to buildings in the
Mid-West Coastal Region of Western Australia**

Initial Release 28 May 2021
Revision released 3 June 2021

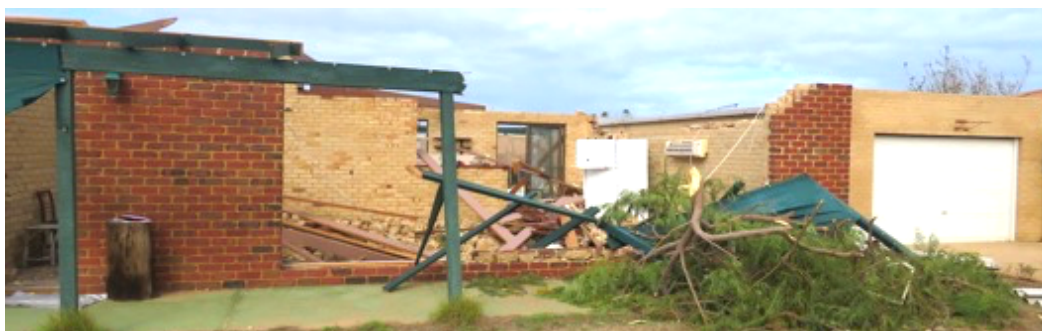
Figure 9-1 Extensive damage to walls and roof

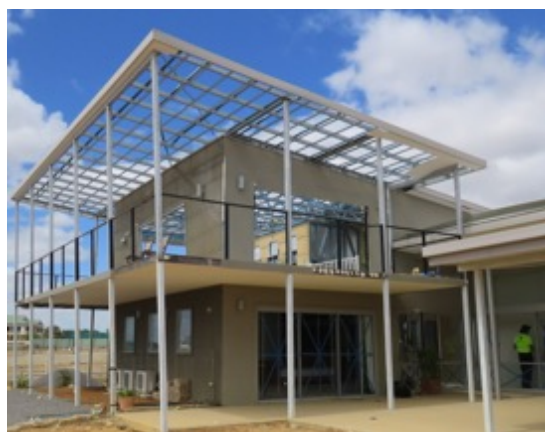
Figure 9-2 Roof loss and damage to walls

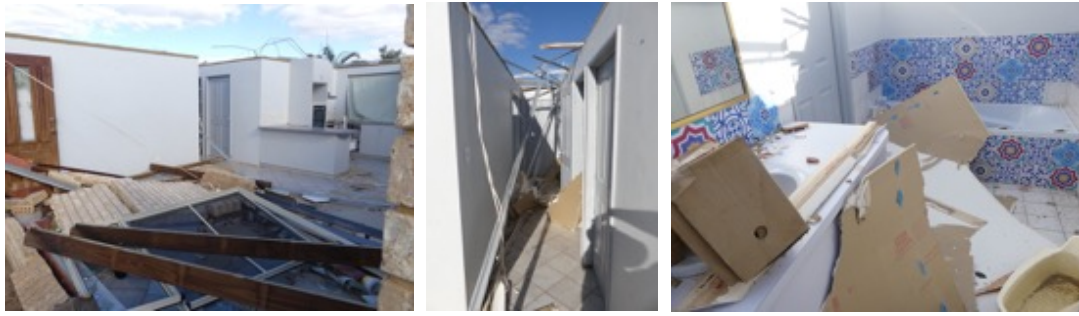
Figure 9-3 Severe damage to a house including hallway and bathroom

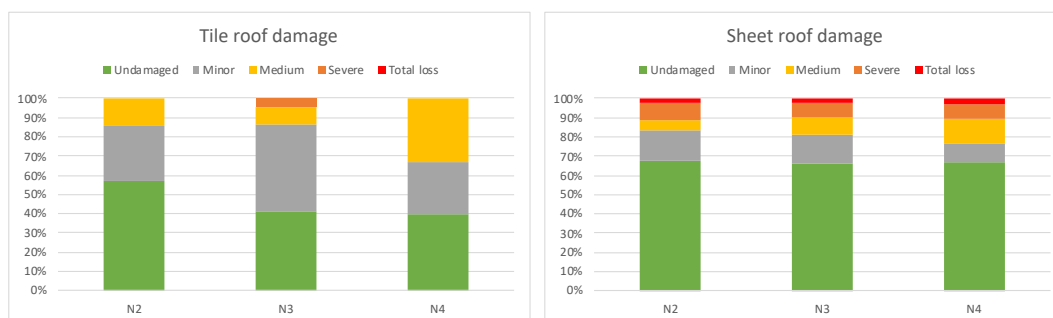
Figure App.3.3 Damage to roofs in different Wind classifications
