North Queensland Study into Water Damage from Cyclones

Project partners: IAG and SUNCORP

Overview of study

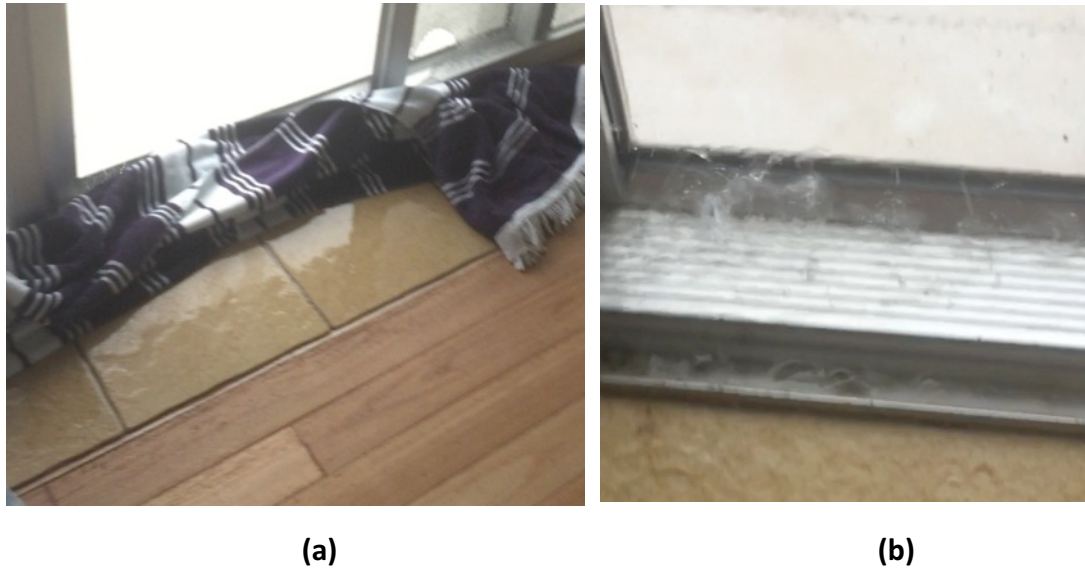
Videos taken during TC Debbie by residents showed that considerable volumes of water came through windows and sliding glass doors, under swinging doors, and through light fittings and ceilings. In many cases, the water entered buildings that had no damage to the building envelope. The rain caused damage to vulnerable elements such as plasterboard wall linings and ceilings; floor coverings; and personal belongings. In multistorey buildings, the rain percolated down through the building for a number of storeys below the original point of entry.

Figure 1 (a) Towels placed in front of large windward wall windows to control large amounts of water, and (b) water spraying into living room from under the door (CTS TR63)

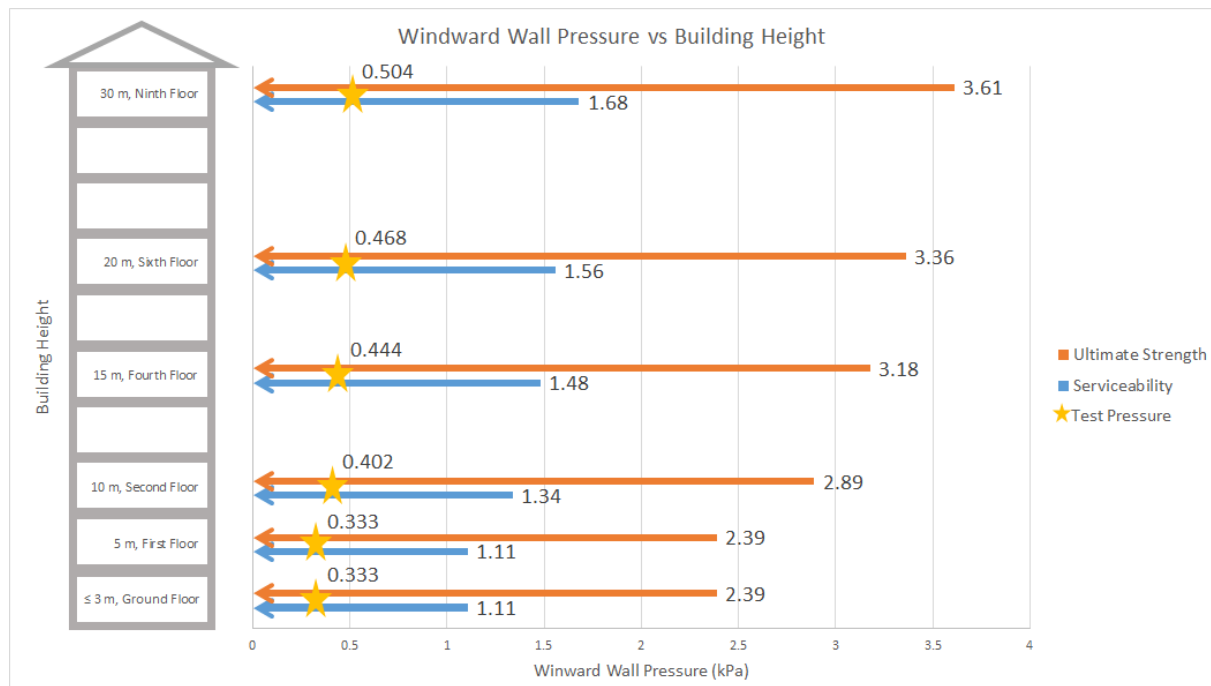
There is a large range of window sill designs in the marketplace; some window sealing and drainage systems are simple, while others are very complex. All windows must satisfy performance criteria in AS 2047 (Standards Australia, 2014), which includes a test to exclude water penetration at the prescribed test pressure. However, **this test pressure is only one-third of the serviceability design pressure (Serviceability design means that the building remains functional during and after this loading).**

Figure 2 Relationship between ultimate strength design pressure, serviceability design pressure and the test pressure for the Australian Standard water penetration test showing how small the test pressure is in relation to the Serviceability design.

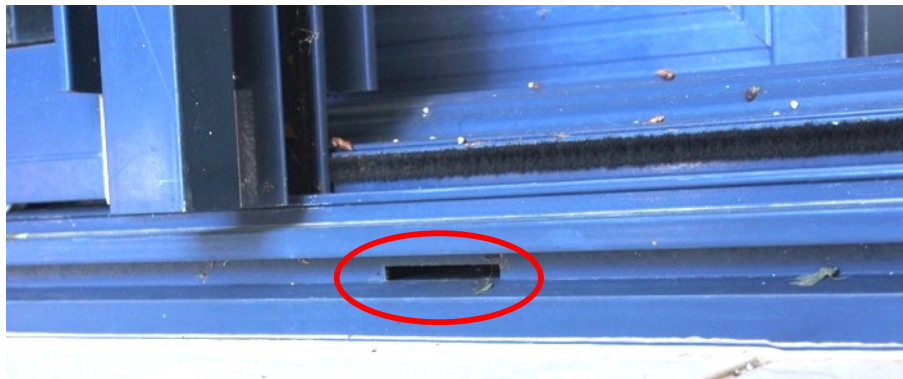
Weep holes in windows or glass sliding doors (Figure 3) are designed to allow condensation and minor leakage around seals to pass from the inside to the outside of the building. However, in high winds, differential pressure forces horizontally driven rain on windward walls through weep holes (i.e. in the opposite direction intended in design) and through other gaps in the building envelope.

Figure 3 Weephole in glass sliding door frame

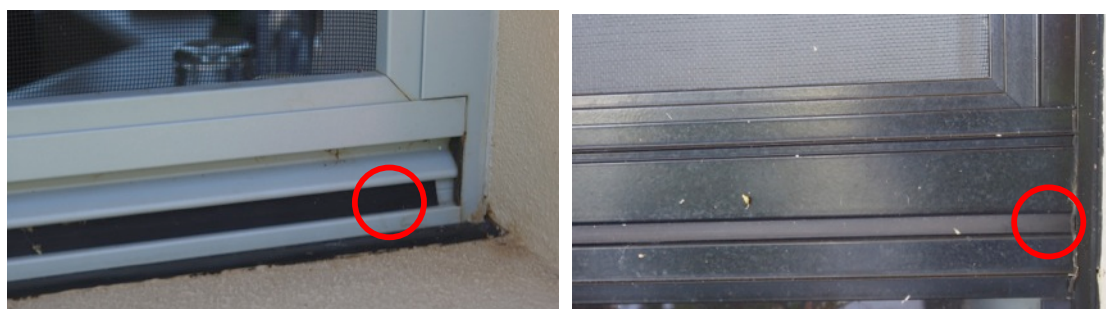
However some people mentioned, who were in either apartments or houses, they had no water or only a small amount of water enter through their sliding windows during TC Debbie. Typically, the windows without significant water ingress had weep holes that were covered by external rubber strips. Figure 4 (a) shows a window from a house and another in a larger apartment building with rubber seals over the weepholes that performed well. The windows and glass sliding doors in another apartment building, Figure 4 (b), had an external baffle that concealed the weepholes; only a small amount of water leaked through them. This door also had a step that would have assisted in reducing water into the unit from water that pooled on the balcony near the bottom of the door.

(a) Sliding windows with rubber flaps over weepholes

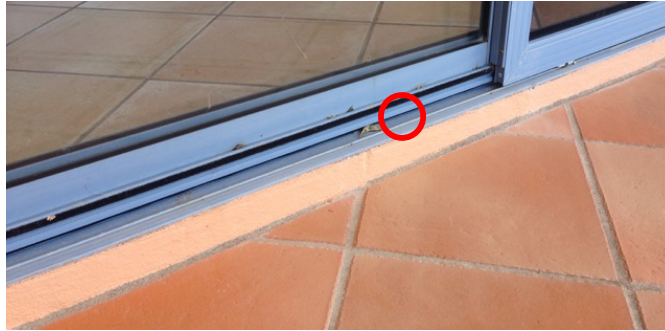
(b) Sliding glass doors with baffle that concealed the weepholes on an apartment balcony

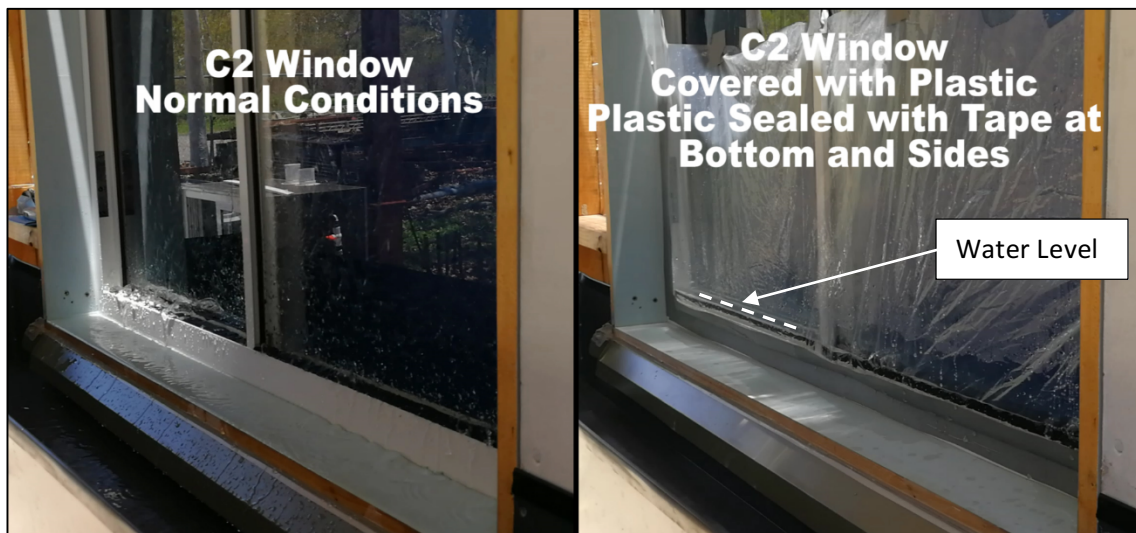
During the testing, all the modern window and door specimens tested were compliant with the AS 2047 rain flow rate and static test pressure of approximately 300 Pa standard, and did not let uncontrolled water into the inside of the building. However, for the fluctuating pressures encountered during wind storms the windows and door leaked, a lot.

Figure 6 Side by side views of normal window and window with the Plastic sheet sill extension during a pressure peak

Various mitigation strategies such as taping over the weep holes were trialled. The only configuration that greatly reduced the amount of water ingress was by using a strip of plastic sheet taped on the inside of the window sill (i.e. outside of WDRS). This strip of thin plastic increased the height of the window sill, caught the water and allowed it to drain back out of the house via the weep holes. Figure 6 shows results side by side during a pressure peak of a fluctuating pressure trace. A significant amount of water is being pushed through the seals and over the sill of the window on the left side, while the water is constrained by the plastic lining on the right side. This was a similar result for the sliding door tests.

Simple measures such as storm shutters on the exterior or the plastic sheet sill extension on the inside face of the window can greatly reduce the amount of driven rain entering our homes.
