Tropical Cyclone Ilsa – Wind field and damage to buildings in the East Pilbara

CTS Technical Report No 67

TECHNICAL REPORT NO. 67

Dr Geoff Boughton¹, Debbie Falck¹, Dr John Ginger¹, Dr David Henderson¹, Lucas van Woensel²

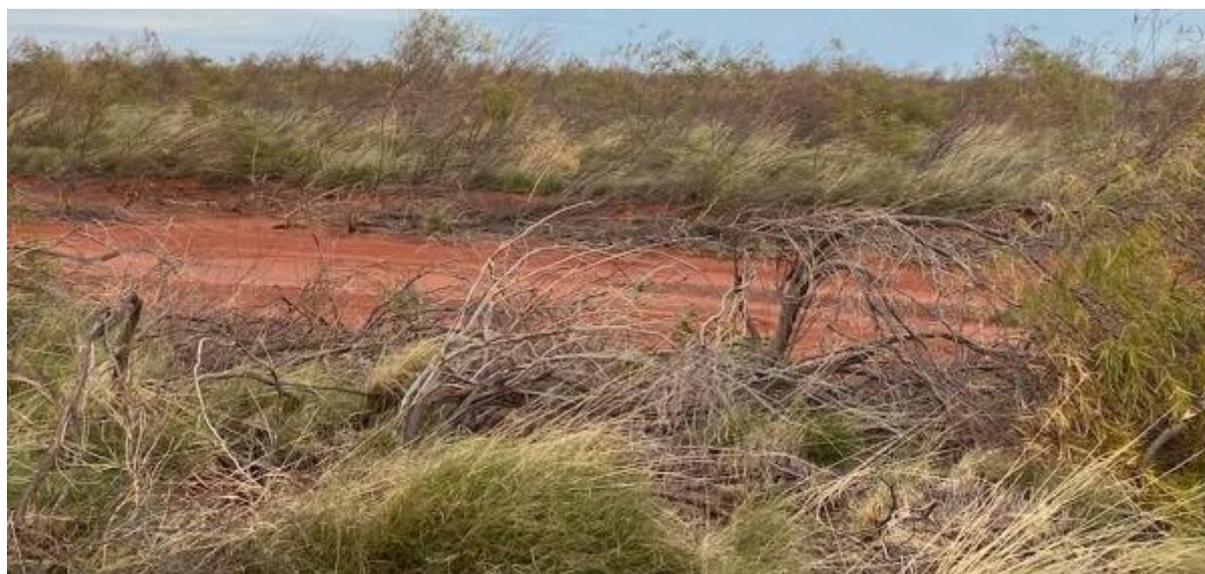
Figure 3-1 Light scrub blown from left to right

Vegetation damage was used to indicate wind direction. Light vegetation, such as wattles, broke off near ground level or was permanently bent. This type of vegetation grew in most locations visited during the investigation and provided a good indication of wind direction. In some cases, evidence of wind from two or more directions was noted. Figure 3-1 shows an example of wind-blown light vegetation with the predominant wind from left-to-right.

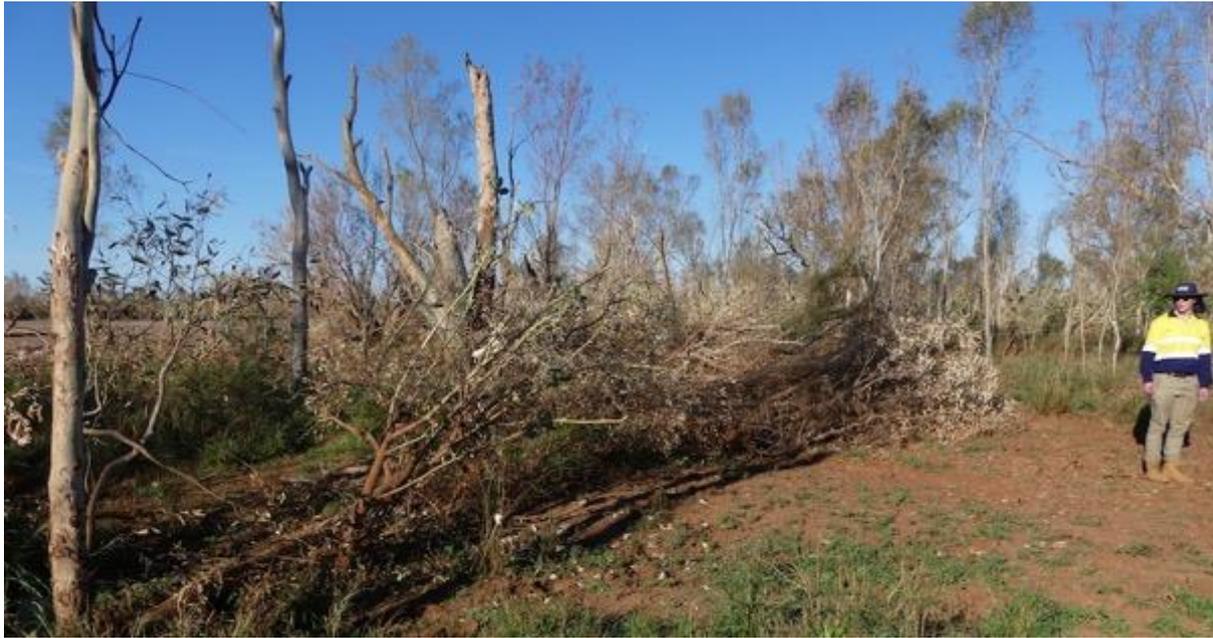
Figure 3-2 River gums damaged by wind

The relatively straight, white-bark river gums were selected as the standard vegetation for assessment of wind, as they were found near rivers, seasonal creeks and floodways that were located throughout the study area. Figure 3-2 shows damage to river gums. The extent of damage to river gums was used to indicate wind speed contour lines, and the direction of fall of the damaged parts of the trees was used to estimate wind direction in some cases.

In addition, the observations of river gum damage illustrated in Figure 3-2 noted the following attributes:

- In lower wind speed areas, the extent and location of leaf cover remaining
- In higher wind speed areas, the diameter of branches or trunks that had been broken.

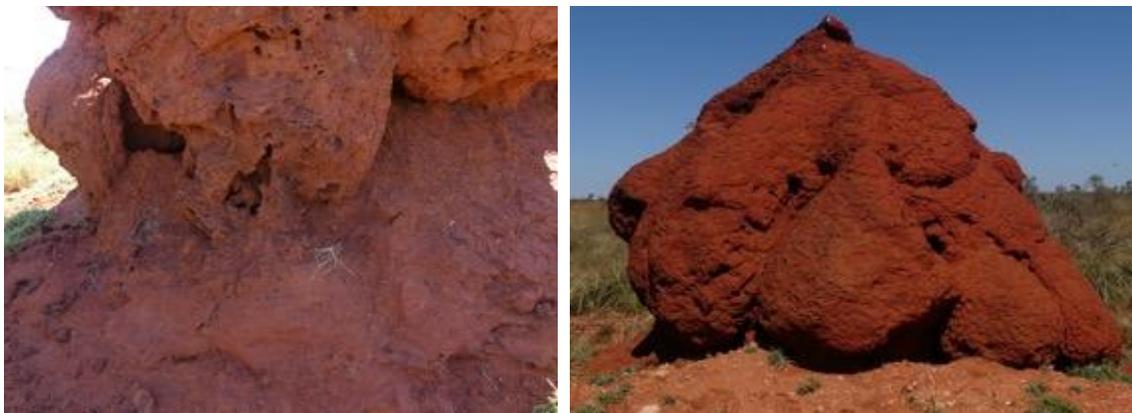
Figure 3-3 Erosion of termite mound by wind, rain and sand

Termite mounds could also give an estimation of wind direction in desert regions. Gravel and sand lifted from the ground by the wind eroded the mounds on the sides from which the wind had been blowing. Figure 3-3 shows a termite mound where the wind had been from the East and had caused erosion on the left side of the mound. The photo on the left indicates that the erosion had exposed galleries and chambers inside the mound.

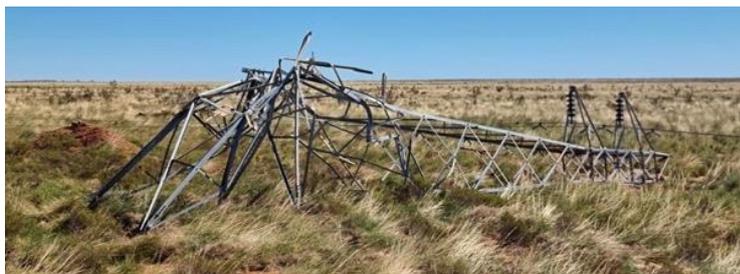
Figure 3-4 Damage to power transmission tower

In addition, where structures had been damaged, the wind direction could be inferred from the direction of travel of the detached elements or by the direction of fall of tall elements such as the power transmission tower shown in Figure 3-4. This part of the line had been decommissioned but the conductors were in place prior to TC Ilsa.

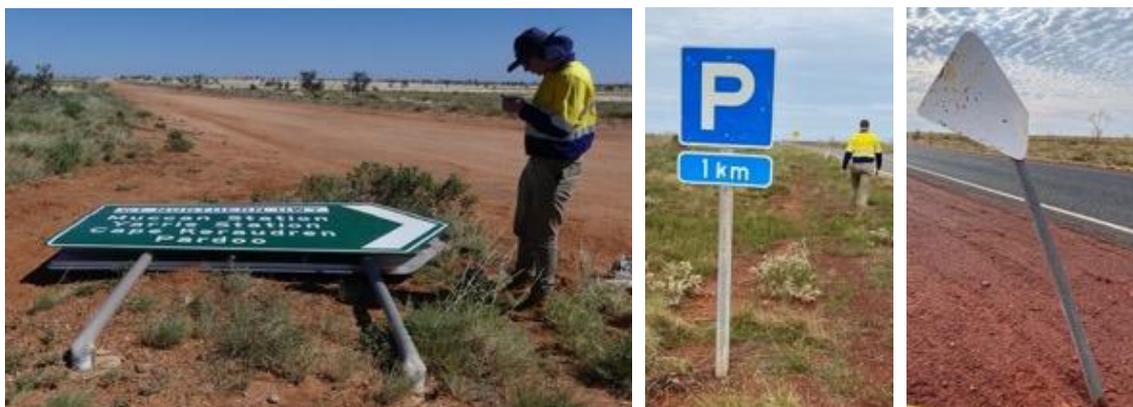
Figure 3-5 Lower-bound and upper-bound road signs

- Lower-bound signs were those which had failed by bending the posts (forming 'plastic hinges'). The wind speed to cause the damage was higher than the wind speed that would have created enough load to fail the post, and this is shown in the left-hand photo of Figure 3-5.
- Upper-bound signs had not failed by forming plastic hinges in the posts and remained upright. The wind speed cannot have exceeded the speed that would have created enough load to fail the post, shown in the middle photo of Figure 3-5.
- Where the pole had just started to fail but hadn't developed a full plastic hinge, the lower-bound wind speed was likely close to the actual wind speed. This is shown in the right-hand photo of Figure 3-5. Note that sand had blasted most of the paint off the surface of this sign.

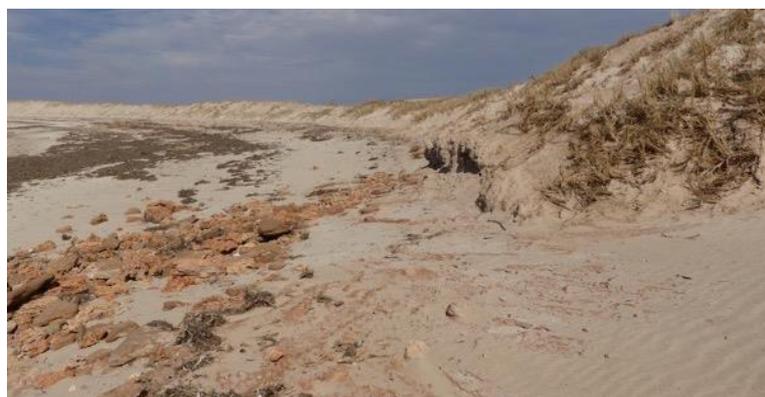
Figure 3-12 Observations of storm tide height

Also, there was no sign of exit channels excavated by the retreating seawater in the car park, which was only just above the base of the dunes. If the car park had been flooded, then the water exiting the wide, flat area of the car park would have created channels. The absence of these channels in the sand between the car park and the beach indicates that the car park had not been inundated by seawater. The highest level likely attained by the storm tide was the base of the dunes – close to the Highest Astronomical Tide. This is a similar conclusion to that presented in Section 3.2 as part of the numerical modelling of TC Ilsa.

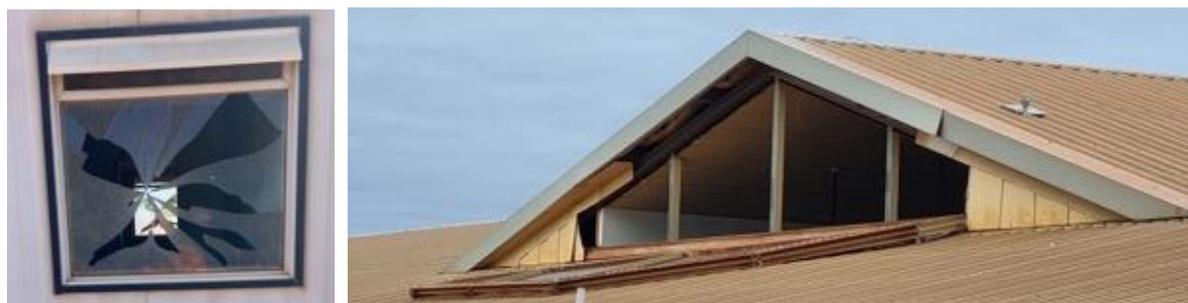
Figure 4-3 Openings created in wind region A

The left-hand plot in Figure 4-2 shows that for 100 km inland of the wind region A boundary, the peak 0.2-sec wind speed was more than the relevant V_{500} . There were no buildings in the area of wind region A that experienced 0.2-sec wind gusts of 120% or more of V_{500} . However, elsewhere within wind region A, wind pressure or small debris created openings in the building envelope (photo on the left in Figure 4-3). The photo on the right shows an opening formed on a leeward surface of a building in wind region A.

Fortunately, both buildings illustrated in Figure 4-3 had been built to withstand high internal pressure, and the structural damage progressed no further. However, there is currently no requirement to design buildings in wind region A for high internal pressure.

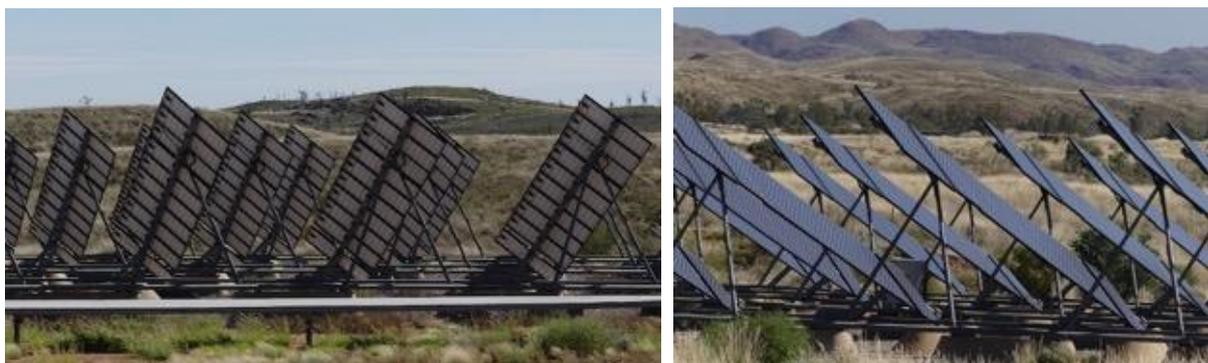
Figure 5-2 Tracking solar array Marble Bar

The tracking panels for the town power supply at Marble Bar were undamaged and functional during and after the event, as shown in Figure 5-2. The maximum peak 0.2-sec standard condition gust wind speed at the Marble Bar AWS was estimated at only 25 m/s.

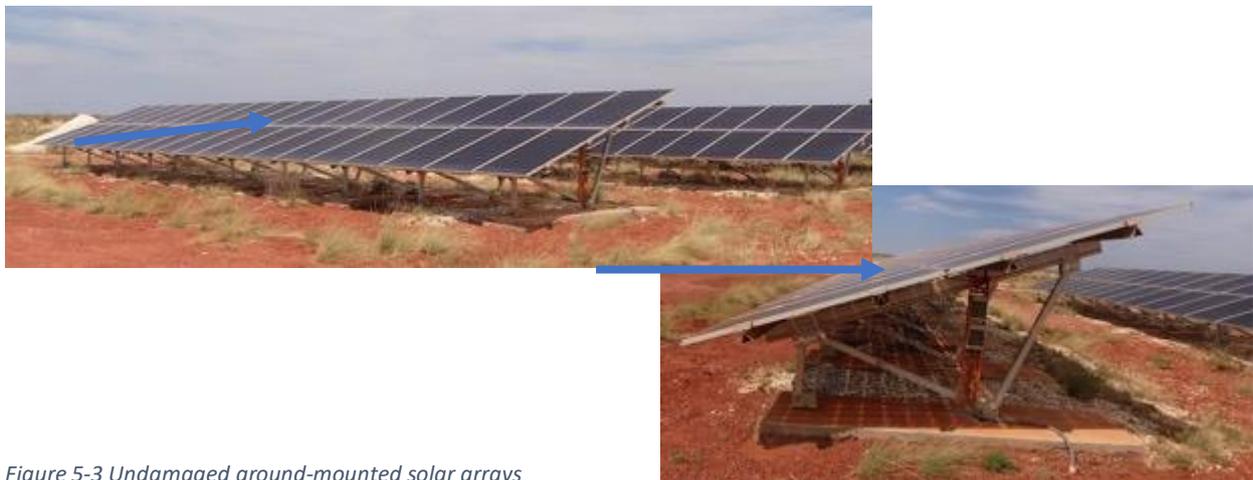
Figure 5-3 Undamaged ground-mounted solar arrays

Figure 5-3 shows a ground-mounted fixed array that experienced 0.2-sec standard condition gusts of around 70 m/s. The highest wind was towards the upward-facing slope, as shown by the blue arrow. There was no sign of bending failures or detachment of the panels. There were few obstructions upwind of the installation that would have introduced extra turbulence or become wind-borne debris if they had failed. Although gravel was on the ground around the panels, the glass had not been broken. The precise details of the mounting system were not observed elsewhere in this study – the clamps were fixed directly to the rails.

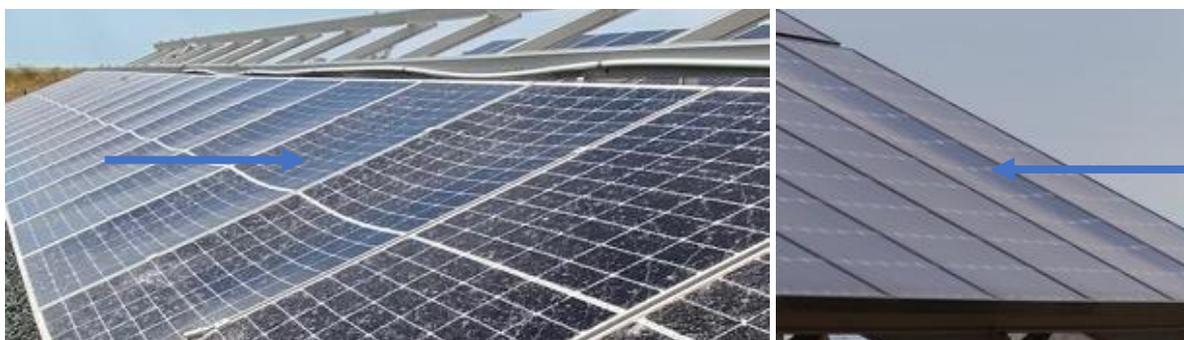
Figure 5-4 Examples of failure of panels due to wind pressure on the upward-facing slope of the panel (net +ve pressure)

Several inclined panels showed bending failures of the panel itself. Where the wind was towards the upward-facing slope of the panels, they failed by bending inwards, and where the wind was towards the downward-facing slope of the panels, they failed upwards. Inward failures are shown in Figure 5-4, and an upward failure is shown in Figure 5-5. The downward failures in the left-hand photo of Figure 5-4 were observed where the peak 0.2-sec standard condition gust exceeded 80 m/s, and in the right-hand photo, the 0.2-sec standard gust exceeded 55 m/s. As Figure 5-3 shows, some other brands of panels could resist wind gusts of 70 m/s without the glass failing in bending.

In some cases, all the panels failed under the action of the wind pressure and in others, just one panel failed. Because the location of the failed panels did not appear to be associated with the location of the highest net pressures on the array, it appears that specific details of each individual panel supplied (such as the characteristics of the glass in the panel and/or its connection with the chassis) contributed to the level of performance achieved. The high variability of the performance of the panels indicated high variability in the characteristics of the panels.

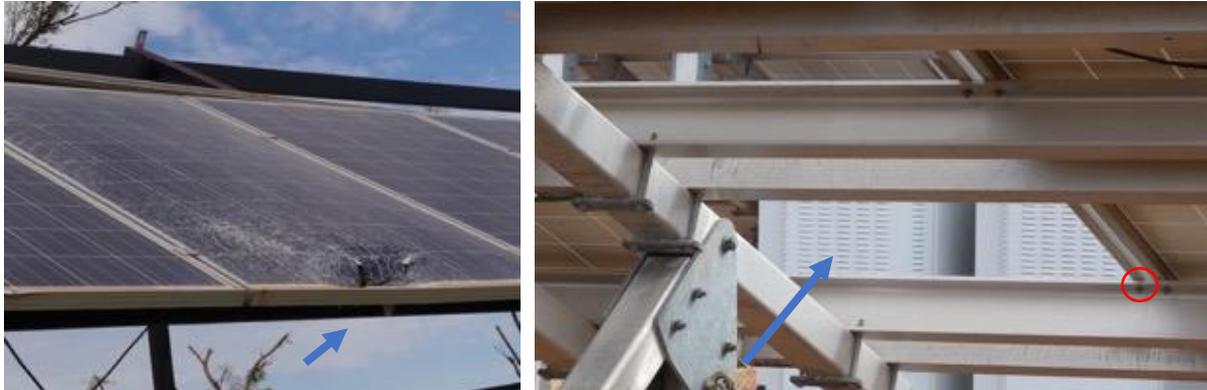
Figure 5-5 Failure of the panel due to wind pressure on the downward-facing slope of the panel (net -ve pressure)

The movement of the panel shown in the left-hand photo of Figure 5-5 was sufficient for it to disengage from the chassis at the base. The chassis remains (photo on the right), but the panel has bowed outward enough to be removed entirely. In this case, the chassis was directly fixed to the rails by bolts – highlighted by the circle.

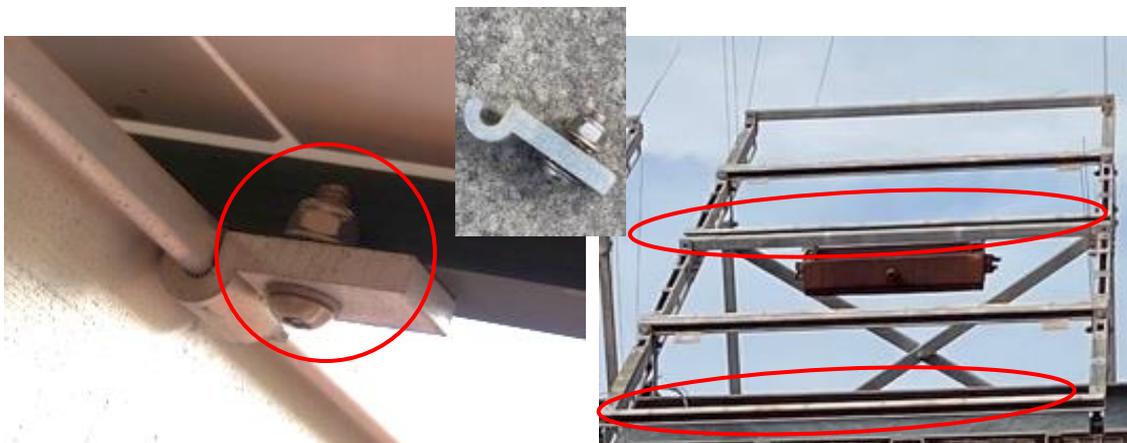
Figure 5-6 Panels in which the chassis tore at the fastenings

Some panels were bolted to a clip through the back of the chassis, and some of them failed by tearing through the thin chassis metal. Under cyclonic loads, the forces on the panels are repeated, and low-cycle metal fatigue may have played a role in the tear-out failure. The photo on the left of Figure 5-6 shows an example of a clip connection that hadn't failed. In other cases, the bolt tore through the chassis and left a small portion of the chassis under the spring washer, as shown in the inset. The photo on the right of Figure 5-6 shows some bolted fastenings left in the frame after they had torn out of the chassis on a directly bolted connection.

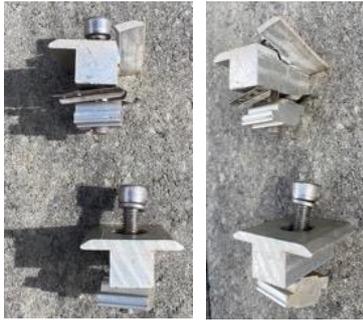
Figure 5-7 Broken clamps

Some inclined solar systems use clamps between the upper surface of the panel chassis and the extruded aluminium frame underneath. Many of these systems, such as the one shown in Figure 5-3, performed well, but in other cases, the clamps either broke, as shown in Figure 5-7, came loose, or were not tightened correctly when installed. Figure 5-8 shows clamps that had not broken but had released the panels. The broken clamp shown in Figure 5-7 may have occurred on a panel that had been partially released by the other clamps. Fluctuating loads may have affected the performance of the clamps and the strength of the chassis at the bolts.

Test solar panel systems using methods that replicate the fluctuating nature of wind loads.

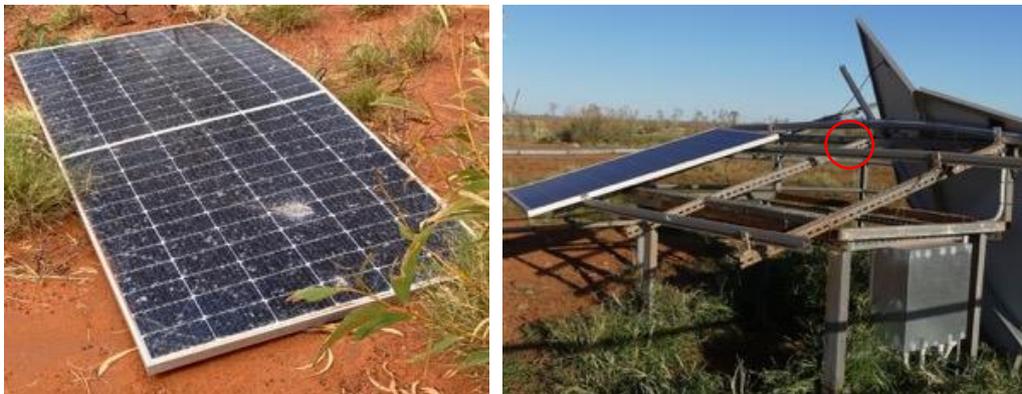
Figure 5-9 Previously clamped panel that has been released from the frame

The left-hand photo in Figure 5-9 shows a panel that had been clamped to an inclined ground-mounted frame but was released by the clamps. The panel had moved more than 100 m from its original location and had sustained damage as it bounced across the ground. The right-hand photo shows a cattle watering point with clips missing from the array.

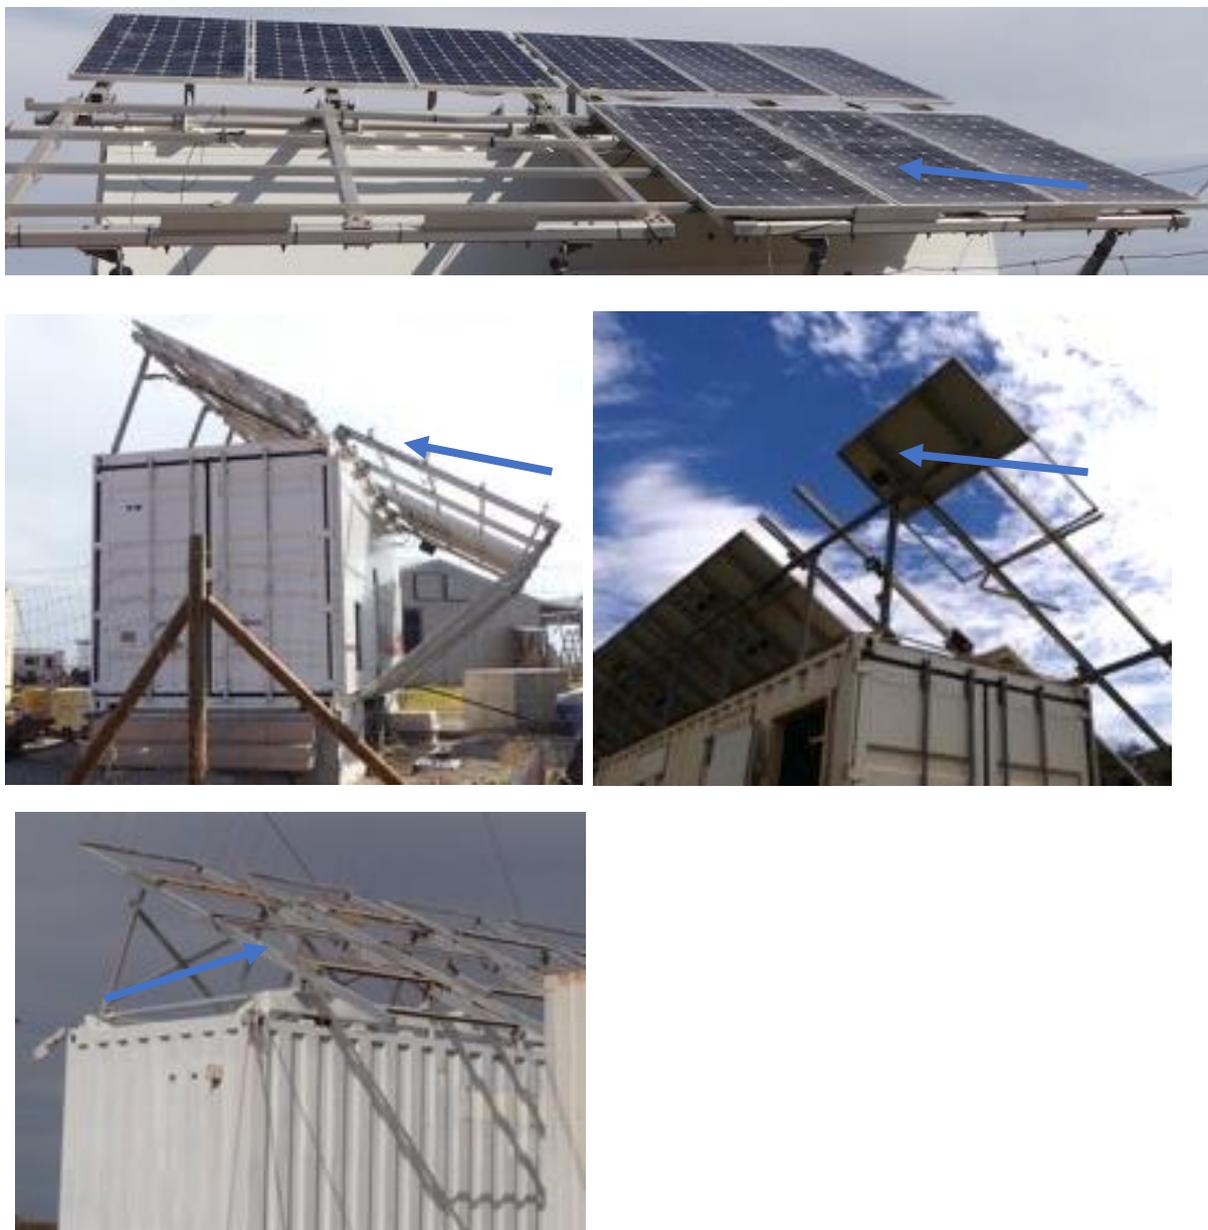
Figure 5-10 Failures of solar panels mounted on shipping containers

The container itself increased the loads on the panels compared with similar ground-mounted systems, as shown in Figure 5-11. The aerodynamics of the container generated an increased net upward pressure onto the panels.

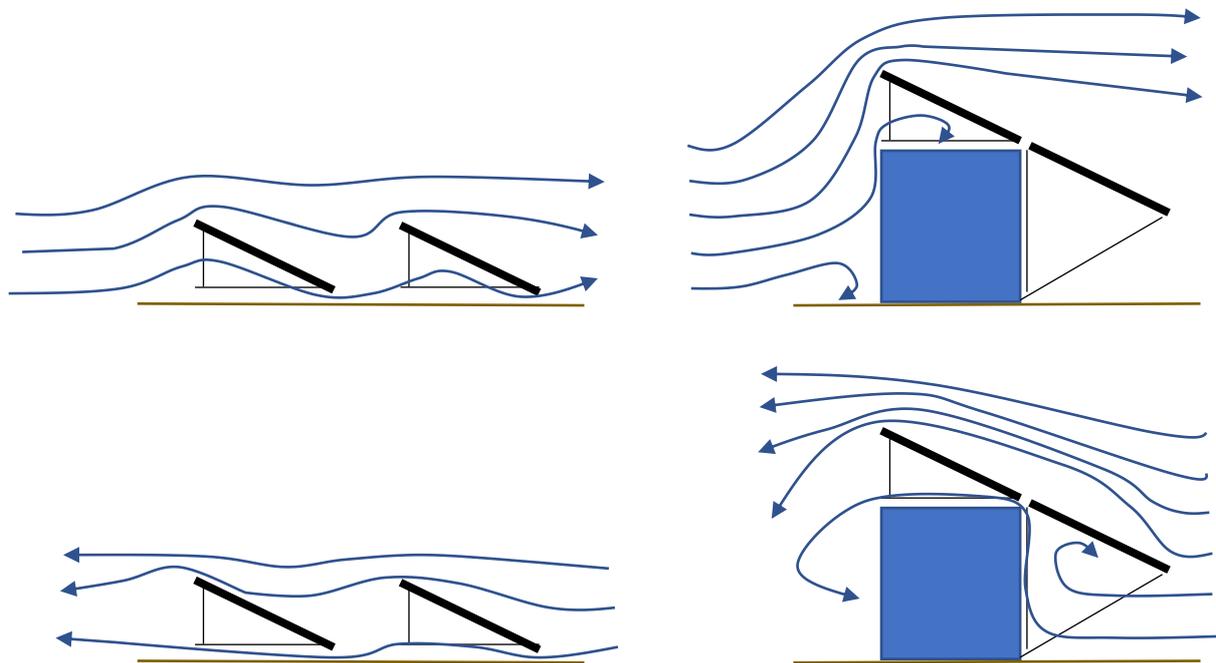
Figure 5-11 Aerodynamic differences between ground-mounted and container-mounted solar arrays

The solid container redirects airflow around it, accelerating the flow onto the solar panels mounted above it. The solar panels' increased height means they are also impacted by higher velocity air than ground-mounted inclined panels, as shown in Figure 5-11.

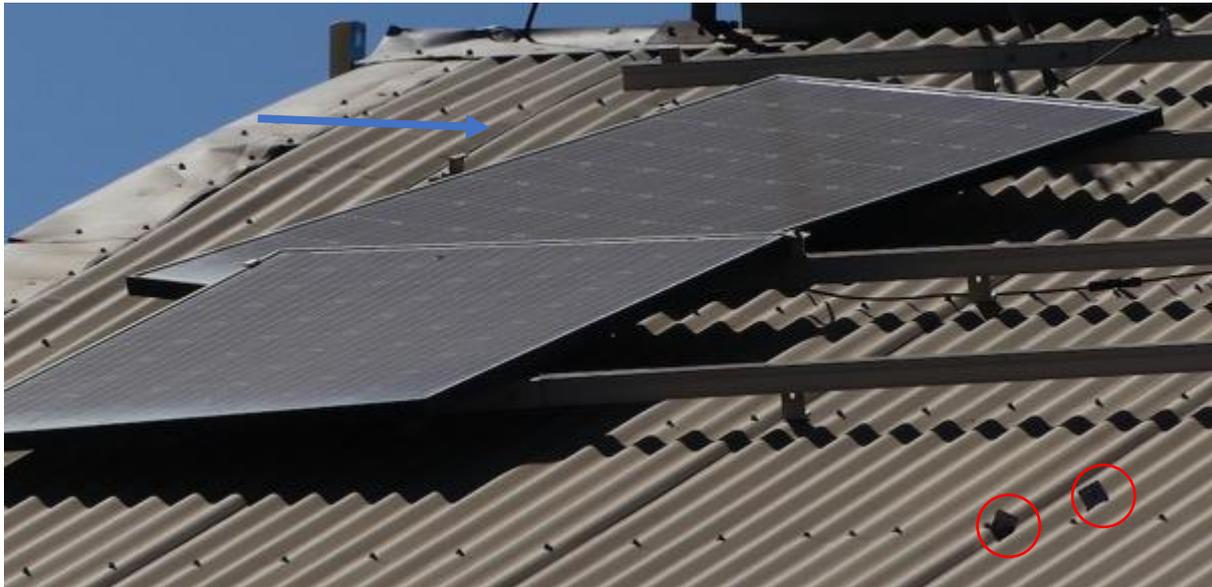
Figure 5-12 Dislodged clamps from roof-mounted roof systems

Failure of the clamps between the chassis and the rails was observed on ground-mounted inclined solar arrays, as discussed in Section 5.2.3. Many similar failures were observed on roof-mounted systems, as illustrated in Figure 5-12. The photos show some loose clamps on the roof sheeting (circled) and some panels remaining on the roof despite the loss of several clamps per panel. Figure 5-7 shows clamps from the same fixing system that were typical of the clamps that were also found on the ground beside this building. The wind direction on this building varied throughout the event, but the last wind direction to have affected the array is shown with the blue arrow.

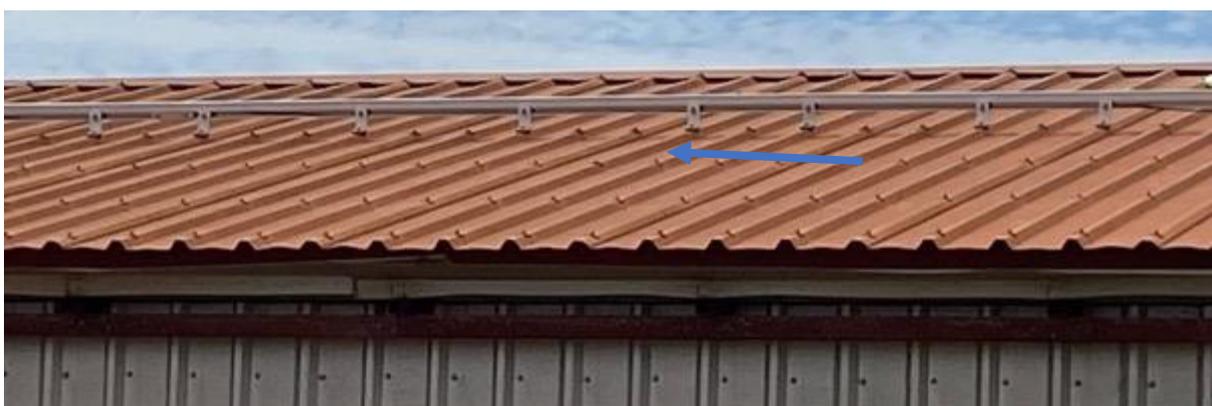
Figure 5-13 Total loss of clamps and one rail

The rails on other buildings remained attached to the roof, but the clamps were missing, as shown in Figure 5-13. Loss of clamps was the most common type of failure for roof-mounted solar panels. This roof experienced winds primarily from the direction indicated by the blue arrow. A rail above the one shown was missing as the brackets had pulled the fasteners out of the purlins. In Figure 5-13 the rail obscures the row of fasteners that had been affected by the loss of the top rail.

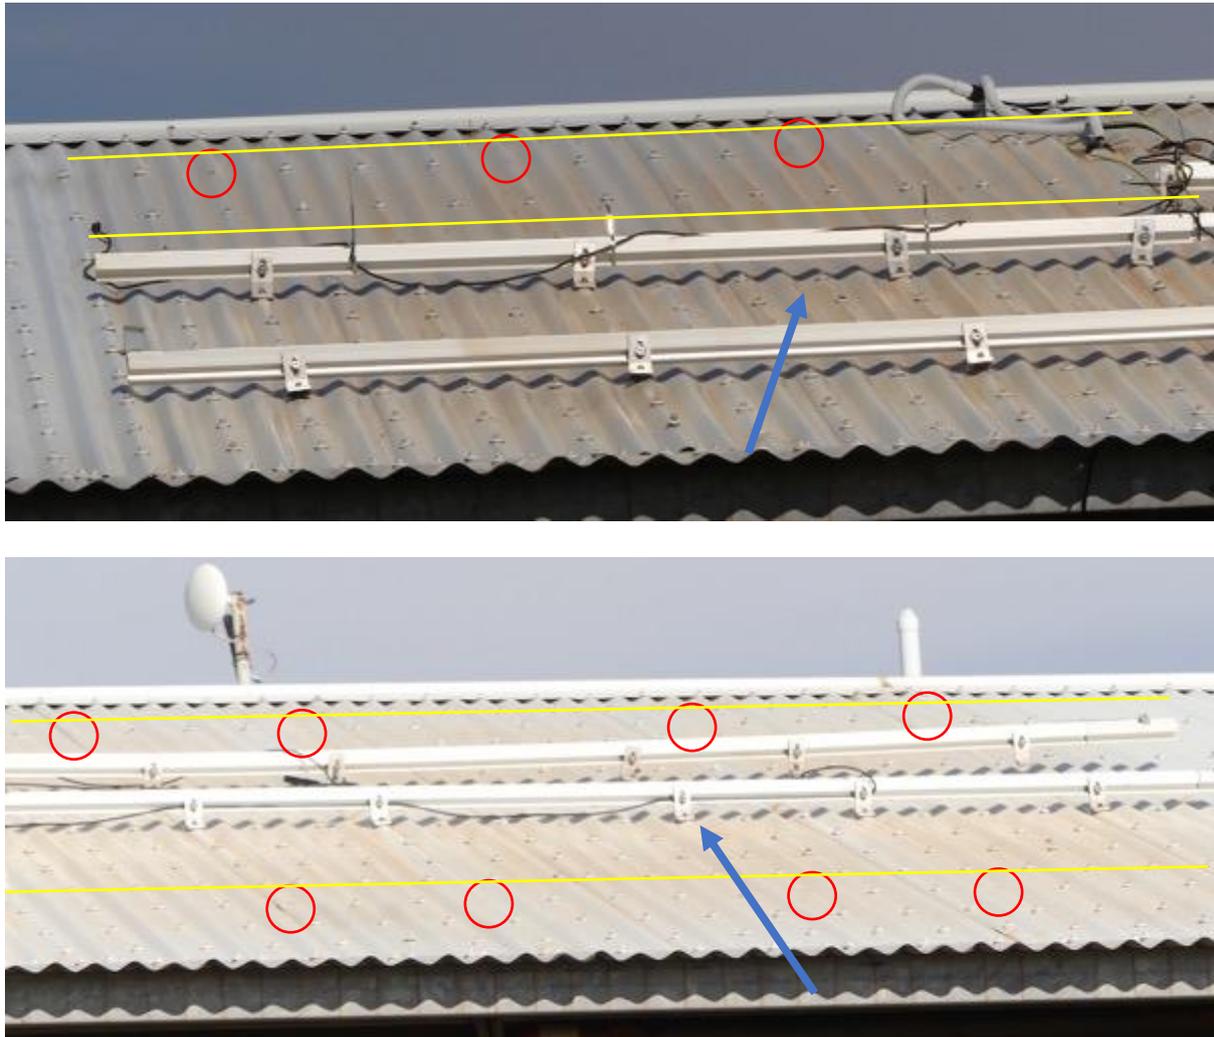
Figure 5-14 Roofs with missing rails and roofing screws

Figure 5-14 shows roofs where the rail brackets had removed the roofing screws from the top hat battens, leading to the complete loss of the rails (their original position is indicated by the yellow lines). In some cases, the loss of roofing screws also compromised the performance of the roof sheeting, but in the roofs shown in Figure 5-14, the roofing remained attached to the roof battens. Red circles highlight the missing roofing fasteners. In the upper photo, two rails are missing, but the missing screws that previously held the lower of the two missing rails are obscured by the remaining upper rail. The blue arrow shows the wind direction that caused this damage.

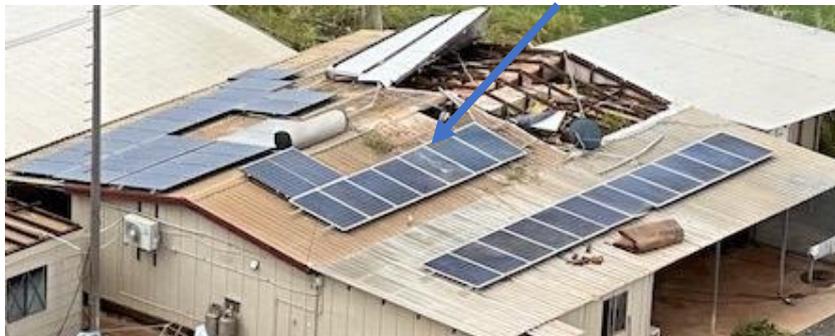
Figure 5-15 Failure of battens and batten straps under solar panels (image courtesy of Warrawagine Station)

The battens and batten straps under the solar panels on one building failed (Figure 5-15). The solar panels had previously extended across the region that was damaged. The wind direction that appeared to cause the damage is indicated by the blue arrow.

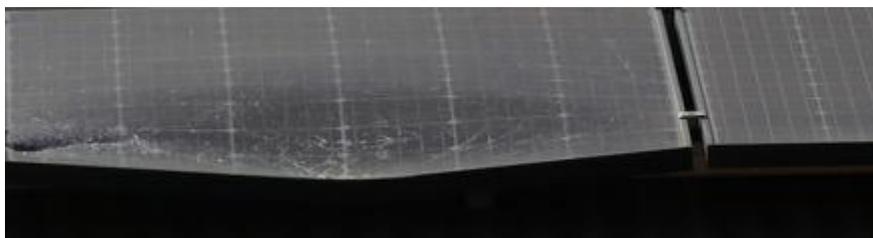
Figure 5-16 Example of damage to solar panels by wind-borne debris

The faces of solar panels are vulnerable to damage from wind-borne debris. Figure 5-16 shows typical damage from trees or debris from damaged buildings.

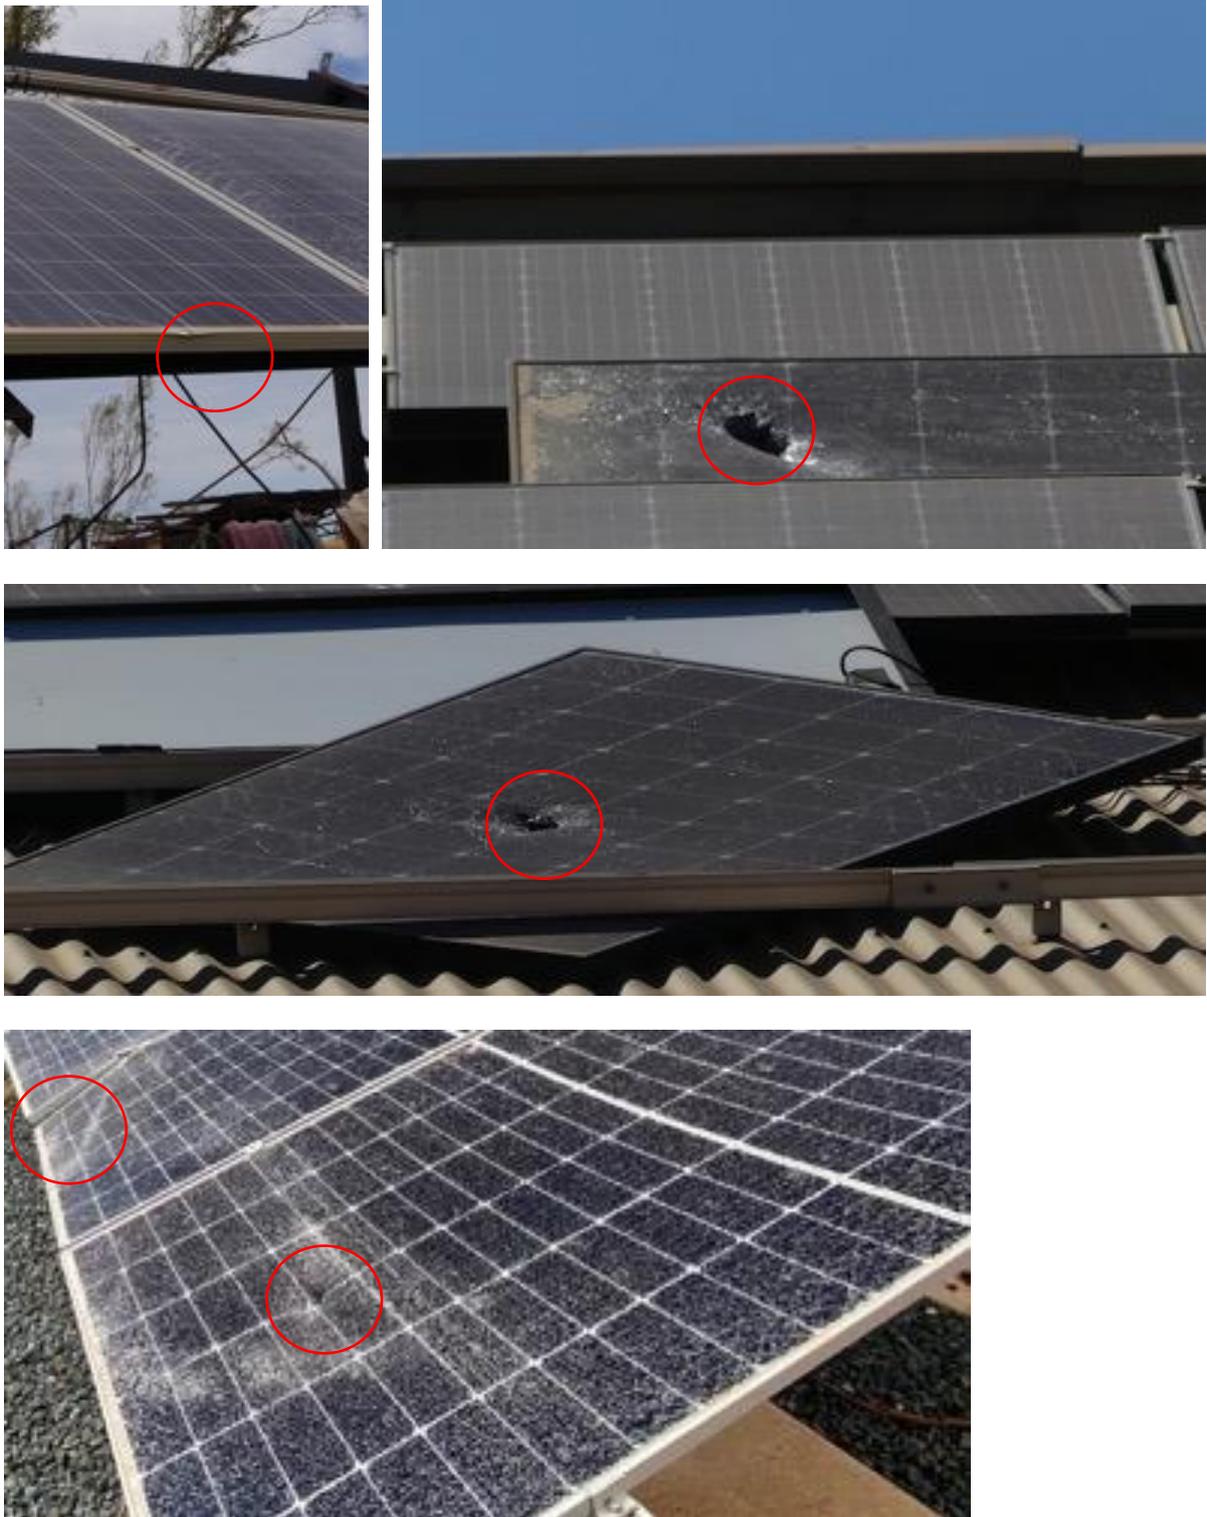
Figure 5-17 Examples of debris damage by other solar panels

Figure 5-17 shows damage caused by the impact of other solar panels that had become wind-borne debris.

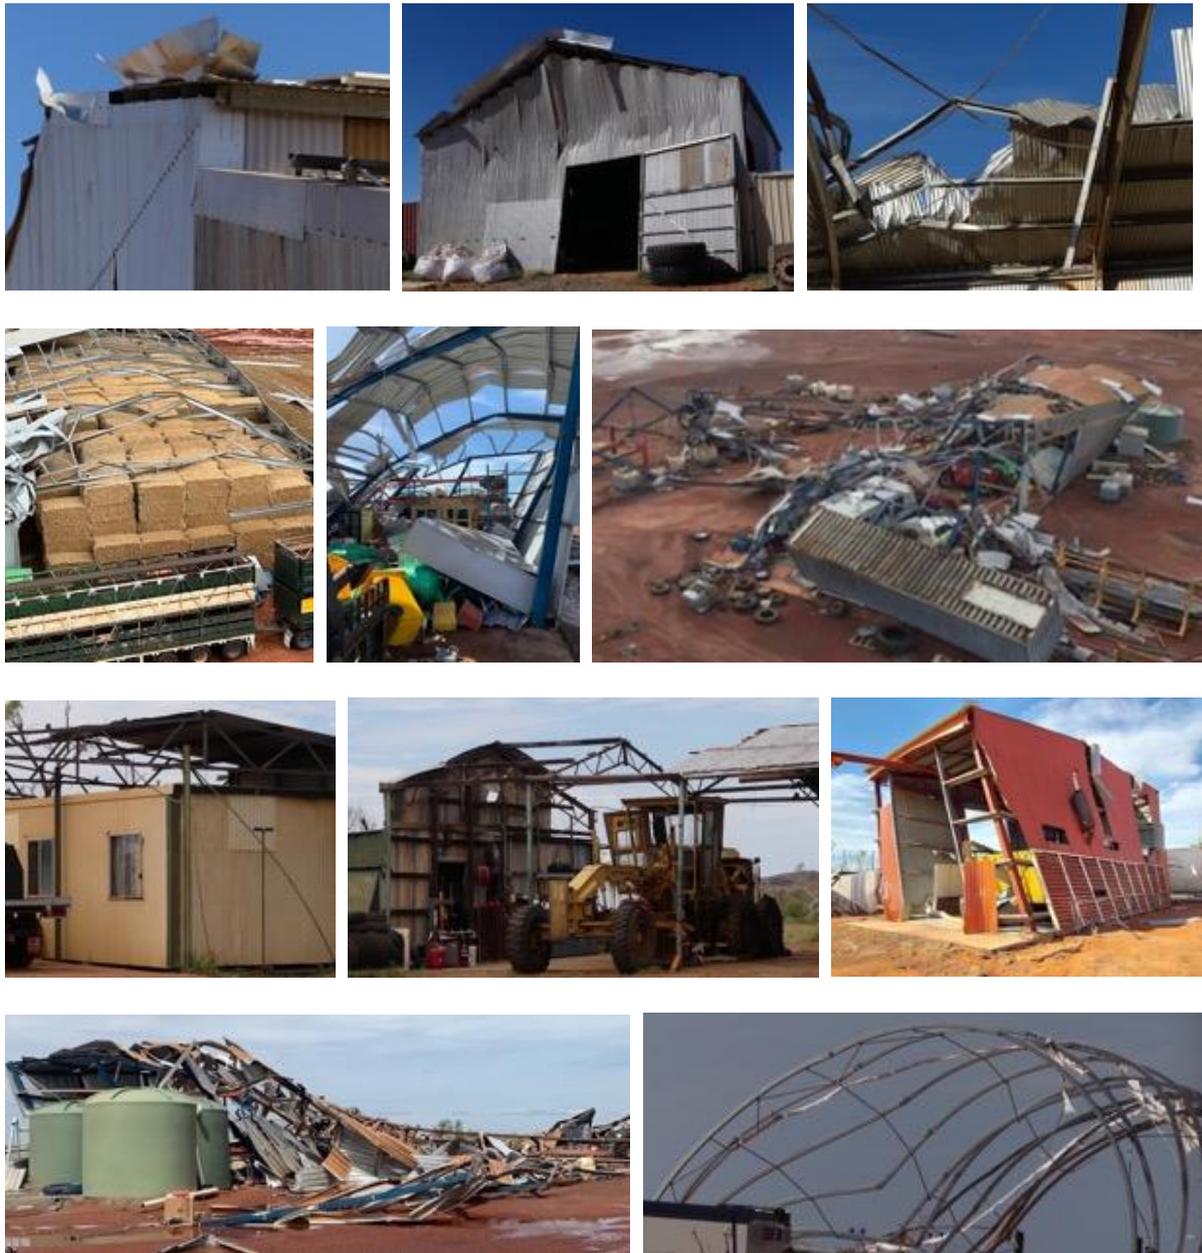
Figure 6-1 Damage to sheds (includes photos supplied by Pardoo station and Warrawagine station).

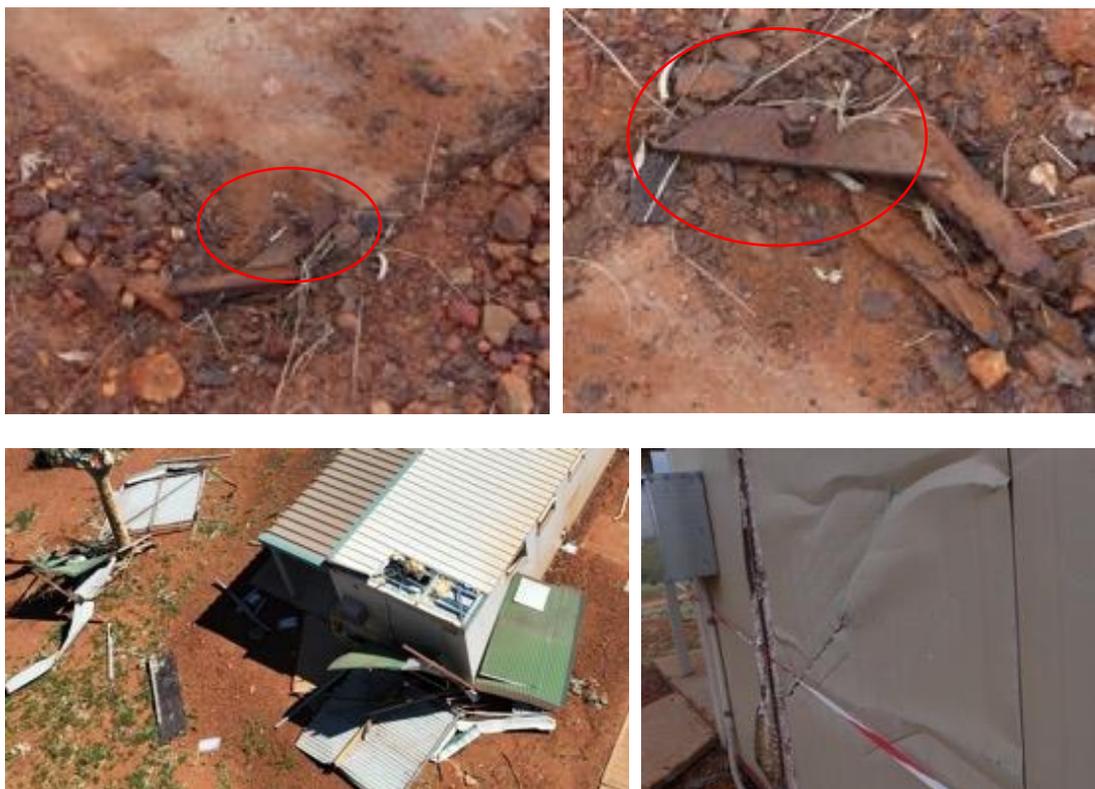
Figure 6-2 Corrosion at the base of a small shed and damage to nearby buildings.

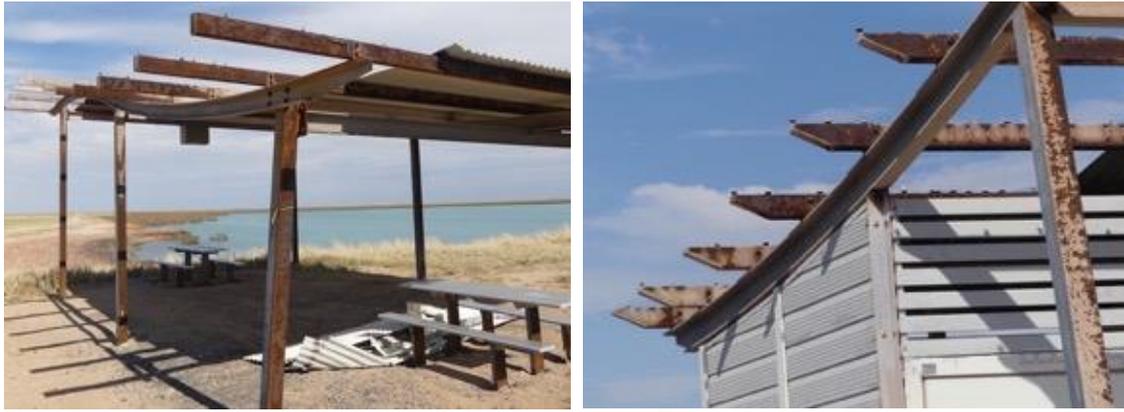
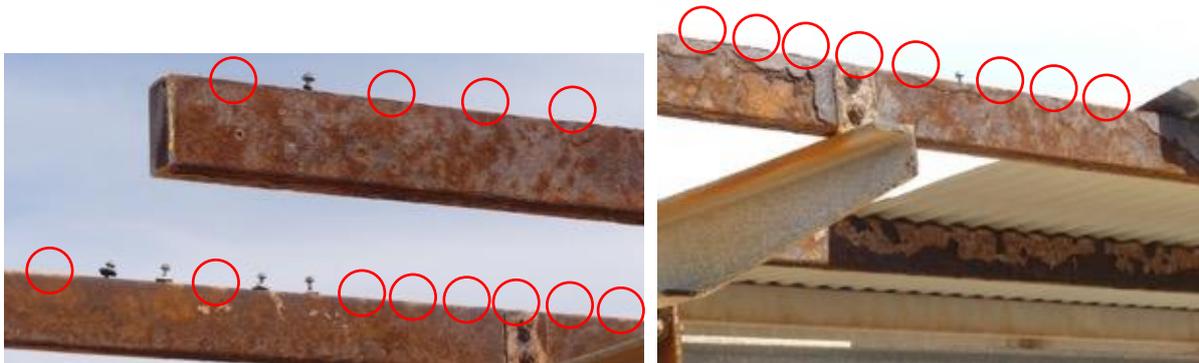
Figure 6-3 Corrosion in members of shelters close to the sea

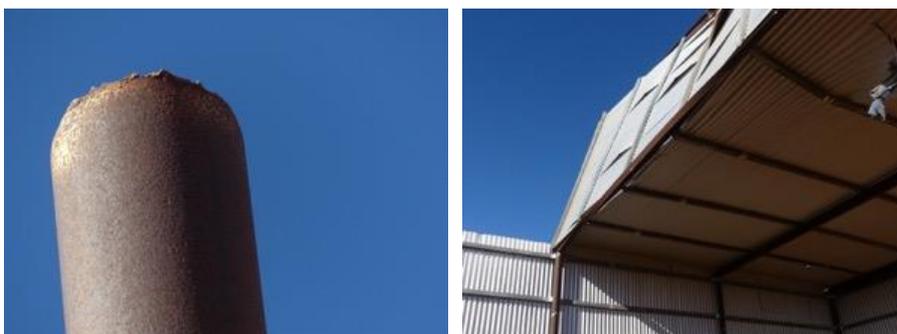
Figure 6-5 Failure of welds at the top of columns

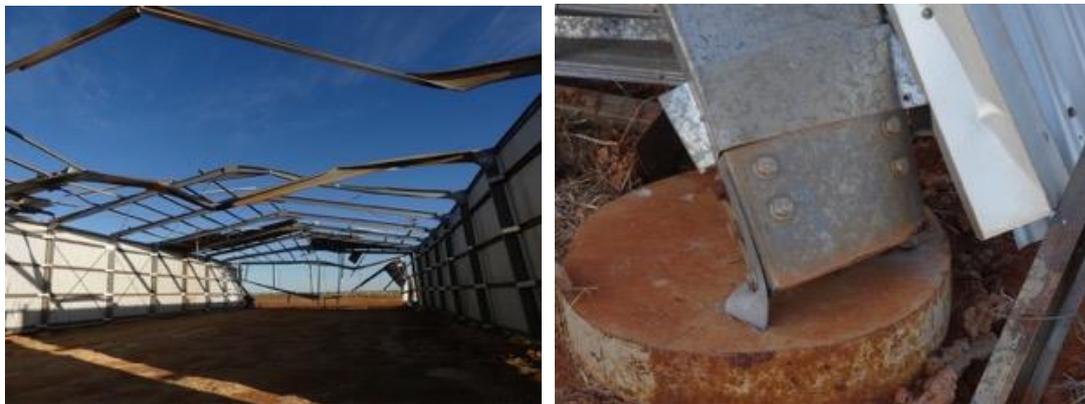
Figure 6-6 Failure of a recent open-ended shed

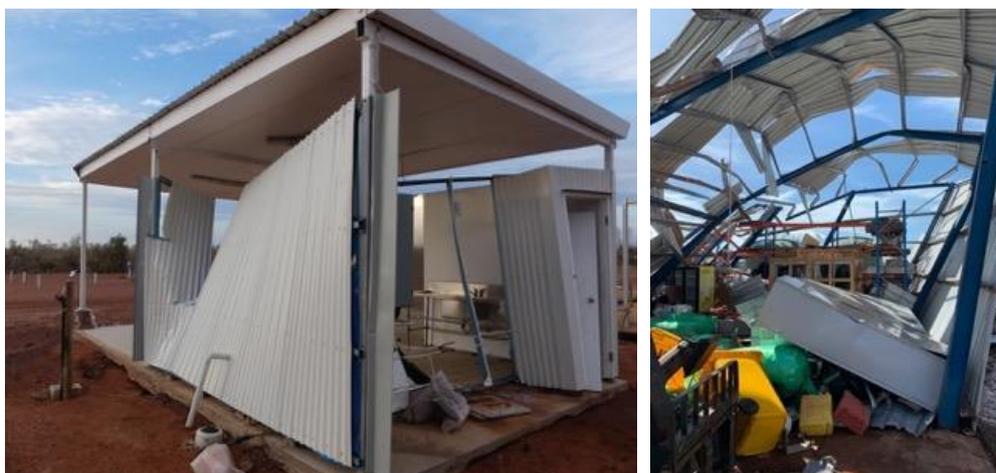
Figure 6-7 Lightweight sheds with very light elements

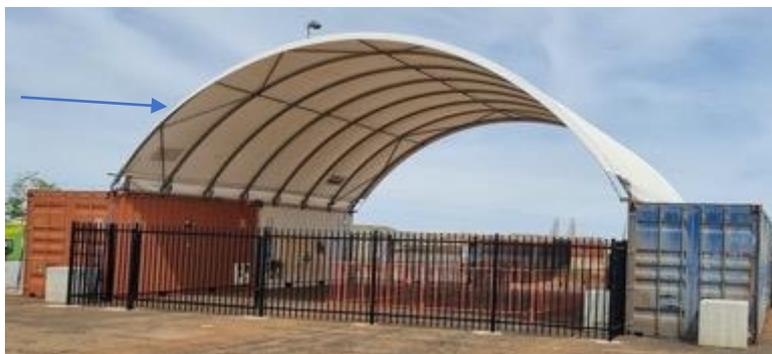
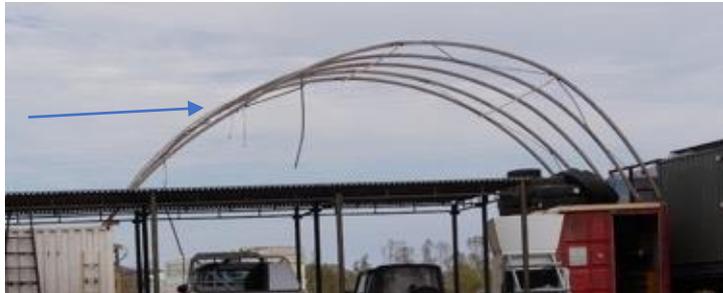
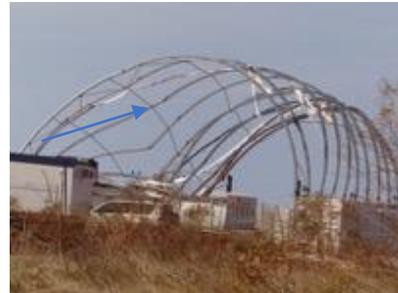
Figure 6-8 Fabric-covered, curved roof shades

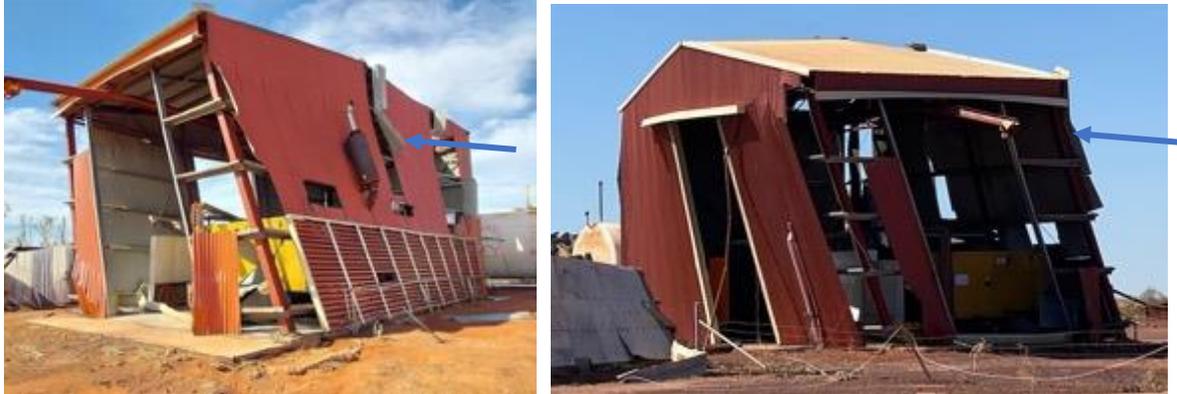
Figure 6-9 Racking failure of a tall shed

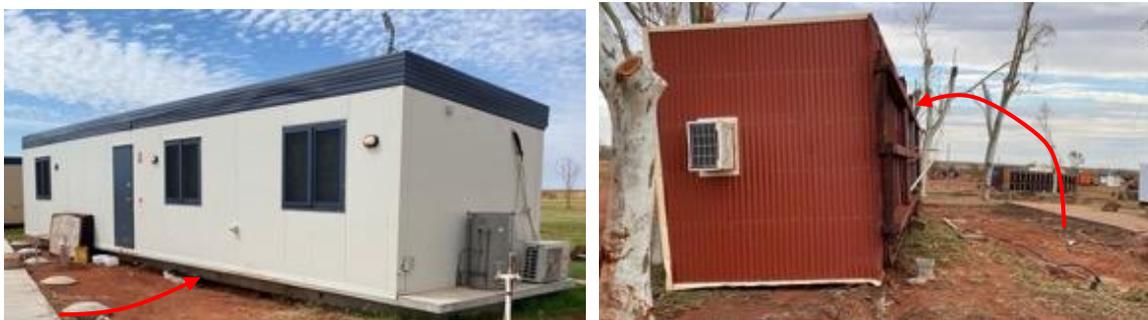
Figure 7-1 Dongas that have moved under wind actions
