Tropical Cyclone Ilsa – Wind field and damage to buildings in the East Pilbara

CTS Technical Report No 67

TECHNICAL REPORT NO. 67

Dr Geoff Boughton¹, Debbie Falck¹, Dr John Ginger¹, Dr David Henderson¹, Lucas van Woensel²

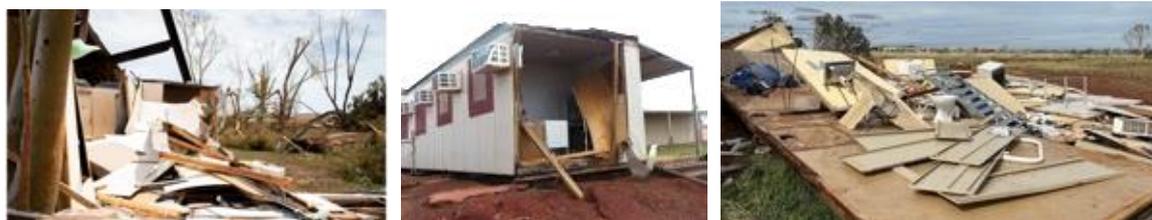
Figure 7-4 Structurally damaged dongas on which no rating plate could be found

Ensure that the wind rating of any second-hand donga is appropriate for its new location and that it has a thorough structural check to ensure that all structural systems are still fit-for-purpose.

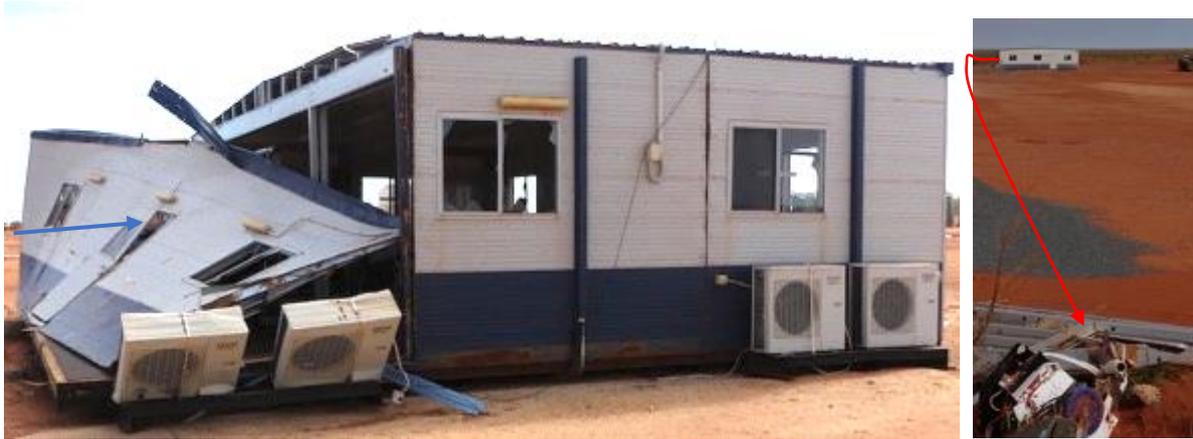
Figure 7-5 Damage to a single unit within a larger building

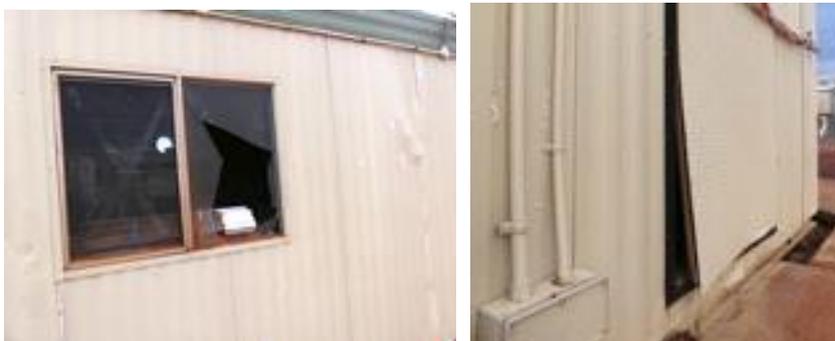
Figure 7-7 Damage to windows and doors

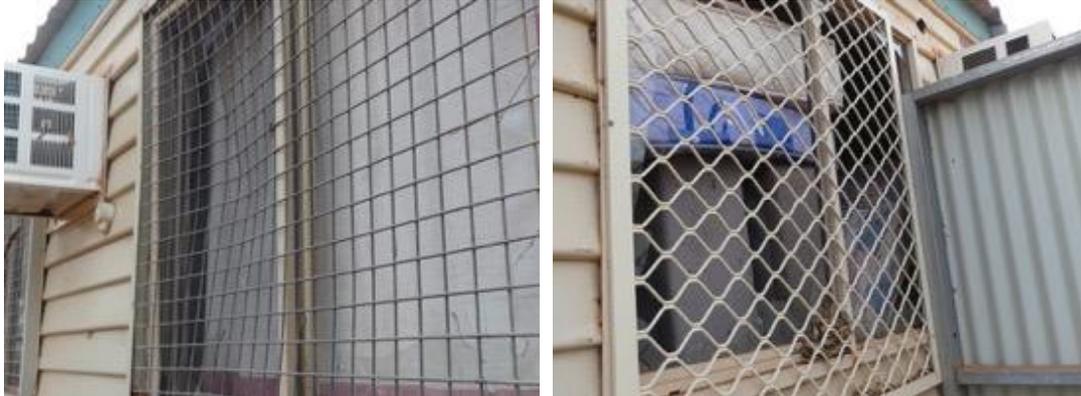
Figure 7-8 Broken windows because the deflection of the screen hit the glass

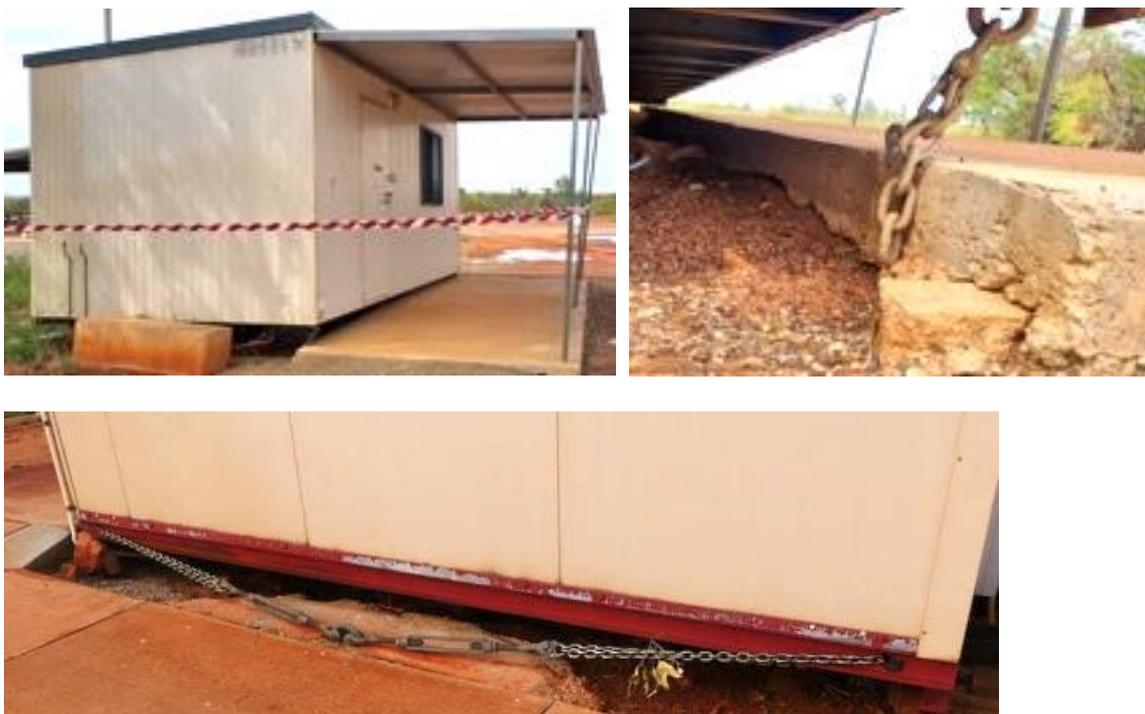
Figure 7-9 Building movement accommodated by slack in chains

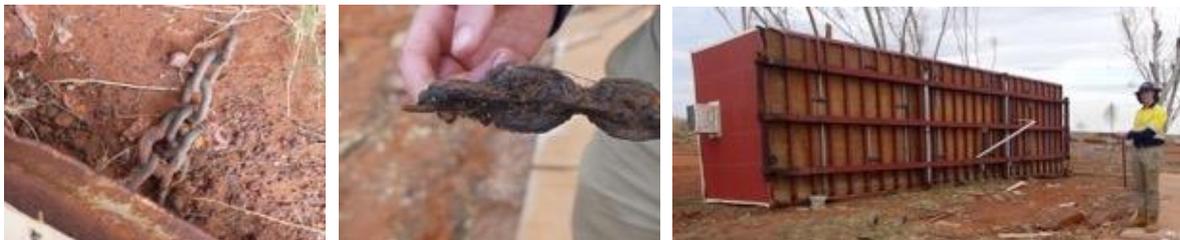
Figure 7-10 Corrosion of anchorage elements

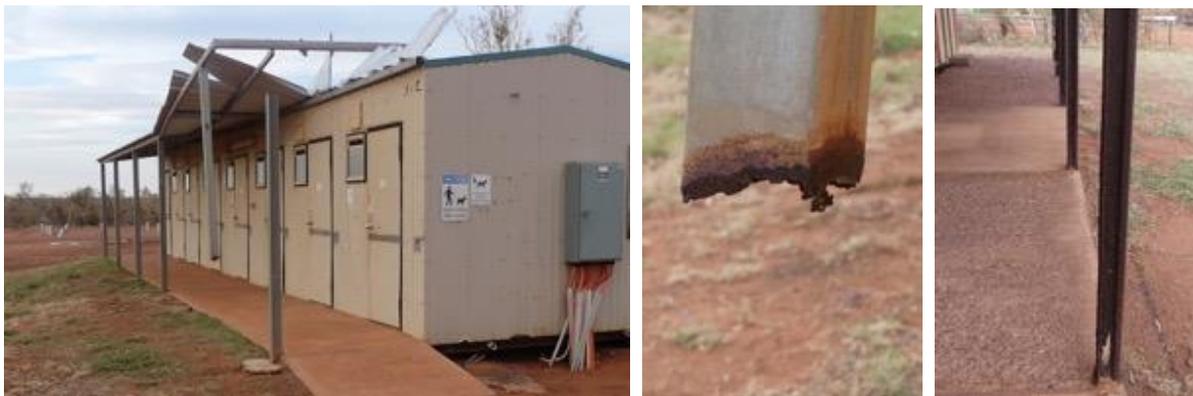
Figure 7-12 Veranda damage

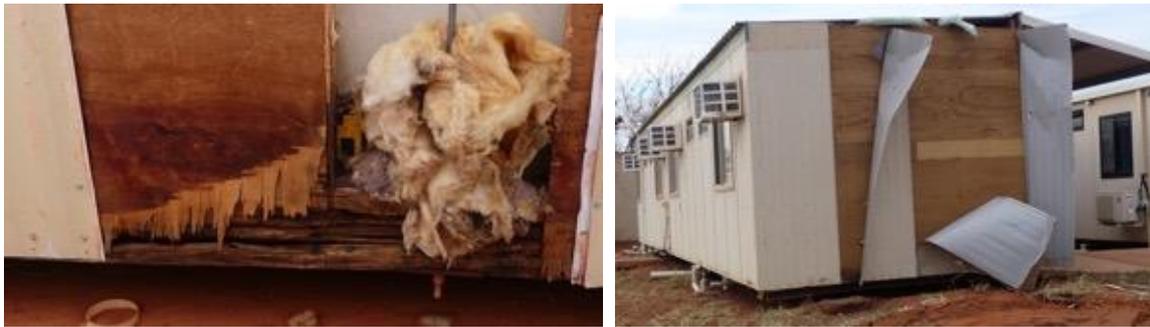
Figure 7-13 Deterioration of structural elements in old dongas

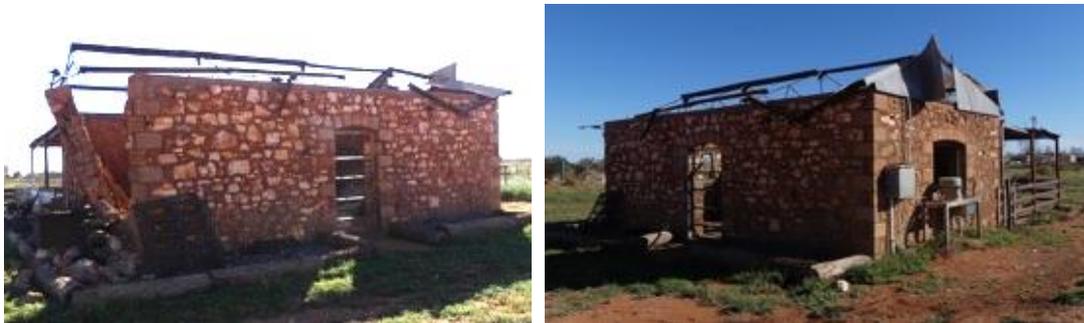
Figure 8-4 Wind damage to a heritage stone building that hadn't yet been upgraded

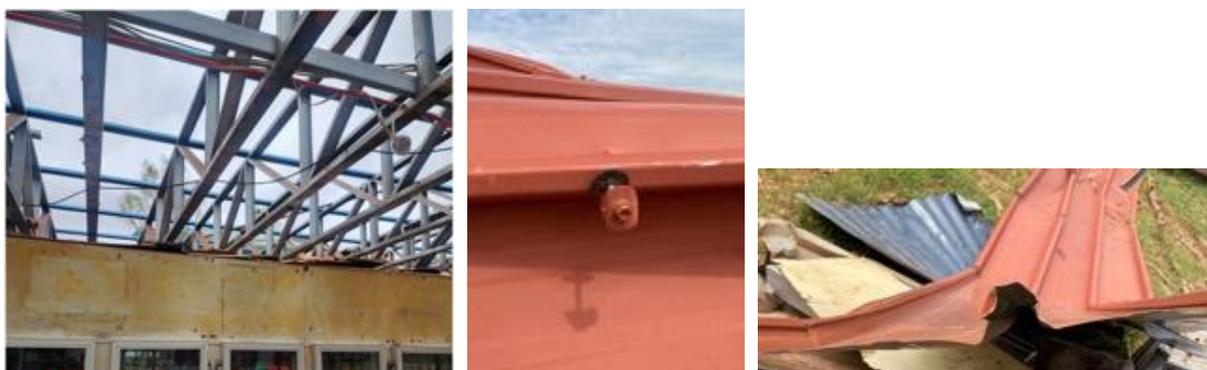
Figure 8-5 Roofing fasteners pulled out of battens

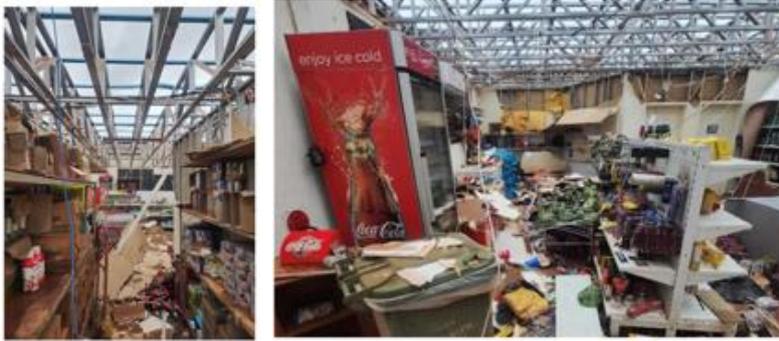
Figure 8-6 Consequences of roofing loss (photos courtesy of media supplied by Pardoo Roadhouse and Tavern)

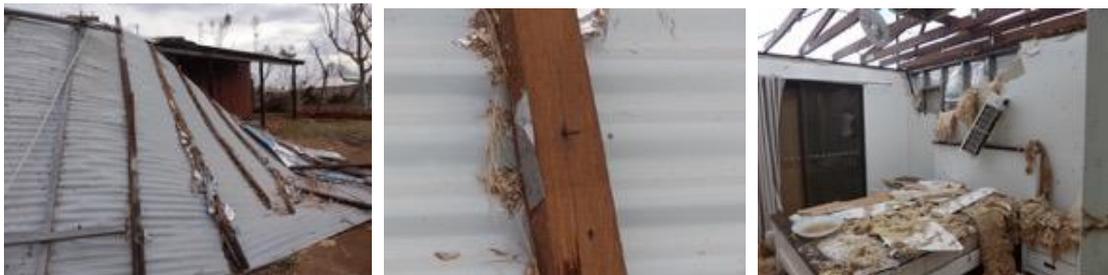
Figure 8-7 Nailed batten to truss connections

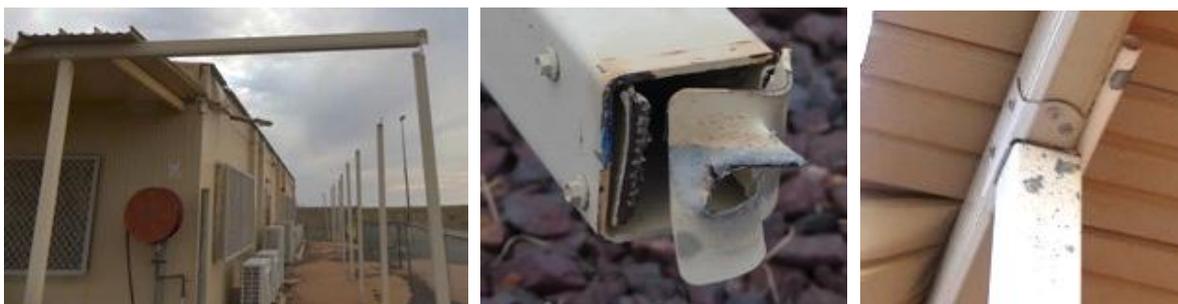
Figure 8-8 Failure of veranda beam to post connections
