CYCLONE TESTING STATION

SIMULATED WIND TESTS ON A HOUSE

Part 1. Description

TECHNICAL REPORT NO. 12

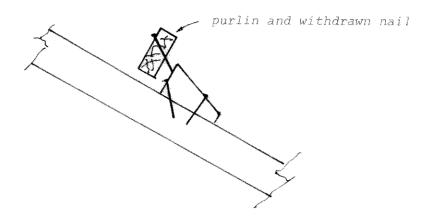
Figure 12. Failure of purlin to rafter detail

(ii) Roof Test - As discussed in Section 3, the roof structure was not typical of a house. The weak link in the uplift chain from purlins to footings, in this instance was the purlin to rafter connection. This detail failed quite suddenly by pull out of the nails driven through the purlin into the nailing block as shown in Figure 12. However, the trusses themselves did suffer some minor damage during the test.

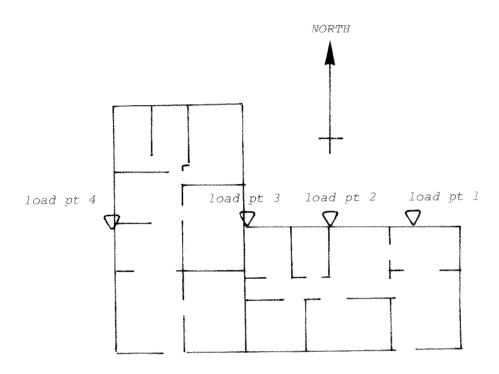
Figure 13. Location of top plate loads

(iii) Top Plate Tests - Loads were applied to the top plate at four locations. One was between an end wall and an internal wall with a large opening. Another was adjacent to a 3 m long internal wall. A third was adjacent to a 6.6 m long internal wall and the fourth was adajcent to an 11 m long external wall. Figure 13 illustrates the locations of the loads.

With the house intact, the capacity of the hydraulic rams used not sufficient to cause failure at loading points 4, 3 or 2 in Figure 13. At point 1, however, the top plate failed in bending causing damage to the ceiling within 1.5 m of the failure point. Evidence of movement of the ceiling could be seen near load points 3, 2 and 1, and movement within the roof sheeting could be heard but not seen. Very little movement was observed near the long transverse walls at load points 3 and 4. The test showed that the action of a house in resisting lateral loads is quite complex. Further comments are made on this action in Section 7.3.

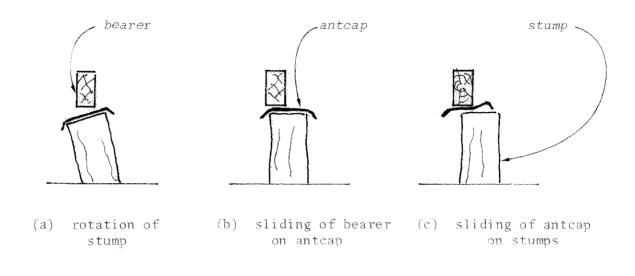
Figure 14. Modes of failure - floor test

(iv) Floor Test - The tie down of the floor system to stumps was by ten 12 mm diameter bolts for the entire house. The bolts from the floor bearers to the stumps proved totally ineffective in resisting any lateral load. This was due to the very badly corroded screws into the stumps. Those that had not corroded through, broke in the course of the test. The floor system showed a classic friction behaviour in sliding across the stumps. Only one stump was observed to rotate significantly, with the bulk of the movement taking place either as sliding of the bearers on the antcaps or as sliding of the antcaps on the top of the stumps, as shown in Figure 14.

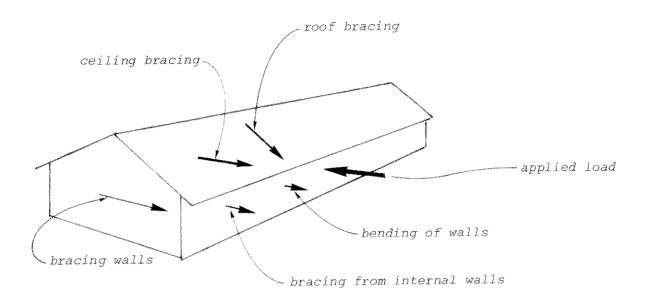
Figure 15. Distribution of horizontal forces within the house

Most of the on-site tests performed were stiffness tests and all were designed to isolate the structural members in the house that distributed lateral loads sideways to bracing walls. The analysis of these results is quite complicated and so will not be treated here. However, the tests showed that substantial loads are carried through bracing action of ceiling sheeting and roof sheeting to the bracing walls. Very little load is carried in actual bending of wall claddings and wall timber, although the ceiling joists and battens may also have helped in load distribution independent of the ceiling cladding. It is to be noted again that excessively heavy ceiling support timber was used in parts of the house. After examining the deflections in detail it will be possible to obtain an accurate distribution of force between the bracing members within the house.
