CYCLONE TESTING STATION

REPORT ON DAMAGE CAUSED BY CYCLONE ISAAC IN TONGA

TECHNICAL REPORT NO. 13

November 1982

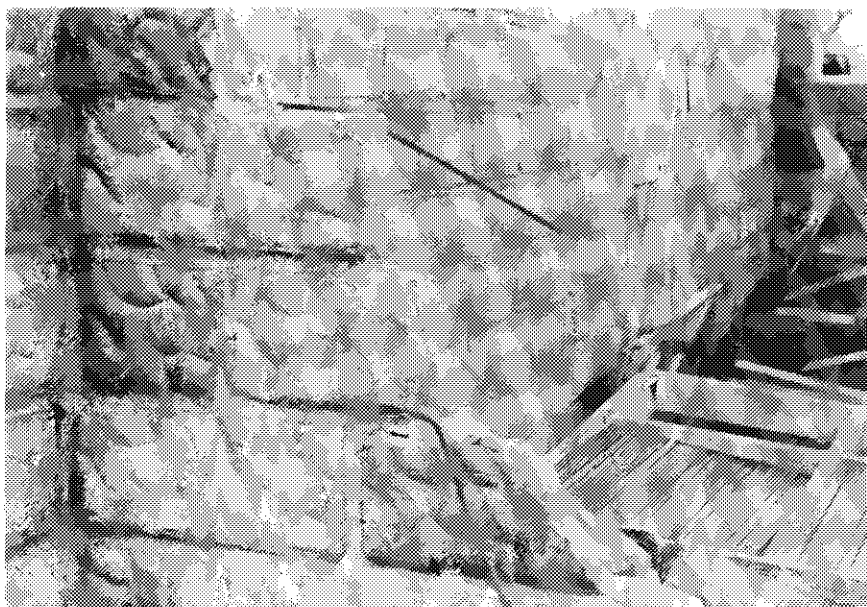
The need for reinforcing concrete block houses was recognised, possibly because this type of construction was more like that used for commercial buildings. On Tongatapu 6 or 8 mm steel rods were used approximately every fifth core, which was then filled with concrete. This compares with the Australian practice of using 12 mm rods every sixth core. Bed joint reinforcing was even observed in a commercial building, Figure 4, at Pangai.

Figure 4. Bed joint reinforcing in blockwork construction

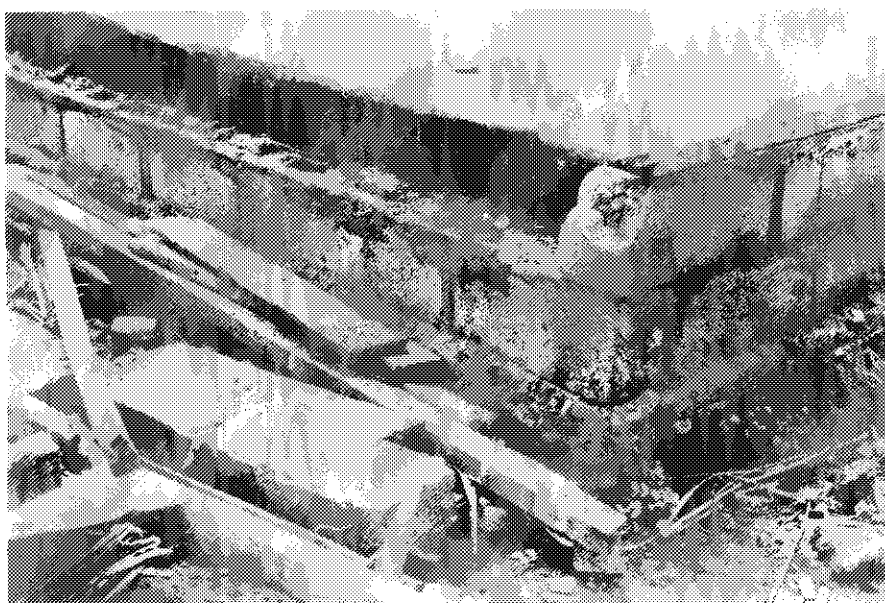
Figure 5. Typical floor slab for domestic construction.
Note nominal thickness of concrete.

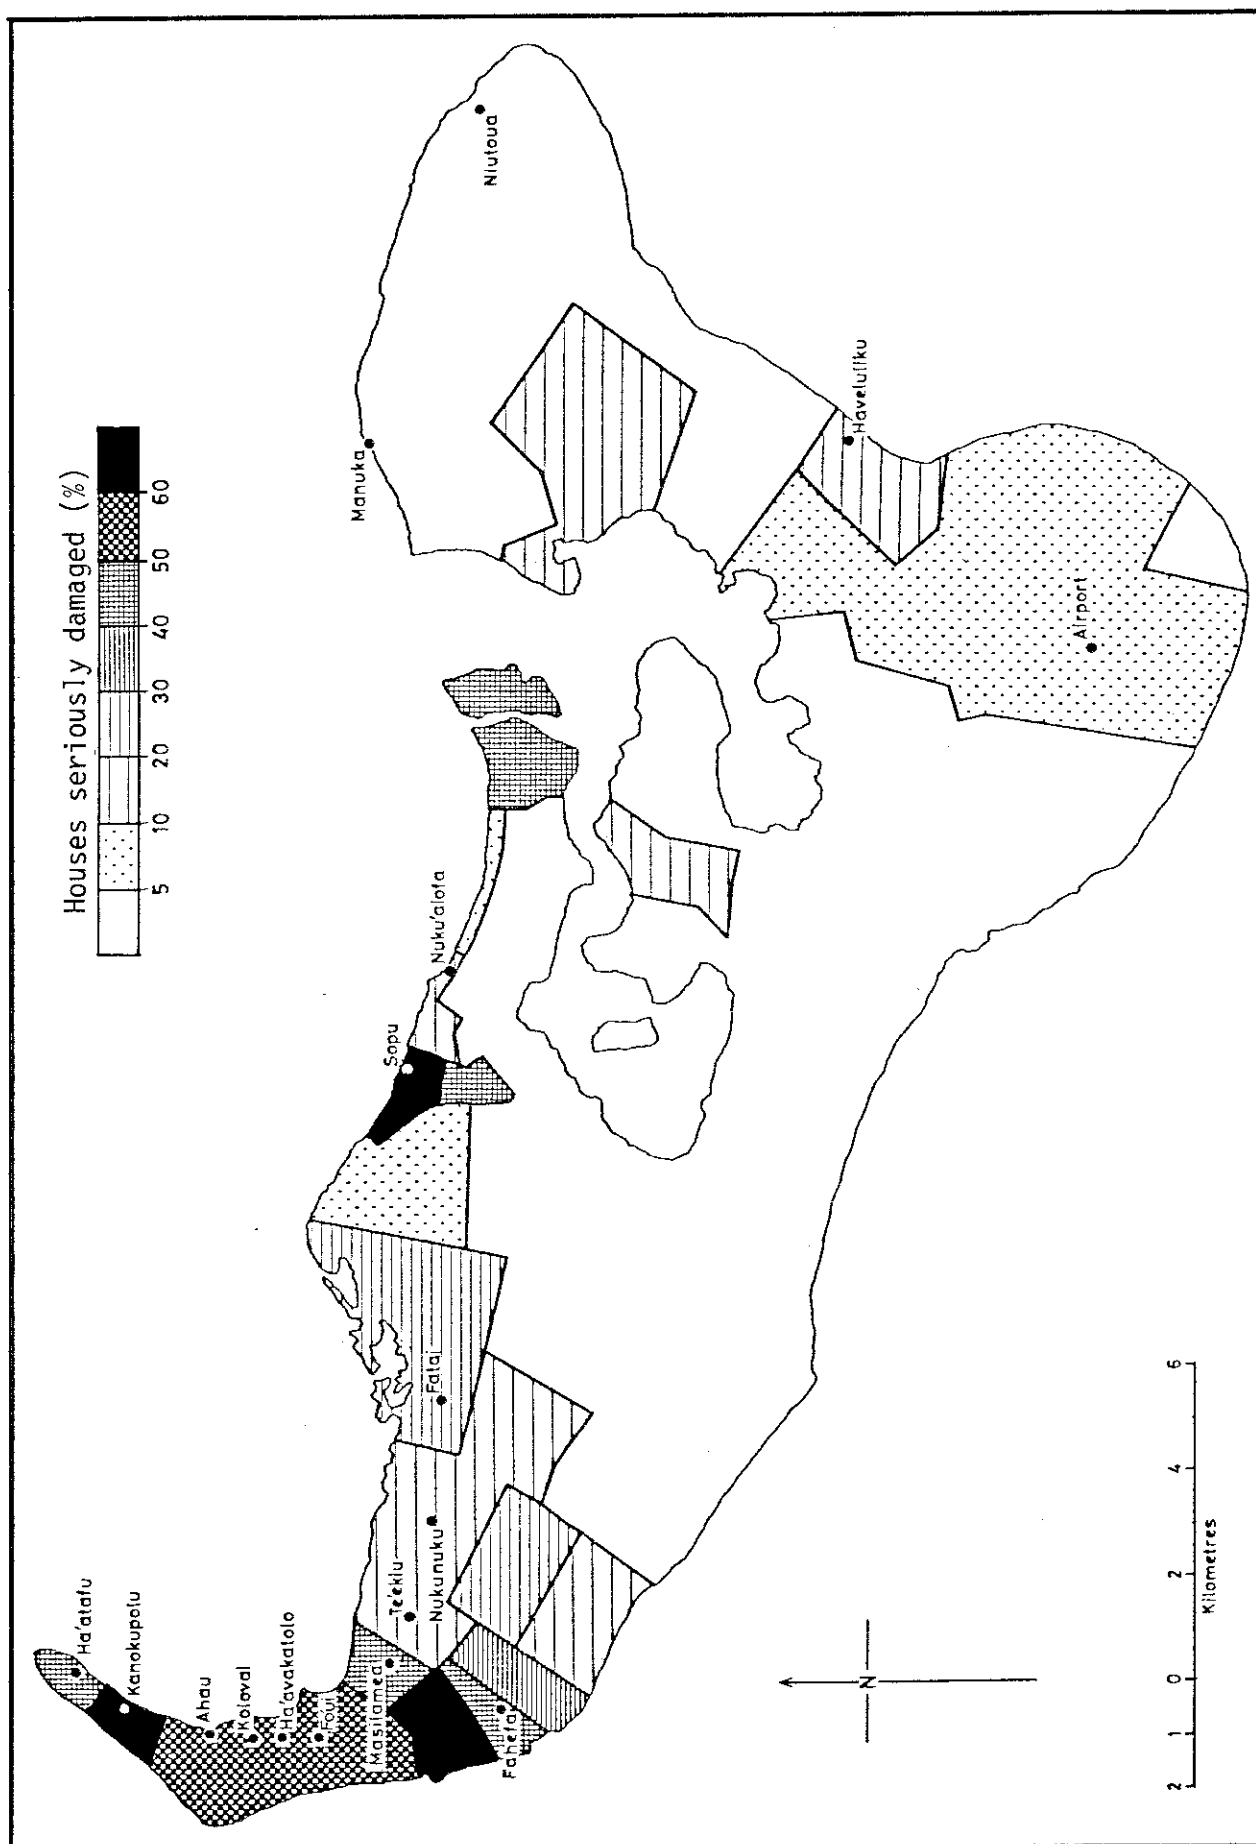
Figure 6 shows a distribution of damage to dwellings based on the two highest categories, Severe and Total. As would be expected the villages on the north-west peninsula experienced the most damage, as they were only about 15 km from the eye. More than forty percent of houses were severely damaged or destroyed. This compares with less than five percent severely damaged or destroyed on the north-eastern area. The estimated cost of damage to buildings, mainly housing, in the north-western peninsula was in excess of T\$1 million.

Figure 6. Distribution on Tongatapu of houses classified as having "severe" or "total" damage (Government Survey).

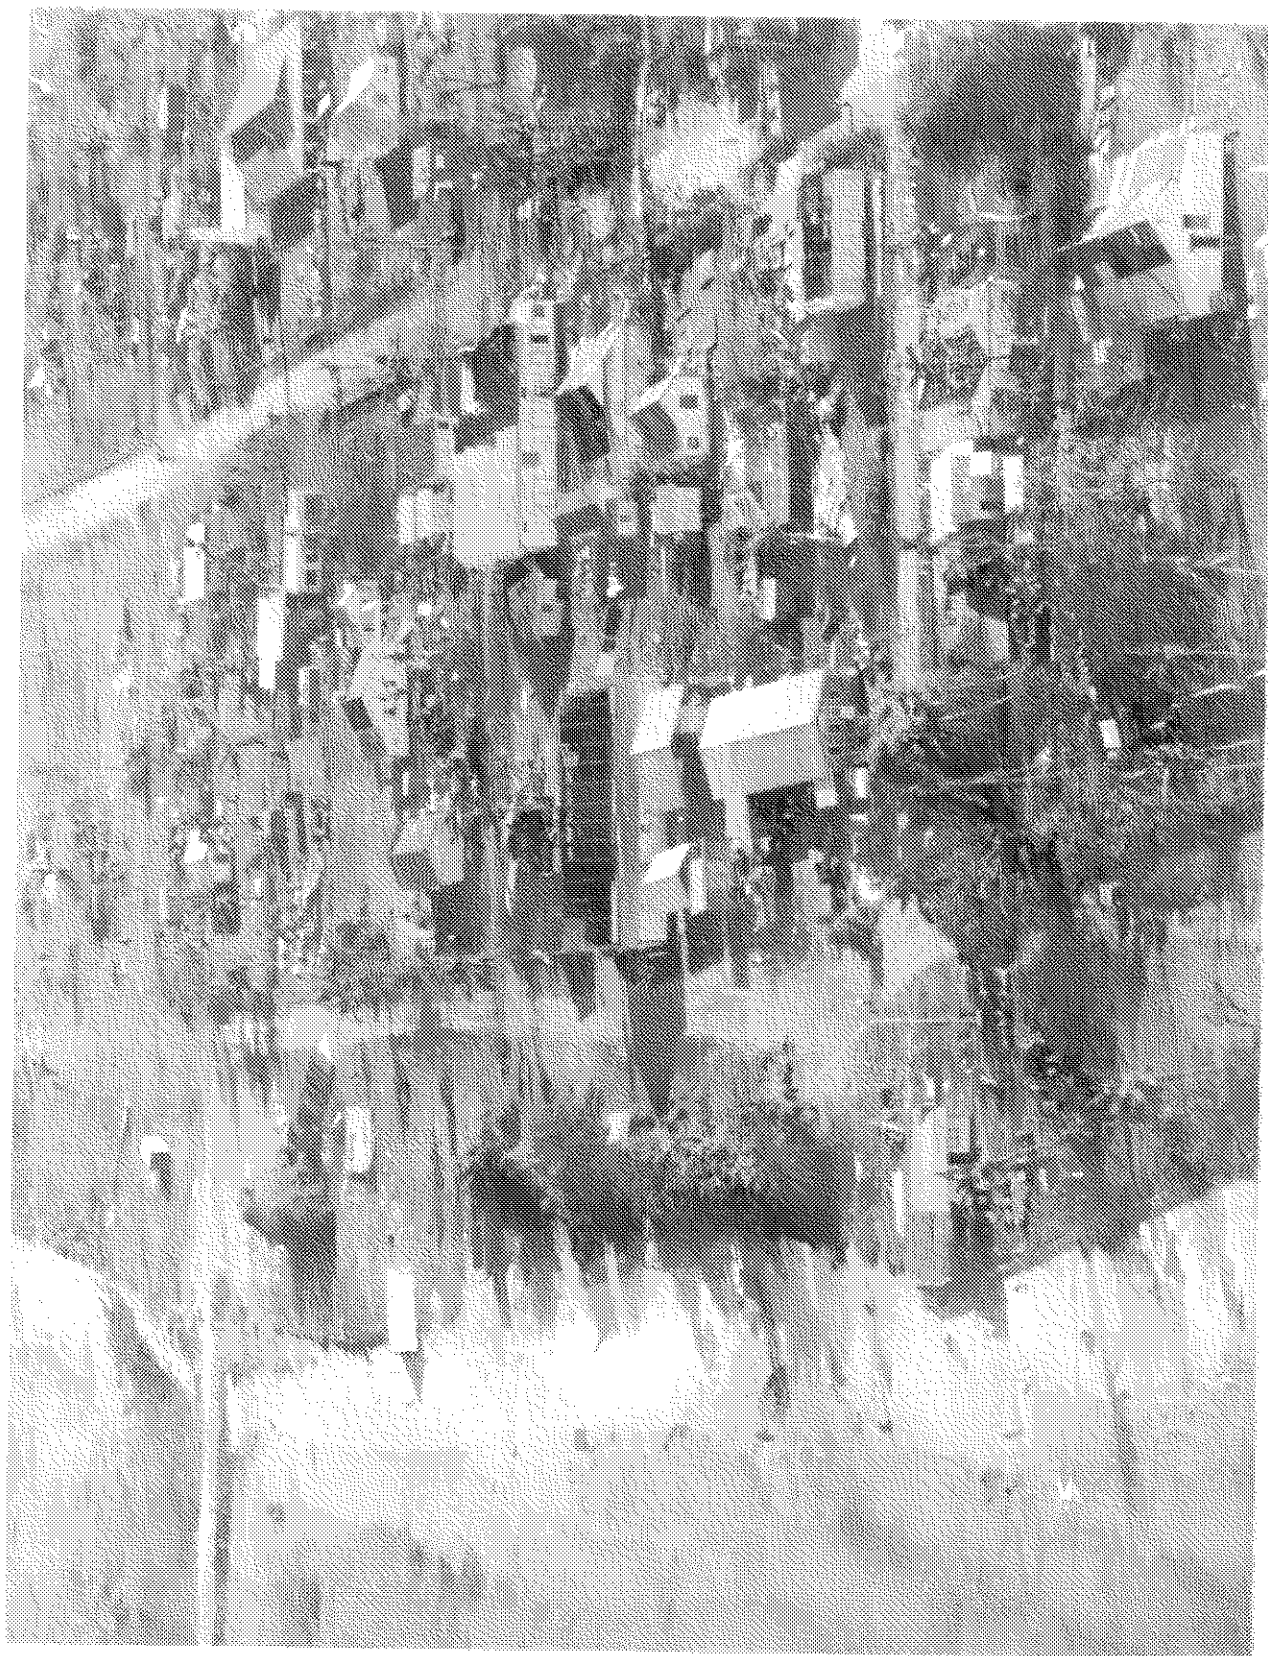
Figure 7. Building damage at Pangai, Lifuka Island.

At Pangai, principal village on Lifuka, the main island in the Ha'apai group, the extent of devastation would be similar to that of north-western Tongatapu. That is, approximately fifty percent of the buildings would have severe or total damage, as defined in the Ministry of Works classification. As Pangai was a large village there were a number of commercial buildings, schools, halls and churches. Many of these were damaged to an extent similar to the houses. Figure 7 shows the extent of damage to houses and commercial buildings in part of Pangai. Once again there was insufficient time to conduct a proper survey to categorize the types of damage.

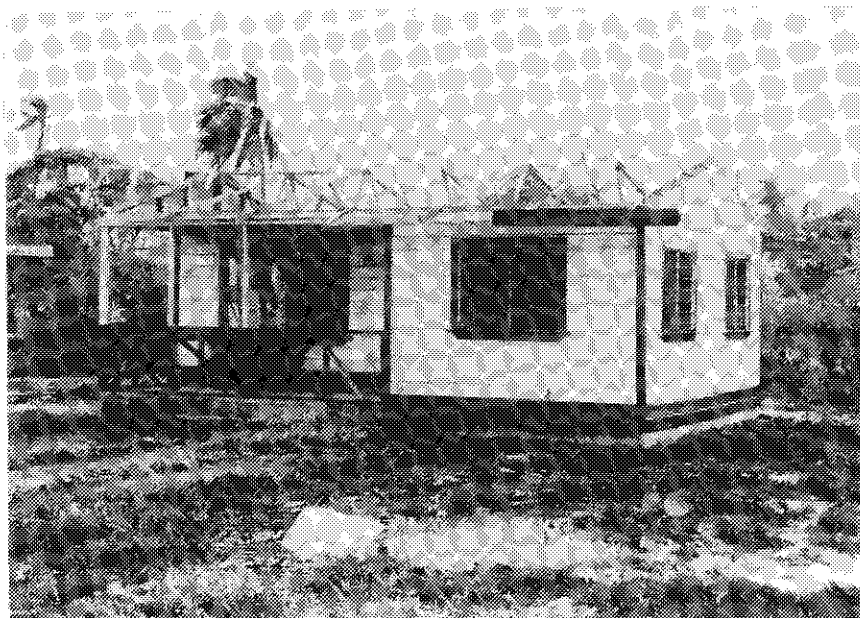
Damage to housing was typical of that reported from other wind storms (Leicester and Reardon, 1976a). The predominant form of damage was to the roof, being either loss of roofing or loss of part of roof structure. A typical example of that type of failure is shown in Figure 8, where the roof sheeting and roofing battens have been blown off. Figure 9 shows a more severe example where the entire roof structure was lifted intact from this house at Pangai. It is obvious therefore that there was insufficient hold-down securing the trusses to the wall framing.

Figure 8. Roofing and some roof structure blown off.

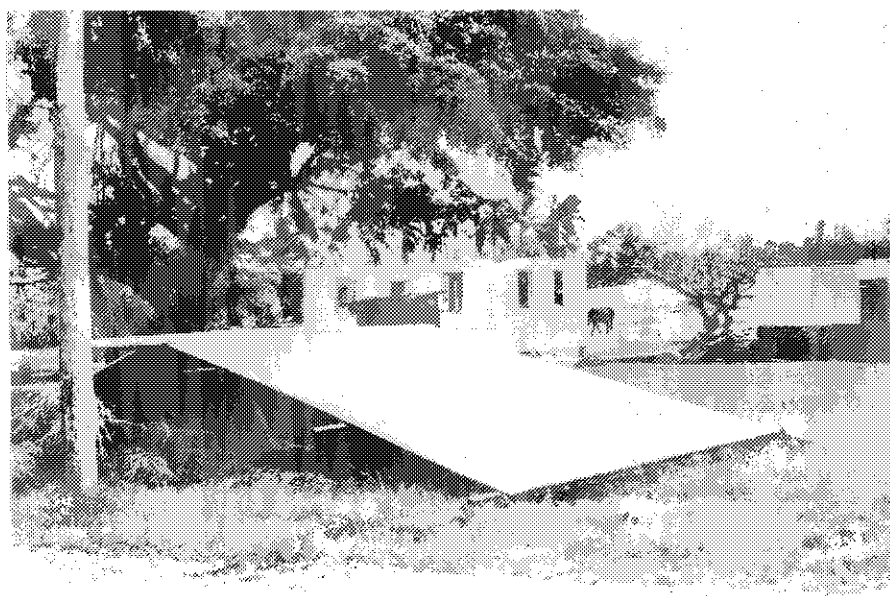
Figure 9. Entire roof structure blown off.

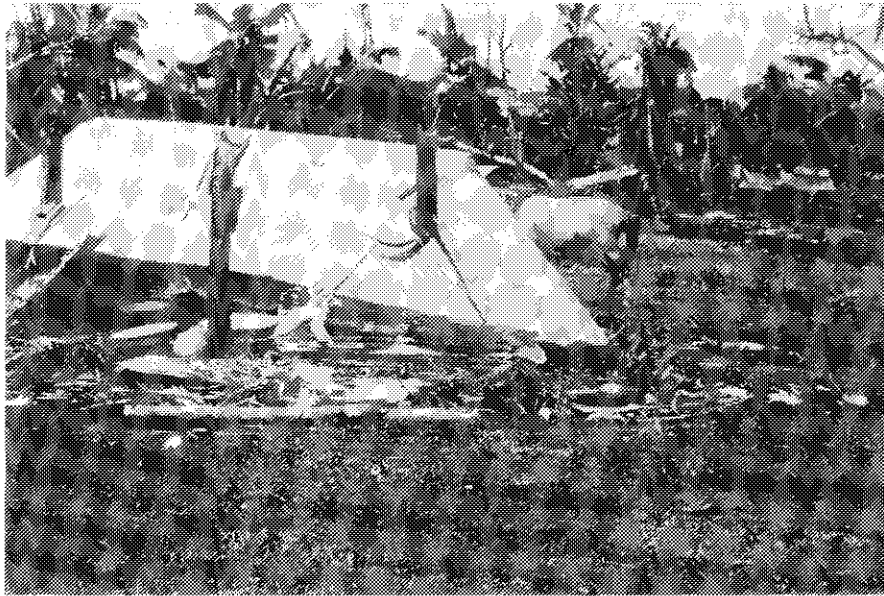
The same type of damage occurred on the islands, Figure 10, where construction was often a mixture of traditional and European styles, galvanized iron roofing with woven palm walls.

Figure 10. Roof structure lifted off fale.

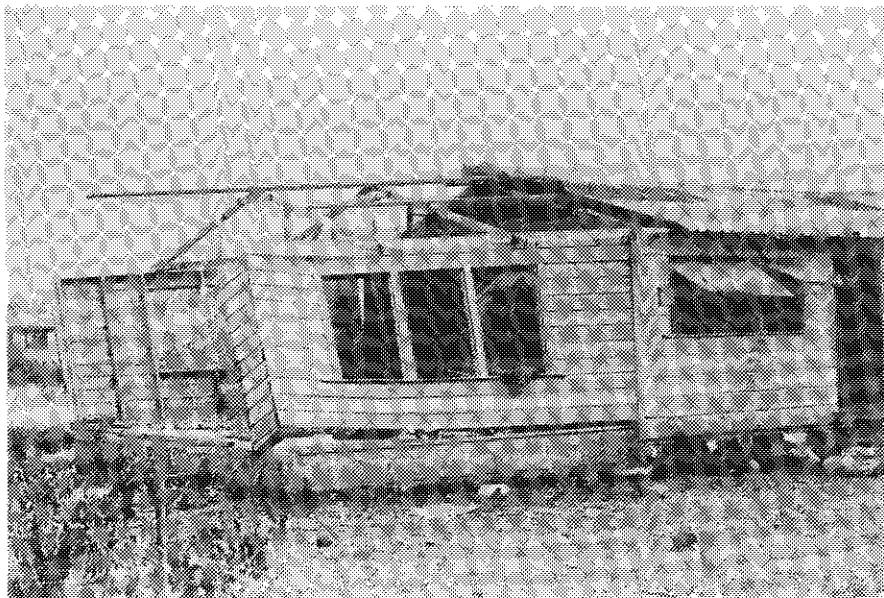
In the European style houses roof trusses not only supported the roofing, but helped to tie the outside walls together, as there were often few internal walls. Thus the loss of trusses made the walls vulnerable to lateral collapse. Figure 11 shows such a wall failure resulting from damage to roof structure.

Figure 11. Severe damage to walls.

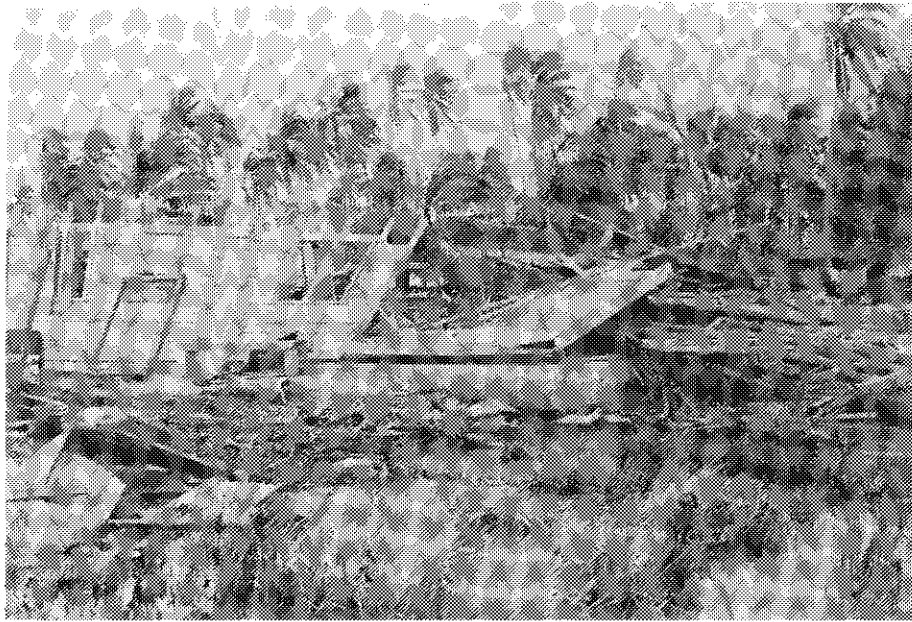
Total wall failure occurred on a number of occasions, Figure 12. This house, at Sopus, lost its entire roof structure which landed some fifty metres away. This loss, together with the lack of wall bracing, resulted in the failure of all walls. An inspection showed that the bottom plates were securely attached to the slab, but there was only nominal attachment of studs to bottom plate.

Figure 12. Total failure of house.

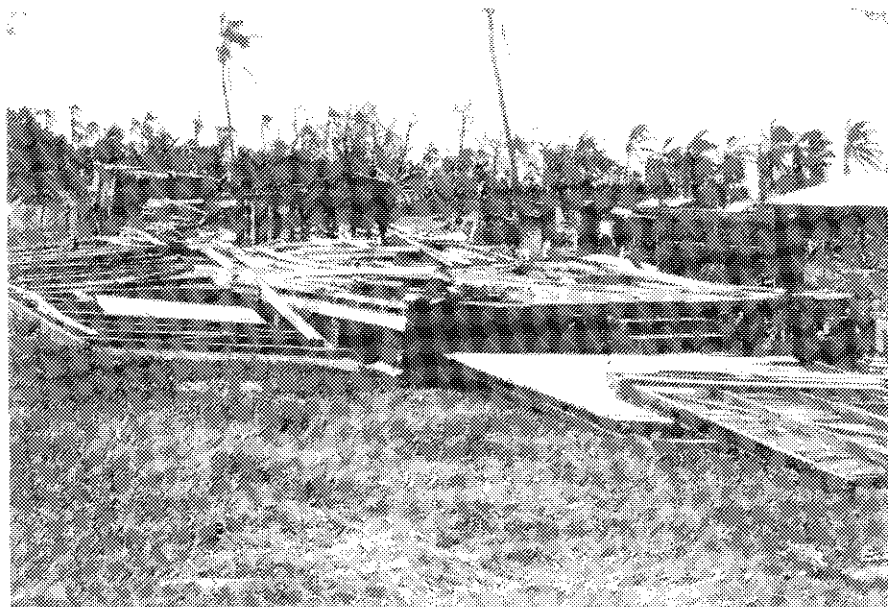
There were many occasions where all walls failed and were blown clear of the floor area. This happened not only in the villages of the north-western peninsula, Figure 13, but also at Sopus near Nuku'alofa and on islands in the Ha'apai group. Figure 14 shows a remaining platform floor on the island of O'ua where forty-eight of the fifty houses were reported damaged. Of further interest was the fact that a group of three houses at Niutoua on the north eastern side of Tongatapu were totally destroyed. However the houses were on a ridge about 16 metres high and half a kilometre from the beach, with open ground in between. About twelve other houses in the same group had minor damage to roof and roofing.

Figure 13. Walls blown clear of floor.

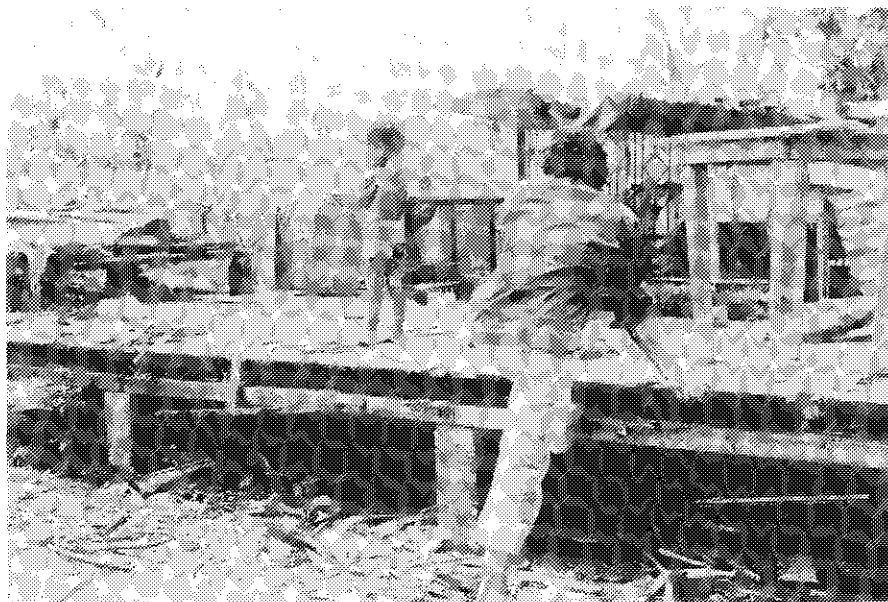
Figure 14. Only platform floor remaining, O'ua Island.

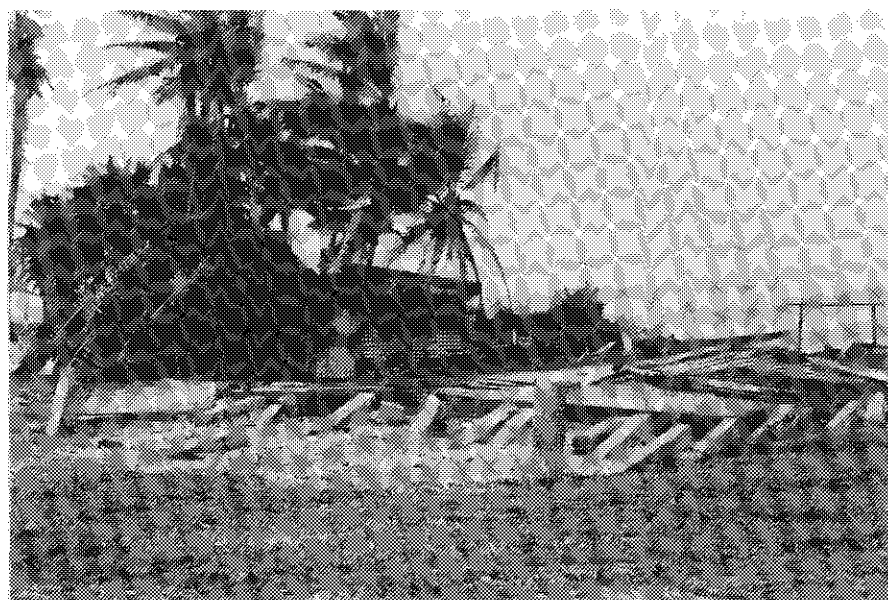
The timber framed houses were usually built about three quarters of a metre above ground, on concrete or timber pole stumps. These stumps were not braced, and it is believed that they were embedded less than half a metre into the ground. There were only a few occasions on which lateral failure of the stumps was observed, such as shown in Figure 15, at Pangai. Actually the stump failure shown in that figure is typical of what would result from storm surge. However severe storm surge did not occur at Pangai, and further, the stumps are leaning towards the sea which is incompatible with storm surge.

Figure 15. Stump failure, Pangai.

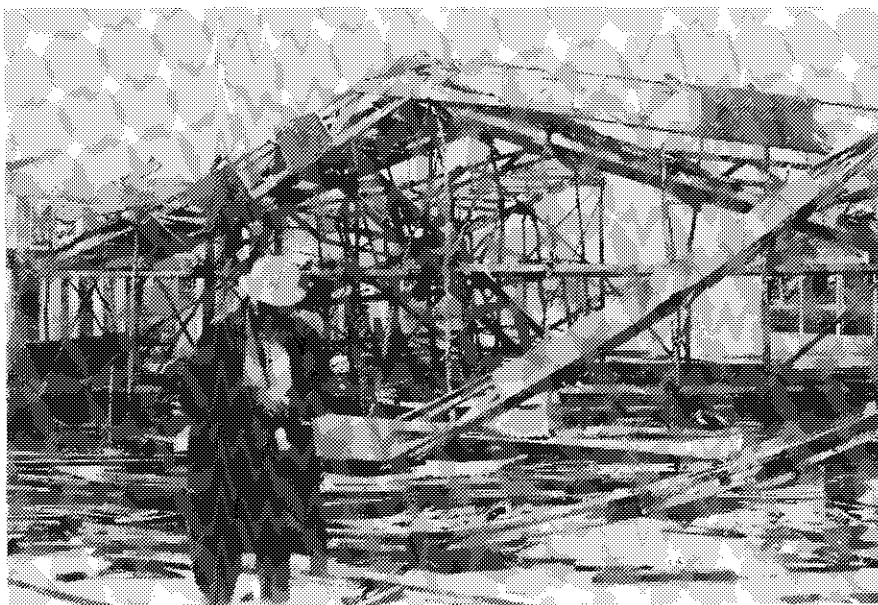
Figure 17. Damage to roof structure of hall.

the roof structure. Figures 17, 18 and 19 show three different aspects of failure of a large hall at Pangai. Figure 17 shows the roof sheeting and purlins having been blown off and some of the timber roof trusses collapsed sideways. Figure 18 illustrates the tie down mechanism used for the trusses. (The entire wall has blown over as a unit!). The reinforcing bar from the pillar was bent over the top chord to secure the truss. Having lost the lateral support provided by the trusses, the wall was unable to resist the horizontal wind forces, and failed as a cantilever. Figure 19 shows failure due to insufficient bond strength. It is suspected that the quality of concrete was not very high and that voids were frequent. Similar failures were observed for other buildings of concrete block construction.

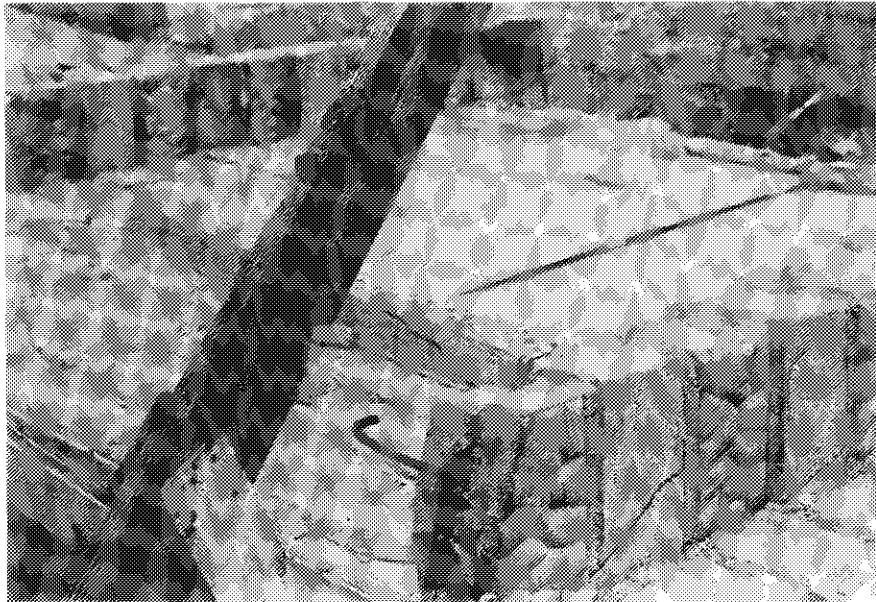
Figure 18. Tie down detail for trusses. (Note: wall has been blown over).

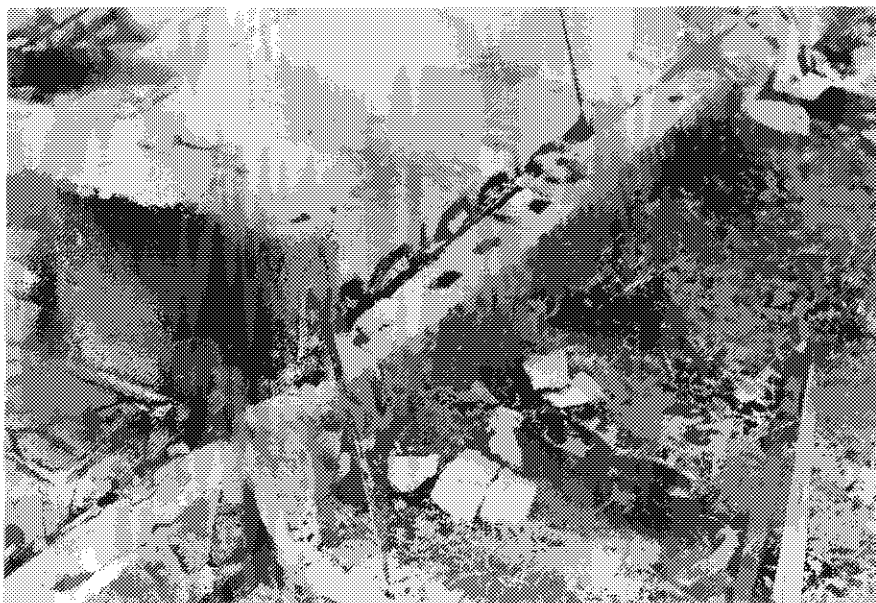
Figure 19. Wall failure due to insufficient bond strength.

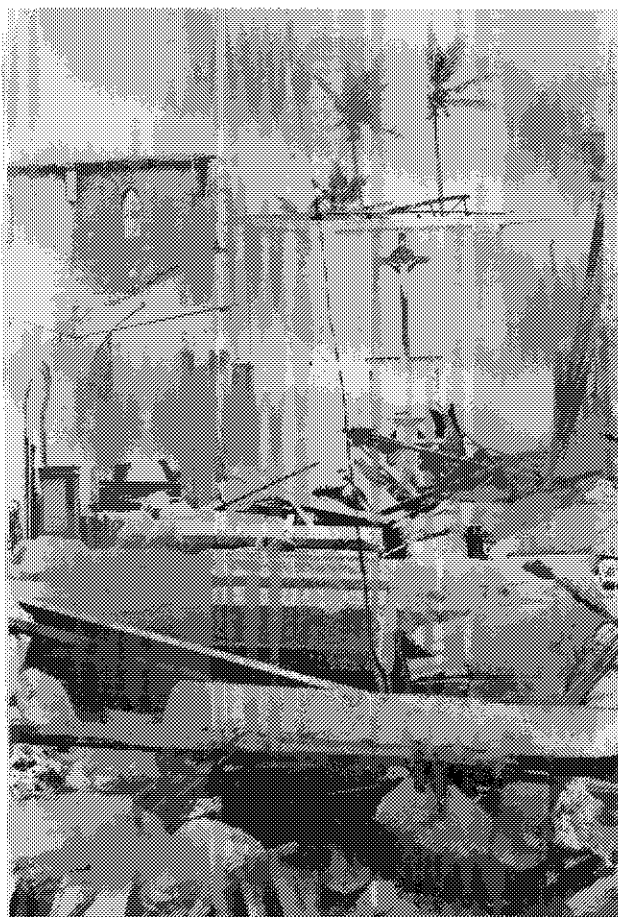
Figure 21 shows a badly damaged church at Pangai. The roof structure was blown off, one wall blown in and a row of massive concrete pillars inside the church was blown over. A close inspection of the pillars revealed that they were unreinforced. It is very difficult to estimate the age of the church, but it may well have been fifty years old, in which case unreinforced pillars could have been an accepted form of construction.

Figure 21. Church at Pangai.

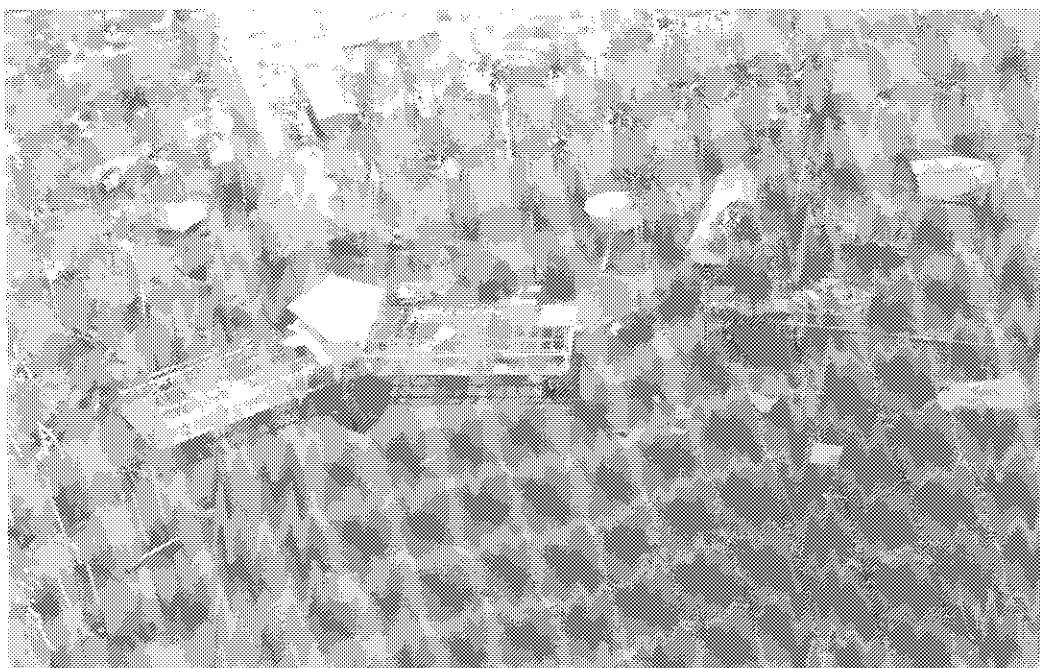
Figure 22. Loss of roof cladding, Atenisi University.
(By courtesy Tonga Chronicle)

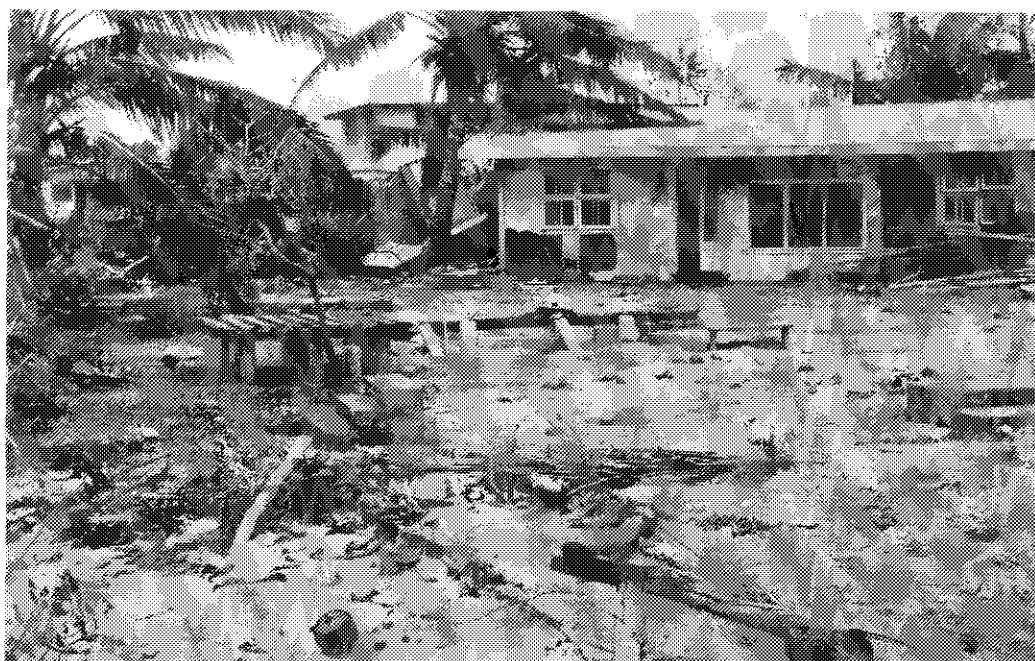
The sea swept five houses from their stumps and carried them about ten or fifteen metres. Figure 23 shows one such house and the remaining stumps and steps. As is usual in a flood situation, the houses still appeared to be reasonably sound. They did not break up, although two had wall damage where they collided. All of these houses fronted the beach road. Apart from them, there appeared to be no other structural damage to houses from storm surge.

Figure 23. House washed from stumps by storm surge.

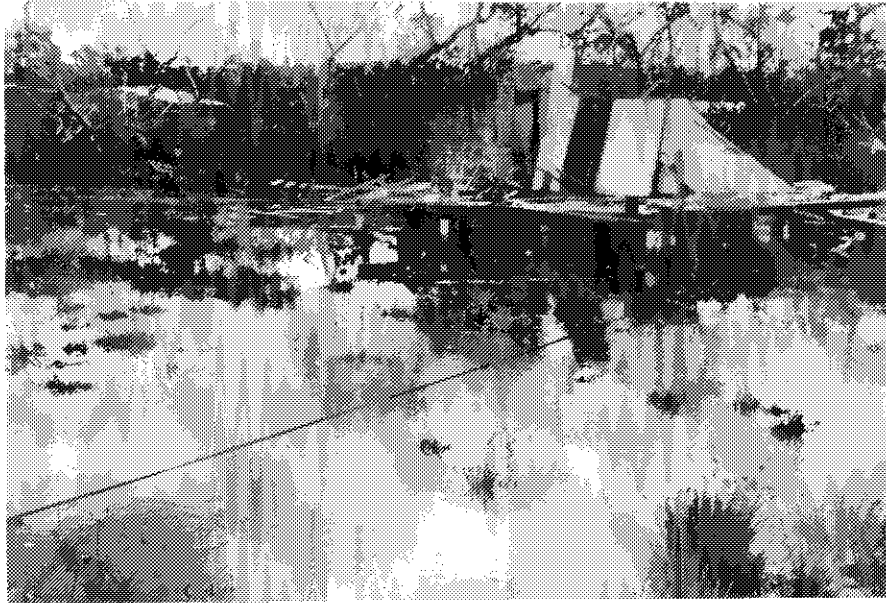
Figure 24. Surge waters still surround damaged house, one week after cyclone.
