# CYCLONE TESTING STATION

## **SIMULATED WIND TESTS ON A HOUSE**

### Part 2 — Results

TECHNICAL REPORT No.14

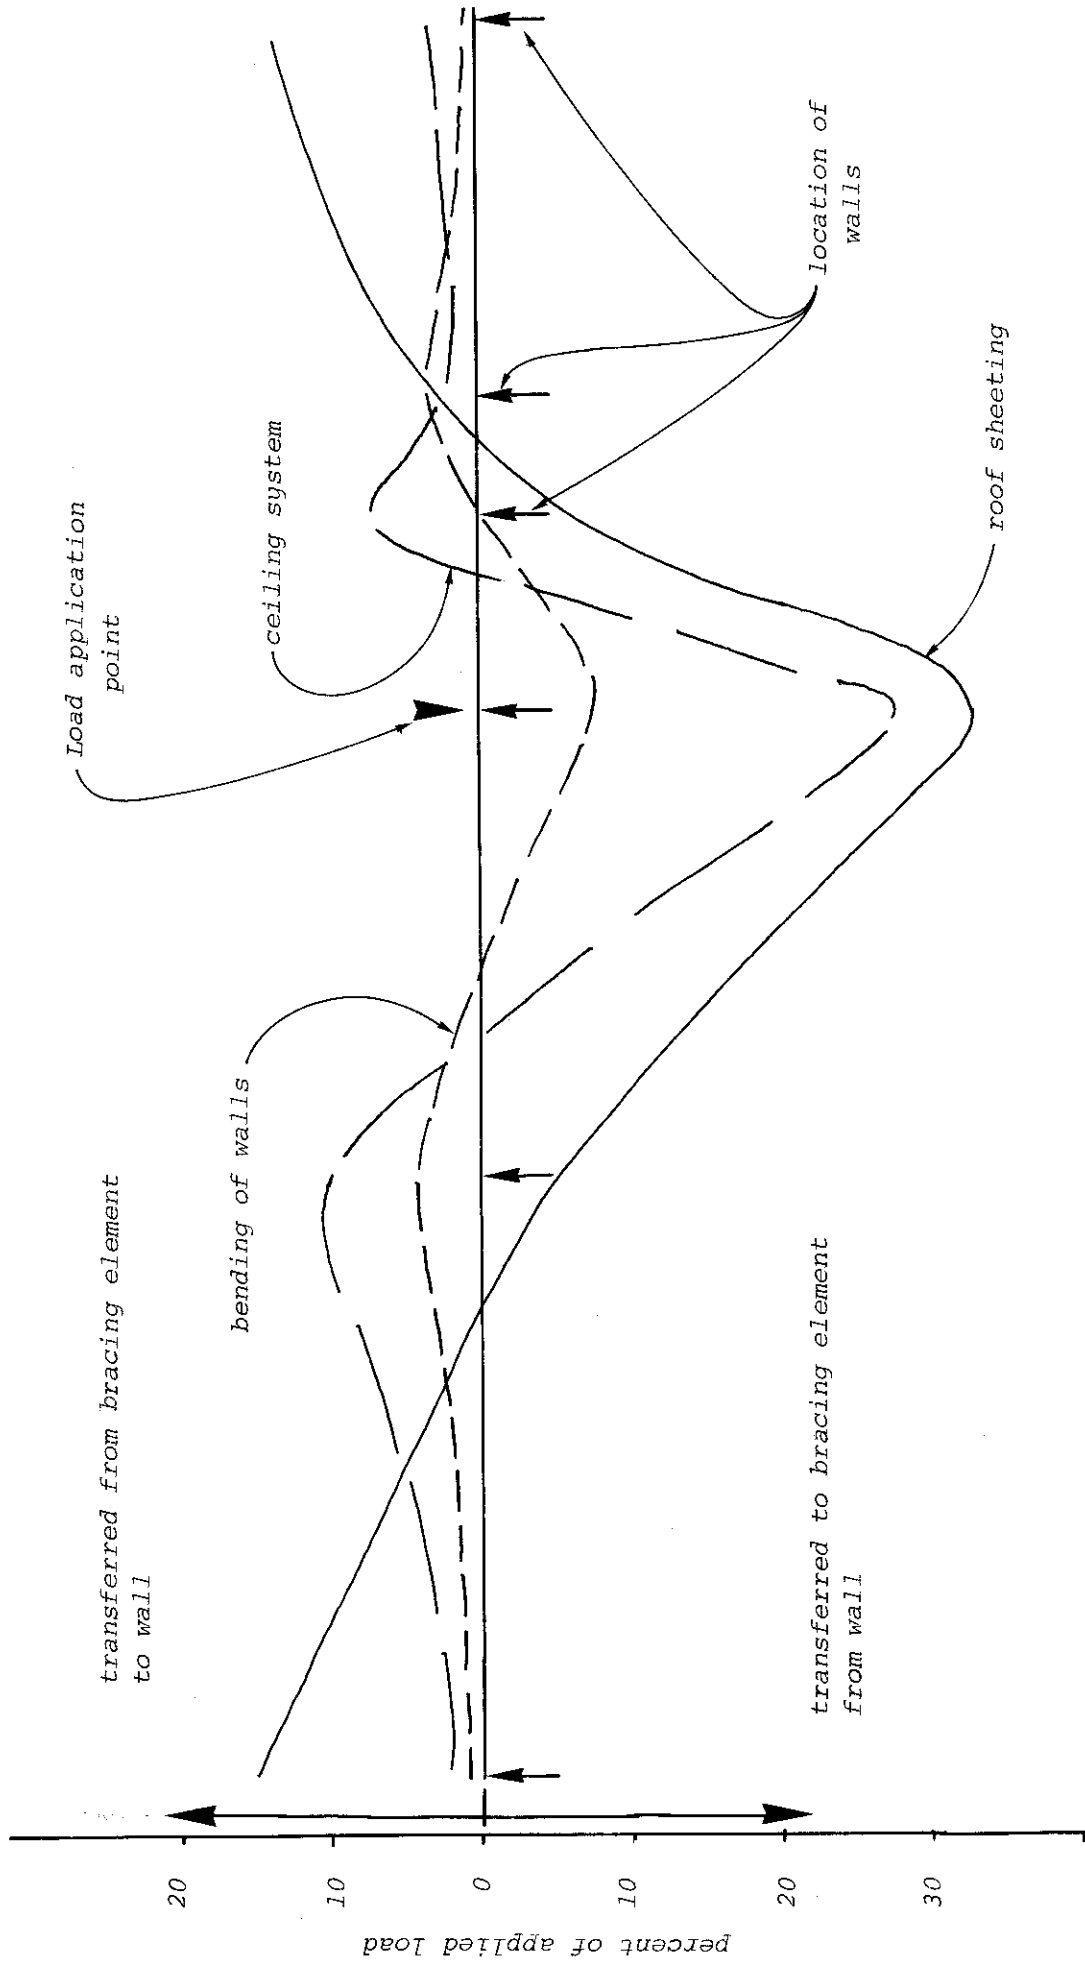
Figure 5. Percentage of applied load carried by lateral bracing elements.

It is clear from this diagram that the bending action of the weatherboards and the bending action of internal walls only spanned very small distances - at most the distance to the nearest bracing wall on each side. As the mechanism involved in the action of both of these elements was bending, the effectiveness of the elements decreased dramatically with an increase in the distance between bracing walls. The action of these two elements in resisting lateral forces is therefore only of any significance in very small rooms such as toilets or laundries, and in these rooms the ceiling diaphragm is also very stiff, and also attracts much lateral load. As weatherboards of the type used on the house in 1942 are not commonly used in modern construction, and the bending of internal walls is dependent on the roof trusses being fixed to all internal walls, a practice generally precluded

in most modern building by-laws, it is recommended that the bending action of internal walls and external cladding not be relied upon for any bracing strength.

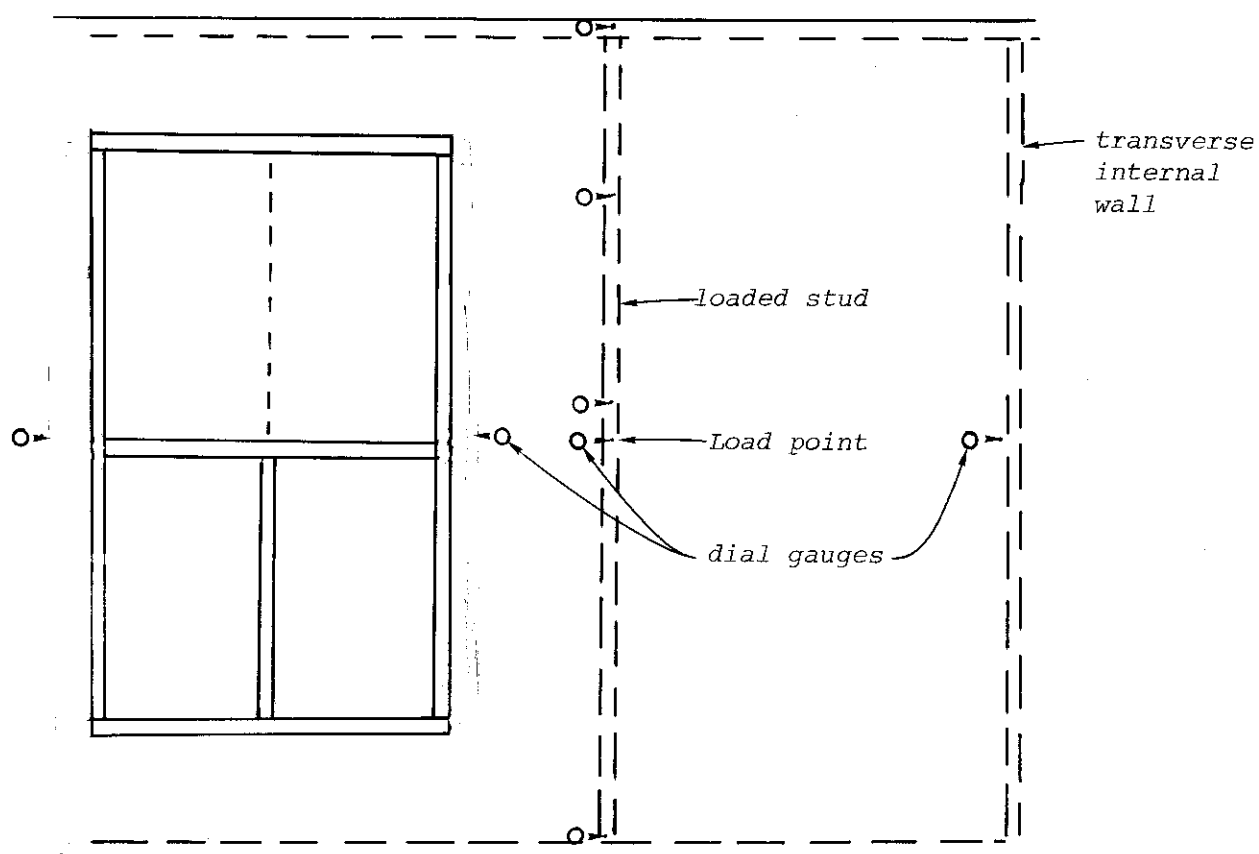
Figure A.4 Test configuration stud test

The ultimate load was reached at 21 kN when the loaded stud failed in flexure 200 mm below the load point at a knot in the hardwood. As a post failure effect the stud deflected excessively, breaking the plywood internal lining and pulling away from the weatherboards over its entire length. The nails securing the stud to the top and bottom plates remained intact throughout the test.

Failure commenced with the loaded stud moving away from the weatherboards in the vicinity of the load at 7 kN load. The ultimate load of 13 kN corresponded to the failure of the loaded stud in flexure at the load point. Again failure resulted in excessive deflection causing damage to internal linings and isolating the stud from the weatherboards, but causing little distress to the nails securing the stud to the top and bottom wall plates.

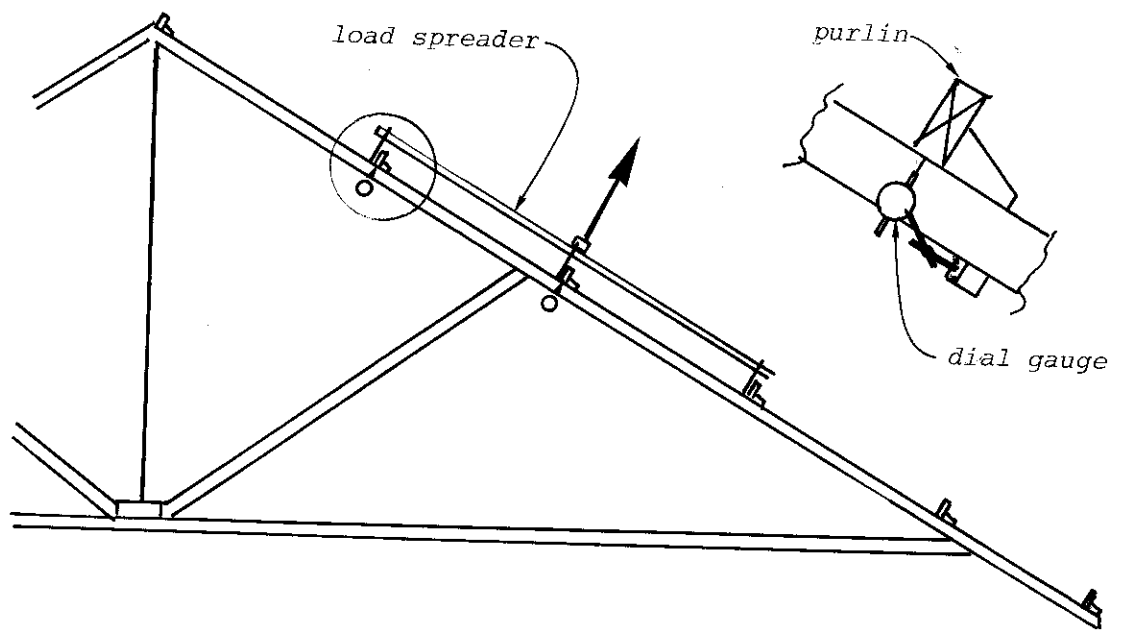
Figure A.6 Test configuration - Uplift test

The actual mode of failure was by withdrawal of the nails securing the purlins to the top chord nailing blocks. Forty nails in twenty locations were affected. This gave the average resistance of each nail at failure as 1.52 kN compared with the allowable design resistance of 0.63 kN (Australian Standard, 1975), i.e. average failure load was 2.4 times allowable load on that joint. The allowable load per joint gave a total permissible load on the test section of 1.01 kPa or 0.57 of the 'AS code' pressure. Thus it appears that the roof was significantly underdesigned with regard to current design rules. Appendix 4 to the Standard Building By Laws does not make a recommendation for holding down of purlins to trusses spaced at 3 metres, but holding down provisions for trusses at closer spacing are more substantial than those utilized in the tested roof.

Failure of the roof structure was sudden and simultaneous release of the twenty loaded joints. A failure of this kind during high wind conditions would have resulted in the sudden removal of a large part of the roof sheeting with purlins attached which would have become a very dangerous single piece of airborne debris.

The load was applied in approximately 4 kN increment. At about 40 kN total load, the struts in the trusses had pulled away from the bottom chord. On relaxation of the load this displacement remained. The loading was continued until failure occurred, by the detachment of the purlins from the nailing blocks on the top plates. This damage is depicted in Figure A.7. A load versus displacement curve for the purlin top chord joint is also given in Figure A.7. The failure was quite sudden with 14 purlin to top chord joints failing simultaneously.

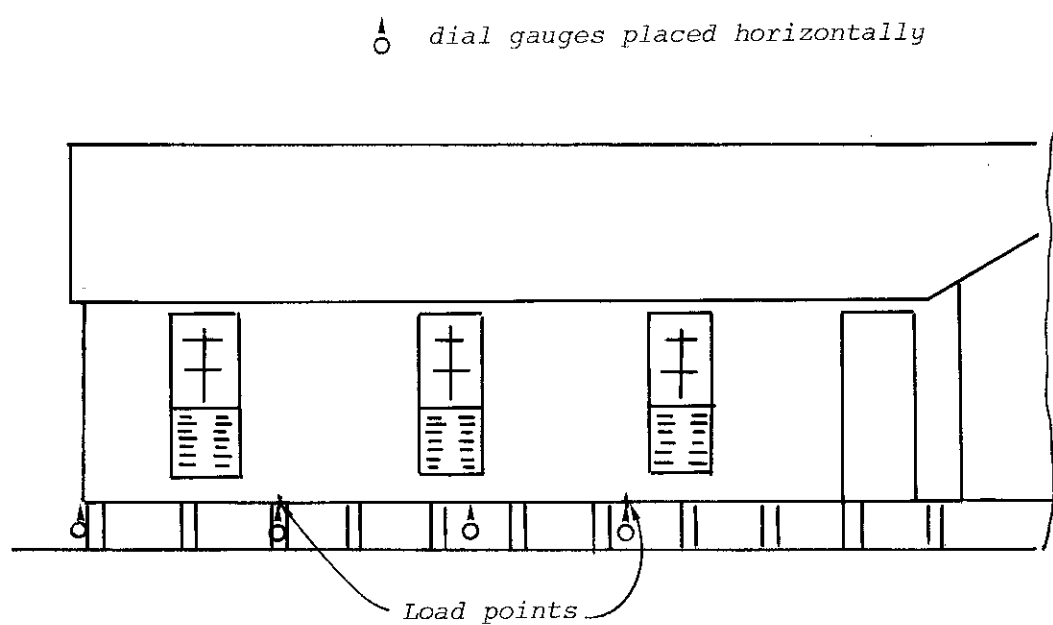
Figure A.8 Test configuration - Load applied at bottom of wall

At a load of 48 kN the top plate and approximately 2 m<sup>2</sup> of ceiling failed immediately adjacent to load point F. The top plate had been notched adjacent to the load point and failure occurred at the notch.

Load was then reapplied to load points G, H and I to 48 kN and the load at G increased to 65 kN with no noticeable damage to the structure. At this point the floor had lifted off the stumps in the vicinity of load point G.
