# CYCLONE TESTING STATION

## **TESTING A HIGH SET HOUSE DESIGNED FOR 42 m/s WINDS**

### Part 1 — Preliminary Results

TECHNICAL REPORT No. 19

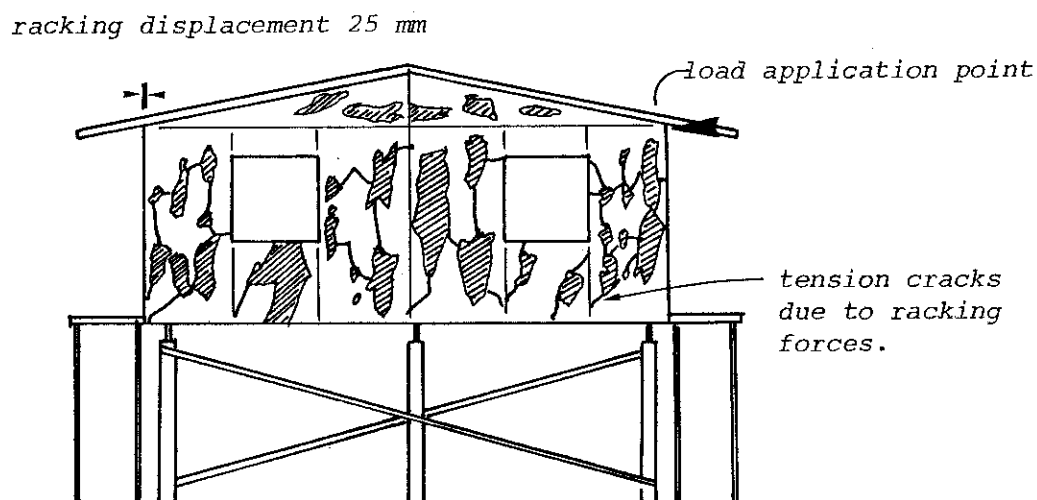
Figure 7 Debris Damage to Side Walls

- (iv) The very high loads that the house was successfully able to withstand suggested that very severe debris damage could be expected to accompany such high velocity winds. Thus both end walls were subjected to a heavy bombardment with pieces of timber. Approximately 50% of the external sheeting was physically removed from the end walls, the internal sheeting was punctured in about ten

places on each end and the plasterboard had been pushed over the heads of some fasteners by the continual pounding. Again 4.75 times design load was applied to the house but this time some damage occurred during the course of the tests. The damaged end walls deflected more than in previous tests, accompanied by buckling of the plasterboard sheeting where it had been pushed over nail heads, and cracking of the remaining external fibre-cement sheeting. The cracks in the external sheeting originated at holes caused by the debris damage and moved upwards towards the loading points and downwards away from the load points. They were thus oriented across the tension diagonals in the bracing wall. See Figure 7 for a sketch of this damage. As these external walls were not capable of carrying the same loads that they had in previous tests, more load was transferred to internal bracing walls. After the total load of 97 kN had been attained, an internal bracing wall failed by tearing of the fasteners in the plasterboard sheeting and a buckling of the sheeting itself. Following this failure, the house carried 77 kN, equivalent to 3.8 times design load inspite of the fact that the main internal bracing wall had failed and that both external bracing walls had been severely damaged. The load was carried primarily by a 1.2 m long bracing wall and four other walls not designed specifically as bracing walls.

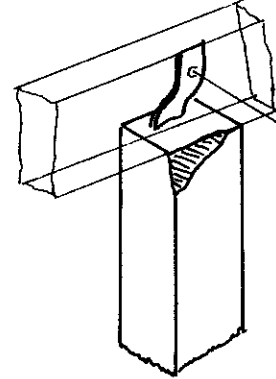
*bent fish tailed  
plate*

Damage at G3, K3

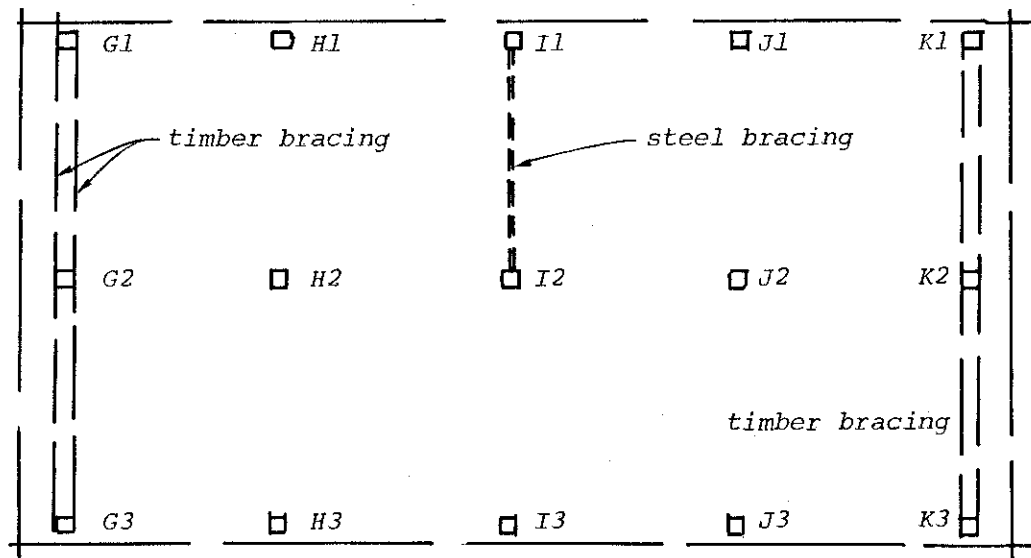
Figure 8 Footing Damage

The lateral loads at floor level were designed specifically to test the ultimate performance of the sub-floor bracing. Problems were associated with the testing of this part of the house as alluded to in the previous section. In the course of loading the house at top plate, those lateral loads had in turn been passed through the structure to the sub-floor bracing. Thus the cyclic loading of the top plate of the house had also caused cyclic loading of the sub-floor bracing although the forces were only half of the appropriate ones for the sub-floor system. However, in the course of applying failure loads to the top plate, the sub-floor bracing was loaded to in excess of design load fourteen times. In the course of applying these loads damage was caused to the foundations and repair and strengthening effected. A summary of these events is included below. Later detailed analysis may show that much is to be learnt from these failures also. An annotated plan of the footings is shown in Figure 8 with some sketches of the damage incurred.

- (i) During the application of a uniformly distributed load at top plate level, failures occurred at column K1, and K3 when the total load on the house was 59 kN or 1.4 times the design load for the sub-floor bracing system. It could be deduced from the load-deflection curves that the fish-tailed plate that secured the bearer to column K3 failed in bending first which removed load from the tension diagonal of the timber bracing set on columns K1, K2 and K3. This transferred extra load to the compression diagonal and caused the concrete failure at the top of column K1.

- (iii) During the application of a uniformly distributed load at top plate level a failure occurred at the top of column K2, again associated with the fish tailed plate securing the bearer to the column. The total load on the house was again 59 kN or 1.4 times design load on the sub-floor bracing.

- (v) At a total lateral load of 93 kN, the expanding masonry anchors securing the base of the steel tension braces to the inside face of the concrete columns failed by pulling out on three separate occasions. The expanding masonry anchors were replaced with 12 mm

- (ii) To prevent a recurrence of that type of damage, temporary steel diagonal tension braces were installed between the top of column K2 to the bottom of column K1. They were secured at each end by two 12 mm expanding masonry anchors into the face of the concrete. The bearer immediately over the column was prevented from rolling by the use of metal brackets as shown in Figure 9. This was repeated for the columns in set G, and similar braces were installed in sets H and J, but the top of the braces were welded to the steel columns.

- (iv) To remove the top of the concrete column from the line of force transfer from house to ground, the steel braces were extended and bolted directly to the top of the bearer over columns G2 and K2. Thus forces from the floor could be carried through the joist to the central bearer, then directly to the steel tension brace and to ground. Framing anchors were used to secure joists to the top of the central bearer thus ensuring efficient lateral force transfer from the floor to the bracing.

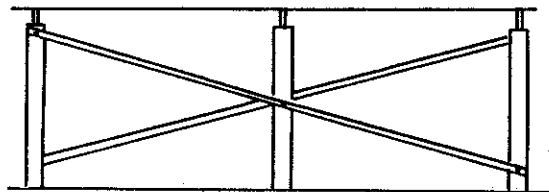
(a) Originally installed

*timber braces  
fixed with one  
16 mm masonry  
anchor each end*

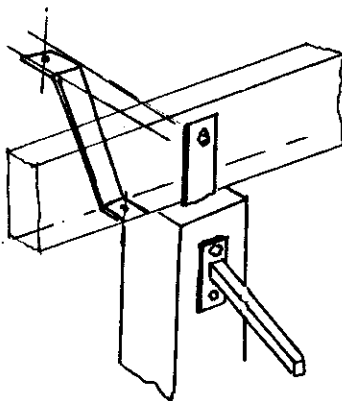
(b) First Modification

*32 mm steel RHS  
fixed with two  
12 mm masonry  
anchors each  
end. Bearer  
restrained against  
rolling.*

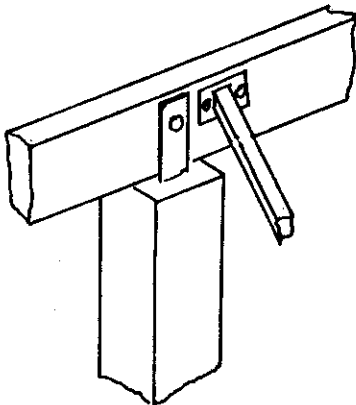
(c) Final Modification

*32 mm steel RHS  
fixed to top of  
bearer with two M12  
Bolts. Base fixed  
with two 12 mm  
chemical anchors.*

The failures of the sub-floor bracing system were all associated with local tension zones in concrete columns which were not designed for such stresses. The obvious solutions for such a problem are either to design for such stresses by including special reinforcing in the column at the brace connection, or to avoid the tension zone by connecting the diagonal brace to some other member. The latter solution was the only one available to try on the test house. Therefore 32 mm square RHS steel diagonal braces were installed from the bottom of the concrete columns to the top of the timber bearer. The braces were bolted with chemical anchors to the column and with two M12 bolts to the central bearer. Figure 9 shows details of the brace.
