CYCLONE TESTING STATION

STRUCTURAL DAMAGE CAUSED BY
CYCLONE 'KATHY' AT BORROLOOLA, N.T.
MARCH 1984

Technical Report No. 21

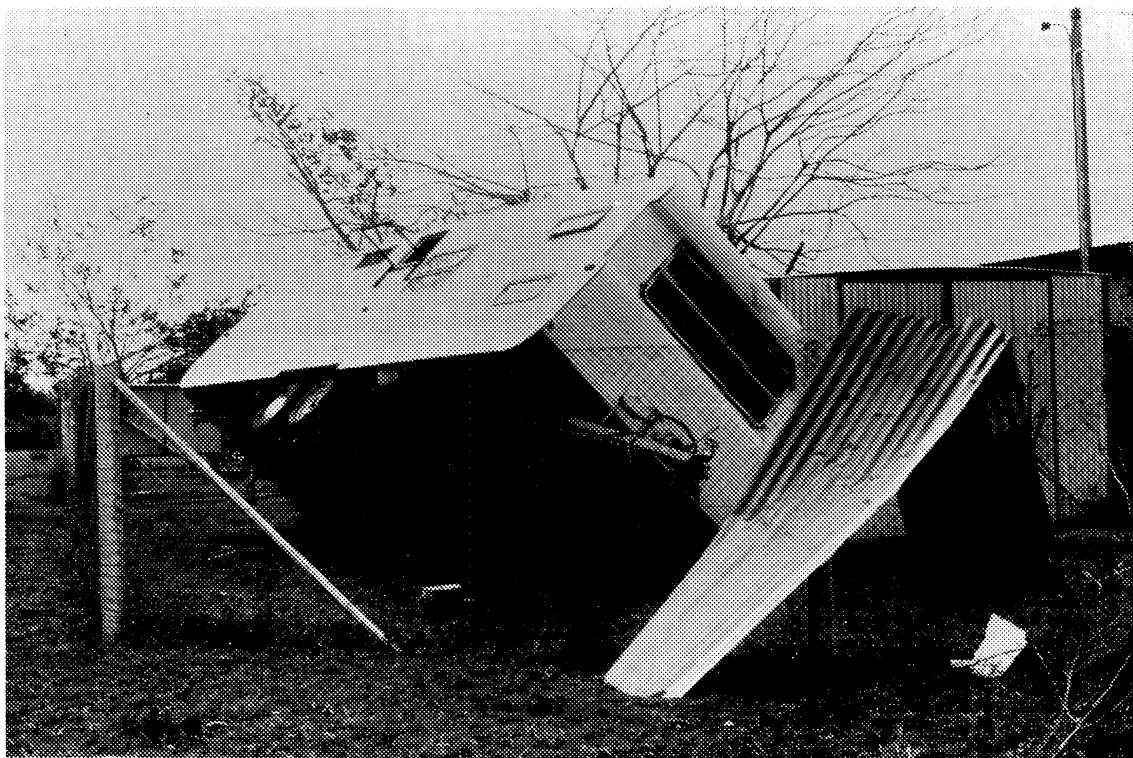
The details of the calculations will not be presented here, but the methodology involved selecting some simple structures - in this case caravans. An upper bound was determined by calculating the wind velocity that would have been required to overturn a van that had remained in place throughout the cyclone, and a lower bound by determining the wind velocity required to overturn a van that had been overturned during the periods of high winds. Both vans presented their largest face nearly normal to the direction of strongest winds. Roy (1983) provided information on the winds required to give specific overturning moments and also indicated that the moment was largely independent of wind direction over a range of 30° each side of normal to the long face of the van. Figure 3 shows one of the caravans used in the analysis.

Figure 3 The force required to overturn this caravan was used to find a lower bound on the maximum wind gust.

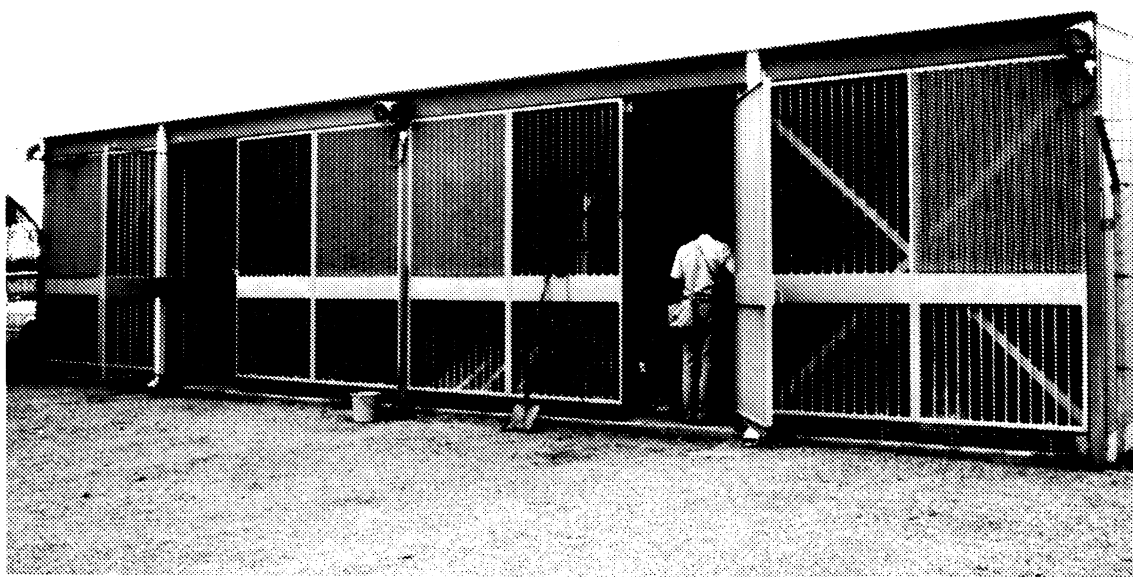
Figure 4 The cell block that accommodated people during the cyclone. Maximum winds normal to bars.

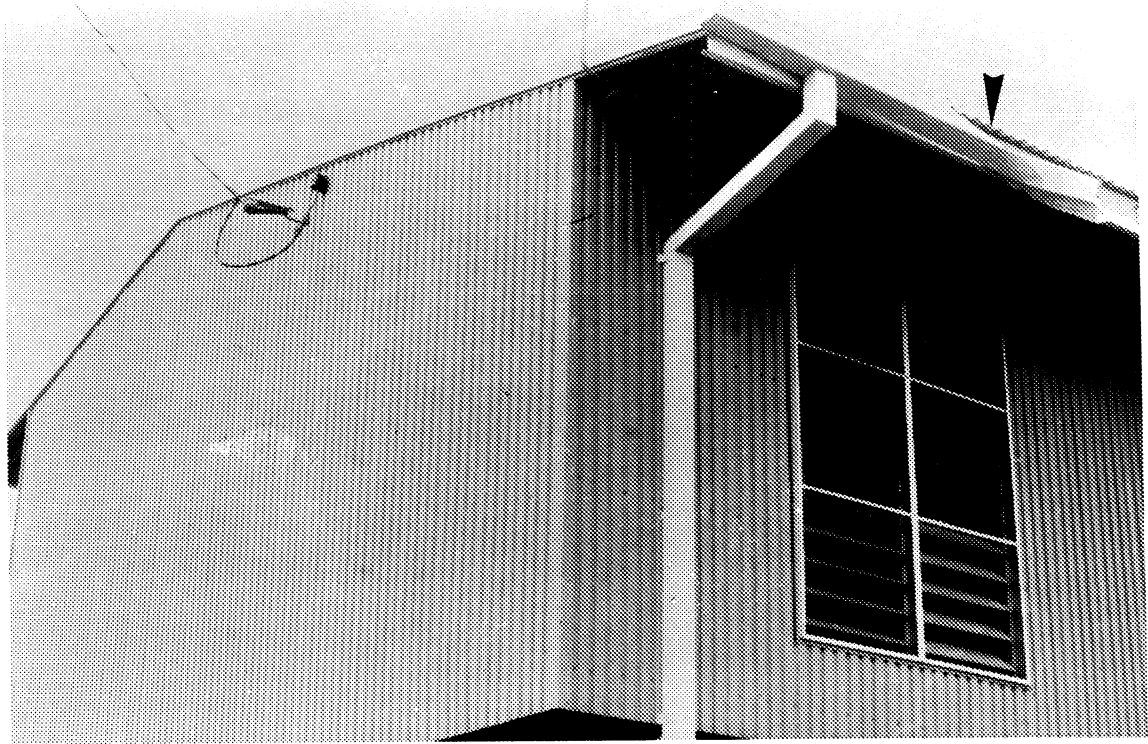
A feature of all of these buildings was the lack of debris damage to them. A wooded area separated them from other parts of the town and seemed to protect those buildings from airborne building materials. No louvres were damaged and even the external fly screens appeared free from tears. These buildings were well designed for a cyclone-prone environment, possibly for a post disaster function, and erected under government supervision. The structural integrity of these buildings that were used as a cyclone shelter undoubtedly contributed to the safety of the townspeople during the cyclone.

Figure 5 Police House showing damage to guttering, but screens and walls free from debris.

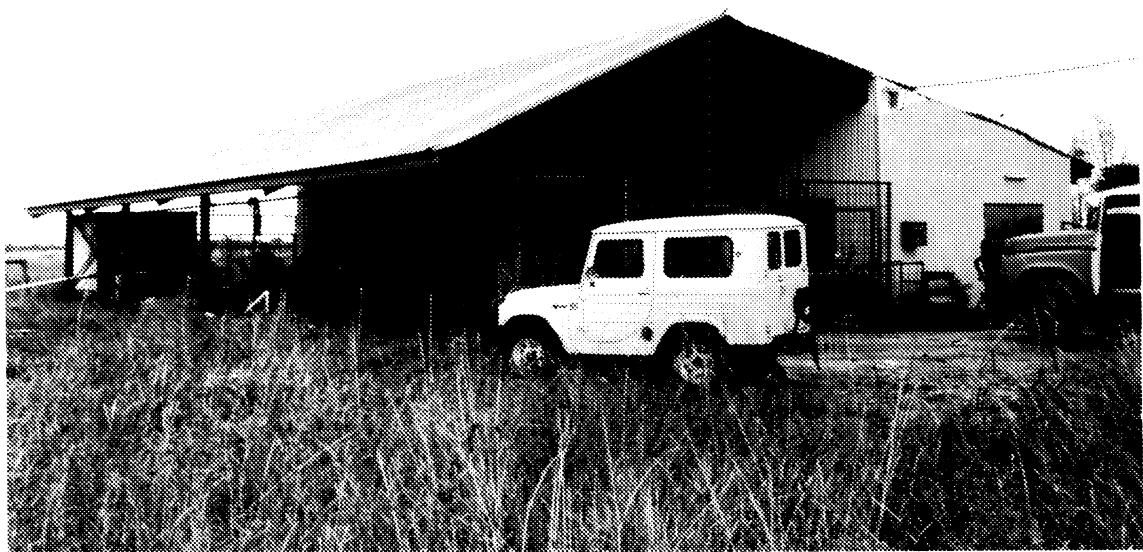
Figure 6 Adult Education Centre - viewed from direction of maximum winds.

Again, this partially enclosed building was used as a cyclone shelter during the event and its good performance was due to the attention to detail during the design and construction of the building. Its basic frame consisted of portal frames bolted at knee and apex joints, and was braced in both directions and in the plane of the roof. Two thirds of the plan area of the building was open and could not have sustained positive internal pressures, however the highest velocity winds were normal to the dominant openings of the enclosed section. Again no damage to cladding was apparent, although the barge trim had been lifted off. The roof was screwed to Z section purlins at every corrugation for the bottom two purlins and at the crest of the roof, and proved adequate to resist the uplift loads. It is again likely that good supervision was used on the construction of this building and adequate fastening, good bracing and sufficient tie down ensured the safety of the building's occupants during the cyclone. The design and construction appeared to have complied with the Northern Territory Cyclone Areas Deemed to Comply Standards.

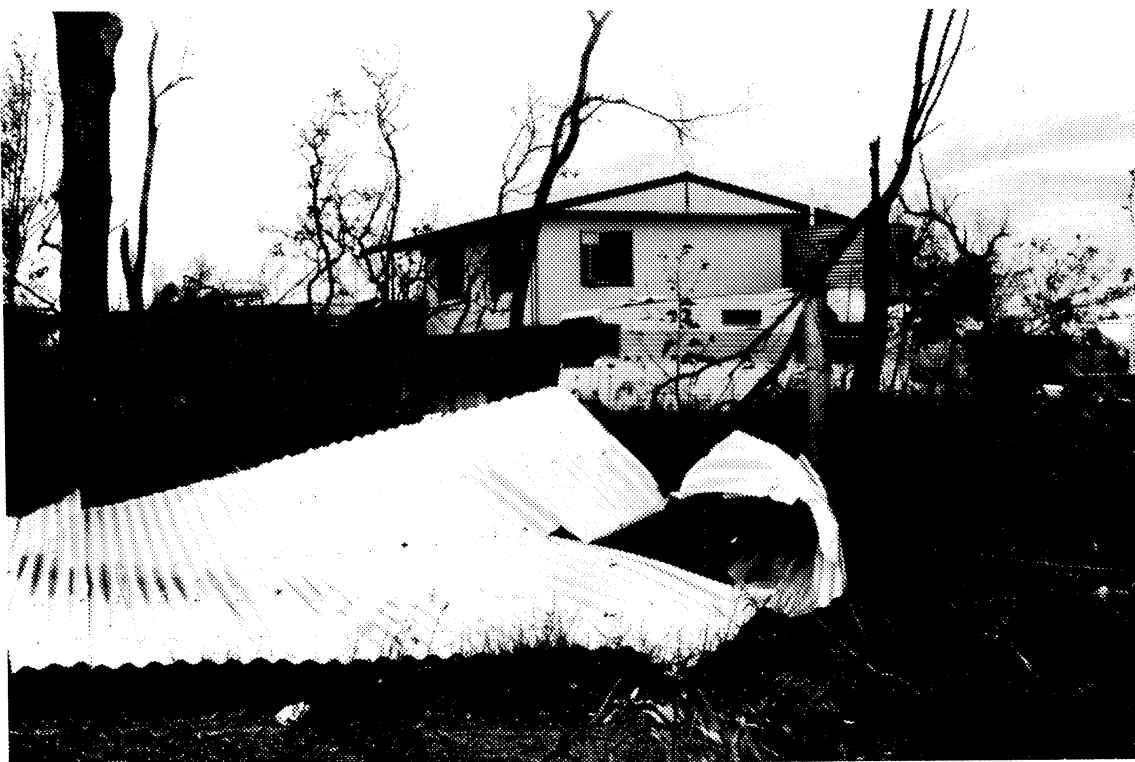
Figure 7 This carport was removed from the otherwise undamaged house in the background.

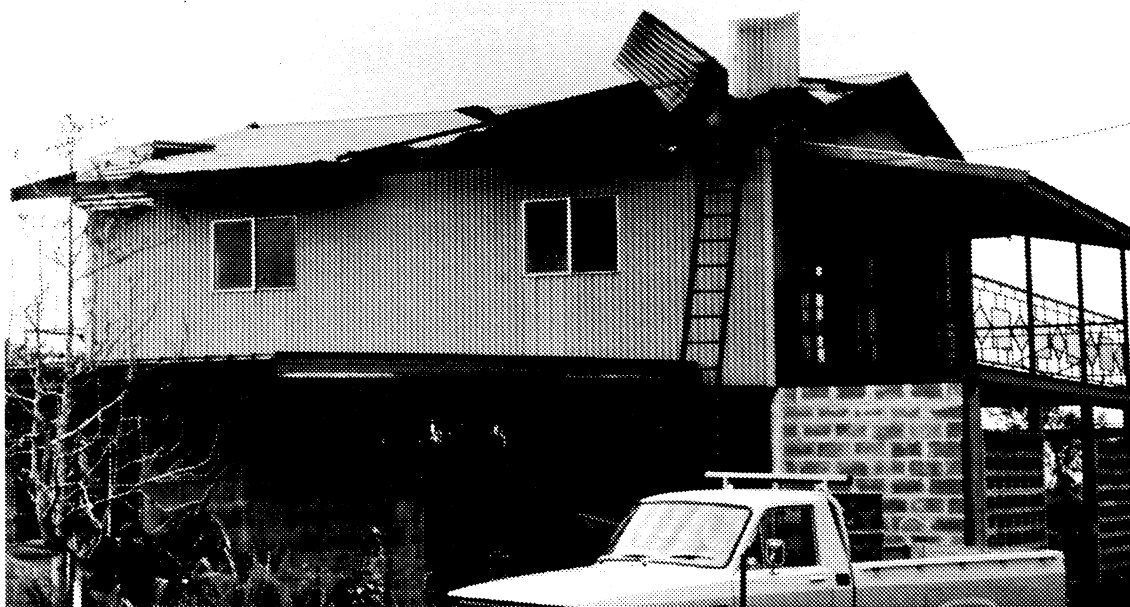
Figure 8 Roof damage near corners.

the fastening was uniform over the entire roof with no special precautions taken at corners and edges. In this case the eaves were either unlined or the eaves lining had been broken away. The strong winds had been predominately normal to the ridge line, and the sheeting in the corners on the windward side had been lifted as shown in Figure 8. The fasteners on the edge batten and the next one up the roof (over the external wall) had pulled through the sheeting, but the sheeting was still secured at the edge batten plus two.

This degree of damage was confined to the two sheets closest to the gable but the next two sheets in showed some damage at the edge batten too. Similar damage patterns were observed on a number of buildings, and some houses that had had new sheets of roofing steel fitted appeared to have suffered similar damage. Most of the houses that suffered this type of damage had battens at 900 mm centres in accordance with the Deemed to Comply Standards, but employed nails or screws with small or no washers at every second crest over the entire roof as a fastening system. This connection detail was not in accordance with the above Standard, and was shown to be ineffective even at the loads applied by the cyclone. Mention has already been made of the police housing which did have additional fasteners at edges and corners and suffered no observable damage to roof sheeting.

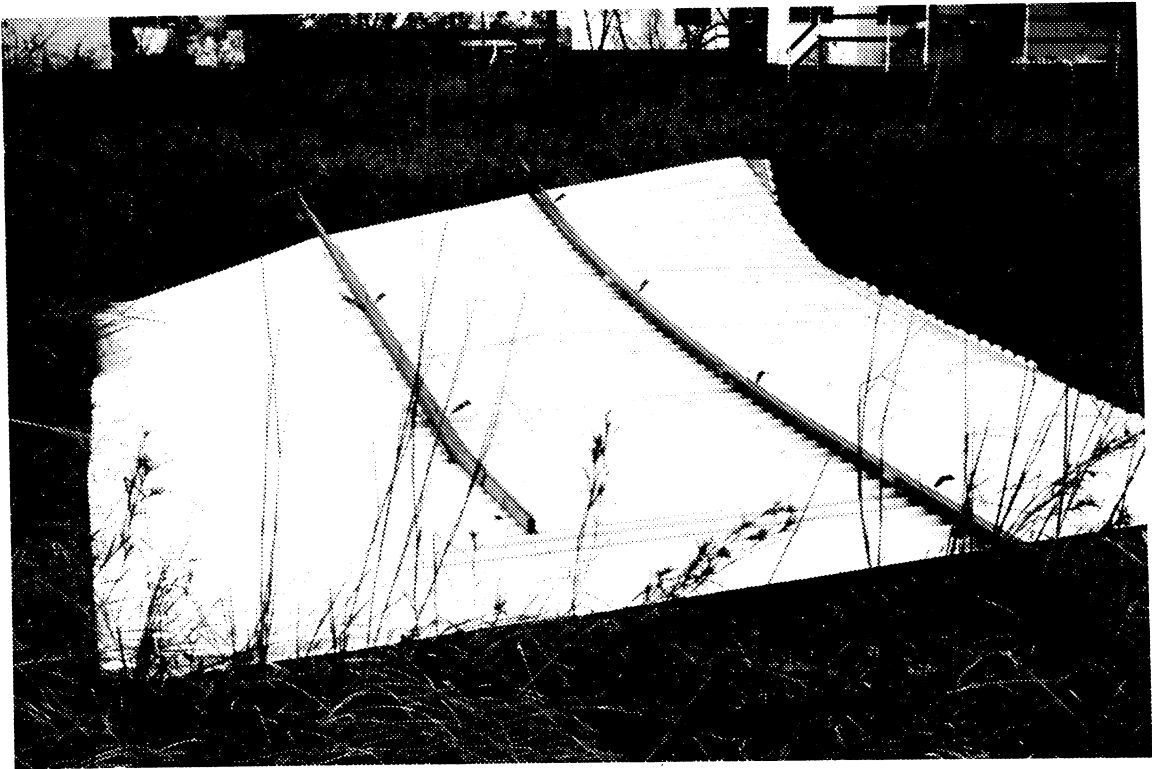
- (iii) A house that had lost a large section of roofing complete with battens: Figure 9 shows a view of the section of roofing removed. This house had a verandah on the windward side which probably led to high upward loads on the roof sheeting on the windward side of the building. The roof sheeting had been adequately fastened to the battens, but the battens had only been connected to the trusses with a single nail through the top of the batten into the truss, and a thin metal strap held to the truss with one nail on each side as shown in Figure 10. Tests on a full scale house with many more nails per strap have shown that these nails tend to be pulled out progressively under cyclic loads unless the load per nail is quite low (Boughton and Reardon 1984b). This type of failure early in the cyclone allowed significant ingress of water and also removed an effective diaphragm for transferring lateral loads. This can lead to further degradation of the structure as other diaphragms are overloaded and lateral failure of walls occurs, however in this case the ceiling diaphragm was able to sustain the load the prevent structural damage due to lateral loads.

Figure 9 Roof panel removed with sheeting still attached to battens.

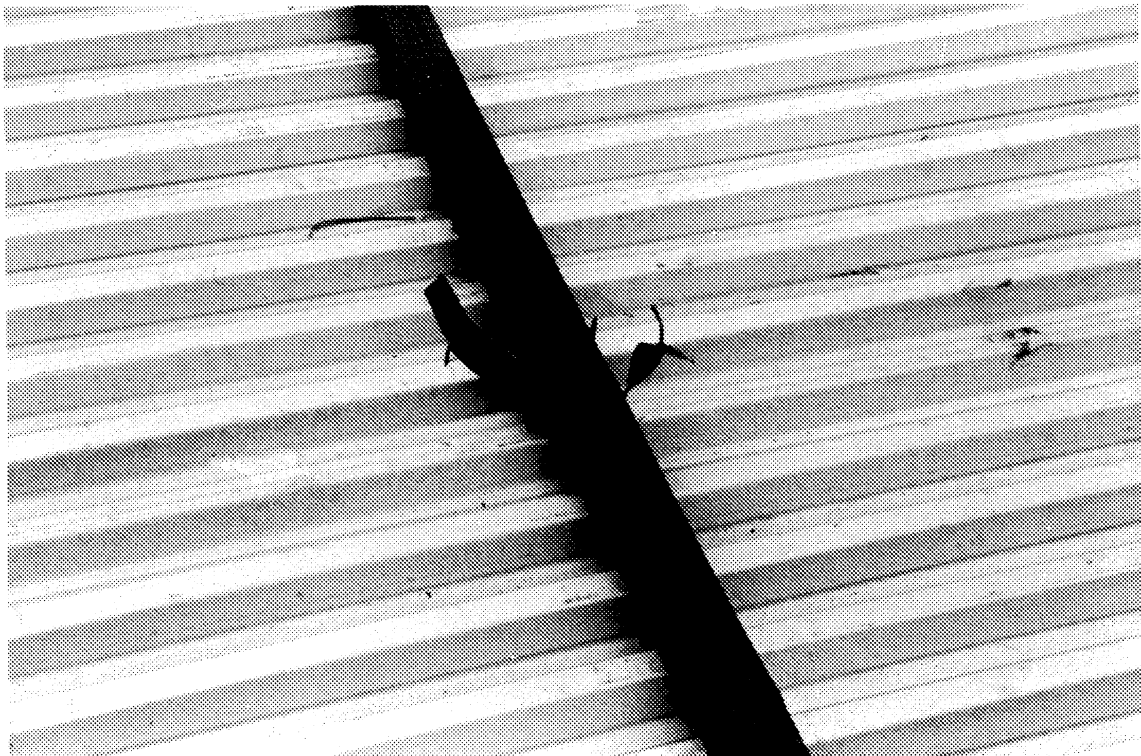
Figure 10 Detail of same panel showing one nail through batten and only one nail in each end of the strap.

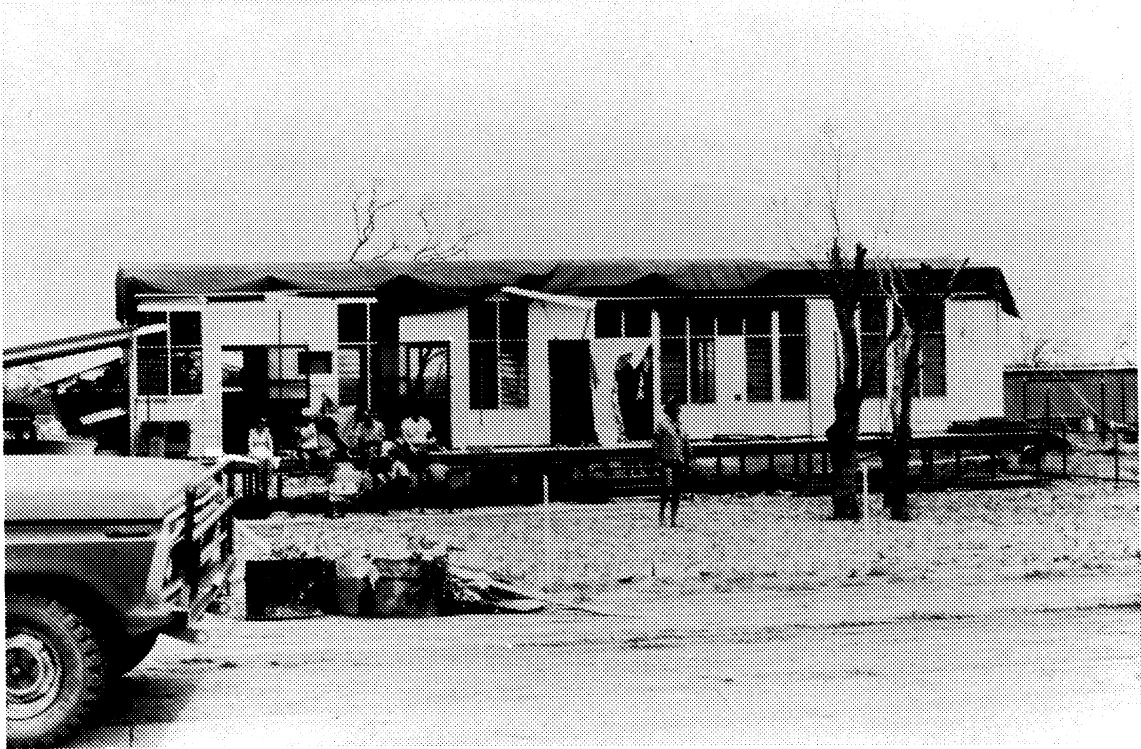
- (iv) A house with a rafter and brace type roof whose structure had been blown off as a single unit: This house had been imported from another town outside the cyclone zone and had only just been assembled on its new site. The owner was aware that the roof needed extra tie down provisions for the new location, but had not had the opportunity to effect these. The rafters were removed complete with battens and roof sheeting and carried for approximately 100 metres. It is probable that this happened early in the first part of the cyclone as a large amount of water had penetrated the ceiling and stained walls, contents and carpets. The wall and ceiling hardboard panelling allowed water to seep through joints and prevented ponding that would have brought the ceiling down and removed all diaphragms in the roof plane. The integrity of the ceiling braced the walls and prevented major structural damage to the walls. In spite of this structural integrity, the degree of water penetration will make the repair bill very high. Figure 11 shows this house with a tarpaulin over the roof preventing further ingress of water.

Figure 11 Recently transported house from outside cyclone area lost its roof structure.

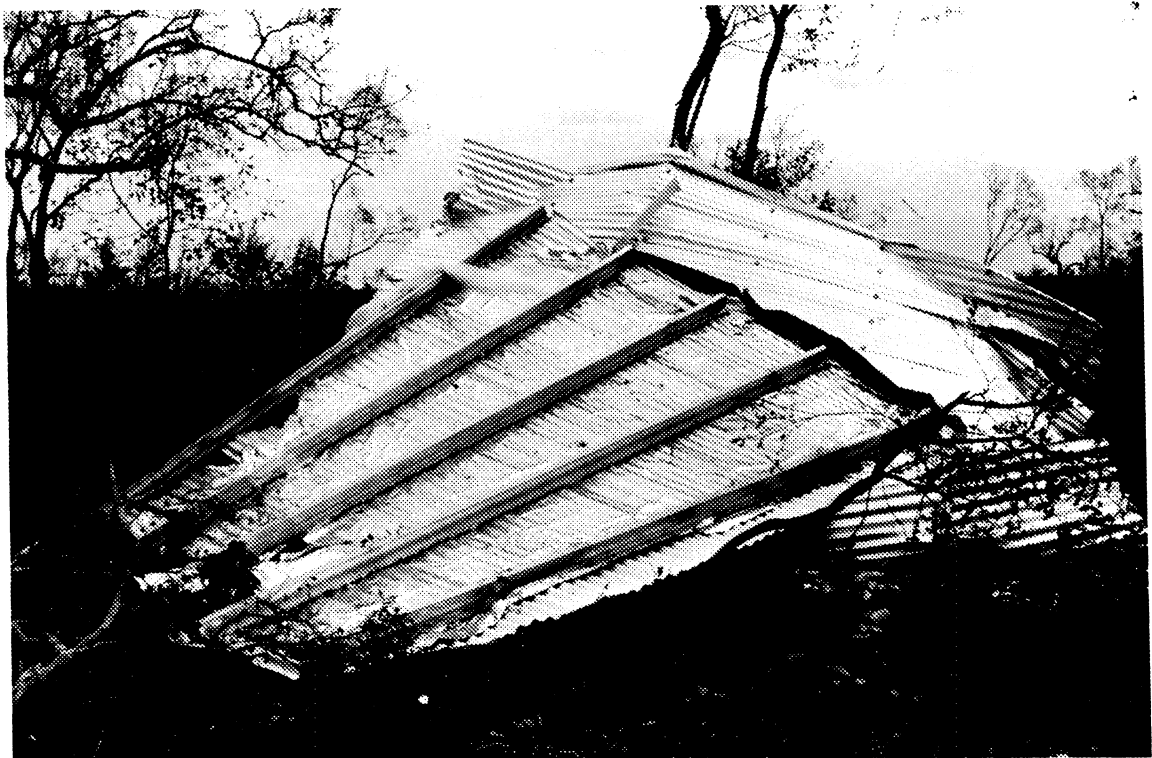
Figure 12 This complete roof structure was removed from its house causing almost total loss of walls.

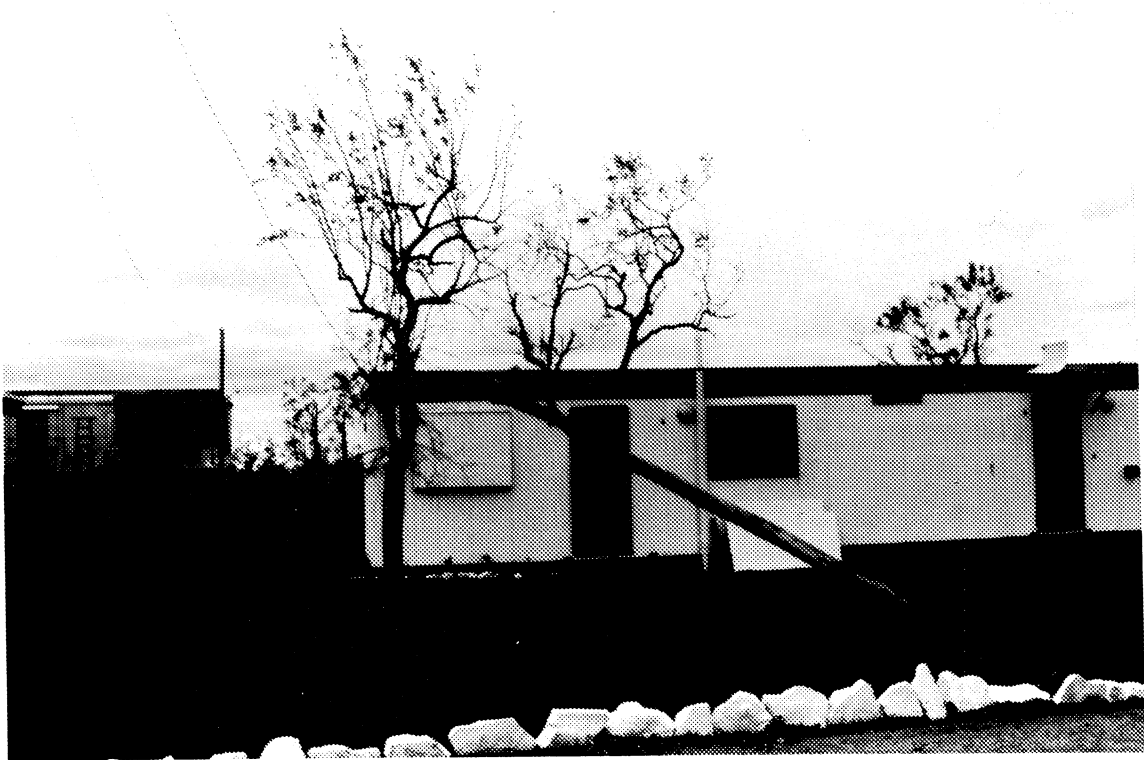
- (i) A group of transportable homes adequately restrained against overturning: These ATCO units of which Figure 13 is a typical example, consisted of transportable complete buildings. The buildings used as teachers' accommodation incorporated a heavy steel chassis of universal beam sections which was clamped in place on large concrete blocks. Metal lugs were held against the bottom flanges of the chassis by bolts cast into the concrete blocks. Fresh minor spalling of the concrete near the chassis support gave evidence to the effectiveness of this restraint to overturning. The spalling indicated that movement and force transfer had indeed taken place at this point, but overturning had been effectively resisted. We were told of some failures of large glass doors and damage to internal partitions to the teachers' residences although speedy repair work to these premises meant that most damage had been remedied within four days of the cyclone's occurrence.

Figure 13 The tie down facility of this ATCO transportable prevented overturning.

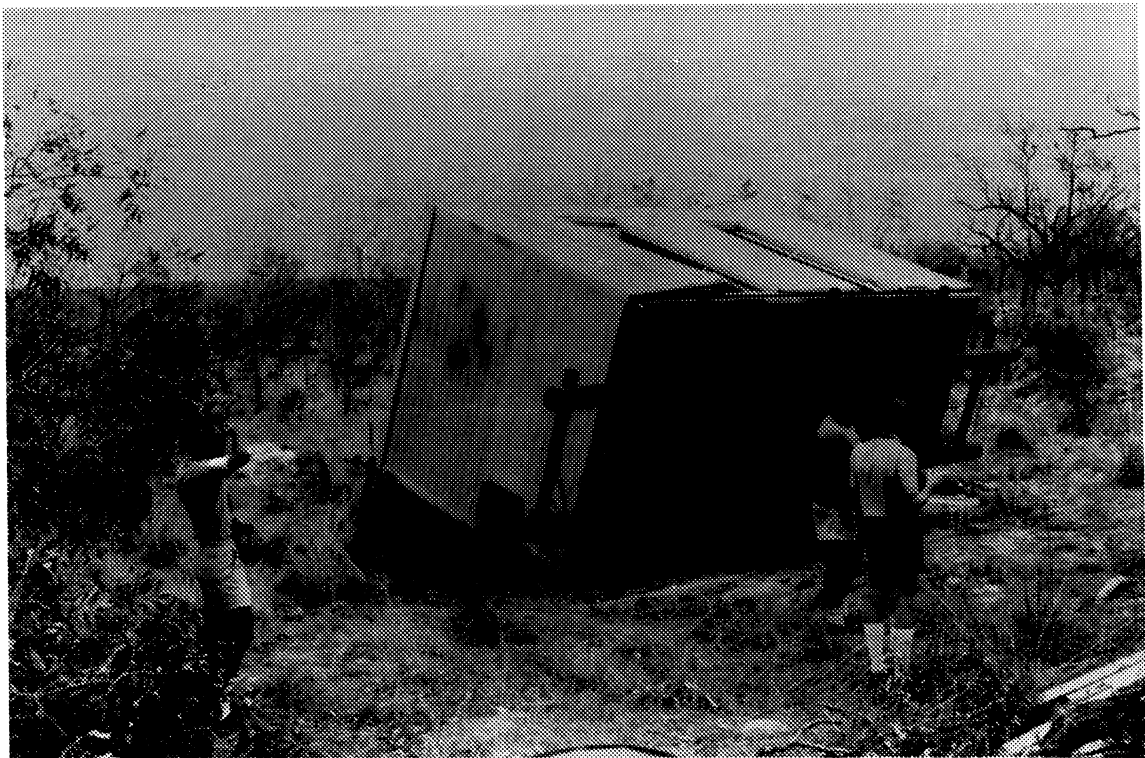
- (ii) A transportable house inadequately restrained against overturning: This house had been transported to Borroloola recently and positioned on site with no tie down provision at all. The roof on the module was profiled aluminium sheeting that had been pop rivetted to battens. The roof sheeting had torn over the pop rivets, but the small room sizes within the module and the rigidity of the walls had prevented significant distortion of the remainder of the module. Rather the lateral forces on the building had caused it to overturn so that one wall was lying on the ground with the roof and the chassis in a near vertical plane as shown in Figure 14. The position of the building indicated that winds primarily from the north had caused the overturning. The building had just been towed into position and no attempt had been made to tie it down. The robust and transportable nature of the building means that it should not have sustained much structural damage in spite of its spectacular position.

Figure 14 This transportable had no restraint against overturning - it had only just been positioned on site.

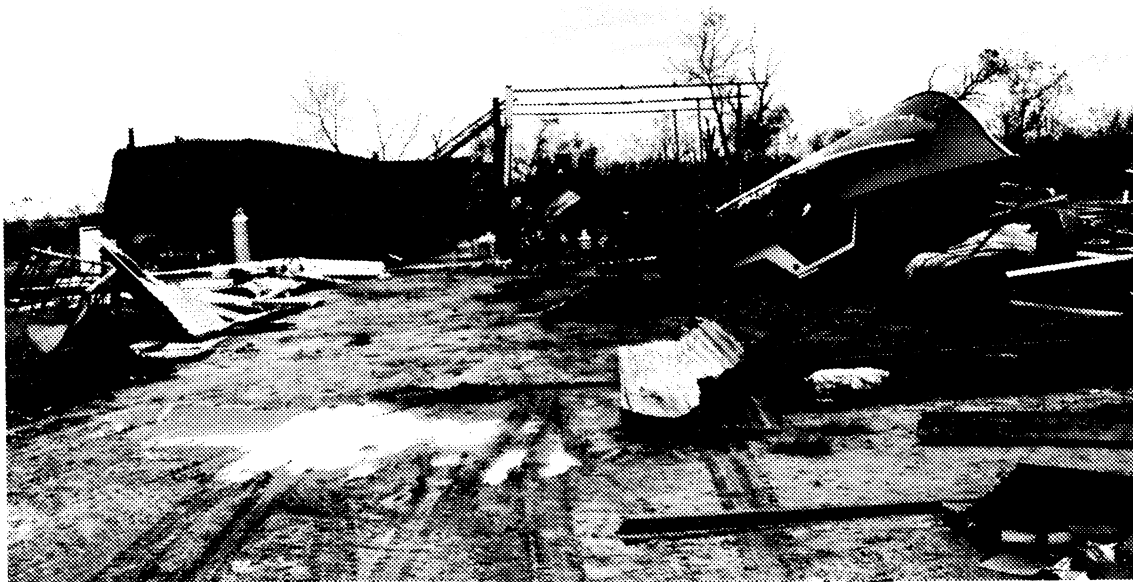
Figure 15 The house on this site was a total loss - The boat was also badly damaged.

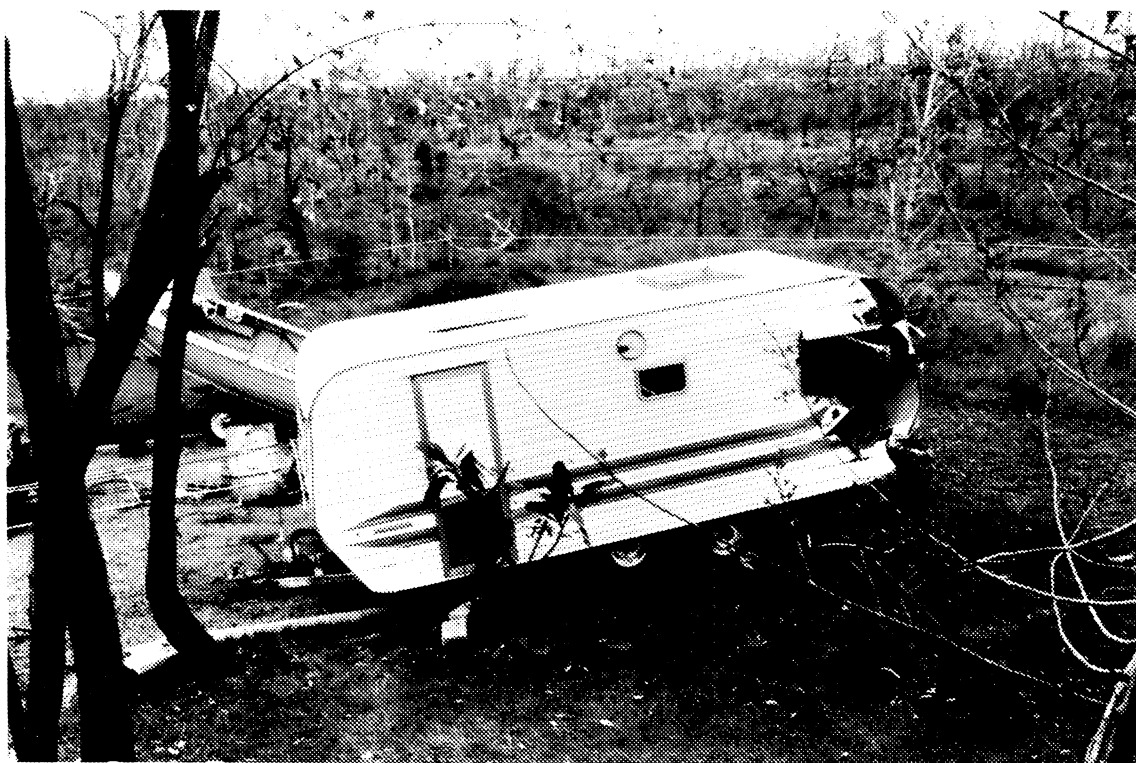
Caravans too generally fared poorly. Generally the very light construction proved susceptible to debris damage, and where the strongest winds were presented to the side of the caravan, overturning occurred. There was little evidence of caravans being tied down in preparation for the cyclone. Some caravans were totally demolished, but none were free of damage. Figure 16 shows typical damage. Of the two caravans that had been towed from Borroloola 9 hours before the cyclone's arrival, one was blown over not far from the town. Unfortunately the road took them right into the path of the eye of the cyclone.

Figure 16 Few caravans were adequately tied down - This was one casualty.

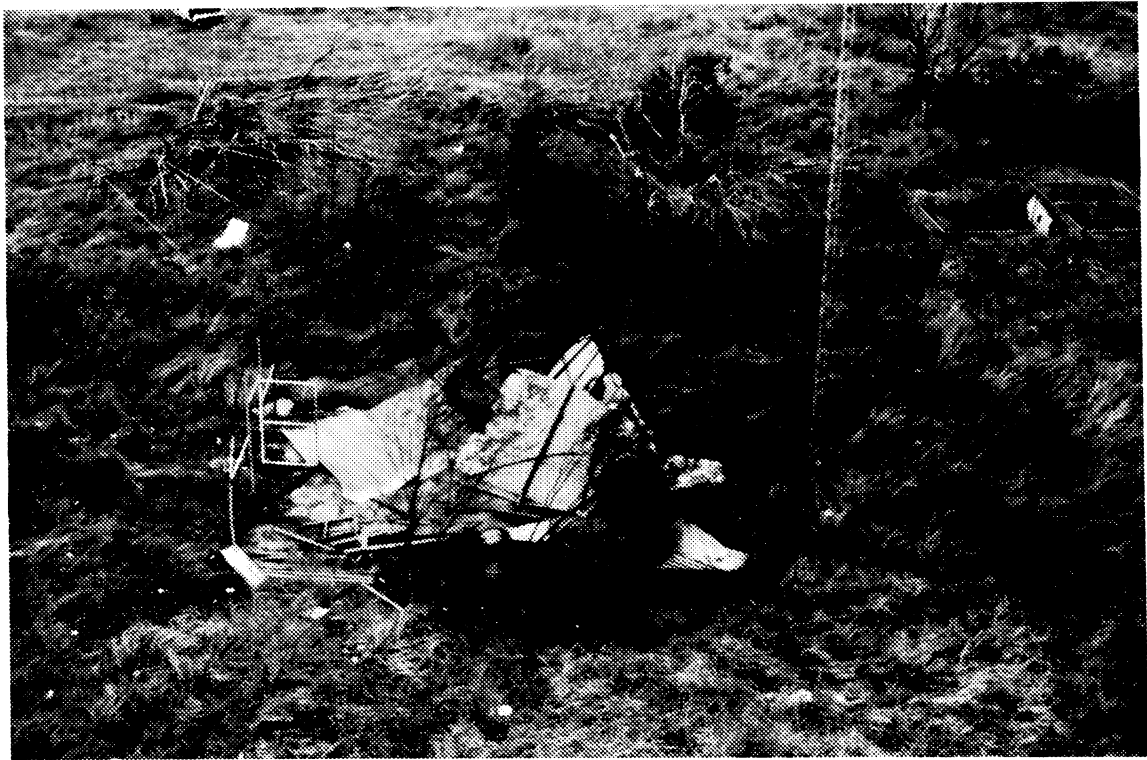
rolled over many times and broken up by a combination of wind pressure and impact due to overturning. One such shed had wall sheeting over 300 metres from its original site. Most of the panels of which the sheds were made did not disintergrate, but separated from other panels as shown in Figure 17.

Figure 17 This light steel shed and its contents were a total loss.

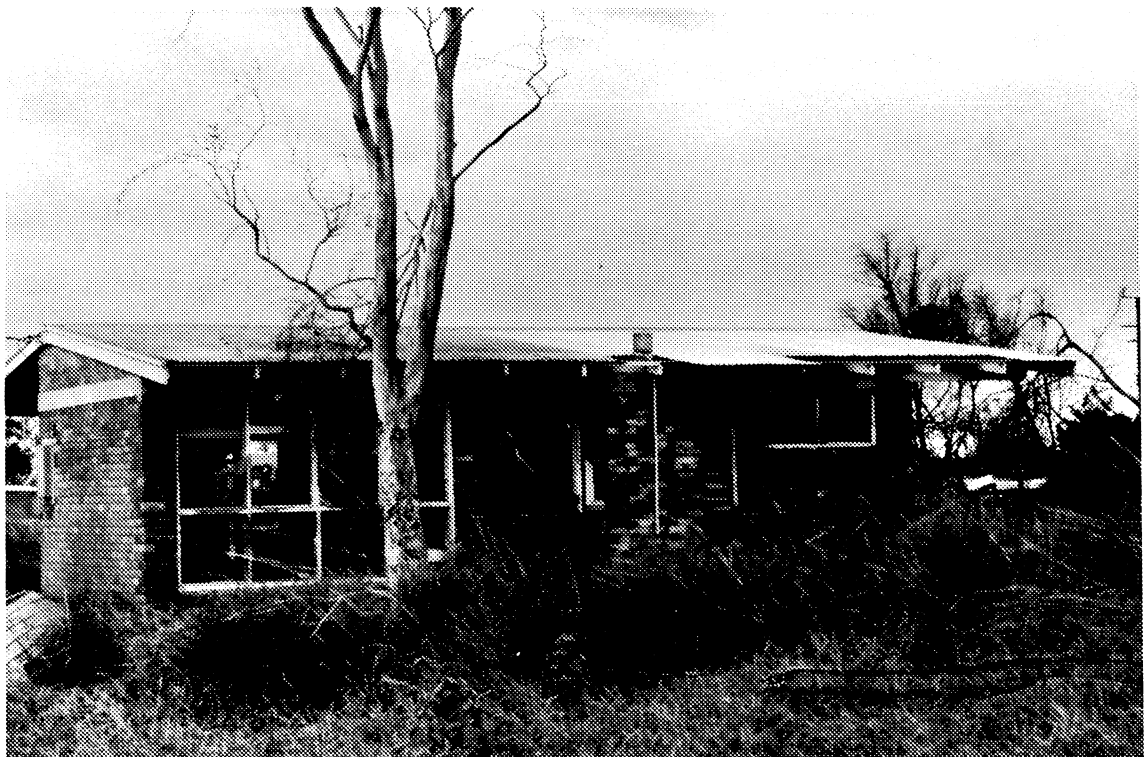
- (i) **Masonry construction Aboriginal Housing:** These houses were of concrete brick construction and there seemed to be about ten identical such houses in the town. They showed very little sign of wind damage. Some louvres may have been lost due to debris damage and certainly some sheets of corrugated steel roofing were lost during the cyclone. Most of the roofing damage occurred near the ends of the roof where no extra fastening had been employed. At least four of the houses were damaged in this way indicating that the problem was systematic. The roof structure, however was quite intact so repair work could be easily effected, and in fact all of these houses were quite servicable within four days of the cyclone as shown in Figure 18.

Figure 18 This masonry aboriginal housing lost some roof sheeting but could be quickly repaired.

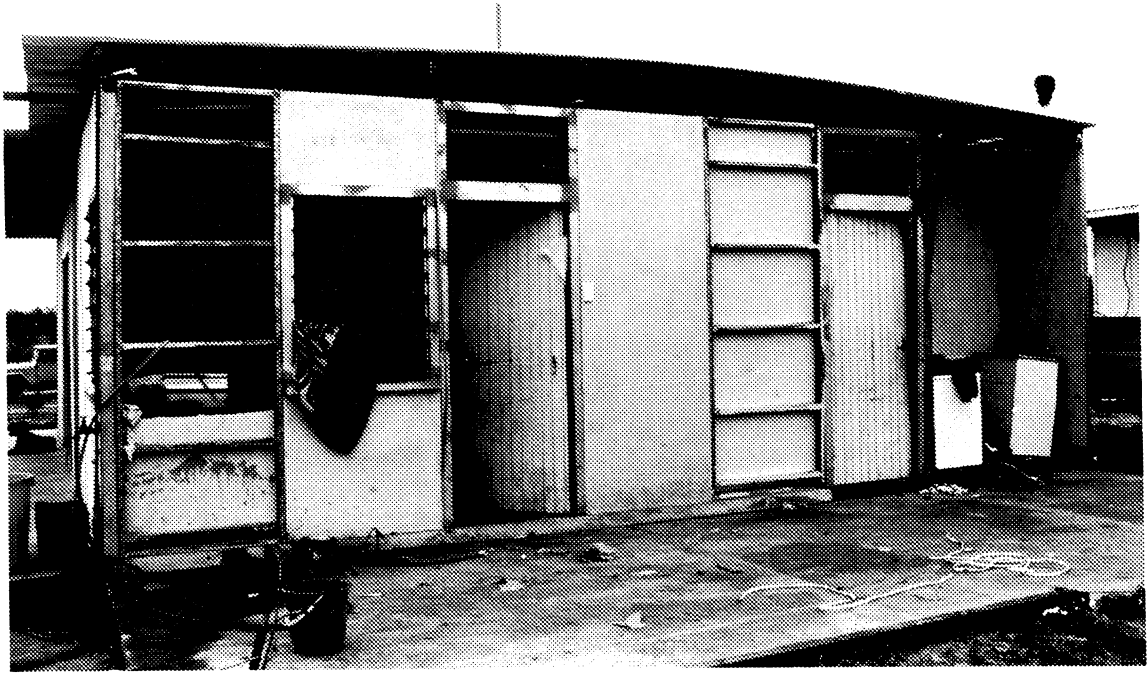
- (ii) **Bell Kit Homes for Aboriginal Housing:** These houses were of light gauge steel frame with fibre cement sheeting glued to it. The roof sheeting was screwed to graded Z section purlins which in turn were bolted to the top of the wall mullions using angle brackets. The houses had minimal eaves but large open verandahs at the back which also corresponded to the windward side of the houses. On one building, the verandah had been completely removed as shown in Figure 19, while on an identical building next door the verandah was quite intact. The verandah was supported on the open end by a steel RHS portal, which at the bottom was tied to a concrete slab. On the house which had lost the verandah, the site was quite level and the verandah floor was concrete which at the corners was less than 80 mm thick and

Figure 19 This steel framed aboriginal house lost some external cladding, and a large open verandah.

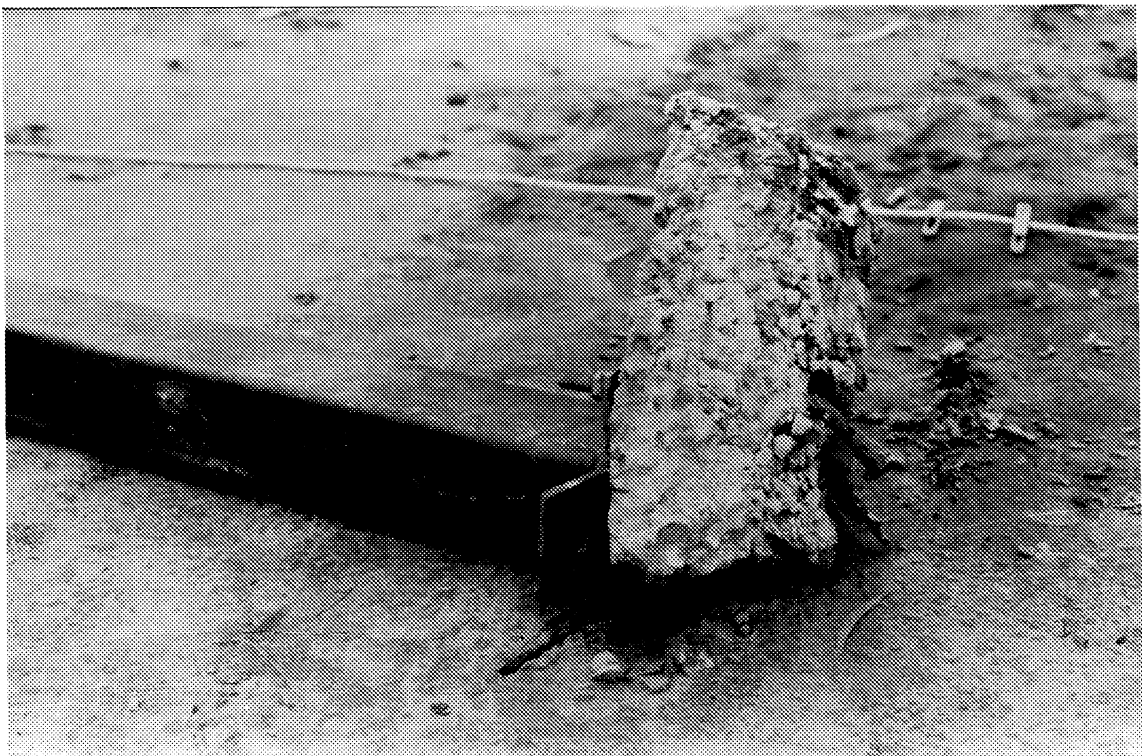
Figure 20 Detail showing failure of concrete slab at tie down column.

unreinforced. Bolts adequately secured the RHS verandah posts to the concrete floor, but the concrete had failed in shear adjacent to the column, and a small plug was still attached to each of the verandah posts as shown in Figure 20. The house next door with the undamaged verandah had thicker concrete at the edges due to its sloping site and this may well have increased the shear strength of the floor so that it could adequately transfer the uplift forces to the floor mass.

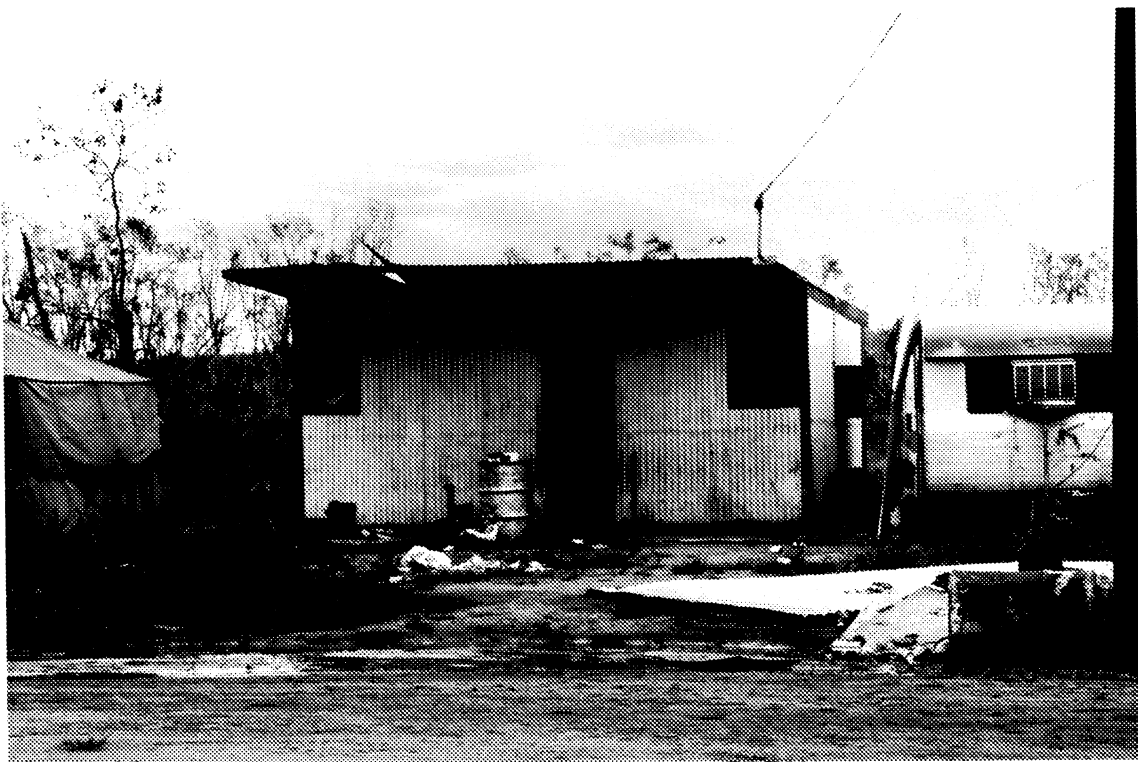
Figure 22 Aboriginal camp housing looking into direction of maximum winds - Little damage.

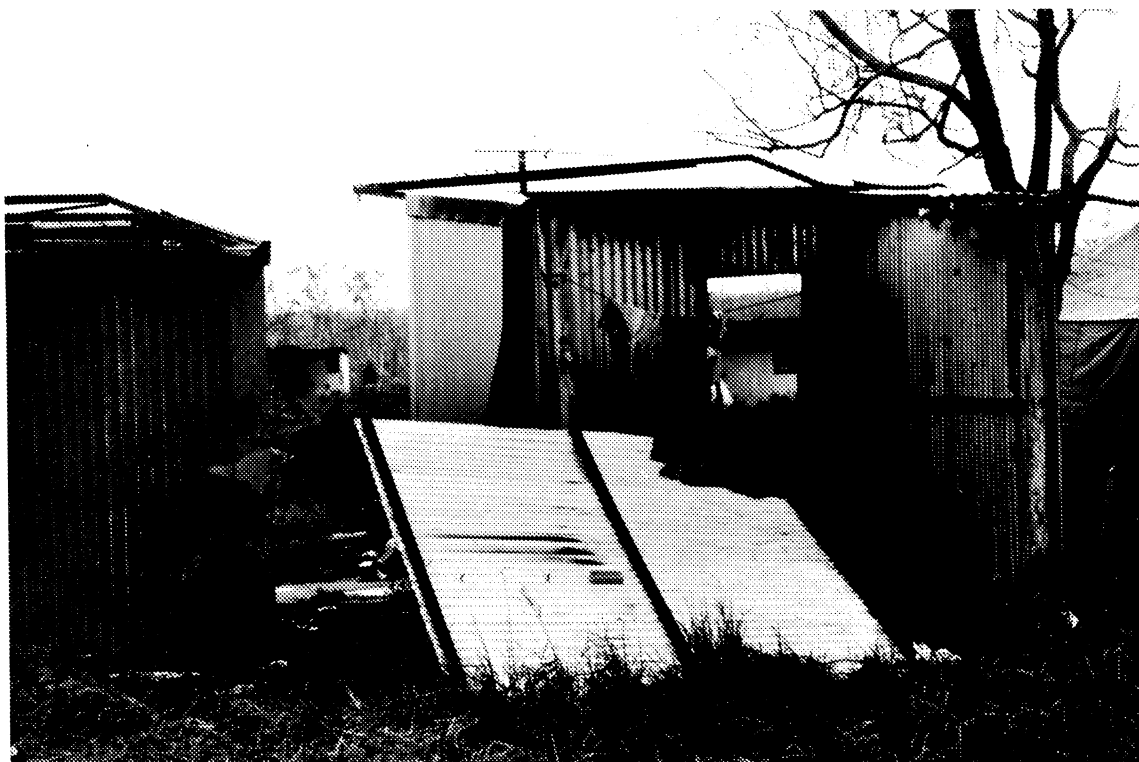
sheeting had been blown off the cantilevered verandah leaving the frame behind, and in some cases, the roof sheeting had lifted off the enclosed part of the building too, as shown in Figure 23. The major openings in the enclosed space faced the verandah, so in the event of a door being left or blown open, significant positive pressures could be developed within the house and would have assisted in the removal of the roof which was fastened to frame members that were approximately 1200 mm apart. It appeared that internal pressures had played a big part in determining the fate of these buildings.

Figure 23 An almost identical building totally destroyed - Verandah and dominant openings on windward side.

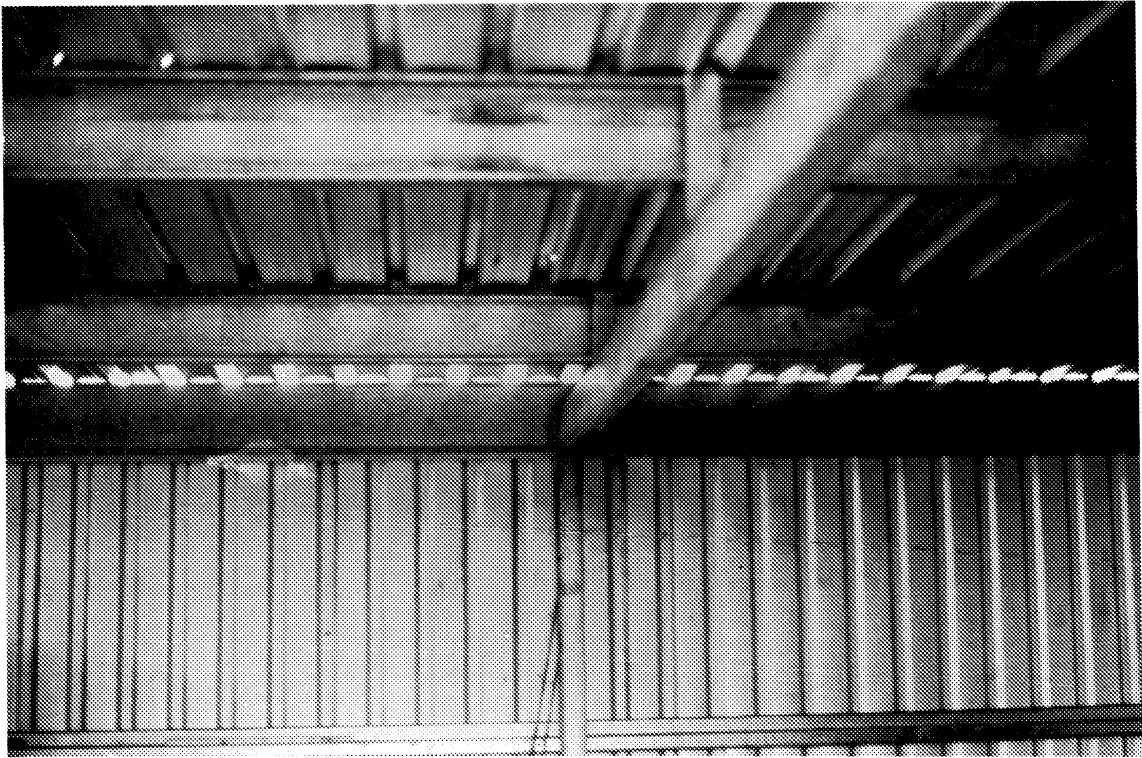
- (i) Two steel clad flat roofed buildings used as homes: These houses, built after the style of light industrial buildings suffered minimal structural damage. One had sustained some debris damage to a wall and the other had lost one sheet of roofing, but the overall performance of each was very much better than that suggested by their construction details. Neither building had any separate structural bracing and both were unlined as illustrated in Figure 24. This meant that all bracing resistance to the lateral forces on the buildings had to be provided by the external skin. Laboratory tests have shown profiled steel cladding to be a very stiff diaphragm (Nash and Boughton 1982) and the experience of both of these buildings bears that out. One building used light gauge steel C sections for purlins and girts spanning approximately 5 metres, and spacing of 1200 mm. The other employed 75 x 50 mm timber battens and girts spanning approximately 4 metres and spaced at 1200 mm. The fastening of the roof sheeting to battens and purlins was at approximately 150 mm centres throughout the entire roof, but the purlins and battens were secured to the frame with very light fasteners. The building that utilized the steel purlins had four pop-rivets at each end of the 5 m span securing the purlin to the portal frames as shown in Figure 25. They showed no sign of distress at all in spite of the fact that the average area of roof held down each pop rivet was 1.5 m²! Certainly the failures of other roofing systems indicate that the performance of the pop-rivets was quite extraordinary. Each of the walls of the four buildings had quite large openings some of which had louvre windows, which were left open by the owners during the evacuation. Thus the net internal pressure was again probably negative, assisting the fasteners in restraining the roof. The owner of one of the sheds assured us that it was approved by a tertiary education institution, but its good performance was largely due to the precautions taken by the owners rather than to the design of the members and connections.

Figure 24 View inside light gauge steel building showing total lack of bracing members.

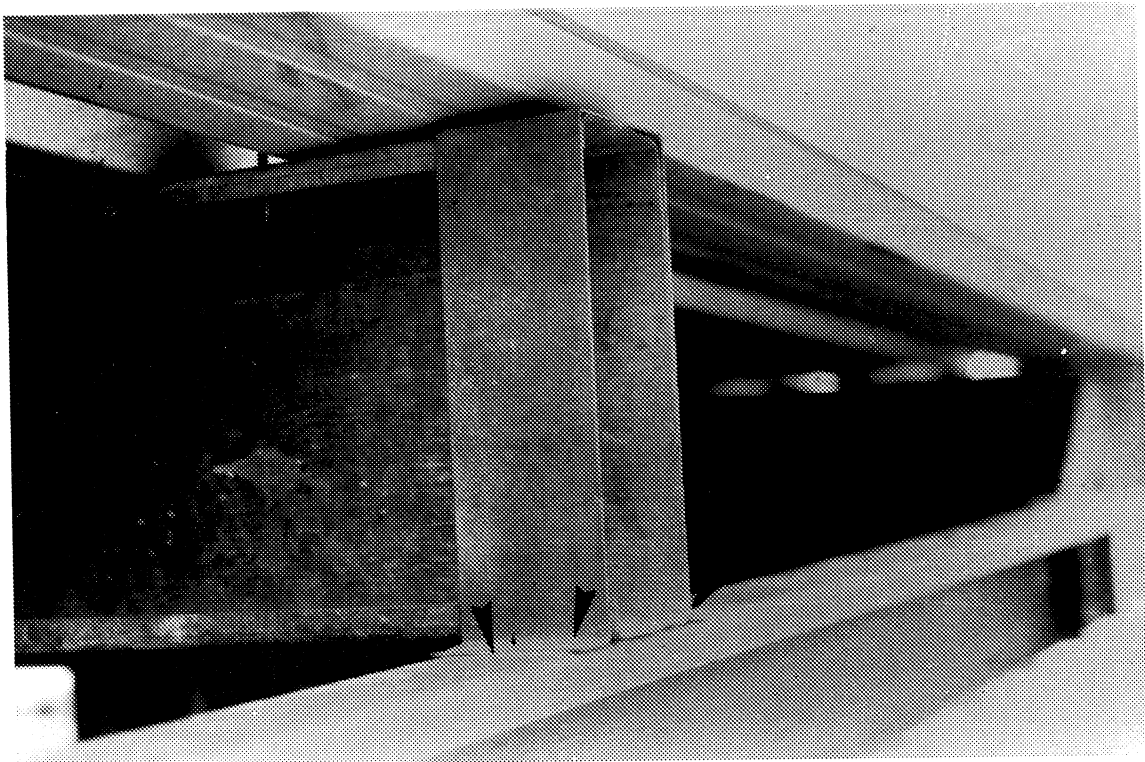
Figure 25 Another view in same house showing fastening of purlin - 4 pop rivets only between strap and frame.
