CYCLONE TESTING STATION

STRUCTURAL DAMAGE CAUSED BY
CYCLONE 'KATHY' AT BORROLOOLA, N.T.
MARCH 1984

Technical Report No. 21

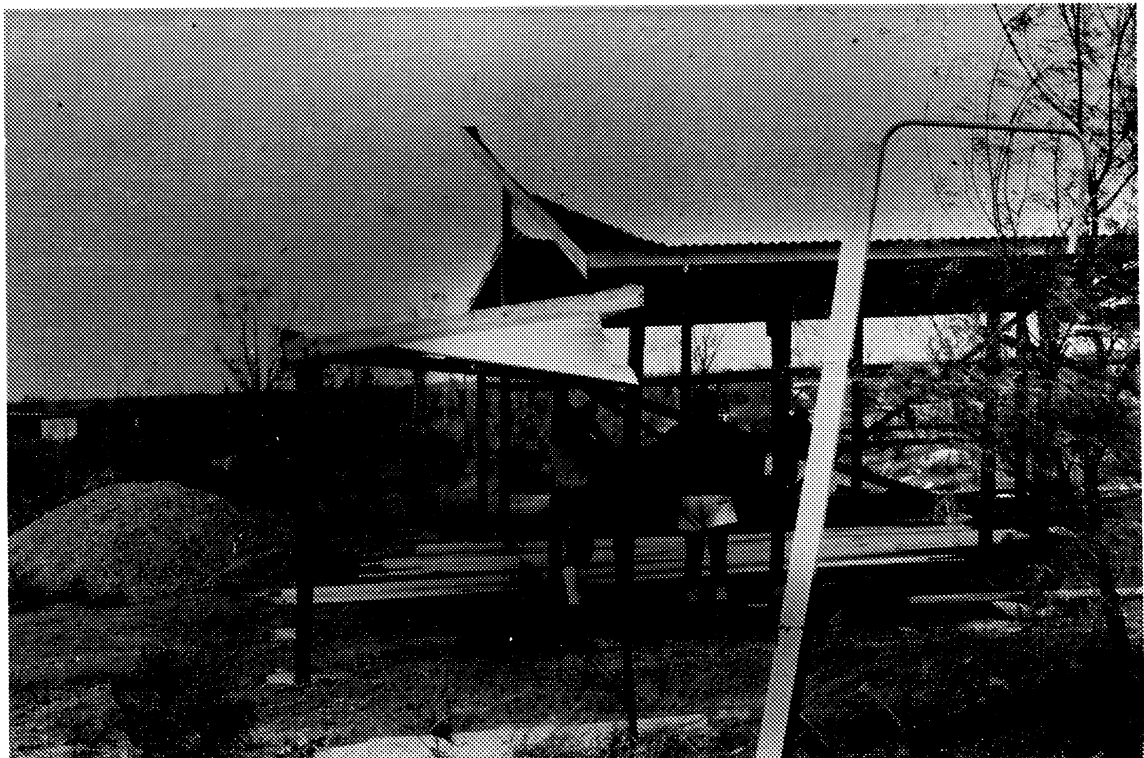
was not complete, it certainly was unable to carry the wind loads placed on it. The roof sheeting had pulled over the screw heads near the corners as detailed for other buildings in Section 4.3. The purlins had been skew nailed to the roof beams in some locations and this detail had not proved adequate to carry the applied wind loads. Both these failures may have manifested themselves had the house been complete when the cyclone struck. However the building frame had racked significantly under the lateral loads attracted by the bare frame and roof as shown in Figure 26. The temporary braces were held in place at each post with nails that had not been driven home and as a result the brace could move away from the posts and bending of the nails then rendered the connection ineffective. The one wall that had been clad lost its sheeting when the wind blew through the open house onto the internal face of the cladding lifting it over the nail heads. The house in that condition was essentially unbraced and the racking failure was therefore inevitable. By contrasting this structure with the previous one where bracing was achieved only by using ribbed steel sheeting, the steel skin on the previous house can be seen to be a very effective bracing element.

Figure 26 Partially completed house showing racking of the frame

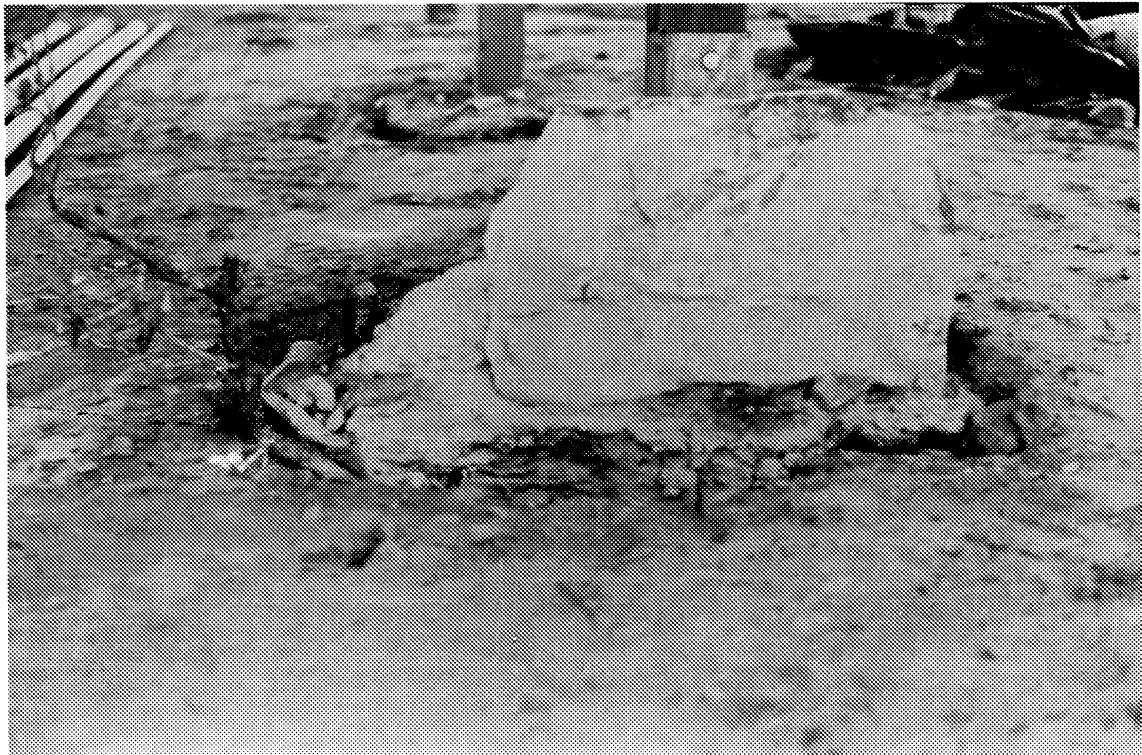
Another type of failure observed on this house, but not elsewhere in the town was the lifting out of the ground of the concrete pads on the end of the posts as shown in Figure 27. Some of these had been lifted over 50 mm in the course of the cyclone but had dropped back in much the same location as the winds abated. Soil filling the space vacated by the concrete prevented them from returning to their original position. This illustrated the severity of the uplift forces on the upper surface of the roof as the internal pressure would have been effectively zero due to the complete lack of walls.

Figure 27 The same house showing uplift of footings

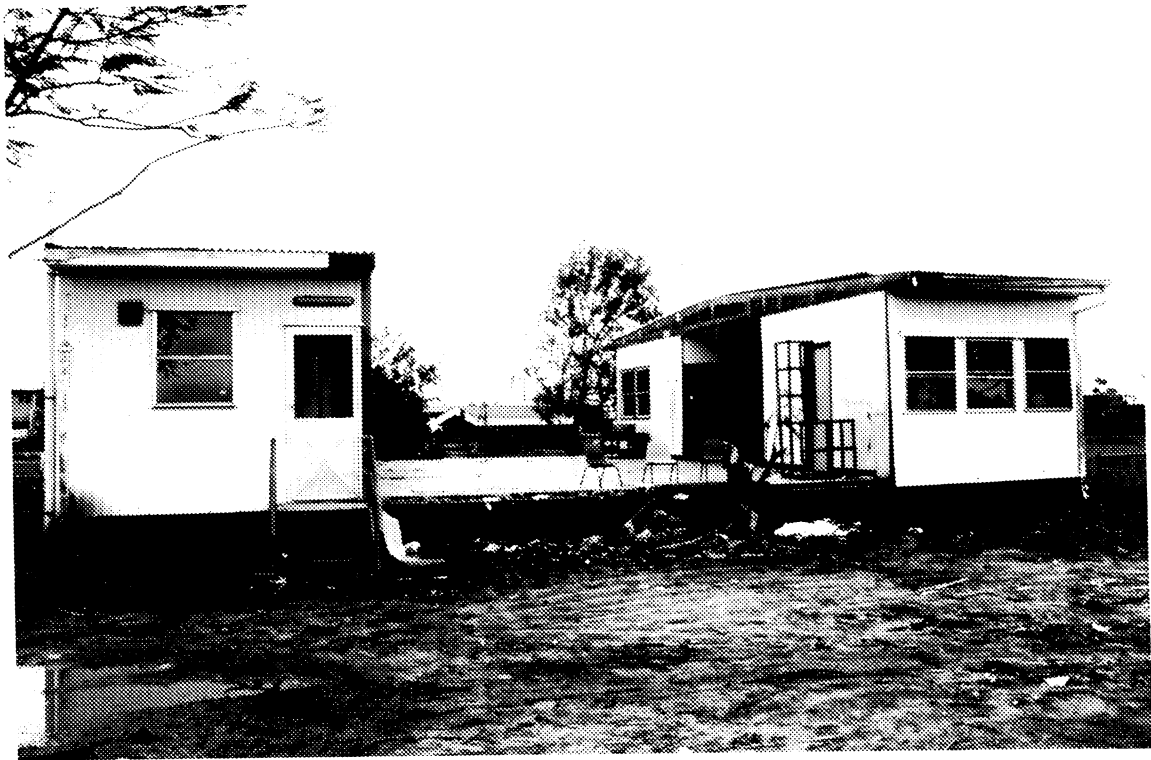
The lateral loads on the windward wall had pushed the two centre modules in leaving the roof on the floor, but the end modules were still quite sound as shown in Figure 29. The roof sheeting had carried a large amount of the lateral load from the centre modules to the end modules, and tearing of the sheeting at the lap joints as shown in Figure 30, indicated that some movement had occurred within the roof diaphragm prior to failure. This failure could have been prevented by tying the roof trusses together effectively at each joint between modules.

Figure 29 Kindergarten Building showing end modules intact.

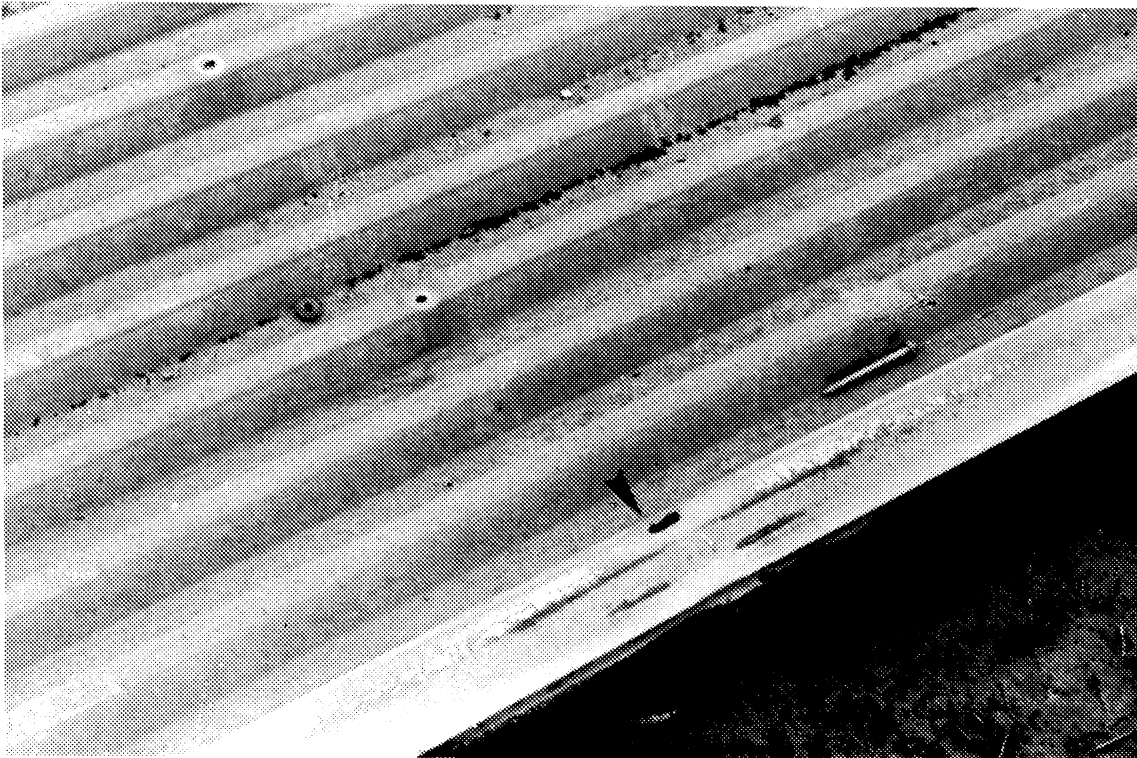
Figure 30 Detail of roofing from kindergarten. Note slotted holes at lap.

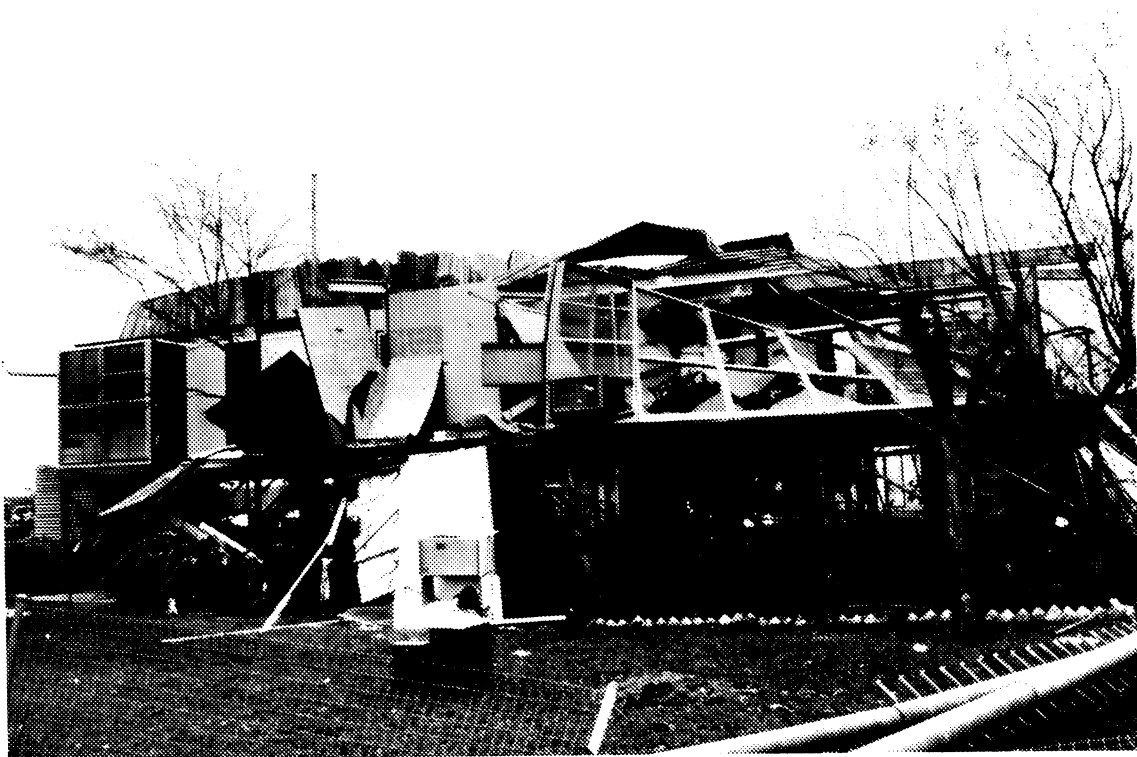
- (iv) A High Set Light Gauge Steel Framed house - The Welfare House: This house was supported on steel columns with very solid welded steel bracing and a blocked in laundry underneath. The floor deck was quite intact and the sub-floor bracing showed no signs of distress. However the house above floor level had sustained considerable damage as shown in Figure 31. The most obvious damage was the failure of the roof over the front half of the house. The basic construction of the house was a series of light gauge steel framed panels forming the walls with Z section steel purlins bolted to the tops of each wall mullion. The direction of the strongest winds was nearly normal to the front wall, and in this part of the building the large rooms gave a total of only four purlin tie down points over the entire width of the house. The high uplift forces on the top of the roof near the windward edge, coupled with significant uplift under the wide eaves caused high loads to be transmitted to the bolts tying the purlins to the wall mullions. These bolts tore slots in the mullions and hence the purlins lifted away from the top of the wall. The loss of the roof over the windward wall meant that it was no longer available to support the top of the wall and as a result the windward wall has been pushed inwards along much of the front of the house. The loss of this wall undoubtedly

Figure 31 'Welfare House' - severe damage.

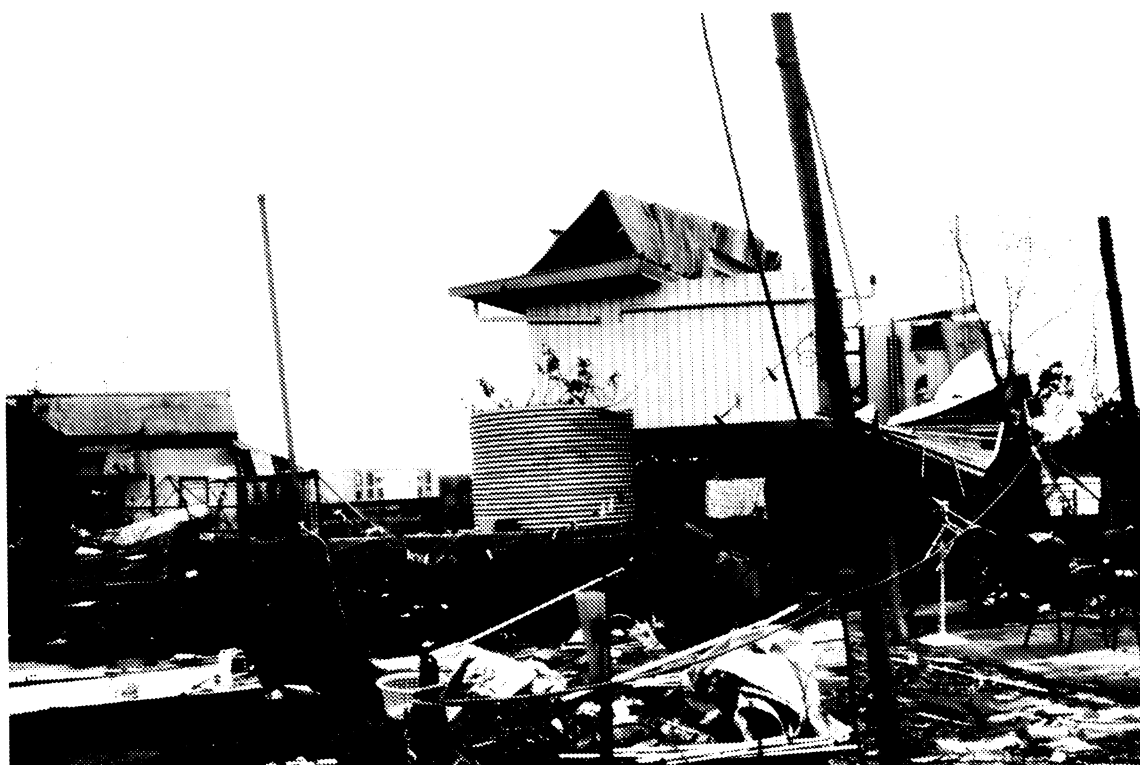
Figure 32 'Welfare House' from end showing roofing folded back along centre line.

would have caused an increase in internal pressure which would have assisted in the removal of more of the roof sheeting. However the purlins on the back half of the roof were tied down at more than 6 locations due to smaller room sizes being utilized at the back of the house. This factor, together with the generally lower external uplift pressures on the back half of the roof contributed to the purlins in the back half of the house remaining fastened to the walls and the roof in place. The roof sheeting had been bent in two along a line that roughly followed the centre of the roof, with the roof sheeting from the front half lying on top of the roof sheeting on the back half as shown in Figure 32. Many of the purlins were still attached to the sheeting, but just removed from the walls over the front part of the house. This house again illustrated the important function performed by the roofing as a bracing element in that once it had been lost, the whole structural integrity of the house was jeopardised. This type of failure has been demonstrated on a house tested in the Cyclone Testing Station's full scale house testing project (Boughton & Reardon 1984a). The failure of the top of the light gauge steel wall mullions

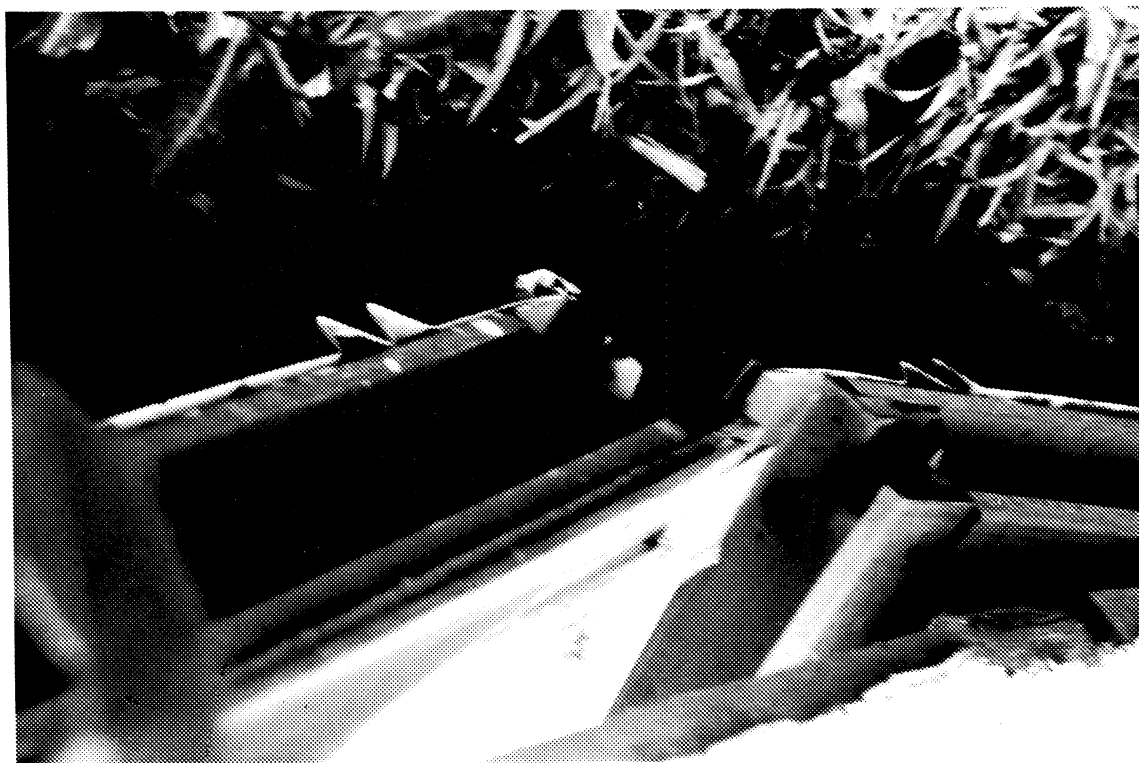
Figure 33 Detail of failure between top of walls and purlins. Note holes in top of mullions are torn.

in tearing, shown in Figure 33, could well have been assisted by fatigue in the steel due to the repetitive nature of the uplift forces and if so bears similarity to failures in light gauge steel sections experienced in controlled cyclic loading tests as part of the Station's work.
