TESTING A LOGAN UNIT HOUSE DESIGNED FOR 63m/s WINDS

TECHNICAL REPORT No. 22

G.F. REARDON

G.N. BOUGHTON

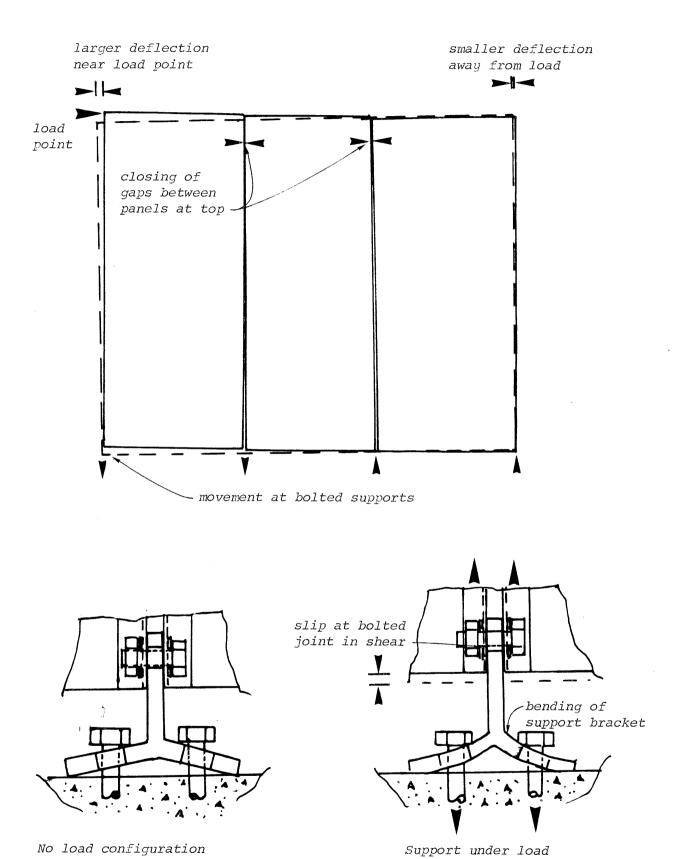
Figure 7. Assumed racking resistance mechanism.

The displacements of the transverse walls of different numbers of panels enabled the racking resistance mechanism to be identified for loads up to design loads. The mechanism identified the principal source of lateral displacement to be overturning of the wall, with most movement at the bolted connections to support brackets at floor level. The bolting between panels proved effective in transferring shear forces between the panels, enabling a multipanel wall to behave as a single composite element. In determining this mechanism, it was assumed that each panel remained rigid, but that the gap between panels could close slightly at the top.

This mechanism was established by assuming different mechanisms and calculating the predicted stiffness of each wall. By comparing actually obtained stiffnesses with predicted stiffnesses, the error in the assumption could be found. It was minimised using the mechanism presented above and illustrated in Figure 7.

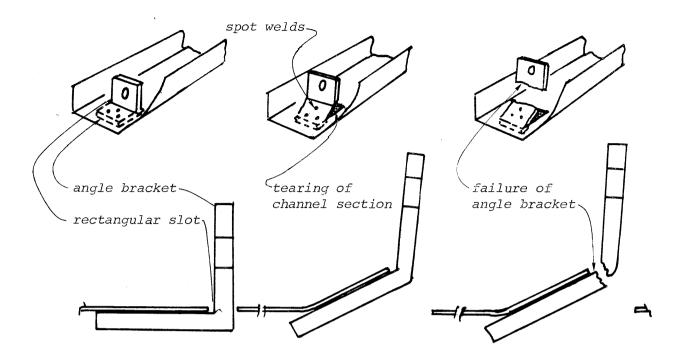
Figure 10. Failure mechanism of angle bracket.

Inspection of the damaged area revealed severe tearing of the top rail over the centre of the window. This was where an angle bracket was used to attach the purlin to the top rail of the wall. Figure 10 shows the detail. The bracket was now broken.

A visual assessment of the force paths showed that the 150 mm purlin over the outside wall was required to resist the entire pressure on the eaves overhang (one module wide) plus a contribution from the roofing spanning to the next purlin. Whilst the normal holding down detail, connecting purlin to a pair of studs, seemed adequate the detail used over the window was unable to resist the applied loads.

It is postulated that most of the tearing of the top rail occurred during the 8000 cycles of 5/8 design load. The bracket which was spot welded to the top rail resisted the first 1000 cycles of 3/4 design load as a tension member, but the fatigue stresses caused it to break completely somewhere between 1200 and 1400 of cycles in this load sequence. This failure caused the purlin to have to span the complete width of the window (two modules) which overloaded the purlin fixings to the stud at each end of the window but did not cause failure there.

As the Engineer from Logan Units was present during the test programme, the opportunity was taken to redesign the purlin hold down detail that had failed. The redesign was a relatively simple exercise as the test had highlighted the weakness in the original detail as being the lack of flexural strength of the web of the top rail. The new detail was therefore designed to transfer the purlin forces into the rail by shear rather than by flexure. Figure 11 shows the redesigned detail.
