CYCLONE TESTING STATION

SIMULATED WIND LOAD TESTS ON THE TONGAN HURRICANE HOUSE

Technical Report No. 23

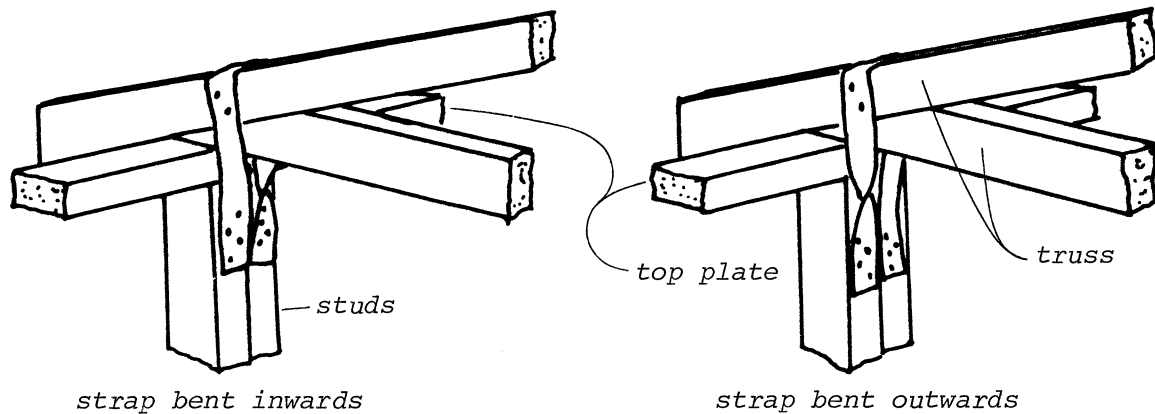
Figure 9 Details of Truss Tie Down

In the prescribed loading pattern, cycles of 5/8 Design Load were applied. The requirement was for the house to resist 800 lateral load cycles and 8000 uplift cycles of this load. However after approximately 2500 uplift cycles (and hence 250 lateral load cycles) a failure was induced in a steel strap used to tie the trusses to the studs in the wall panels. The strap that failed had been installed so that the edge of the strap that

was closest to the ridge on the roof truss was twisted outwards to be nailed to the stud. All of the other straps had been installed so that the edge closest to the ridge on the roof truss was twisted inwards at the stud. This is illustrated in Figure 9. The outwards twist on the strap that failed concentrated tensile forces at the edge of the strap more severely than the inwards twist configuration, and this probably led to a premature failure of that strap. At this stage it was noted that where only three nails had been used on other straps, the nails had started to work out of the timber. The inherent free play in the joint allowed the strap to slide down on the shank of the nail on the unload stroke, and then grip the shank on the upward stroke pulling the nail out by a small amount with each cycle. The process is illustrated in Figure 10.

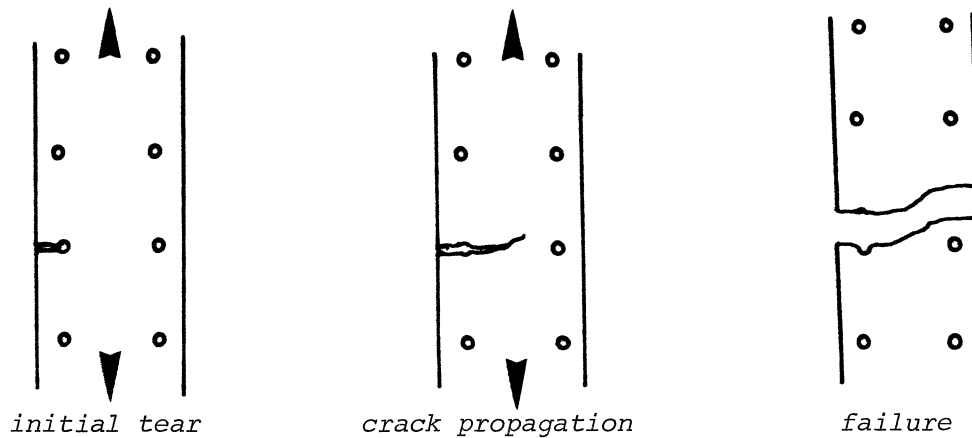
Figure 11 Progressive Tearing of Straps

between the outside edge and a prepunched hole and slowly propagated across the width of the strap as shown in Figure 11. In this case the side that had not failed was capable of carrying the required load, so the test was continued. However, at a total of 4144 two more straps failed in very quick succession giving detachment of the roof on the windward side and resulting in significant lateral deformation of the top of that wall.

It was noted that of ten such truss tie down straps in the building four had failed due to crack propagation and of these three had been on the windward wall. The tie down detail on the windward wall, not only had to resist the uplift forces but also transmitted lateral load from the top of the wall to the roof structure, where diaphragm action of the roof sheeting served to spread it to the transverse walls. Reardon (1979) obtained failure loads of approximately 10 kN by nail pull out for similar straps with three nails per leg. Had four nails per leg been used the average failure load could have been as high as 13 kN. In the test house the uplift load at failure was 5.8 kN. The load in the strap due to lateral load was variable, but if the effect of the skew nails into the top plate and friction between truss and top plate was ignored

As a result of the systematic failure of the looped strap securing the trusses to the tops of the wall, all such straps were removed from the truss to wall joints and replaced with an alternative fastening which is detailed in Section 7. The house was then subjected to a new series of cyclic tests at 5/8 of Design Load. However, because more than half of the required cycles had been successfully endured by most elements within the house, it did not seem appropriate to subject them to the full number of cycles again. On the other hand, it was necessary to adequately test the new detail in context within the house. A compromise was struck whereby 8000 cycles of 5/8 Design Uplift Load would be applied simultaneously with

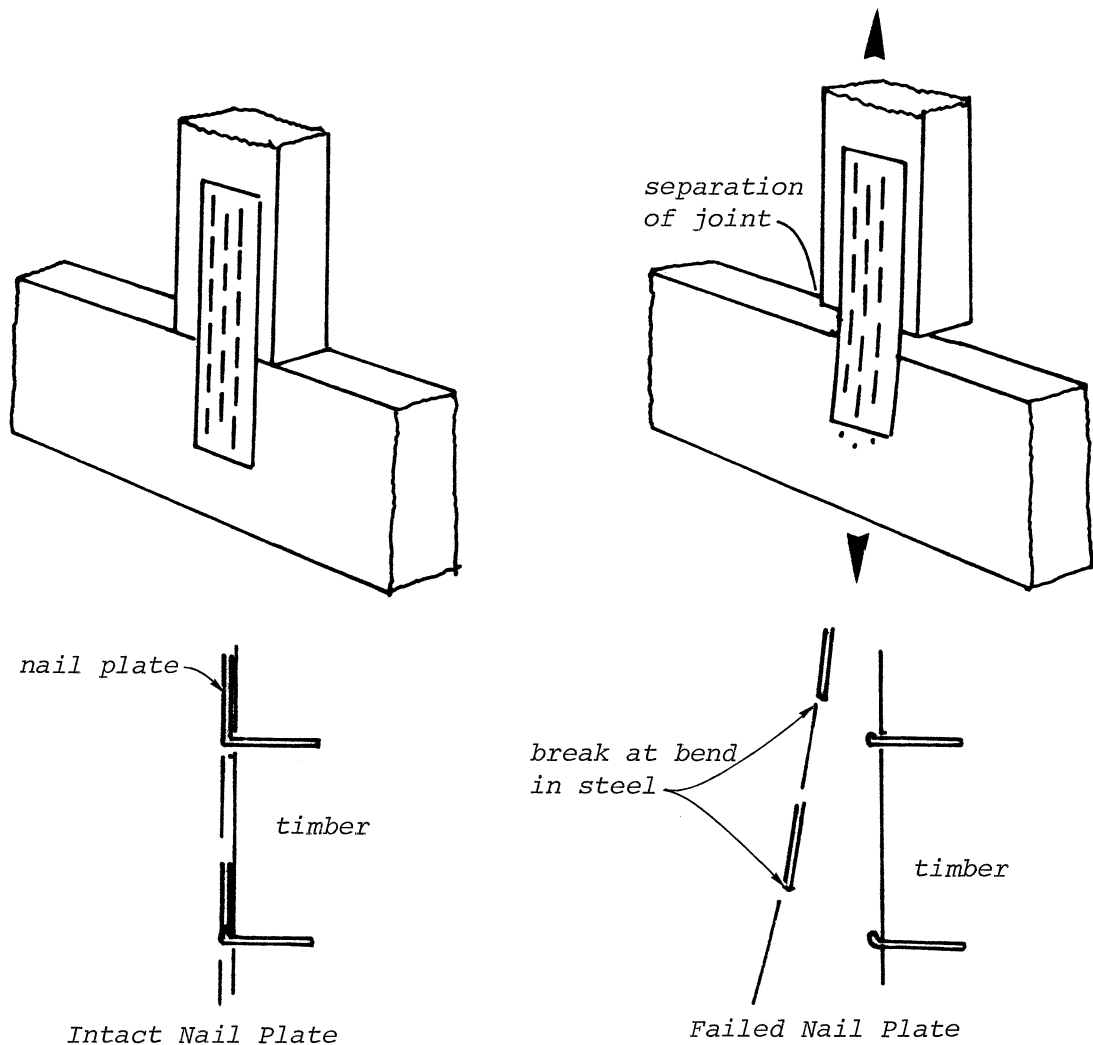
Figure 12 Failure of Nail Plate Teeth

After 5600 uplift cycles under these conditions, there were signs of structural distress in the vicinity of the internal wall. The toothed nail plates on each side of one of the short web members had failed by breaking of the teeth at the right angle bend as shown in Figure 12.

This joint acted in direct tension as the bottom chord of the truss was nailed directly to the top plate of the internal wall. In direct tension the bends in the steel nail plate tended to flex causing a stress reversal at that point. After some 5600 such stress reversals, metal fatigue had reduced the capacity of the teeth to carry load so that the entire joint had failed. The brads that secured the hardboard sheeting to the pine frame on the internal wall had also started to pull out. As the sheeting carried much of the tension from the uplift forces transferred directly from the truss to the top plate, the fasteners that held the sheeting to the top and bottom plates of the framework carried substantial load. The repeated nature of the loading caused those brads to work out of the pine in a similar manner to that described for the nails in the truss tie-down straps.

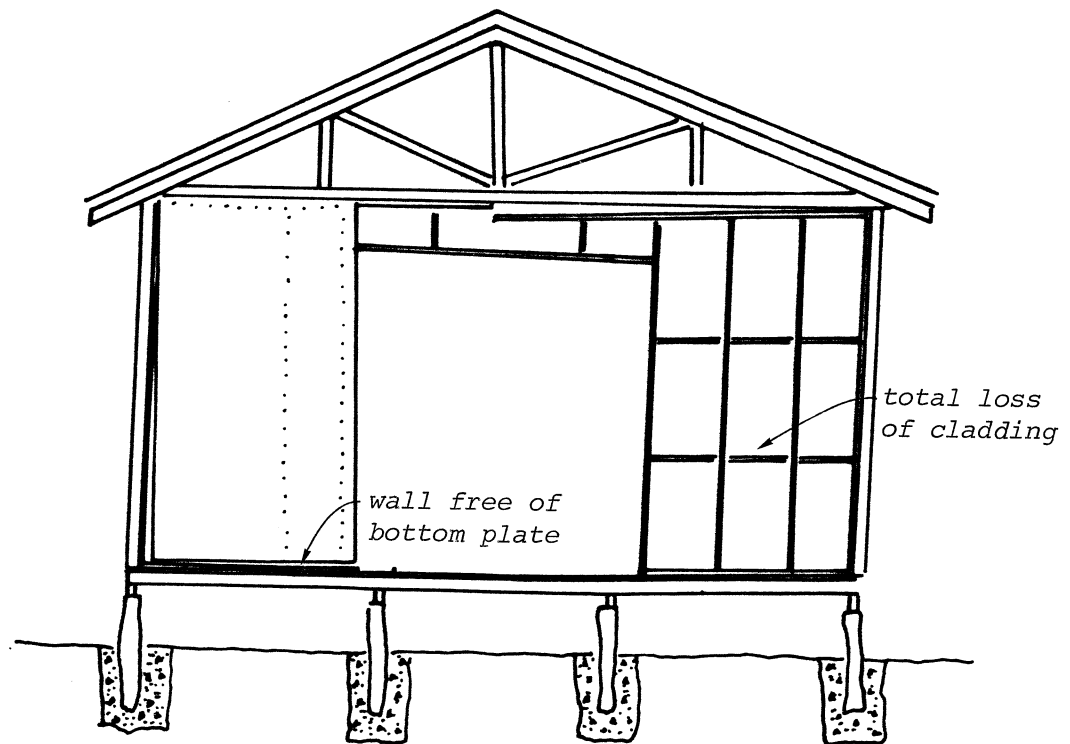
Figure 14 Failure of Internal Wall

The demise of the internal wall also continued with the withdrawal of more brads securing the hardboard sheeting and the complete failure of a stud to bottom plate joint. On the windward side of the wide doorway, the damage seemed to be mainly concentrated in the frame. The hardboard sheeting and one stud had separated from the bottom plate of the wall, the sheeting was still secured to the studs and top plate. Racking deflection was accommodated by separation of the wall from the bottom plate, allowing the entire wall to overturn. On the leeward side of the wide doorway, the hardboard sheeting had separated from the frame almost entirely, and had allowed the wall to deform from a rectangular shape to a parallelogram shape without major damage to the timber wall framework.

After 5 lateral load cycles and 50 uplift cycles at Design Load with compensation for internal pressure, the concrete footing blocks were lifting 90 mm and the internal wall was totally destroyed as shown in Figure 14. On the windward side of the large doorway, the wall had completely separated from the bottom plate, and hence could no longer function as a bracing wall, and on the leeward side, all of the hardboard cladding had worked loose allowing the frame to deform in racking. In spite of the loss of this wall as a restraining device, the house was still able to resist load. Most of the deflection transducers were not capable of reading the large range of deflections encountered on each cycle, so no further readings were taken.

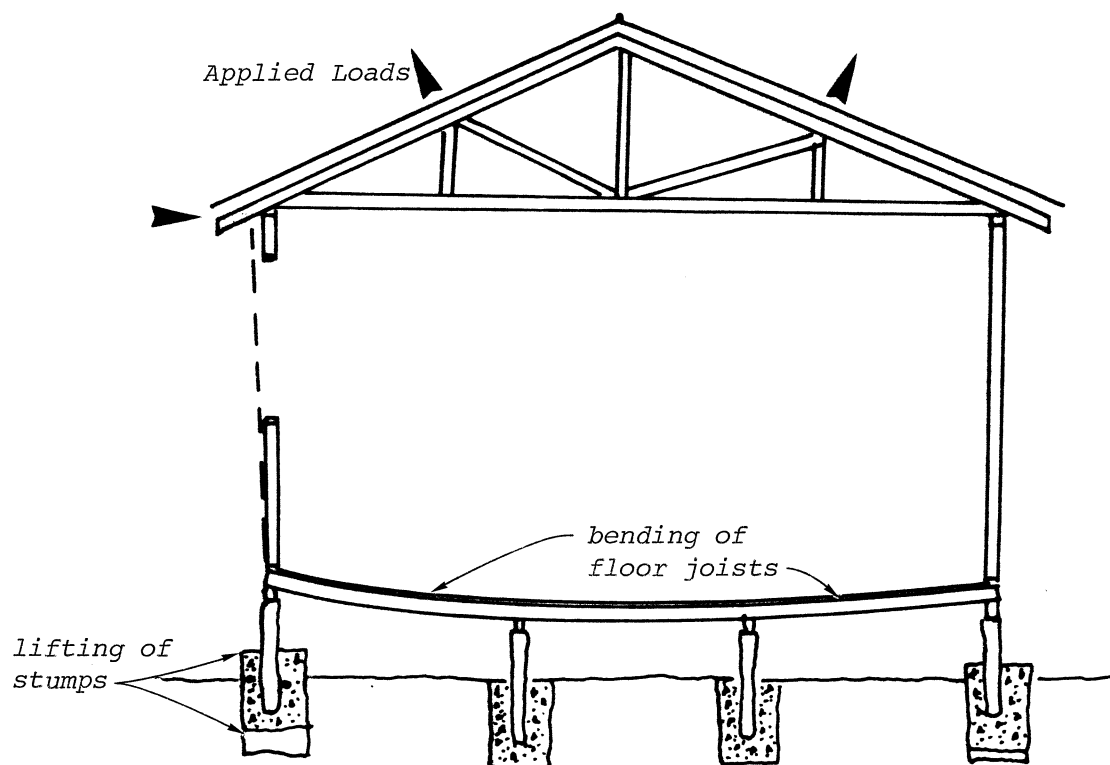
Figure 16 Overturning of the House - drawn to scale

the simulated internal pressure acting downwards on the floor was left at the Design Load figure. On the application of 130% of Design Load, the house had pulled out of the ground in overturning so far that there was no travel left on the hydraulic rams to apply further loading. The appearance of the house is shown to scale in Figure 16.

provided by the weight of the house above floor level and the mass of the footings was 28 kN per side of the house. Some lifting of the footings was first observed when the applied loads produced 36 kN uplift on the windward wall. This was a combination of uplift at roof level and overturning due to the applied lateral load. Thus the applied load was approximately 130% of the nominal resistance. The extra resistance was provided by bending of the floor on withdrawal of the footings under the windward wall, transferring some uplift to other footings near the centre of the house as shown in Figure 16.

Calculations show that had the uplift and moment combined to reach 75 kN uplift at the windward wall, uncontrolled overturning would have resulted. 1.3 times Design Load, which was the point at which the uncontrolled overturning was observed, produced 77 kN of uplift at the windward wall.

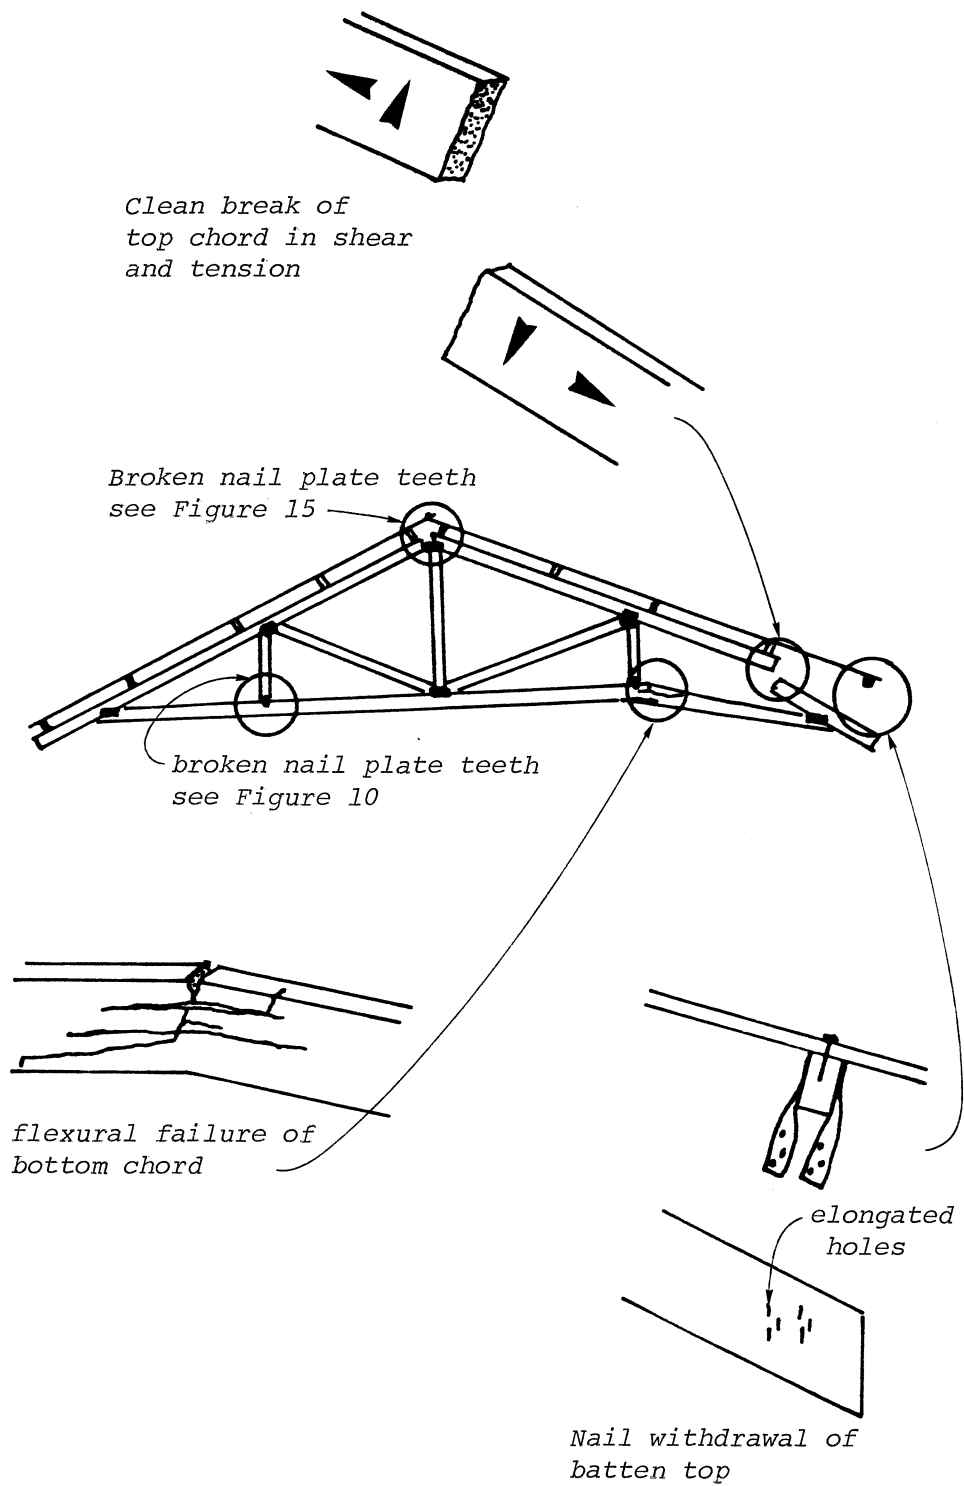
Figure 17 Details of Truss Failures

The primary cause of failure was a brittle fracture of a truss top chord. The line of the break ran through defect free timber immediately adjacent to the overbatten tie down, and was almost exactly perpendicular to the grain. This suggested that shear stresses may have played a significant role in the fracture. Calculations showed that at the failure load, the shear stress in the top chord was 3.3 MPa, over 2.2 times the basic allowable working shear stress at joints designated in AS 1720, the SAA Timber Engineering Code. Also the tension stress at failure was calculated at 7.3 MPa or over 1.2 times the basic allowable working tensile stress for wind loads. Failure was clearly due to the combination of these two stresses being in excess of allowable.

A sketch of the failure is given in Figure 17. It shows the failure of the top chord, nearly perpendicular to the grain, and the other associated failures in the vicinity of the primary failure. A possible sequence of failure is as follows: as the break occurred, the major part of the upper chord would have been lifted clear of the break by the uplift forces. The roof sheeting would have had to bend over the discontinuity, increasing the load on the lowest batten which was still attached to the separated part of the top chord near the heel of the truss. It is postulated that this overload caused the failure of the batten fixing straps at that point by nail withdrawal. The loss of this strap placed a significant bending moment on the bottom chord of the truss. This timber member was the sole remaining connection between the two parts of the broken truss and its failure was a classical bending fracture.

The combination of these three failures, shown in Figure 17, meant that broken truss over the internal partition was not transmitting uplift loads to the walls at the southern end. The battens therefore carried this load to adjacent trusses causing overloading of their truss tie down. Under these circumstances, the actually applied load at the truss ties could have been up to 2 times design load. These details failed, causing overloading of all of the other truss restraints, effectively freeing the roof structure from the southern or leeward wall.

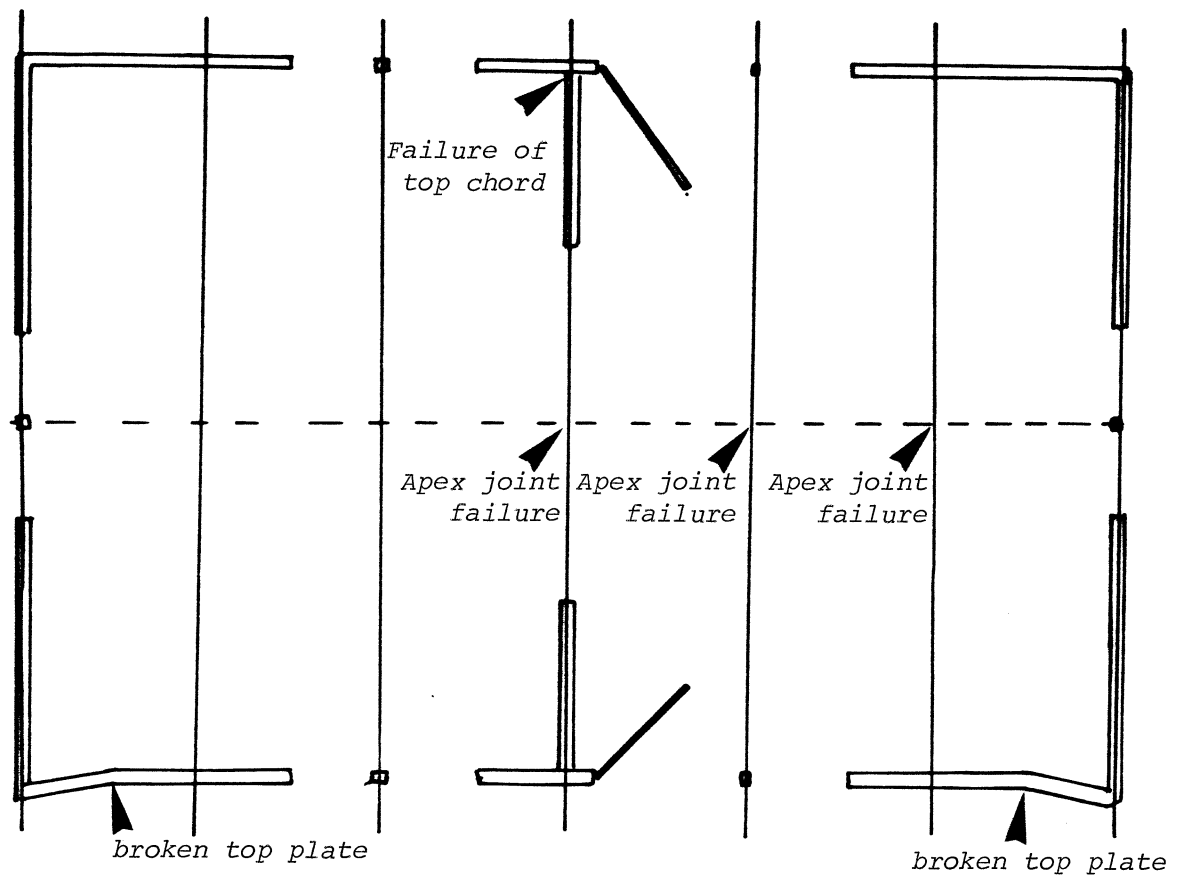
Figure 18 Plan showing Locations of Detail Failures

The roofing system had been performing a vital structural role, in that it braced the top of the windward wall using diaphragm action. The roof structure, now freed from one complete wall of the house was less effective in performing that task and shed some of its load to the windward wall top plate. The top plate failed in two places due to a combination of bending and shear stresses. The plan of the house given in Figure 18 shows the location of all of the failures associated with this destructive test.

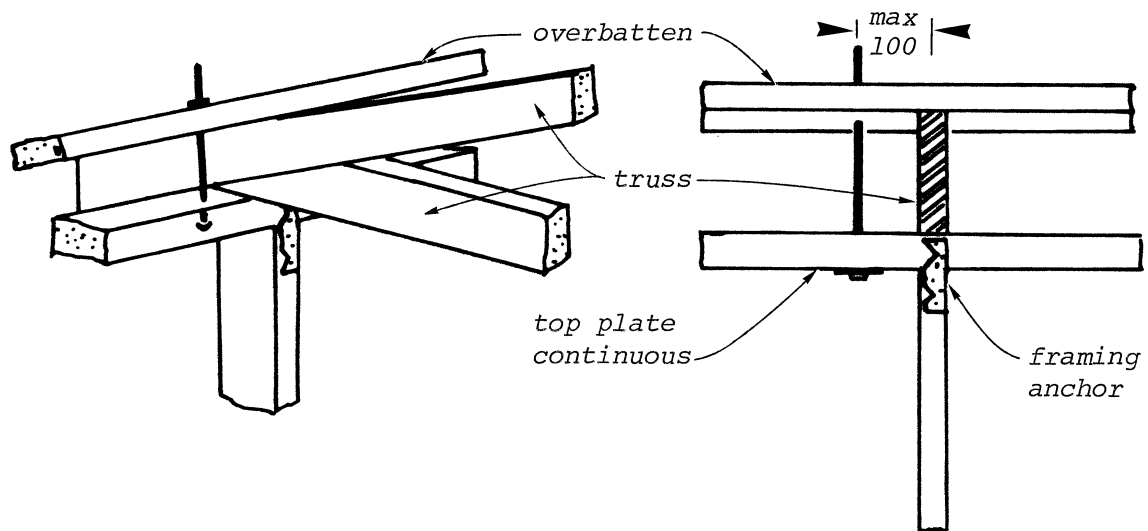
Figure 19 Bolting of Overbatten

Because the test loading system was based on a fail-safe technique, the roof structure had been lifted only a few centimetres off the wall when failure of the straps occurred. The house, although deemed to have structurally failed, was quite sound except for a few broken metal straps. Thus, having established a weakness in the original design, the authors seized the opportunity to implement repairs so that the test programme could continue and therefore recommendations for improving the system could be made to the Tongan Government.

One constraint was put on the repairs. They had to be simple and easy to effect in the existing houses in Tonga. An obvious solution was the use of overbattens, that is lengths of timber that could be installed on top of the top chord of the trusses directly over the external walls. These overbattens were bolted to the top plate of the wall, adjacent to the trusses. Figure 19 illustrates the system.

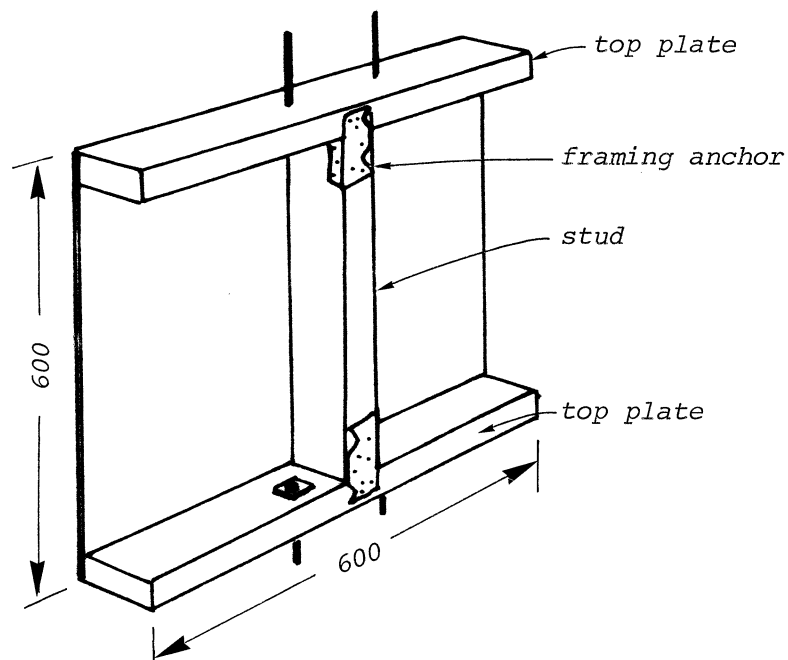
Figure 20 - Laboratory Tests Specimen - Top Plate to Stud Joint

Two other specimens were both tested in cyclic loading. They resisted 8000 cycles at 8.5 kN with only a small amount of cracking of the timber plates. Both specimens failed during cycling to 10 kN, the first after 250 cycles and the second after 1250 cycles. These failing loads compare with the design uplift reaction of a truss calculated as approximately 8.2 kN.

Although the failure load of the laboratory specimens was little in excess of the design uplift load, a few other aspects should be taken into consideration. Because each specimen consisted of two prototype joints, one at the top plate and the other at the bottom plate, the failing load must represent the lower of two possible values. Thus the tests yielded the lower two of four joint strengths.
