JAMES COOK CYCLONE STRUCTURAL TESTING STATION

EFFECTS OF CYCLONE WINIFRED ON BUILDINGS

TECHNICAL REPORT No. 27

G.F. Reardon
G.R. Walker
E.D. Jancauskas

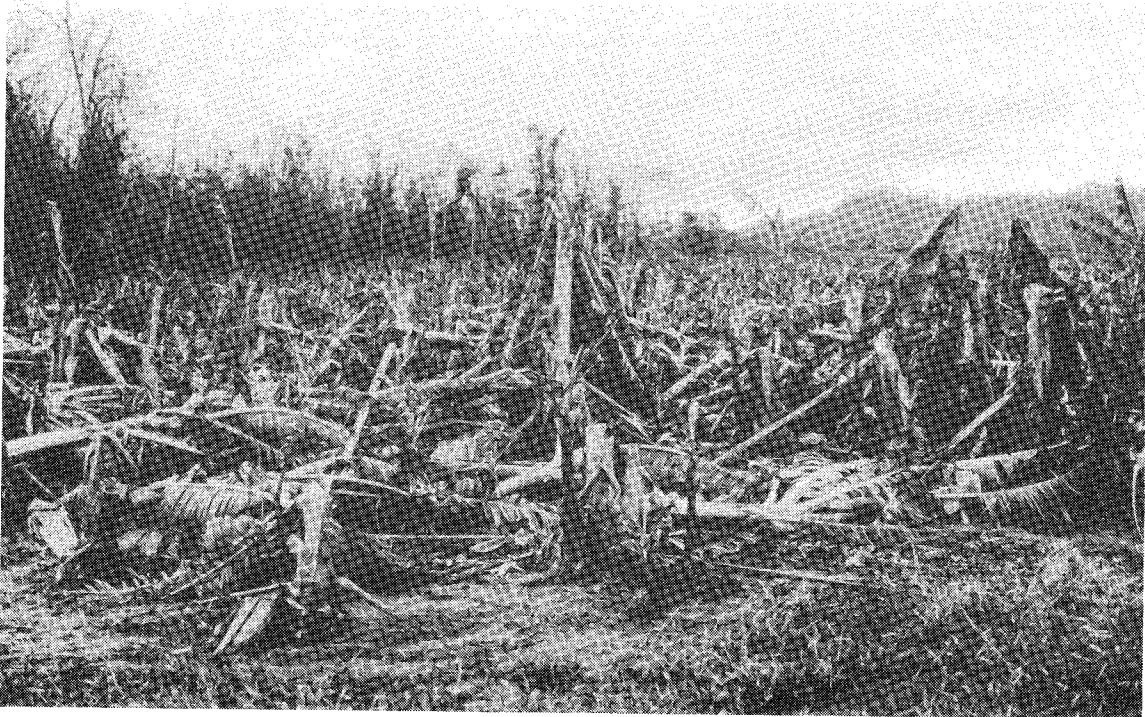
Figure 1. Banana Plantation Flattened

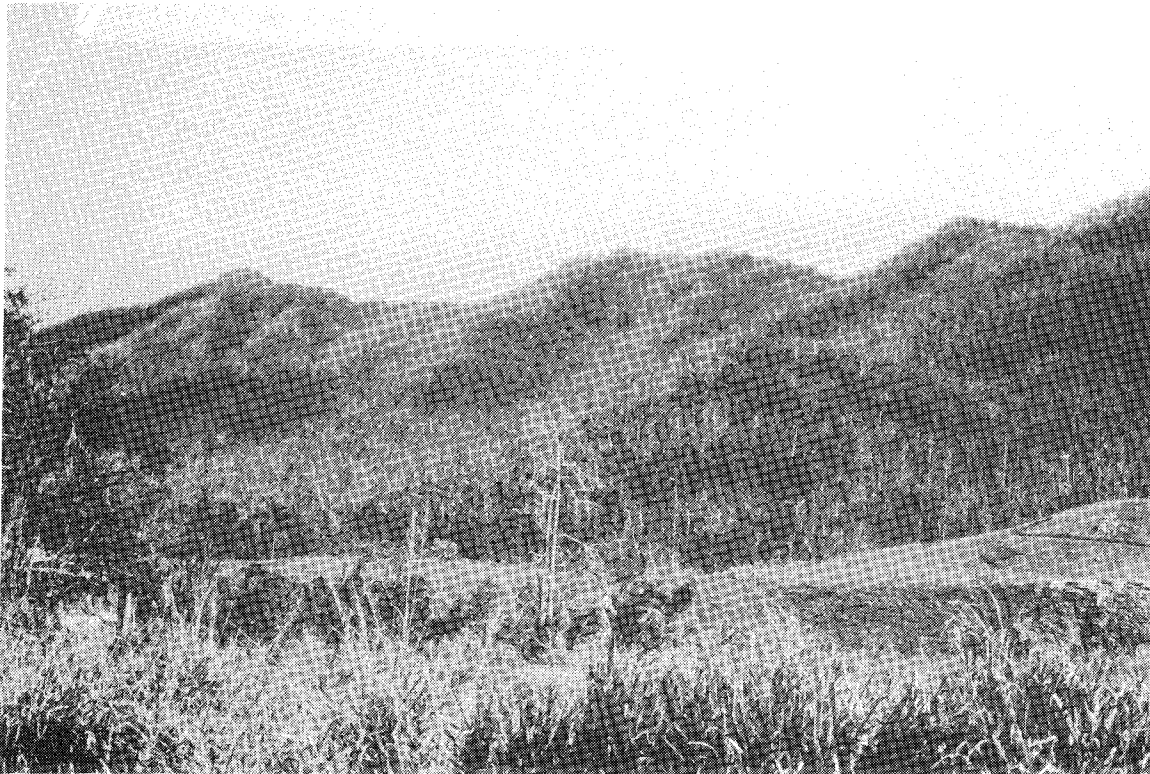
Figure 2. Wind-burnt Rain Forest

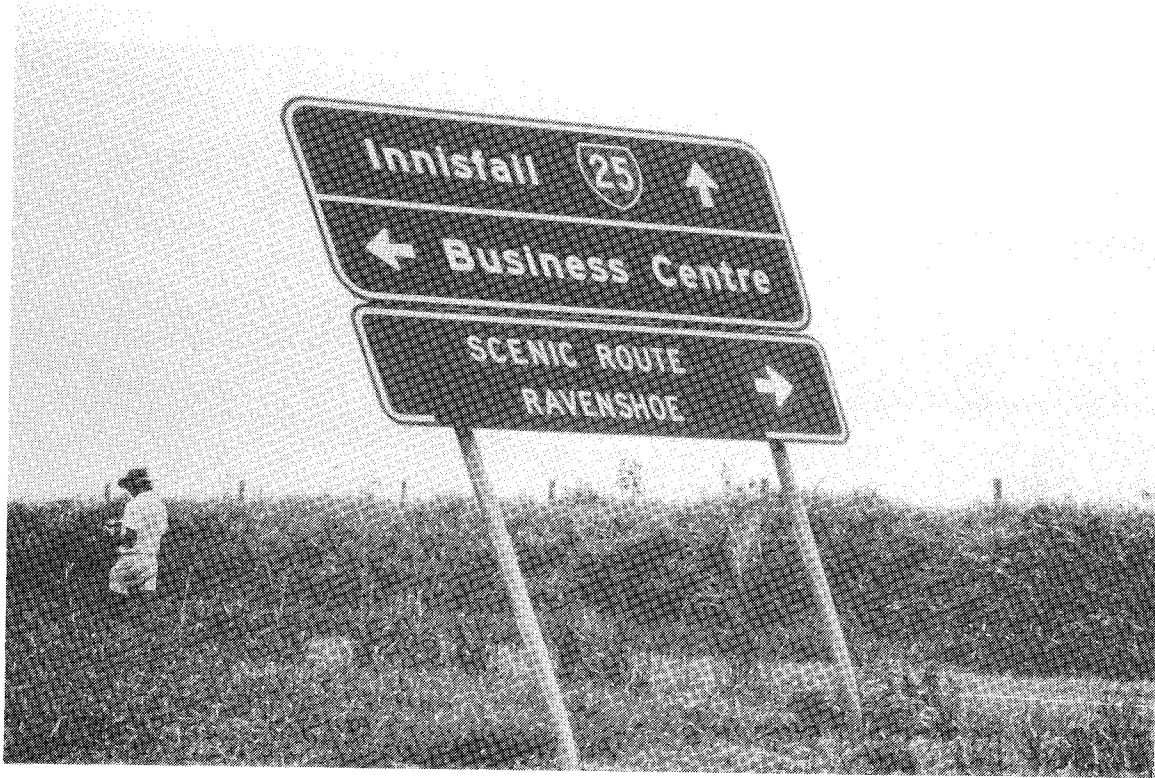
A preliminary analysis of the performance of road signs in cyclone Winifred, Figure 9, indicates maximum wind speeds greater than 45 m/s and less than 65 m/s in the Innisfail-Mourilyan area. Only unbraced pole supported signs which were either undamaged, or had failed by bending of the supporting poles at ground level were considered. Failed systems showing any evidence of having been hit by debris were excluded.

As with the other approaches, there are many uncertainties associated with the analysis of road signs. In addition to assumptions about exposure, wind direction, wind structure (for extrapolating to 10 m height) and material properties, there are also questions about dynamic response and the possibility of local buckling rather than plastic yielding initiating failure. These latter factors are the subject of studies currently being undertaken at James Cook University. Because of the relatively large difference in strength between those that failed and those that survived, with one exception - and other factors could account for that - this method is relatively imprecise for defining the maximum wind speed, but the range is consistent with maximum wind gusts of the order of 50 m/s.

Figure 9. Road Sign Bent by Wind Forces

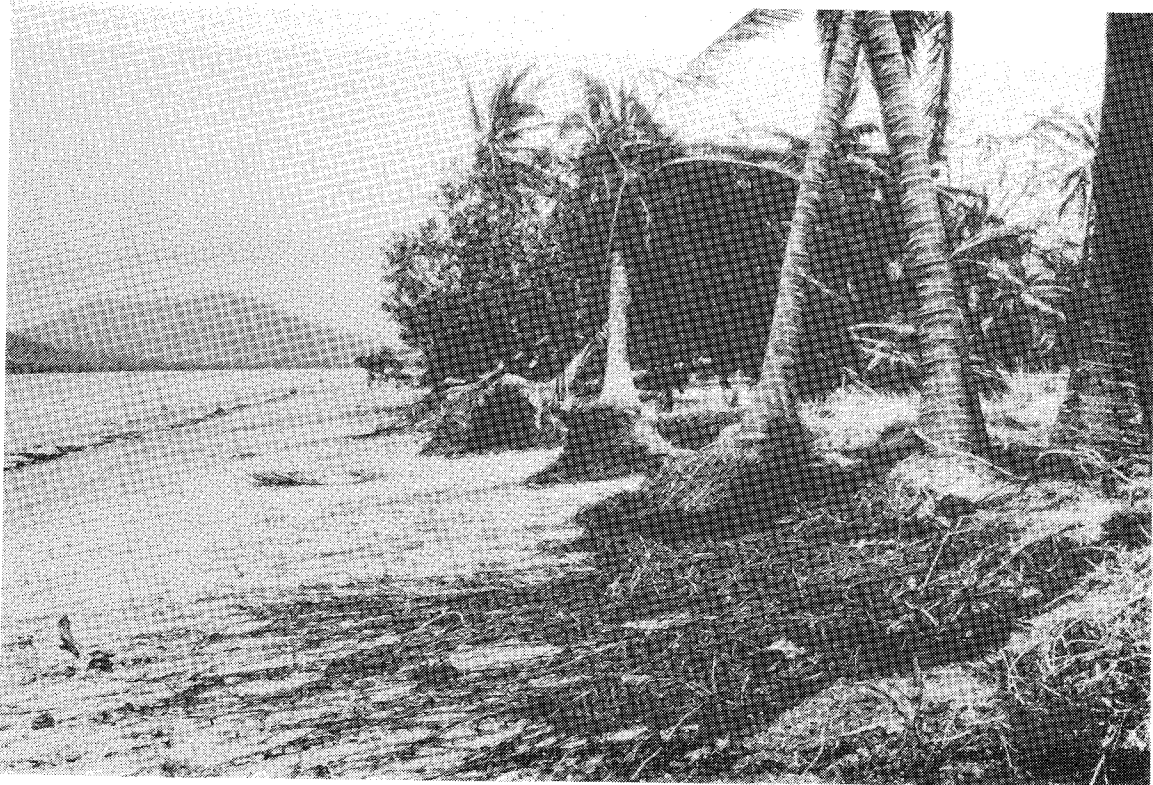
Figure 10. Beach Erosion Caused by Storm Surge

was minimal, being generally restricted to beach erosion, Figure 10. This fortunate occurrence should not be allowed to lead to a reduction of the public perception of the risk from storm surge. A cyclone crossing coincident with high tide poses a severe threat to the coastal communities, and the recommended evacuation of low lying coastal areas during Winifred was certainly justified.

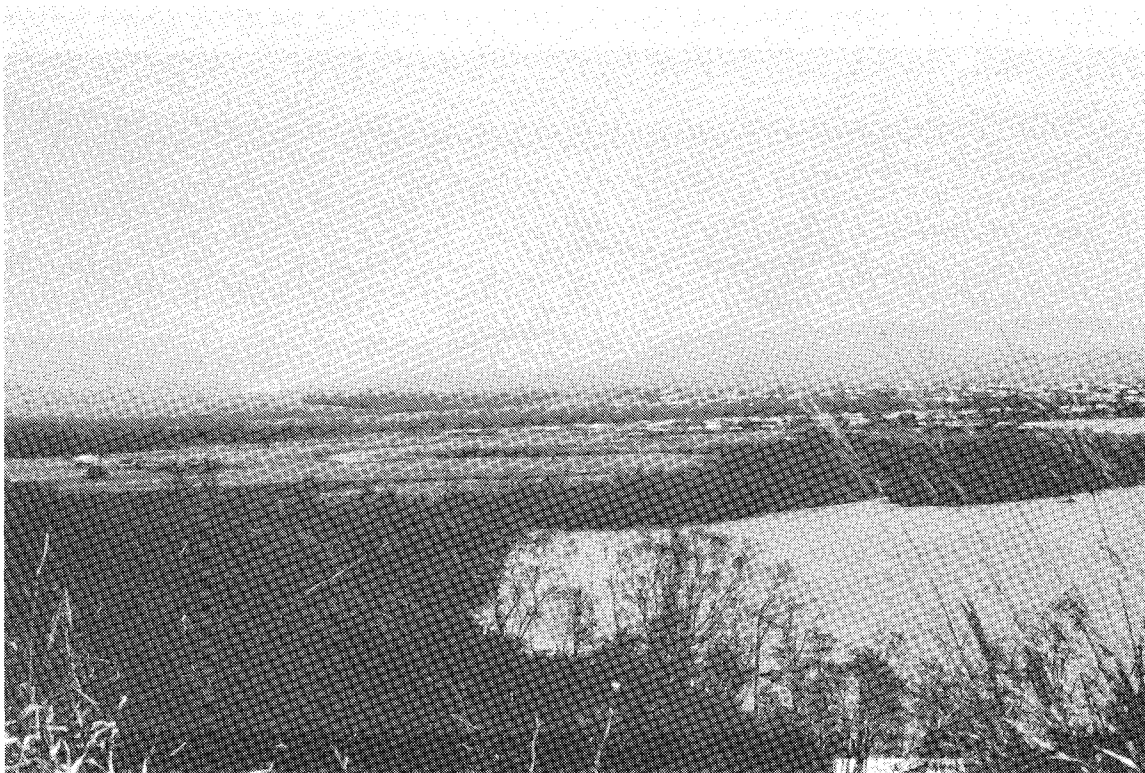
Coquette Point consists of a ridge with steeply rising sides. Figure 11 shows a view from the ridge, virtually at the location of the damaged house. The height of the ridge at that position is approximately 70 metres.

Figure 11. View From Coquette Point Ridge

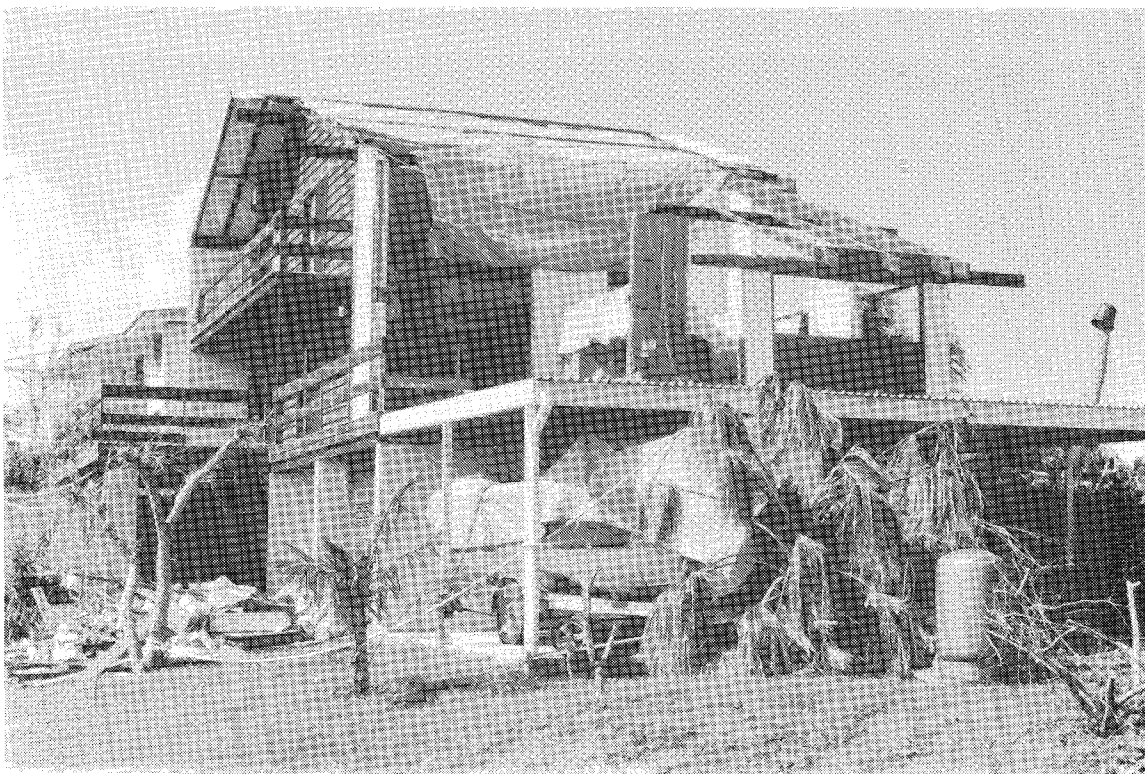
The house lost part of its roof and walls, Figure 12. A detailed examination of the building could not be made as it was partly covered with tarpaulins, the debris had been cleaned up and the owner was away. It was apparent that much of the roofing and battens had blown off and some walls had collapsed. Two reinforced concrete block columns that were part of the front wall structure had also been blown over.

Figure 12. Roof and Wall Damage to Modern House

Using the current Wind Loading Code (13), a maximum design wind speed of 85 m/s can be calculated for Coquette Point. This value, based on category 1 approach along the river, would extend for some 70 m back from the crest and values above 80 m/s would apply for a similar length in front of the crest. Proposals to be included in the Limit State edition of the code would result in a maximum design wind speed of 100 m/s at the crest of the Coquette Point ridge and about 82 m/s at 100 m away from the crest. It is unlikely that the house would have been designed for wind speeds of 85 m/s or more.

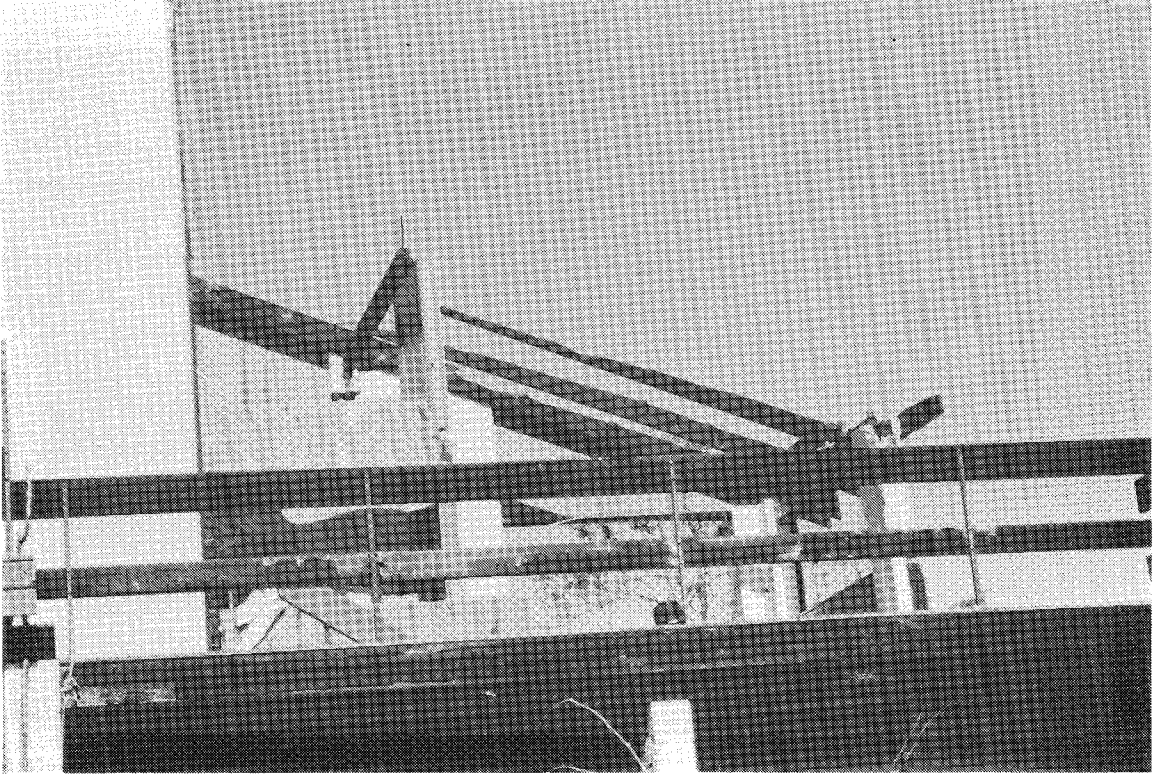
One unusual mode of failure in this house was the longitudinal splitting of some exposed rafter members, Figure 13. It is not clear how the battens were attached to the rafters, but they were probably either nailed or fastened with framing anchors. The longitudinal splitting would have been caused by the uplift pressure on the roofing and failure of the timber by tension stresses acting perpendicular to the grain. The timber was probably imported Douglas fir (oregon).

Figure 13. Splitting of Exposed Rafters

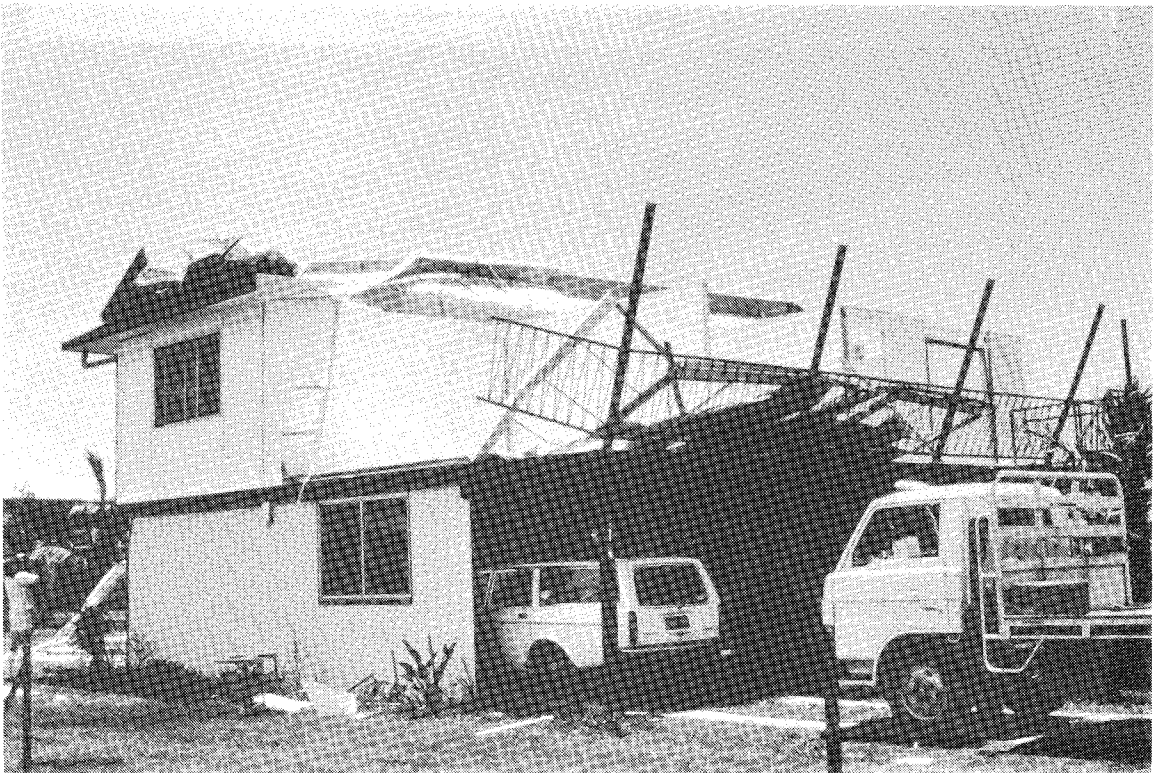
Figure 14 shows a damaged house in suburban Innisfail. As it was the only house severely damaged in that general location, its construction details were questioned. The house was a kit home, reportedly assembled by a builder. Its basic components were wall panels approximately one metre long, graded purlin roof construction and continuous roof decking. All the elements were made from light gauge steel and bolted together. The ribbed roofing was fastened with screws and cyclone washers at every rib. Usually the components of such houses are engineer designed.

From a brief inspection it appeared that the failure was initiated by the purlin lifting off the verandah posts. This failure then severely overloaded the bolts holding down the next purlin and progressive failure occurred at each purlin. Figure 15 shows a purlin hold down detail through which the bolts had burst. After the purlin supporting the front wall was lifted, the wall collapsed laterally and the ceiling panels fell in. There was no obvious evidence of the roof sheeting coming away from the purlins.

Figure 14. Damage to Panelized House

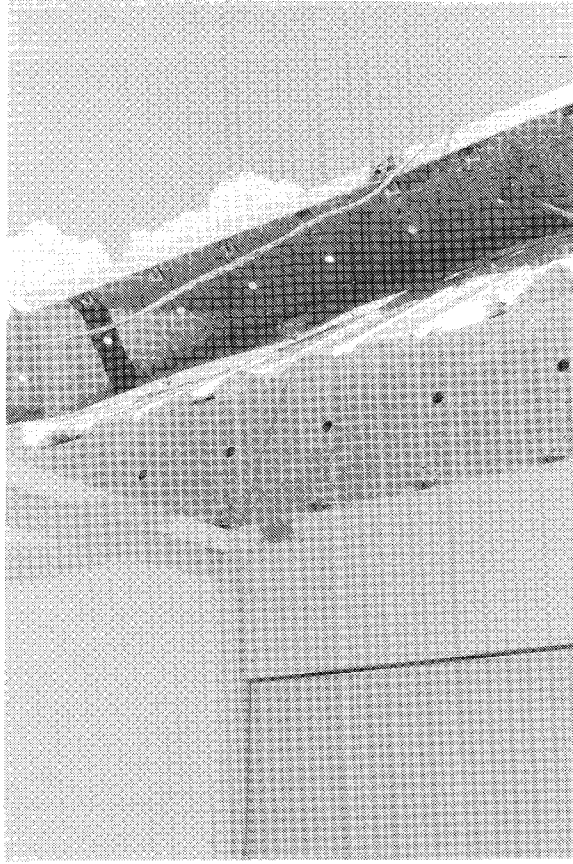
Figure 15. Bolts had Burst Through Purlin Attachment

The current owner of the house maintained that undersized bolts had been incorrectly used to secure the purlin to the verandah posts and that they had pulled through the comparatively oversized holes.

It was noted that the graded purlins had been fabricated in two lengths and spot welded together, possibly on site. (All joints were in the same alignment, which is not good practice.) Most of the welds that were visible had broken, but this may have been a result of the roof lifting rather than a contributing cause of failure.

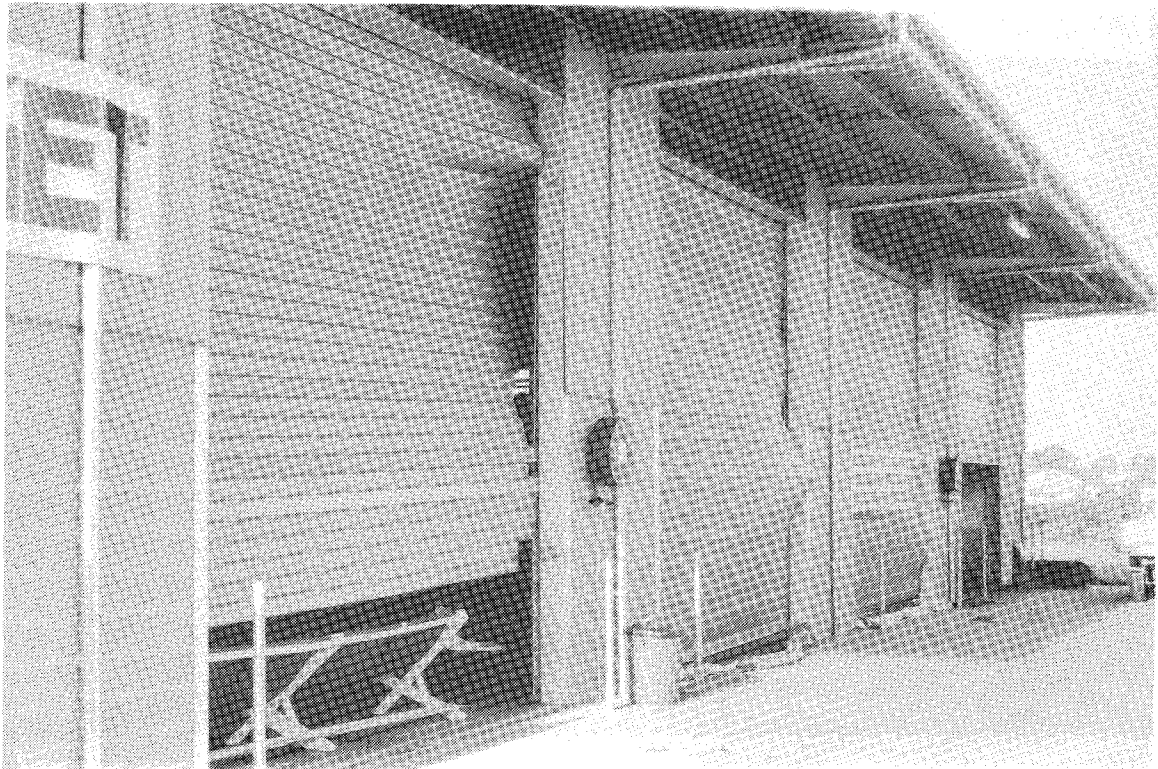
Figure 16. Damaged Roll-away Doors

Although no structural damage to well designed commercial or industrial buildings was observed, there were frequent reports of damage to large doors. Figure 16 shows a bad example of the performance of roll-away doors. There were at least seven roll-away doors in this building and six were damaged as shown. The damage was not restricted to rolling doors; similar reports were made about doors using a tilting mechanism to open and close. There is an obvious need for improvement in the performance of these types of door.

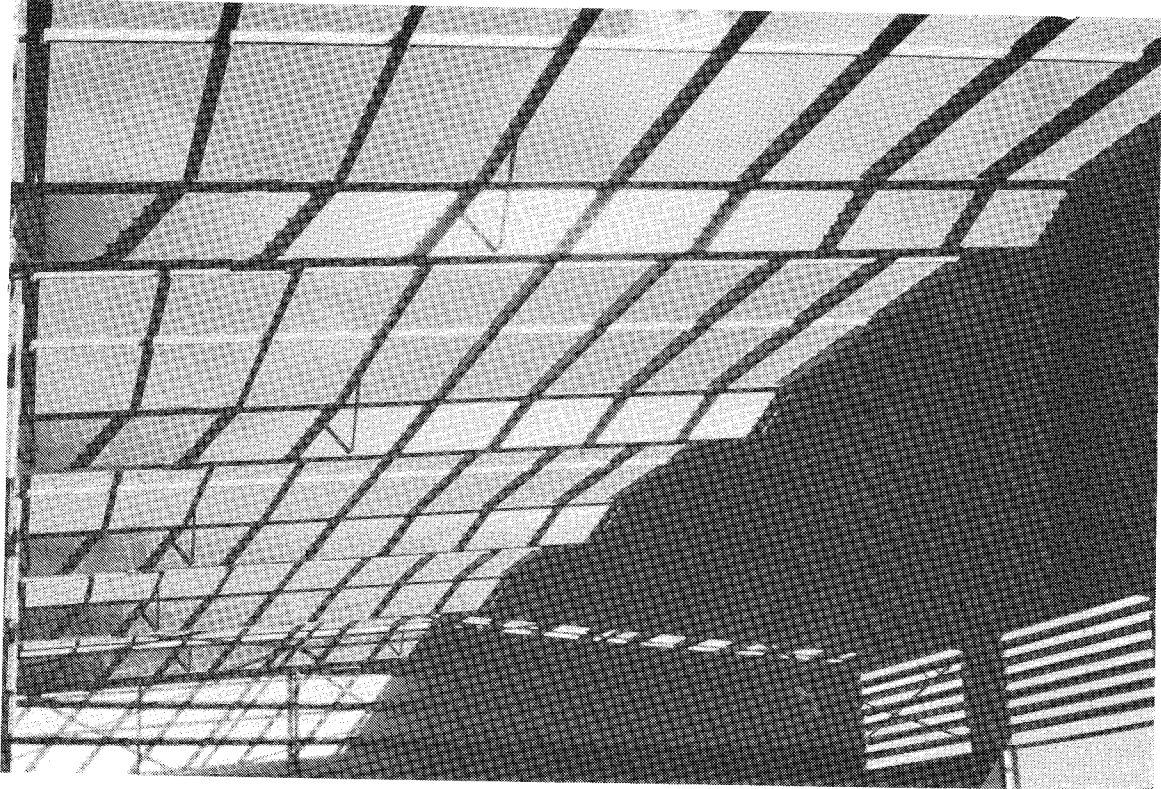
Figure 17. Secret Fixed Roofing Blown Off Building

At Woree High School, in suburban Cairns, a large assembly building lost half of its roofing. There was no structural damage to the portal frames but all of the secret fixed roof sheeting was blown off one slope. The fastening clips were left attached to the battens, Figure 17.

The postulation for the walkways would not necessarily hold for the assembly building. The effect of overtightening screws at the ridge would hardly extend beyond the nearest adjacent batten.

The maximum wind gust recorded at Cairns airport was 33 m/s. As it is unlikely that the Woree school experienced gusts in excess of this figure the poor performance of the roof cladding must have been caused by inadequate fixing. This therefore raises the question of the suitability of secret fixed roof sheeting in cyclone prone areas. Whilst secret fixing of roof sheeting may be more pleasing architecturally and far less prone to leakage, it does not allow any visual assessment of the security of the roofing. It would be very difficult to check that all the clips on a secret fixed roof were properly engaged.

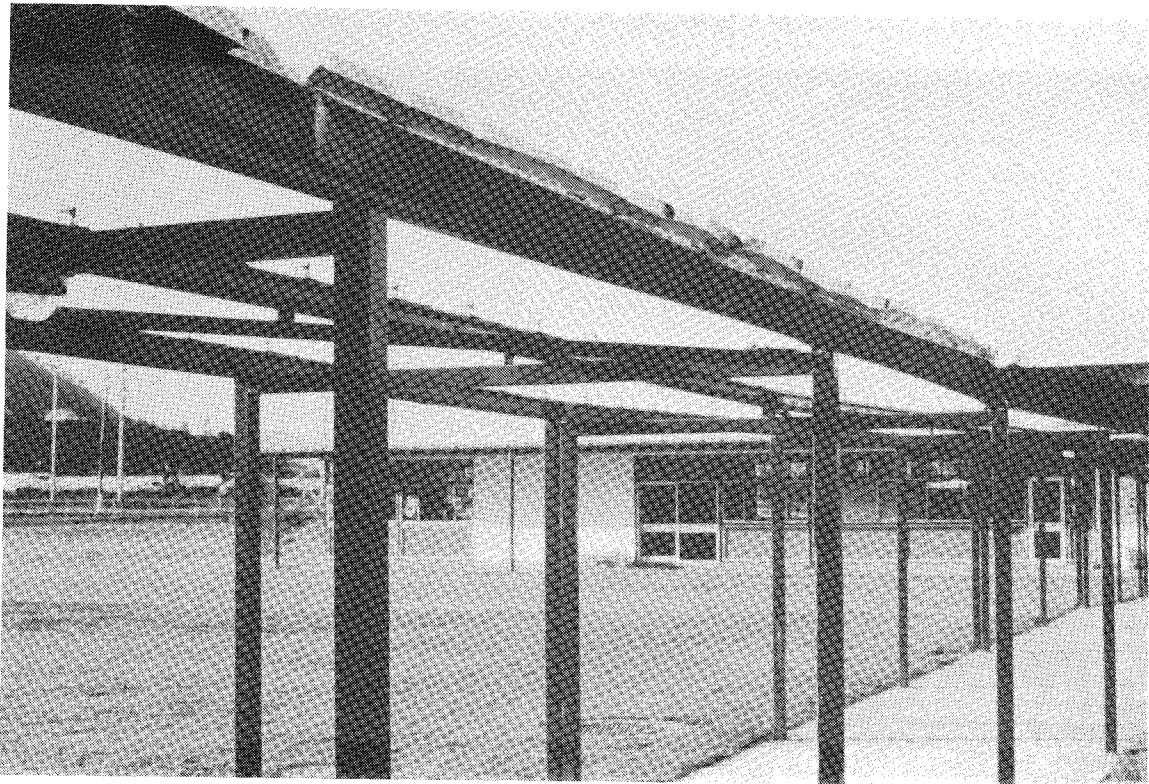
Figure 18. Secret Fixed Roofing Blown Off Walkway

It is postulated that failure of the walkway roofing may have been caused by the presence of screws inserted through the flashing and each rib. As the screws would have been installed after the roofing was fitted onto the clips, they may have compressed the ribs sufficiently to allow the clips to spring out.

The bent flashing and broken screws evident in Figure 18 indicate that the roofing lifted away from the clips and rotated about the flashing, bending the screws until they broke.

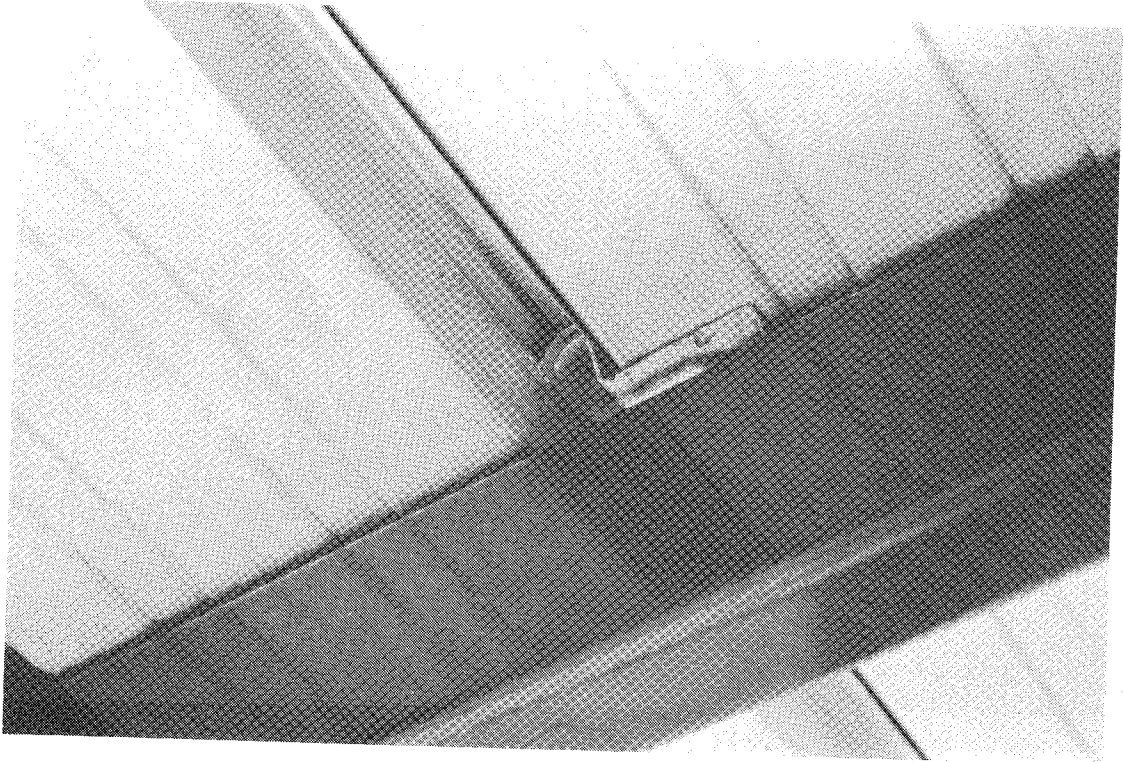
Figure 19. Roofing Clip not Properly Engaged

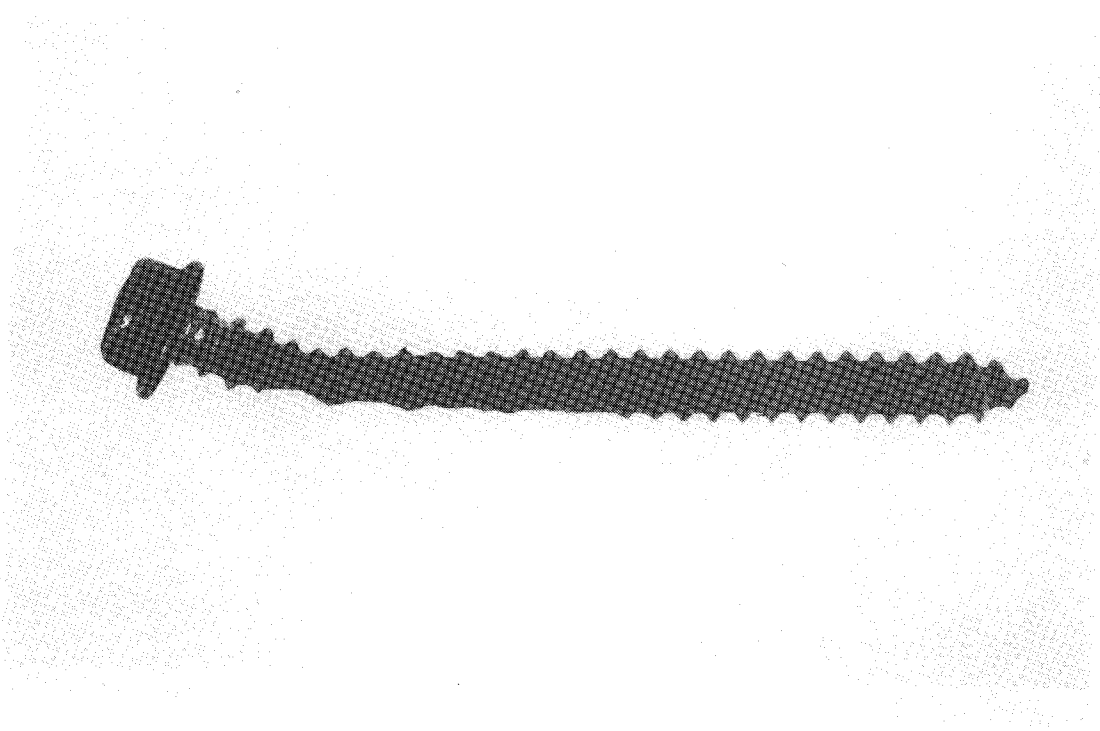
Figure 20. Severely Corroded Roofing Screw

The cyclone brought to notice a new concern in respect of roof security. Two separate examples of corrosion of roofing screws were discovered, one at Innisfail and the other at Atherton. The houses containing the screws were approximately two years and four years old respectively. Figure 20 shows a corroded Innisfail screw. In both cases the screws were unbranded, indicating that they were possibly "cheap imports". Australian manufacturers stamp their screw heads with a brand mark. The Atherton house had a mixture of branded and unbranded screws. It was reported that the branded screws showed no signs of corrosion.

The position of the corrosion on the screws indicates that it was probably initiated by condensation from the underside of the roof sheeting. Both Innisfail and Atherton are high rainfall areas.

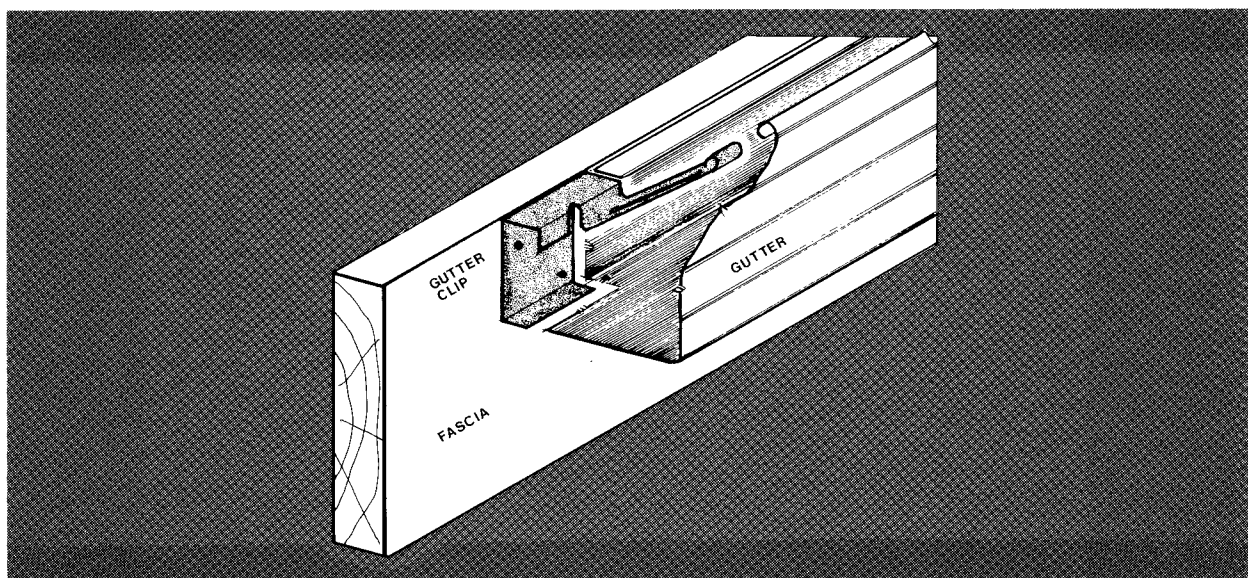
Many houses that were probably only a few years old had no structural damage, but lost lengths of guttering. Enquiries revealed that a relatively new gutter bracket is frequently being used by many plumbers. It enables the guttering to easily snap into position, saving installation time. Figure 21 illustrates the bracket. Although manufacturers recommend that a screw or pop rivet be used to fix the bracket to the guttering, there was no evidence of such a fastening for the cases inspected. Without that fixing the guttering was able to work free of the clips during the cyclone.

Figure 21. Gutter Bracket. Arm of Bracket Should be Fixed to Guttering

As there were many examples of this type of failure it appears that either fixings are not normally installed or that the brackets were not designed to resist uplift forces. In either case manufacturers should review the design of the bracket.

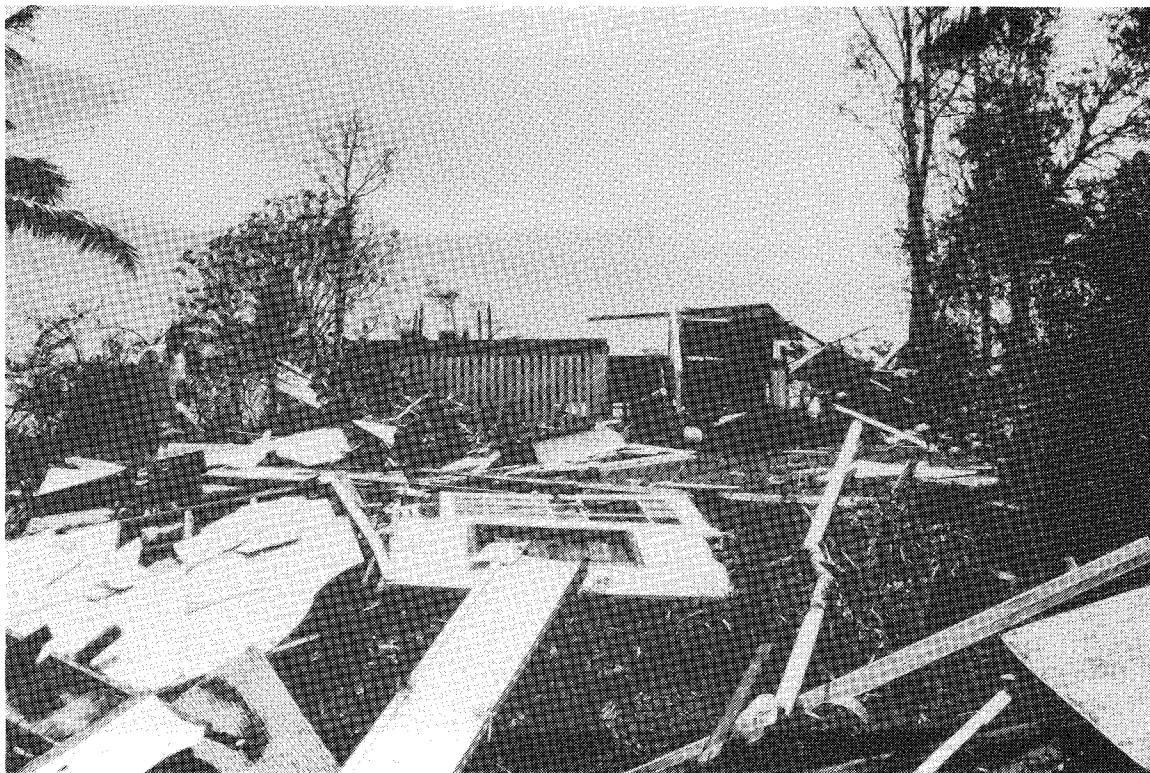
Flying Fish Point would probably represent the greatest concentration of damage caused by cyclone Winifred. Only the two houses at the bottom of the street had minimal damage. All of the others had significant structural damage and one was totally destroyed, Figure 22. The damage included loss of roofing, loss of roof structure and some walls blown in. Figure 23 shows one of the houses that had lost some roof structure and walls.

Because of the extent of the damage and the age of the buildings, a detailed inspection was not made. The debris around the houses indicated that inadequate structural fastening and a lack of suitable bracing probably contributed to the failure of these houses. It is most likely, however, that the main factor contributing to the concentration of damage in this particular location was topography.

In current terminology, Flying Fish Point would be considered as having exposure equivalent to terrain category 1 compounded by the effects of the ridge. The design wind speed at the top of the ridge would be in excess of 70 m/s, which would require houses to be nearly three times the strength of one

Figure 22. House Destroyed on Flying Fish Point

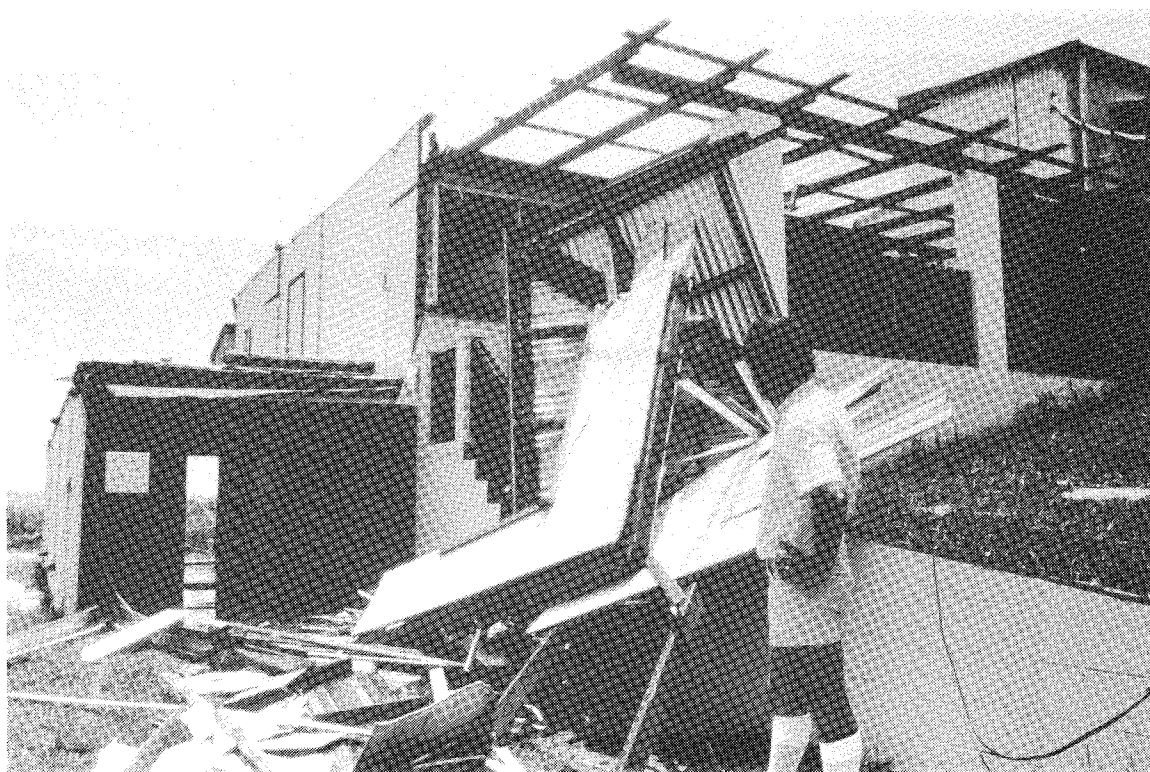
Figure 23. Portion of Roof and Walls Blown Out

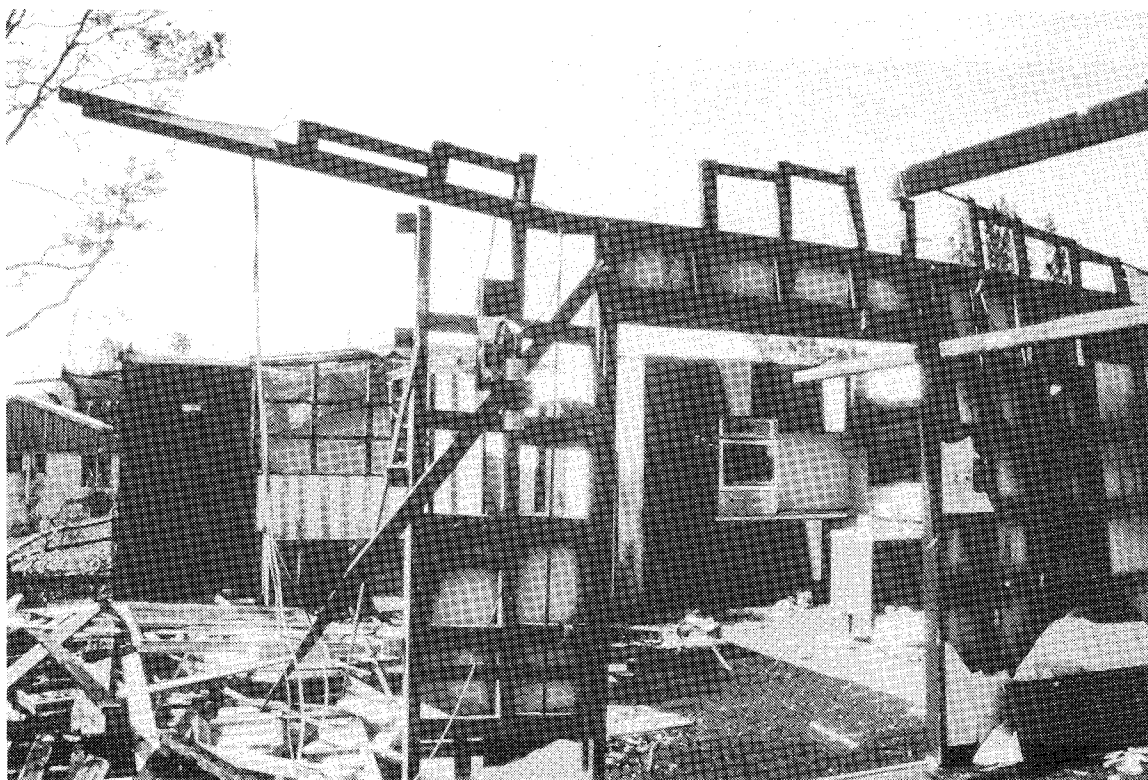
Figure 24. Older House Destroyed, Coquette Point

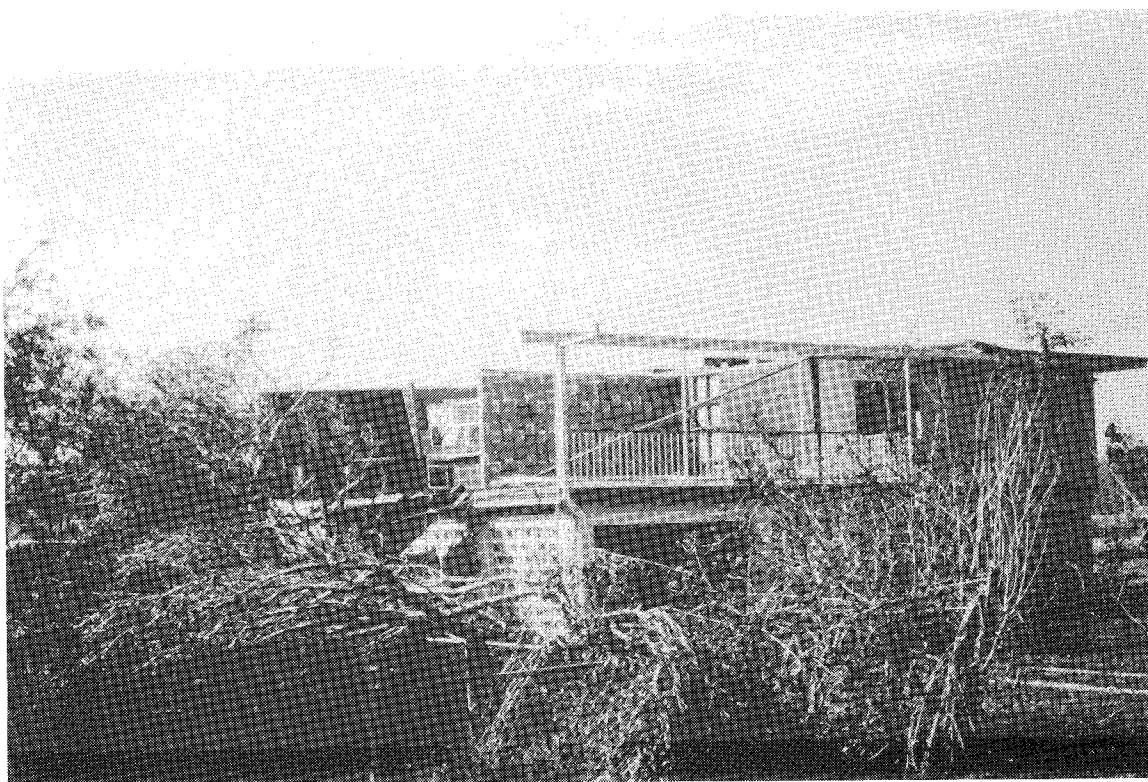
Figure 25. Portion of Roof and Walls Blown Over, Babinda

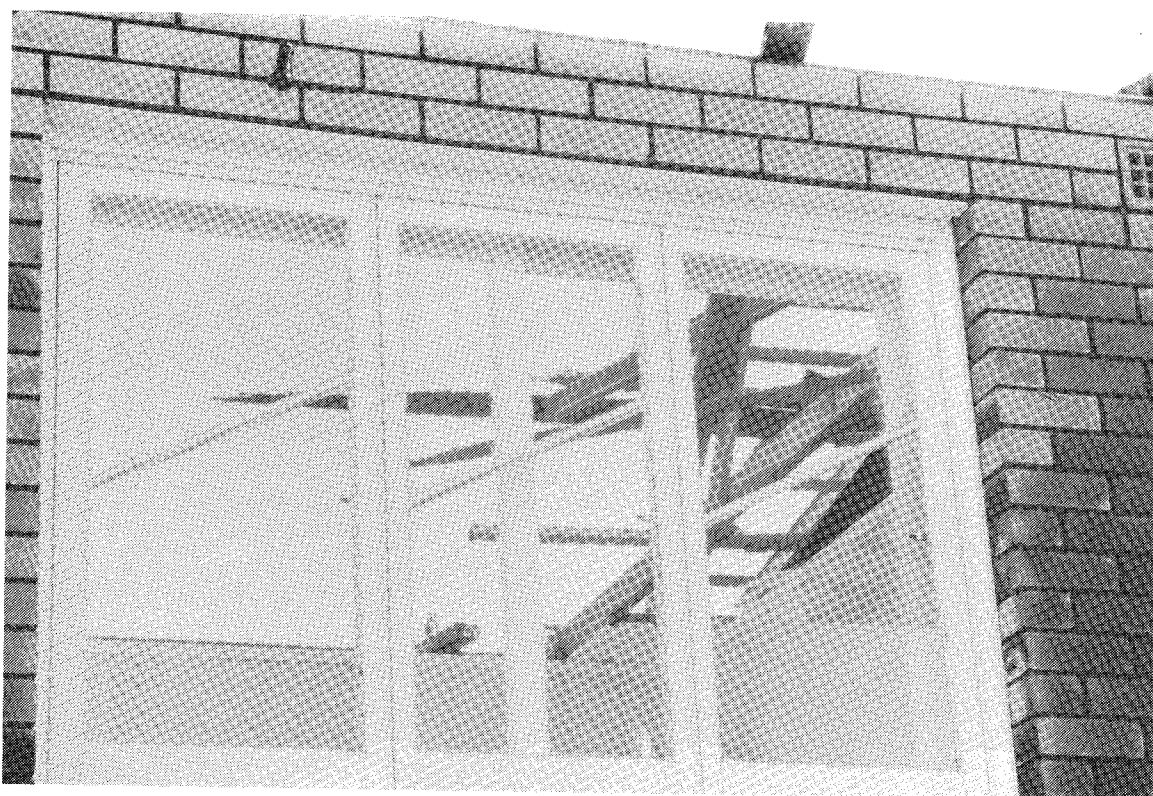
Figure 26. Roof Damage to Flats, Innisfail

cut-in rafters and separate ceiling joists. With the exception of the top plates being bolted to the brickwork the roof structure was totally nailed together. Apparently the skew nails holding rafter to top plate were inadequate to resist the uplift wind forces on the roof. Timber failure evident in the figure was probably a subsequent failure.

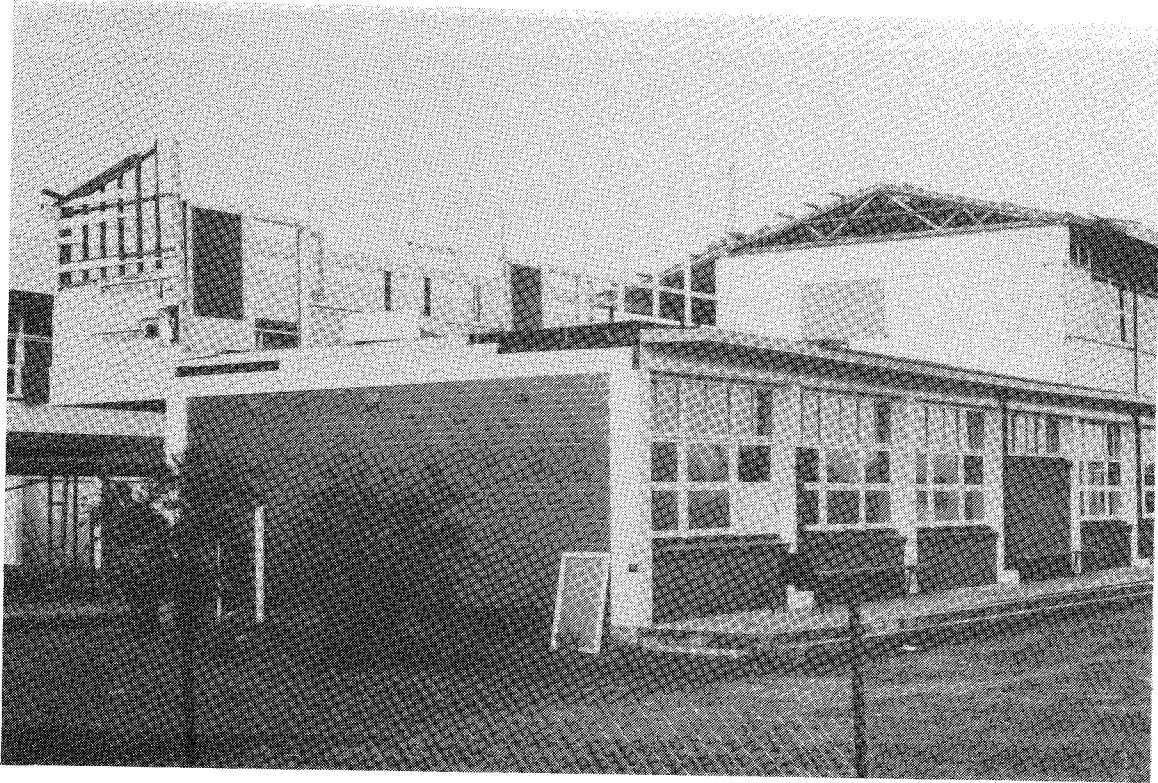
Figure 27. Damage to Classroom Block, Innisfail

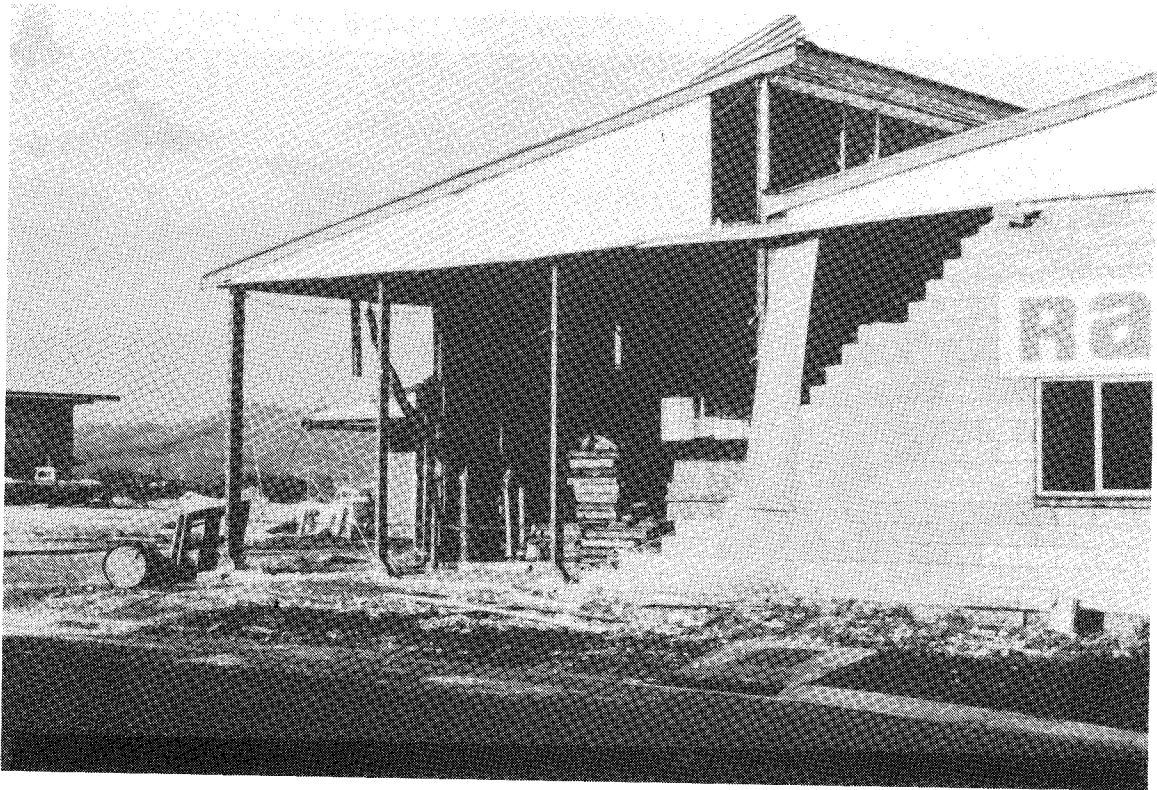
Older industrial buildings performed similarly to older agricultural buildings. Some lost roofing or roof structure. There was one case, in Innisfail, of an entire concrete block wall having blown over, Figure 28. It is believed that the doors blew open during the cyclone, allowing the wind to pressurize the inside of the building and subsequently cause failure of the wall.

Figure 28. Factory Blockwork Wall Blown Over, Innisfail

The wall had a reinforced bond beam at the top and had some cores filled with concrete and reinforced, but these were obviously inadequate to resist the wind force. Only a few ties between the blockwork and the structural steel frame were evident. This is an example of where a little more care in construction would probably have saved the building.
