JAMES COOK CYCLONE STRUCTURAL TESTING STATION

EFFECTS OF CYCLONE WINIFRED ON BUILDINGS

TECHNICAL REPORT No. 27

G.F. Reardon
G.R. Walker
E.D. Jancauskas

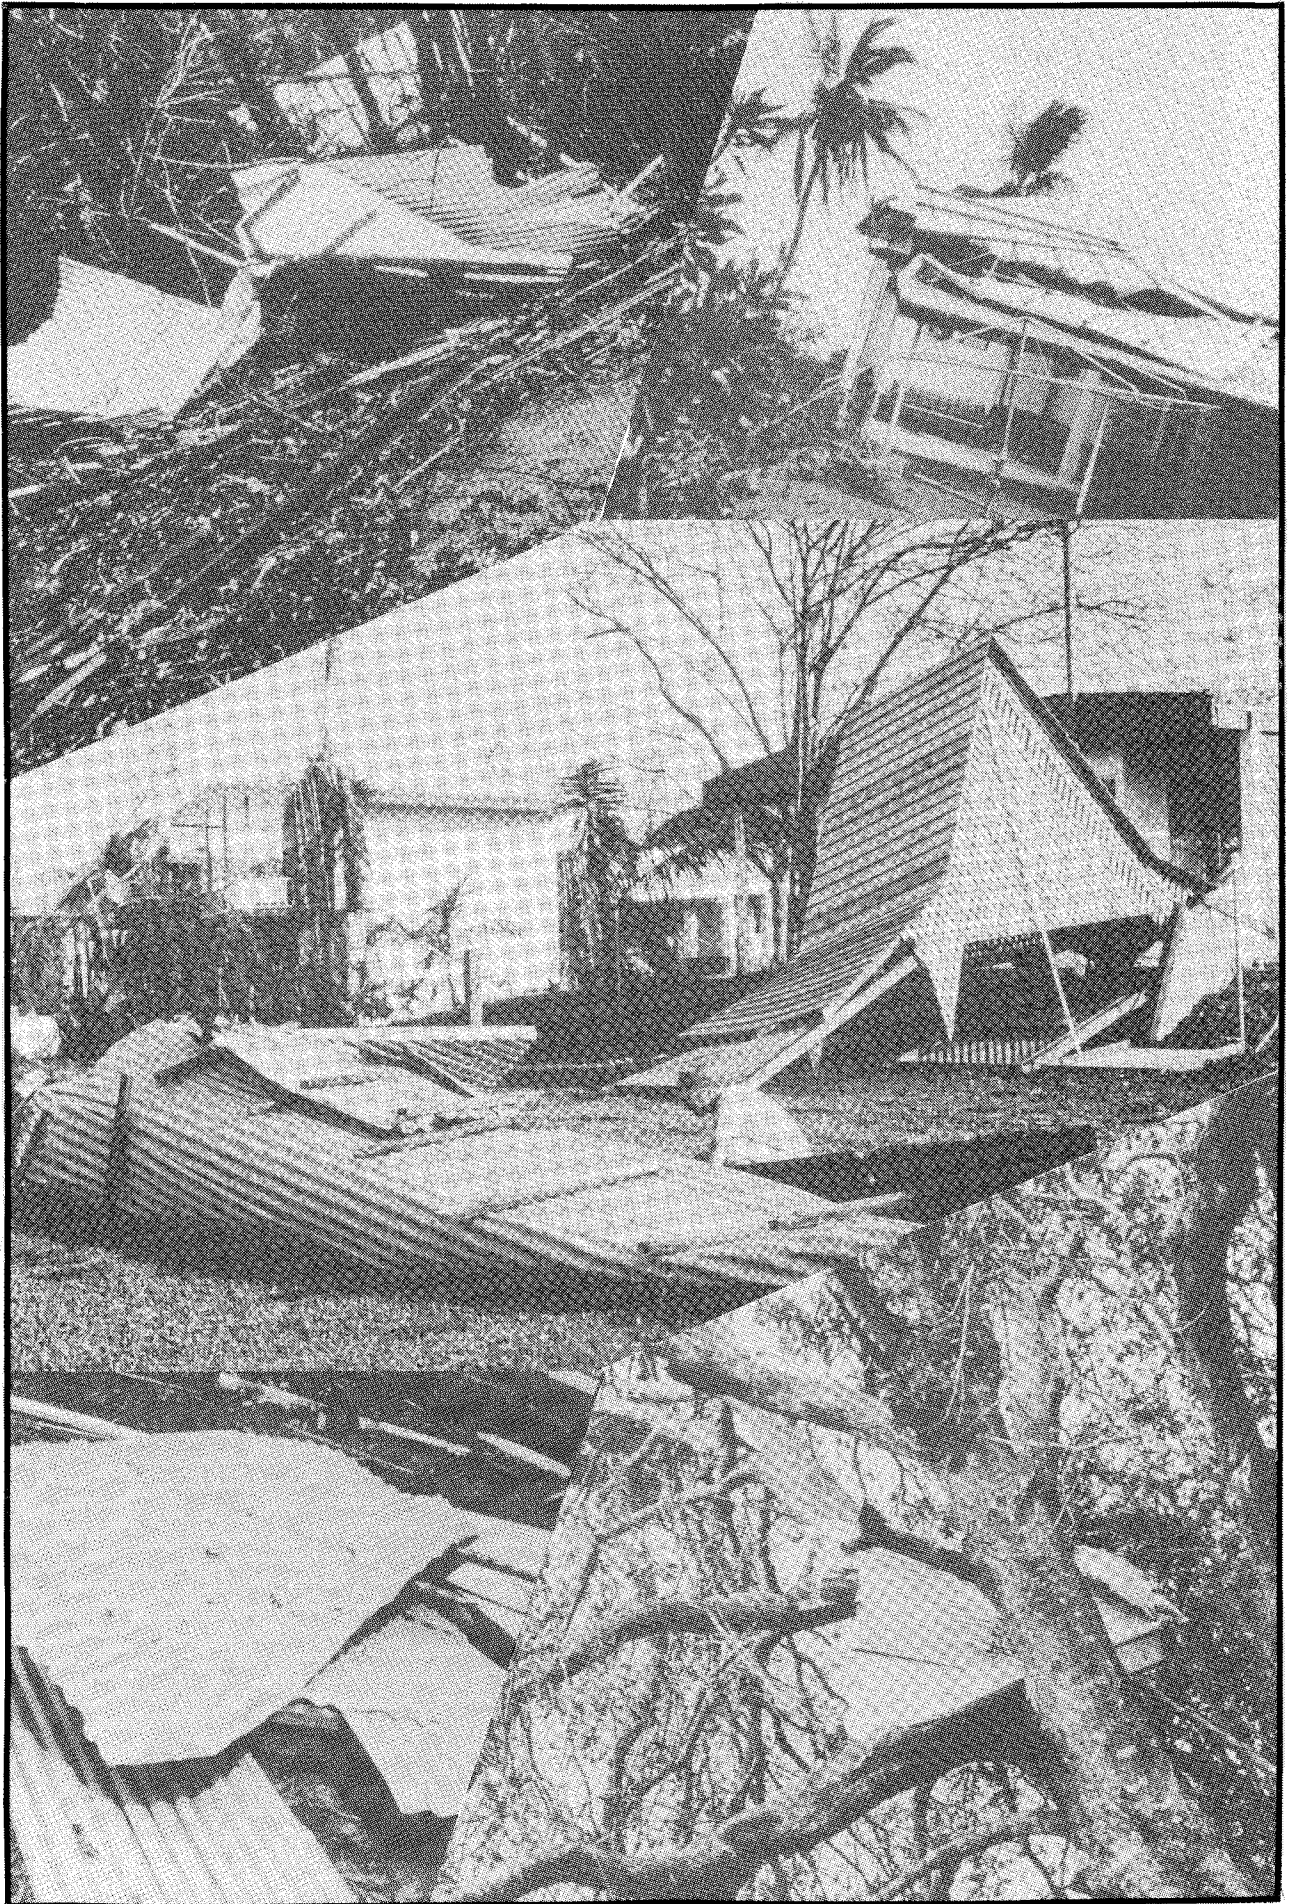
Figure 29. Roofing and Battens Blown off Buildings

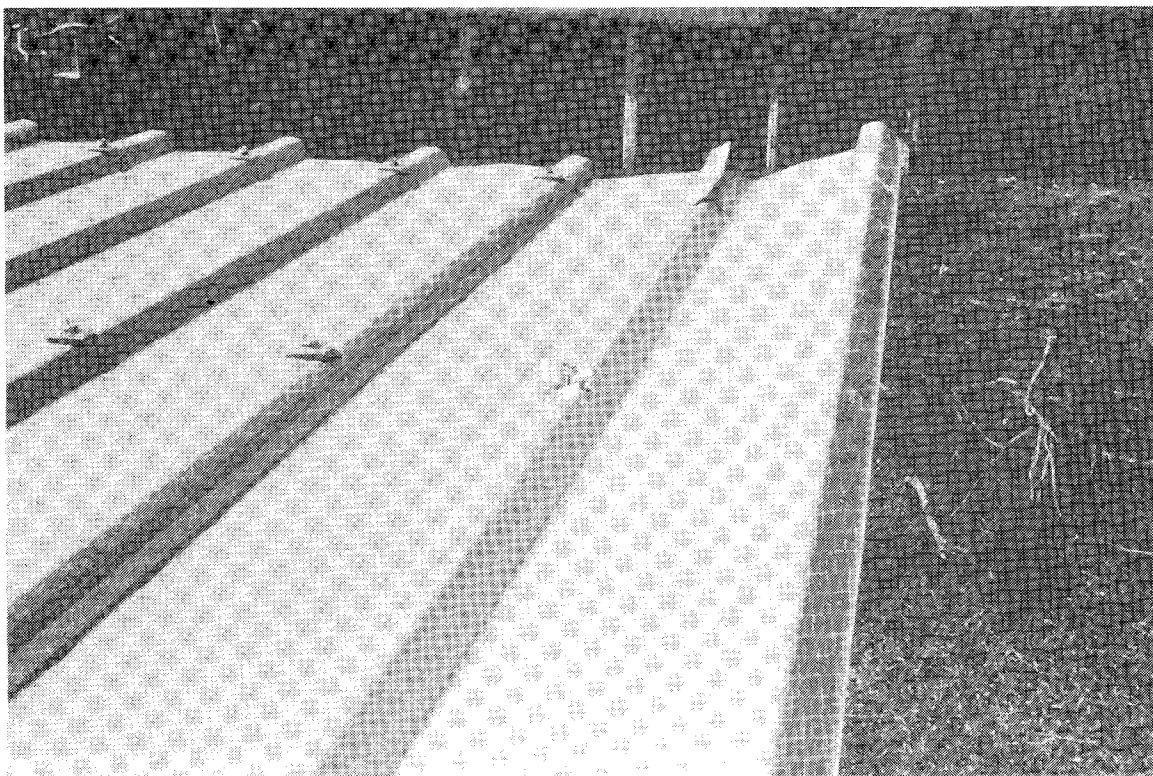
Figure 30. Faulty Construction - Lack of Fasteners in Edge Rib

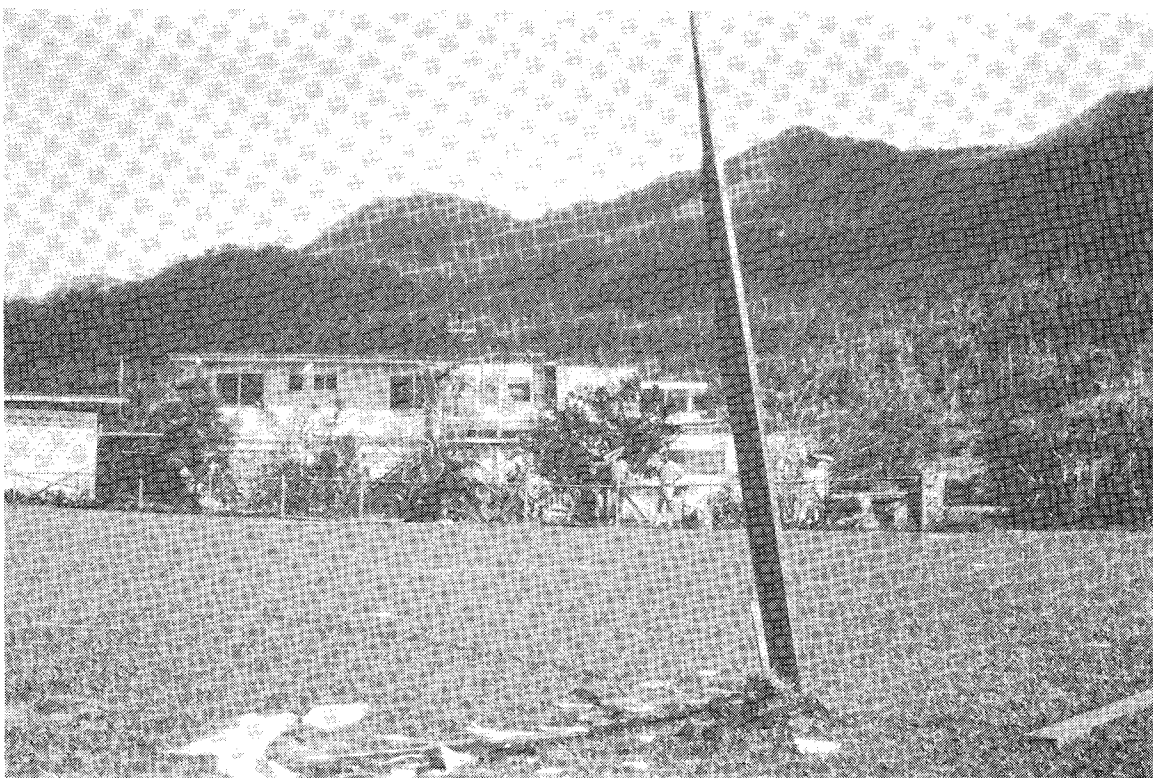
The loss of roofing during the cyclone created a potential hazard from flying debris. Figure 31 shows a section of rafter having been lifted from the house in the background. Despite these missiles there was little evidence of damage to walls by flying debris. The only obvious example was at Innisfail High School, already mentioned in Section 4.3.1. There were a number of claims, and some evidence, of roofs having been hit by flying debris from a neighbouring building, but it must be concluded that the overall debris damage was small compared with the potential for damage.

Figure 31. Broken Rafter from House in Background, Babinda

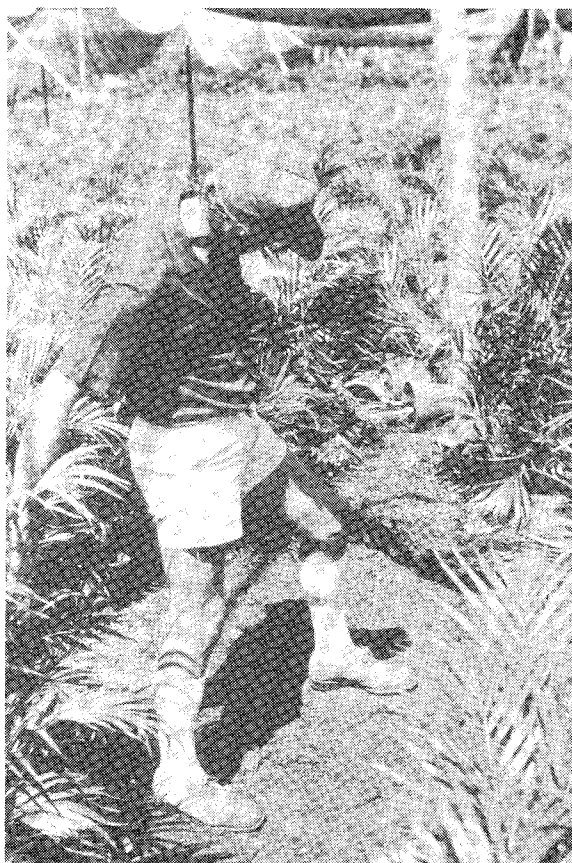
It was not surprising therefore to see some damage to the large shade house. The uplift forces were apparently greater than anticipated and fractured the connecting piece between a pole and a guy cable. This allowed some other support poles to lift and pull their footings out of the ground. Figure 32 shows a support pole and footing that had been lifted and displaced sideways by about 1 1/2 metres. Some poles pierced the cloth as it flapped in the wind, and eventually allowed it to fall onto the plants.

Figure 32. Support Pole and Footing Displaced from Original Position
(at right foot)
