CYCLONE TESTING STATION

SIMULATED CYCLONE WIND LOADING OF A BRICK VENEER HOUSE

TECHNICAL REPORT No. 28

G.F. REARDON

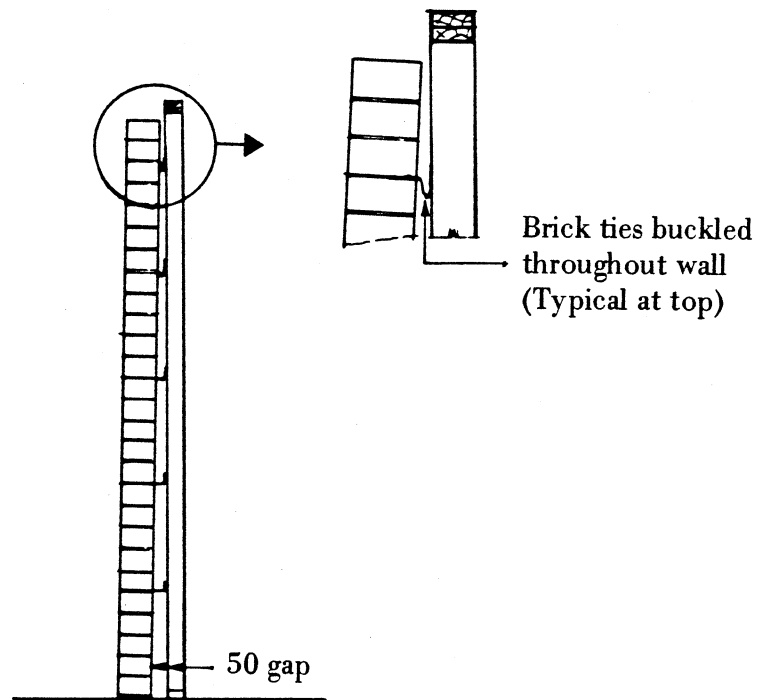
Figure 12 Brickwork failure by Rigid Body Rotation

Failure of the brick wall had occurred by a rigid body rotation about the floor slab. Figure 12 illustrates the mode of failure. The brick ties at the top of the wall had buckled severely and those on lower courses showed progressively

less buckling of the bottom tie. There was no evidence of movement of ties within the mortar nor of any cracking of the mortar joints, except at the bottom joint where the failure occurred. Also, there was no evidence of lateral translation of the brickwork on the surface of the slab, despite the presence of the damp proof membrane.

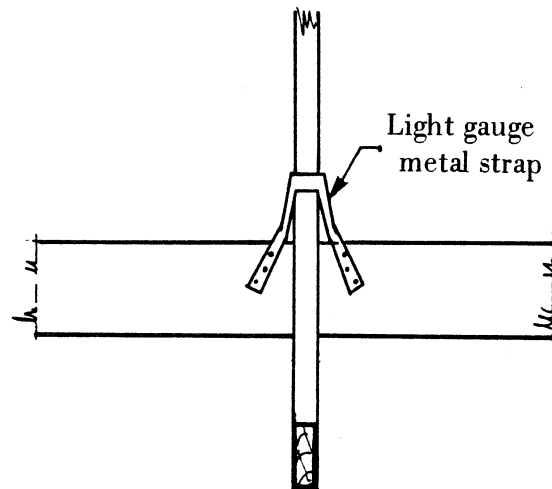
Figure 15 Truss Tie-down over Lintel

The south end of truss 18 was located on the lintel beam over the laundry doorway. As such, the specified looped strap tie down connection had not been used but had been replaced with a simple strap connection, having straight legs as shown in Figure 15. This type of connection is not in accordance with the provisions of the Home Building Code and therefore should not have been used. At other positions where trusses were located on lintels, two framing anchors were used as tie down in accordance with the code.

The tie down failure at truss 18 was caused by the same prising mechanism previously mentioned for nearby trusses. However because the strap was not looped under the top plate the loss of some nails by prising was critical and resulted in overloading of the remainder. It is assumed that this failure of the tie down at truss 18 caused the fracture of the tie down strap at truss 19.

The two tie down systems were then repaired and the test programme was continued.

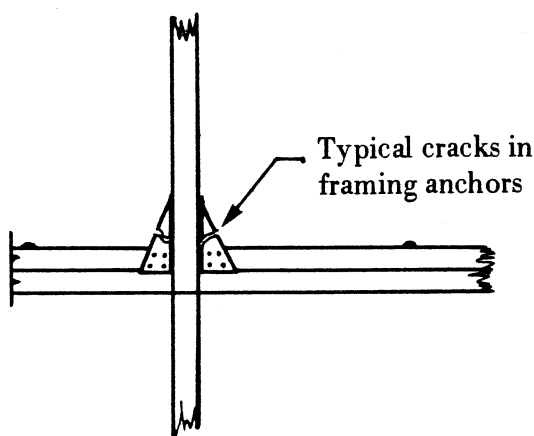
Figure 16 Framing Anchors Cracked

At about 7500 uplift cycles the ceiling at the midspan of the trusses in the lounge was rising about 40 mm during each cycle. This reflected large displacements at the north end of trusses 12, 13 and 14 which had broken their

tie down details. On trusses 11 and 12 both framing anchors had cracked right through, as shown in Figure 16. On truss 14 one framing anchor cracked through and the other pulled out of the top plate. The framing anchors on truss 13 had not broken but had lifted the top section of the ribbon top plate, as shown in Figure 17.

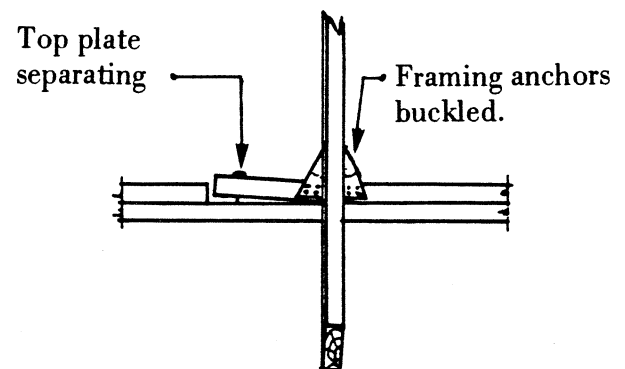
Figure 17 Top Plate Failure

By 7000 uplift cycles the framing anchor on truss 14 north had cracked further and truss 13 was lifting about 8-10 mm and separating the ribbon top plate. The upper member of the top plate had been joined adjacent to truss 13. These increasing movements of the house frame caused the rate of load cycling to decrease significantly. The last thousand cycles in the sequence had an average rate of about 50 seconds.

- (xvii) The use of framing anchors with ribbon plate construction is not recommended as the anchors can be attached to the top laminate only.
