JAMES COOK CYCLONE STRUCTURAL TESTING STATION

## **A SURVEY OF THE CORROSION OF BUILDING COMPONENTS**

**TECHNICAL REPORT No 32**

**August 1988**

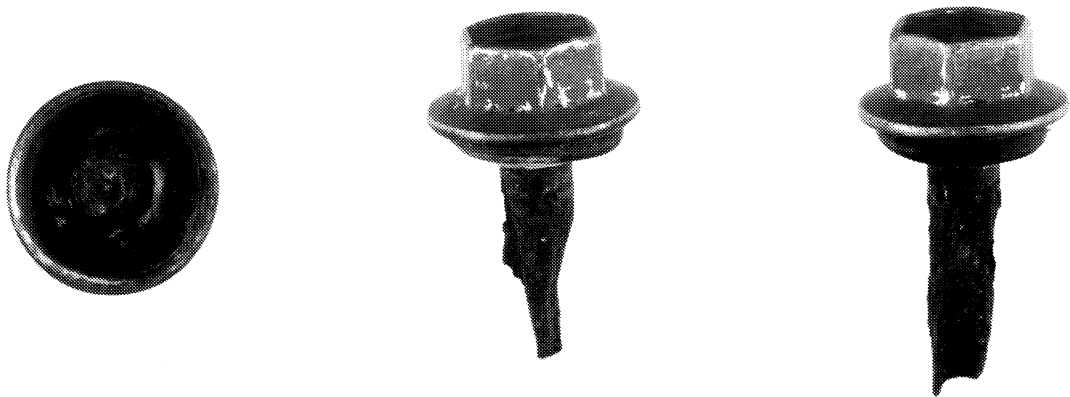
FIGURE 1 Corroded screws sent to the Station

Some time after cyclone Winifred a number of severely corroded roofing screws were sent to the Cyclone Structural Testing Station at James Cook University from the Atherton Tablelands area. Figure 1 shows some of the screws. They had been taken from a three year old building in Atherton. The building in question is shown in Figure 2. The portion of the building

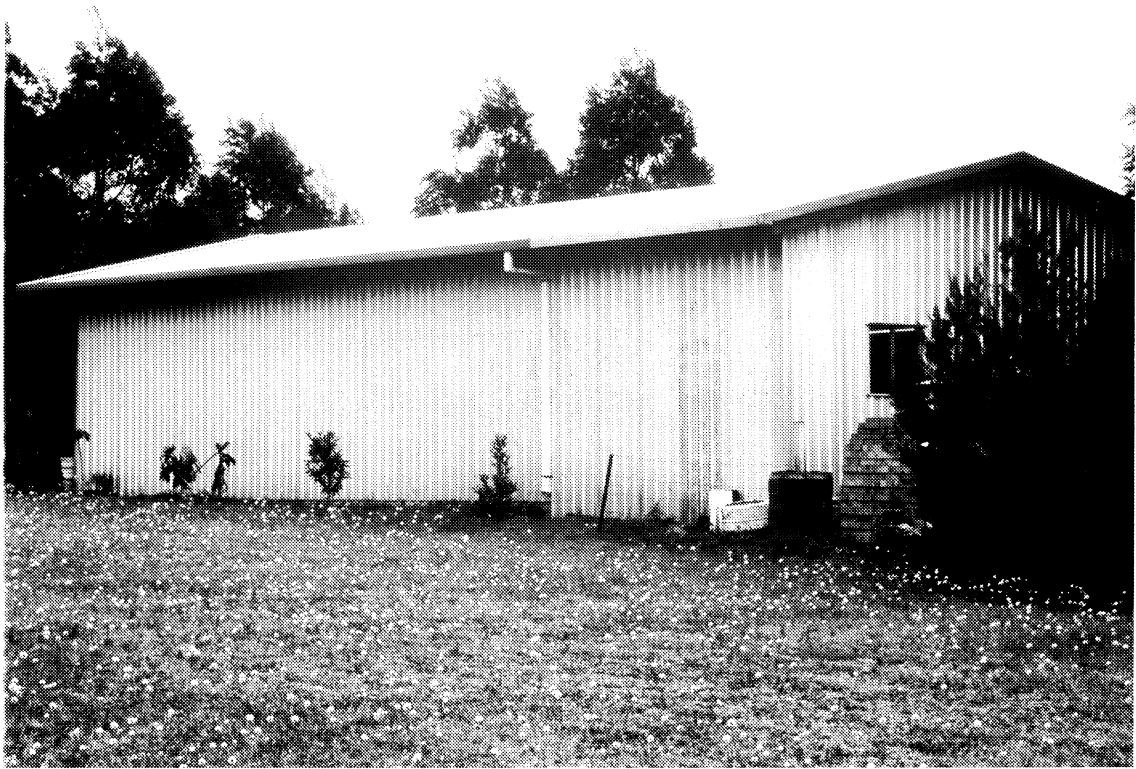
Figure 2 Building having corroded screws

to the right hand side of the downpipe was added early in 1986 after some roof sheeting had been lost during the cyclone. During that rebuilding programme all of the screws on the near slope of the roof had to be replaced. The corrosion in some of them was so bad that it had almost eaten through the 5.2 mm shank diameter of the 14 gauge screw. It had all occurred on the shank of the screw beneath the roof sheeting but above the roofing batten. However the heads of the screws were still in good condition, illustrating little evidence of their condition beneath the roofing. It was reported that the screws sent to the Station were representative of many of those taken from the building.

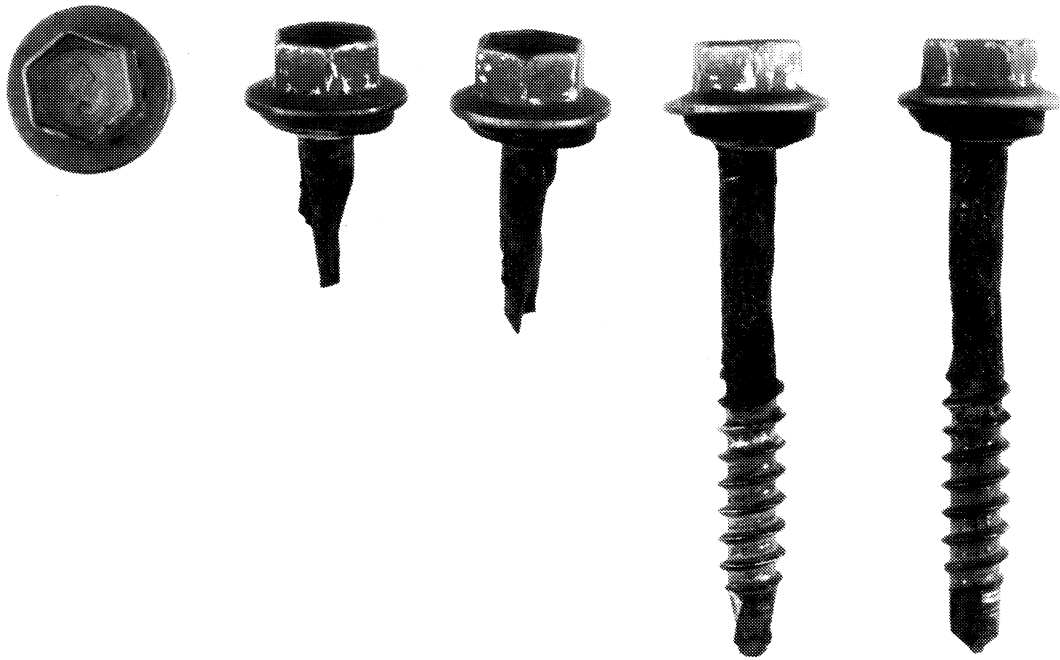
Most observations were made of the roofing and its fixings. Where possible they were inspected from both inside and outside. Because this survey was prompted by the evidence of screw corrosion, a particular emphasis was placed on observing the condition of roofing screws. It is estimated that approximately 350,000 screws would have been observed on the buildings. Of that number, approximately 1000 had either rusted through or were considered to have negligible strength because of corrosion. This latter figure does not include the badly corroded screws in the shed shown in Figure 1, which initiated this survey. Examples of badly corroded screws and others showing signs of corrosion are given in Figure 5.

Figure 5 Range of corroded screws

A disturbing aspect is that on most occasions where the shank had rusted through, the head showed little evidence of corrosion. The four screws shown in Figure 5 illustrate this point very well as all have sound heads despite the condition of their shanks. Figure 5 also illustrates the lack of corrosion of the threaded part of the screw or its point, a feature that has already been mentioned. As well as the head usually being relatively free of corrosion the sealing washer was usually also in good condition. Thus the condition of the screw, and its effectiveness, cannot be accurately judged by the condition of its head.

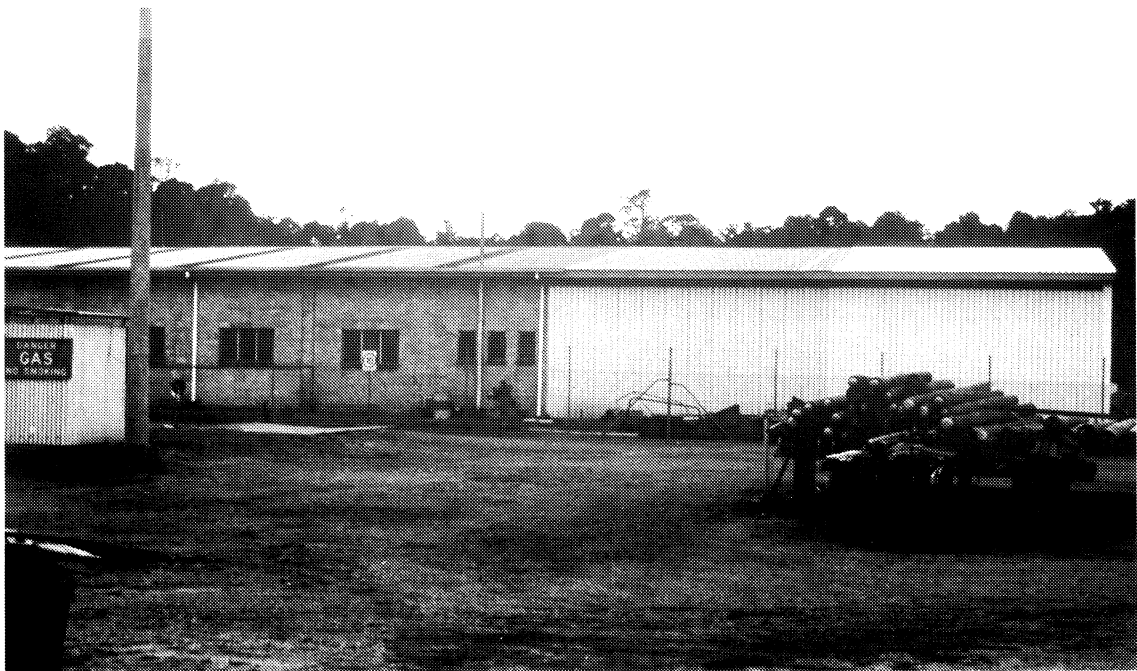
The worst individual case in the survey was an industrial building at Atherton, illustrated as Figure 6. The 40 x 15 m building, about 10 years old, would have had approximately 6000 screws in its roof. In the bottom two purlins on the side nearest to the prevailing wind, 71 of the 500 screws were totally rusted through, 70 appeared to be in good condition and the remainder were in various states of corrosion. As can be seen from the photograph the building consists of an original section and extensions at the right end. The extensions were approximately two years old when the building was inspected. At least five screws in the second bottom purlin were considered to be in poor condition because of corrosion. Three of those five screws broke on being withdrawn from the steel purlin.

Figure 6 A building at Atherton containing the most corroded screws

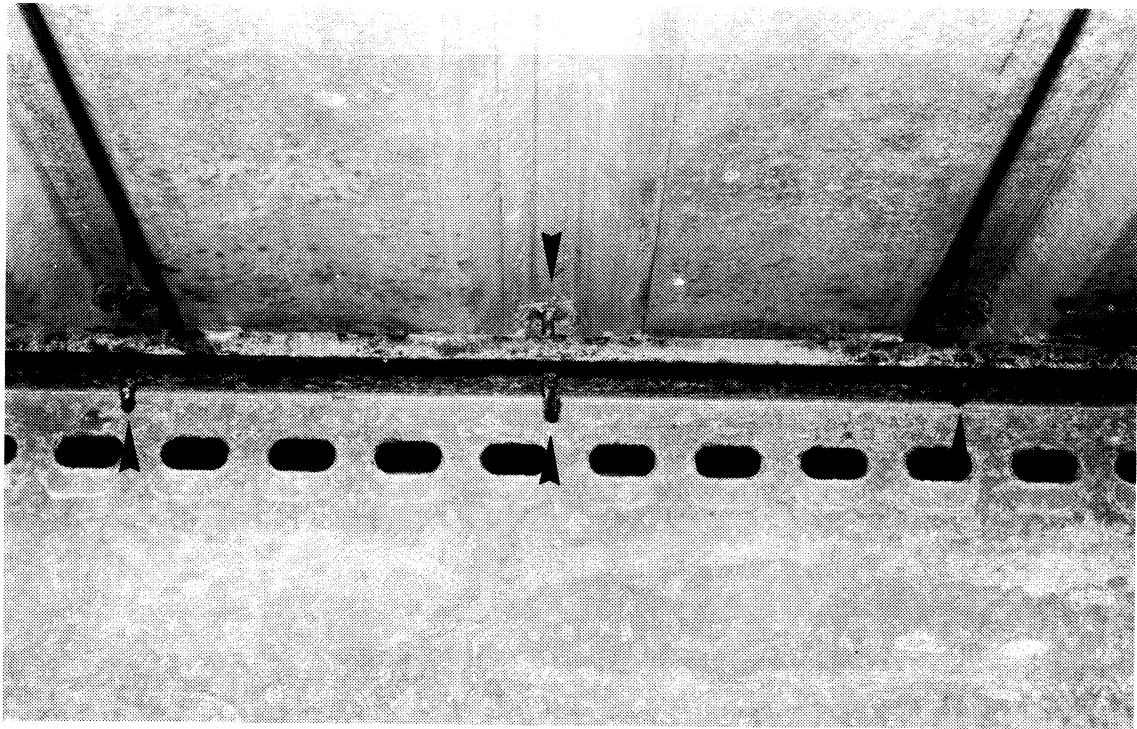
Some of the original screws in the ten year old part of the building had completely rusted through. Figure 7 shows a group of three screws driven through the roof decking and into a steel purlin. For clarity the screws are marked with an arrow. While the shank on the central screw is still reasonably sound, the shanks of the other two screws have rusted

Figure 7 Two badly corroded screws in group of three

completely through. The purlin was the third one from the eaves of the building and therefore was virtually over the external wall.

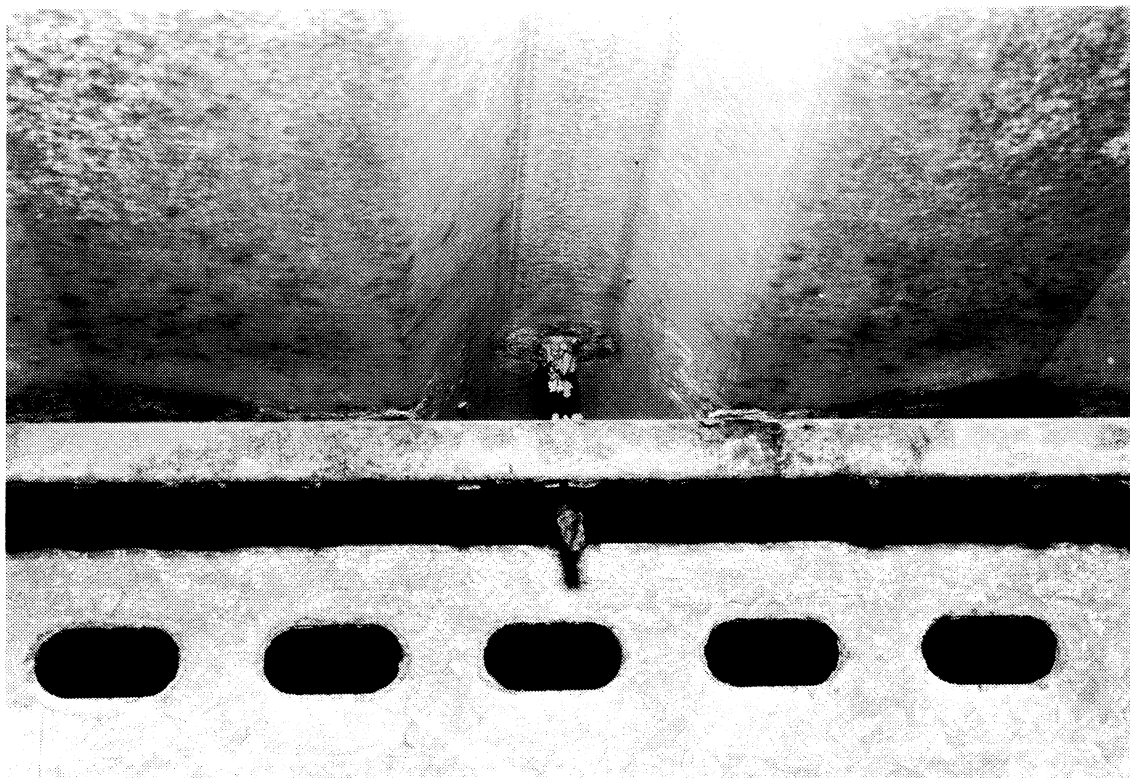
Because of difficulties regarding access, inspection of screw shanks was made in unlined buildings only. Of the 15 cases in the Innisfail and Atherton areas that were reported by the building surveyors as being serious, only 9 could be visited. In each of these nine buildings, severely corroded screw shanks were observed. The main location for rust was in the shank just above the purlin, that is, beneath the crest or rib in the roofing. In many instances the screw shanks were completely rusted through and their heads could be lifted off the roofing - albeit with some difficulty due to fusing of the sealing washer onto the roofing and the screw. Figure 8 shows a roofing screw with its shank having rusted through completely. It was located further along the purlin described in Figure 7. A point of interest is that the portion of the screw penetrating the purlin is showing virtually no evidence of rust. Both the cutting edge of the thread and the point of the screw are still quite sharp.

Figure 8 Screw shank rusted completely through

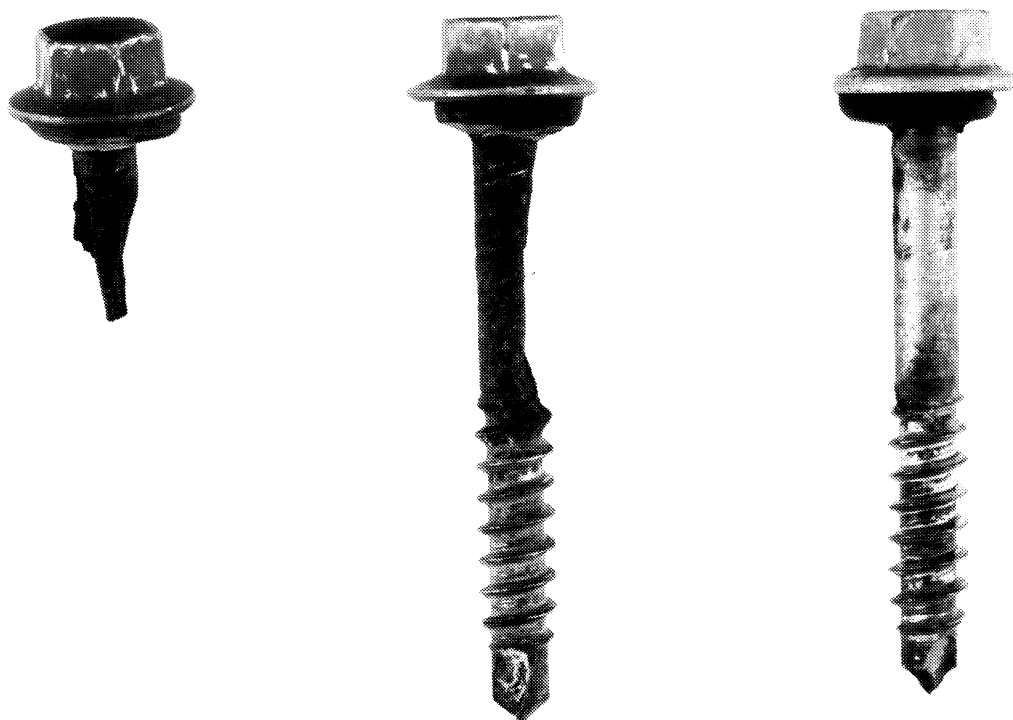
Corrosion of the screw shank appeared to be unaffected by the type of purlin to which it was attached, whether it was timber or steel. Likewise the part of the screw embedded in the timber purlin showed virtually no effect of corrosion. Most of the screws that were withdrawn from timber purlins were still sound along the length that had been embedded.

Figure 9 Screws taken from adjacent purlins

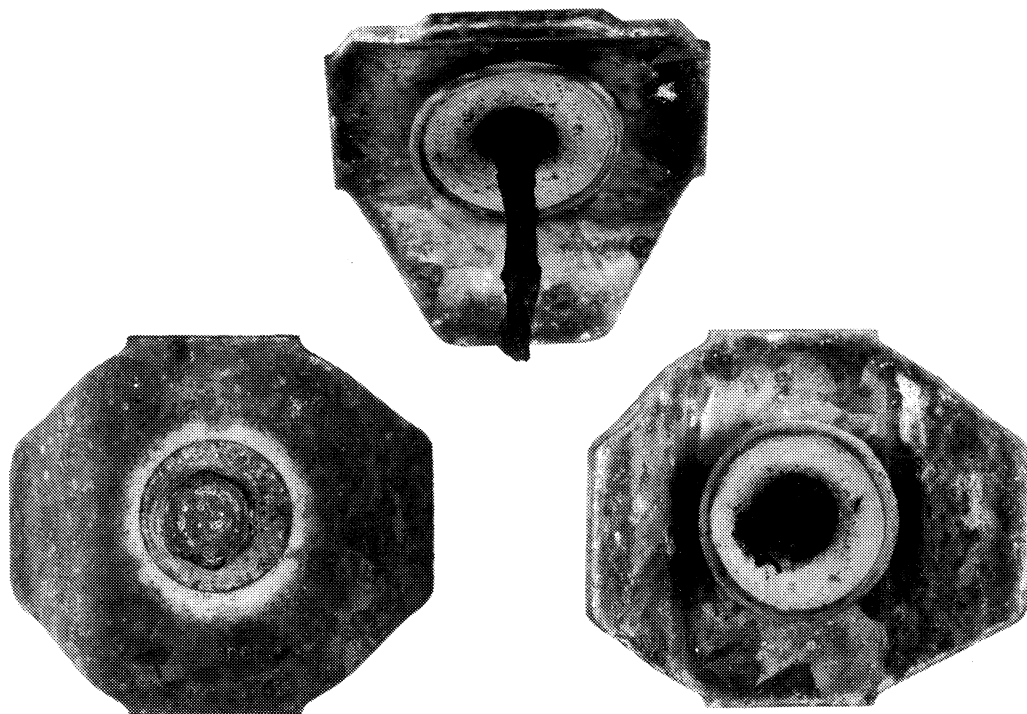
Many of the buildings inspected included cyclone washers in their roof security systems. The presence of washers did not seem to influence the degree of corrosion of the screws. However the galvanised washers themselves showed very little evidence of corrosion. Figure 10 shows a cyclone assembly taken from the roof of a building at Ayr. The figure graphically illustrates the effects of the atmosphere on three different surfaces. The shank of the screw has virtually corroded through. The galvanised exposed surface of the cyclone washer has become dull, indicating that the galvanising is working to protect the steel. The underside of cyclone washer, which was protected from the atmosphere by its sealing washer, is still bright. While the age of the building was not determined, an upper limit can be estimated by the presence of cyclone assemblies. They were not used on steel roofing before cyclone Tracy hit Darwin in December 1984. The roof security system could therefore not have been more than 13 years old at the time of the survey.

Figure 10 Cyclone assembly demonstrating the difference in corrosion protection

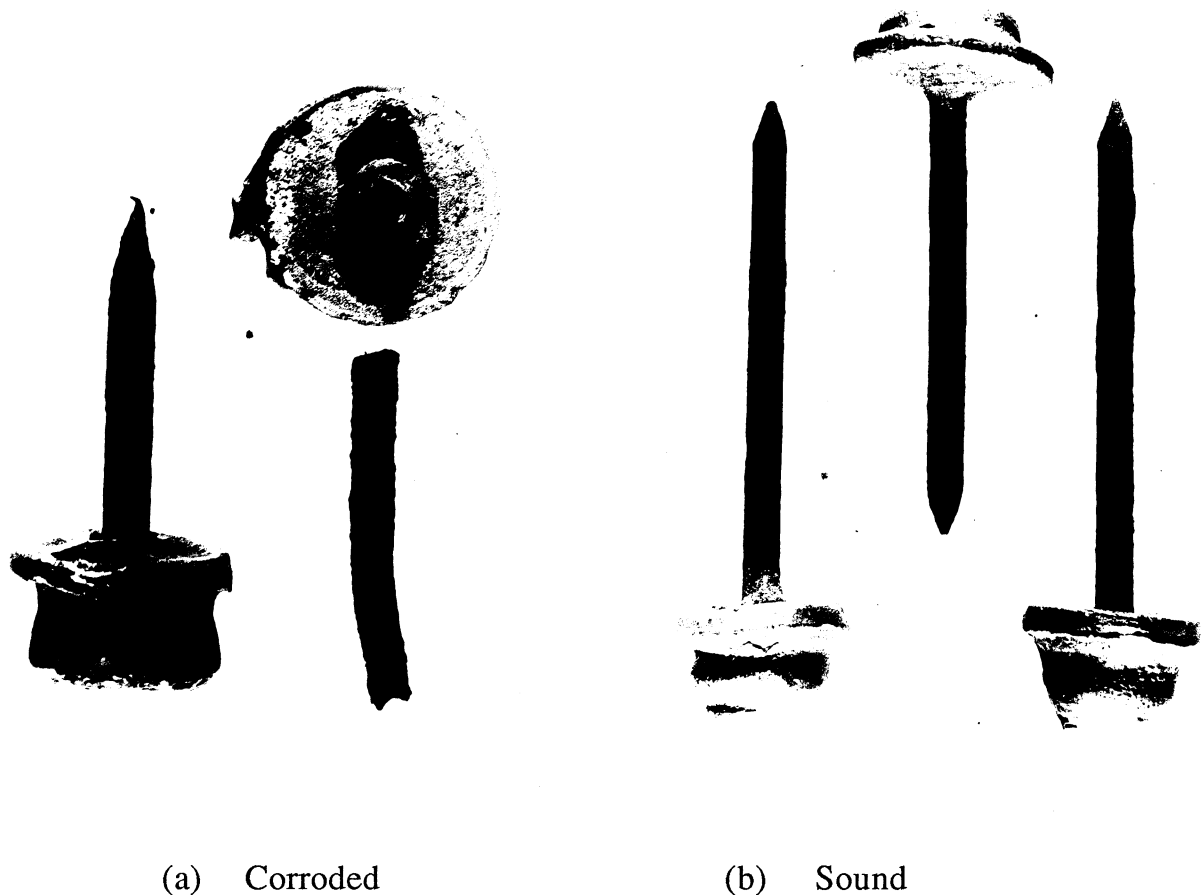
Figure 11 Lead headed roofing nails

Figure 11(a) shows some corroded nails while Figure 11(b) shows relatively sound ones of similar age. Further, with the current trend away from the use of roofing nails in favour of screws, the average age of the nails would have been greater than that of the screws.

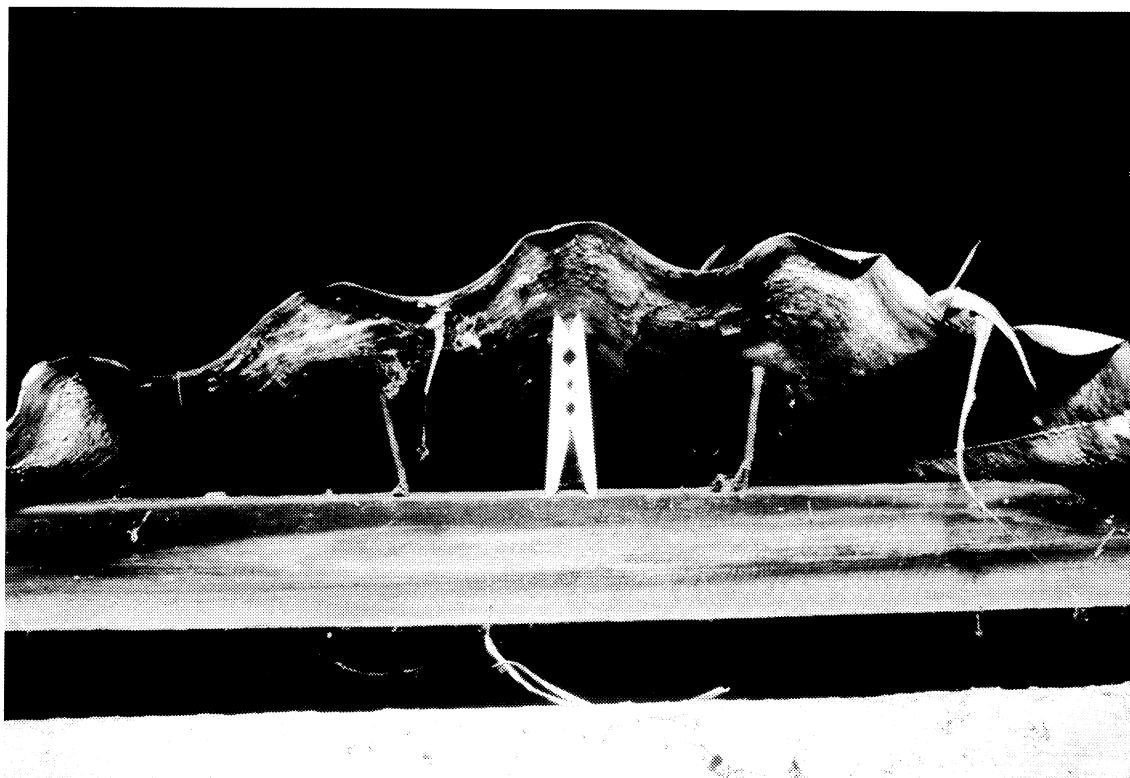
The perennial problem of nail popping was observed. Some nails at lap joints were as much as 15 mm proud of the roofing. In other cases nails had become so loose that they could be withdrawn by hand. This was usually associated with a very local rotting of the timber batten around the nail hole while the rest of it was still relatively sound. Possibly the same moisture conditions that were causing the screw shanks to corrode

Figure 12 Roof of old shed showing loose nails

were causing this rot by having moisture run down the shank of the nail onto the timber. Figure 12 shows the roof of an old shed in Townsville where the nails, although hardly corroded, had totally lost their grip on the timber. Although this is quite a different problem from the corrosion of a fastener, it can leave a roof in an equally weakened state and susceptible to wind damage.

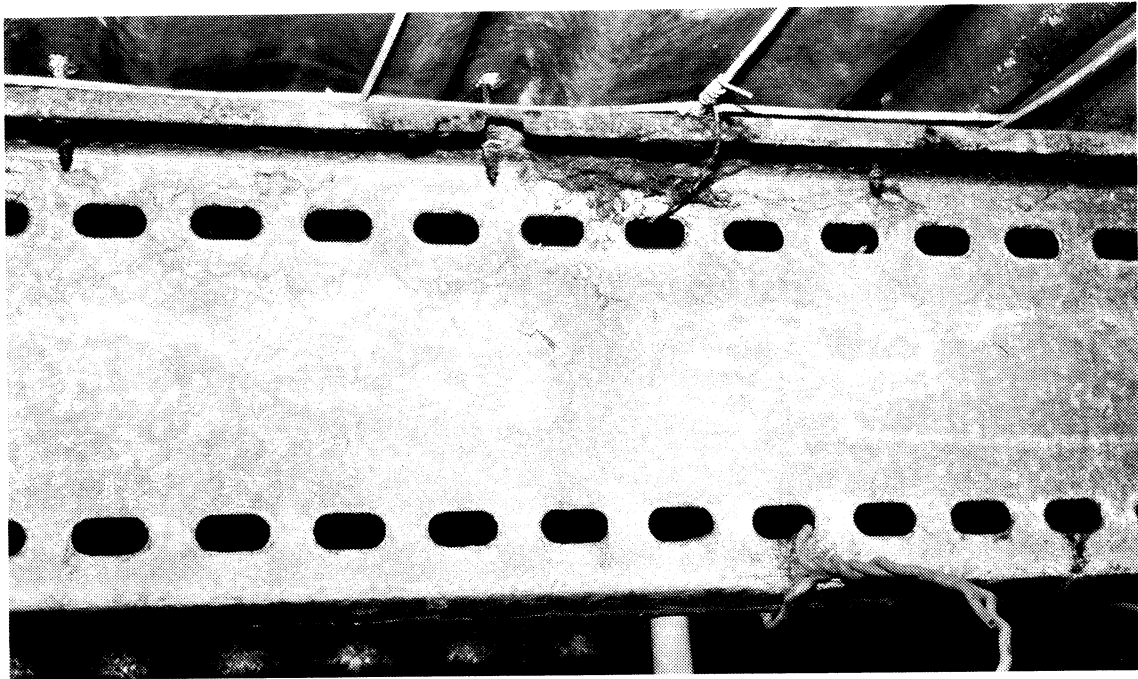
Although the survey tended to concentrate on corrosion of fasteners, a cursory inspection of the structure was usually made. There was generally little evidence of corrosion of structural components, although on two separate occasions, one in the Atherton Shire and the other in the Johnstone Shire, severe corrosion of light gauge galvanized steel purlins was noted. In each case the building was about eight years old and only one of approximately 150 purlins was affected. It was one in the line of purlins directly above the wall facing the direction of the prevailing wind, where the screws attaching the roofing to those particular purlins were severely corroded, but the roofing appeared in good condition. The other purlins in that area had only traces of oxidation whereas the two rusted ones had corroded to a critical level. Figure 13 shows severe corrosion of the top lip of a purlin in the Atherton building.

Figure 13 Corrosion of top lip of purlin

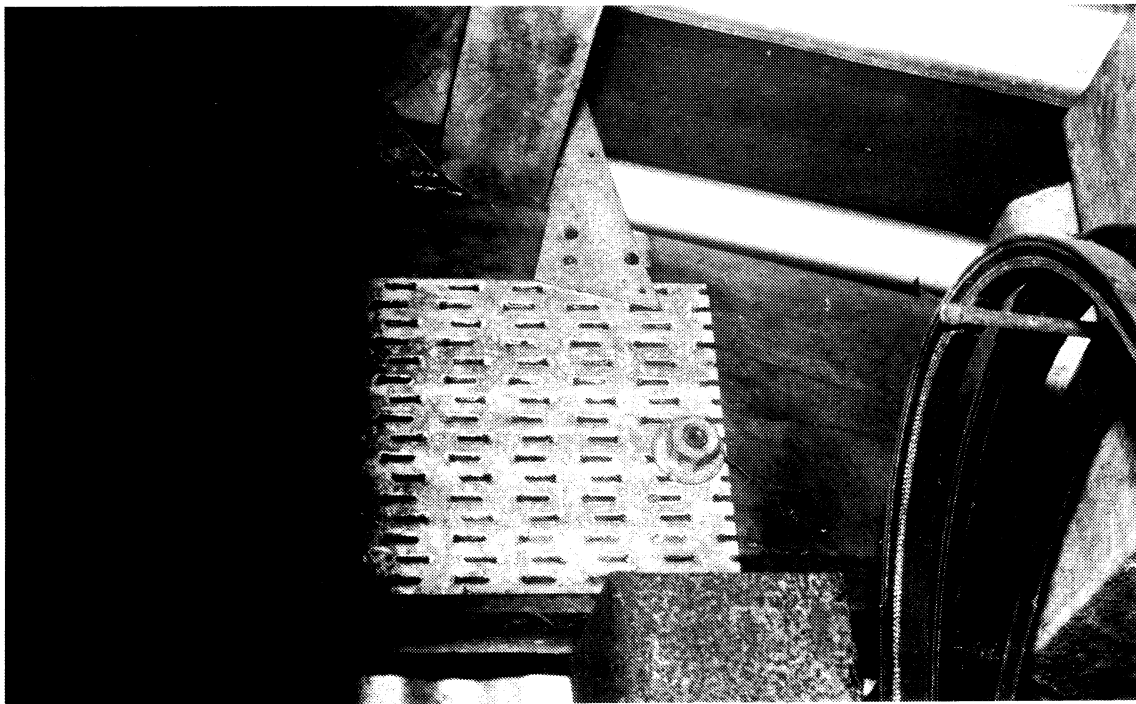
Figure 14 Toothed metal plate and framing anchor without corrosion

There appears to be no problems with corrosion of pressed nailing plates (Gang Nails and the like) used in truss construction. The plates exposed in unceiled buildings all appeared to be in good condition. There was no evidence of rusting at the cut edges of the metal where the teeth had been formed. Figure 14 shows a pressed metal plate in the heel of a truss in the building shown in Figure 2, where there was serious corrosion of the roofing screws in the purlin above the wall. Also shown in Figure 14 is a framing anchor with no evidence of corrosion.
