SIMULATED WIND LOADING OF A MELBOURNE STYLE BRICK VENEER HOUSE

TECHNICAL REPORT No 34

November 1988

G. F. Reardon
and
M. Mahendran

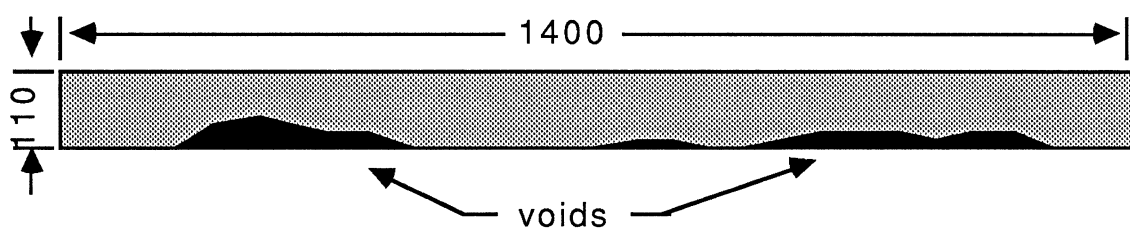
FIGURE 14 Plan of a Mortar Bed Indicating Lack of Contact

These problems were related to the quality of workmanship, the lack of experience of the Station's staff in visually assessing brickwork quality and the opportunity for people to see the internal face of brick veneer construction. The bricks were laid by a tradesman with many years experience based on a formal apprenticeship in New South Wales. (He advised that some states do not require apprenticeship training for bricklaying.) The authors believe that the bricklayer did his job in the usual manner. He was most obliging and was interested in the Station's research. However the fact that the internal lining had not been fixed on the windward wall allowed the inner face of the brickwork to be inspected. This unusual situation revealed that the brickwork did not conform with some requirements of the Brickwork Code, AS 1640 (SAA, 1974). In Section 5.5, entitled "Workmanship", Clause 5.5.1 states in part that bricks must be laid on a full bed of mortar. In many instances the mortar beds in the test house did not fill the joint between rows of bricks at their inside face. It appeared that the trowel had been wiped on the inside edge of the bricks causing the mortar to slope away from the brick above. A 20 mm wide, 0.5 mm thick ruler was used as a probe to gauge the depth of the voids in various bed joints in the short length of brickwork at the north end of wall 4. Figure 14 illustrates to scale the plan of the mortar on one of the worst bed joints. Lack of full contact is indicated by the dark area. The perpend joints generally had less contact area than the bed joints. On more than one occasion the void in a perpend measured up to 85 mm in depth.

When the situation was explained to the bricklayer, he advised that this was normal practice as tradesmen were also required to ensure that there were no mortar droppings at the bottom of the cavity and this method of laying bricks was the best way of ensuring that. Indeed, the bottom of the cavity was very clean.

The Station's staff were then left with the dilemma of deciding whether or not to accept the brickwork. It was clearly not to code requirements but may well represent the norm, as this inner face of brickwork is very rarely available for inspection. Help was sought from others with wider practical experience. Two engineers, an architect, a brick industry representative and a construction supervisor all suggested that the brickwork should be replaced. Their recommendations were accepted.

As it was suspected that the lateral loading on the brickwork would cause failure at one or both of the free standing lengths of the windward wall at the lounge room (see Figures 1 and 2), the bricklayer was asked to rebuild only those short lengths. Because of other commitments he was unable to commence the work immediately. In fact, because of the time delay in assessing the situation the rejected lengths of wall were just 28 days old when they were due to be replaced. This provided the opportunity for them to be tested in their original condition and form the basis of comparison for later tests on the brickwork conforming to the code.

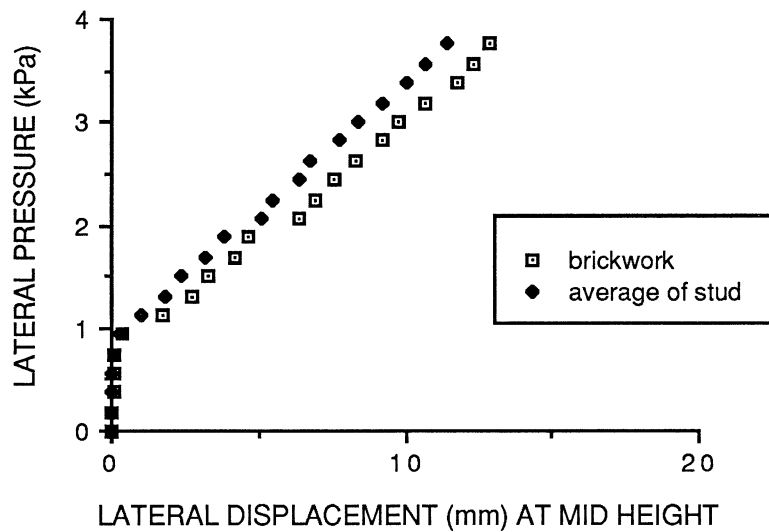
FIGURE 15 Response of First Isolated Wall to Positive Pressure

During the test the load was increased steadily and the response of both the brick skin and the timber framework were closely monitored. It was soon apparent that even this wall with its incorrectly laid bricks had strength well in excess of the design pressures listed in Table 9. The first obvious failure occurred at a pressure of 2.3 kPa when cracking of the bottom mortar joint was observed. By 2.7 kPa cracking was obvious at

the 8th and 16th mortar courses above the floor. However the wall managed to resist 7.6 kPa before it finally broke at the 8th mortar joint and the adjacent studs twisted severely. A detailed inspection showed that the timber studs had suffered a permanent torsional distortion in accepting the load transferred from the brickwork, the ties had bent at the weak corner position where their cross section was flat (see Figure 4). Although the cracking of the brickwork occurred first, it was possible for either failure of the ties at mid height or the bending failure of the brickwork at the mortar joint to have caused the sudden failure of the wall. As the failure was very sudden it was not obvious which of the two mechanisms initiated the failure. Also the stud/top plate joints showed permanent deformation, with one stud having moved about 5 mm relative to the plate. It should be noted that the absence of internal lining and cornice on this windward wall may have contributed to this stud/plate deformation. It might not even have happened had the cornice been in position.

The deflection pattern of this isolated wall gives a good insight into its structural response. For lateral pressures up to 1 kPa, i.e. about four times the design pressure for Melbourne or 2.5 times that for Brisbane, there was practically no movement of either the brickwork or the frame. After this load both of those elements responded in an almost linear elastic manner until failure. It was quite obvious that the brickwork was transferring its loads directly to the frame during that response. That is, the wall ties were able to act very effectively as columns. The displacements of the bricks and adjacent studs nearly matched each other, whereas the bricks between studs moved a little more than the average stud movement. The overall profile of the brick wall, measured between the central studs, showed that at a pressure of 3.95 kPa there was practically no movement of the bottom course, 12.8 mm movement at mid height, but only 3.7 mm at the top course. Figure 15 shows a graph of lateral pressure vs. lateral displacement at mid height of the brickwork between the two studs and the average mid height displacement of the two adjacent studs for pressures up to 3.95 kPa.

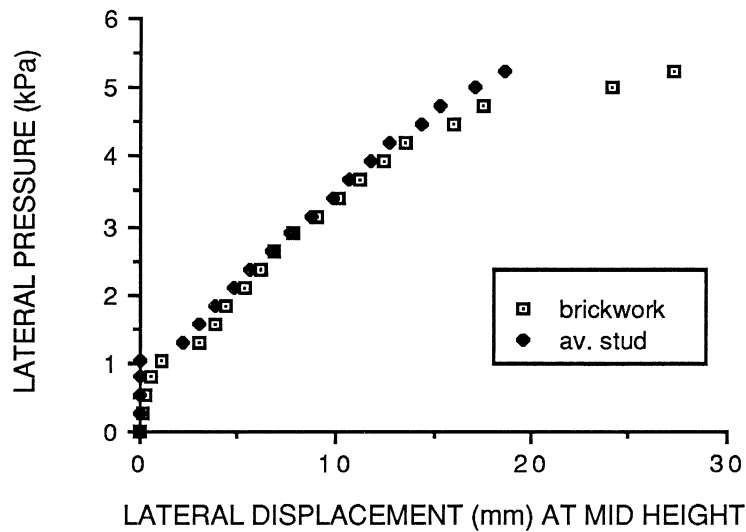
FIGURE 16 Response of Second Isolated Wall to Positive Pressure

The second isolated wall, next to the garage, was 1550 mm (6.5 bricks) long and 2250 mm (26 bricks) high. It was also connected to four studs by ties at every fifth course measured from the floor. Once again the uniform pressure was increased in steps and the response of both the brick skin and timber frame was monitored. The first crack was noticed at the 12th mortar joint at 2.9 kPa. The next occurred at the 16th joint at 4.2 kPa and final failure occurred at that same joint at 5.3 kPa. In this test the failure of the wall was caused by a classical bending failure along the mortar joint. The only ties that bent were at joint 11, but this was probably subsequent to the main failure. There was no torsional failure of the studs nor was there any significant permanent deformation between plates and studs.

The lateral response of this wall panel was similar to the previous one until the failure at 4.2 kPa when the brickwork showed a significant movement. As would be expected, the frame also responded at that load level but the magnitude was much less because it was responding to load transfer from the brickwork rather than its own failure. Maximum lateral displacements of up to 27 mm were recorded at mid height just before failure, but these were only about 13.5 mm before the initial failure at 4.2 kPa. Figure 16 shows a graph of lateral pressure vs. the mid height displacement at the centre of the brickwork and the average displacement of the adjacent studs.

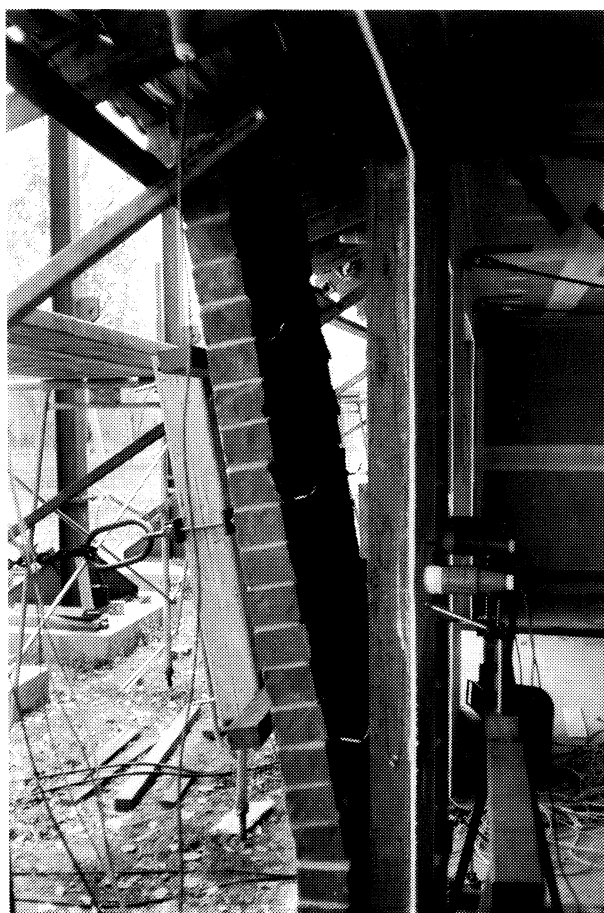
FIGURE 19 Bending Failure of Brickwork

Any overstress would have shown up on the graph in Figure 19. By comparing both the strength and the response of this panel tested for suction forces and its previous version tested for positive lateral forces it is evident that the wall ties play a very important role in the strength of brickwork. This role is possibly even more important than the amount of mortar, which was the basis of rejection of the earlier brickwork.

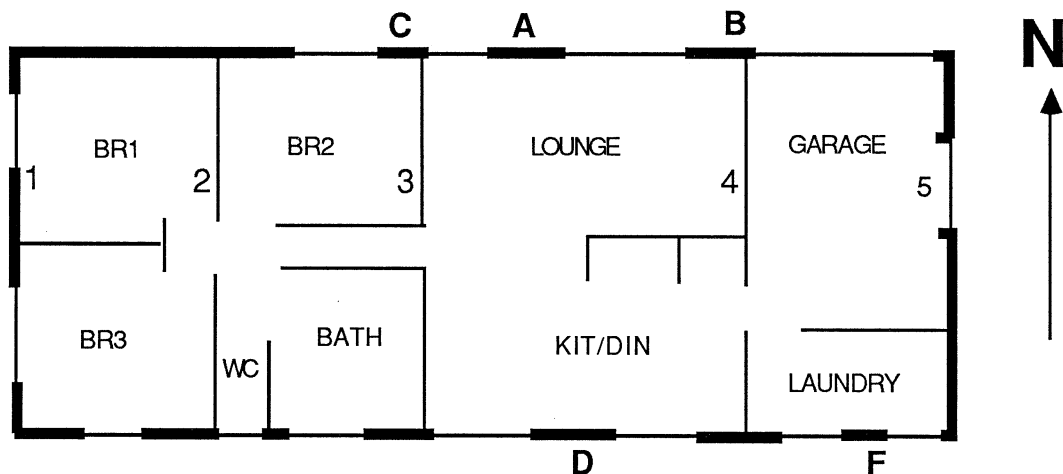
FIGURE 20 Location of Test Wall Panels

Table 10 summarises the test results of the six wall panels subjected to simulated negative pressure loading. Some explanation of the table is needed. As has already been explained, isolated panels A and B both failed ultimately in classical bending and therefore their loads at failure can be expressed in terms of pressure acting on the panel. Because of this failure mode the tensile forces in all the wall ties did not reach a maximum value before the wall failed in bending and thus only those at mid height failed. The failure mechanism of panel C was part bending

and part sliding, therefore both equivalent pressure and tensile load at failure have been included. The panel broke at the mortar line at the bottom of the window opening. The pressure to cause bending failure is a little higher than that of panels A and B, reflecting the influence of the sliding mode of failure.

Although the three smaller panels were tested in a similar manner to the larger panels, the results indicate that they were influenced by the adjoining larger portion of the wall and therefore did not fail in a bending mode. Instead, all of the ties above the lower level of the adjacent window openings pulled out of the mortar bed suddenly, leading to the collapse of the panels. The results are therefore expressed in terms of the average tensile force in the wall ties. The similarity between the three results indicates that this approach is sound.

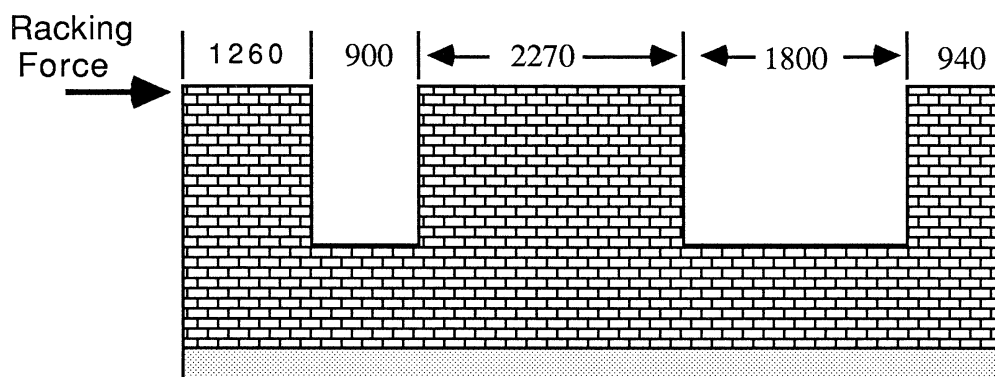
FIGURE 25 Brick Skin of Wall 1 and Initial Racking Position

Both of these loads at failure compare favourably with published design racking loads for single leaf brick walls (Brick Development Research Institute, 1987). The design racking load for a 1200 mm wall is 0.8 kN,

while that for a 2400 mm long wall is 3.3 kN. The test results demonstrate a factor of almost 5 between design strength and ultimate strength.
