CYCLONE TESTING STATION

DAMAGE IN THE PILBARA
CAUSED BY CYCLONES AMY AND DEAN

G.F. Reardon

TECHNICAL REPORT NO. 4

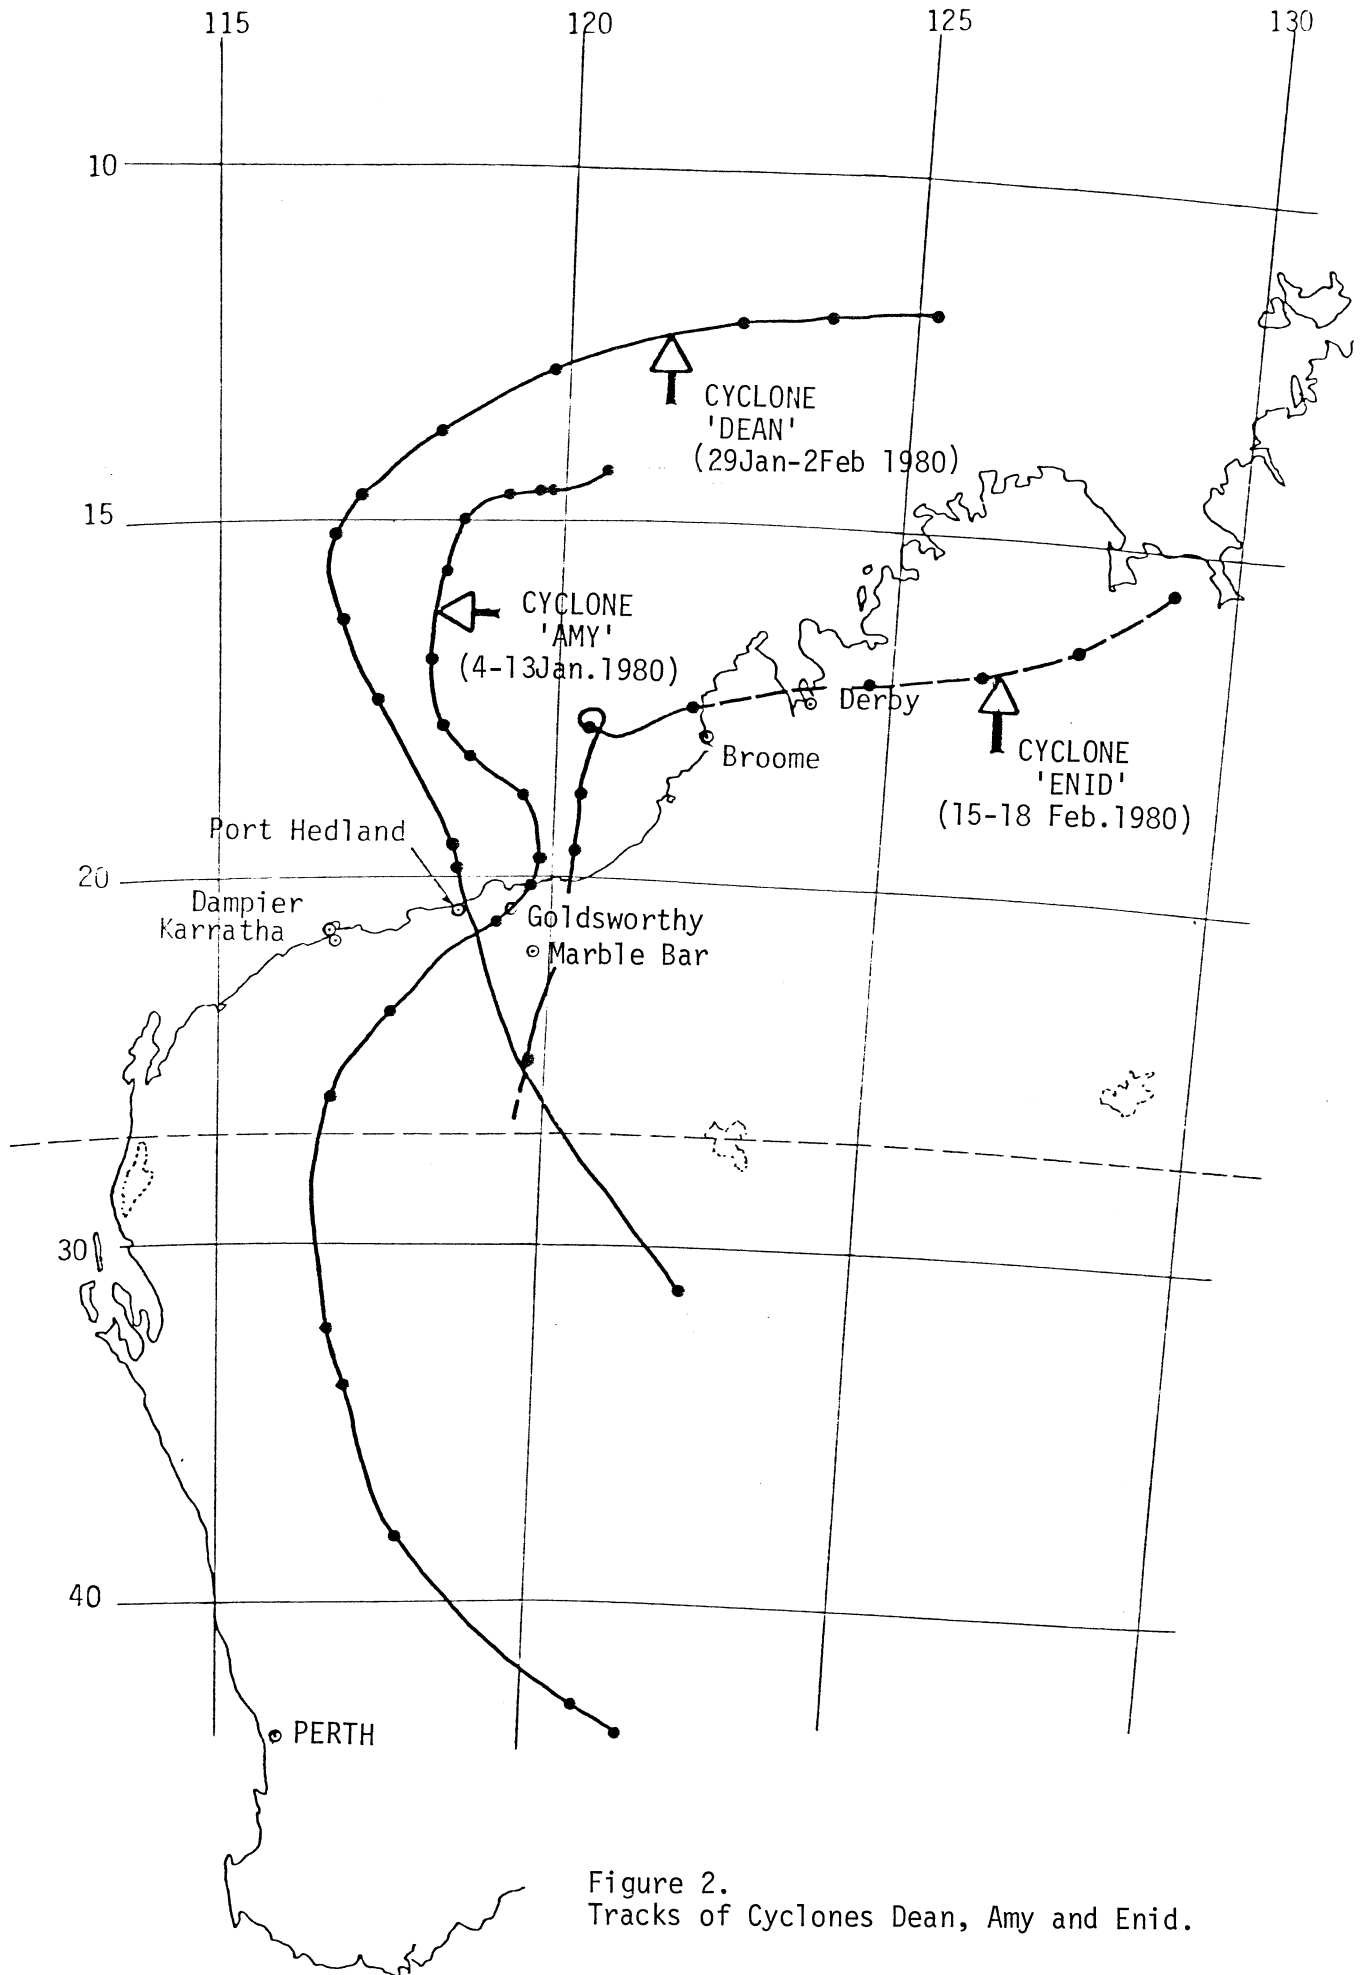
Figure 2.
Tracks of Cyclones Dean, Amy and Enid.

The Bureau of Meteorology maintains an office and weather recording instruments at Port Hedland aerodrome. This office tracked the two cyclones and issued statements on the position and intensity of each. Figure 2 shows the track of the two cyclones.

As can be seen from Figure 2, both cyclones made landfall east of Port Hedland. Amy crossed the coast approximately 140 km from Port Hedland and Dean crossed only 20 km from the city.
