**Damage investigation of buildings at Minjilang, Cape
Don and Smith Point in NT following Cyclone Ingrid**

Report: TR50
September, 2005

TECHNICAL REPORT NO. 50

**By
David Henderson and Cam Leitch**

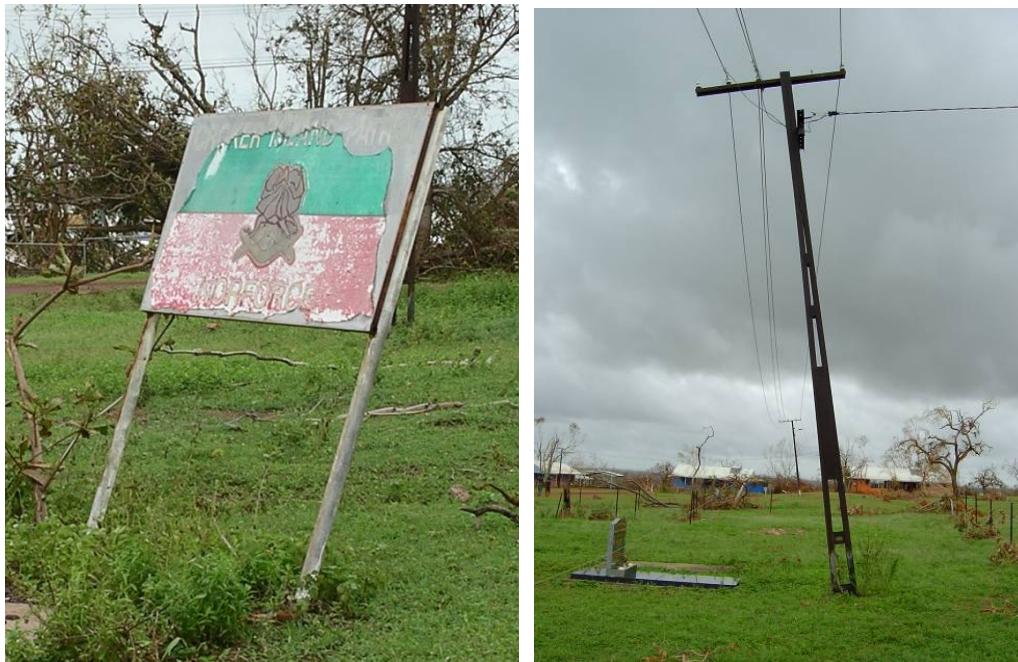
Figure 5: Footing failures - poor ‘windicators’

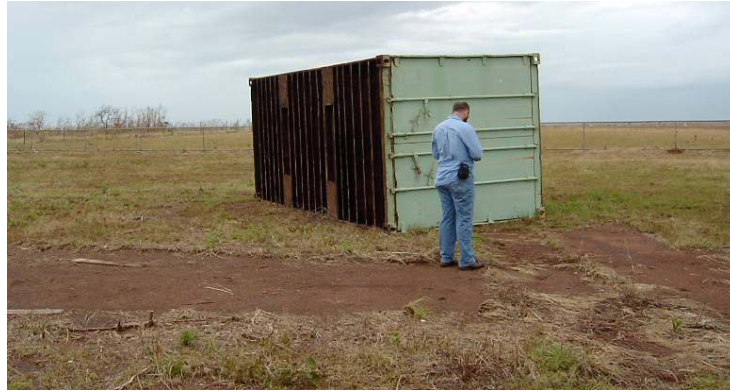
Figure 6: Empty container (lifted and overturned as no drag marks observed)

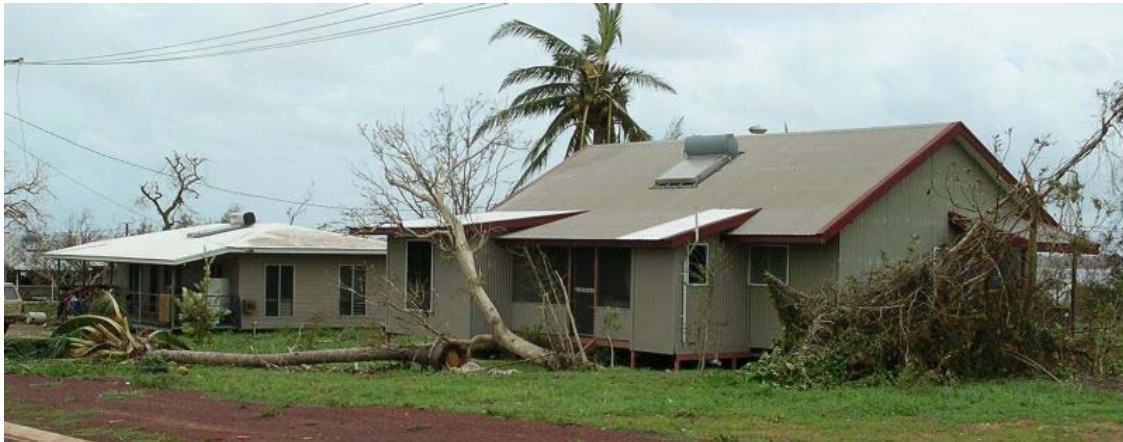
Typically housing that was constructed in the past 10 to 15 years survived with minimal structural damage from wind loads observed (Figure 9 and Figure 10). Impact from wind driven debris, fallen trees, flashing loss (Figure 11) and soffit loss was noted.

Figure 10: Minor tree damage to post Tracy houses

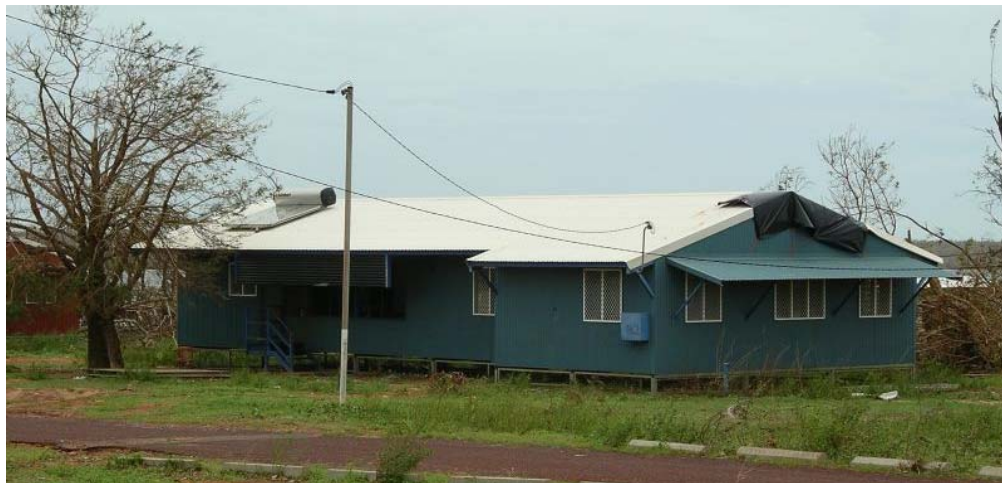
Figure 11: Minor loss of flashing

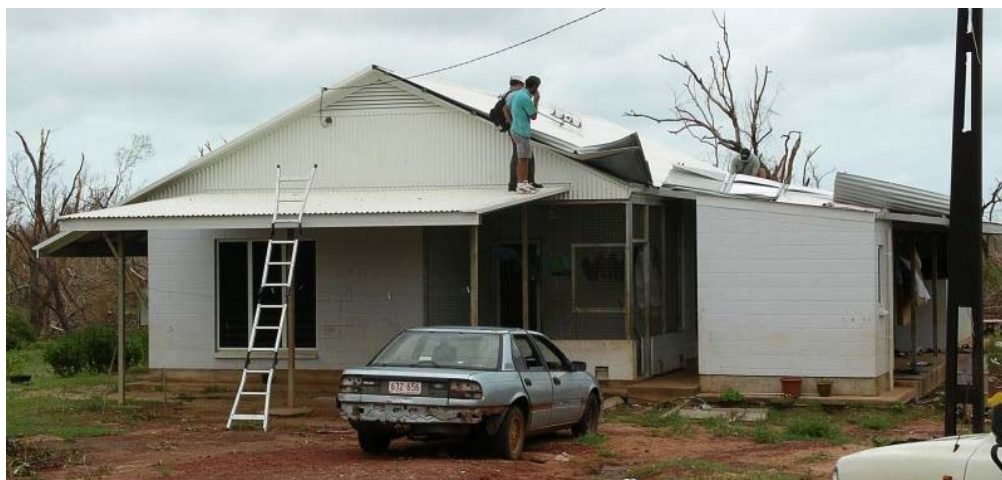
One noted exception was a reinforced masonry block house that was built within the last couple of years (Figure 12). Part of the roof had peeled back, as shown in Figure 13, from the windward edge. It is postulated that a missing nut on a rafter hold down allowed the edge rafter to lift over the hold down rod.

Figure 12: Roof structure damage to new house (windward wall)

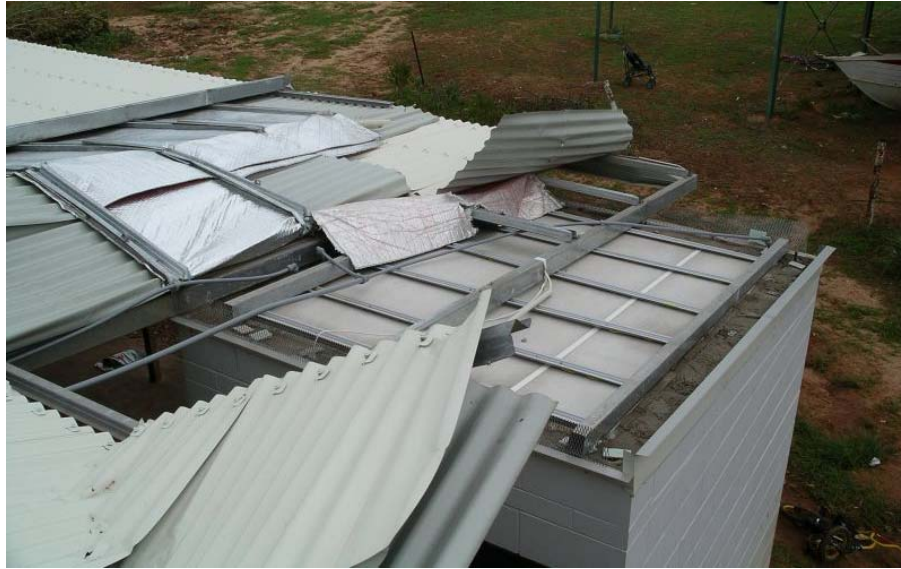
Figure 13: View of damaged roof on new house

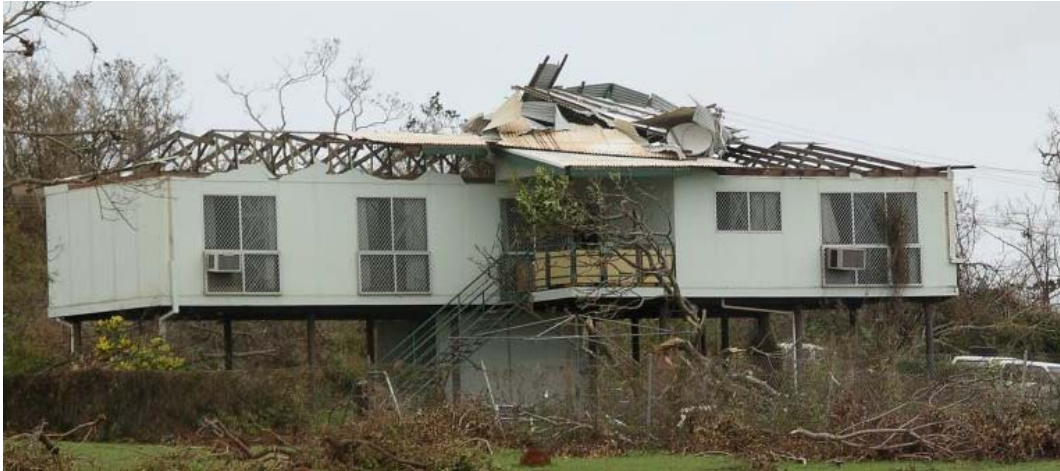
The highset fibro clad rectangular plan house suffered loss of roof cladding and battens (Figure 14 and Figure 15). It was advised that the house had been retrofitted as per some of the houses in Darwin that survived Cyclone Tracy.

Figure 14: East face (photo looking NW)

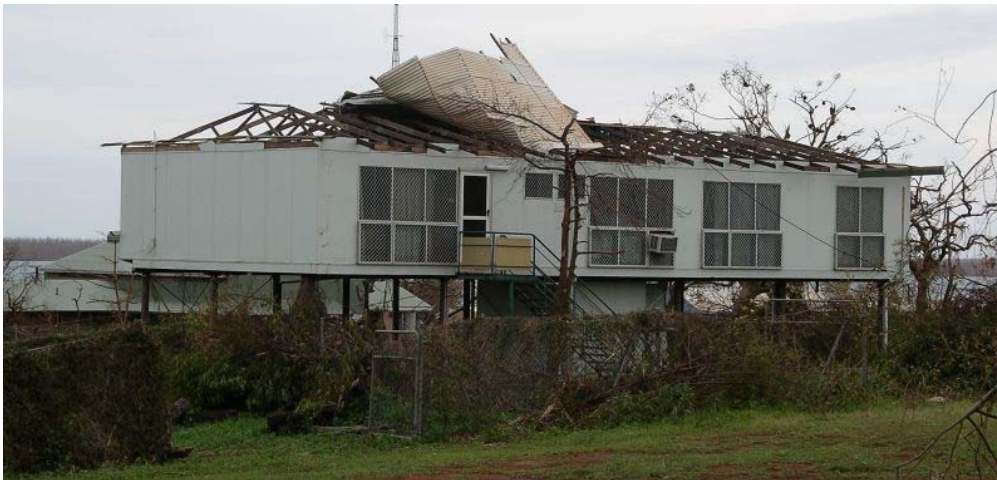
Figure 15: West face (photo taken looking SE)

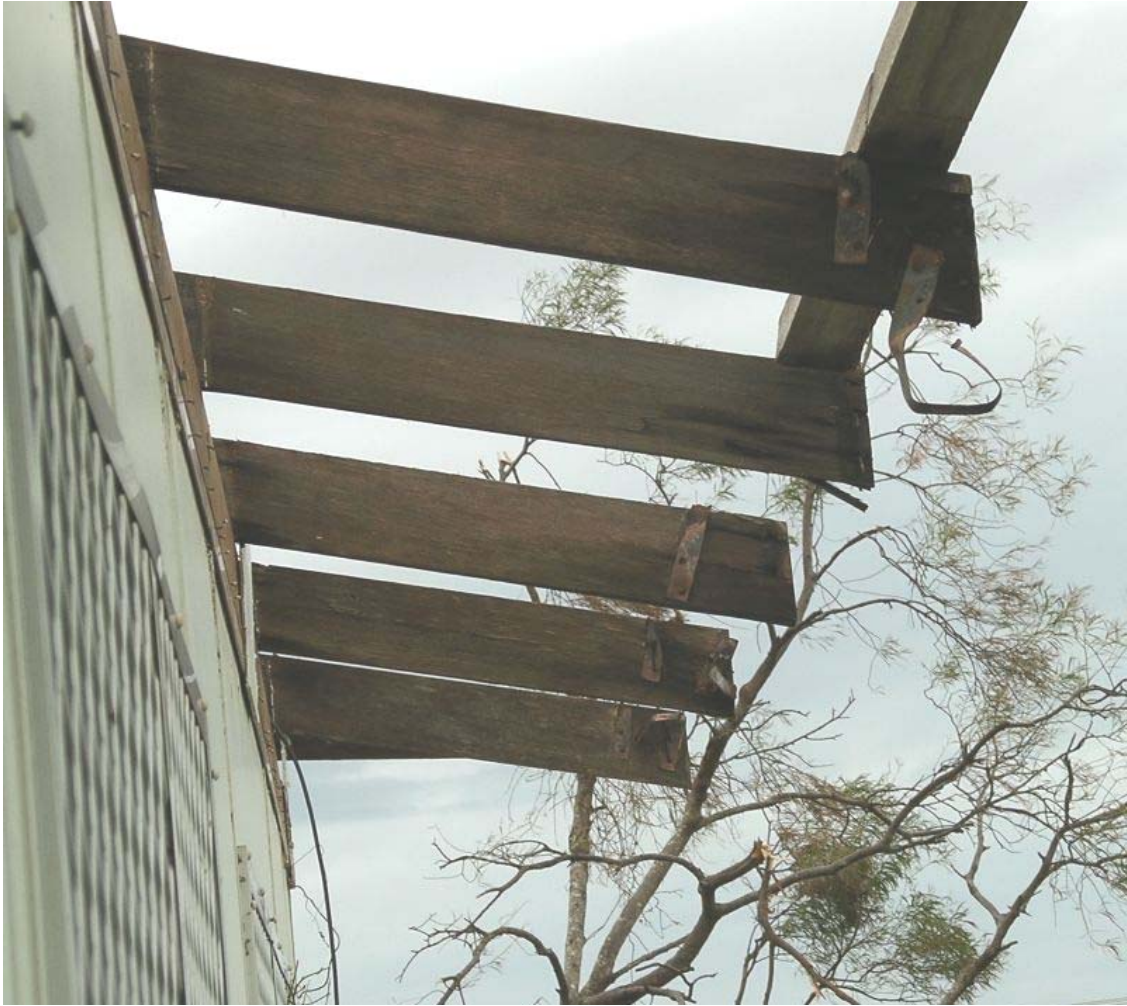
Failure was initiated by missing hold down connectors between the battens and trusses. Corrosion of batten straps along the exposed eaves (Figure 16) and some batten to truss fixings not installed in the body of the roof space were observed. A truss to top plate hold down Z bracket was lying on the ceiling (Figure 17). So if the cladding had held on, part of the roof structure may have been blown off due to inadequate truss hold down. A section of the roof from this house was found 200 m to the South East (Figure 40).

Figure 16: Corroded batten hold down straps

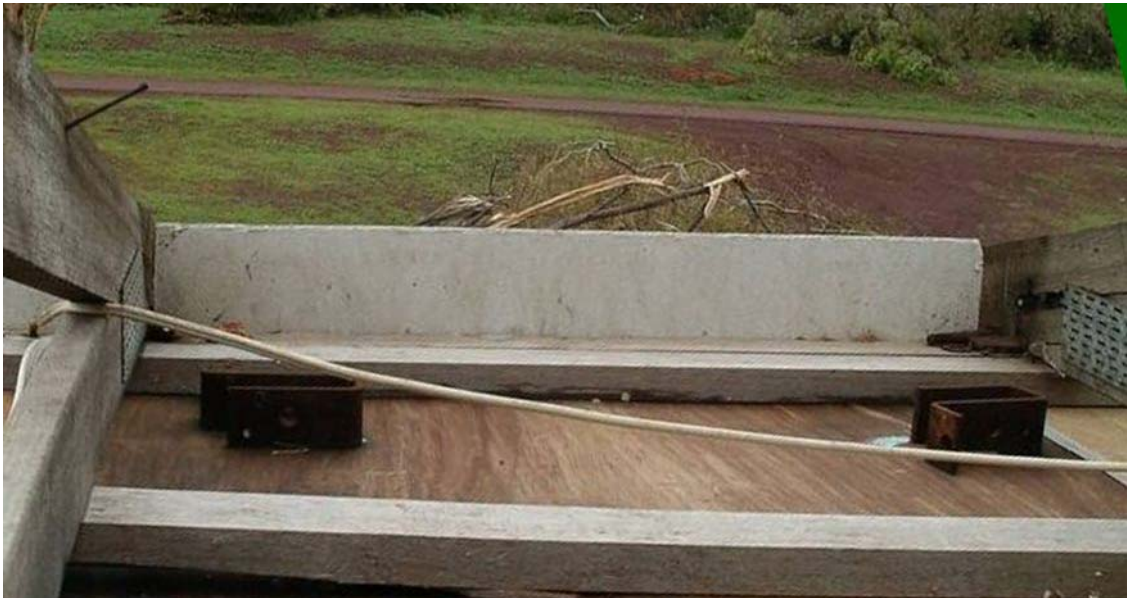
Figure 17: Truss hold down brackets not installed to a couple of trusses

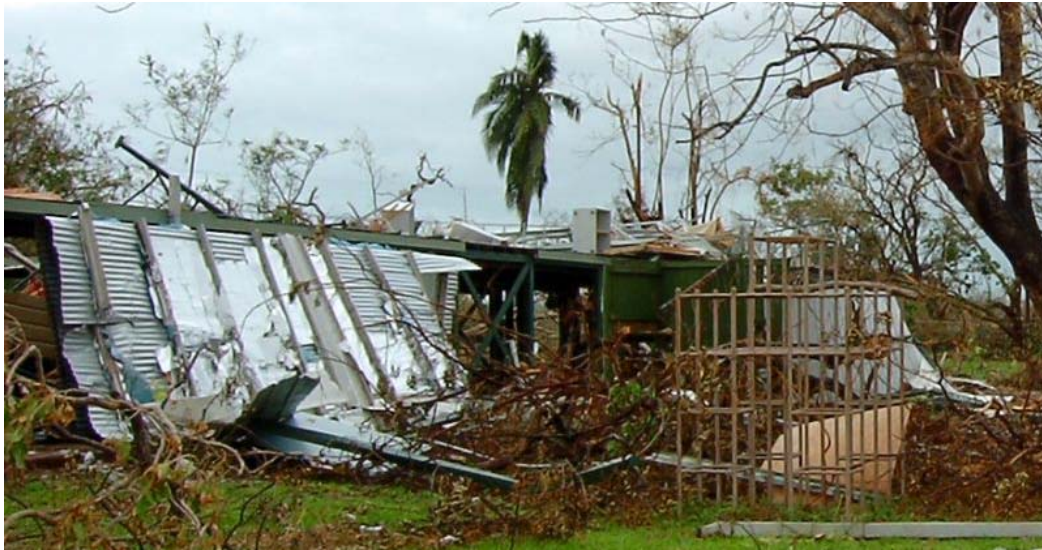
The high set school lost all top storey wall and roof structure as the wall frame was unable to resist the uplift forces (Figure 18 and Figure 19). It was advised that the classrooms were a 1950s aluminium framed 'kit' structure which was built on the elevated timber framed floor.

Figure 18: Elevated school platform (roofing screwed to I beams)

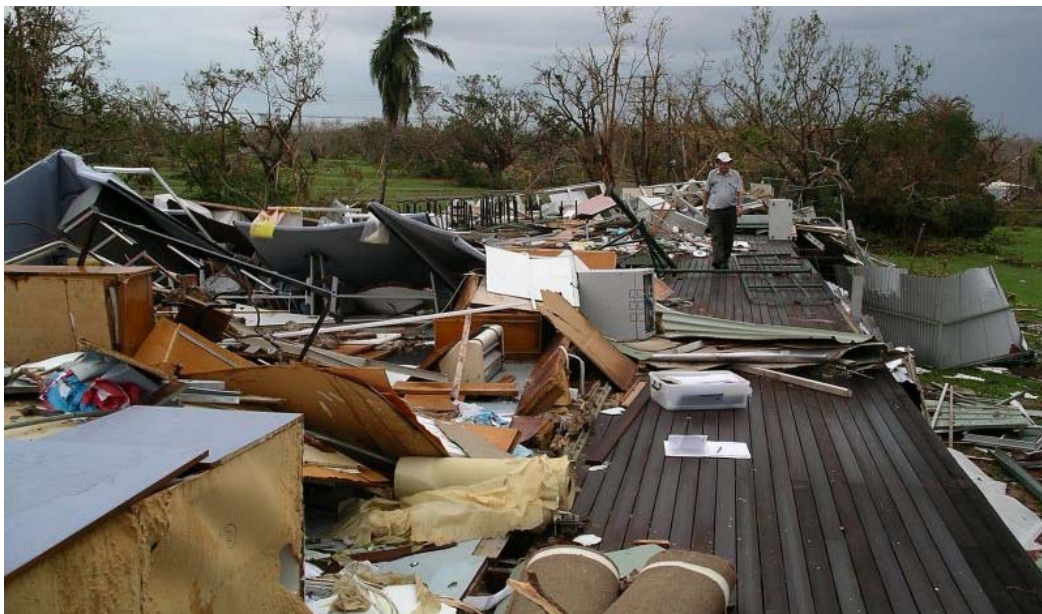
Figure 19: Remains of classrooms

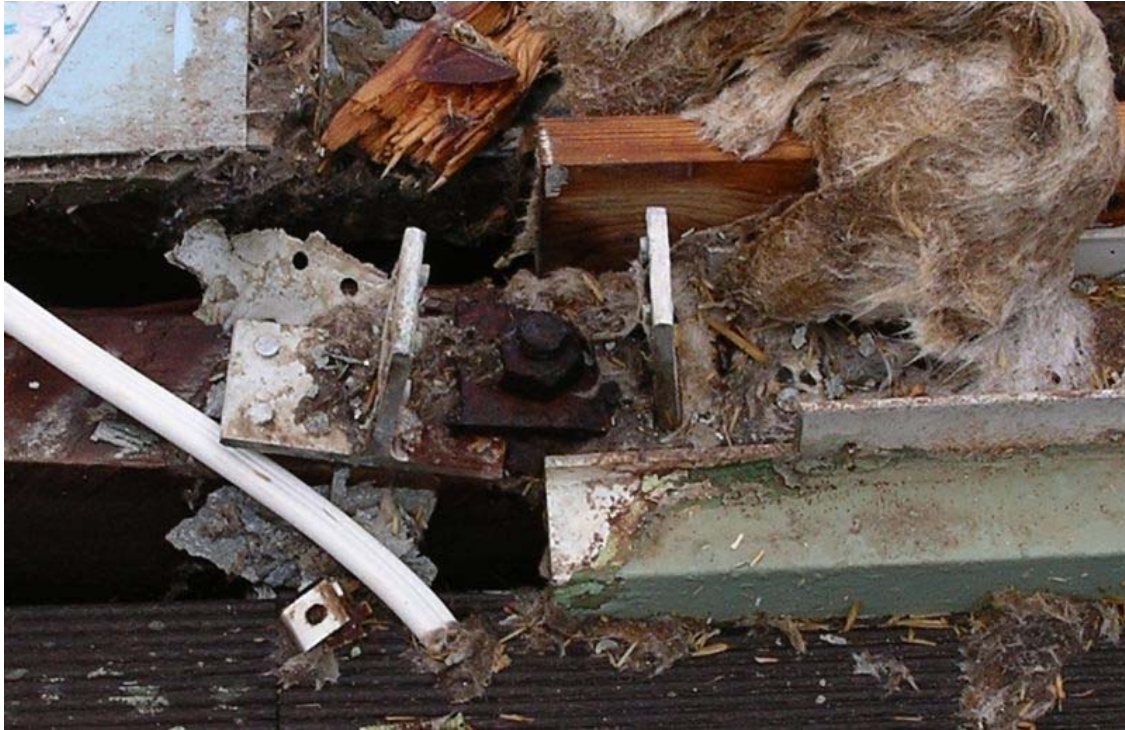
The roof of the building had been re-roofed with corrugated G550 cladding and fixed to the existing aluminium I beams with Type 17 screws with cyclone assemblies. No other post Cyclone Tracy retrofitting was evident. The classrooms wall and roof framing members were made from aluminium. The top plate and bottom plates were riveted to the studs via aluminium T sections. Figure 20 and Figure 21 show sheared rivets in a T connection and a corroded bottom plate hold down bolt.

Figure 20: Aluminium inverted T brackets and rusted hold down bolt

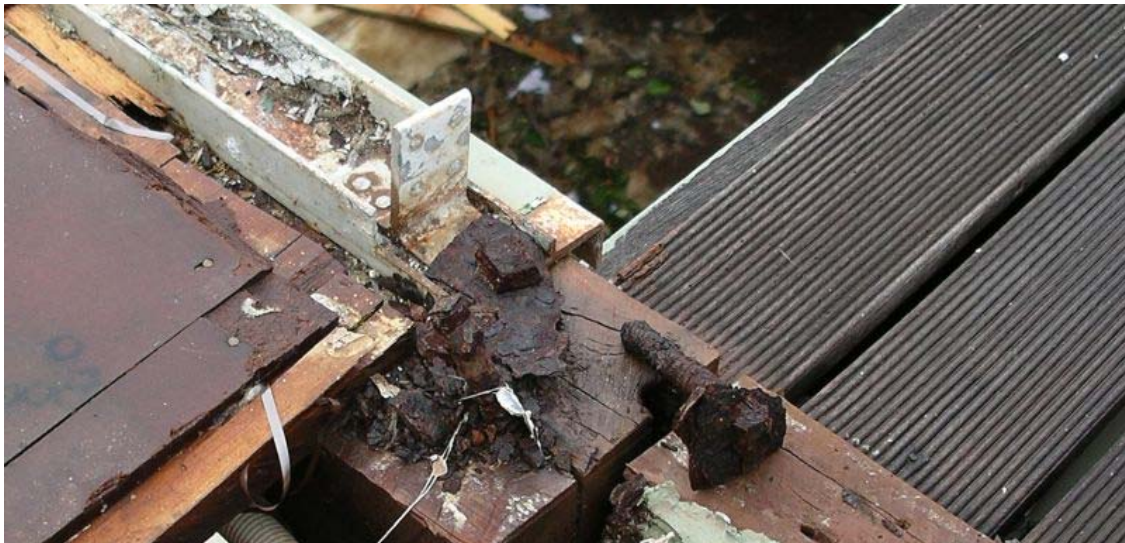
Figure 21: Aluminium inverted T bracket showing sheared rivets

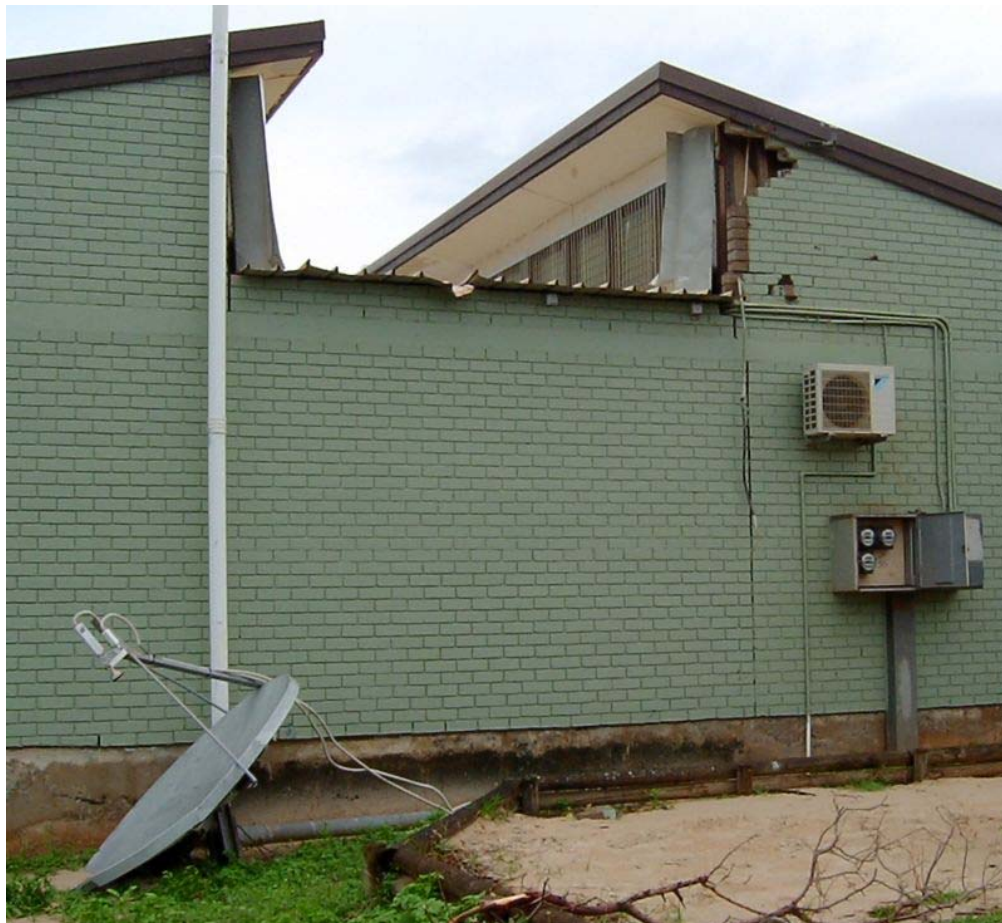
- loss of some flashings,
- damage to the brick skin adjacent to a gable truss end where a satellite dish was attached, and

Figure 23: Failure of mounting point for satellite dish

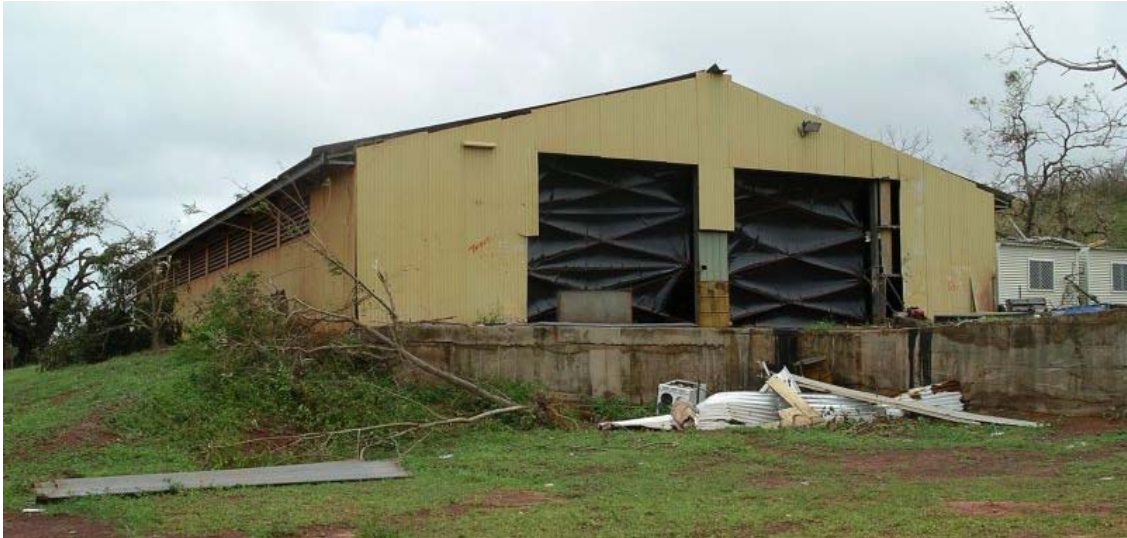
The portal framed shed in the North of the town suffered loss of roller doors, and minor cladding and flashing loss with resultant water and wind damage to contents. Tearing of the wall cladding around some fasteners was observed, however the fixing spacings were found to be larger than typical manufacturer's specifications.

Figure 24: Wind ward wall (North face) Note openings have been covered with plastic

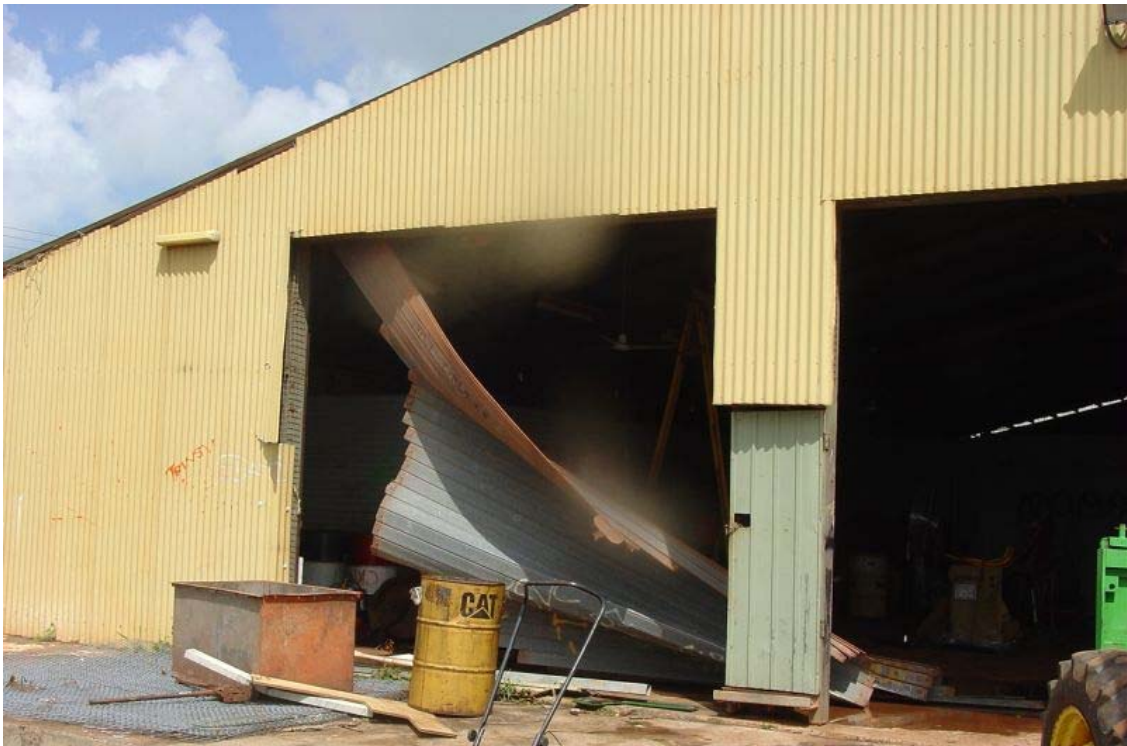
Figure 25: Roller door failure (Photo from DIPE)

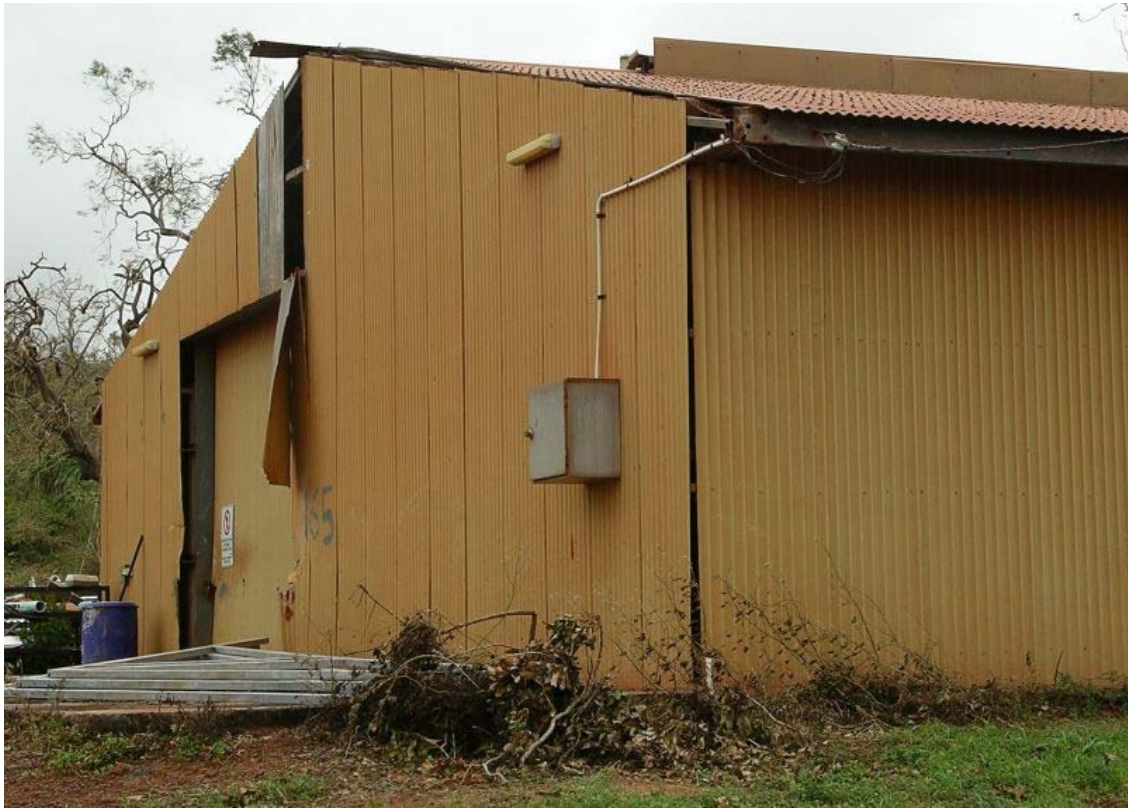
Figure 26: Leeward wall cladding and flashing failure

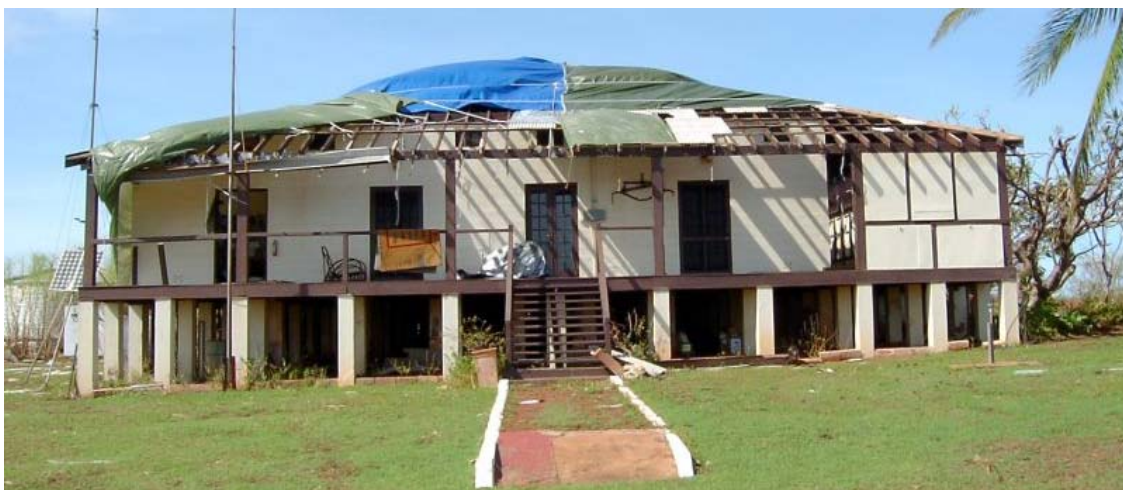
The guest lodge suffered major loss of roof cladding (Figure 27). Some of the screws fixing the corrugated asbestos cement cladding had corroded. Severe corrosion was also noted in the batten fixings and rafter connections (Figure 28). It was advised that the cleanup and removal of the asbestos cladding was going to be a major undertaking (Figure 29).

Figure 27: North face of guest lodge

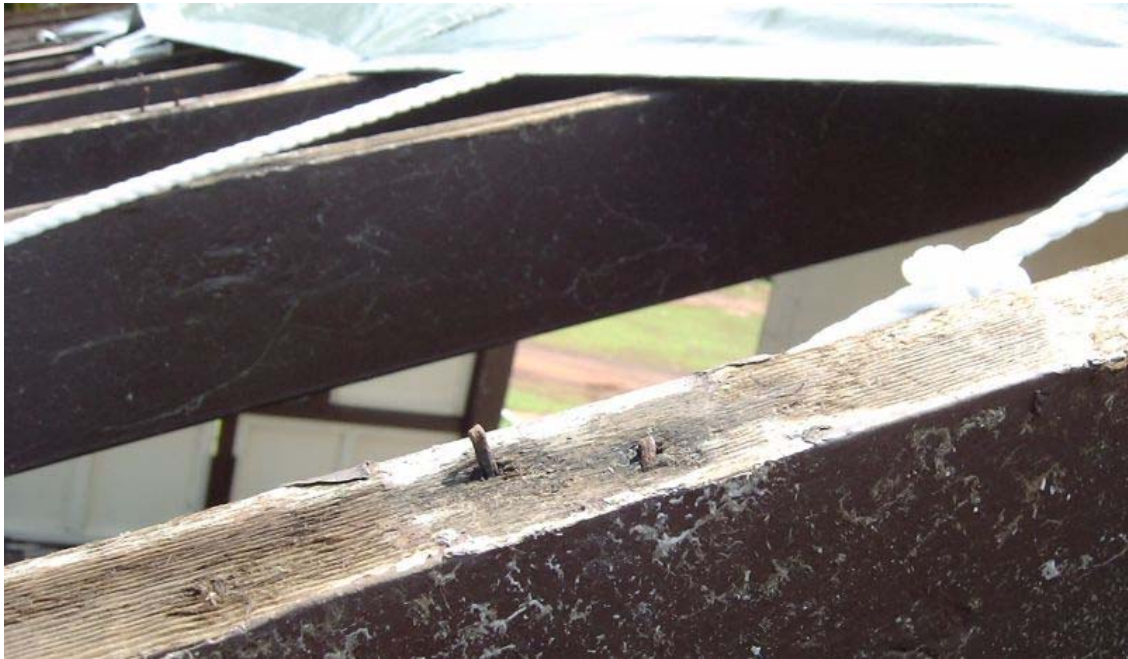
Figure 28: Corroded and inadequate batten fixings

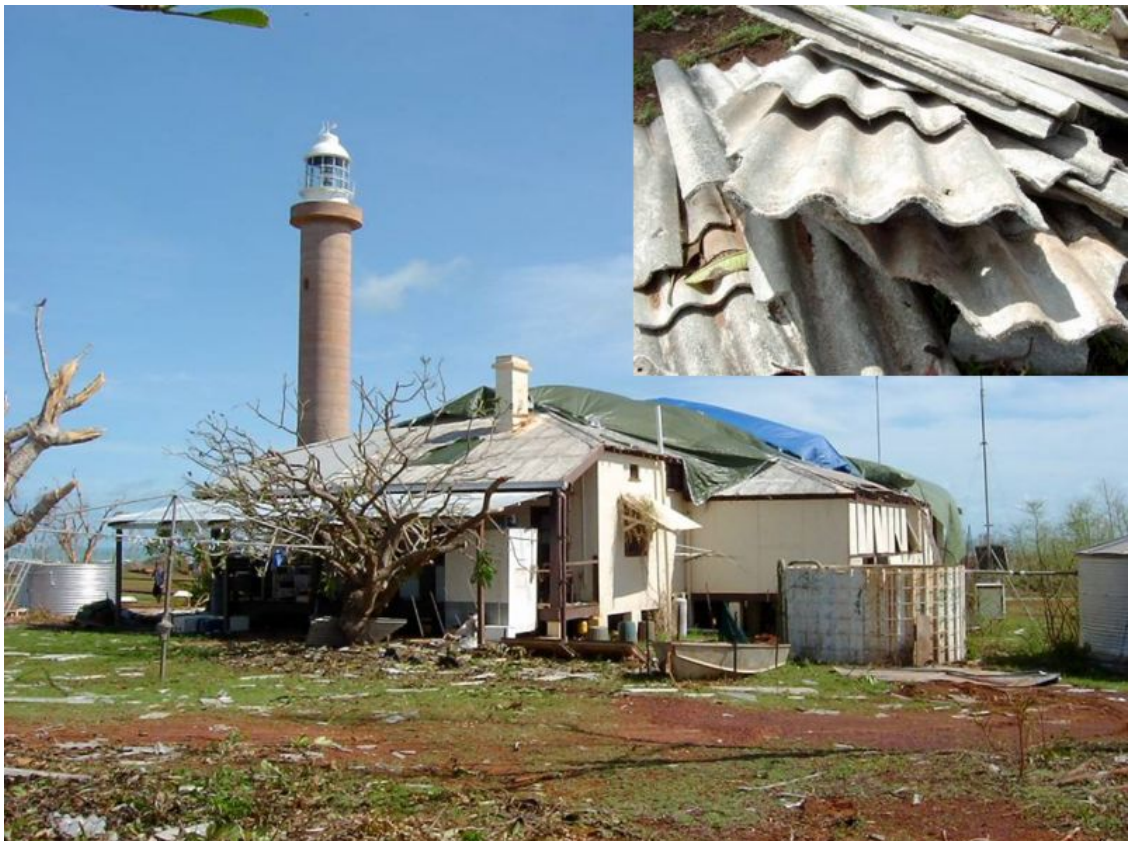
Figure 29: Rear of guest lodge with scatter of corrugated asbestos cladding

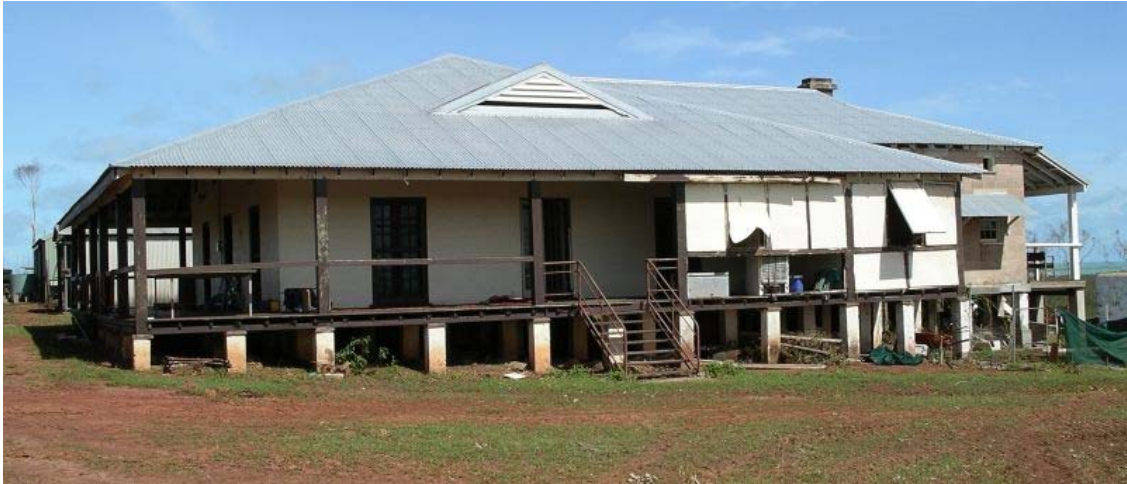
In comparison, the retrofitted staff lodge suffered no loss of roof cladding (Figure 30). Corrugated metal roof cladding was screw fixed with cyclone assemblies to timber battens at nominally 600 mm centres. The battens were strapped to nominally every second rafter (Figure 31). The rafters were spaced at nominally 450 mm centres. The loss of fascia, guttering and damage to some awning cladding was observed.

Figure 30: New roof on staff lodge

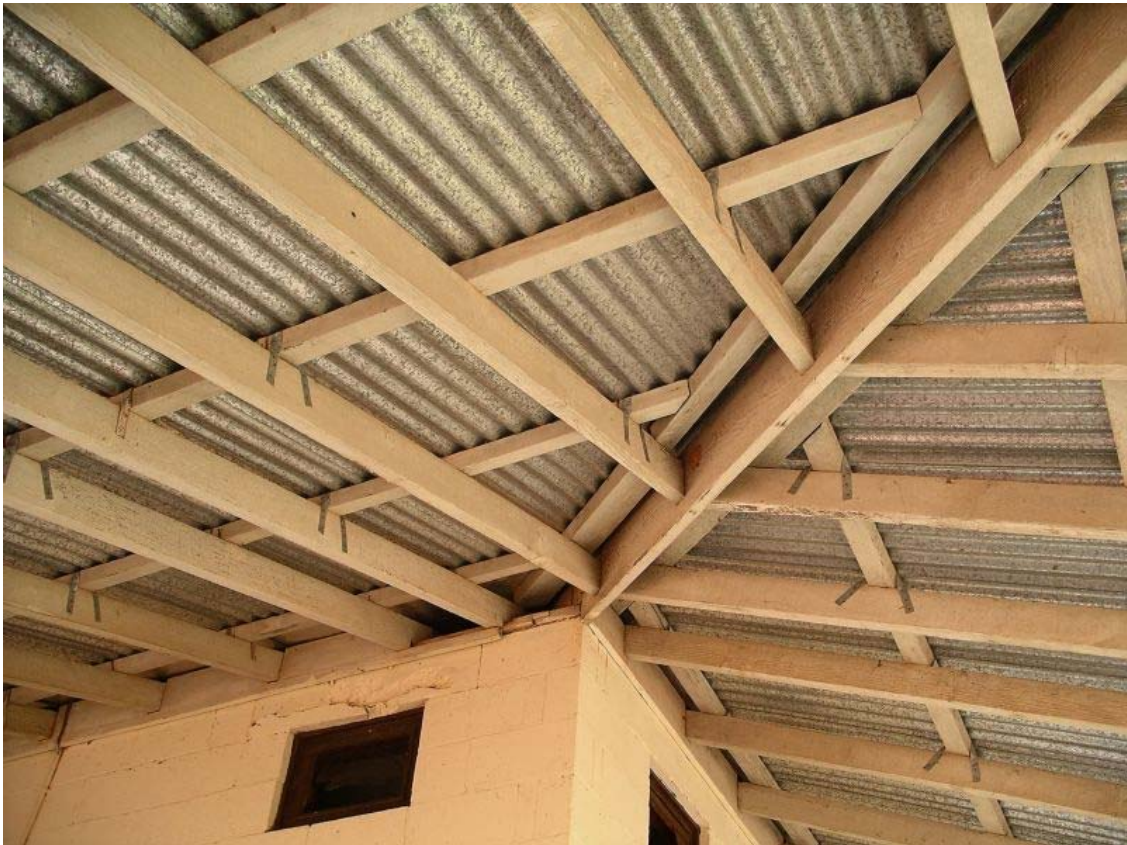
Figure 31: New batten straps on staff lodge

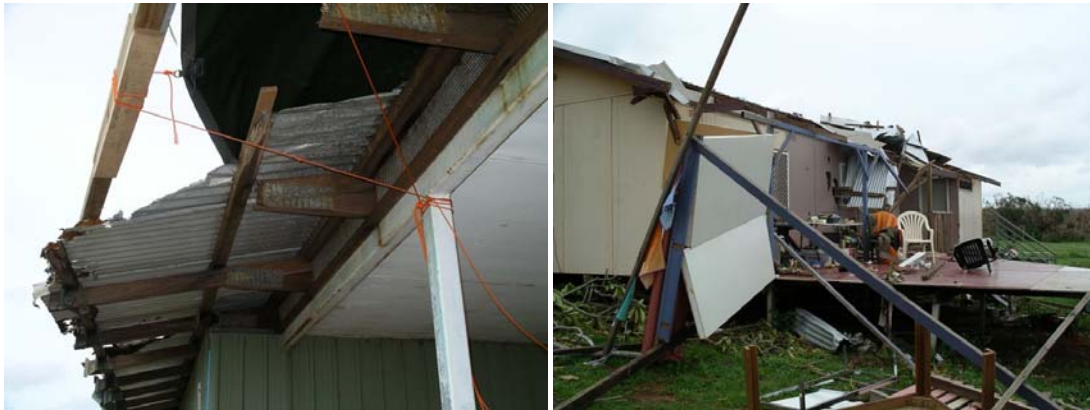
Inadequate design and attachment of elements such as fascias, awnings and soffits can lead to damage to structure, increased water ingress and contribute to wind driven debris. Figure 32 (a) shows the failure to truss top chord eaves from the awning being peeled back.

Figure 32 (a) and (b): Failure of eaves, awnings and associated damage to structures

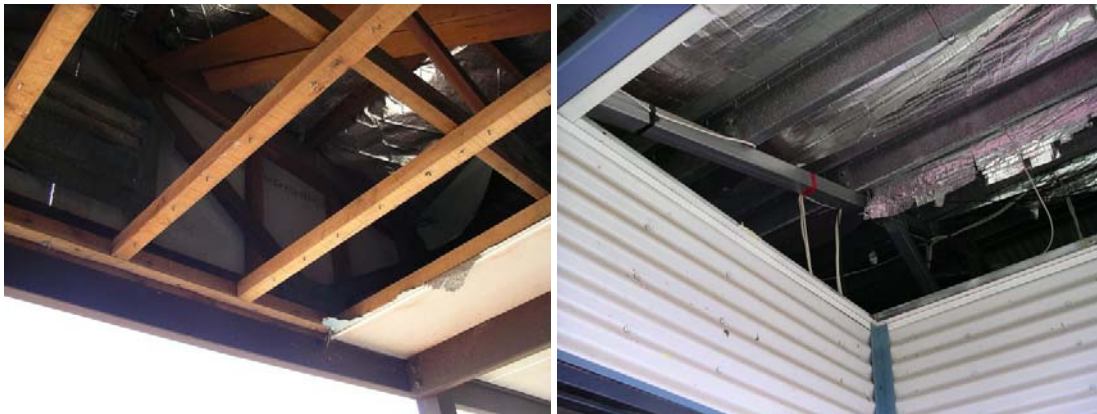
Figure 33 (a) and (b): Soffit damage at Smith Point and Minjilang

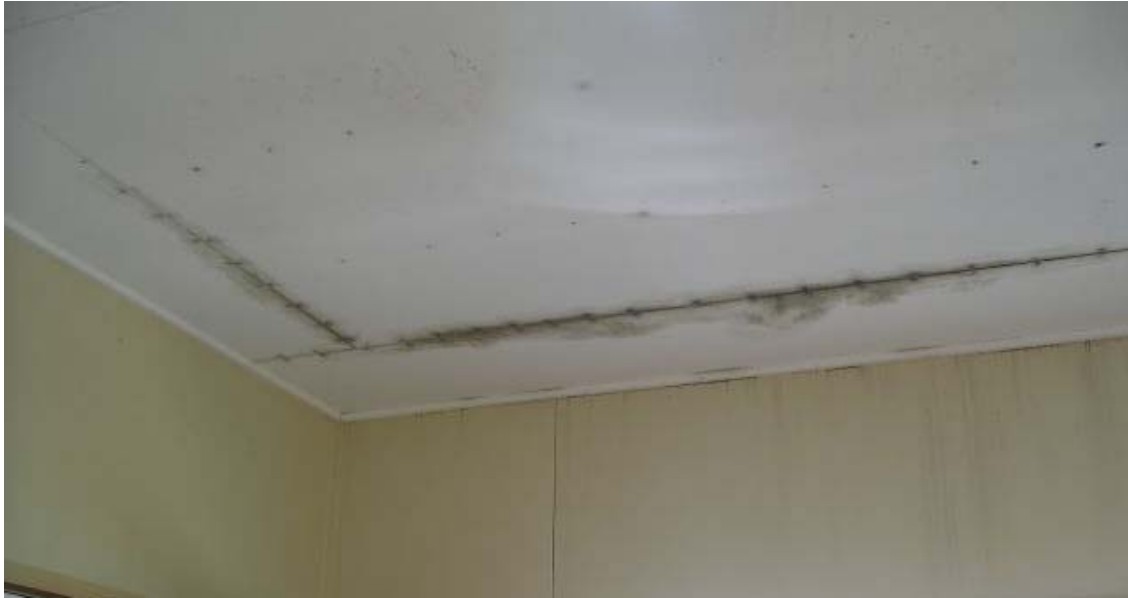
Figure 34: Water ingress at Ranger house on Smith Point

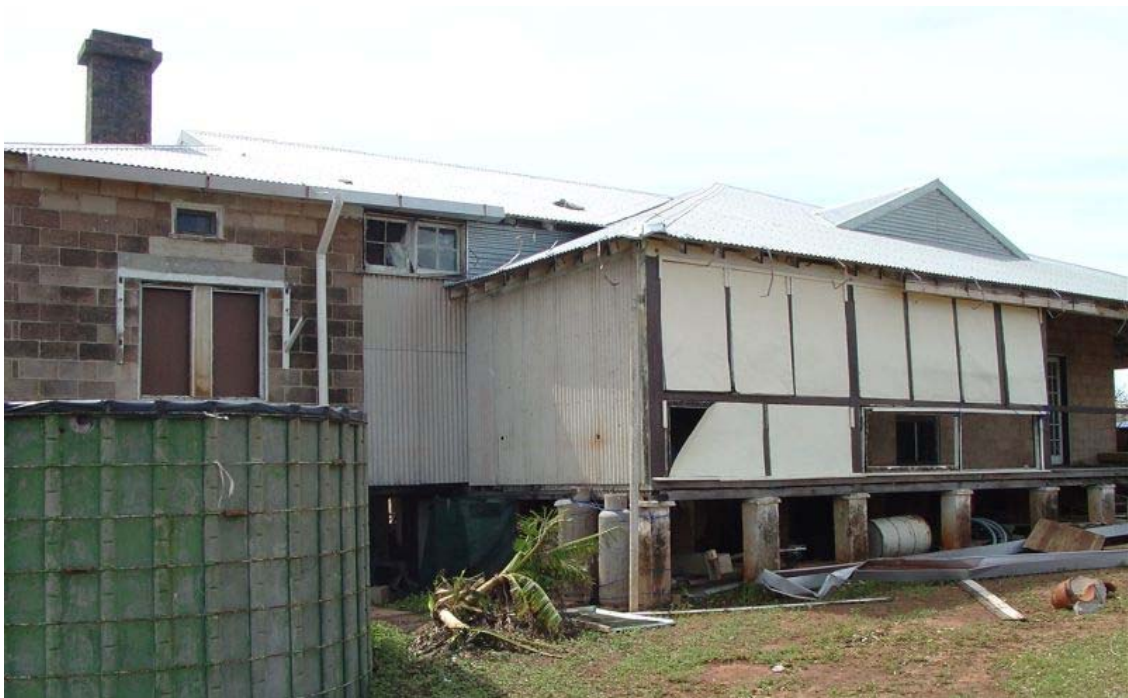
Figure 35: Loss of guttering, fascia and awnings at Cape Don (photo from DIPE)

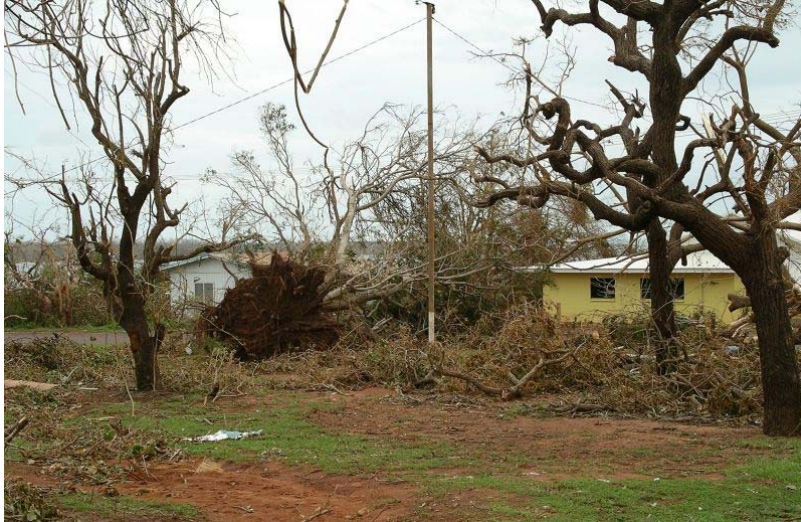
Figure 36: Fallen trees at Minjilang

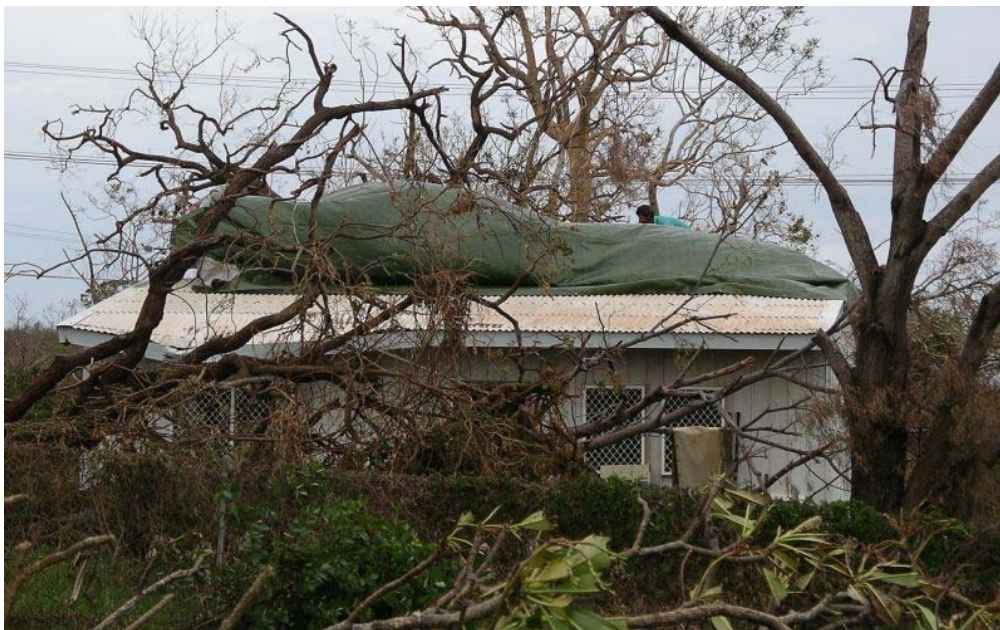
Figure 37: House damaged by tree at Minjilang

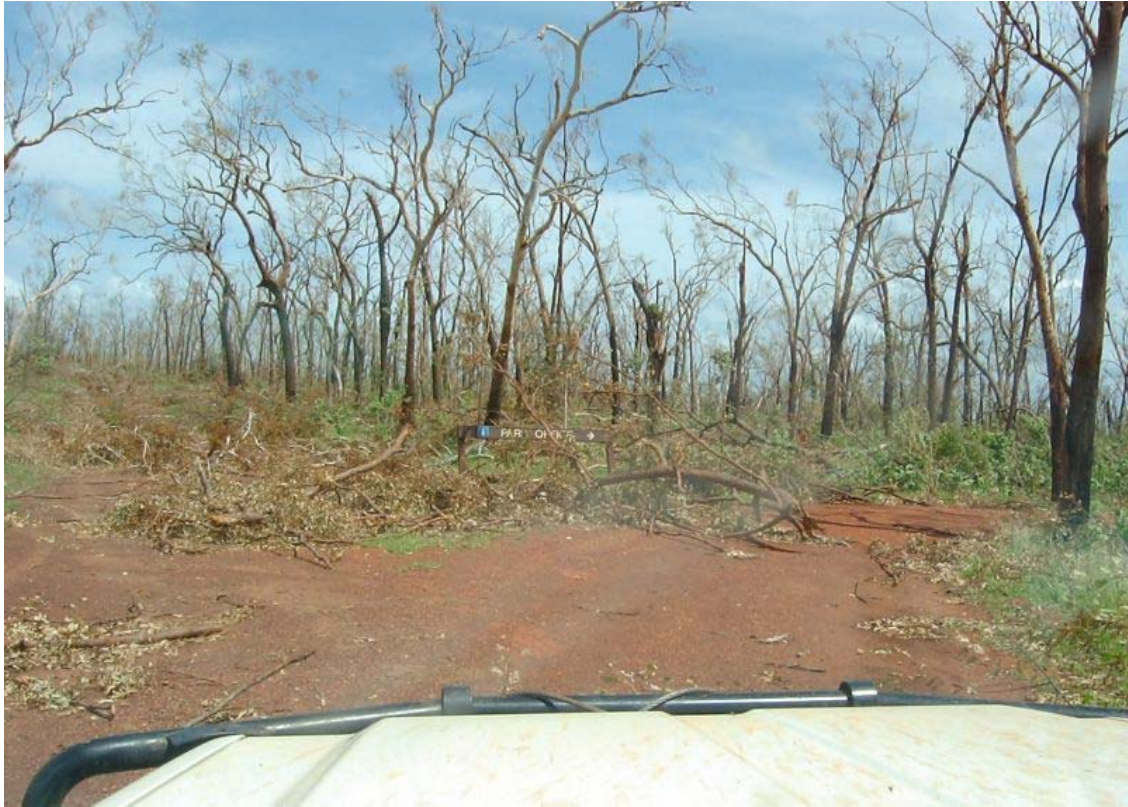
There was extensive tree damage caused by the cyclone. The National Parks advised that there would be an increased fire risk when the fallen timber dried out (Figure 38) [5].

Figure 38: Defoliation of canopy across Coburg Peninsular

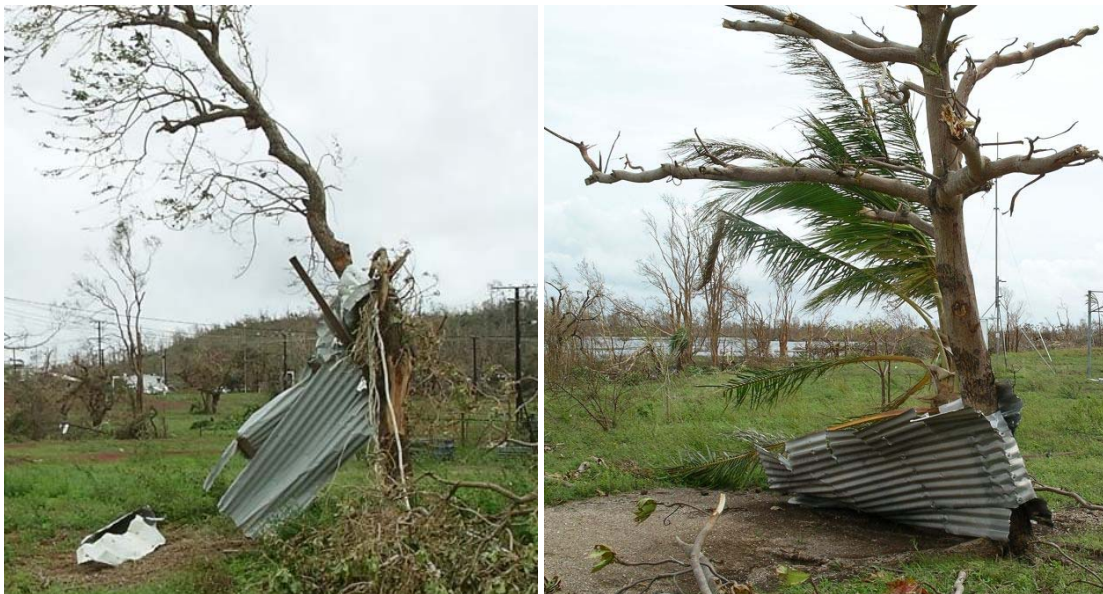
Figure 39: Examples of wind driven cladding (predominantly with battens attached)

Wind driven debris poses a risk to life and property. Correct design and installation of materials is required.

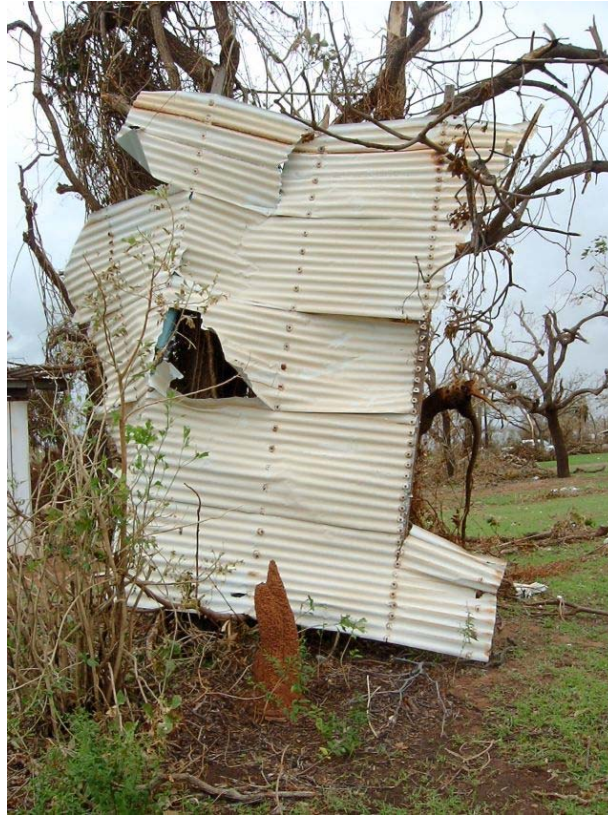
Figure 40: Part of roof from highset house in Minjilang

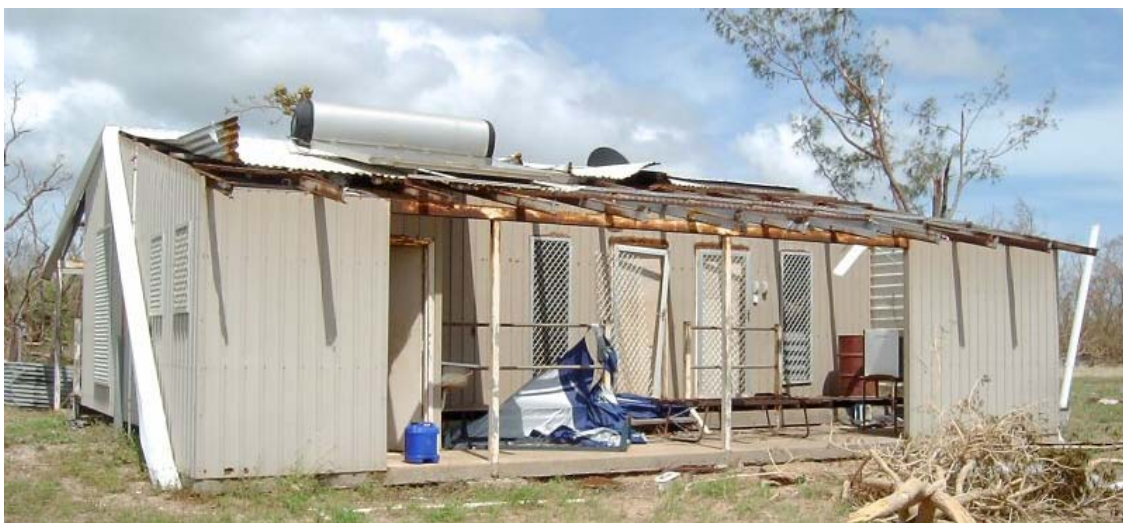
Many of the failures observed were initiated from structural elements suffering severe corrosion. Correct specification and installation of materials to suit the level of exposure along with ongoing maintenance is required for structures. The ongoing maintenance is particularly important in cyclone regions as it may be many years until a severe cyclone impacts the building.

Figure 41: Corrosion of frames, battens, fixings and claddings
