**Damage investigation of buildings at Minjilang, Cape
Don and Smith Point in NT following Cyclone Ingrid**

Report: TR50
September, 2005

TECHNICAL REPORT NO. 50

**By
David Henderson and Cam Leitch**

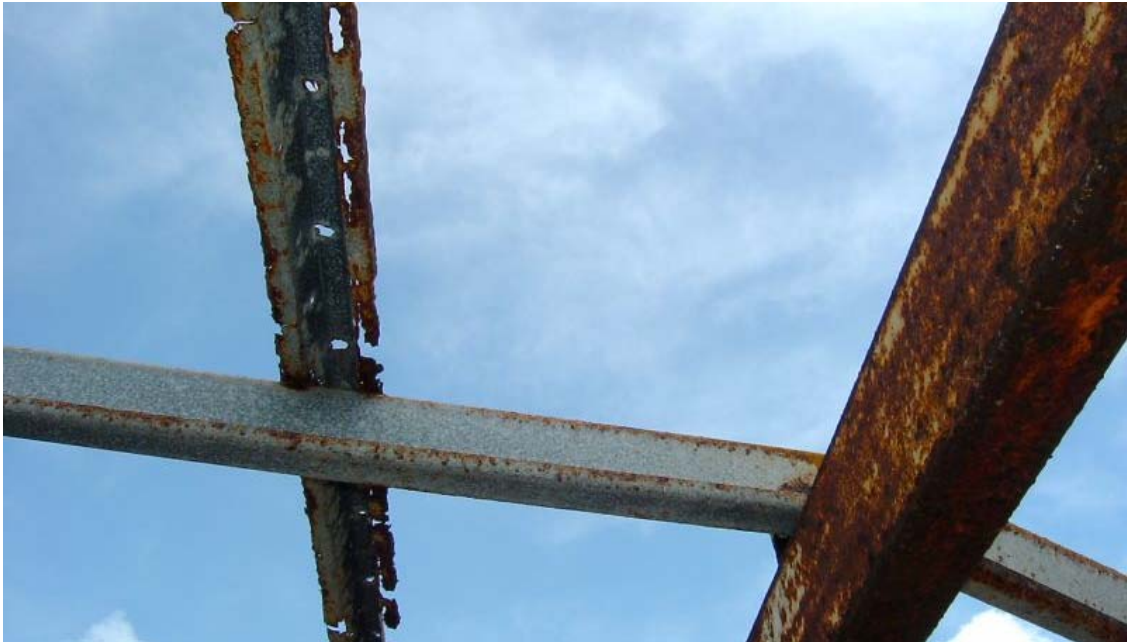
Figure 42: Detail of corrosion of top hat batten

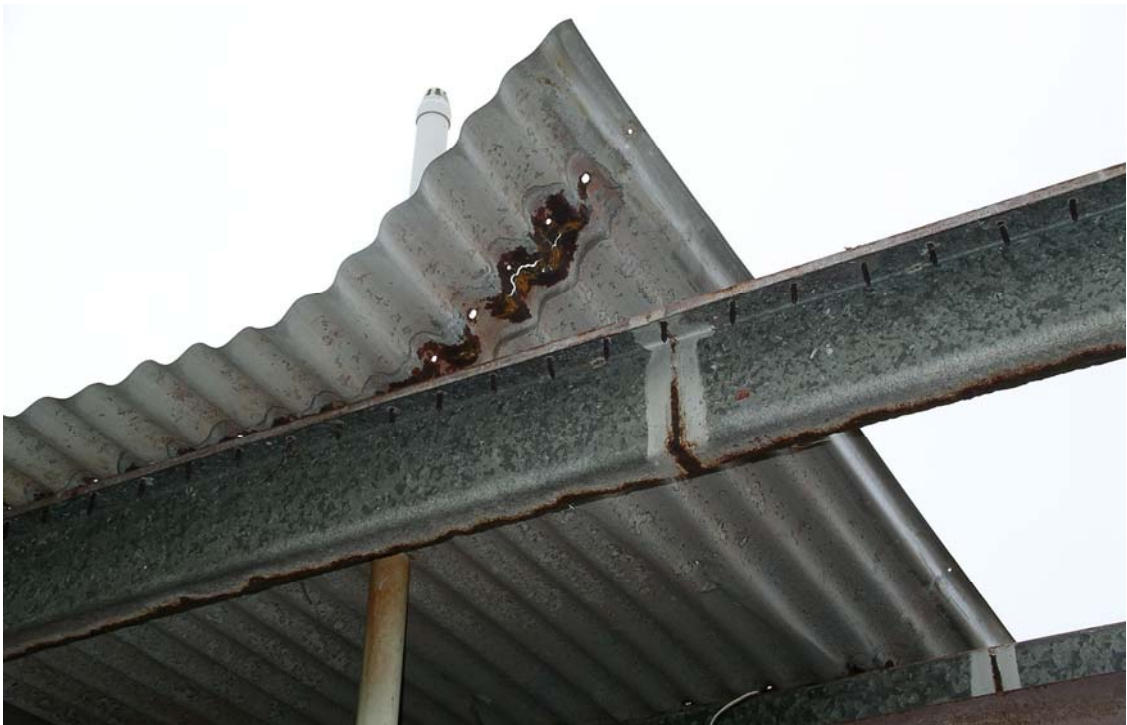
Figure 43: Corroded screws and cladding at Minjilang
