# **Tropical Cyclone Larry**

**Damage to buildings in the Innisfail area**

**CTS Technical report: TR51**

**September 2006**

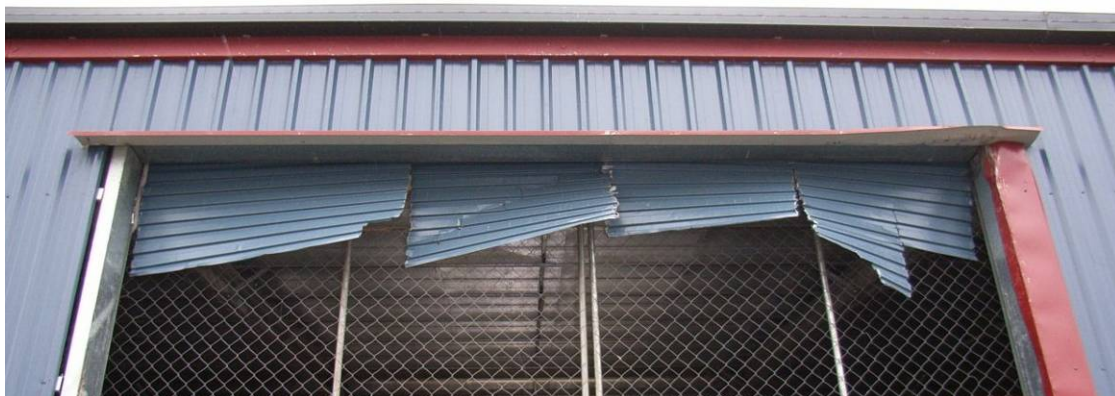
**Figure 5.10: Torn sheet type roller door**

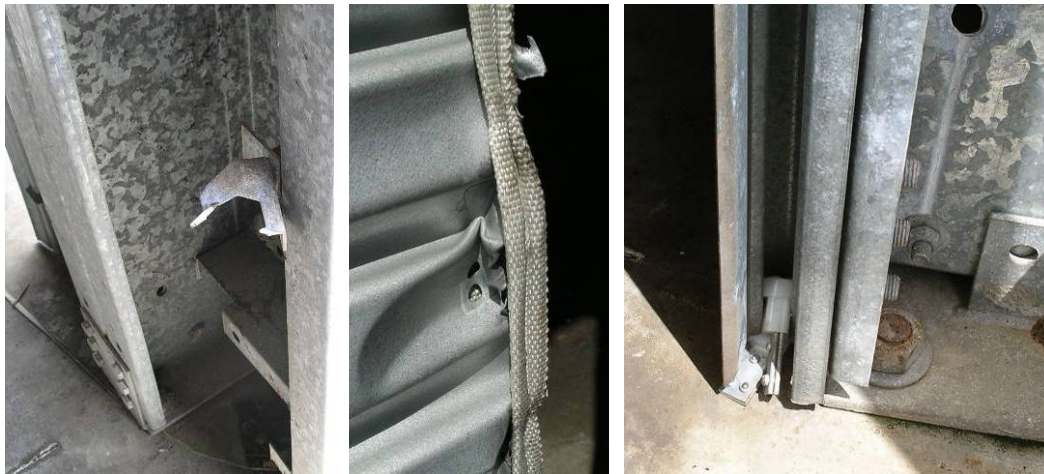
Roller doors can be designed with hooks fitted to each end of the slats (wind locks) so that when the slats are subjected to wind loading, they can use membrane action to support this pressure. However, the tensile forces generated in the slats by this membrane action can be quite large (especially if the deflection at the centre of the slat span is small) and so the tracks to each side of the slats need to be fixed very securely. Common failures associated with wind locks are shown in Figure 5.12.

(a) Failed track bracket (b) Windlock torn from door (c) Wind lock in track

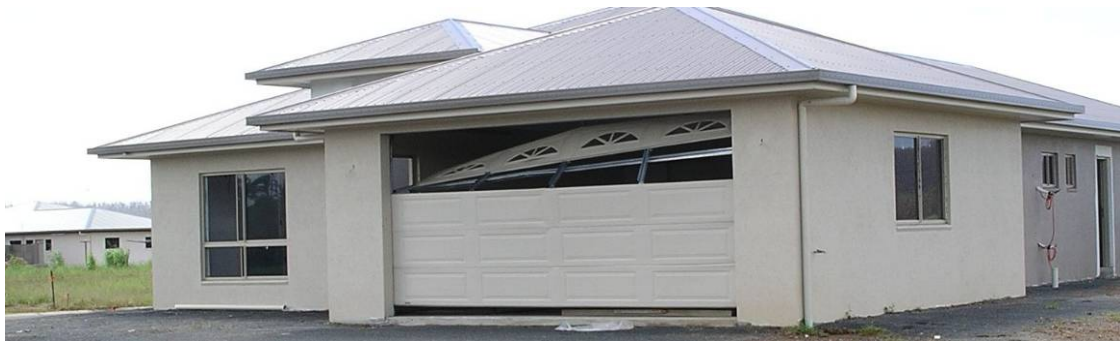
**Figure 5.13: Panel garage door failure**

For housing, most of the roller doors observed had failed by the roller door becoming disengaged from the tracks. Failures of panel lift doors were also observed (Figure 5.13).

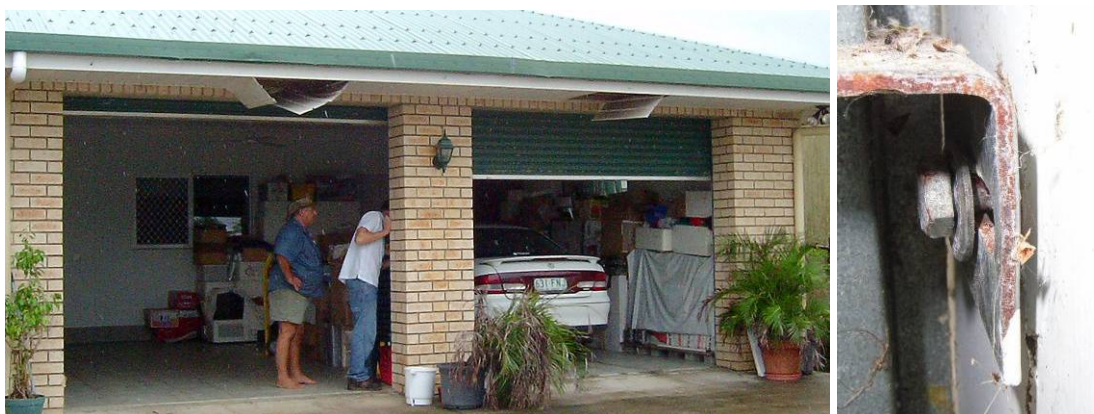
On examining an apparently undamaged roller door, the tracks showed that they were starting to pull away from their fixings to the supporting masonry walls (Figure 5.14). This indicates that the membrane (tensile) force developed in the roller door was large enough to start pulling the track support fixings out of the wall.

(a) Twin doors

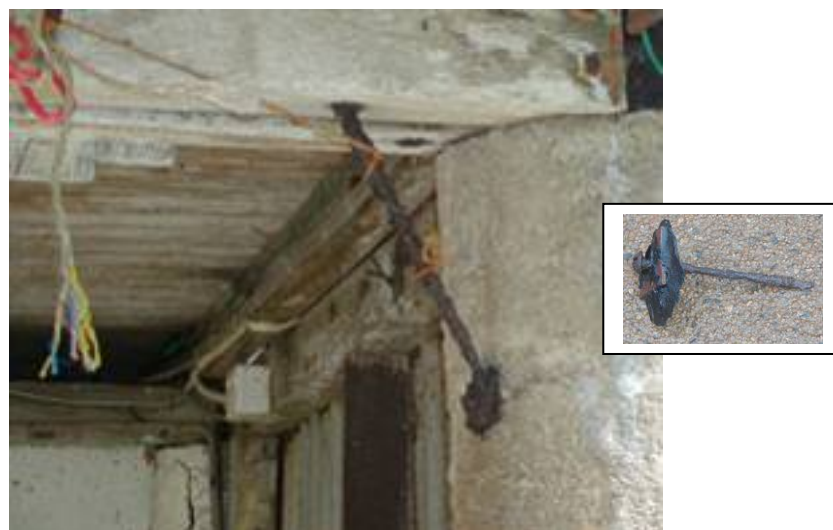
**Figure 6.1: Corrosion of Connections**

- In some cases, fasteners had corroded, rendering load paths ineffective, as shown in Figure 6.1.
- In some cases, timber had deteriorated so that connections were not effective as shown in Figure 6.2.

(Main photo shows floor to stumps anchorage. Inset shows a corroded roofing screw.)

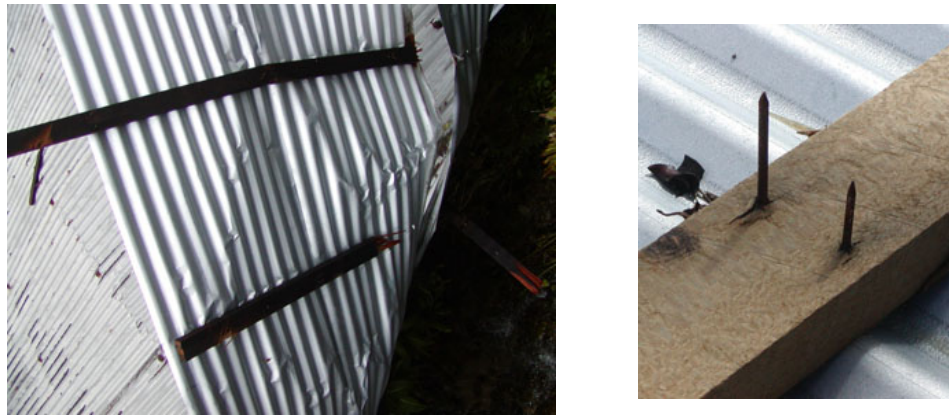
**Figure 6.3: Failure of batten-to-rafter connection**  
(Refurbished roofing on an “Old Queenslander”)

The most common type of failures on housing of this era was roof system failure, usually the batten-to-rafter connection as illustrated in Figure 6.3. It was primarily nailed connections that failed with mostly two nails per connection, but in a few older roofs, one 75 mm nail per joint. There were few failures that were associated with the originally installed roof. (Most roofing systems were screw fixed to the battens, and in many cases, the battens had been replaced at the same time, but fixed only with plain shank nails.)

Batten to rafter connections are detailed in AS1684.3 [6] with simple details and design data in tables allowing the calculation of uplift force on a connection, and giving the capacity of a number of different connection details. Two deformed shank nails do not have sufficient capacity for edge zones in a metal deck roof, and plain shank nails are not even listed as options for use in the cyclone regions.

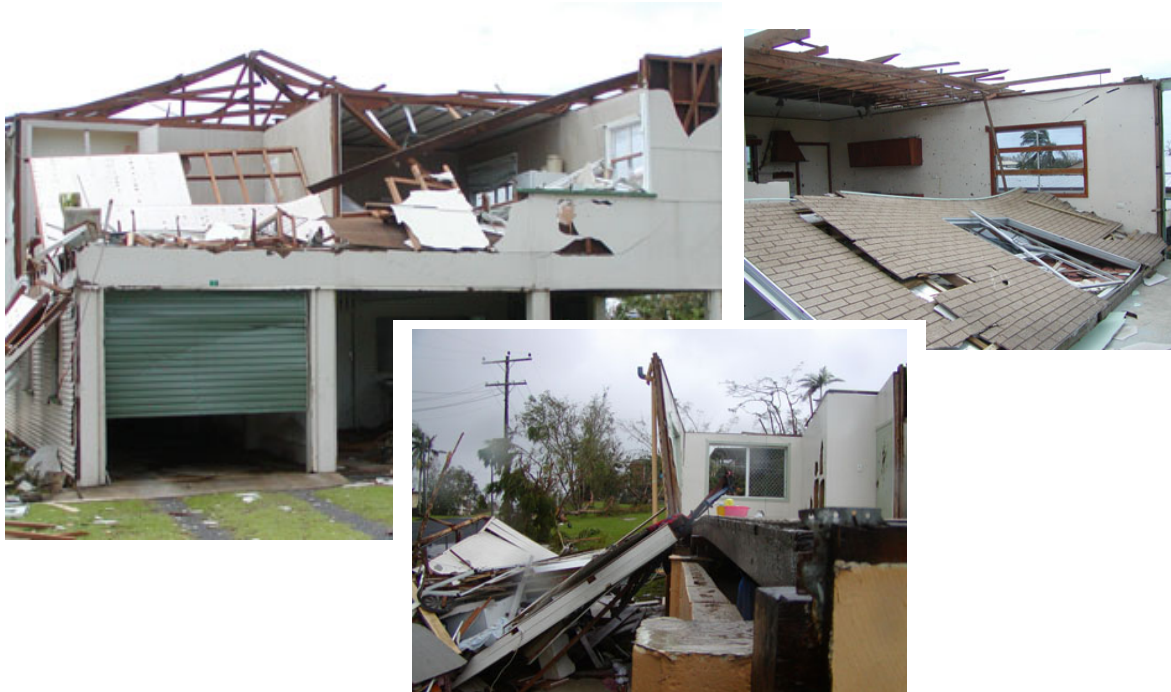
**Figure 6.5: Loss of walls following roof structure damage**

Inspections were conducted on houses that had lost walls, as shown in Figure 6.5. When the roof had been lost, the collapse of walls occurred due to loss of support from the ceiling and roof structure combined in some cases with deterioration of the structure at floor level.

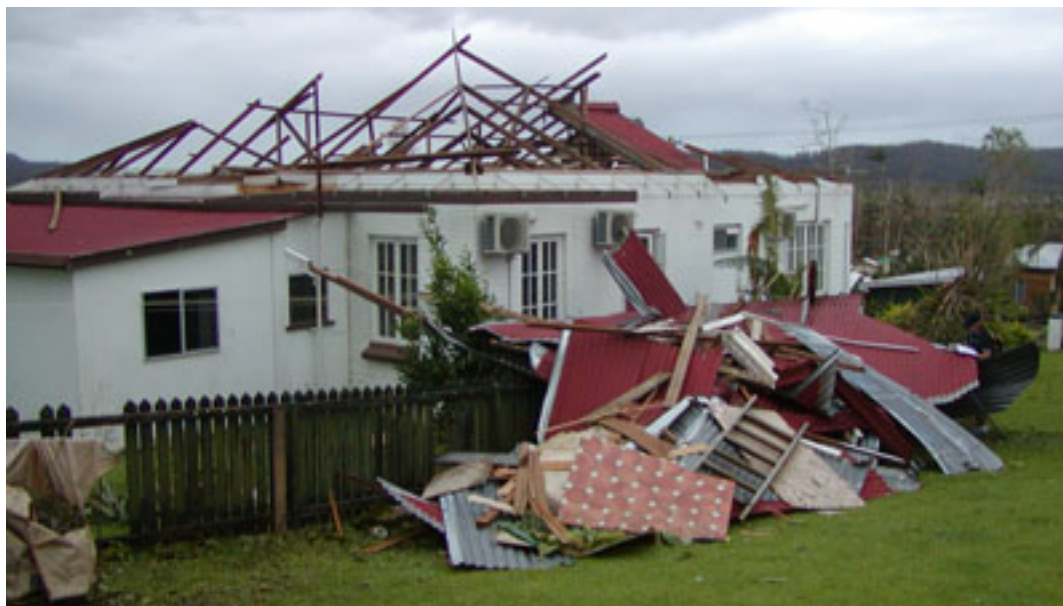
**Figure 6.6: Loss of ridge beams**

- Batten-to-rafter connection failures which allowed the roof to separate from the structure in large pieces. This was similar to the failures shown in Figure 6.3.
- Loss of the central part of the roof as shown in Figure 6.6. Generally these roofs were anchored with over-battens around the edge and relied on ridge beams and underpurlins for support of the rafters at the top and centre of each rafter run. So when these support points did not offer enough anchorage against the uplift forces, they failed, with sometimes leaving the outside connection of the rafters still attached to the wall, but the centre part of the roof missing.

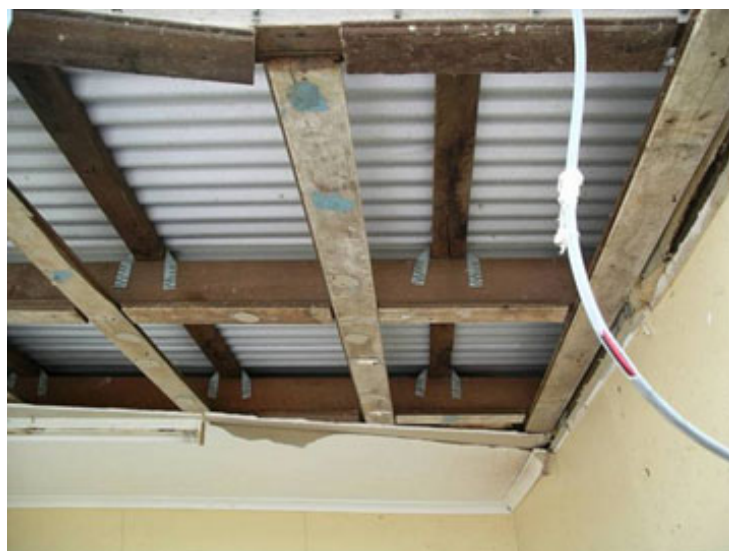
**Figure 6.8: Improvements in batten-to-rafter connection**

Where refurbishment of the connections between battens and rafters, and between rafters and wall plates, had been undertaken, the performance was significantly improved.

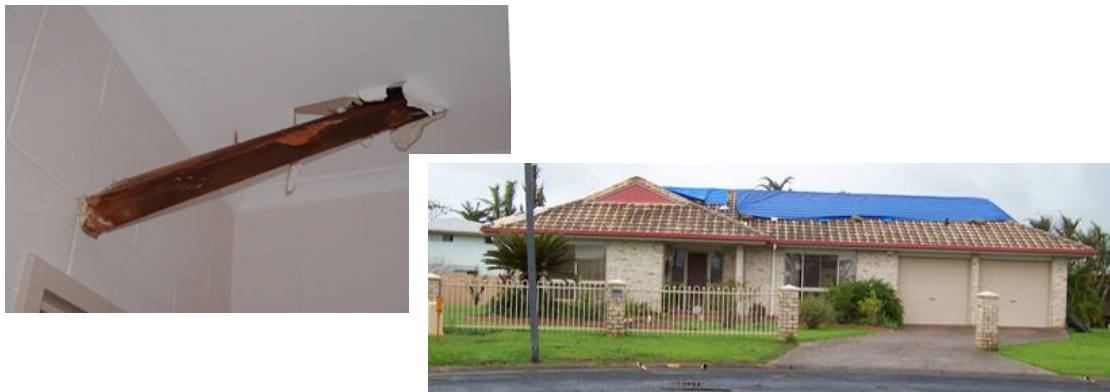
**Figure 6.9: Debris damage to contemporary housing**

- There were examples of wind driven debris penetrating metal deck roofs, as shown in Figure 6.9 (a) and Figure 6.10.
- Some of the tile damage had been precipitated by debris impact on the roof.
- In other cases, the tiles including ridge capping had been poorly anchored.

(a) debris penetration through metal roof (b) tile damage after debris impact

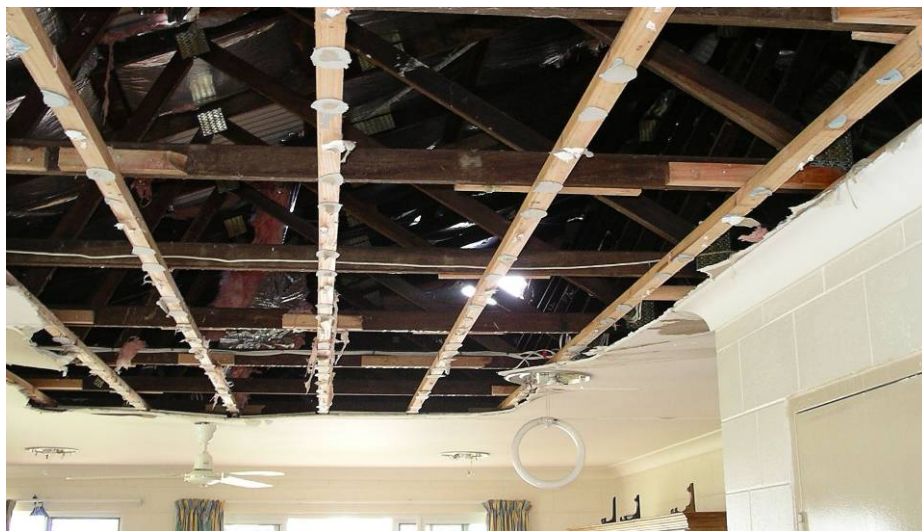
**Figure 6.10: Debris damage to Dutch gable and roof cladding leading to collapse of ceiling from water ingress**

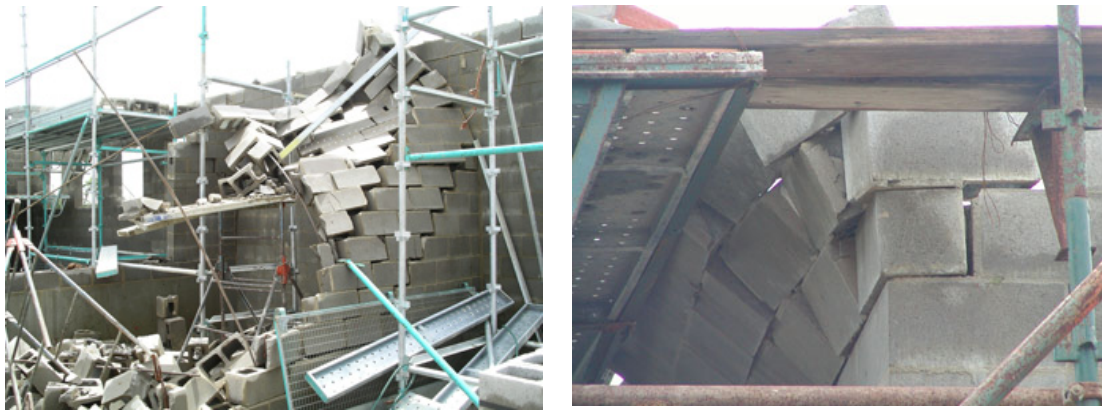
**Figure 6.11: Damage to Concrete block work under construction**

Most of the contemporary houses in the study area were slab on ground houses. The majority of these had hollow concrete block walls. Only one instance of a completed hollow concrete block house with wall damage was observed, and it had deficiencies in the filling of the cores. However hollow concrete block buildings under construction suffered some wall damage as shown in Figure 6.11. The cores had not yet been filled and highlight the necessity for the reinforced concrete cores.

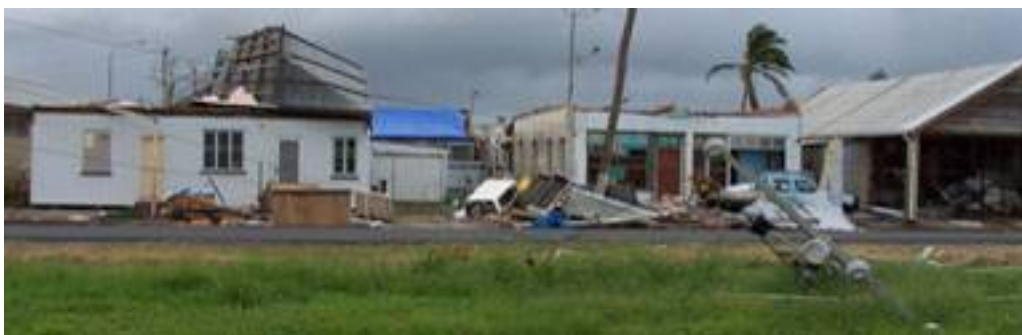
**Figure 6.12: Damage to older commercial buildings Mourilyan**

The performance of public and commercial buildings was mainly dependent on the structural systems and the age of the building. The older timber framed or unreinforced masonry buildings suffered more structural damage than the newer reinforced masonry or hot rolled steel framed buildings (Figure 6.12 and Figure 6.13).

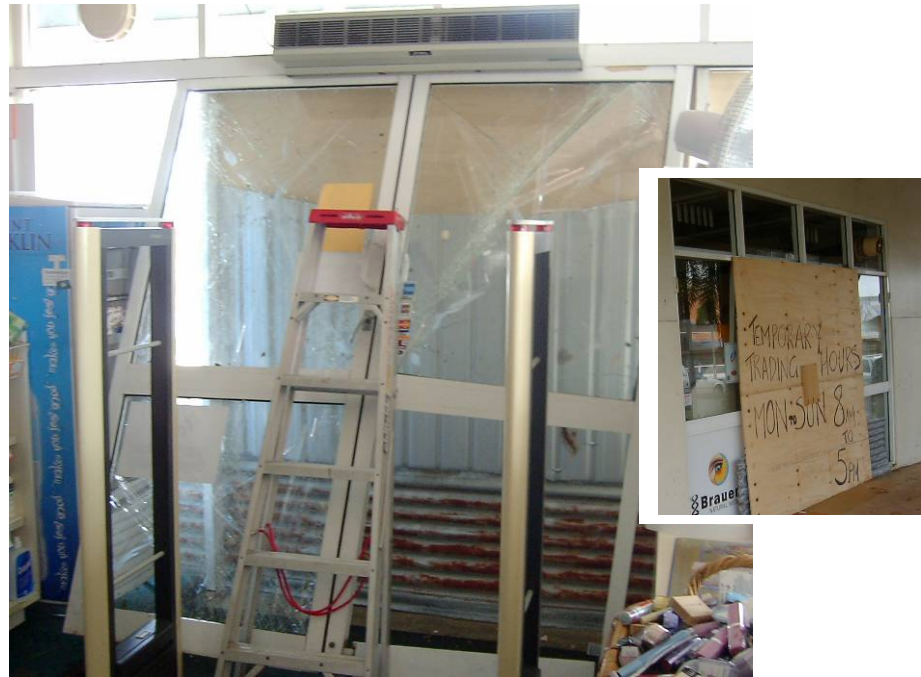
**Figure 6.14: Damaged sliding shop doors**

As it is estimated that the wind speeds in TC Larry were about 90% or less than the design wind speed (only about 80% or less of the design wind load), a significant level of structural failures would not be expected to occur in engineered structures built in the last 30 years. However, windows, doors and roller doors on these buildings failed, causing water ingress and contents damage (Figure 6.14).

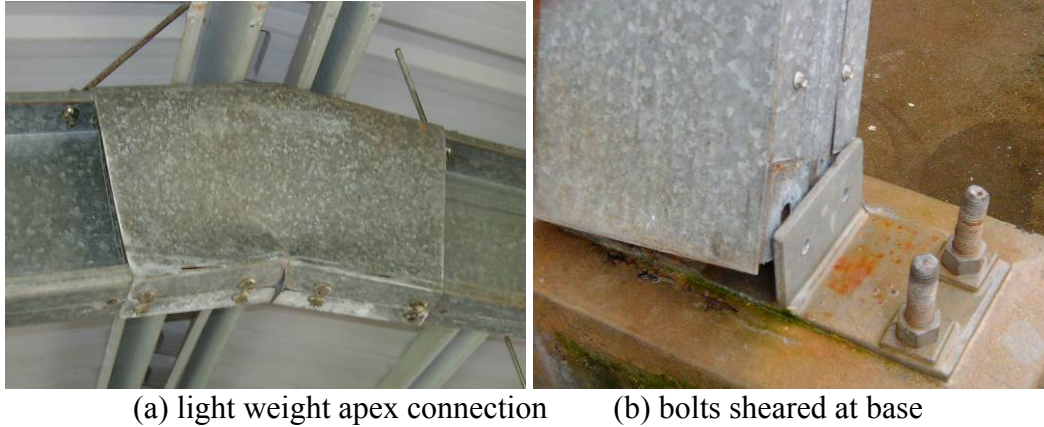
**Figure 6.15: Poor connection details**

- Under designed frame moment connections (both at ridge and the knee) – light gauge connection plates often weaker than the sections to be joined, (eg a flat web plate with no flanges) as shown in Figure 6.15(a).
- Inadequate frame hold down connections to footings (e.g. bolts too small, cast in columns corroded, etc). An example is shown in Figure 6.15(b).

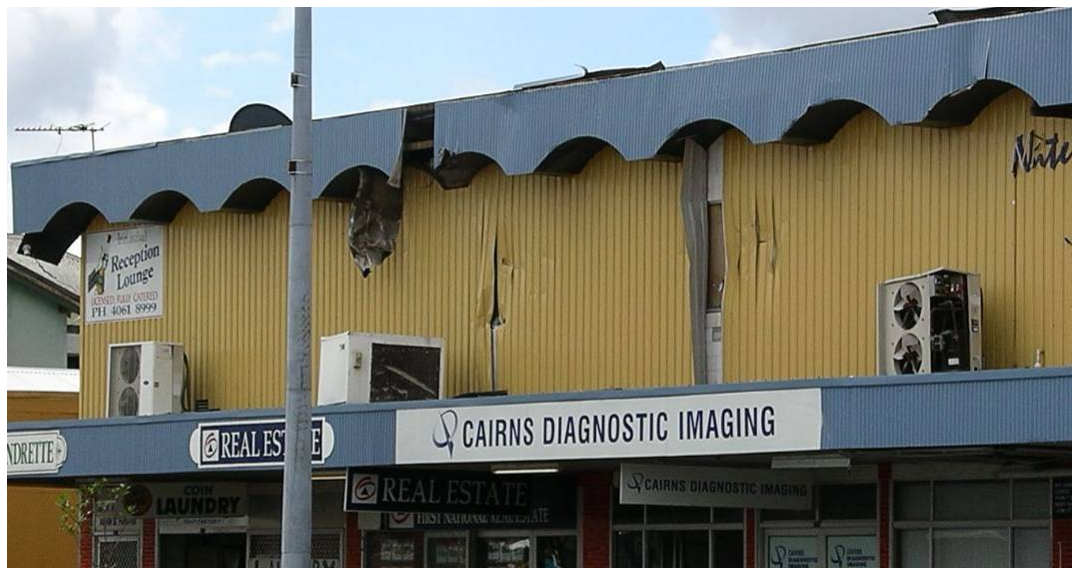
**Figure 6.16: Damage to and from air conditioning units**

There were many instances where air conditioning units and large ventilators had dislodged and become missiles that rolled or bounced along the roof causing impact damage during TC Larry. This type of damage was observed in the business district and was caused by the failure of mountings or connections of these mechanical units on the structure (Figure 6.16). In some cases this problem was exacerbated by corrosion resulting in a further reduction in strength. Some domestic ventilators also failed as shown in Figure 6.17. In each case, the loss of ventilators caused water ingress and contributed to debris damage.

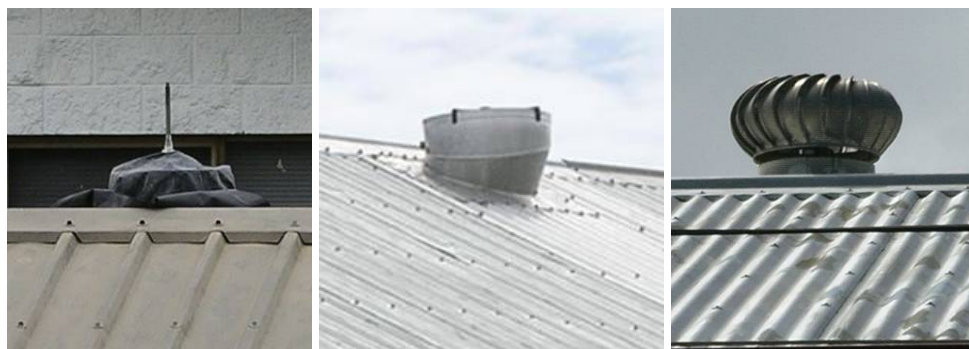
**Figure 6.17: Missing ventilators and a distorted ventilator due to fast rotation**

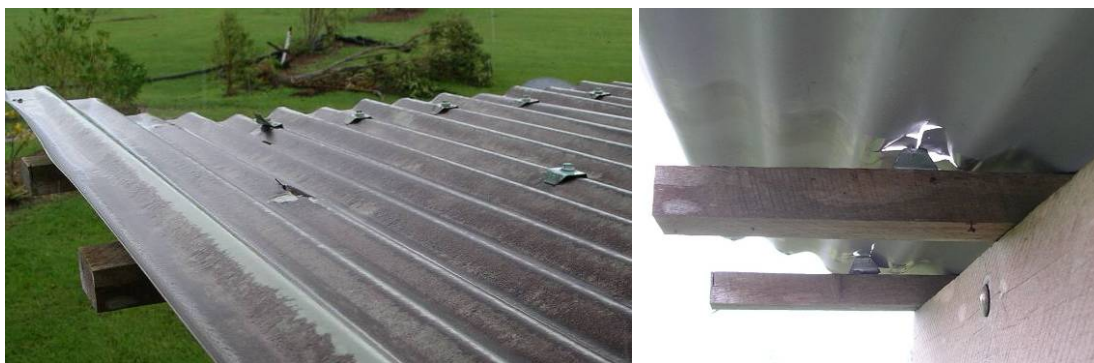
**Figure 6.20: Inadequate fixing spacing and excessive side edge distance**

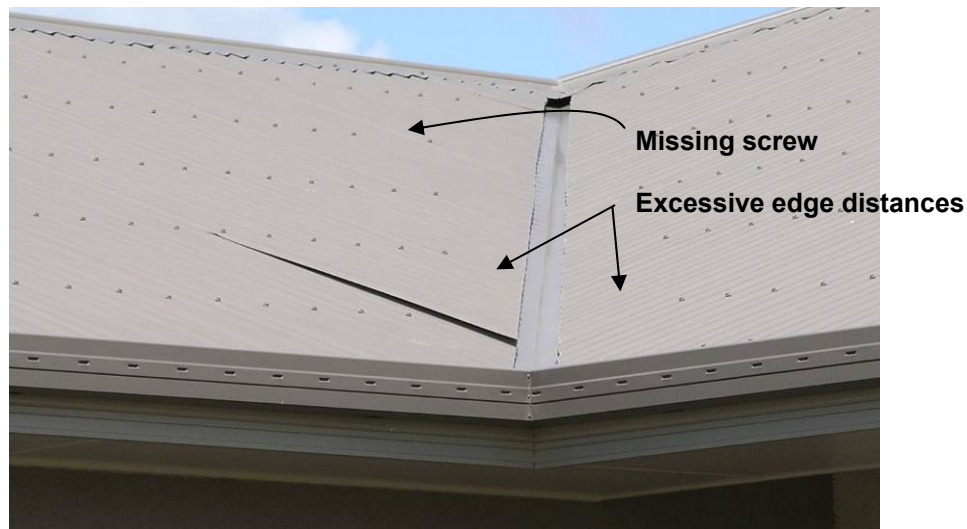
**Figure 6.21: Large edge distance and missing fixings**

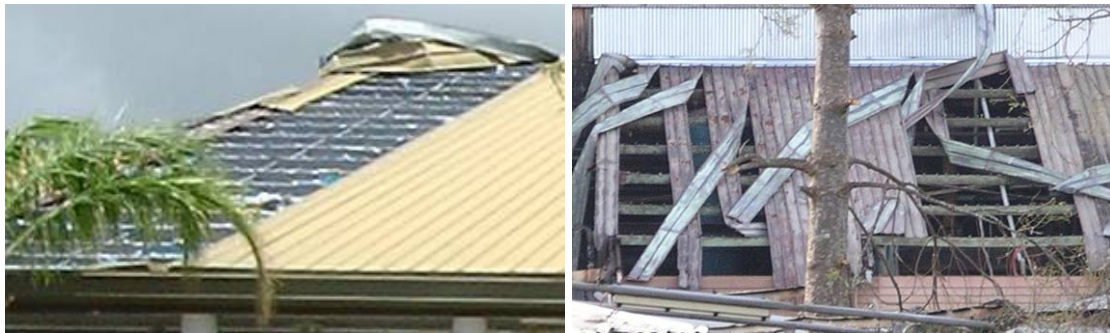
**Figure 6.22: Loss of secret fixed cladding**

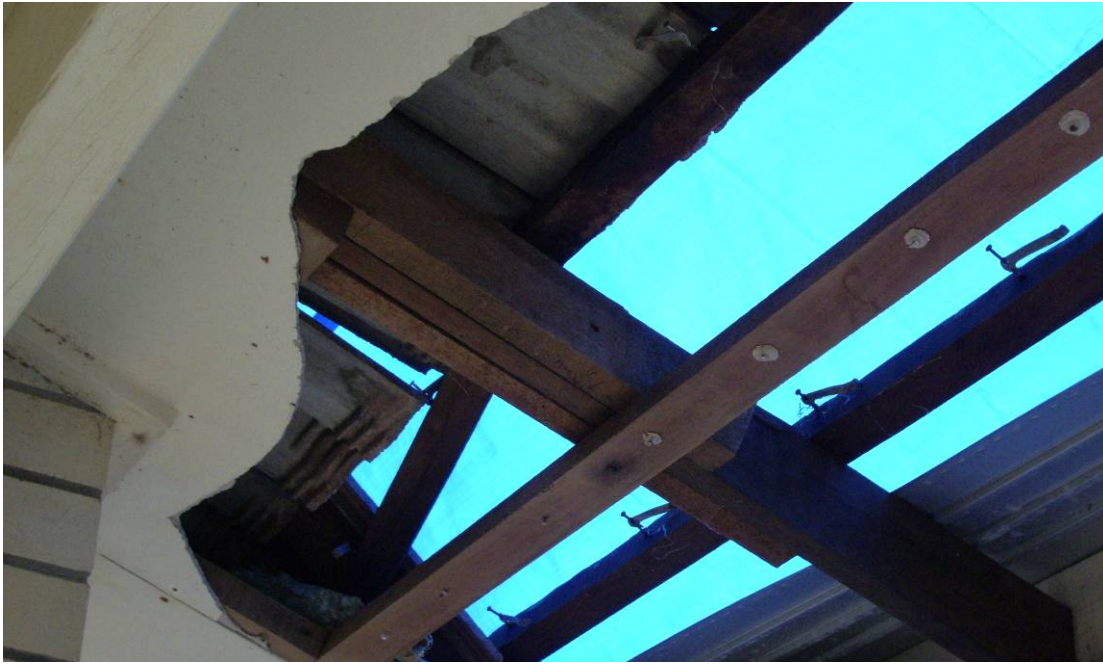
**Figure 6.23: Detail of tile roof cladding failure**

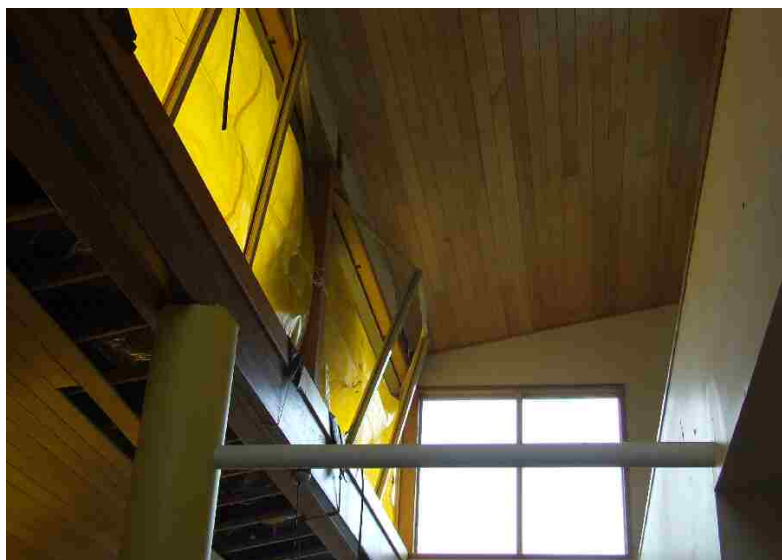
**Figure 7.3: Failure of Windows & Frames at SE Wall at Mezzanine Level**

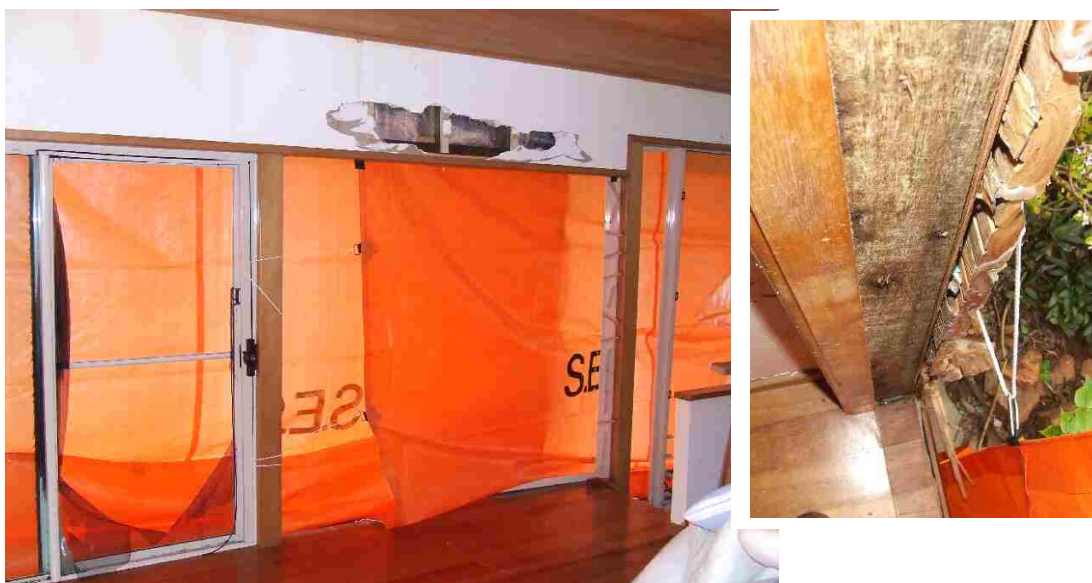
**Figure 7.4: Failure of Windows & Frames in windward Wall at Main Level**

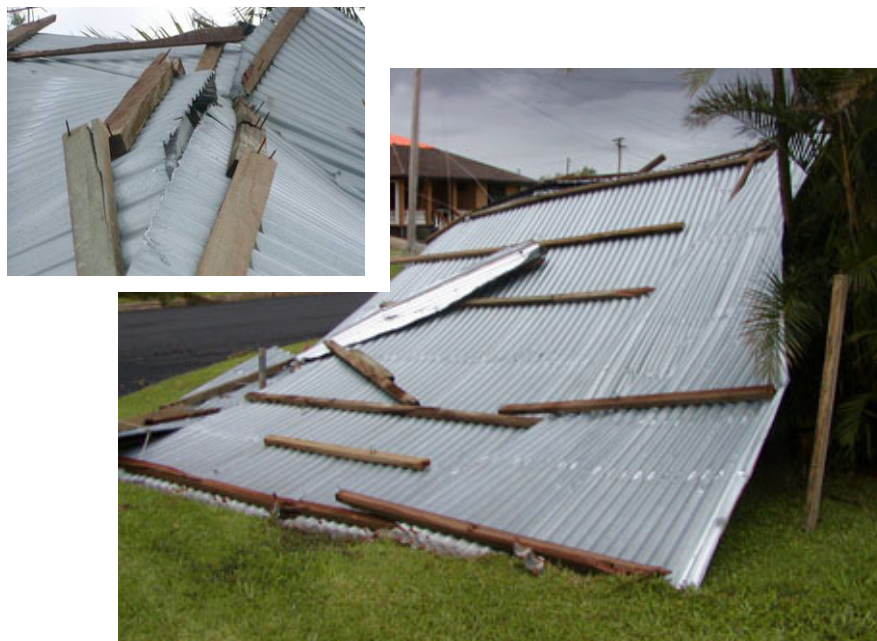
**Figure 7.5: Batten to rafter connection failure**

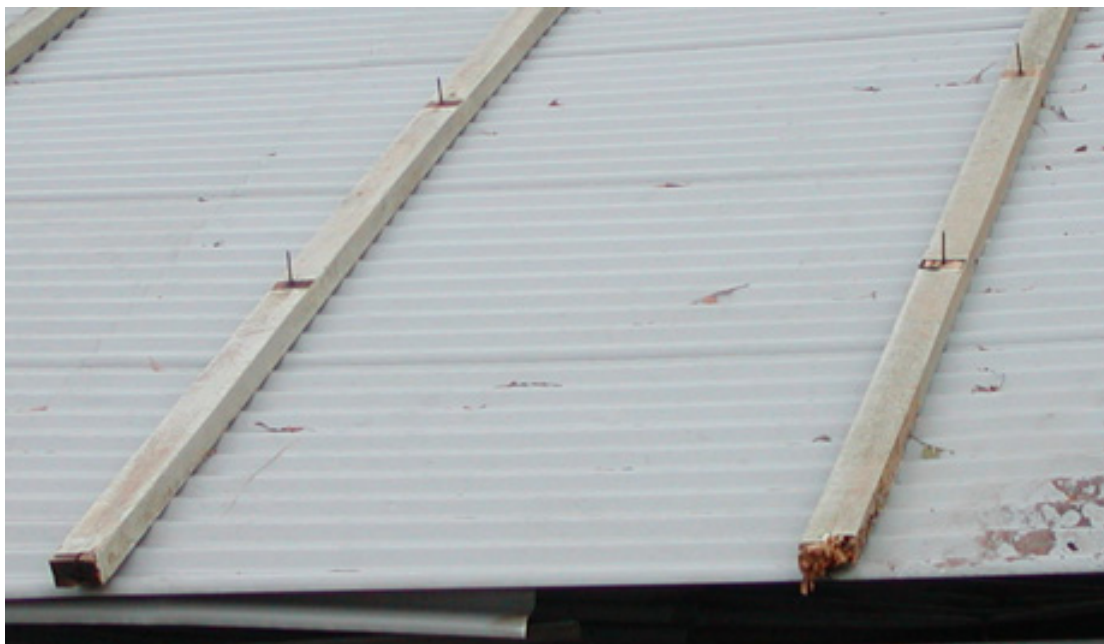
**Figure 7.6: Batten to rafter failure with one nail per joint**

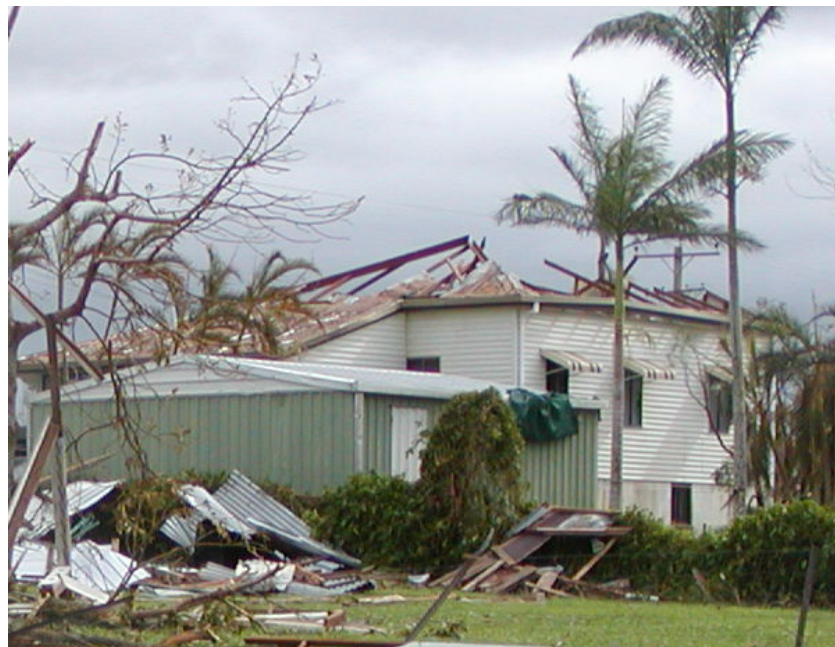
**Figure 7.8: Loss of ridge and struts**

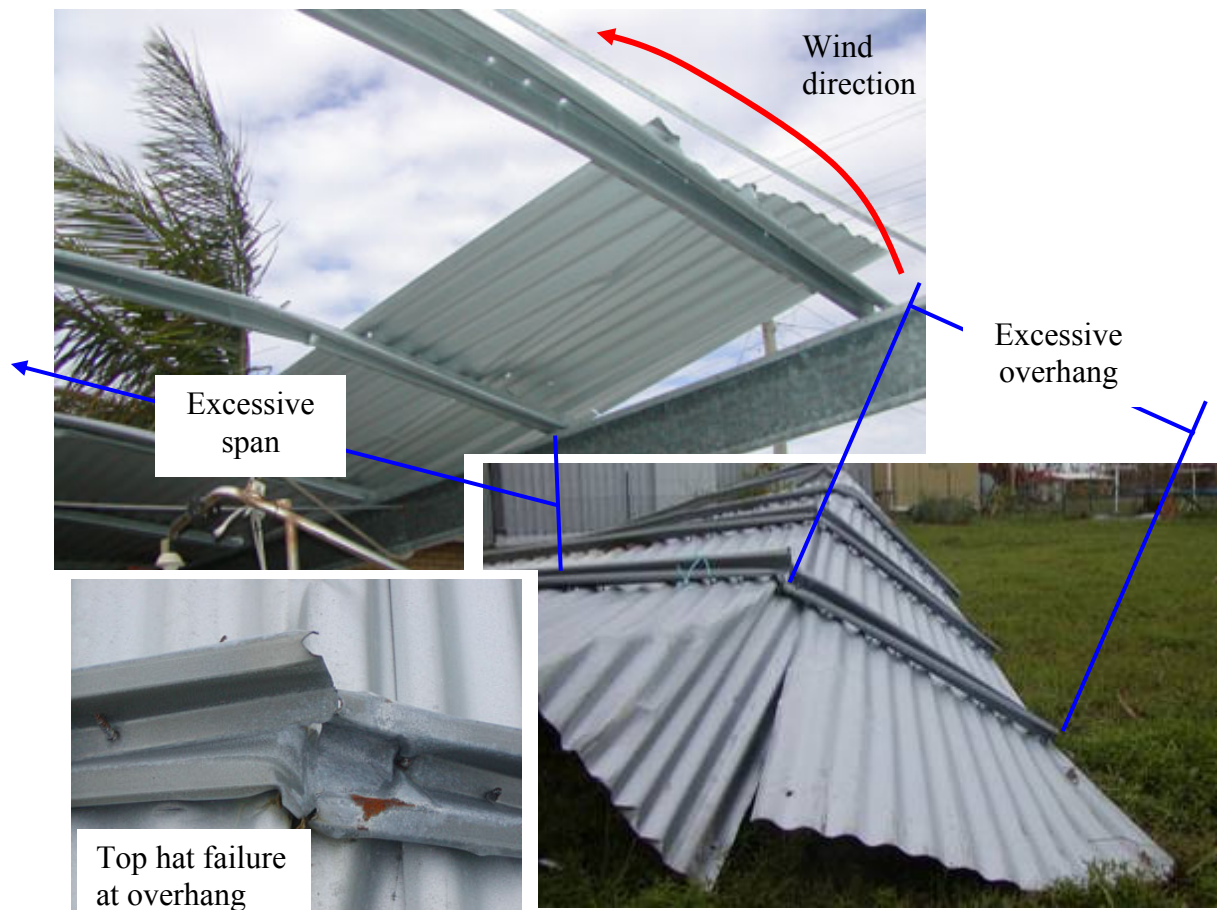
**Figure 7.9: Excessive spans in top hat battens**

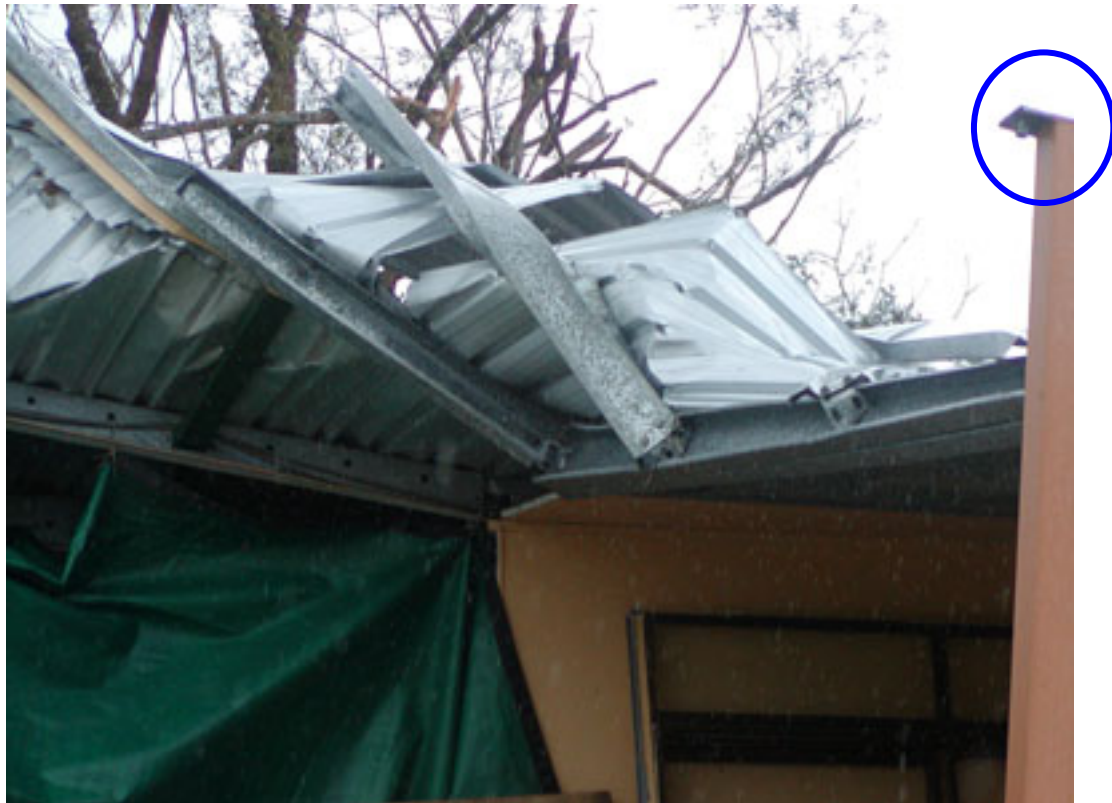
**Figure 7.10: Failure of steel beam to post connection**

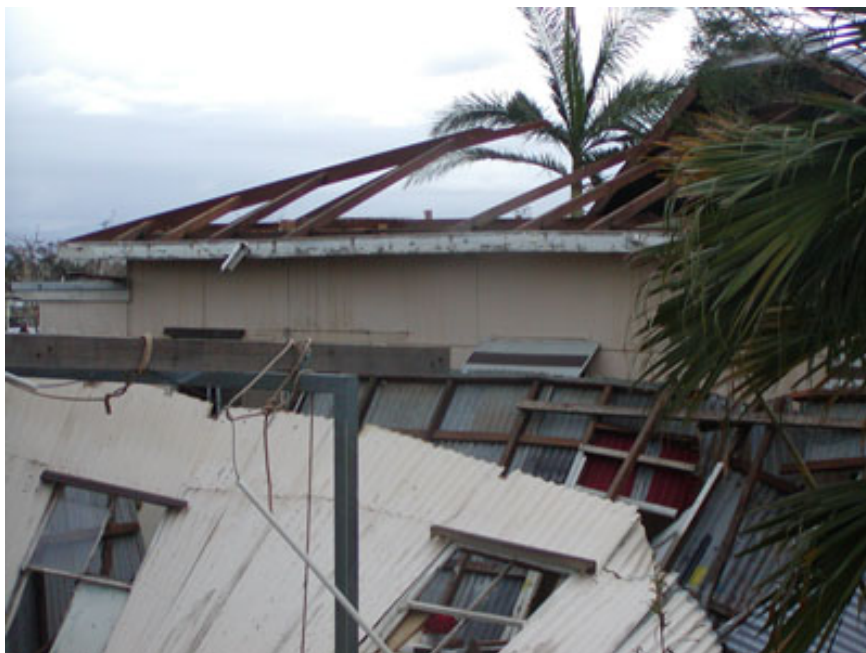
**Figure 7.13: Garage damage and partial loss of house roof**

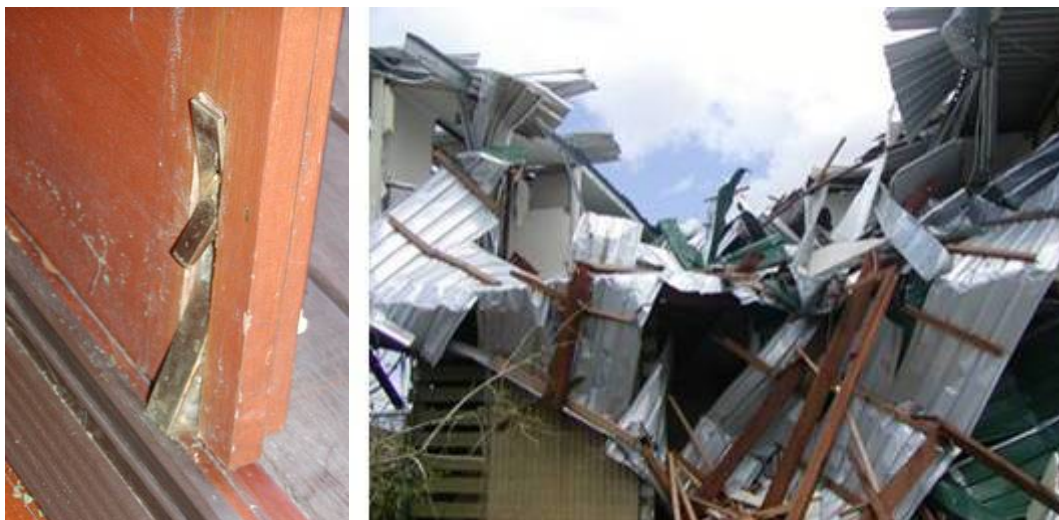
(a) window and door furniture    (b) large debris damaging whole walls

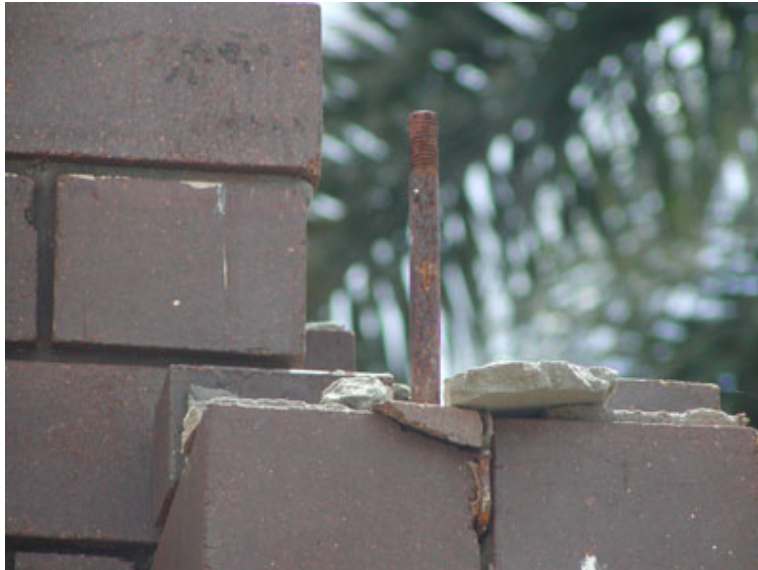
**Figure 7.15: Broken tie-down bolt at garage lintel**

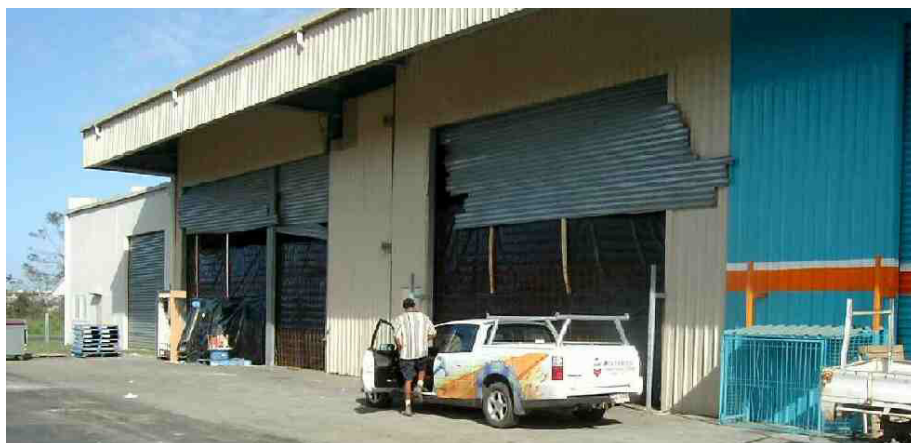
**Figure 7.17: Two of the failed roller doors**

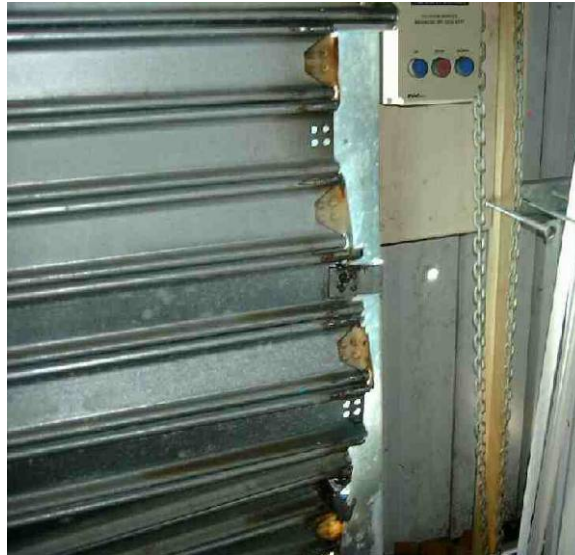
Figure 7.18 provides a detailed view of the wind locks fitted to one of these failed roller doors.

**Figure 7.18: Detailed View of Failed Wind Locks to Roller Door**  
(Wind locks fitted to every second slat)

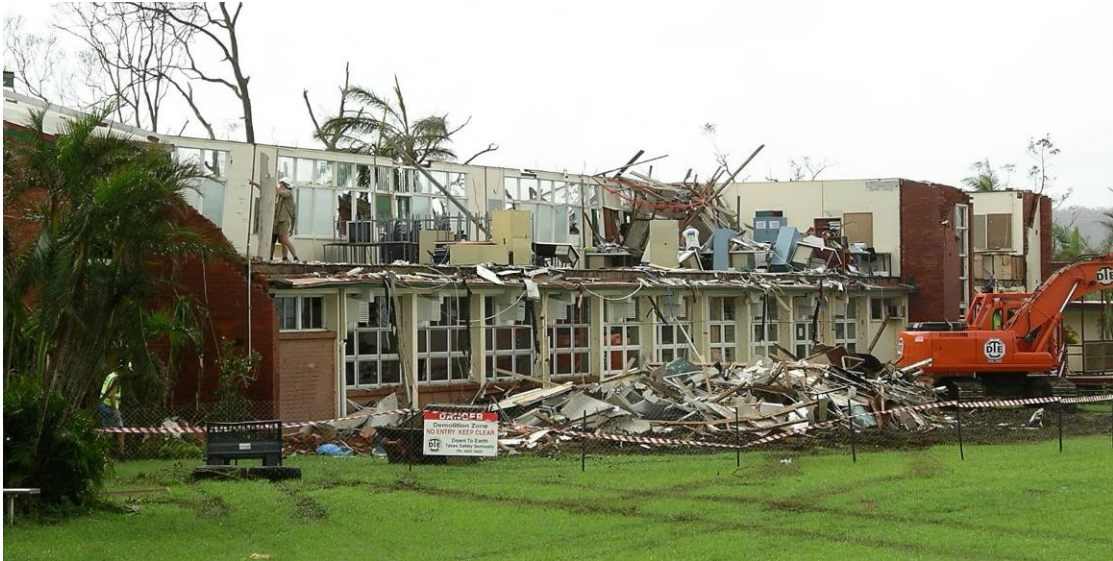
**Figure 7.20: Loss of roof and wall structure**

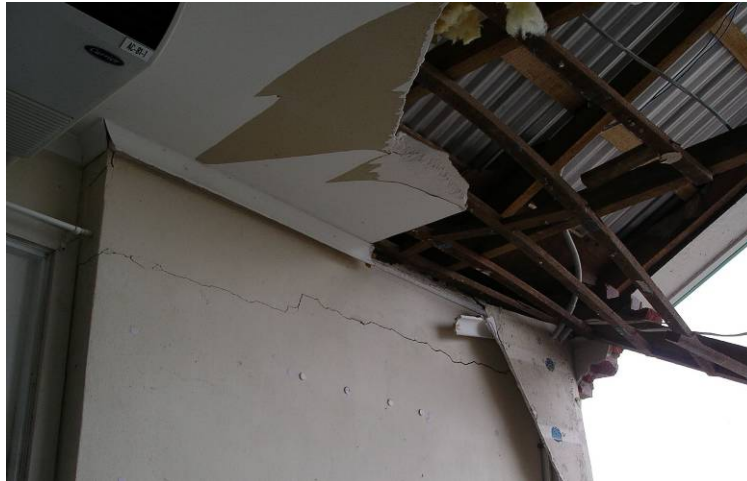
(a) Crack in pier

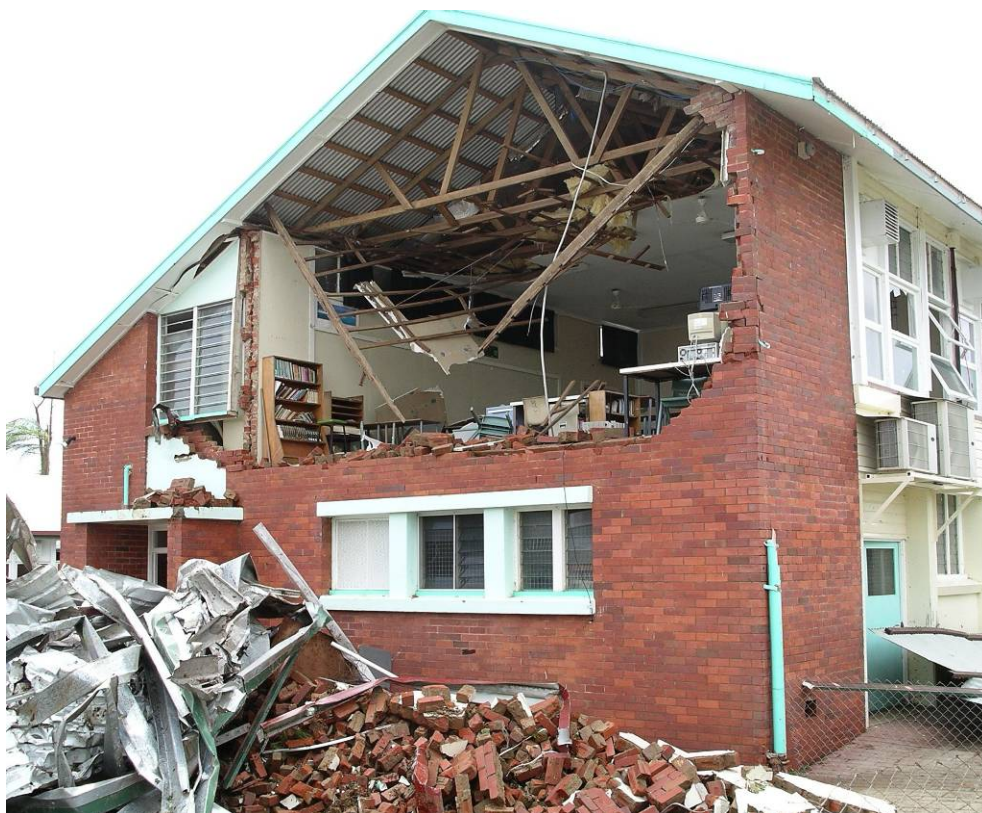
(b) End wall collapse

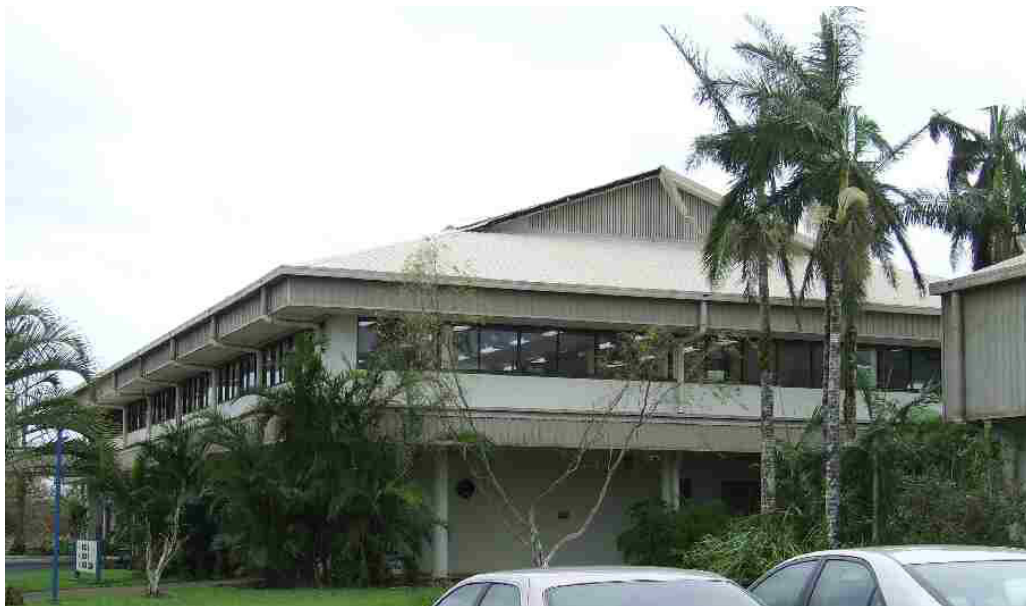
**Figure 7.23: Loss of flashing at Dutch gable end**

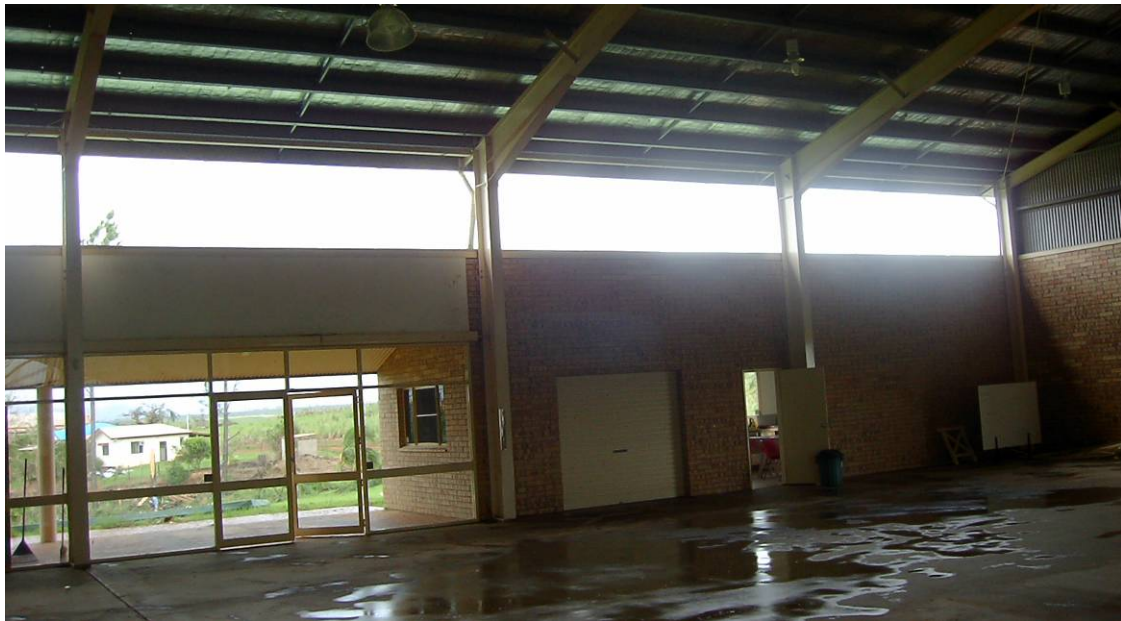
**Figure 7.25: View of Failed Banks of Louvre Windows to Large Hall**
