# **Tropical Cyclone Larry**

**Damage to buildings in the Innisfail area**

**CTS Technical report: TR51**

**September 2006**

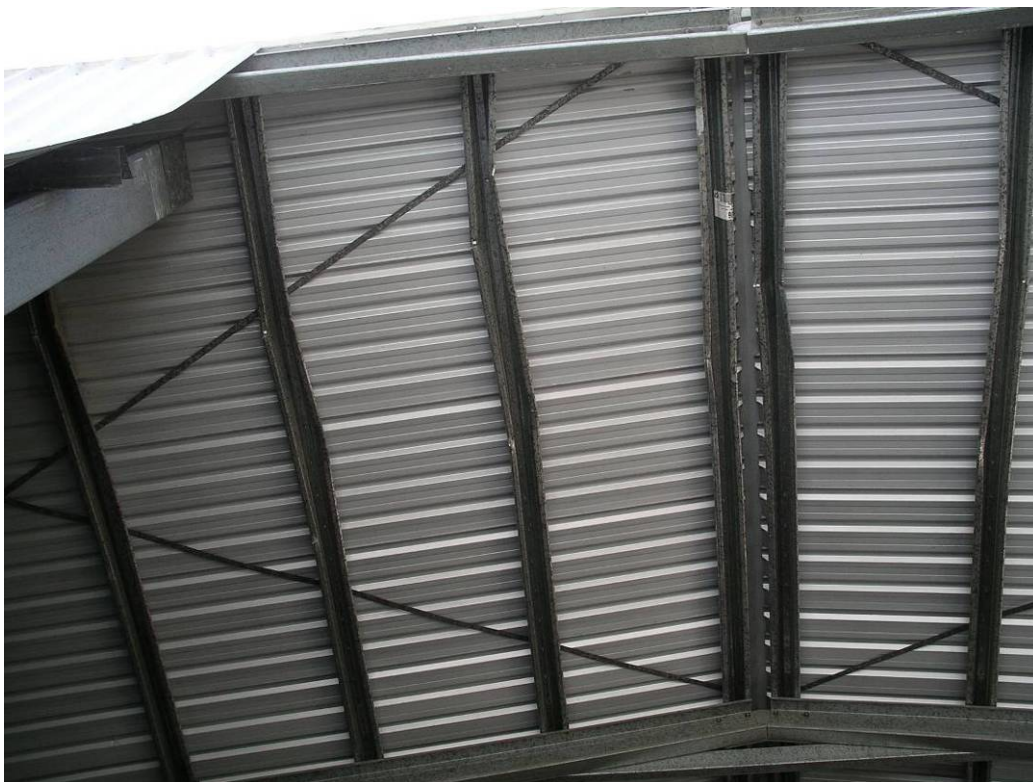
**Figure 7.26: Buckled top hat roof battens in end bay**
