Tropical Cyclone George

Damage to buildings in the Port Hedland area

Report: TR52

Authors: G. Boughton, and D. Falck (TimberED Services, Perth)

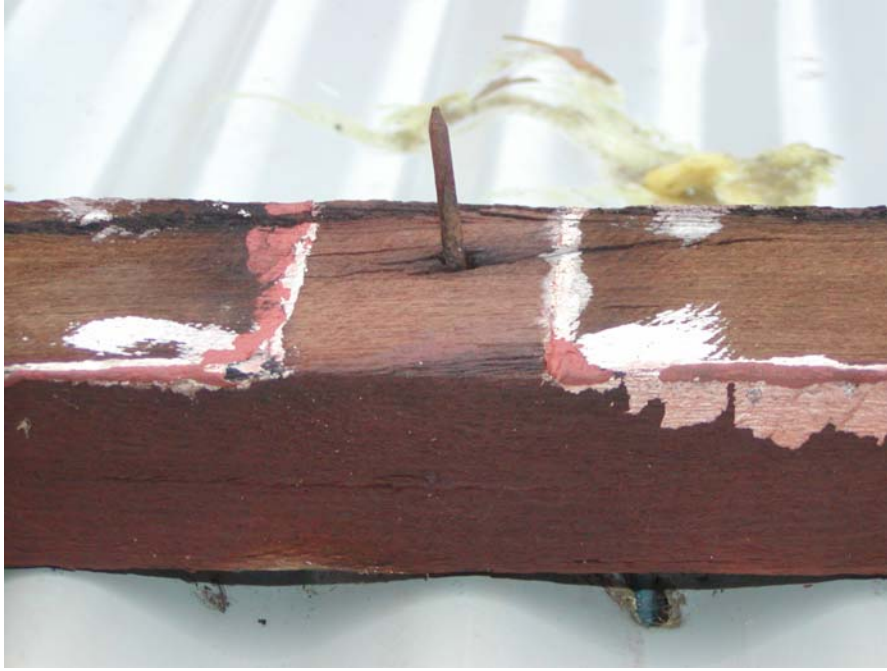
The most obvious damage in a number of older houses that had lost substantial portions of roofing was failure of the batten to rafter connections. In a number of houses, the roofing had been replaced and stronger roofing connectors installed as opposed to the spring head nails used during initial construction. However, no attempt had been made to increase the capacity of other elements in the roof structure. Figure 4.2 illustrates this type of failure.

Where these connections had failed, the rafters remained attached to the remainder of the house, but the battens were removed with the roof sheeting. The main details that had failed were simple nailed connections with one or two nails per batten to rafter connection. Current practice would require a screw, strap (locally called a pap-strap) or a framing anchor.

(a) nail failed

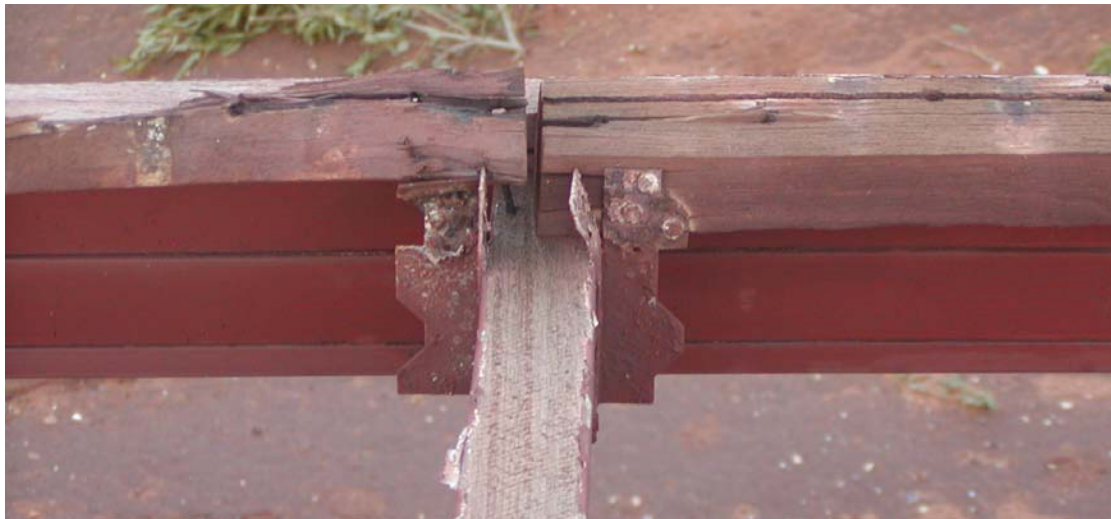
Two houses were observed where framing anchors had been used, but failures still occurred:

On one, framing anchors had been used only on the edge batten, and uplift forces on the remainder of the roof had caused failure that eventually overloaded the other anchorages in the system – in parts of the roof, roofing screws, and in other parts, the framing anchors.

On the other, framing anchors had only been installed on battens in the centre portion of roof, and the higher uplift forces at the edge of the roof had caused failure of the batten to rafter connections, firstly at the edge, and spreading rapidly to the rest of the roof. Both of these cases highlight the need for the use of the appropriate fasteners throughout the roof.

(b) framing anchors remained intact

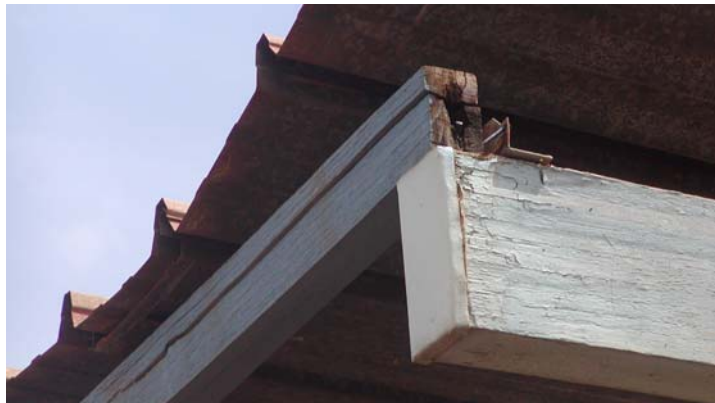
(c) failure of nails in rotting timber at framing anchor

Two flat roofed transportable houses lost a substantial portion of secret fixed cladding (“Kliplok” or similar) after failure of a batten to rafter connection. In this case, short

lengths of batten were fixed over the rafters by framing anchors, but the outer batten had rotted near its end grain and compromised the framing anchors. The loss of the batten caused a number of sheets of roofing to “un-clip” across the roof. Figure 4.2(c) shows the failure.

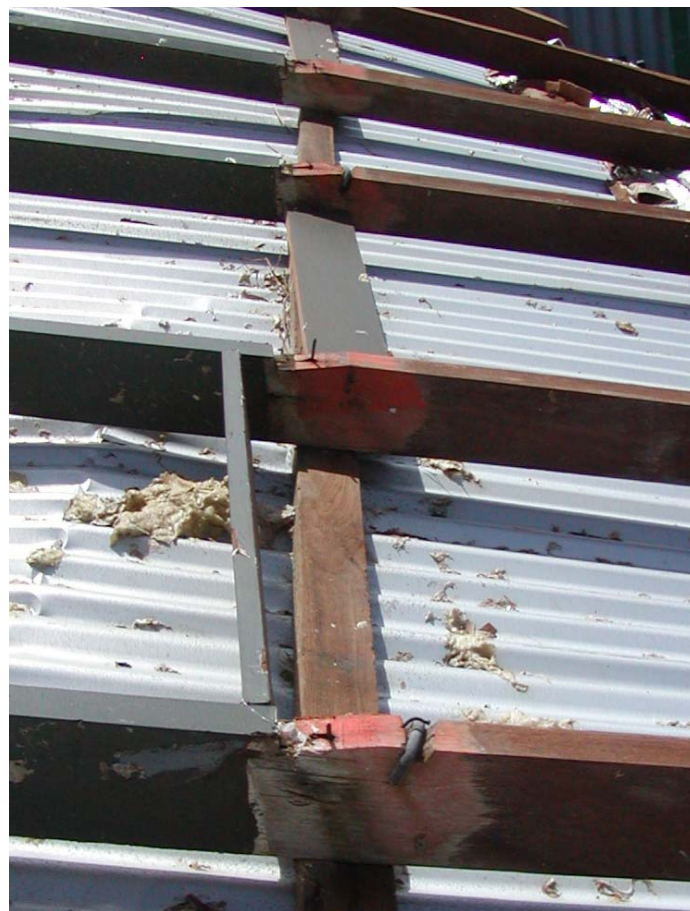
Before the 1970s, many roofs in Port Hedland were anchored to the top of walls with skew nails. Where the batten to rafter connection had sufficient strength to transmit the forces to the rafters and where there were no other systems in place to hold the roof down, the skew nails did not have sufficient capacity to resist the wind loads. Figure 4.3 illustrates this type of failure.

Figure 4.3 Failure of Rafter to Wall Connection

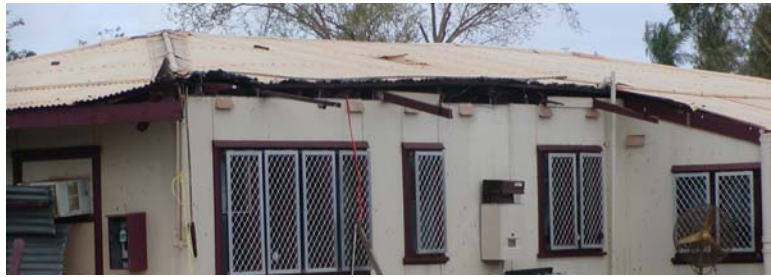
Previous cyclones in WA [4] have shown that where the roofing outside the over-batten (over the eaves) lifts due to either failure of the sheeting anchorage or the batten to rafter connections, the damaged roof folds back over the over-batten, but the main body of the roof remains attached, as shown in Figure 4.5(a). In this way, the over-batten assists batten-to-rafter connections and rafter-to-wall connections, allowing these to function with two nails each.

(a) roof failure arrested by over-battens

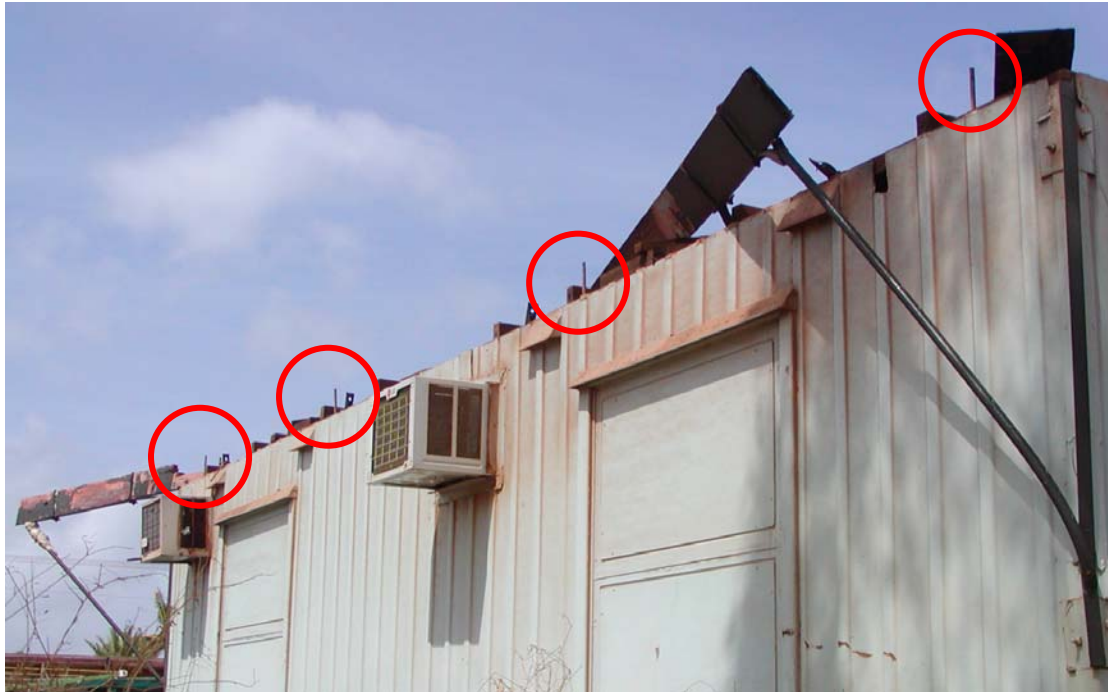
Seven roofs of the twenty three houses with some structural damage had been built using over-battens, but the tie-down rods had been oxy-cut in the past. These houses had each been re-roofed at some stage, but the over-battens had not been replaced, and no other tie-down system had been installed in any of these houses. Figure 4.7 shows a roof failure with the cut tie-down rods highlighted. In this case, the rafters had detached from the walls but the hip rafters which were independently anchored had remained.

Figure 4.7: Removal of Over-batten on re-roofing led to roof failure

Many of the batten-to-rafter failures and the rafter-to-wall failures listed in Table 4.1 were due to the removal of the over-battens. It is imperative that where a tie-down system is significantly changed, a replacement load path is installed.

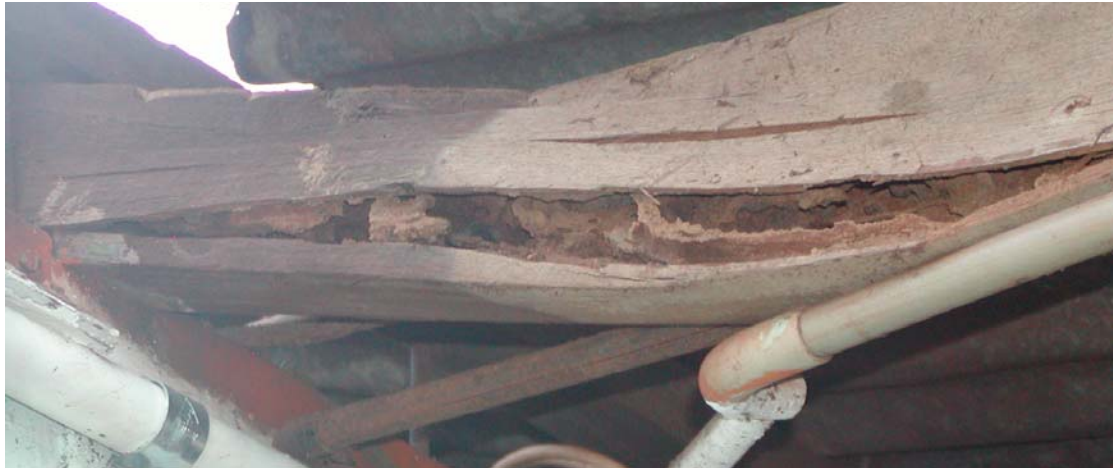
Figure 4.8 shows some rafters that had been seriously compromised by termite activity. This led to partial roof loss, and caused safety issues for workers installing tarpaulins during the response phase.

Figure 4.8: Termite-damaged rafters led to partial roof loss

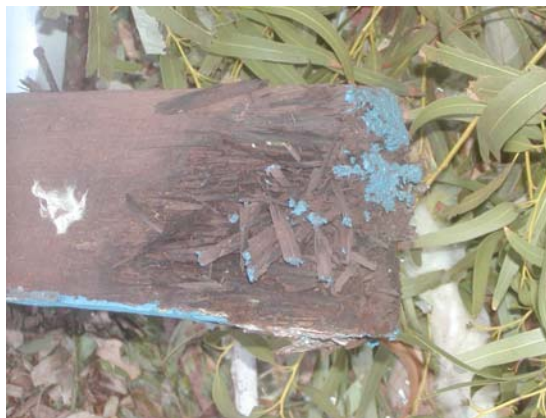
Figures 4.9 and 4.10 show some rot and corrosion in timber framed structures. There were also many instances of corroded roofing, though in most of these, the corrosion was not the prime cause of the failure.

Figure 4.9: Rot-damaged rafters led to partial roof loss

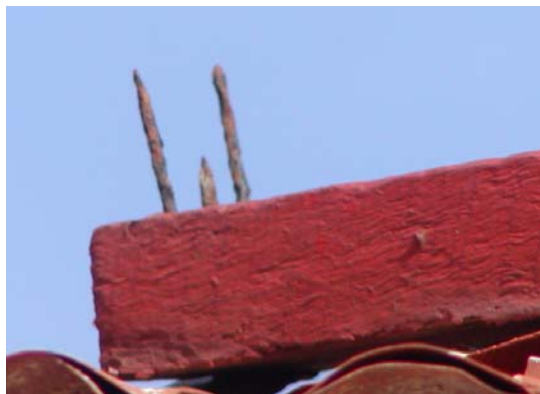
Figure 4.10: Corroded fasteners contributed to partial roof loss

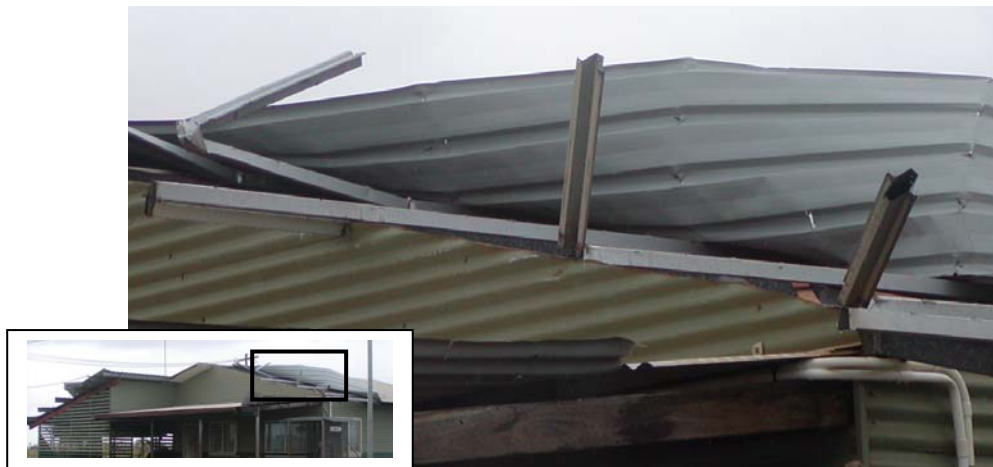
One type of standard house uses a 600 mm cantilever on the end of a deep top hat batten. This is more than the design recommendations suggest for this region. Figure 4.11 shows the failure of this cantilever.

Figure 4.11: Failure of cantilevered top-hat battens

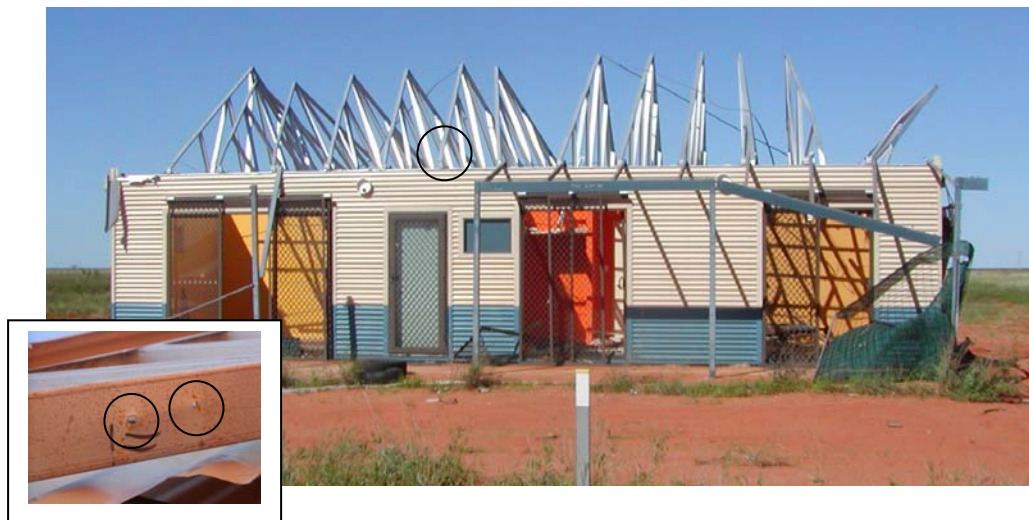
An aboriginal community that experienced the eye wall wind speeds (estimated at less than 75 m/s) had two identical houses that lost all of the roof battens. These battens had pulled their fasteners out of the light gauge truss elements as shown in the inset in Figure 4.12.

Figure 4.12: batten loss from steel roof trusses
(inset shows detail of truss top chord)

The batten fasteners had worked their way out of the trusses which appeared to have a steel thickness of around 1 mm. The truss steel had locally deformed at the anchorage (highlighted by the circles in the inset). A number of the trusses showed signs of buckling at the batten anchorage also highlighted by a circle in the main photo. As the wind speed did not exceed the design speed for this house, the performance of the connection was of concern. Further investigation of anchorage of light steel battens into light steel trusses is required.

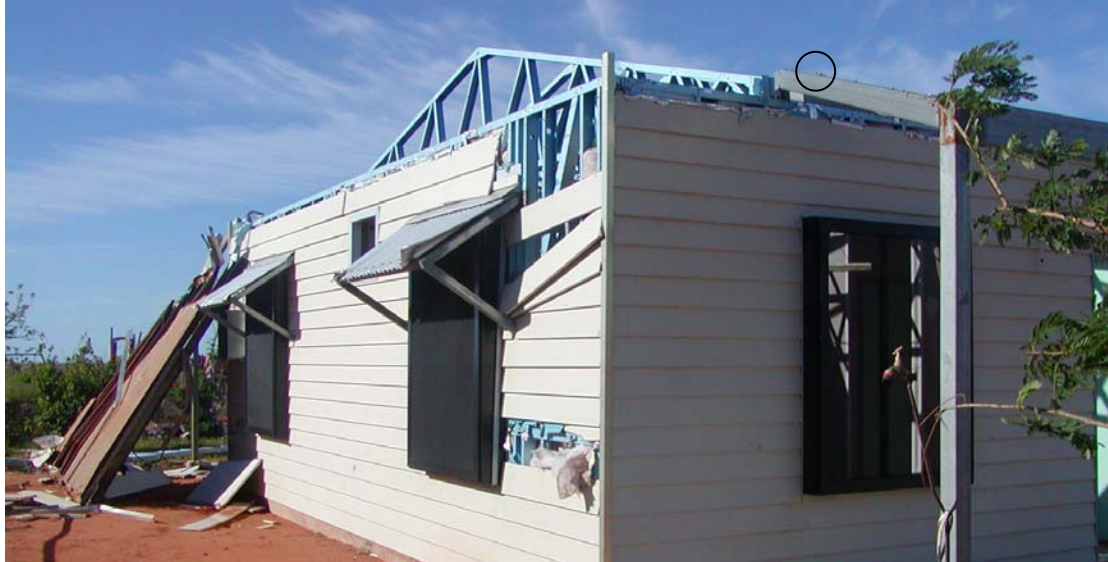
A third failure in a modern light gauge steel framed roof is illustrated in Figure 4.13. This building was also in an area that experienced the eye wall wind speeds. Although the steel trusses appeared to use a slightly thicker gauge steel than the trusses

illustrated in Figure 4.12, debris damage initiated failure of batten to verandah rafter connection, causing progressive failure of the remaining batten to rafter anchorages. A circle in Figure 4.13 shows that the batten screws remained in the RHS verandah rafters, and the screws pulled through the 0.75 mm thick battens. In the trussed portion of the roof, the screws pulled out of the trusses as shown in Figure 4.12.

Figure 4.13: batten loss from steel framed roof

The batten spacing on the verandah was 450 mm which performed well at this wind speed on an identical house next door. However, once one anchorage had been lost, the load on adjacent anchorages increased beyond their capacity. This system is sensitive to damage caused by debris or irregularities in anchorage installation.

This failure also highlights concerns about the performance of very light gauge steel elements in roofs at less than the design wind speed.

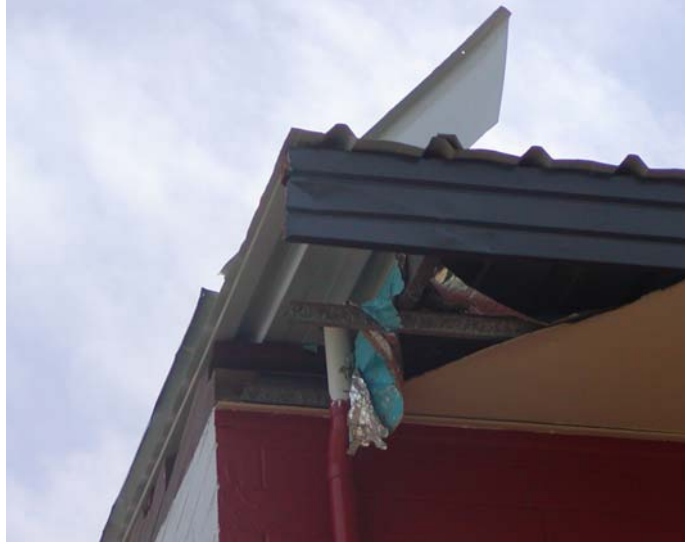
In one case, a trim became detached from a barge board and dragged two sheets from the roof when they might otherwise have stayed attached. This type of failure is shown in Figure 4.14. (The soffit damage evident was a secondary failure.) Similar damage to trim was also observed in schools.

Figure 4.14: Failure of trim

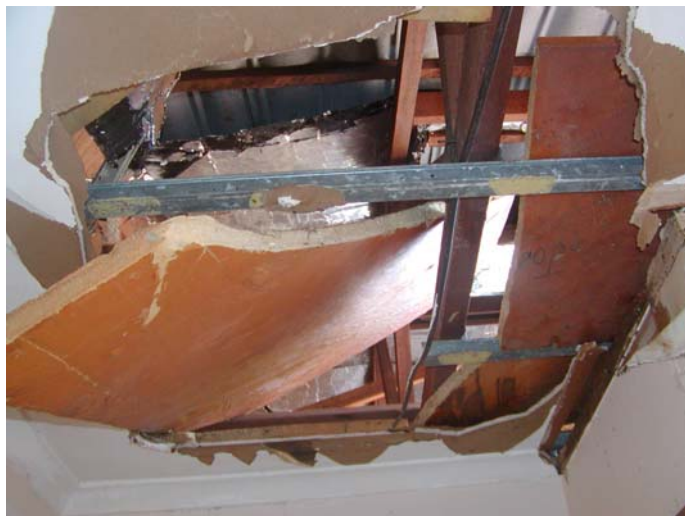
Figure 4.15: Water damage to plasterboard ceilings

Plaster ceilings suffered water damage, even if the roofing was only very slightly damaged. Also, damage to gable panels allowed water entry to the roof space and caused damage to ceilings as shown in Figure 4.15.

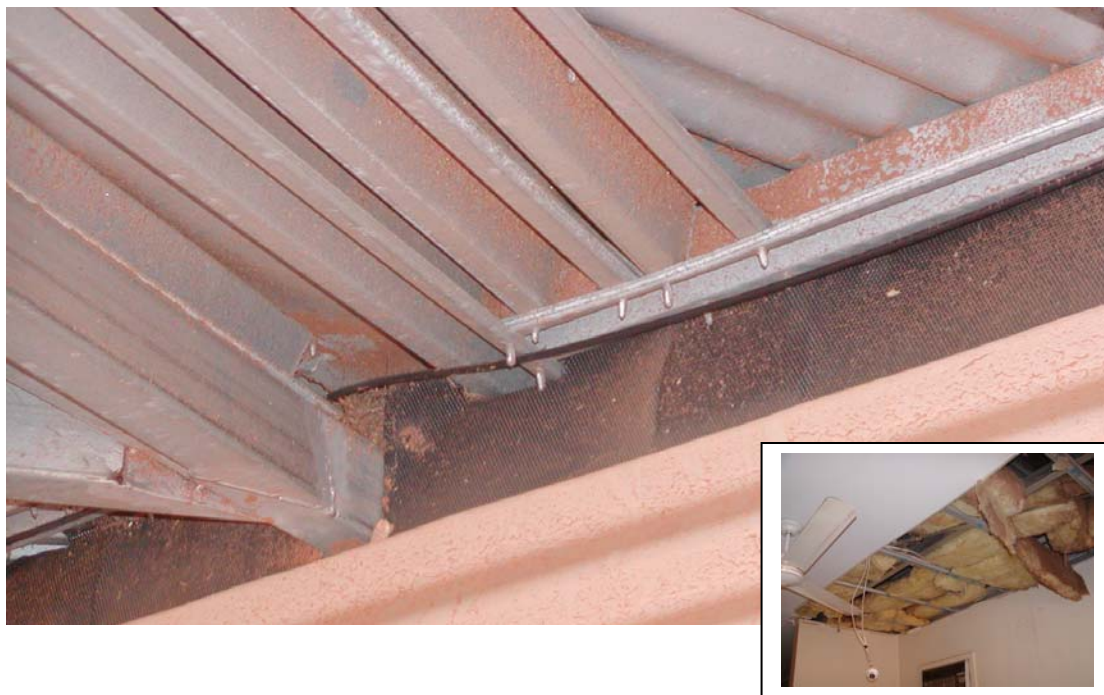
In a number of houses, fine mesh was installed in place of bird boards between the trusses to provide ventilation into the roof space, as shown in Figure 4.16. Unfortunately, wind borne rain was driven through the mesh, ponded on the plasterboard ceilings, and lead to collapse of the ceiling.

Figure 4.16: Mesh ventilation to roof space
Inset: Water damage to plasterboard ceiling

Figure 4.16 shows soil that has been blown onto the underside of the roof and onto the wall cladding on the windward wall. The soil and water were blown through the mesh shown between the top of the cladding and the underside of the battens. Where such ventilation is used, resilient lining materials must be installed. Alternatively, where plasterboard or other water sensitive lining materials are installed, roof space ventilation openings are not recommended.

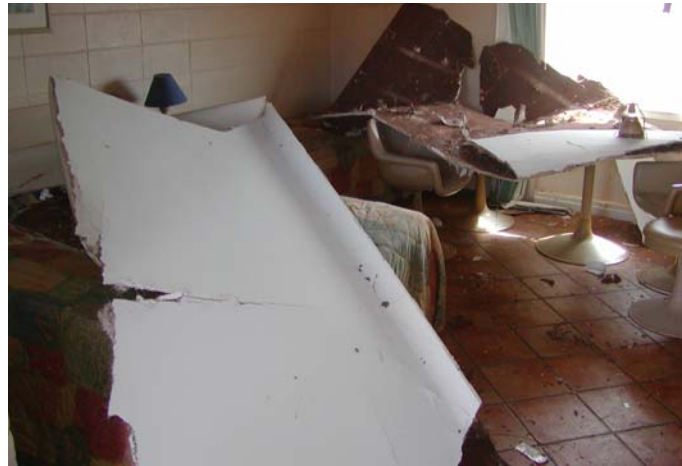
Pressurisation of the roof space through gable ventilators caused downward pressure on ceilings and a number of dry ceiling collapses were due to this effect. An example of this type of damage was seen in motel rooms, illustrated in Figure 4.17. In each case in which this was observed, there was no opening that could develop dominant internal suction in the affected rooms, though any leakage through doors and windows

would have been from suction surfaces. The affected rooms were not adjacent to the windward wall, but were some distance from it. Any water blown in through the vent landed on ceilings closer to the vent.

Figure 4.17: Collapse of dry plasterboard ceiling due to roof space pressure

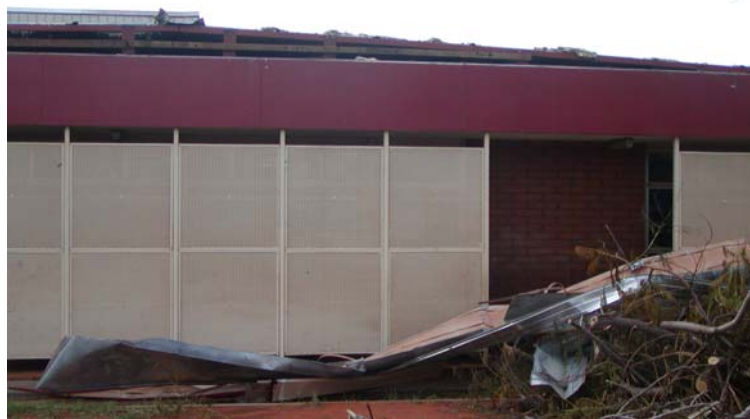
A number of school buildings and the Civic Centre had some damage to the roof that appeared to originate at flashings on the windward edge of the roof. In each case, the flashing seemed very large (around 600 mm wide). Flashings are not normally regarded as structural elements, but in this case, the flashing takes loads comparable to loads on roof sheeting that is regarded as a structural element. The flashings are located in a local pressure zone, which can double the loads on specific fasteners.

Figure 4.18: Damage to wide flashings roofing and trim on windward edge of roof

As this type of detail appears to be quite common in public buildings of this age, it may be advantageous to have the structural adequacy of the wide flashings verified by structural engineers. (Wide flashings and trim can be treated in the same way as roofing.) If needed extra fasteners should be fitted to this detail wherever it occurs in the cyclone regions (C or D) [5].

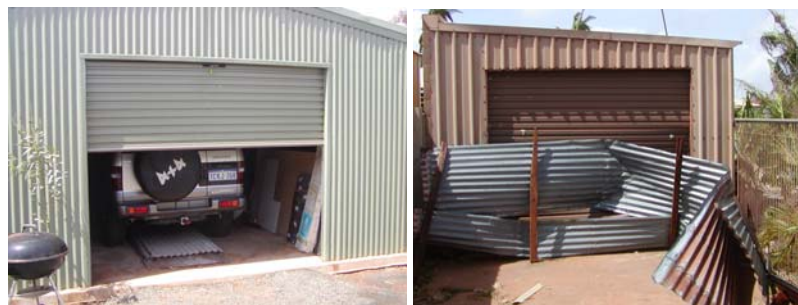
Roller doors were rarely used in house garages with carports the favoured shelter. Two exceptions were seen, and both of these doors were undamaged and operational. They are shown in Figure 4.19(b). Neither had been fitted with any special anchorages.

(b) Undamaged Domestic roller doors
Figure 4.19: Roller and sliding doors
