## **Investigation of Performance of Housing in Brisbane Following Storms on 16 and 19 November 2008**

**Report: TR55**  
April, 2009

Cyclone Testing Station  
School of Engineering and Physical Sciences  
James Cook University  
Townsville Q 4811

**TECHNICAL REPORT NO. 55**

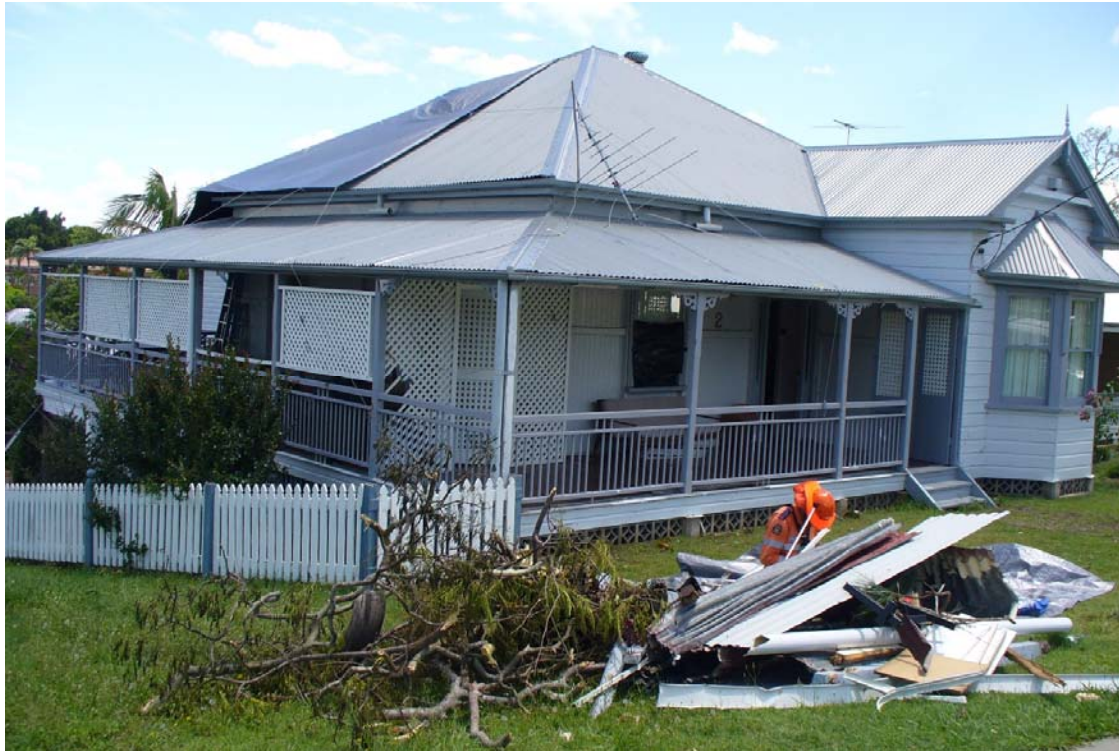
**Figure 5.4: General view of a Pre 1980 house with Damage Index of 303**

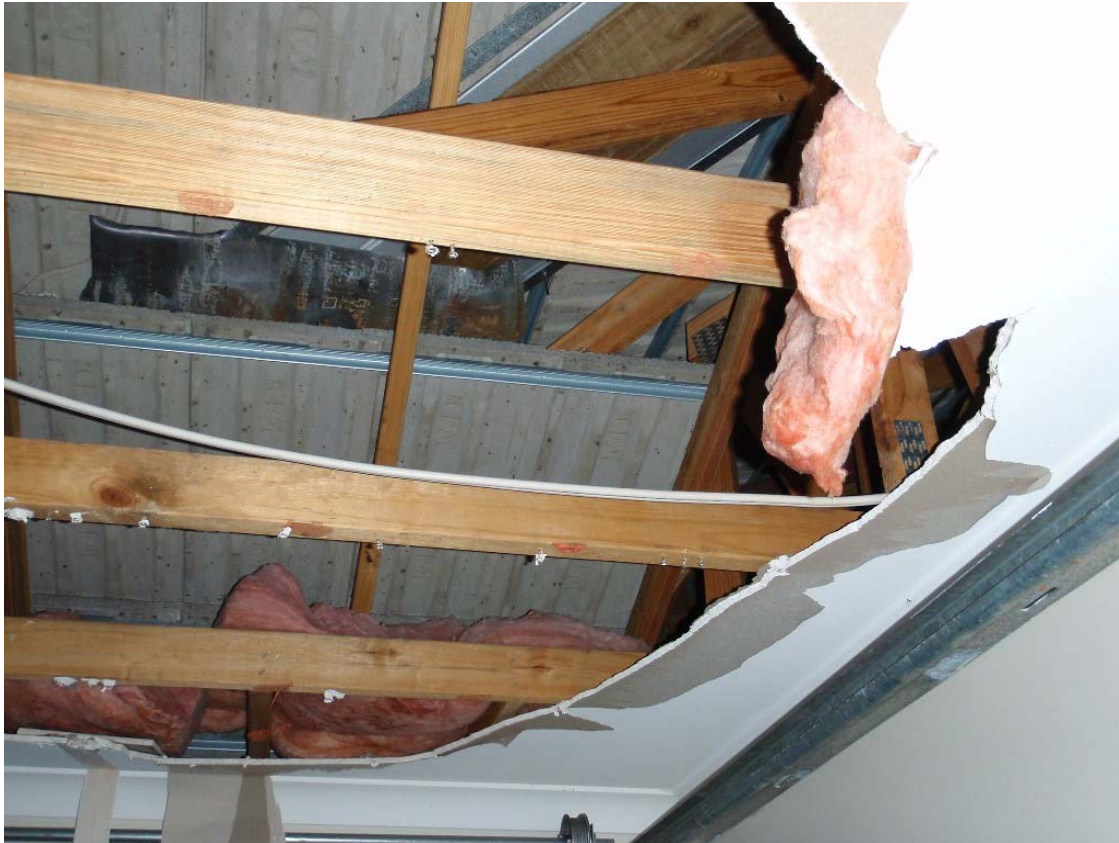
The investigations into the damage to new housing at Redbank Plains indicated that there was a significant water ingress problem through unsarked tiled roofs. This leakage allowed water ingress onto the top of plasterboard ceilings, which became waterlogged and then collapsed. Figure 5.5 shows a typical example of a small area of plasterboard ceiling to a garage, which had collapsed.

**Figure 5.5: General view of typical ceiling collapse due to water penetration**

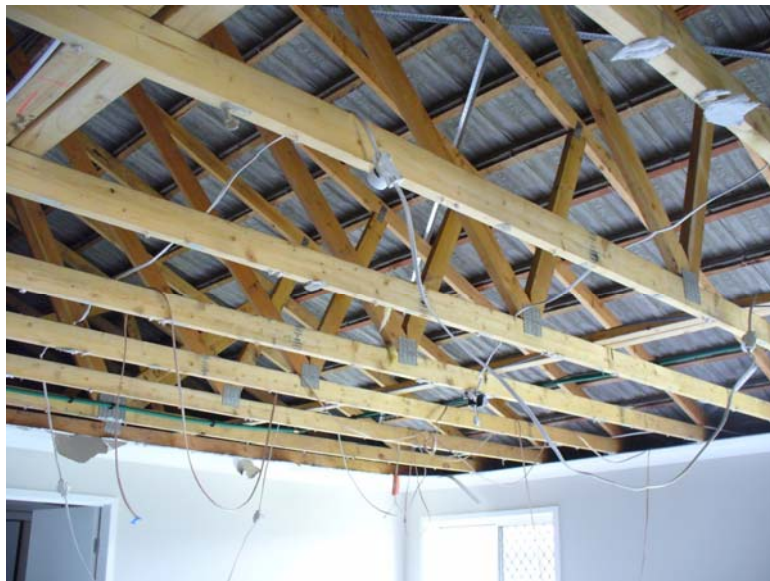
Figure 6.1 shows a general view of the exposed timber trusses supporting a tiled roof (without sarking), after the collapse of a plasterboard ceiling, caused by water ingress through the tiled roof.

**Figure 6.1: General view of typical ceiling collapse (unsarked tile roof)**

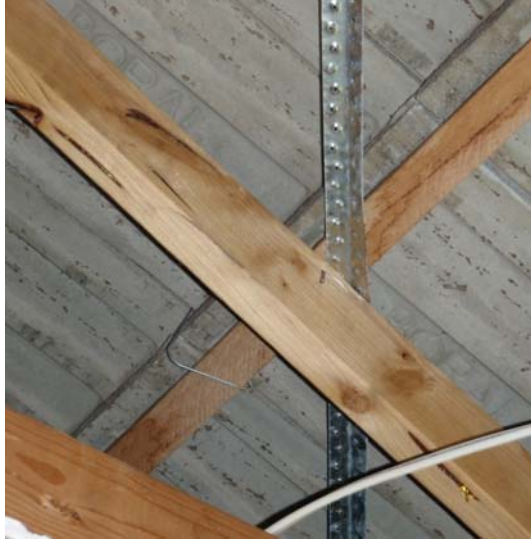
Figure 6.3 shows two examples of construction errors for a tile roof fixed to timber battens. Figure 6.3 (a) shows both a construction error where a batten nail has been installed too close to the truss edge and missed the supporting truss member and also shows a typical tile clip to timber batten connection. Figure 6.3 (b) shows a tile clip not fully secured to the supporting timber batten.

(a) Batten nail missed truss and tile clip to batten

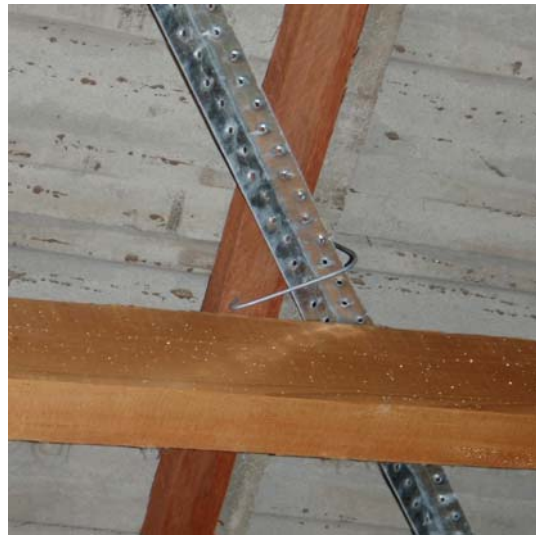
(b) Tile clip not fully secured to timber batten

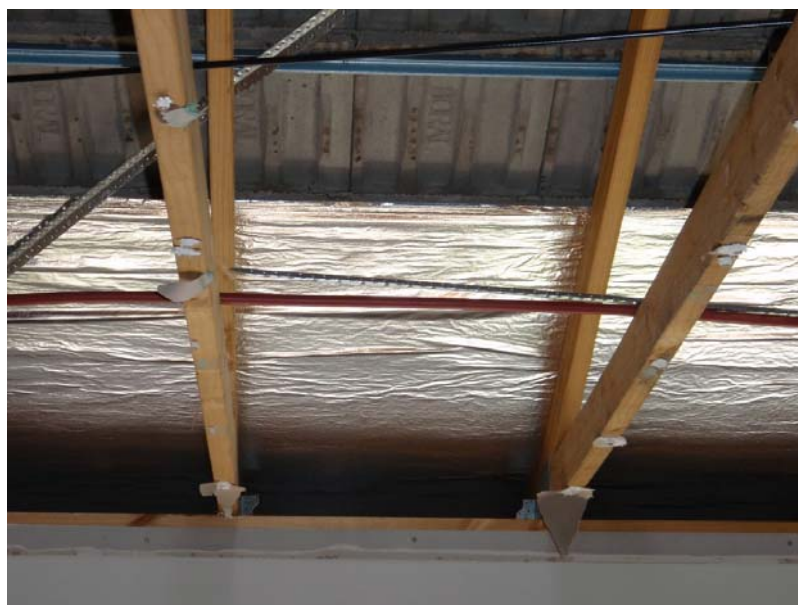
For the three *ceiling collapse* houses visited in Redbank Plains, two of them had no sarking at all and one of them used sarking for about the first metre of roof, closest to the fascia, as shown in Figure 6.4. Note that the BCA requires sarking where the roof run exceeds 6000 mm, for example a roof run of 7500 mm requires the roof to be sarked 1500 mm up from the fascia.

**Figure 6.4: Tiled roof with sarking to lower 1m of roof**

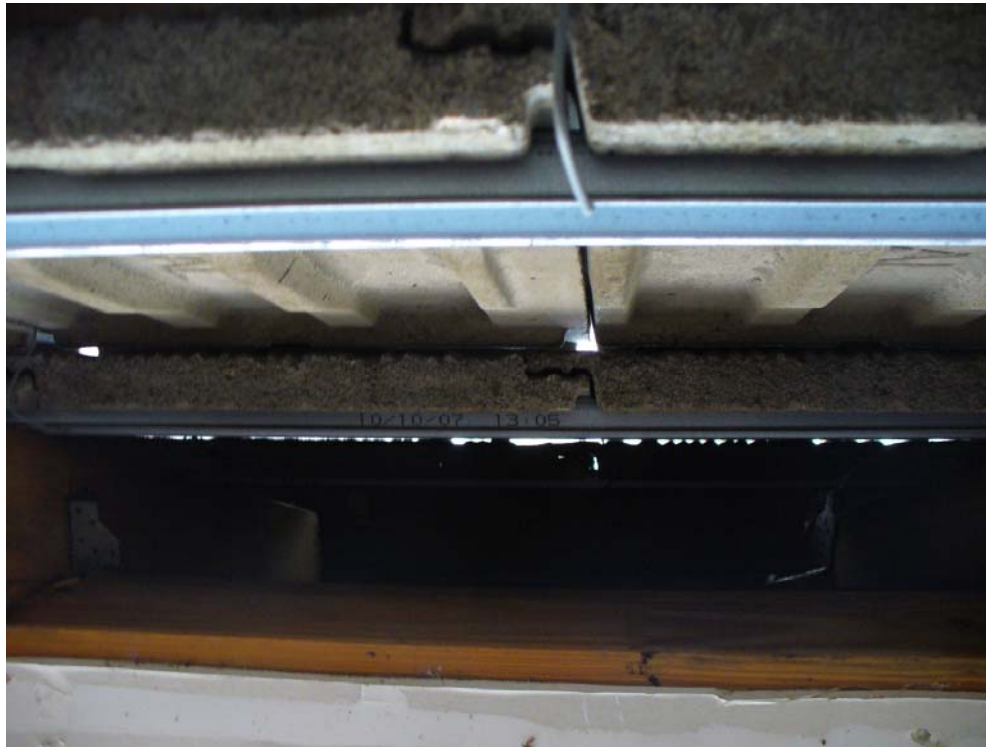
Figure 6.5 shows a general view of typical gaps to a tiled roof.

**Figure 6.5: Detail of gaps to tiled roof**

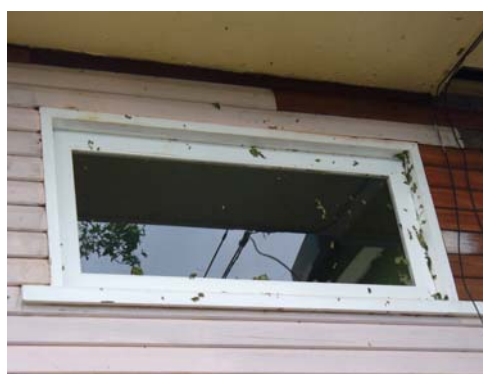
Figure 7.1 shows two views of windows to a house in The Gap, with this shredded leaf litter still in place.

(a) Leaf litter around a closed window

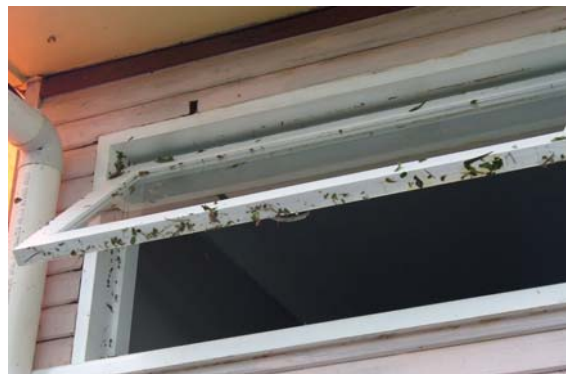
(b) Leaf litter driven into the gaps around the frame of a hopper window

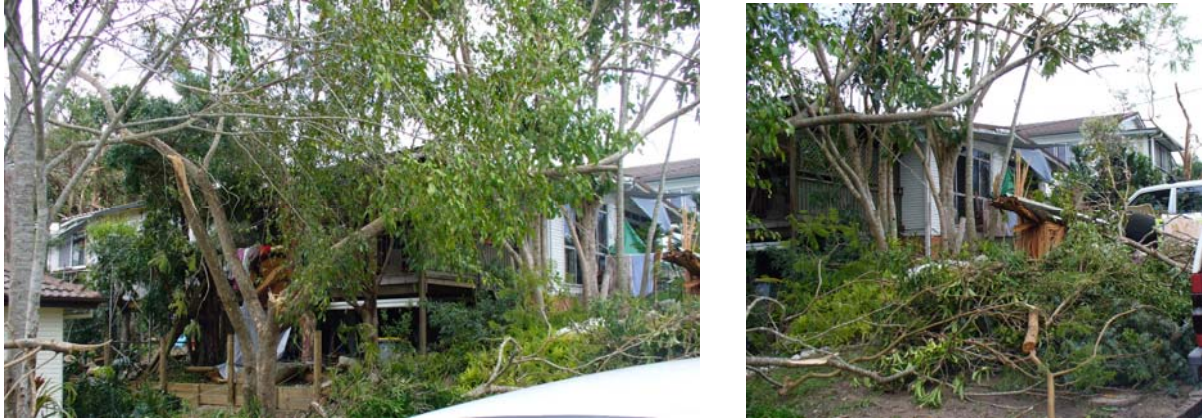
Figure 7.2 shows damage to smaller trees and shrubs contributing to housing damage around *The Gap*.

**Figure 7.2: Typical shrub and smaller tree damage near housing in The Gap**

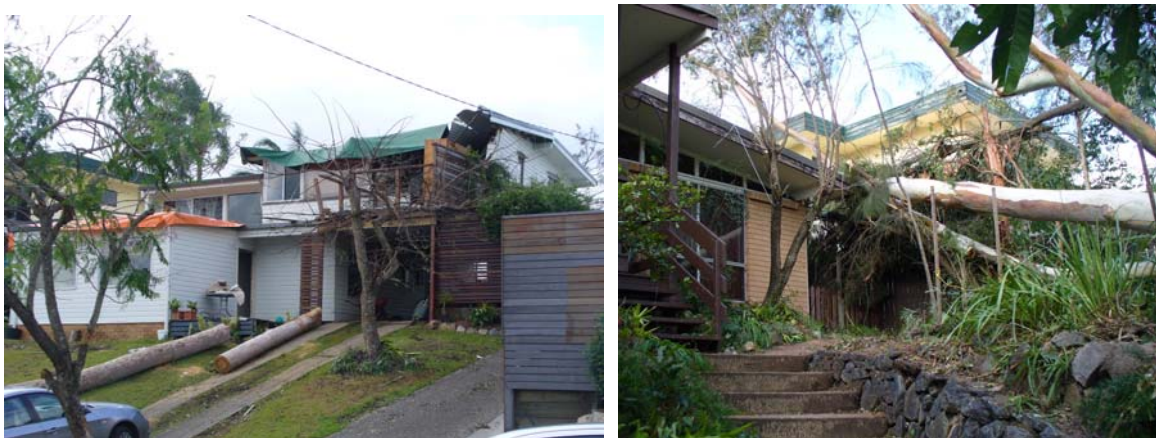
For this report, roof damage caused by falling trees was recorded as a Damage Number of 2. Figure 7.3 shows two houses in The Gap that suffered damage, caused by large trees falling on the roof.

**Figure 7.3: Damage to housing caused by large falling trees in The Gap**

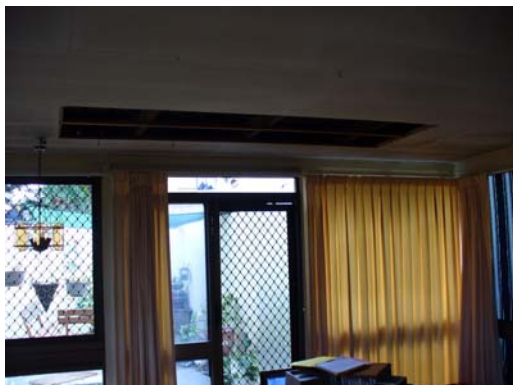
Figure 7.4 shows a damaged house in The Gap, where the gutters were filled with hailstones. Wind driven rain then penetrated into the ceiling space, wetting one panel of plasterboard, which collapsed.

(a) View of hole in ceiling, after collapse of one plasterboard panel

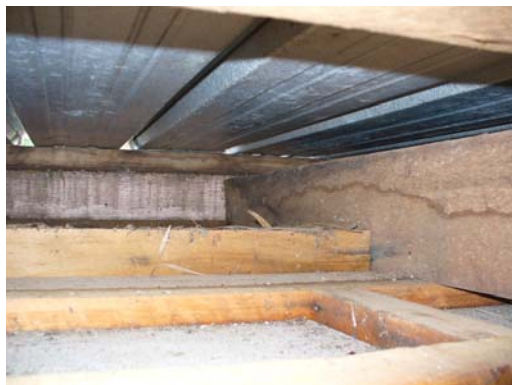
(b) View inside ceiling space showing water staining on rafter overhang

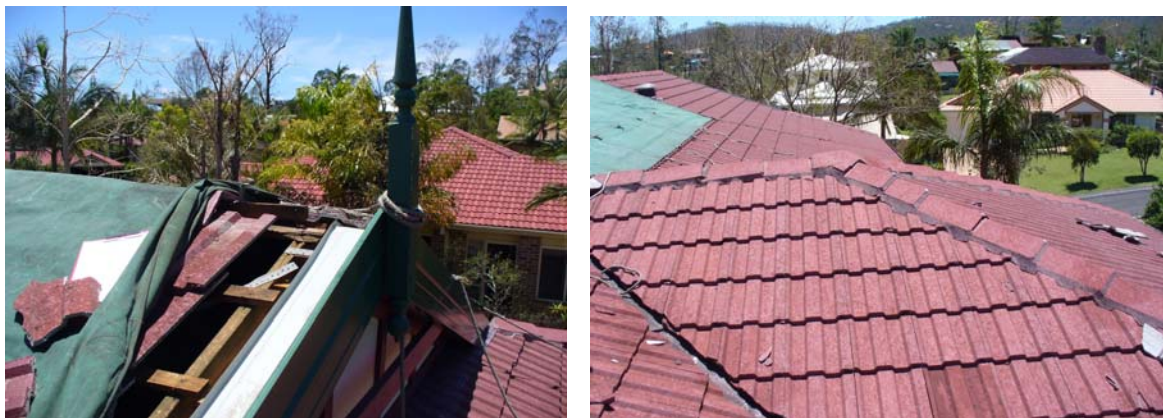
Figure 7.5 (b) clearly shows that many of the ridge and hip tiles were not fixed in accordance with AS2050 (2002) which requires every ridge, hip and barge tiles to be mechanically fastened for all wind classifications.

(a) View of failed ridge tiles under tarpaulin

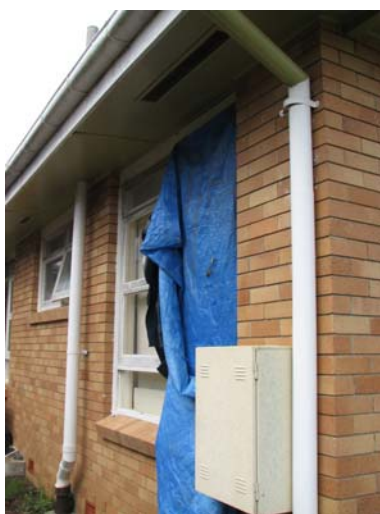
(a) Hail damage and window pushed in

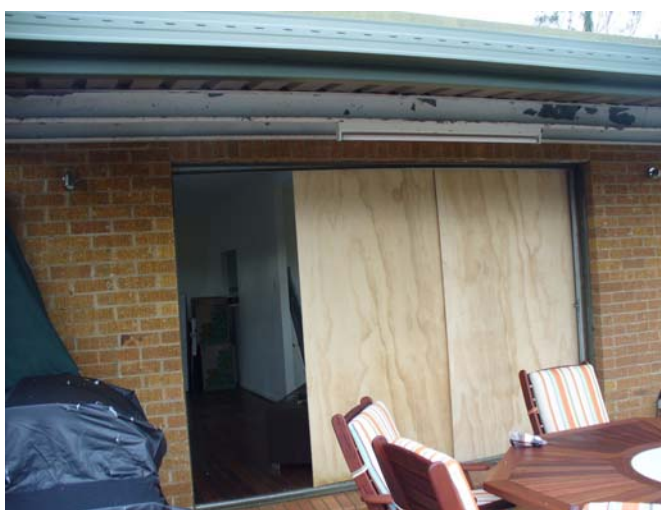
Another case involved a complete sliding door failing as shown in Figure 7.6 (b).

(b) Sliding door failed

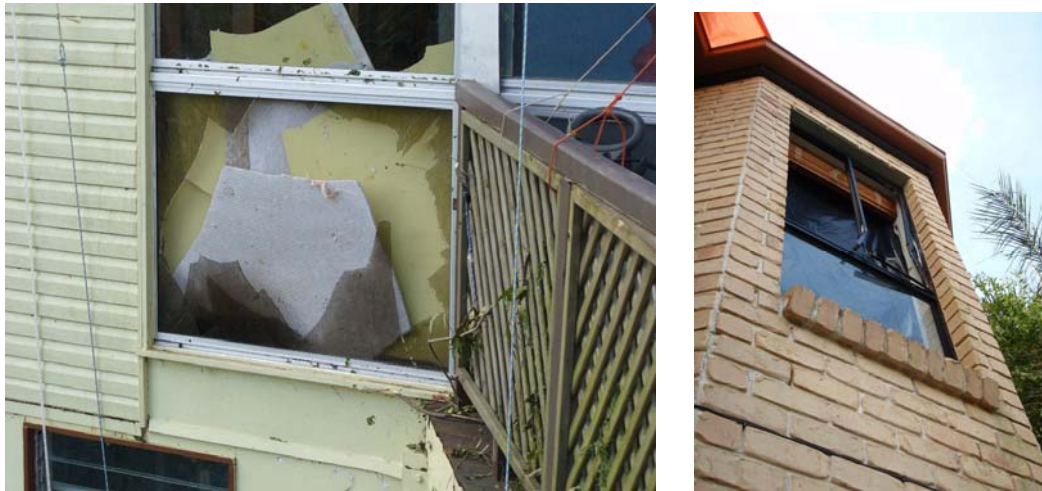
There were also some instances where asbestos cement corrugated roof cladding had failed, dislodged and become flying debris to impact and damage the doors and windows of downwind houses.

**Figure 7.7: Typical flying debris damage to windows**

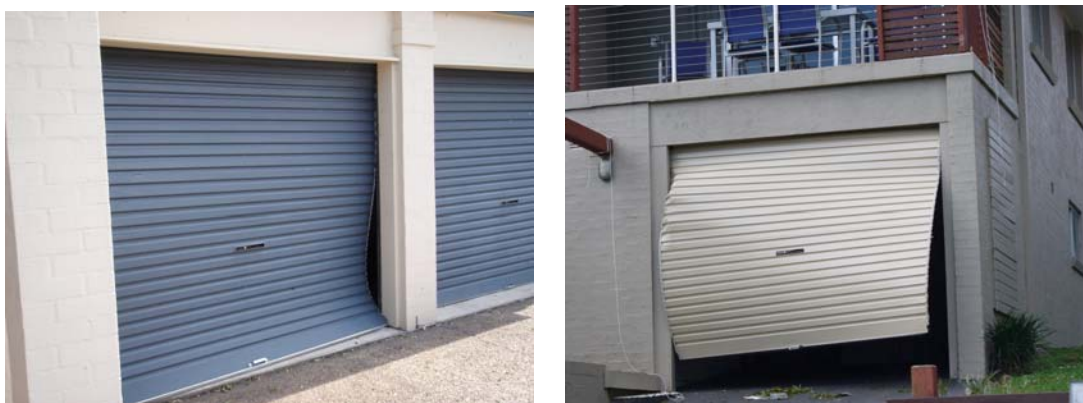
Some garage doors (both roller doors and panel-lift doors) failed during the event. Figure 7.8 shows two typical failed roller doors from houses in The Gap.

**Figure 7.8: Typical roller door failures**

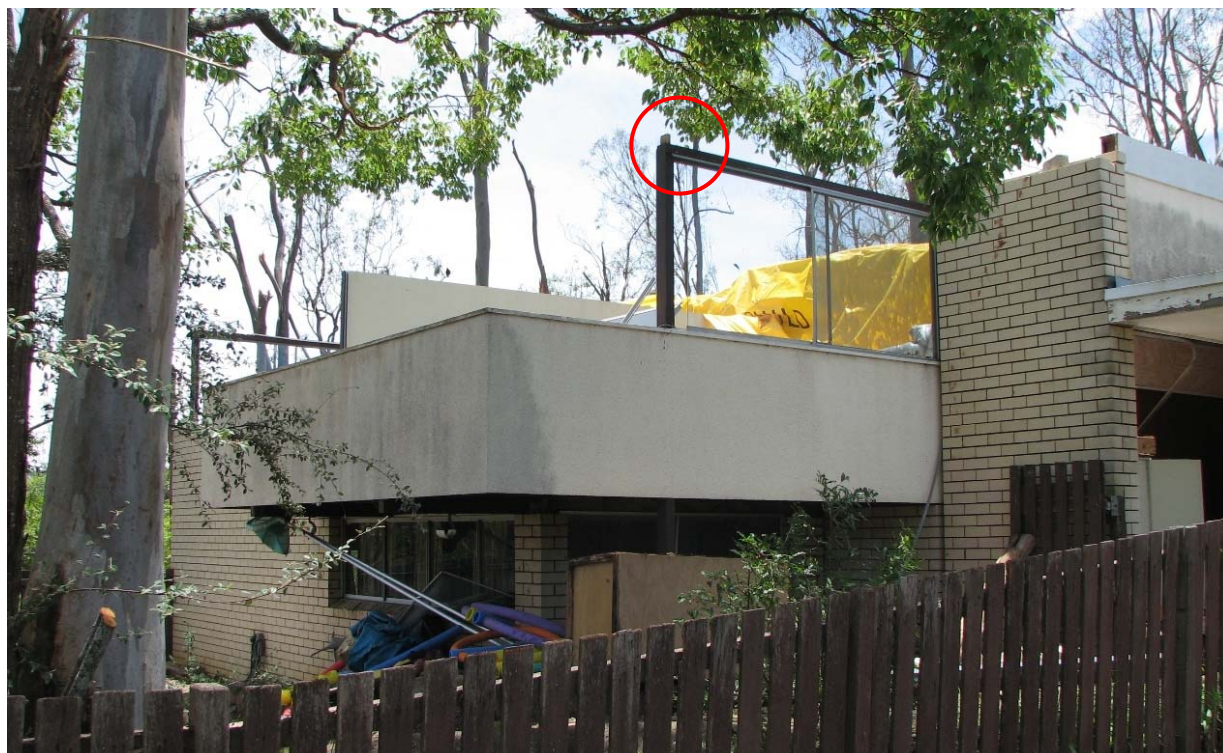
Figure 8.1 shows a view of the front of the house, without the roof. The tenon joint to the top of one of the timber columns used to support the timber beams is circled, in the photograph.

**Figure 8.1: General view of front of house without roof**

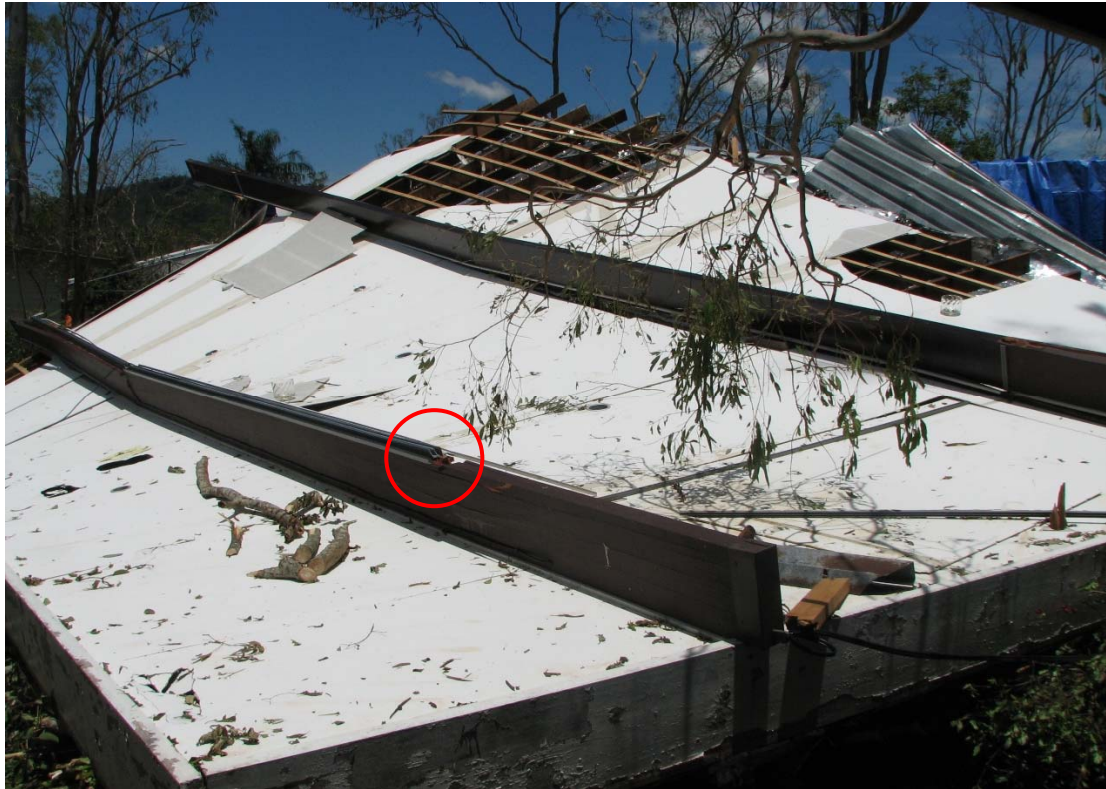
Figure 8.2 is a general view of the section of roof that had been broken away from the house and deposited upside-down in the backyard. A typical mortice to the beam is circled in this photograph.

**Figure 8.2: General view of upside-down roof**

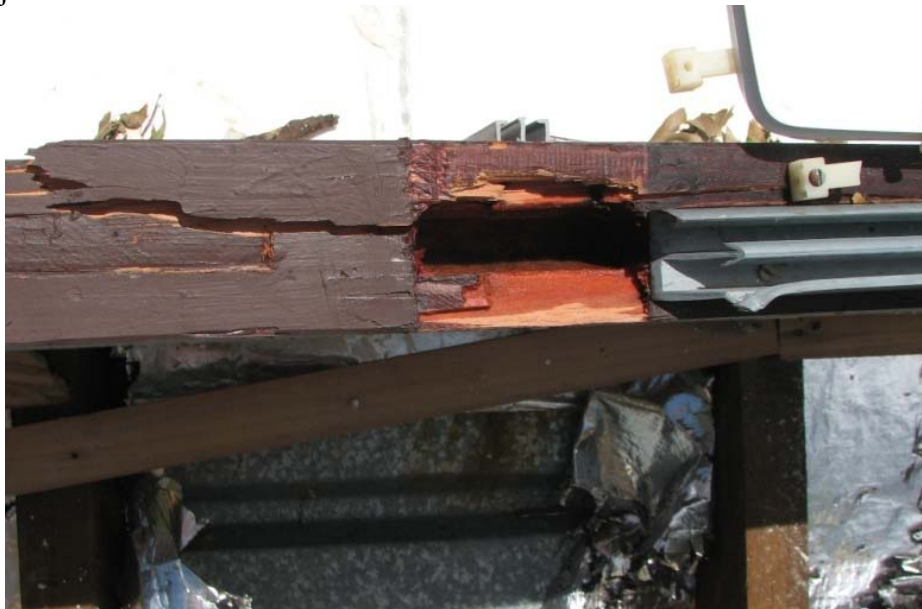
Figure 8.3 is a detailed view of a typical mortice to the roof beam, showing where the mortice and tenon joints failed.

**Figure 8.3: Typical view of a failed mortice joint to roof beam**

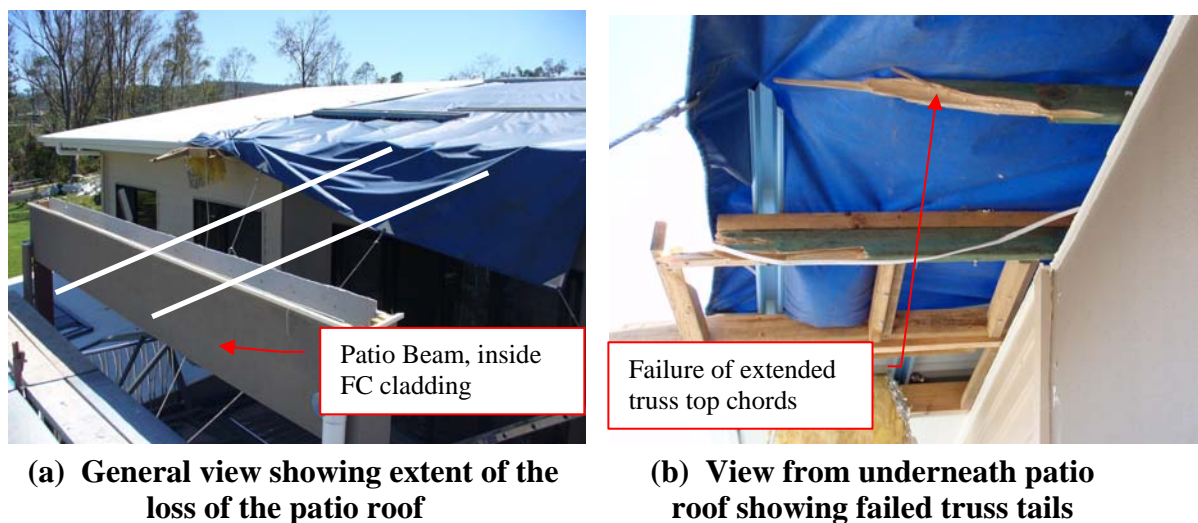
A new two-storey house lost all of the patio roof structure (cladding, battens and extended truss top chords) with roof failure extending into the area above the main living area. Figure 8.4 (a) shows a general view of the upper level of the house and the location of the missing patio roof that failed. Two white lines have been added to this photograph to indicate the typical locations of the former extended truss top chords. These main roof trusses had the top chord extended by about 4 m and were supported at their far ends by a single span structural timber beam, located towards the bottom and inside non-structural FC cladding, as also shown in Figure 8.4 (a). Figure 8.4 (b) is a view from underneath the patio roof and shows some typical failures of the extended truss top chords. This house was included in the street survey with a Damage Index of 700.

**Figure 8.4: Failed patio roof structure**

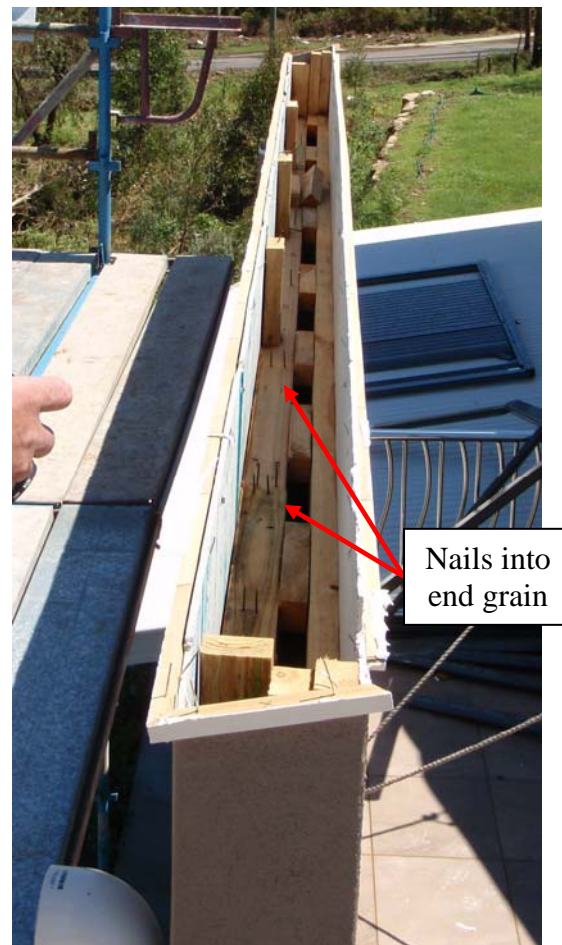
Figure 8.5 is a detailed view inside the FC cladding and shows some of the nails remaining from the failed joints between the jack studs and the top plate.

**Figure 8.5: Detailed view inside FC cladding showing failure of nailed joints to jack studs**

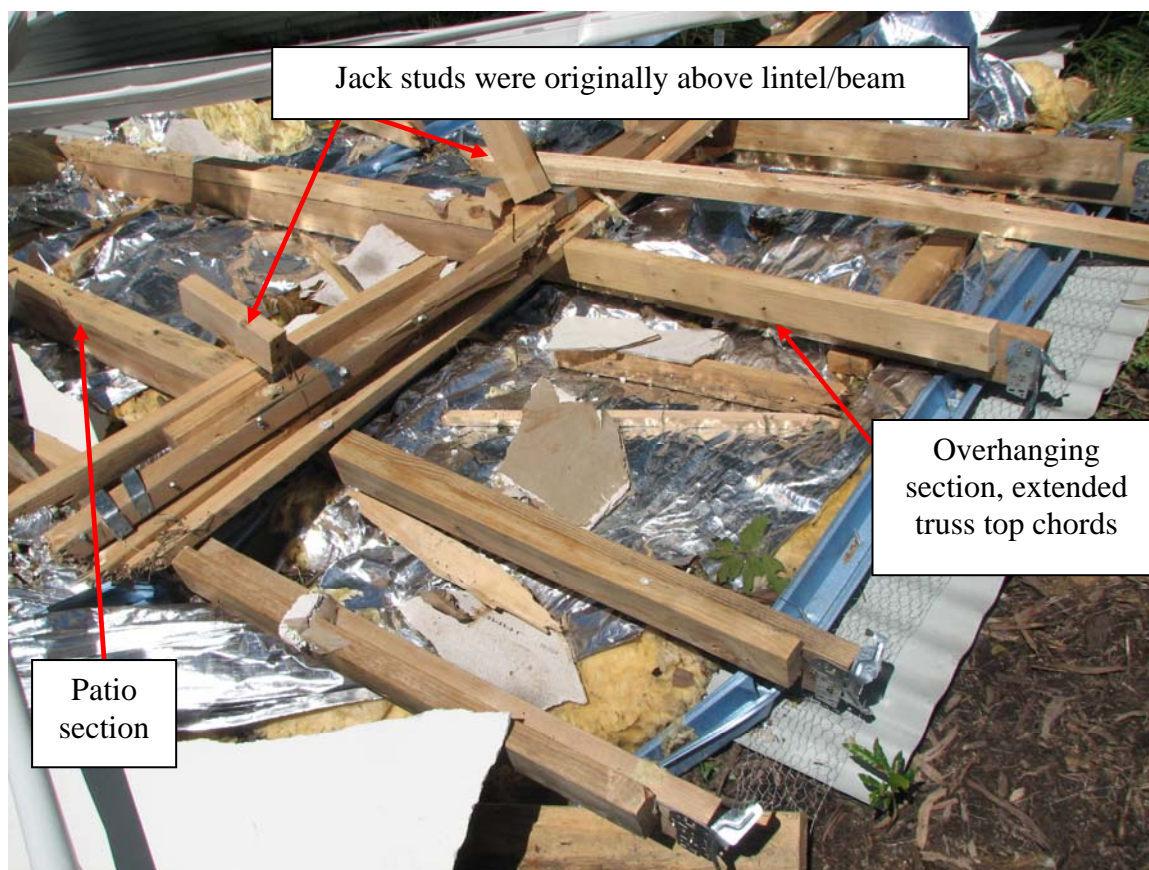
Also on this house, a nominally 1.0 m wide gable overhang failed (the overhang was torn off the roof) due to inadequate tie-down fixings of the out-riggers forming the overhang to the raking and standard trusses. The small approximately 300 mm back span of the out-riggers exacerbated the problem.

**Figure 8.6: Failed patio roof structure about 200m downwind from house**

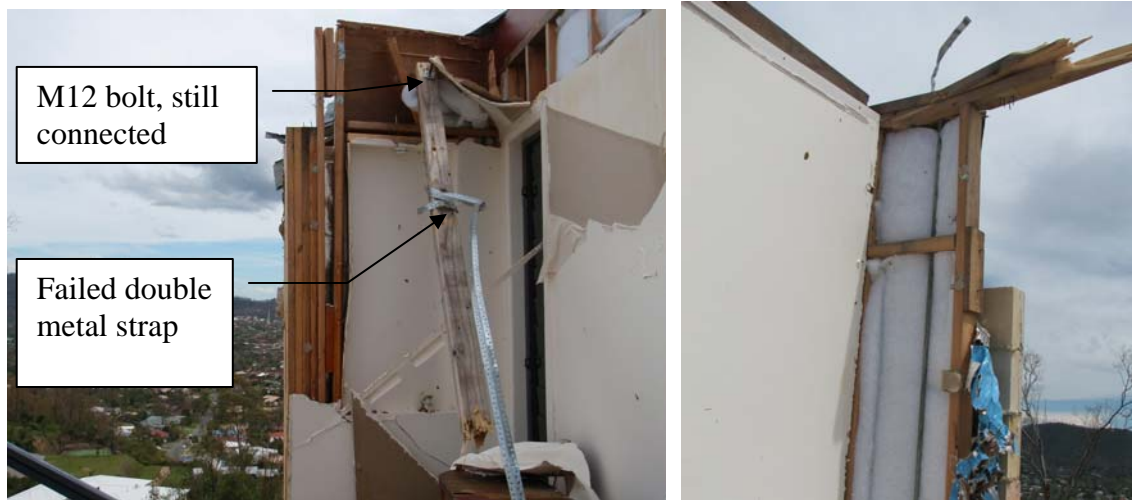
Figure 8.7 (b) shows an M16 rod beside another opening and it appears likely that the failure of the top plate was caused by excessive shear due to the M16 rod not being configured as required by AS1684 Table 9.20 (d) or (e).

**(a) One end of top plate– strap failed & M12 bolt too far away**

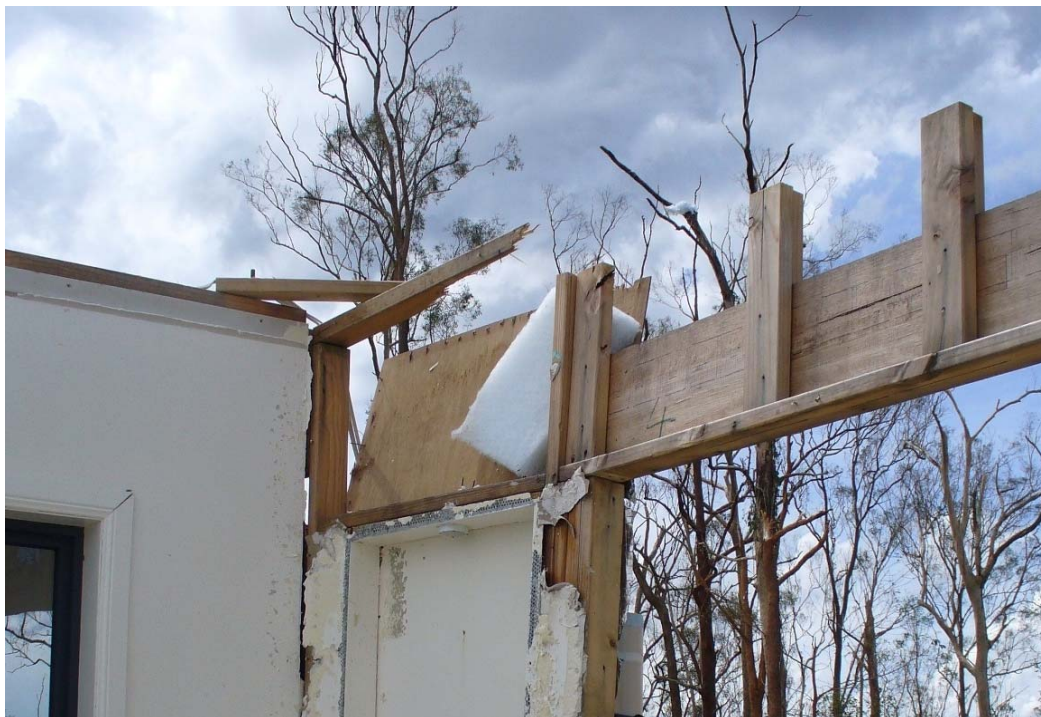
Note that it appears that the plywood bracing was being used as the tie-down beside the opening shown in Figure 8.7 (a).

**Figure 8.8: Lintel to back window – held down by ply bracing panel**

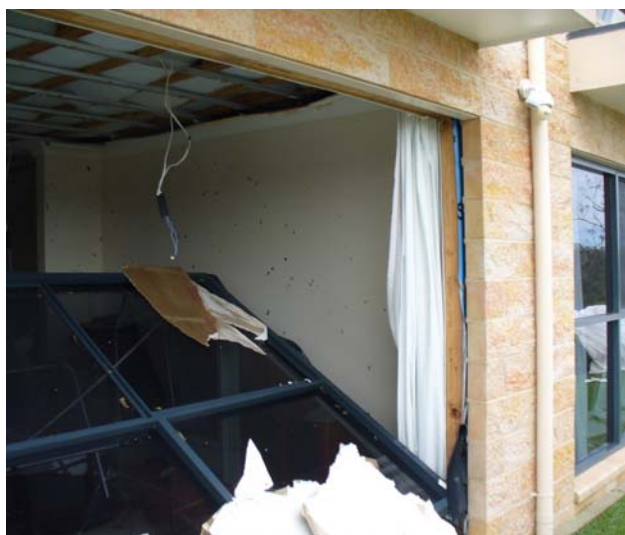
**(a) Complete unbroken window pushed in**

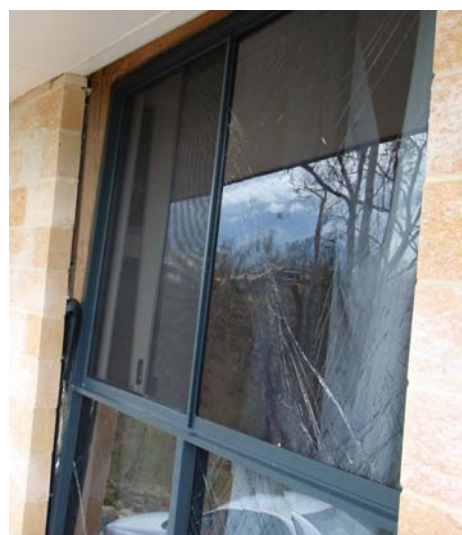
**(b) Window dislodged from jamb studs**
