**Investigation of housing and sheds in Proserpine, Midge Point
and Airlie Beach, following Tropical Cyclone Ului**

Report: TR56
August, 2010

Cyclone Testing Station
School of Engineering and Physical Sciences
James Cook University
Queensland, 4811, Australia

TECHNICAL REPORT NO. 56

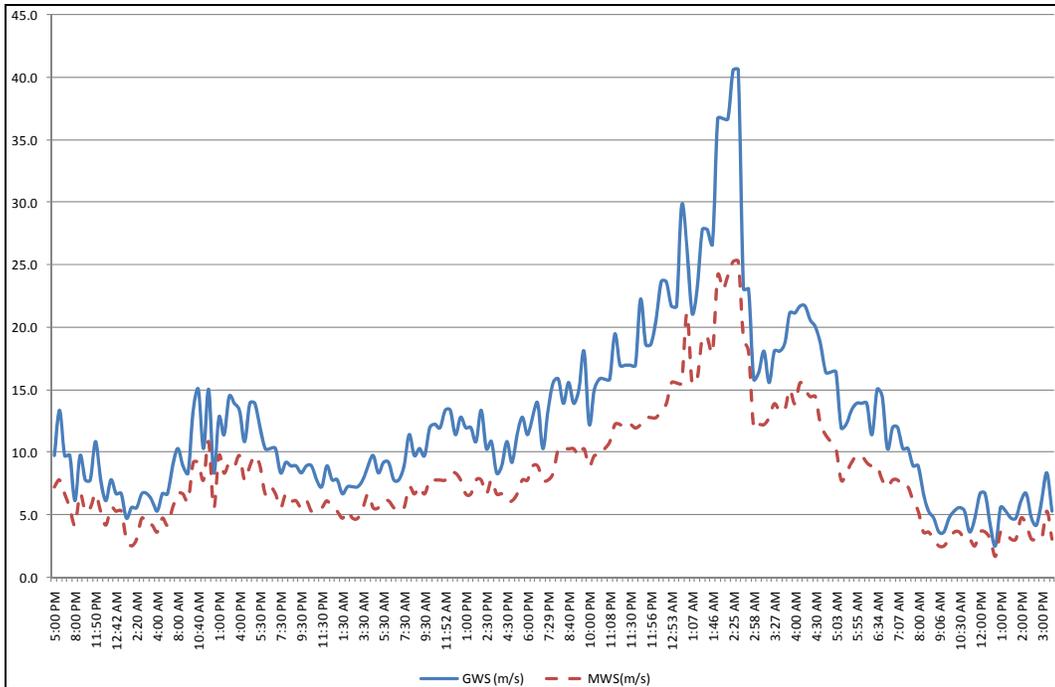
The Bureau of Meteorology operates an Automatic Weather Station (AWS) at Proserpine Airport located about 30 km inland. The gust and mean wind speed measured at 10 m height, and the corresponding approach wind directions (i.e., from the North is 0° and from the East is 90°), are given in Figure 2.1 and Figure 2.2, respectively. The AWS was located in open terrain with an unobstructed fetch in the direction of maximum winds. The maximum gust wind speed measured was 146 km/h (41 m/s) at approximately 2.00 am with the wind approaching from the South. This is followed by a rapid reduction in wind speed and a change in direction as the "eye" passed over the AWS. A lower peak gust wind speed from a Northerly direction was then observed at around 3.30 am. The minimum recorded barometric pressure was 980.5 hPa at 2:25 am.

Figure 2.1: Gust and mean wind speeds measured at the AWS-Proserpine Airport
(Courtesy Bureau of Meteorology)

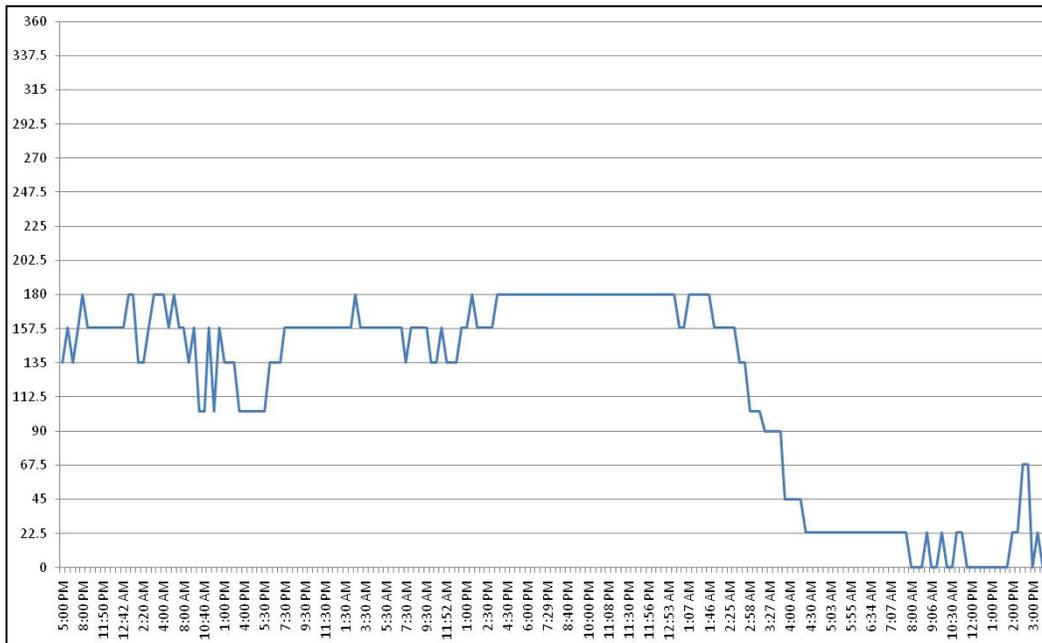
Figure 2.2: Wind directions measured at the AWS-Proserpine Airport
(Courtesy Bureau of Meteorology)

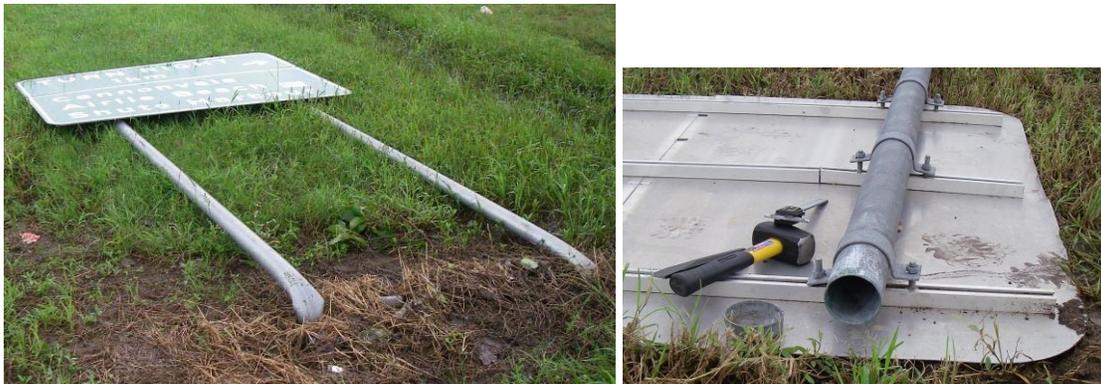
Cantilevered road signs provide a means of obtaining a measure of the spatial variation of gust wind speeds in the surveyed areas. These signs are generally flat plates that are attached to one or two cantilevered posts and located in exposed flat terrain adjacent to the road. The wind loads acting on these plates can be calculated and upper (U) and lower (L) bound wind speeds from signs that were bent-over, shown in Figure 2.3, and those that remained upright, as described in the CTS report on TC Larry (Henderson et al 2006, Ginger et al 2007).

Basic analysis of cantilevered road signs and qualitative assessment of damage, suggest gust wind speeds in the order of 140 k/hr in Proserpine and Airlie Beach to approximately 160 k/hr (45 m/s at 10m height in open terrain), in the vicinity of Midge Point, as shown in Figure 2.4. The Bureau of Meteorology states that the larger gust wind speeds measured at Hamilton Island resulted from the enhanced exposure of the site.

Figure 2.3: Bent road signs and measurement of pipe dimensions

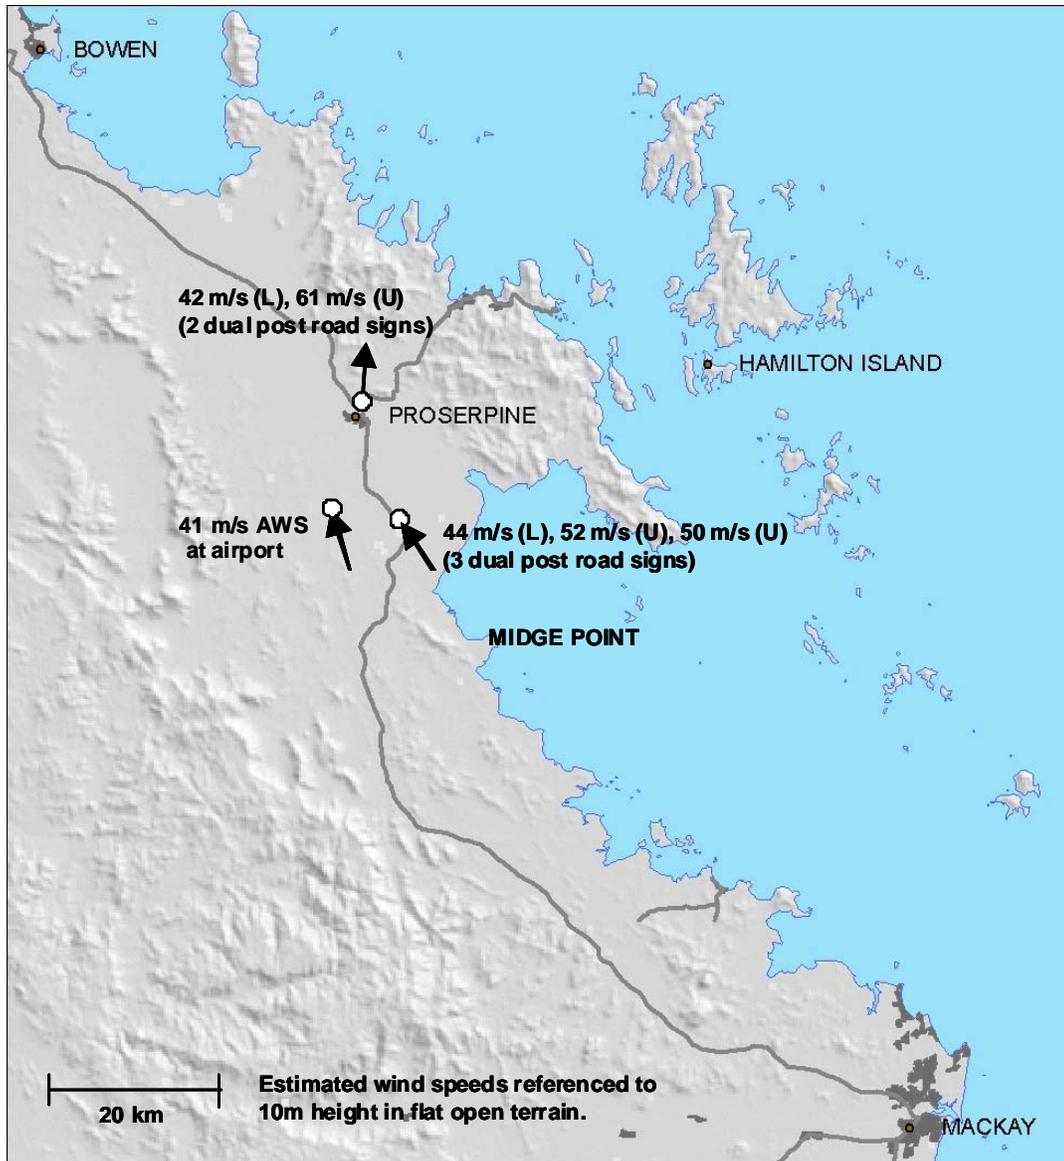
Figure 2.4: Estimate of wind speeds and direction

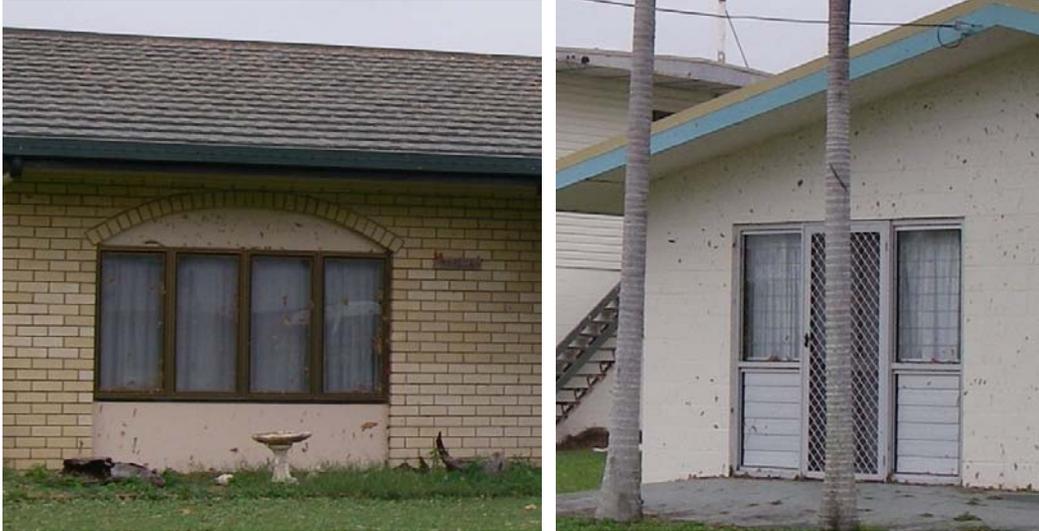
Typically housing that was constructed in the past 30 years survived with minimal structural damage from the wind loads, as shown in Figure 3.1. There was observed damage from fallen trees.

Figure 3.1: Houses splattered with vegetation but structurally resisted loads

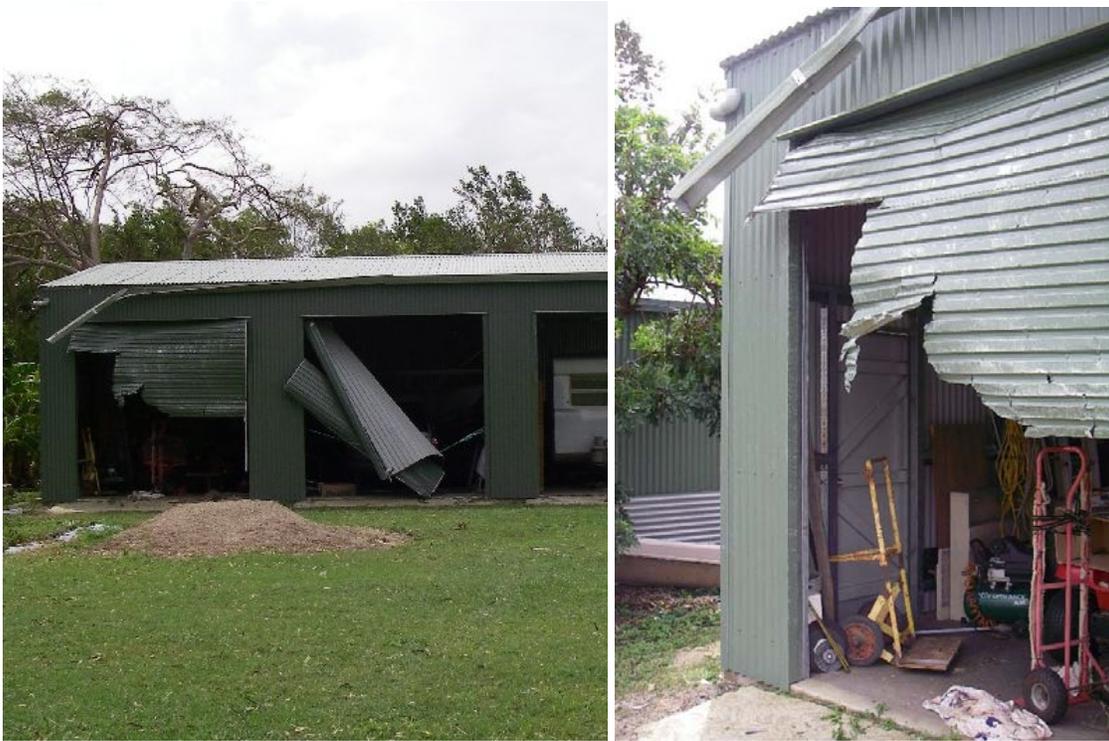
In the Midge Point area, several shed roller door failures were observed, with an example shown in Figure 3.2. However, several other shed doors of similar dimensions, construction and orientation were still intact. Conversations with the owners of the sheds with intact roller doors revealed that these doors had been strengthened by various means, such as temporarily installing taut steel wire ropes behind the doors (e.g., Figure 3.3), erecting internal timber struts, or even backing cars onto the door from the inside.

Figure 3.2: roller door failure

- Domestic and commercial roller doors including mullions etc. be designed and installed so that they can support design wind loading.
- Shade cloth either be designed for 500 year return period wind speed or taken down during cyclone preparation stage.

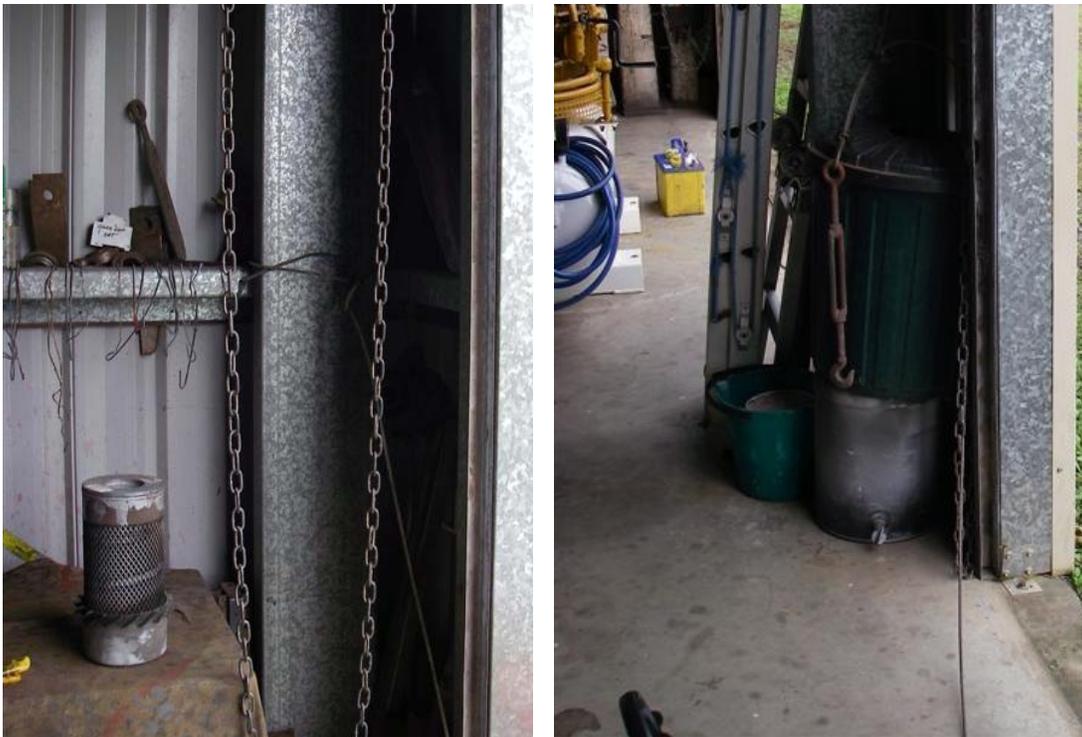
Figure 3.3: Steel wire rope and turnbuckle used to support roller doors

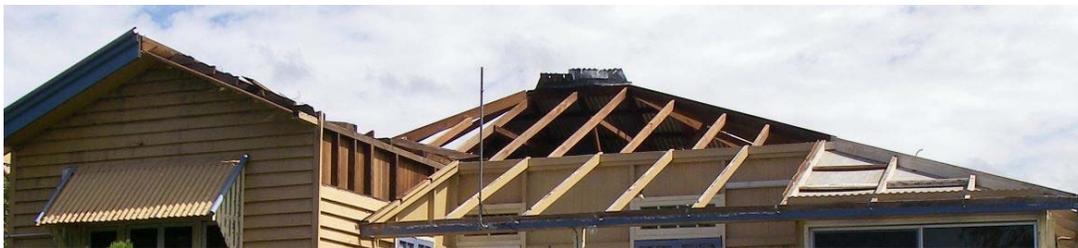
In these few instances the failure typically originated at the batten to rafter connection with the nailed connections not having sufficient load carrying capacity. Figure 3.4 and Figure 3.5 show loss of roof structure (cladding and battens) caused by failure of batten to rafter nail connections. The battens were nailed to the trusses or rafters, with only one nail at some batten to rafter joints. Examples are shown in Figure 3.6 and Figure 3.7.

Figure 3.4: Failure at batten to rafter connections on windward face of house

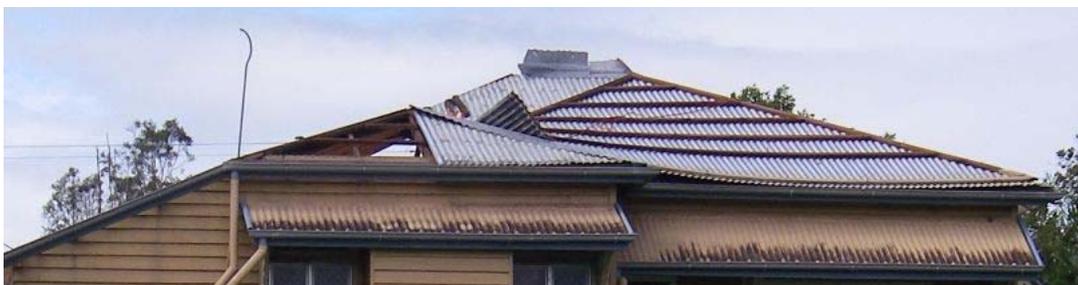
Figure 3.5: Roof leaf lifted from the side of house and laid on leeward face of roof, with hip flashing still attached.

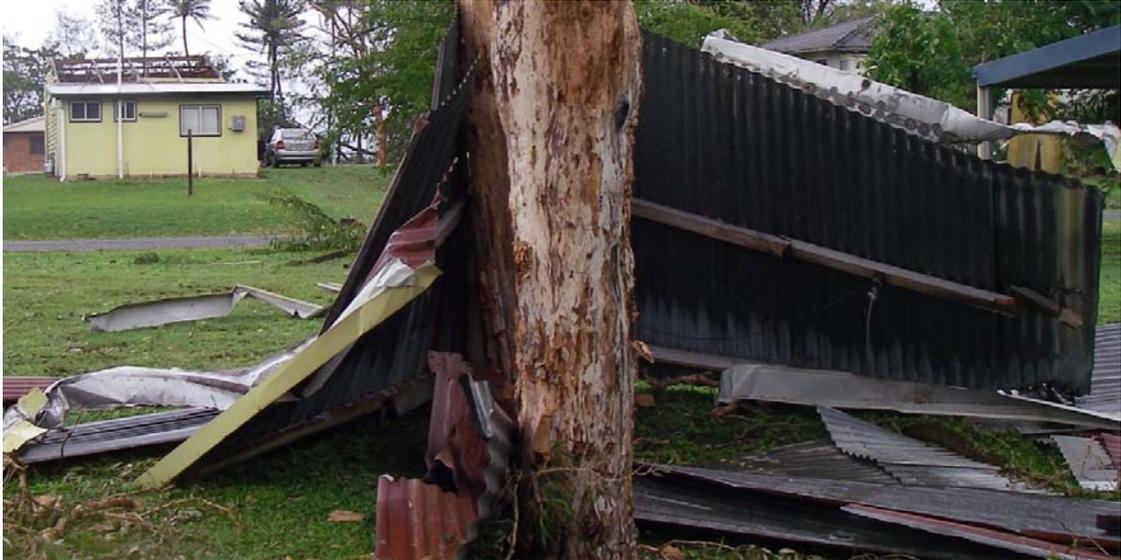
Figure 3.6: Roofing screwed to battens but insufficient strength at batten to rafter connections

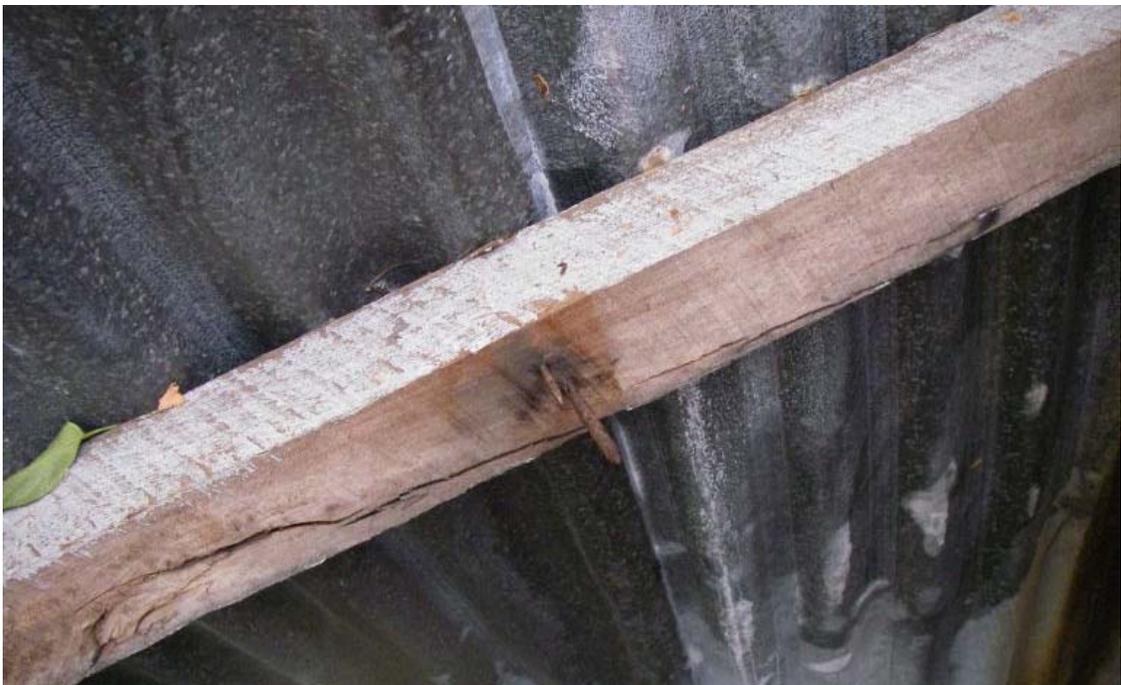
Figure 3.7: Insufficient capacity at batten to rafter joint

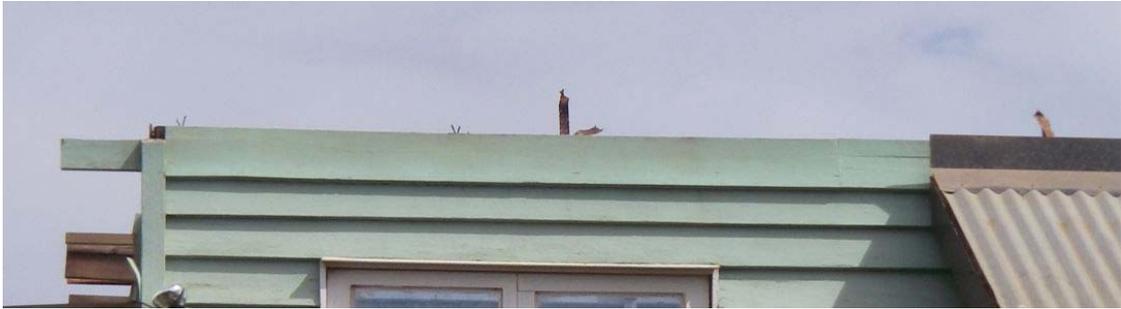
The current timber framing standard AS1684.3 (2006) details batten screws or galvanised straps for the batten to rafter connections for the edge zones of a metal clad roof. In some cases the roofing had been replaced without any strengthening or upgrading of the connections of the roof batten to rafter or rafter to top plate. Loss of the entire roof structure is shown in Figure 3.8, where the roofing had been replaced and screwed to existing battens. The rafter to top plate connections, which consisted of skew nails and some metal strapping, was not sufficient to resist the wind loads. Large elements of the roof had travelled approximately 200 m down wind. Figure 3.9 shows cladding torn over roofing screws at edge batten.

Figure 3.8: Loss of cladding, battens and rafters showing skew nails and strap at top plate

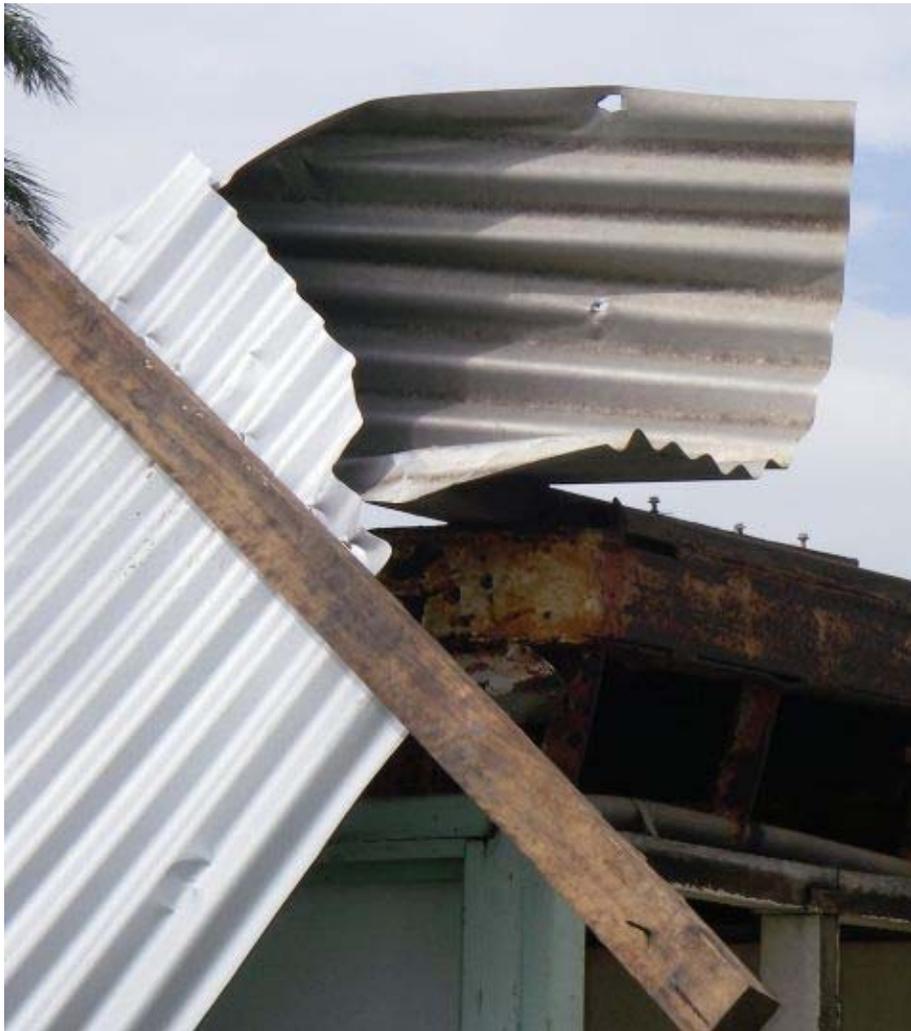
Figure 3.9: Failure of under strength batten connection followed by tearing of cladding over cladding screws spaced too far apart

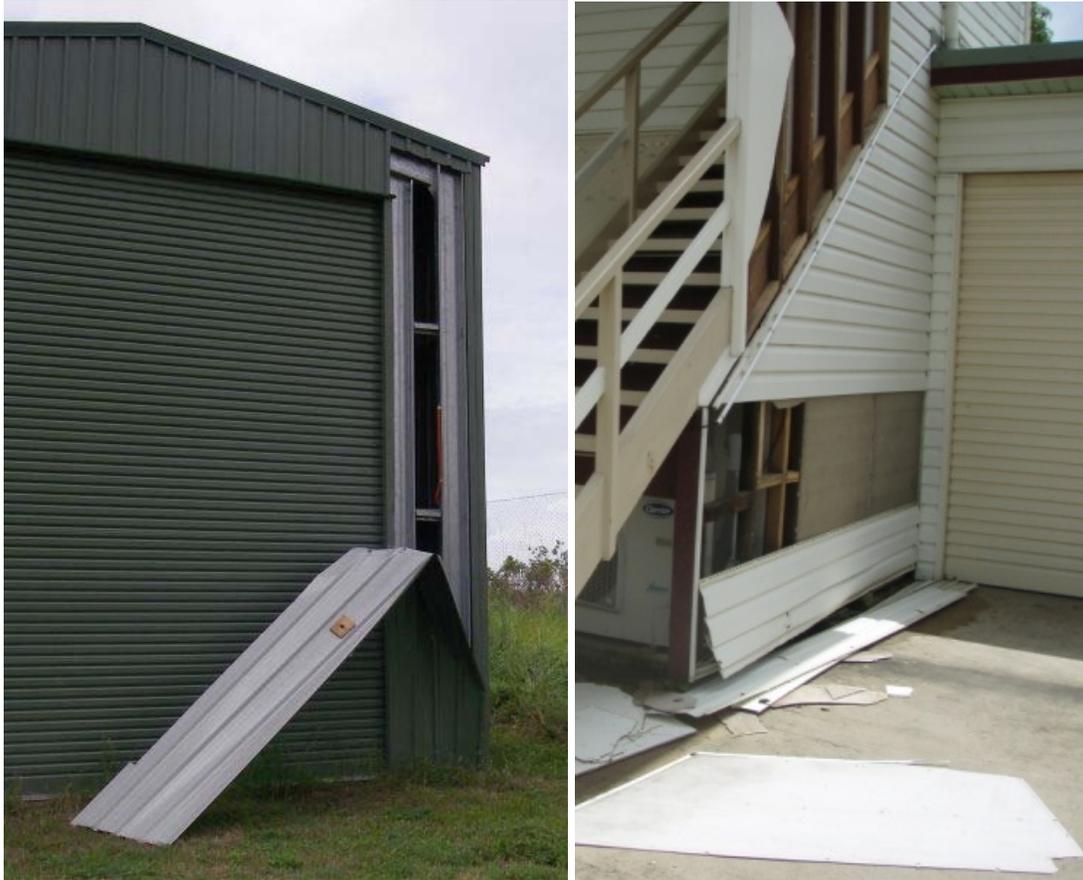
Structurally the majority of engineered buildings performed well. Some industrial sheds and commercial buildings lost wall cladding and flashing elements due to inadequate fixings, as shown in Figure 4.1 and Figure 4.2 respectively. Failures of sidewalk awnings and covered areas were noted, with some elements being dislodged and adding to wind borne debris.

Figure 4.1: Loss of cladding

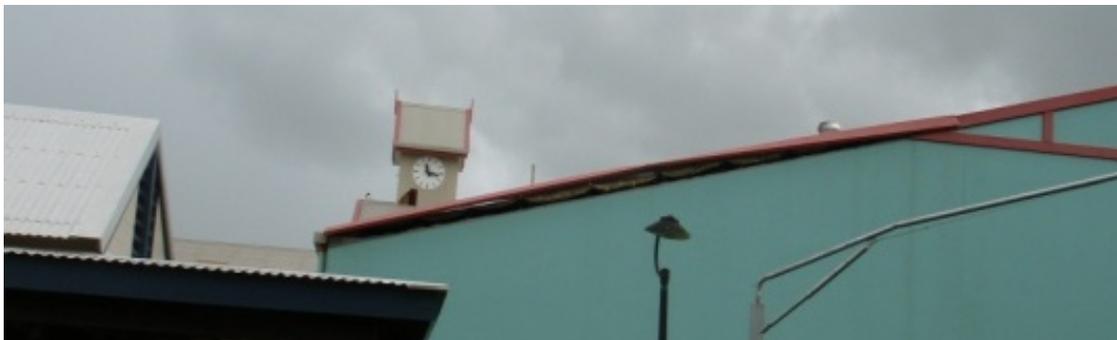
Figure 4.2: Loss of flashing on side wall (relative to wind direction)

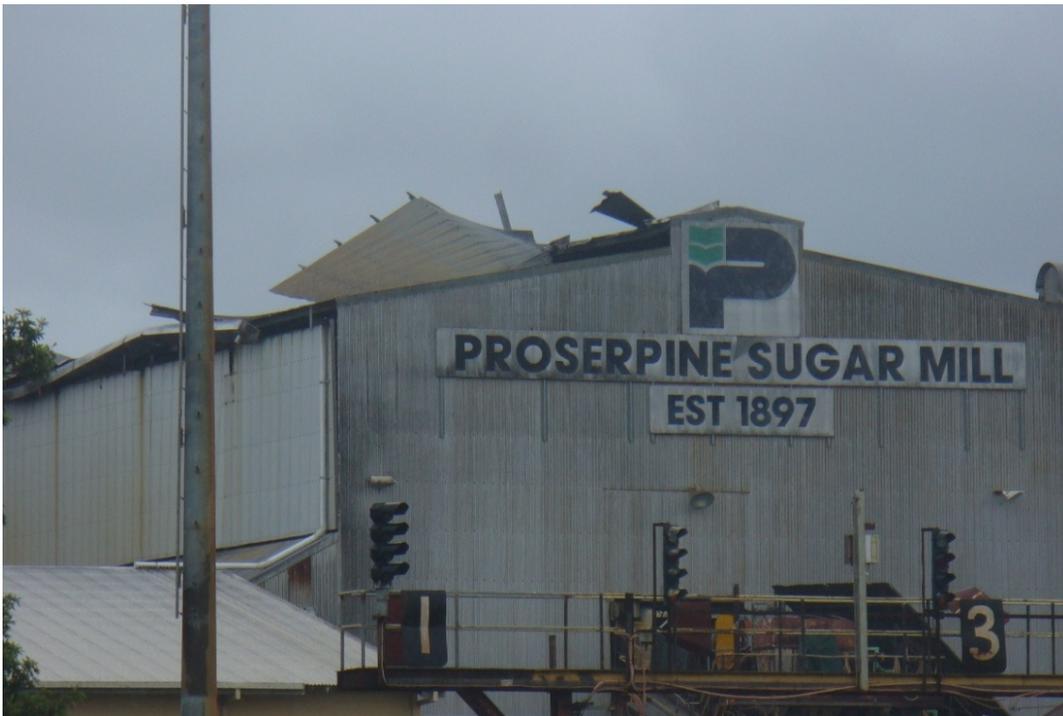
The Proserpine Sugar Mill lost a significant portion of the roof to one of its older mill buildings, as shown in Figure 4.3. CTS inspectors spoke to staff from the mill, on the day after the cyclone struck and were allowed to take photographs of the failure from outside the building but not able to conduct a closer inspection as a safety clearance had yet to be completed on the damaged building. Figure 4.4 (a) is a view of the South facing wall (that is, the windward wall prior to the passage of the eye) and damaged roof.

Figure 4.3 General View of Roof Failure to Proserpine Sugar Mill Building

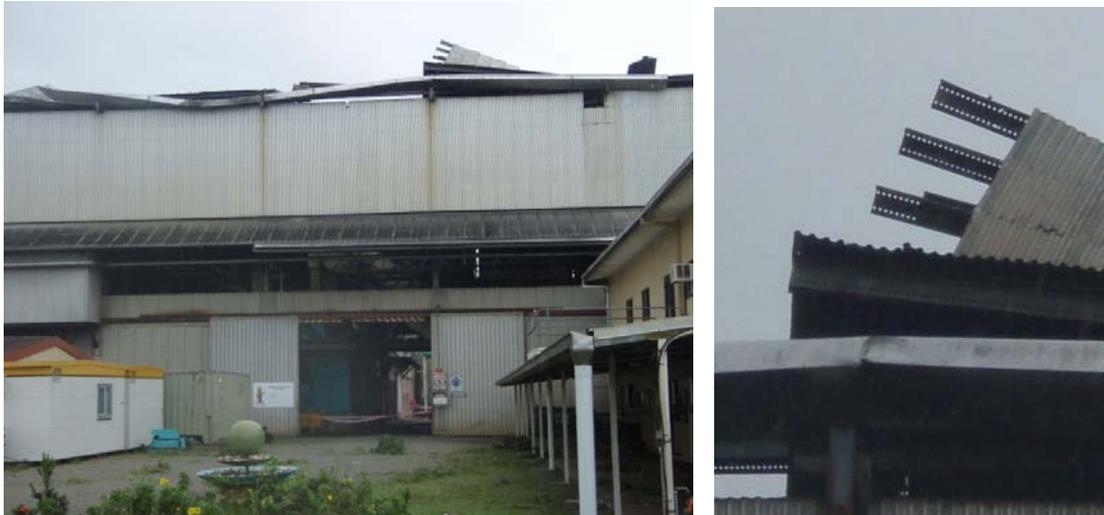
Figure 4.4 (b) is a more detailed view of some of the remnants of the failed steel purlins and roof cladding still attached to the building. Some sections of roof panels (cladding and steel purlins) were completely missing, but it was not possible to determine a likely cause of this failure without a closer inspection.

(a) General view of South facing wall

(b) Detail of roof failure

Figure 4.4 Views of damaged roof from outside Mill building

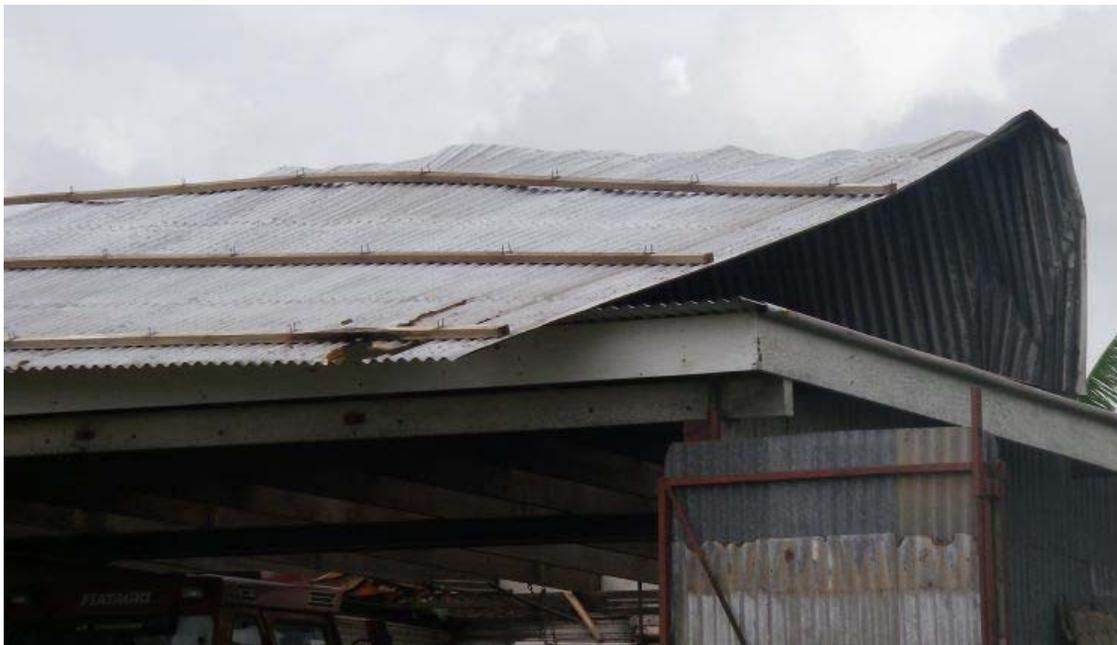
Figure 4.5 shows failure of batten to rafter nailed connections in an old farm shed. The shed was located adjacent to housing.

**Figure 4.5: Failure of batten to rafter connections in old farm shed adjacent to housing**

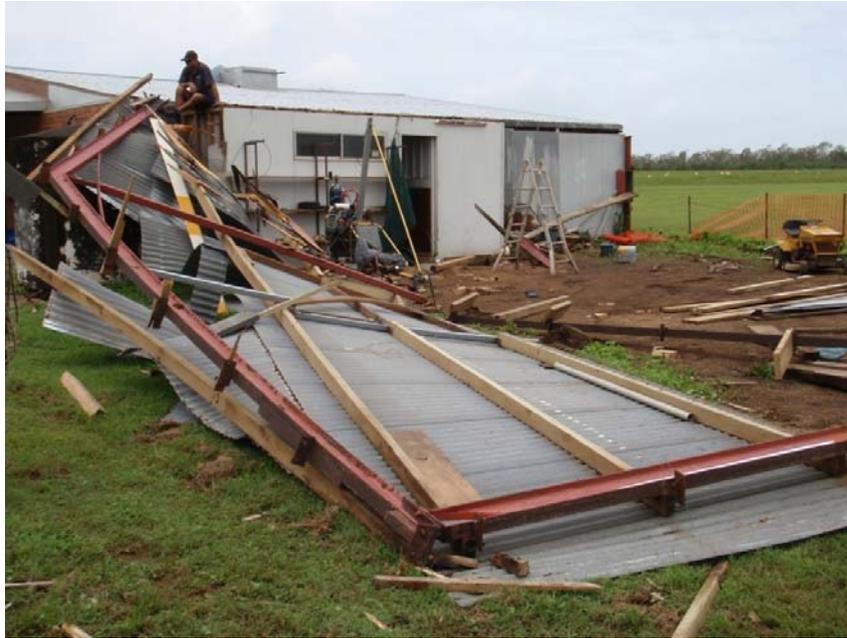
A commercial shed suffered collapse of entire structure due to severe corrosion of major framing elements, as shown in Figure 4.6. The structure had an open south face towards the predominant wind direction. The intense Southerly winds generated large internal pressure causing the failure of the severely corroded base connection of the first frame (Figure 4.7), pulling out of the adjacent frame's 700mm deep footings.

Figure 4.6: Overall failure of shed

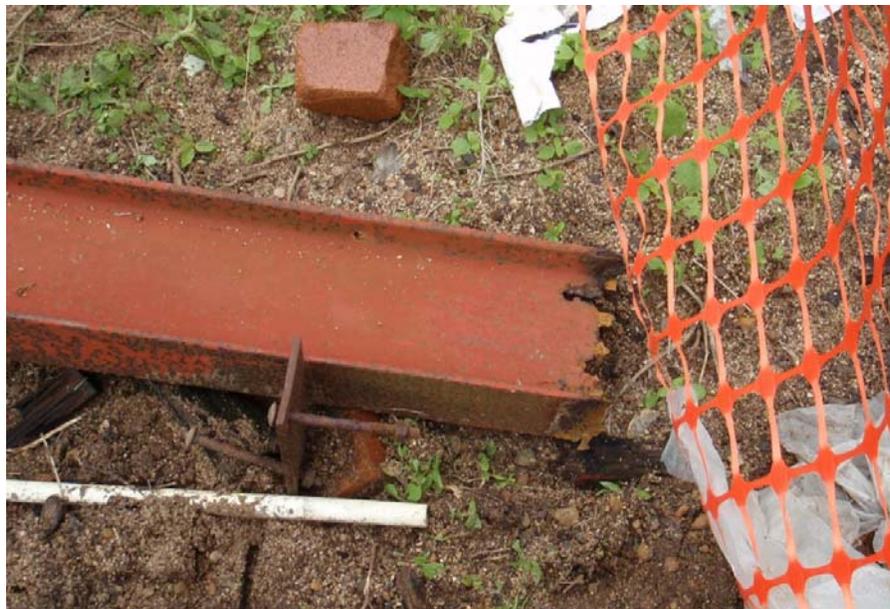
Figure 4.7: Failure of severely corroded portal frame near the base

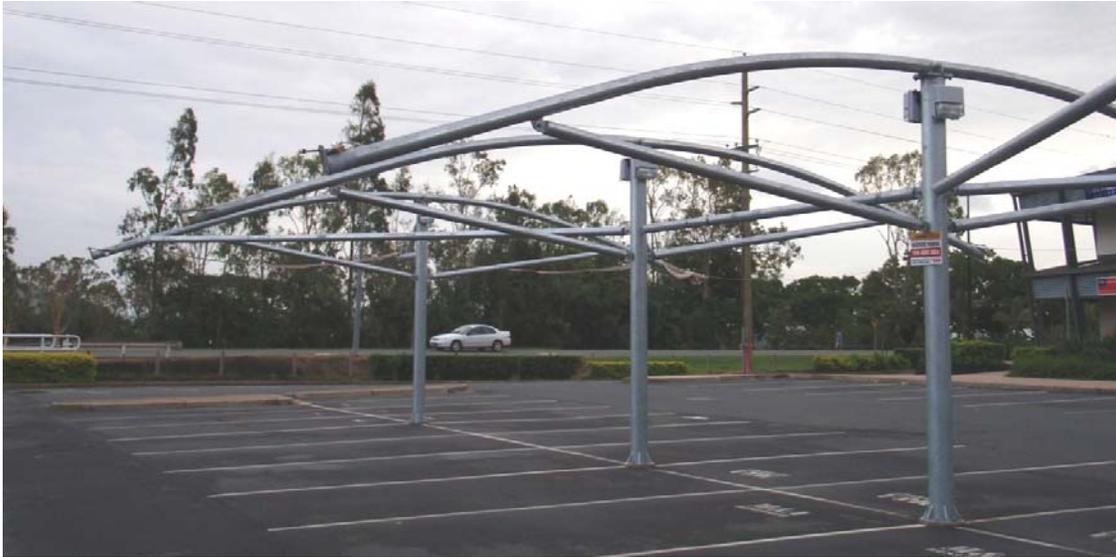
There were a number of instances across the survey area where shade cloth, used as open canopy roofing, had failed due to wind loading, as shown in Figure 4.8 and Figure 4.9.

Figure 4.8: Shade cloth failure at a shopping centre car park

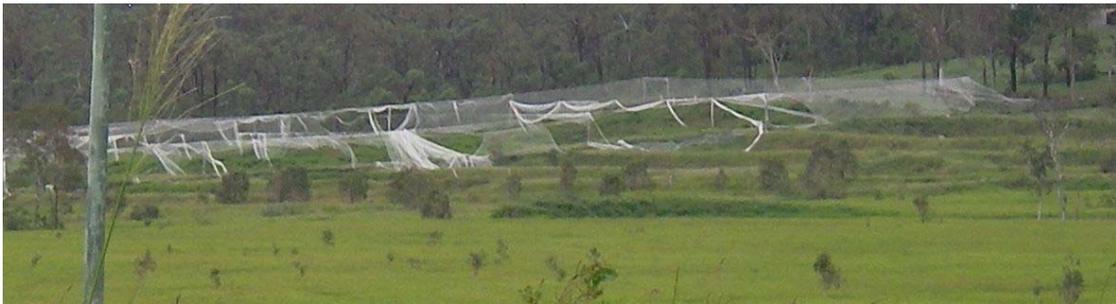
Figure 4.9: Damaged netting on commercial crop protection

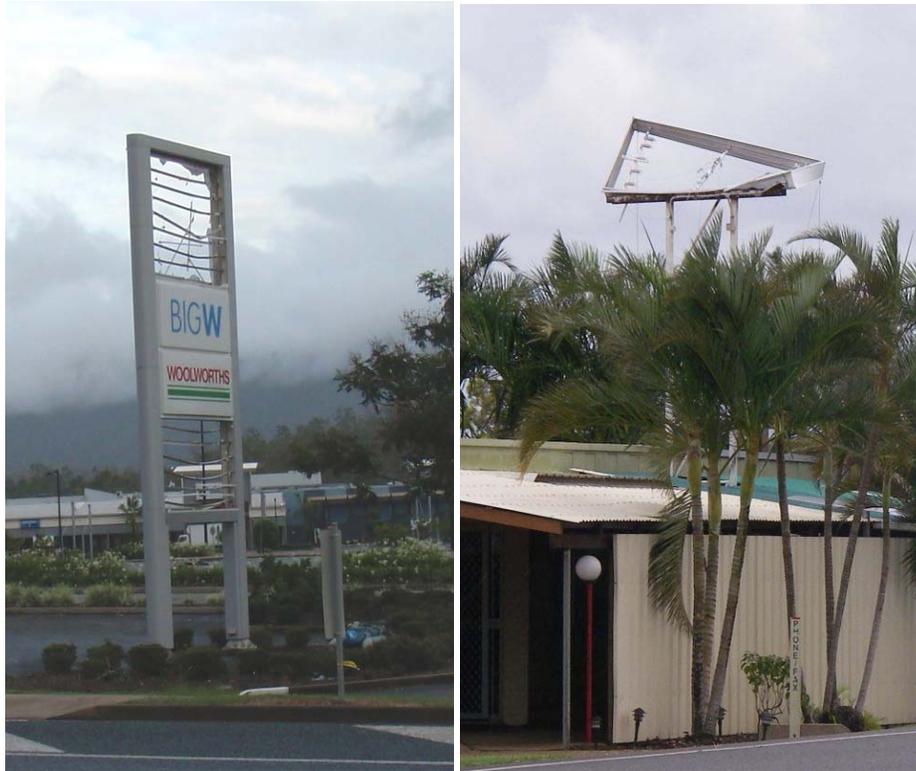
It was observed that many of the commercial illuminated signage had not resisted the wind pressures, as shown in Figure 4.10. Damage to signage ranged from small hotel signs through to the large shopping centre signage. The “plastic” inserts had fractured or popped out of the frames exposing the lighting inside. In these instances the support structure stayed upright. These “inserts” do not appear to be designed and checked for structural adequacy for cyclonic regions, and are prone to failure in windstorms.

Figure 4.10: Examples of failure of signage elements

- Specify and use appropriate materials suitable for the site exposure conditions.
- Ensure that illuminated signage is designed and constructed so that it can support specified wind loading

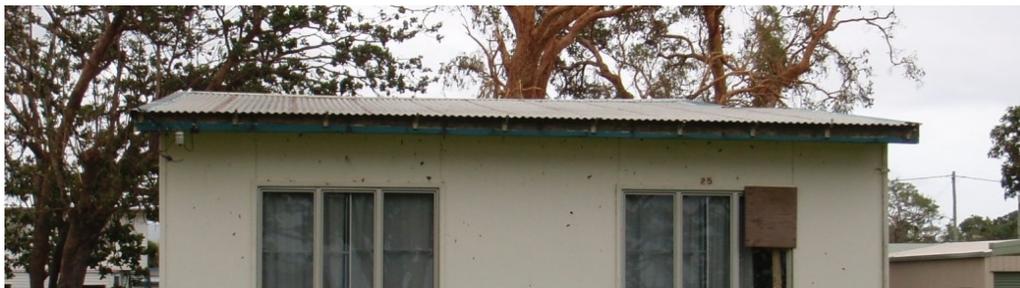
Inadequate design and attachment of elements such as fascias, guttering and awnings can lead to damage to structure, increased water ingress and contribute to wind borne debris. Loss of gutters and down pipes was observed, as shown in Figure 5.1 and Figure 5.2. Figure 5.3 shows a failed solar hot water panel.

Figure 5.1: Loss of guttering and downpipes

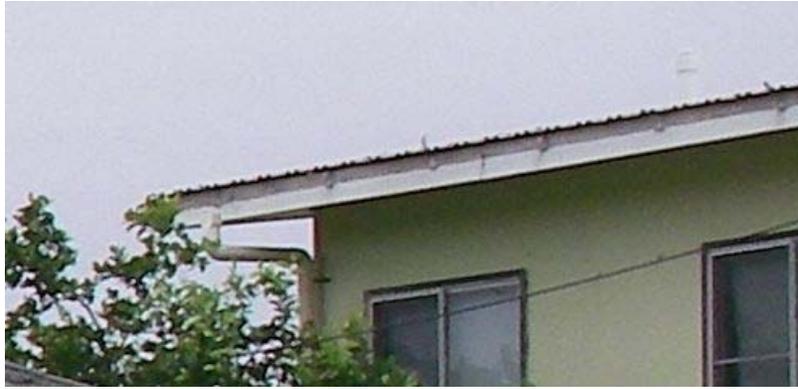
Figure 5.2: Loss of guttering

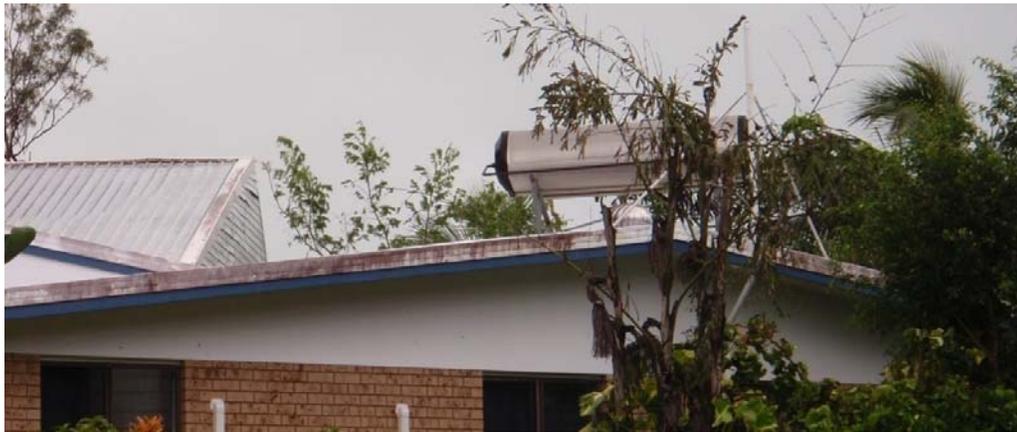
Figure 5.3: Solar panel failure in Cannonvale

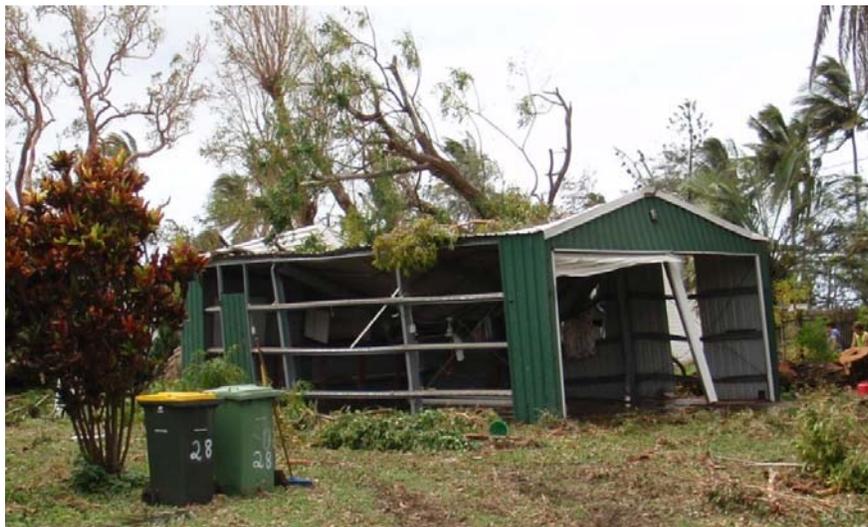
Figure 5.4: Shed destroyed by fallen tree

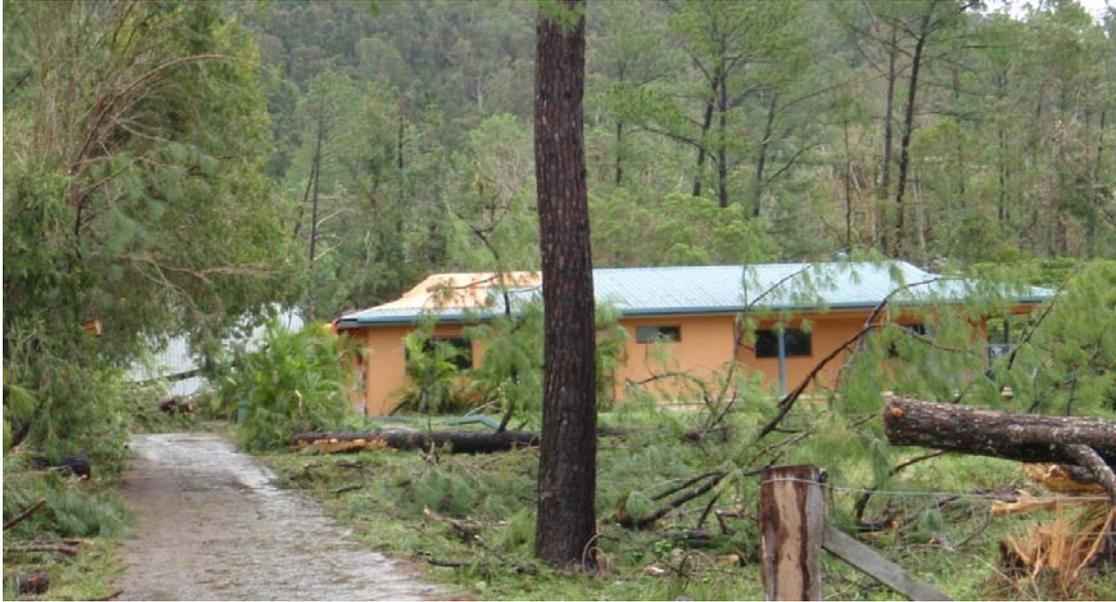
Figure 5.5: Roof damage to newer house by fallen trees

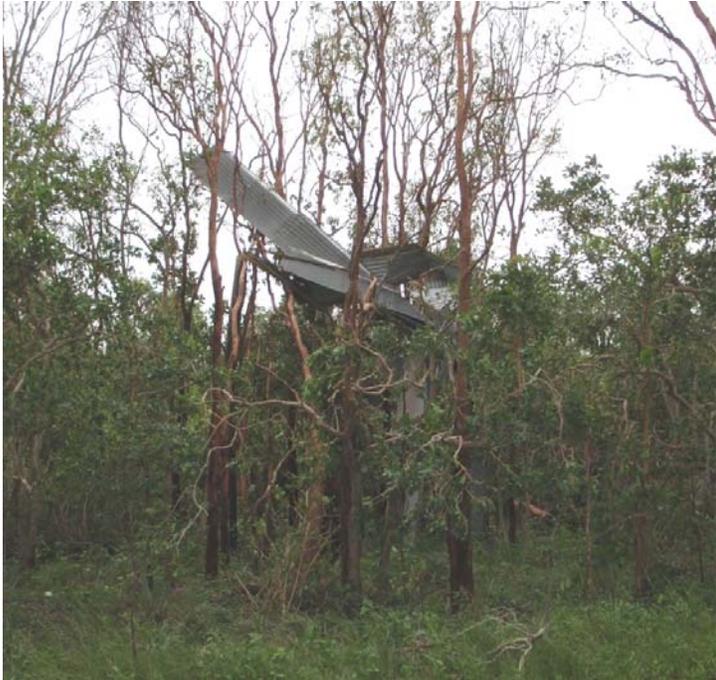
Figure 5.6: Failed roof cladding 60m downwind of shed

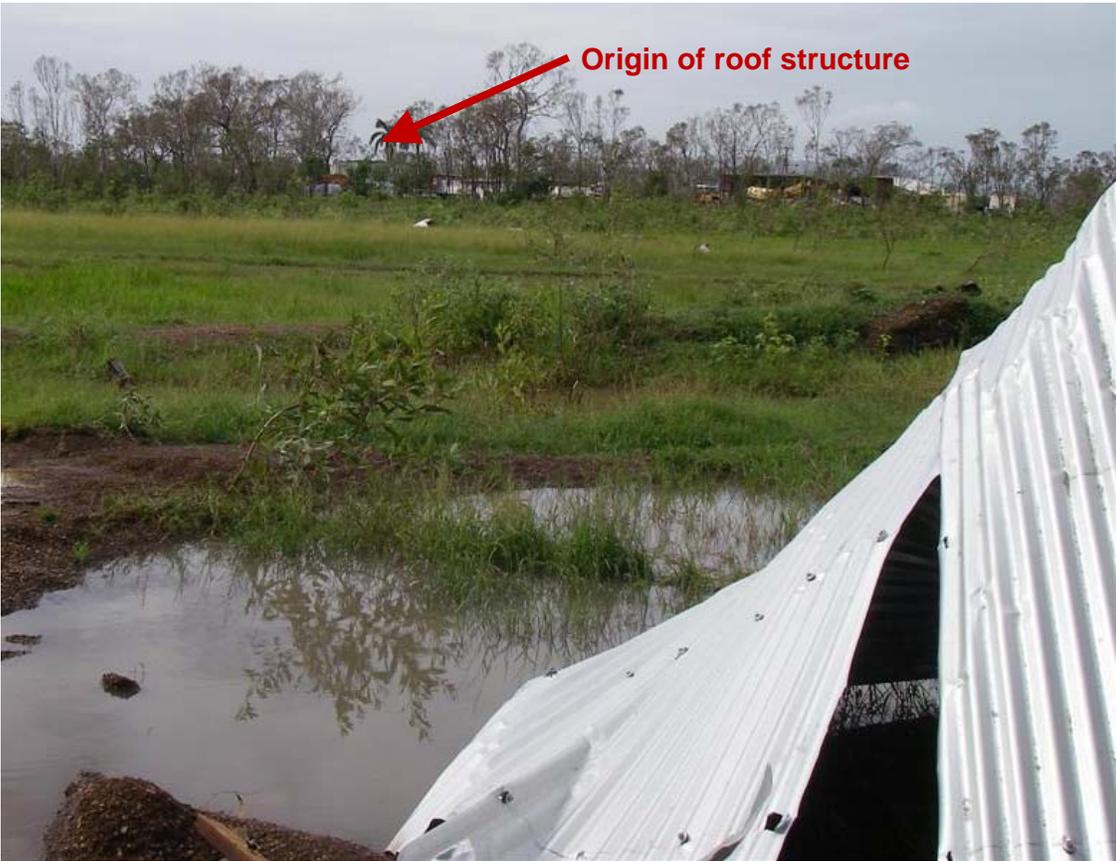
Failed elements, such as roofing, awnings, guttering, flashings etc, were blown by the wind. In some cases the roofing elements travelled more than 200 m, highlighting the threat to life safety and potential for further damage to other structures.

**Figure 5.7: Loss of majority of roof blown over 200m downwind
(From the house shown by arrow)**

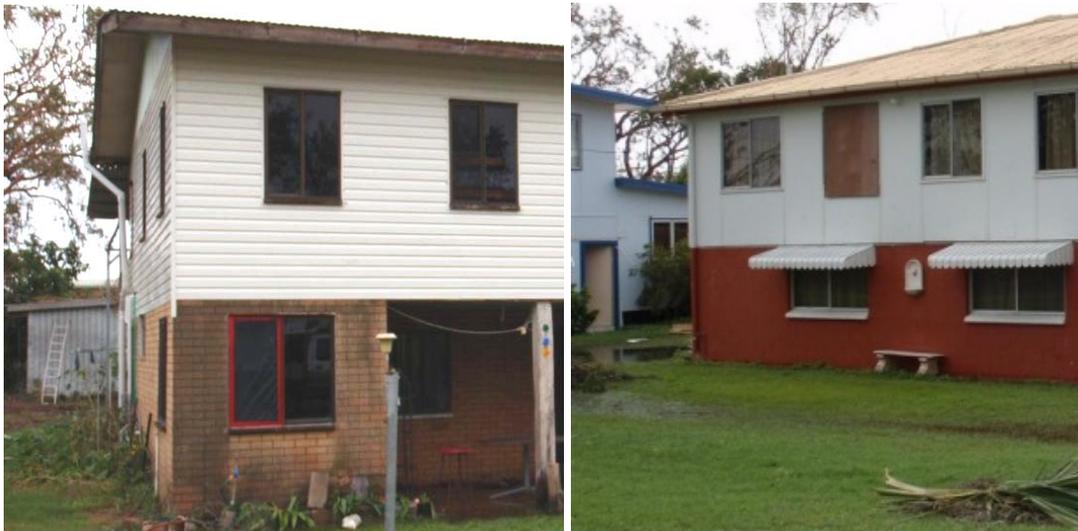
Furthermore, where wind borne debris impacts occurred, the impact velocities were not sufficient to induce significant damage to the building envelopes, apart from a small number of broken windows. This observation is consistent with current research in the way that the resultant damage is a function of debris velocity, mass and impact area. It has been found that for brittle materials such as glass or fibre cement (most houses here were clad with fibre cement sheeting) there is no range of deformation damage, the damage threshold virtually divides the states of intact/undamaged and punctured/shattered.

Figure 5.8: Broken windows

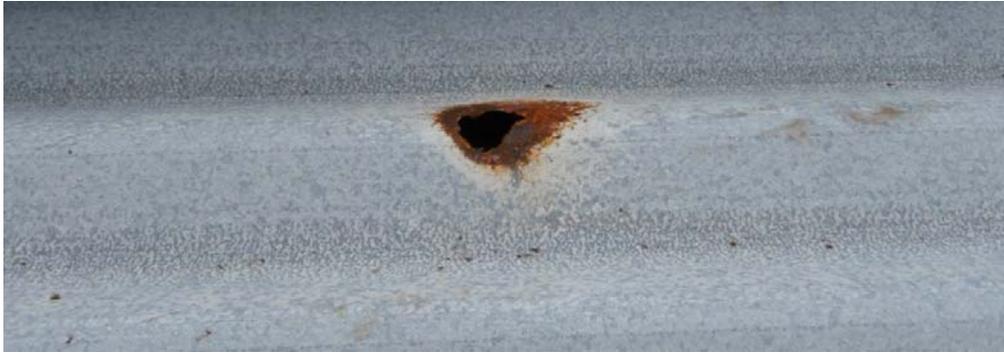
Many of the failures observed were initiated from structural elements suffering severe deterioration (i.e. corrosion or rot). Structures require correct specification and installation of materials to suit the level of exposure, combined with ongoing maintenance. The ongoing maintenance is particularly important in cyclone regions as it may be many years until a severe cyclone impacts the building. Severe corrosion of cladding is shown in Figure 4.7, Figure 5.9 and Figure 5.10.

Figure 5.9: Corrosion in cladding adjacent to screw

- Regular inspection of structural elements (including in the roof space) to look for signs of deterioration (e.g. corrosion, rot, etc).
