**Investigation of housing and sheds in Proserpine, Midge Point
and Airlie Beach, following Tropical Cyclone Ului**

Report: TR56
August, 2010

Cyclone Testing Station
School of Engineering and Physical Sciences
James Cook University
Queensland, 4811, Australia

TECHNICAL REPORT NO. 56

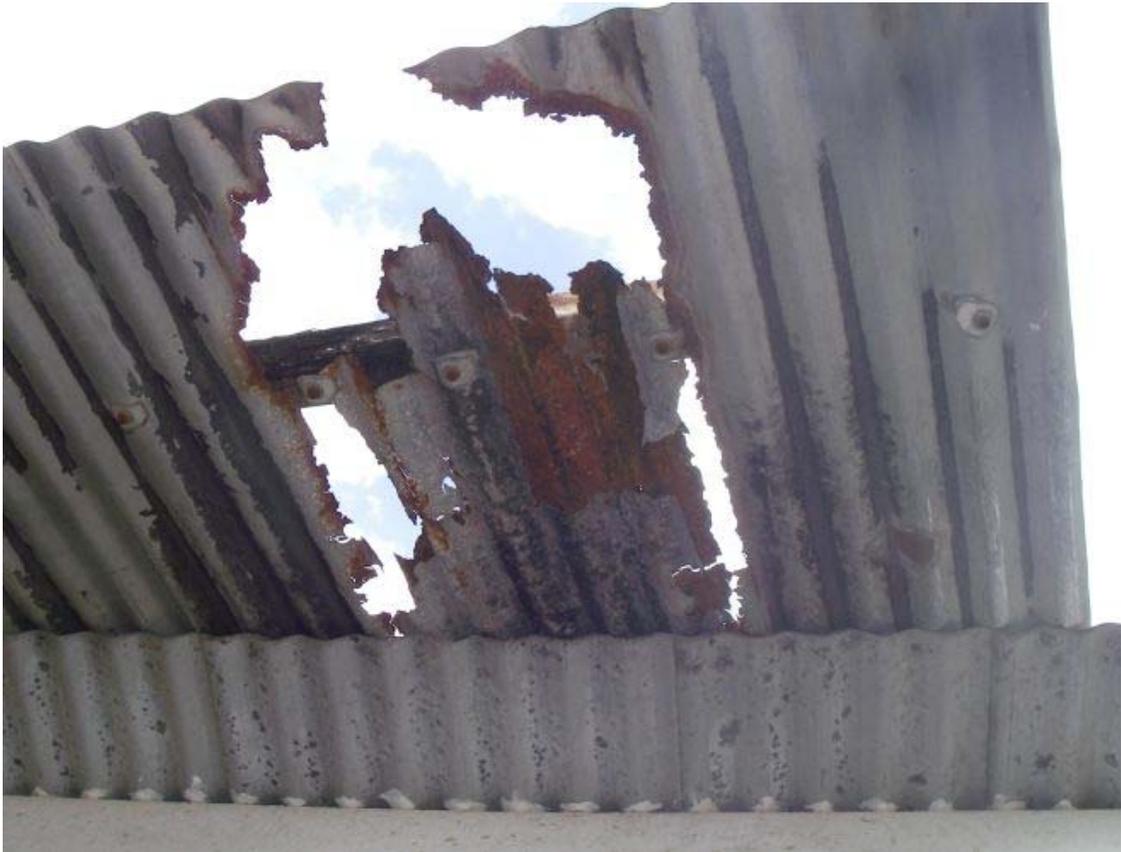
Many of the failures observed were initiated from structural elements suffering severe deterioration (i.e. corrosion or rot). Structures require correct specification and installation of materials to suit the level of exposure, combined with ongoing maintenance. The ongoing maintenance is particularly important in cyclone regions as it may be many years until a severe cyclone impacts the building. Severe corrosion of cladding is shown in Figure 4.7, Figure 5.9 and Figure 5.10.

Figure 5.10: Severe corrosion of cladding

- Regular inspection of structural elements (including in the roof space) to look for signs of deterioration (e.g. corrosion, rot, etc).
