Investigation of Townsville Tornado, 20 March 2012

Report: TR58

June, 2012

Cyclone Testing Station
School of Engineering and Physical Sciences
James Cook University
Queensland, 4811, Australia

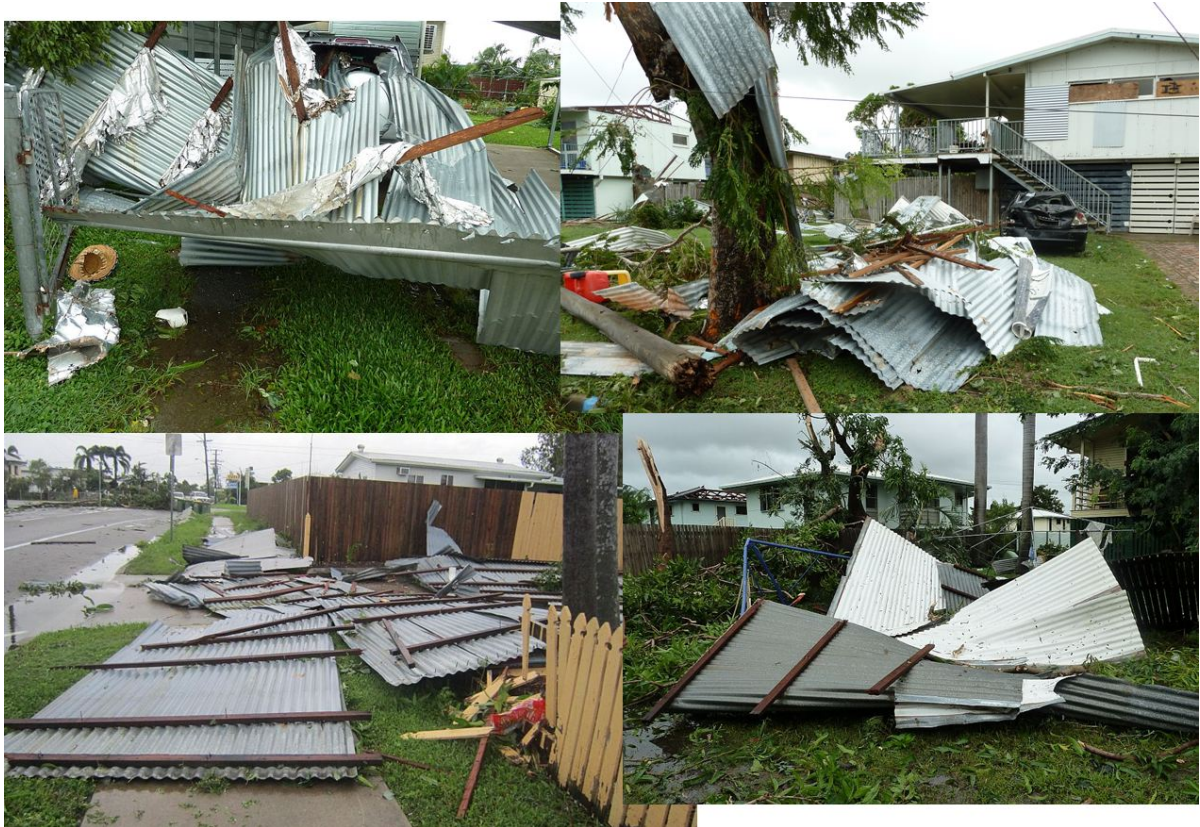
Typically, the loss of roofing consisted of the timber battens attached to the cladding as shown in Figure 3.1. In these cases the battens were only nailed to the rafters and the nailed connections did not have sufficient load carrying capacity. Building standards for current construction require the roof battens to be screw fixed or strapped to the rafters as detailed in AS1684.3 (2005).

Figure 3.1 Roof cladding attached to battens (battens were only nailed to rafters)

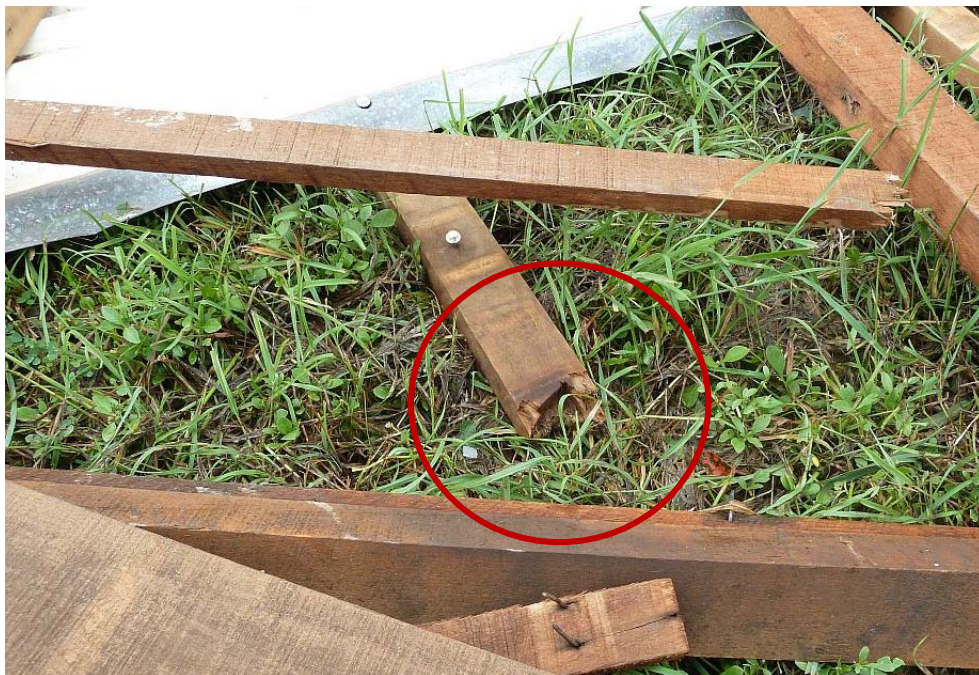
Loss of roof structure in one of the houses was observed at the timber over-batten. The timber over-batten appeared to have failed at the large checked recess as shown in Figure 3.2. This recess is required for the embedment of the end of the steel tie down rods as shown in Figure 3.3. This is a connection type used in some older housing prior to the introduction of current standards.

Figure 3.2 Checked recess in overbatten for rafter tie down

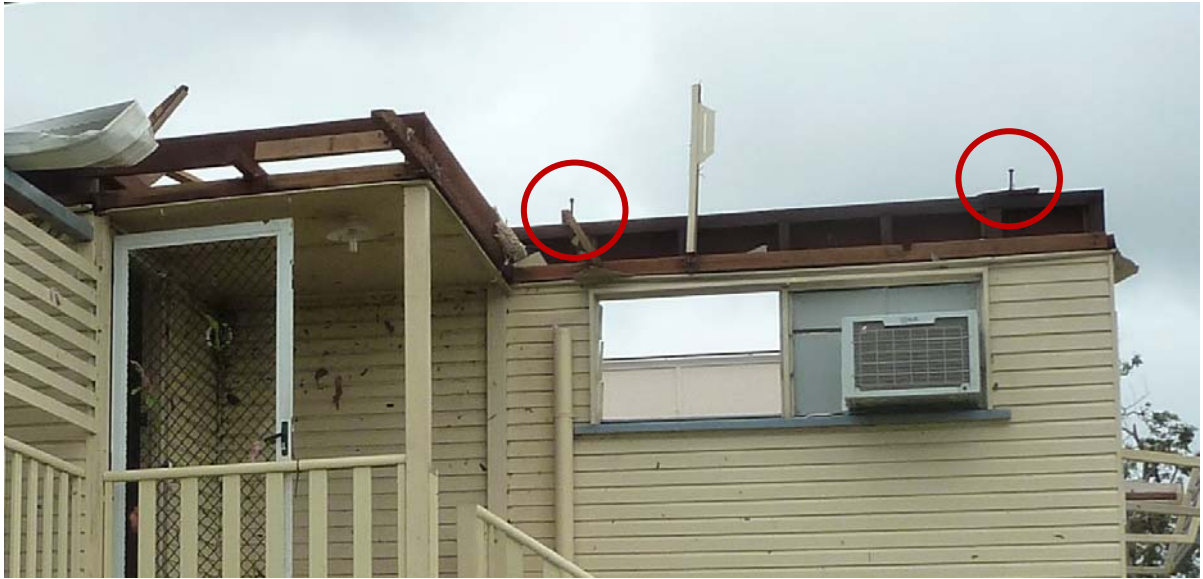
Figure 3.3 Tie down rods that were connected to the overbatten

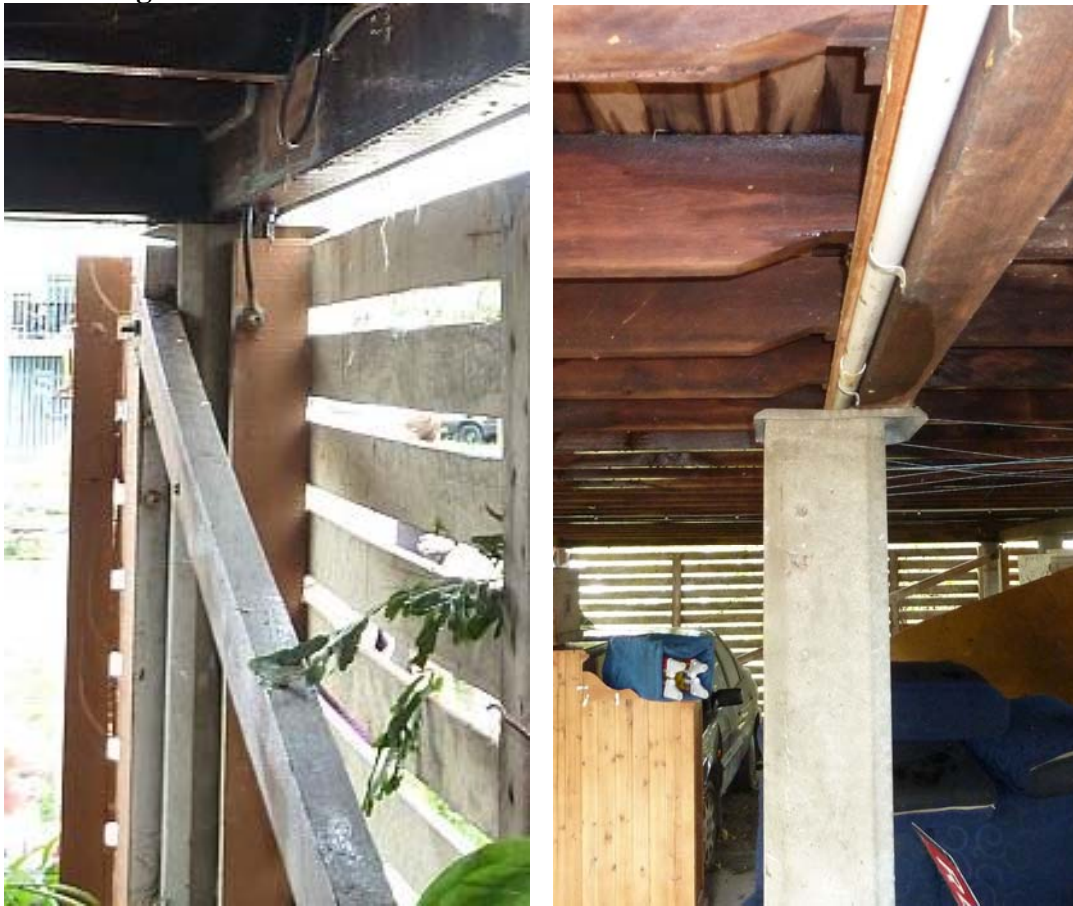
Inspection of this same two storey house also revealed that the house had translated at the floor bearers on the ant caps to the south by approximately 50 to 80 mm. The house was supported on concrete stumps, typical for its age. The perimeter piers had cranked tie down rods to the floor bearer, as shown in Figure 3.4(a). These connectors had rotated in direction of house movement. No hold-down rods were observed in any of the interior concrete piers as shown in Figure 3.4(b).

Figure 3.4 (a) Rotated cranked rod, (b) House shifted on piers

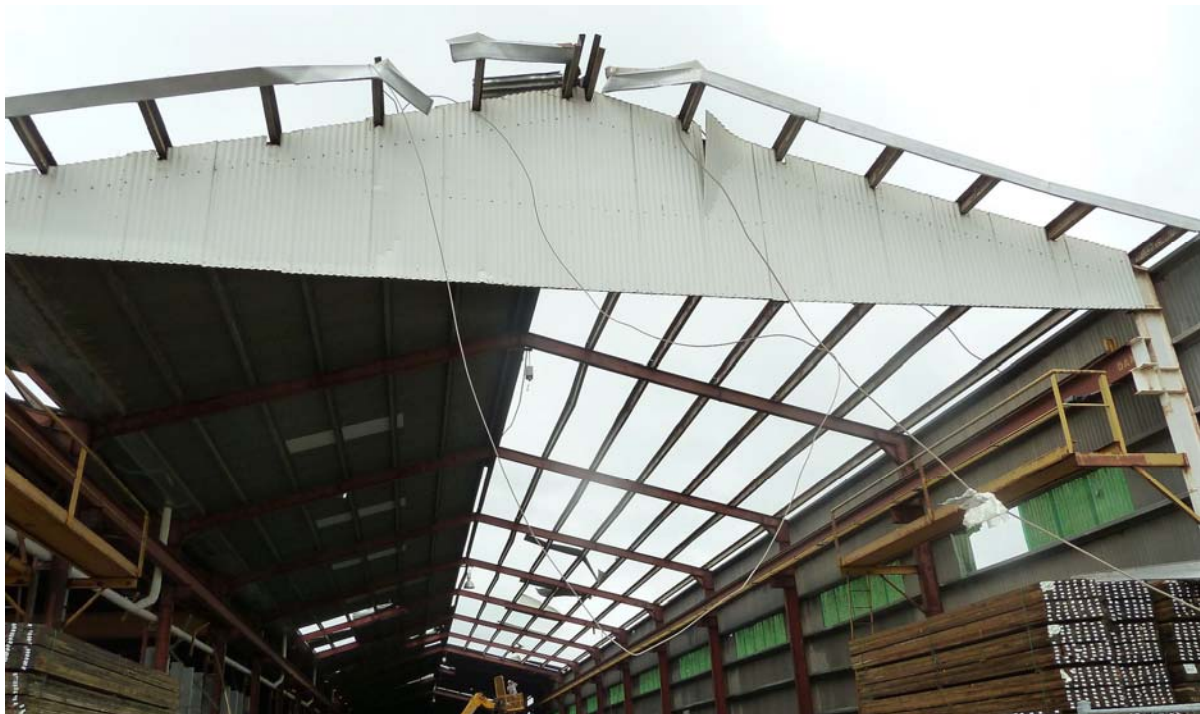
One large shed shown in Figure 3.5 said by the owners to be at least 30 years old with substantial roofing failure was inspected in detail. Its corrugated roof cladding was screwed to the purlins in a 3-4-3 pattern which is indicative of fixing patterns used prior to the current building standards. This fixing pattern has less than half the capacity during dynamic loading than current installation methods with screws in every alternate crest. The windward portal was clad from apex to knee and the leeward was clad from apex to approximately half frame height. Both these windward and leeward end “walls” were bowed due to the wind load. Several of the simple-span (i.e. non-lapped) cold formed Z purlins were buckled from a combination of axial loading and wind uplift. The purlins had no bridging.

Figure 3.5: Loss of cladding and buckled purlins

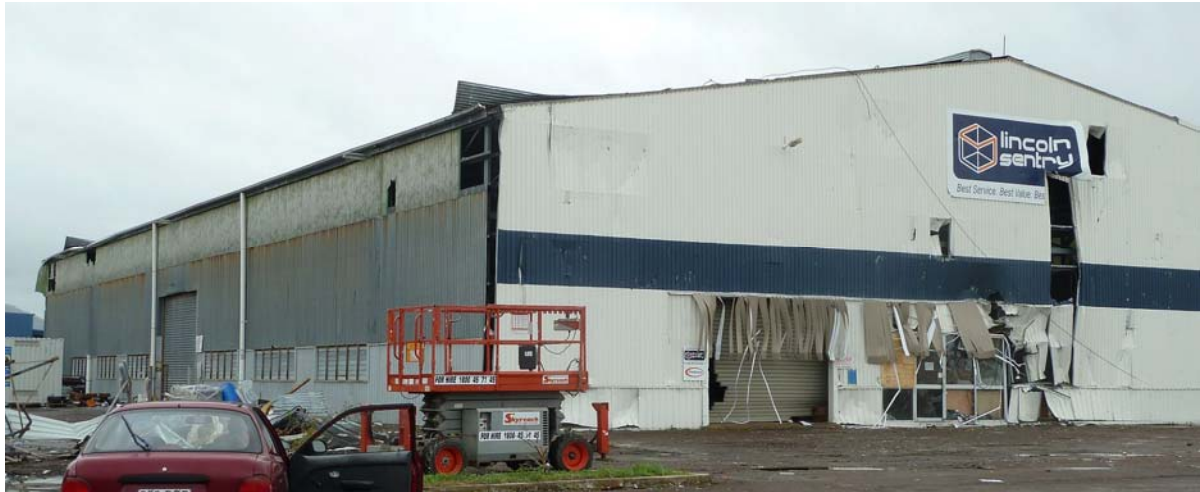
An adjacent shed, shown in Figure 3.6 of similar size was subjected to a windward dominant opening from loss of roller door and debris damage from an old awning structure from across the road. The shed had a minor amount of roof cladding peeling up at locations along eaves with the cladding fixed to the purlins at every alternate crest.

Figure 3.6: Debris damage and broken roller door on “windward” wall, and failed translucent wall cladding and peeled roofing on side wall

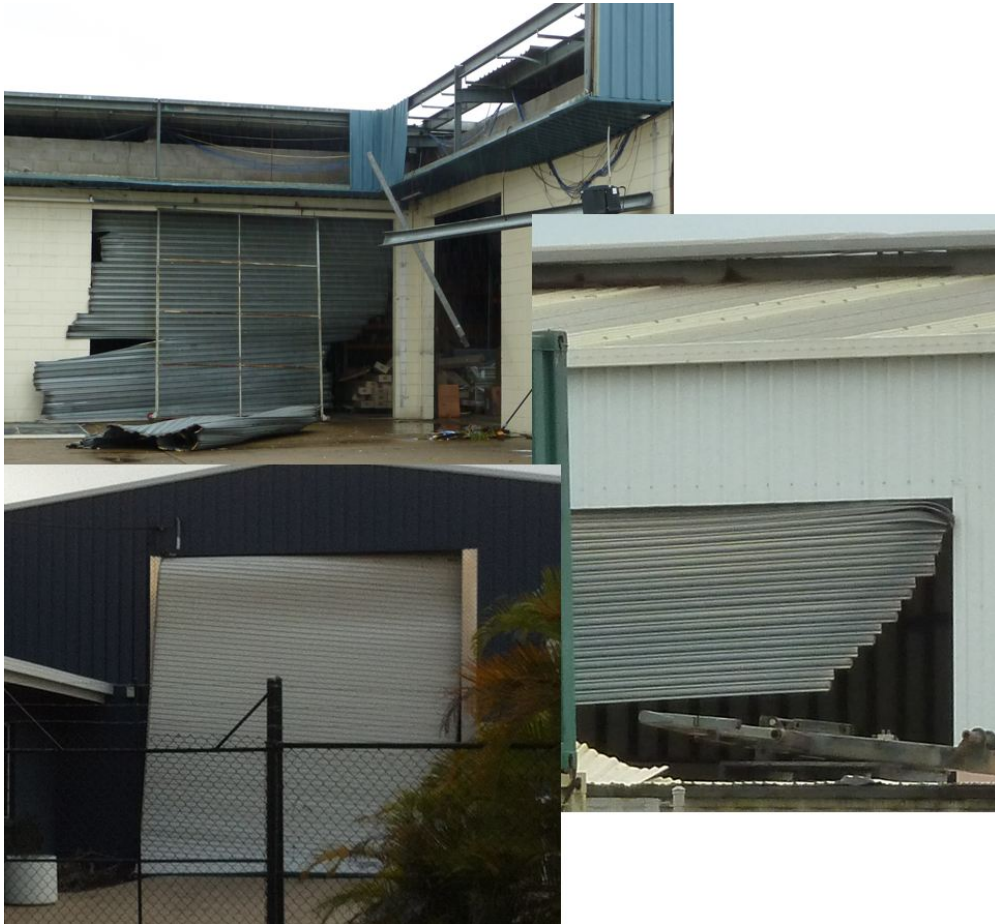
Several examples of failures of large doors were observed as shown in Figure 3.7. The majority of these were roller doors. Failure of sliding doors on one shed was observed as shown in Figure 3.8. One roller door that had been replaced after Cyclone Yasi and was fitted with wind locks, generating large membrane forces to be developed which transferred the failure to the mullions as shown in Figure 3.9.

Figure 3.7: Damaged roller doors

- Domestic and commercial roller doors including mullions etc. should be designed and installed so that they can support design wind loading.
- Regular inspection of structural elements (including in the roof space) should be carried out to look for signs of deterioration (e.g. corrosion, rot, etc). The CTS brochure “Is your house prepared for a cyclone?” contains further information;
<http://www.emergency.qld.gov.au/emq/css/pdf/cyclonebrochure-house.pdf>

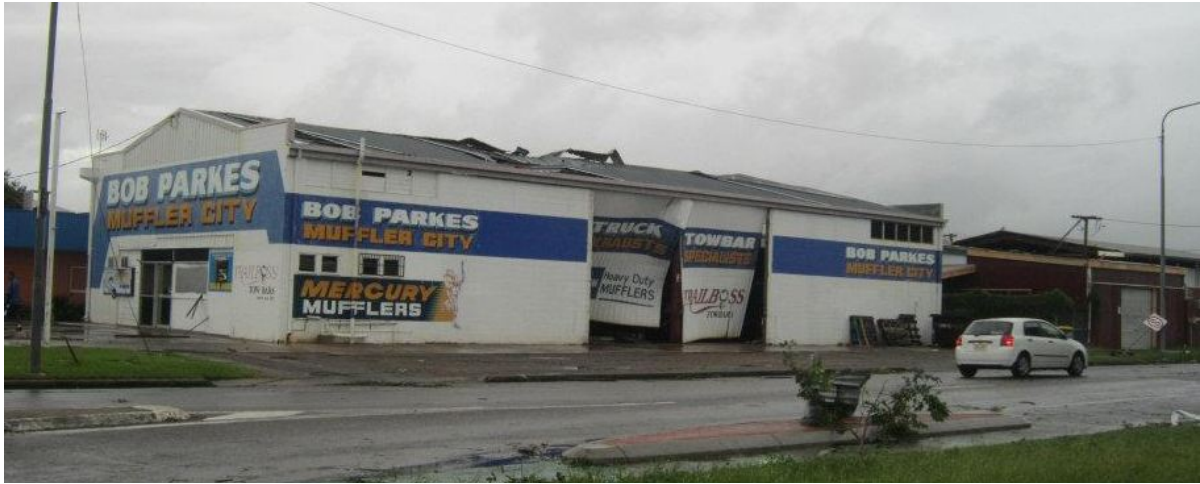
Figure 3.8: Impact to end wall, roof and failure of sliding doors and roof cladding

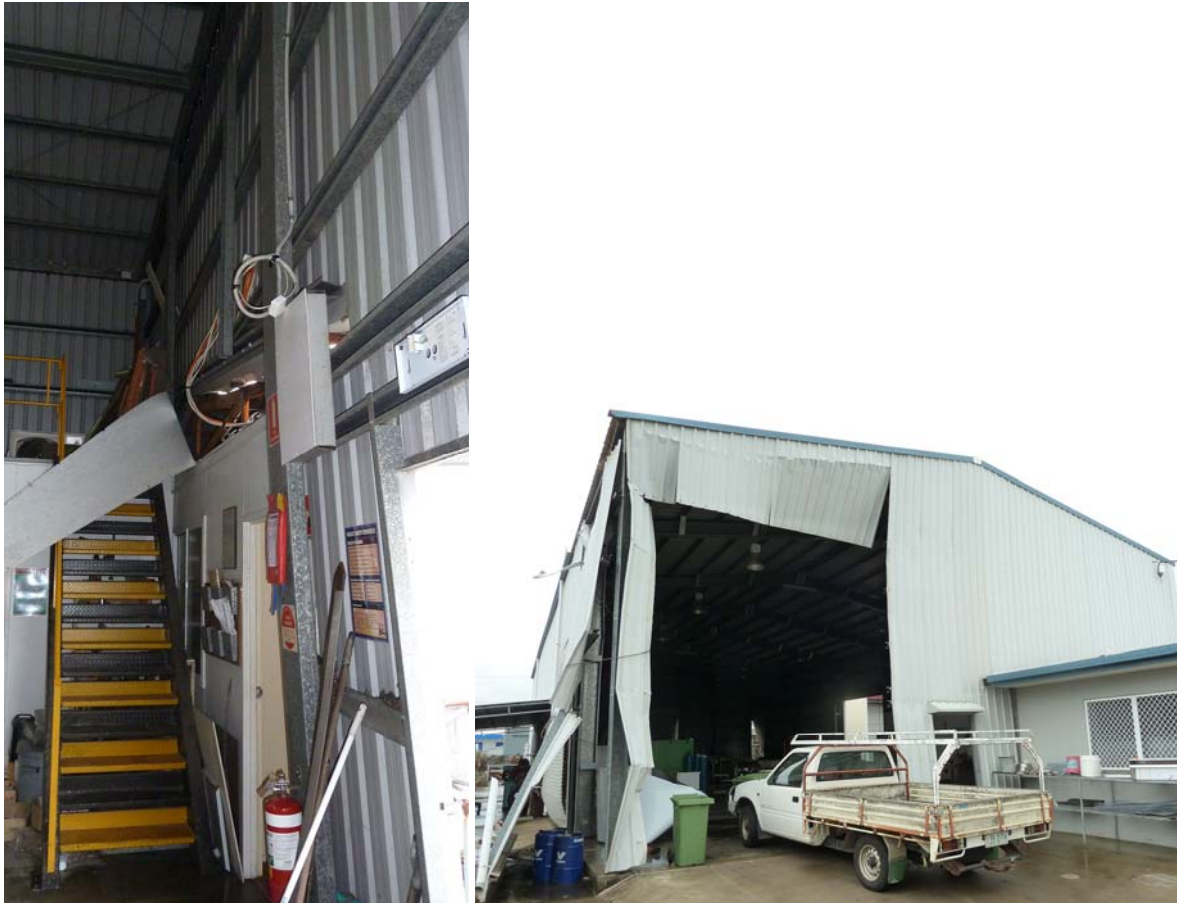
Figure 3.9: (a) Bend windward wall column, (b) Distortion of end portal frame and loss of roller door

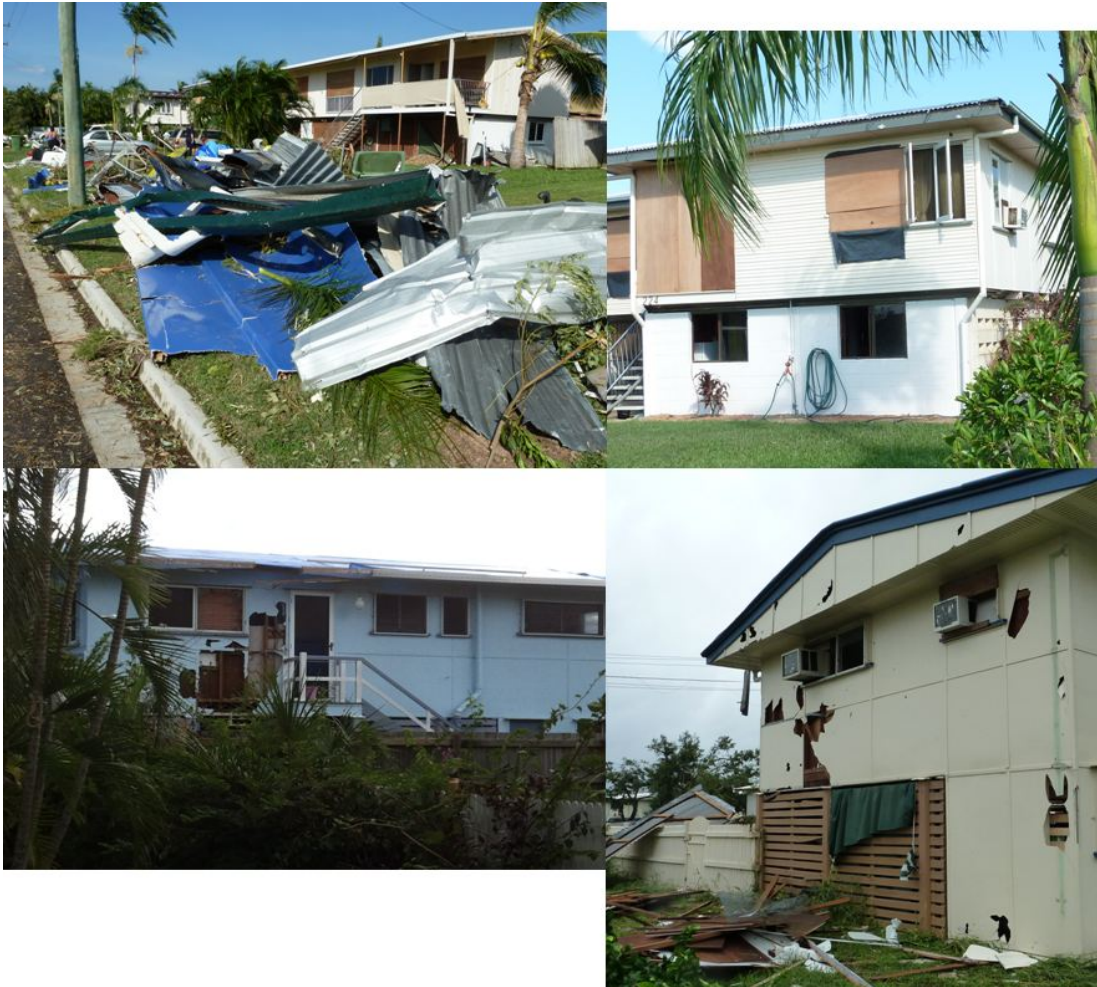
Failed elements, such as roofing, awnings, guttering, flashings etc, were blown by the wind. In some cases roof cladding was found approximately 500 m from source building. Sections of a fibreglass pool (had been empty, not installed and sitting above ground) were found approximately 250 m from its original location. Examples of the windborne debris and impact on buildings are shown in Figure 3.10.

Figure 3.10: Wind driven debris and impacts on housing

The suddenness (and rarity) of this event did not afford preparation time; however the community should have carried out tree pruning and maintenance of the house as part of being prepared for the season. The removal or securing of potential objects and structures that could become wind borne debris plays a part in minimizing damage.
