Investigation of Damage: Brisbane 27 Nov 2014 Severe Storm Event

CTS Technical Report No 60

February 2015

Investigation of Damage: Brisbane, 27 November 2014 Severe Storm Event

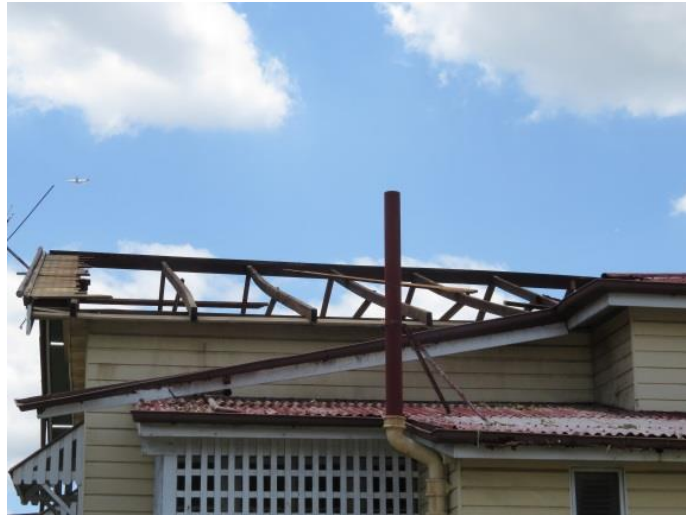
Figure 10: Loss of metal cladding and battens of an older house, original lead-headed nails were used to secure cladding to battens.

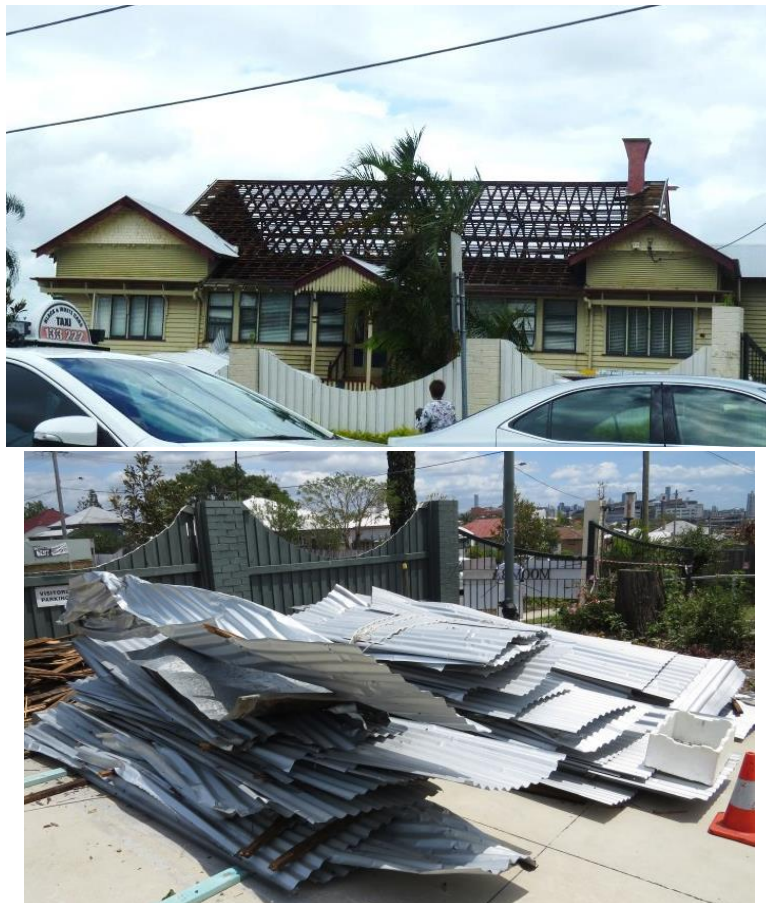
Figure 11: Loss of cladding and battens of a church hall. Originally a tile roof, new metal cladding was fixed to every 3rd existing batten

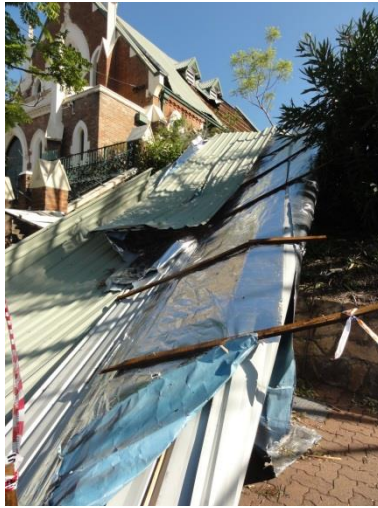
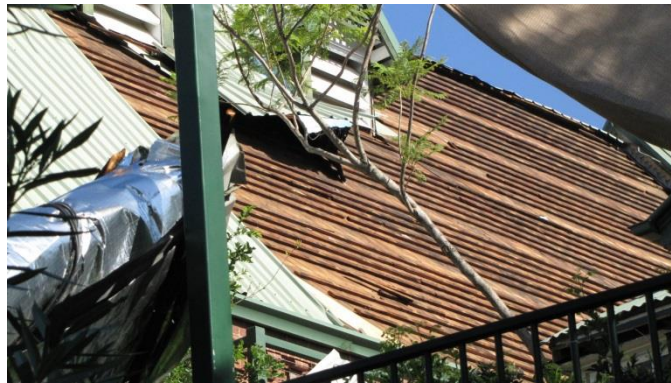
Figure 12: Loss of metal cladding and battens of a church. Originally a tile roof, the new metal roof was only secured to every 6th timber batten.

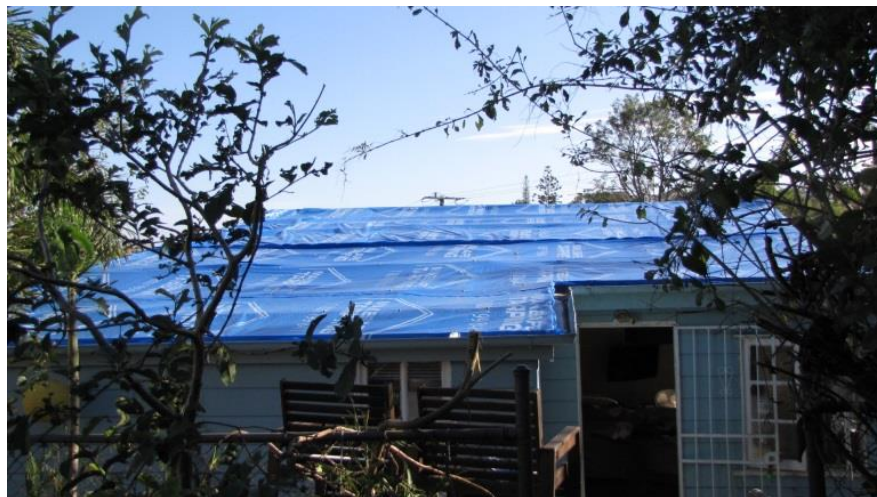
Figure 13: Loss of cladding and battens of an older home new cladding had been installed onto the original battens

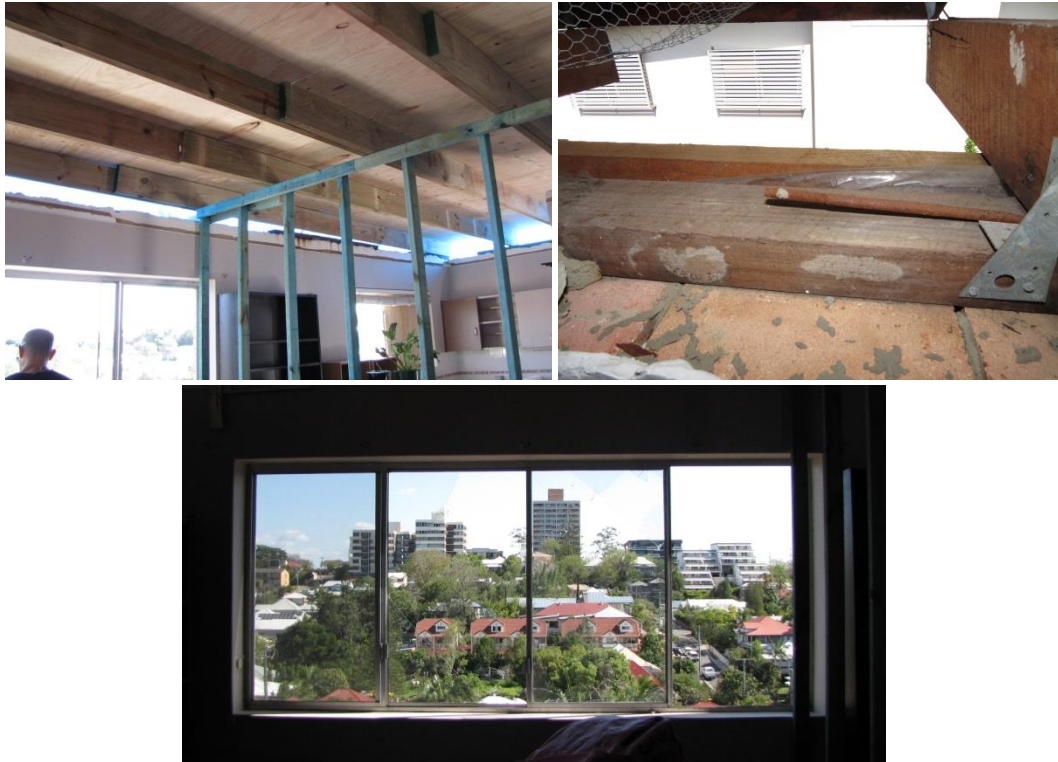
Complete roof loss had occurred to top floor units of some apartments. For one site that was surveyed, this had occurred due to window damage by hail and a subsequent dramatic increase in internal pressure. The timber roof of this apartment was observed to have insufficient tie down as hold down rods were only bent over top plates, no nuts were used.

Figure 14: An example of complete roof loss of the top storey unit of a 3 storey apartment building (New roofing currently being installed). Original timber rafters had inadequate tie down to withstand internal pressure due to the breakage of a large Southern facing window. The unit was also located on top of an escarpment (outlook shown in the lower photograph) and may have experienced slightly higher wind speeds.

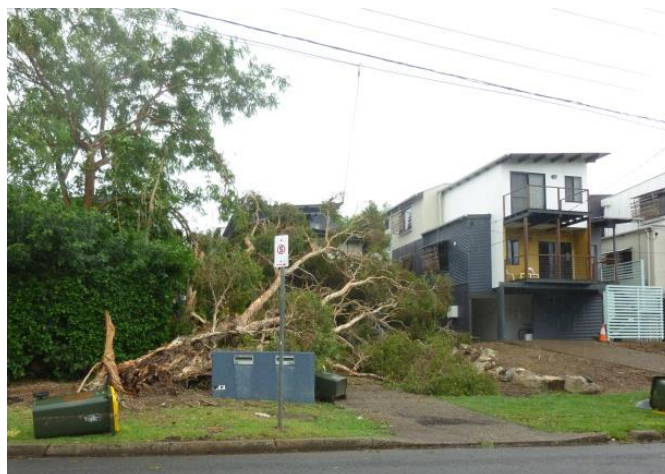
Figure 15: Fallen trees were common, often causing damage to power lines and housing

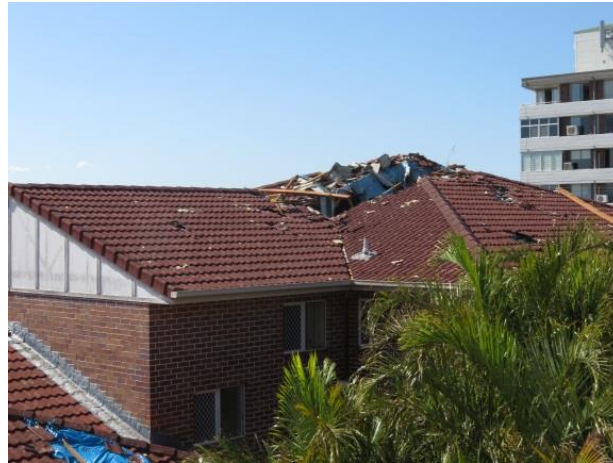
Figure 16: Damage caused by debris originating from a neighbouring apartment building. The tile roof, including the large south (windward) facing gable, appears otherwise undamaged

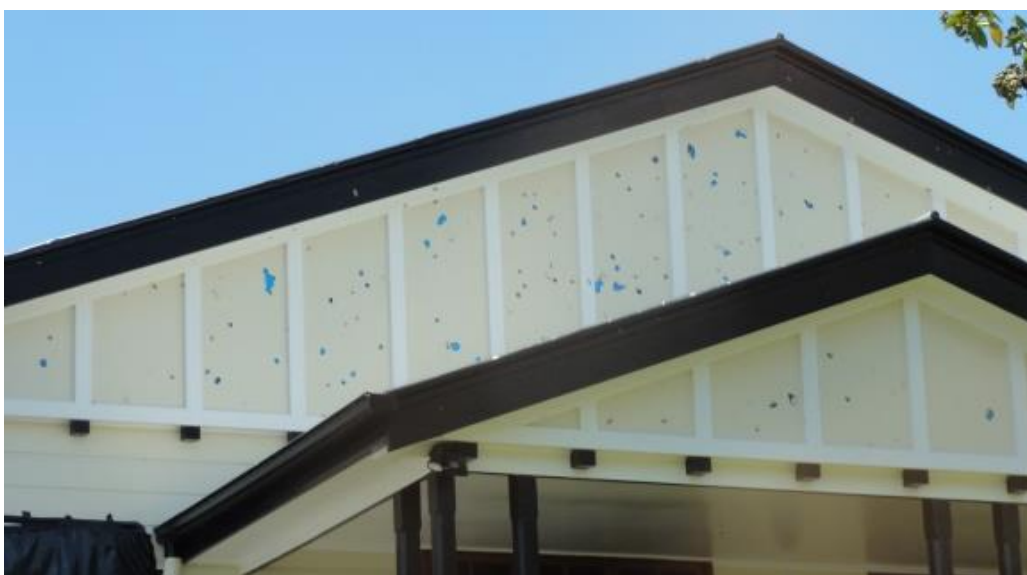
Figure 17: Hail damage from ‘golf ball’ sized hail (reported by resident) to the gable of a newer home

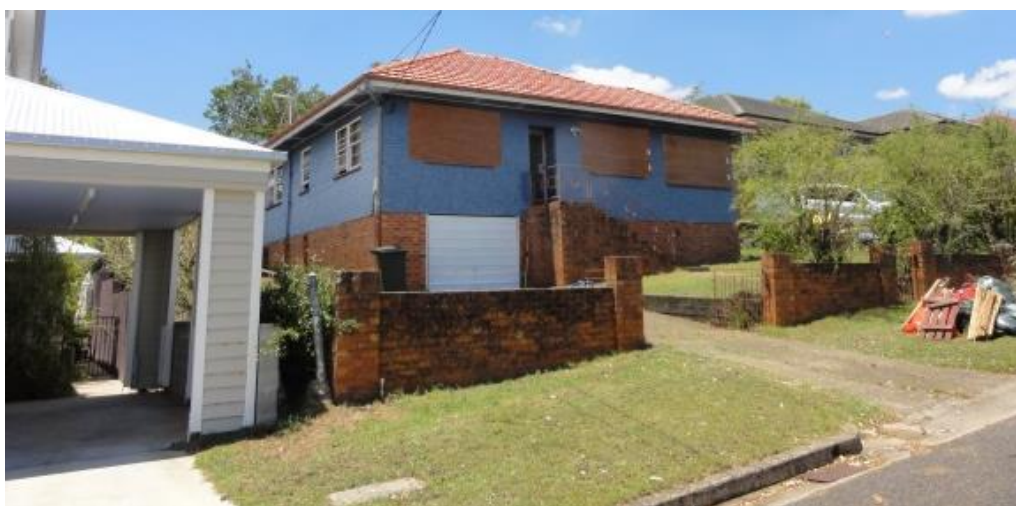
Figure 18: A common observation of many houses were several broken windows on the southern face as well as water damaged goods placed at the front for collection

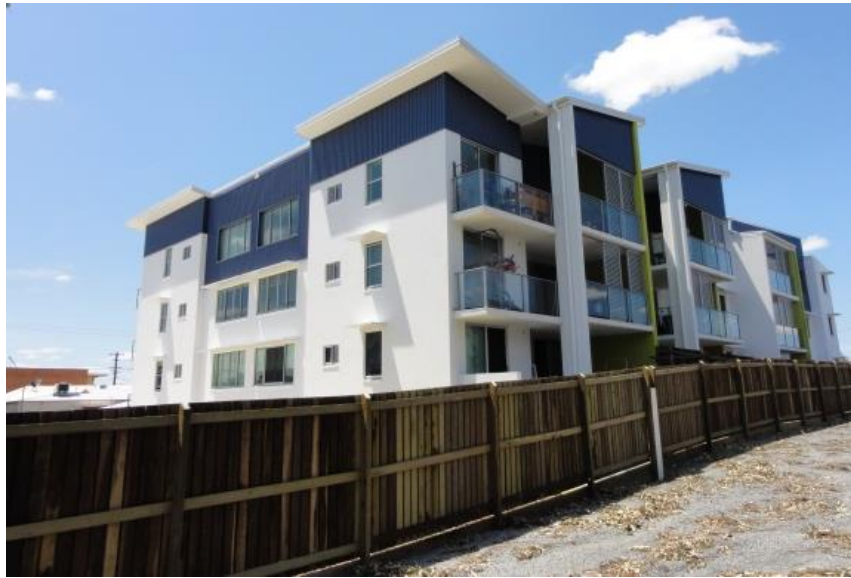
Figure 19: A new apartment building in a storm affected neighbourhood, all windows on the exposed southern side were undamaged, indicating the improved performance of new window glass.

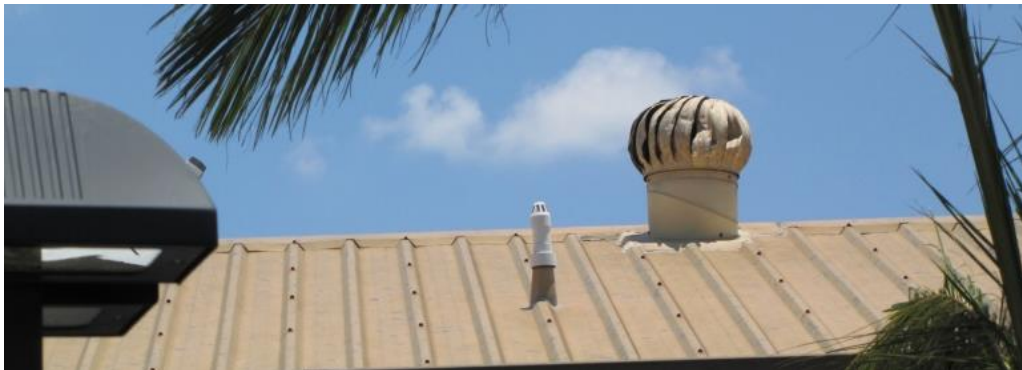
Figure 20: Typical hail damage to roof vent

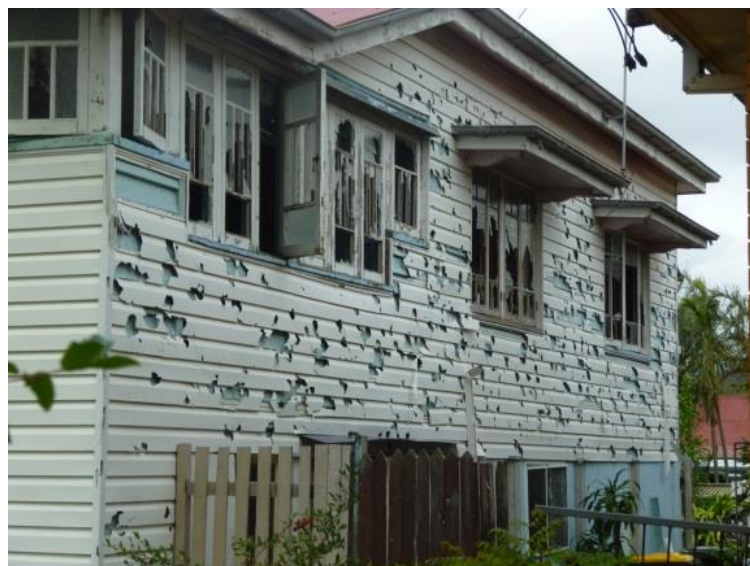
Figure 21: Hail damage to windows and vinyl cladding of an older house. The proximity of the neighbouring house on the right and the size of the window shades suggest hail being driven at a sharp angle by the wind.

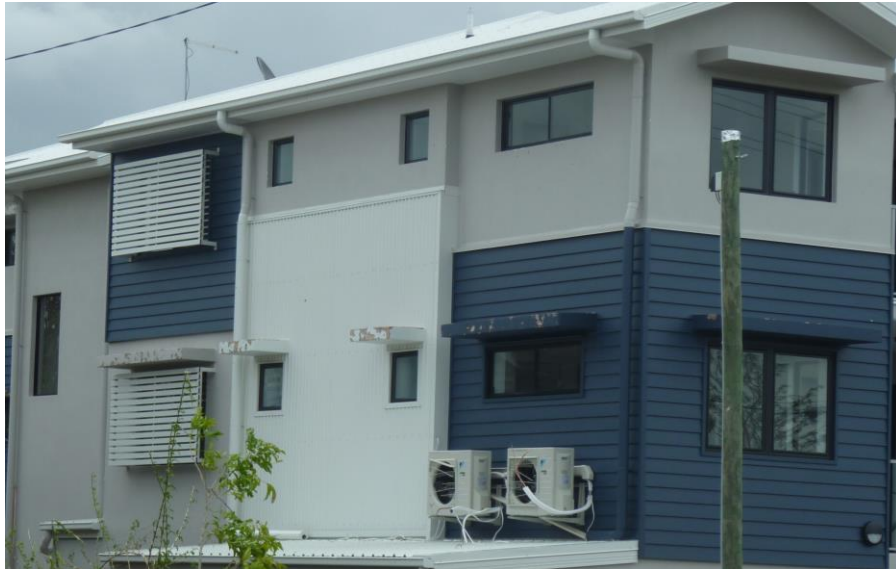
Figure 22: Significant hail damage to air-conditioning units of a newer apartment building. Note that all windows are undamaged, even those without overhanging eaves (far left), once again indicating the improved performance of new window glass in comparison to older windows in adjacent buildings.

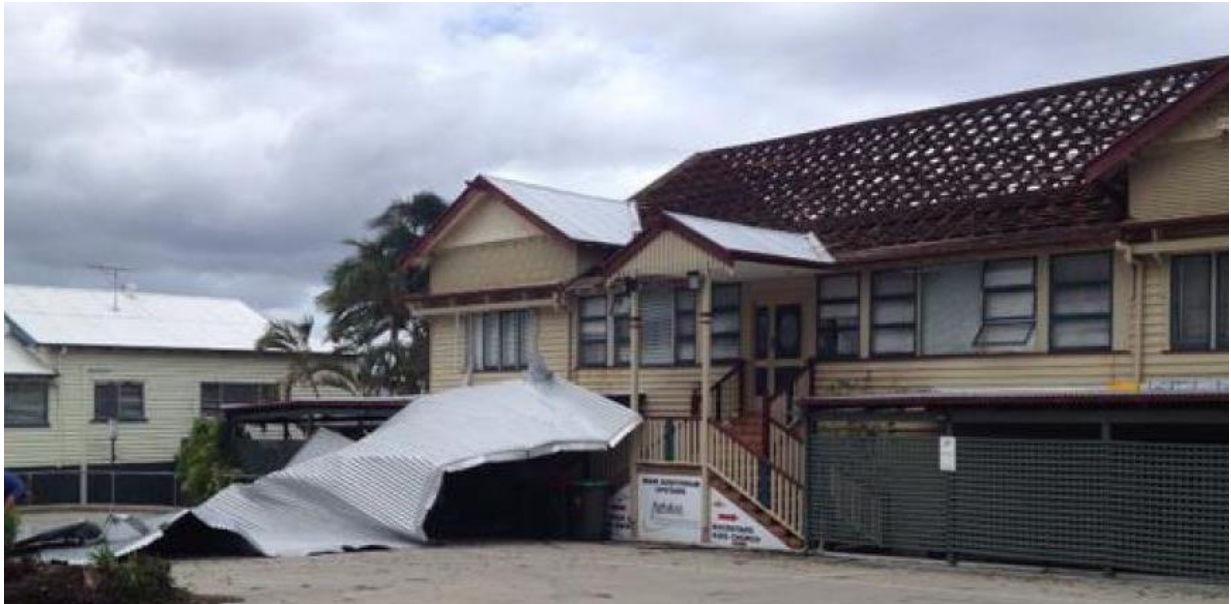
The roof sheeting from this church has been torn off its battens. The roof appears to have been tiled before being replaced by metal sheeting. *Photographer:* Andree Withey. *Location:* Ipswich road, Annerley. *Source:* <<http://www.abc.net.au/news/2014-11-28/roof-gone-in-brisbane-storm/5926234>>

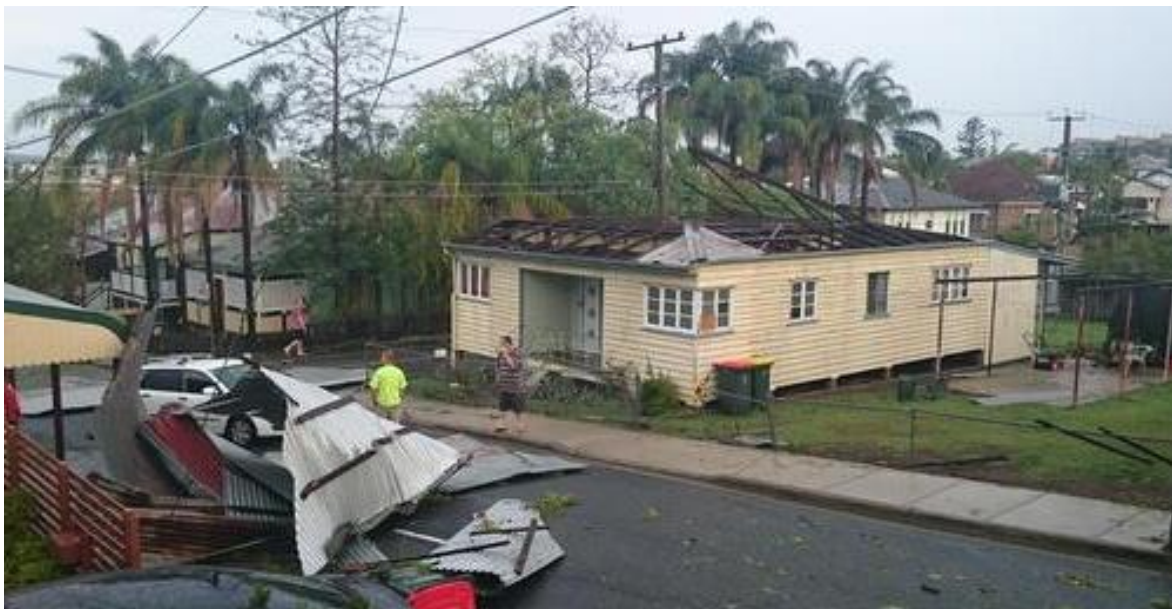
Roof sheeting attached to battens along with rafters have been torn off this worker's cottage. *Photographer:* Brad Schultz. *Location:* Ross St, Woolloongabba. *Source:* <<https://twitter.com/superbrudd/status/537871622980382720/photo/1>>

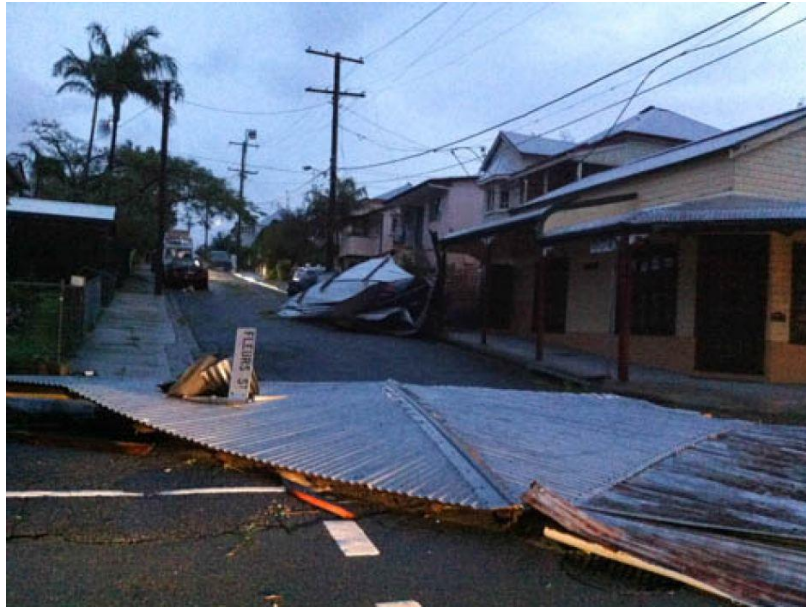
Roof sheeting with battens attached torn off building. *Photographer:* Brendan Fearn. *Location:* Woolloongabba. *Source:* <<http://www.abc.net.au/news/2014-11-27/roofs-litter-the-streets-in-woolloongabba-after-the-storm/5923980>>

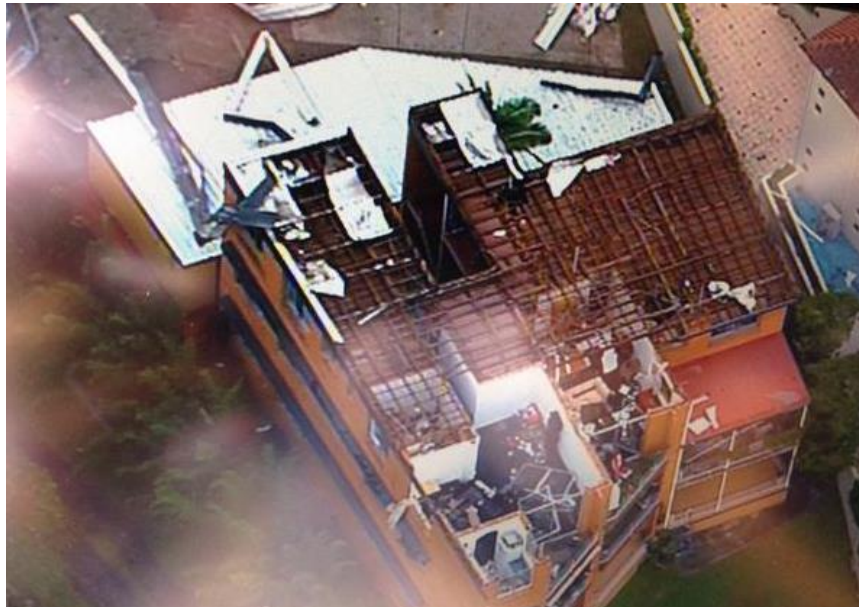
Concealed fixed roof sheeting torn off clips, unit complex with river frontage. *Photographer:* Peter Doherty. *Location:* Toowong. *Source:* <<https://twitter.com/peterdoherty7>>

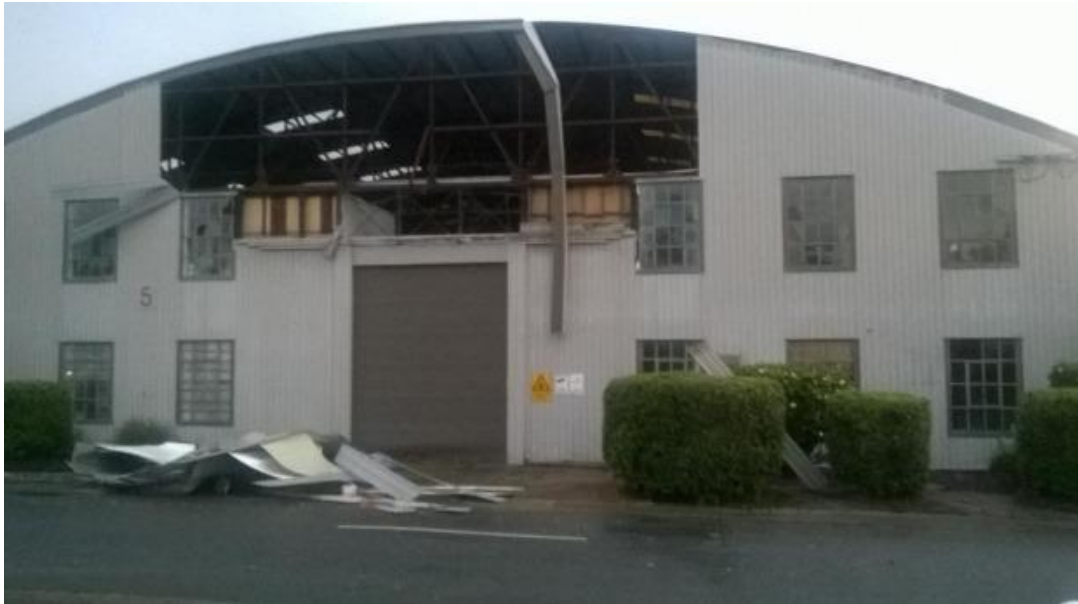
Damage aircraft hangar at Archerfield Airport, failure of a door, window or skylight may have contributed to the wall sheeting being blown off from the inside.

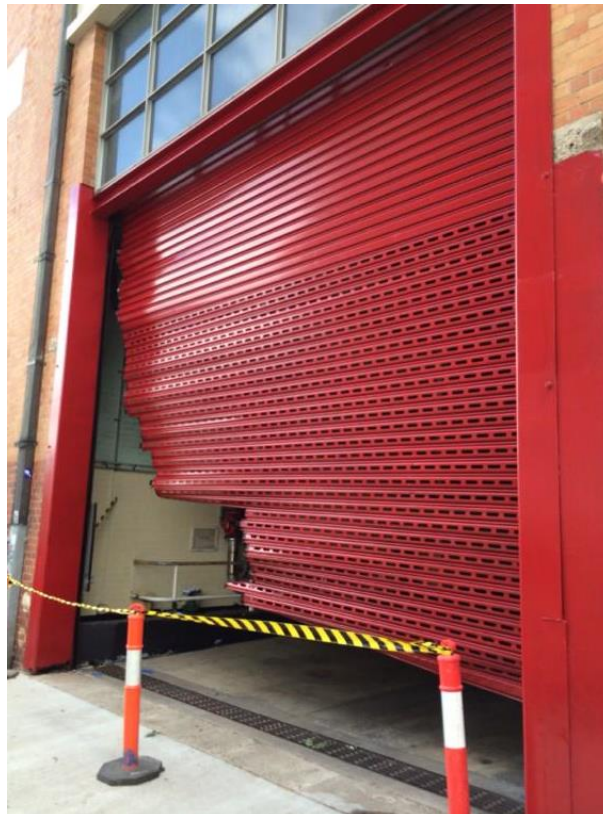
Perforated roller door failure of the XXXX Brewery, Milton. Source: Alex Tilbury, <https://twitter.com/hashtag/bnestorm?src=hash>

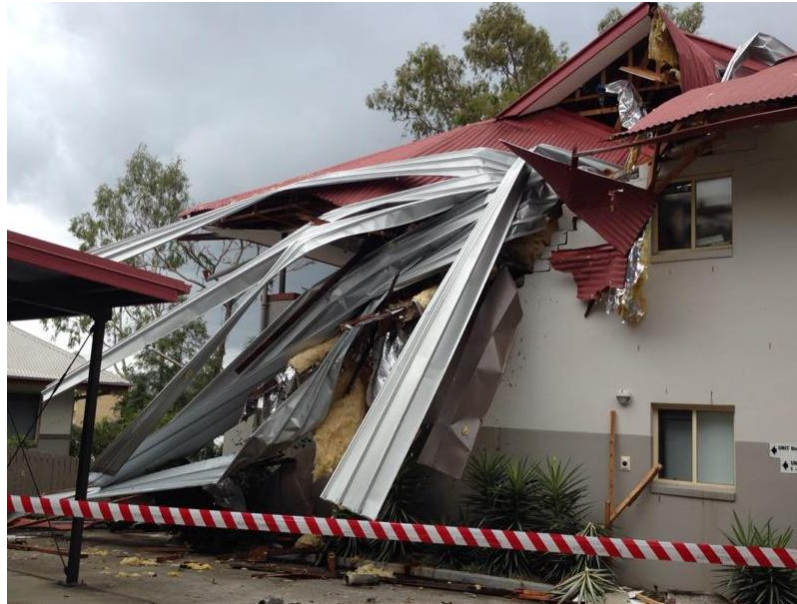
Severe debris damage to house at Herston. *Source:* Stefan Armbruster, <<https://twitter.com/stefarmbruster>>

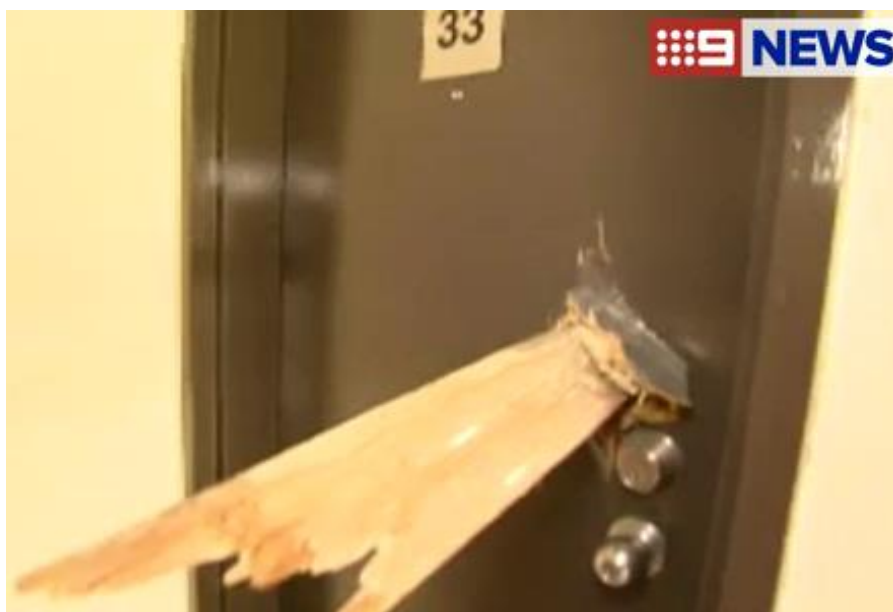
Apartment door pieced by debris at Herston. *Source:* Nine News Brisbane, <<https://twitter.com/9NewsBrisbane/status/538150543882194945/photo/1>>

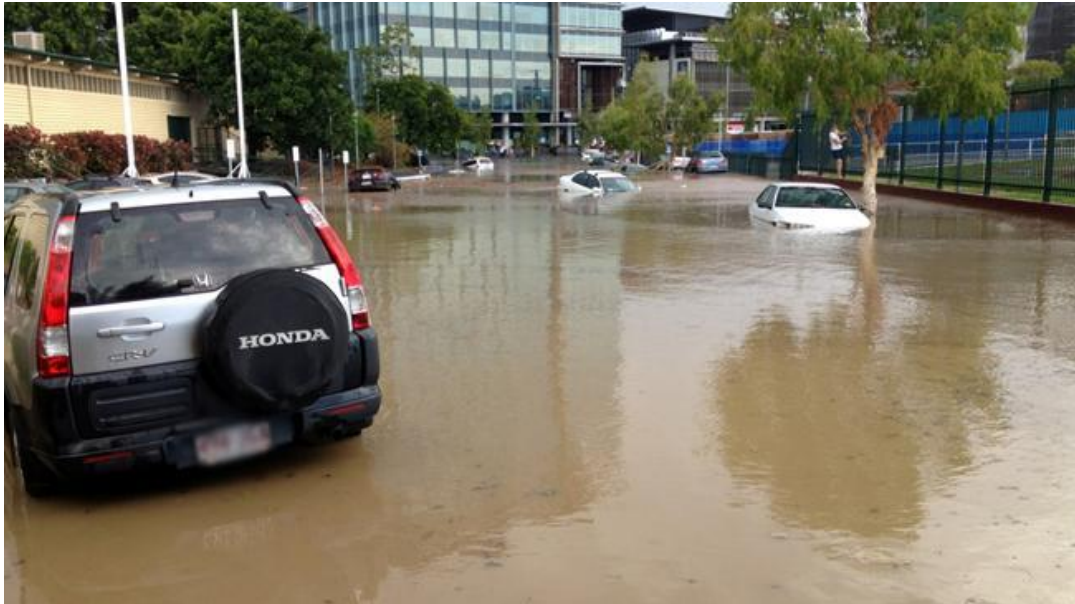
Flooding at Bowen Hills, of streets. *Source:* Darren England , The Courier Mail,
<http://www.couriermail.com.au/news/queensland/above-average-temperatures-as-southeast-prepares-for-supercell-storms>

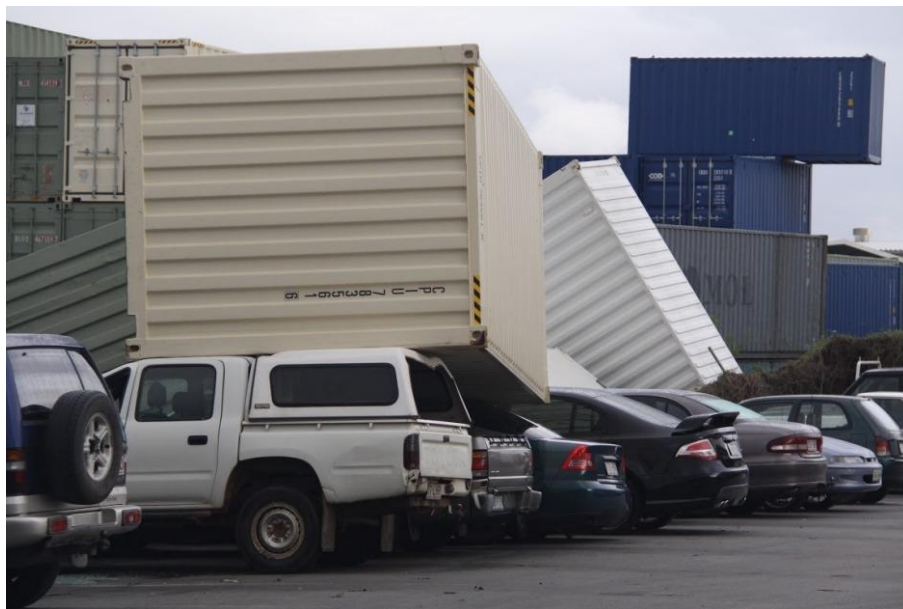
Shipping containers blown over onto carpark at the Port of Brisbane *Source:* Grant Spicer
<http://www.brisbanetimes.com.au/environment/weather/violent-storm-lashes-brisbane-thursday-november-27-20141127-11>

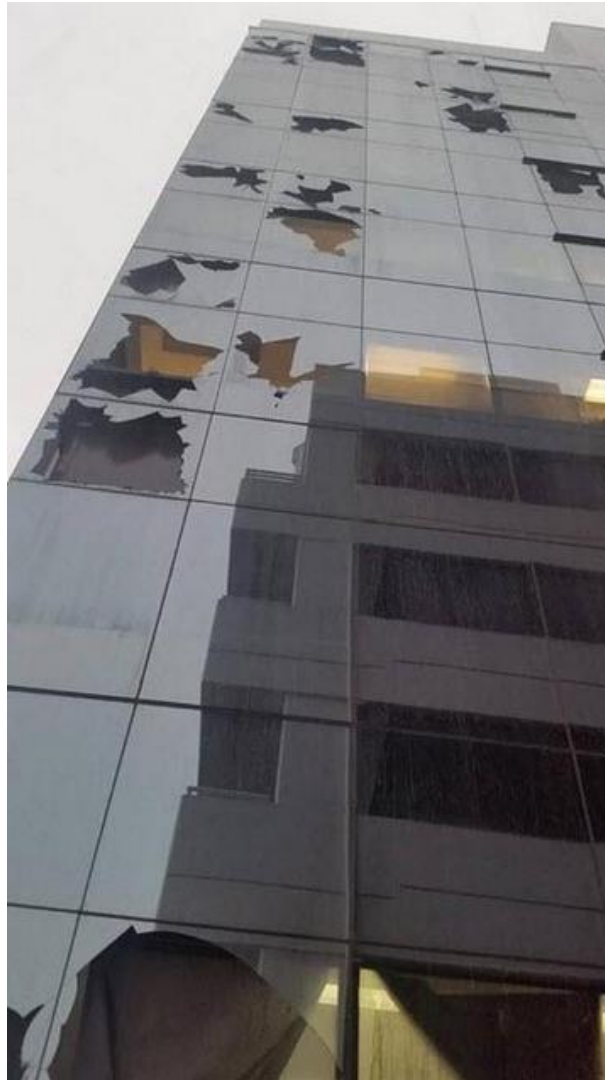
Hail damage to glass façade, Turbot St, Brisbane CBD. *Source:* Jessy Sahota <<https://twitter.com/JessySahota>>

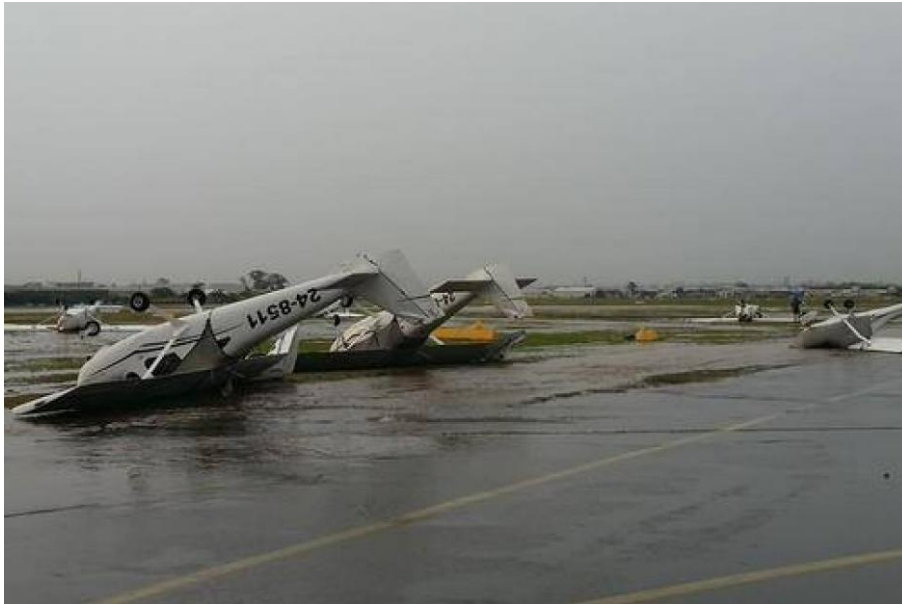
Planes flipped over. Photo: Higgins Storm Chasing Location: Archerfield Airport. *Source:* The Age, <http://www.theage.com.au/environment/weather/violent-storm-lashes-brisbane-thursday-november-27-20141127-11viro.html>

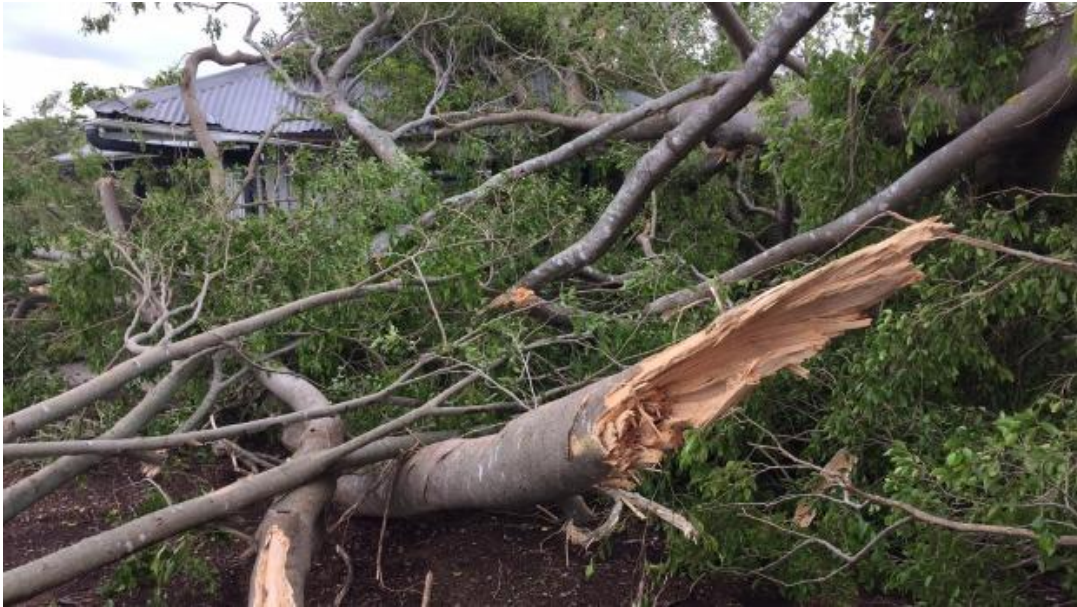
Fallen trees on house, Orleigh Park West End. *Source:*

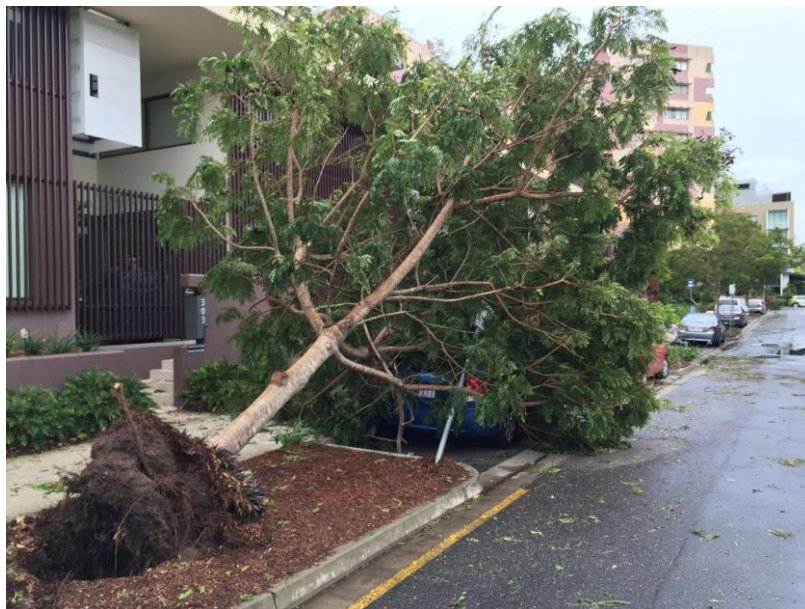
Tree blown over in Montague Street West End. *Source:* Brisbane Times,

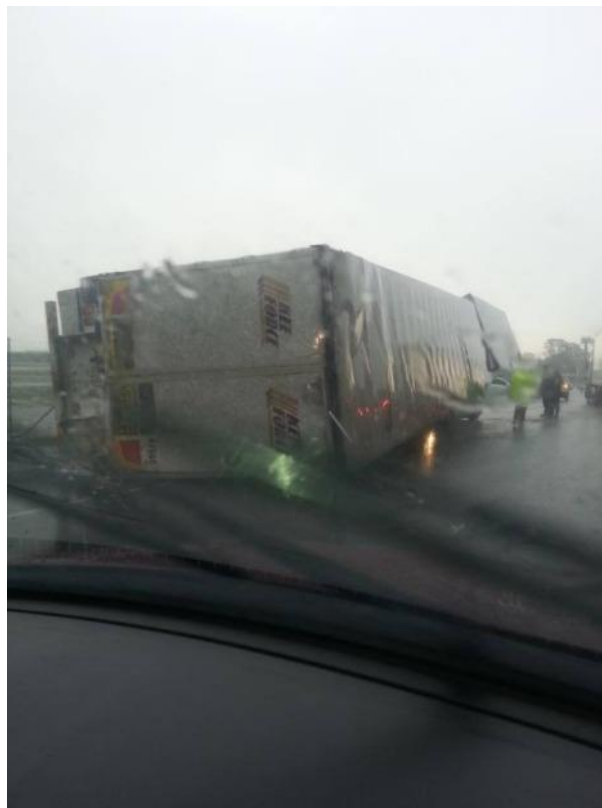
Truck overturned at Archerfield. *Source:* Higgins Storm Chasing
