Tropical Cyclone Olwyn  
Damage to buildings in Exmouth, Western Australia

**CTS Technical Report No 61**

March, 2015

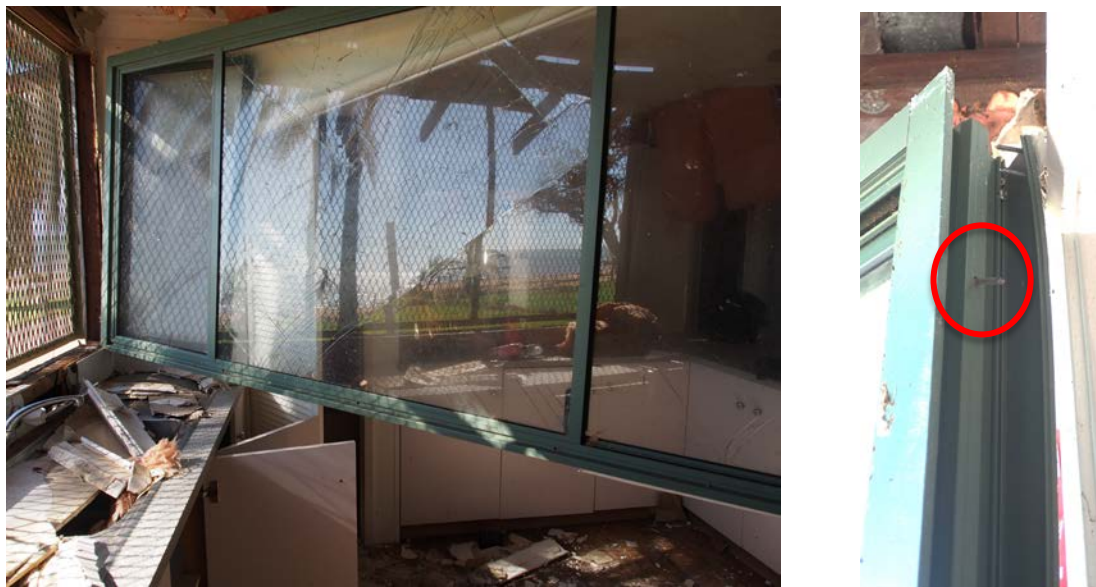
A window frame in one of the houses investigated was only fixed to the building using four screws and each penetrated around 10 mm into the jarrah building frame (see Figure 3.4). This damage was a feature of many of the “Norwesters” after TC Vance. (Reardon, Henderson and Ginger, 1999). An example of inadequate fixing of the window frame after TC Vance is shown in Figure 3.5. The Australian Window Association (AWA) has published a window fixing guide that is available on their website to illustrate appropriate installation practices. (AWA 2010)

*Figure 3.4 – Window frame failure in an older house during TC Olwyn*

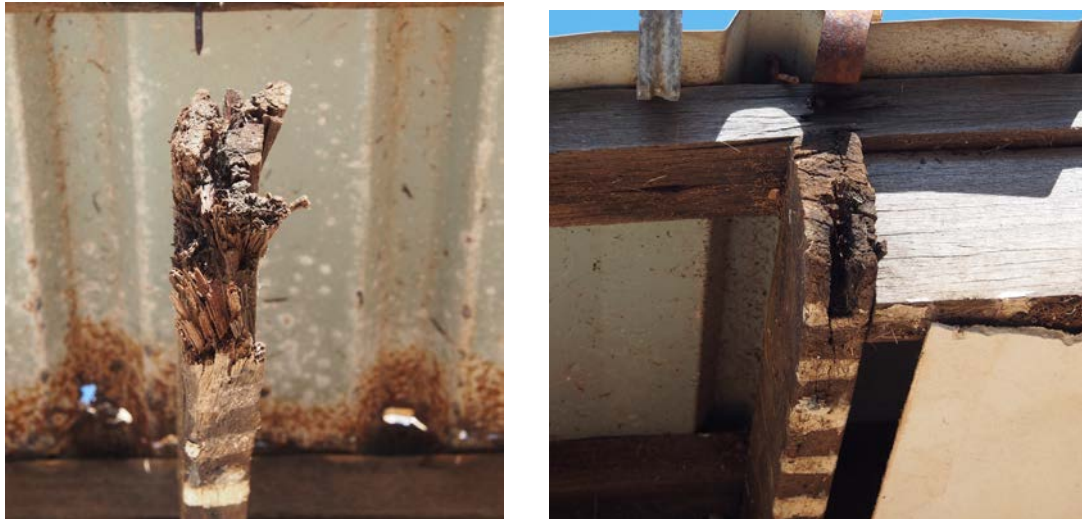
In many cases some deterioration in structural elements was noted. Figure 3.6 shows deterioration in the ends of rafters that allowed withdrawal of coach screws that had been used to attach a pergola in 2000 (after TC Vance). In this case, the loss of the pergola led to some roof damage on the same building. The roofing itself was in poor condition, which over many years may have let water into the timber, and led to its deterioration.

***Figure 3.6 – Deterioration of rafter ends at pergola fixing point and corrosion of cladding.***

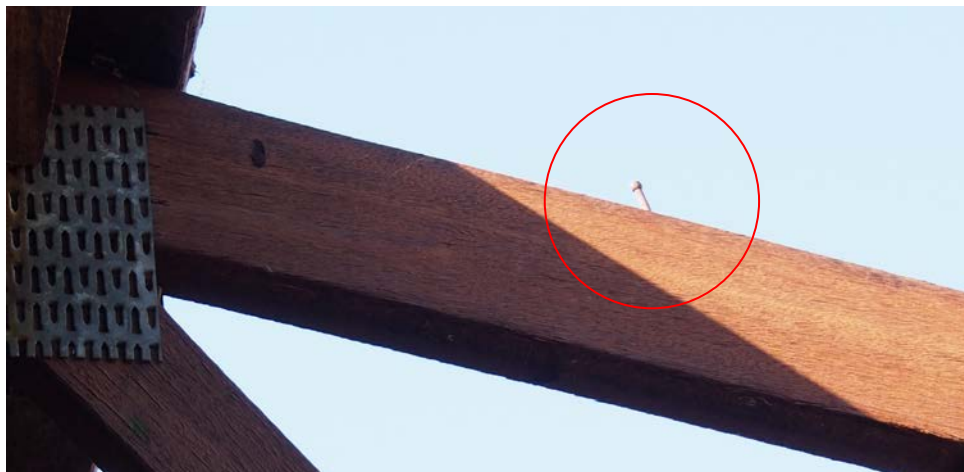
The report on TC Vance (Reardon, Henderson and Ginger, 1999) indicated that a significant problem in older houses was the single nail used to secure battens to trusses or rafters. In many of the older houses, an angle iron overbatten above the external walls secured the whole roof structure to the walls. (The overbatten is shown in Figure 3.3(a).) However in TC Vance, battens separated from the trusses closer to the ridge and this allowed significant damage to roofs in spite of the overbattens still remaining. After TC Olwyn, at least one older house was seen in which battens had separated from trusses that were fastened by only one nail. Figure 3.7 shows a truss with the single nail connector remaining after the batten had been pulled over it.

***Figure 3.7 – Single nail batten to truss fixing after TC Olwyn.***

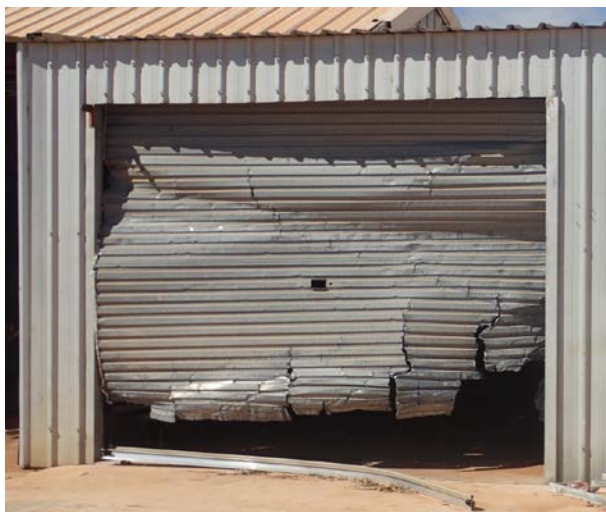
Only one badly damaged roller door was seen in the investigation following TC Olwyn, shown in Figure 3.8.

*Figure 3.8 – Failure of an older conventional roller door in TC Olwyn.*

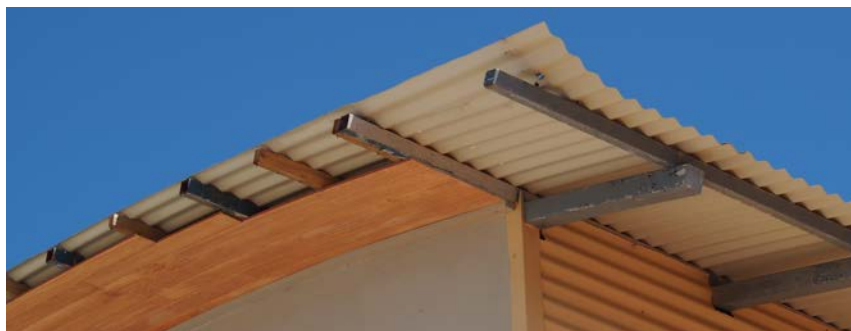
Almost all recently constructed buildings have sheet metal roofs. Some corners of roofing had lifted where the flashing had been lost. Figure 3.10 is a typical example. In this case, and others like it, the problem was associated with the extra loads applied to the partially connected flashing after connections of the vertical surface failed. The failure did not progress beyond the area near the loss of the flashing. There were sufficient reserves of strength in the roofing fasteners to stop the sheeting from detaching at the low loads experienced.

*Figure 3.10 – Lifting of roofing at loss of flashing*

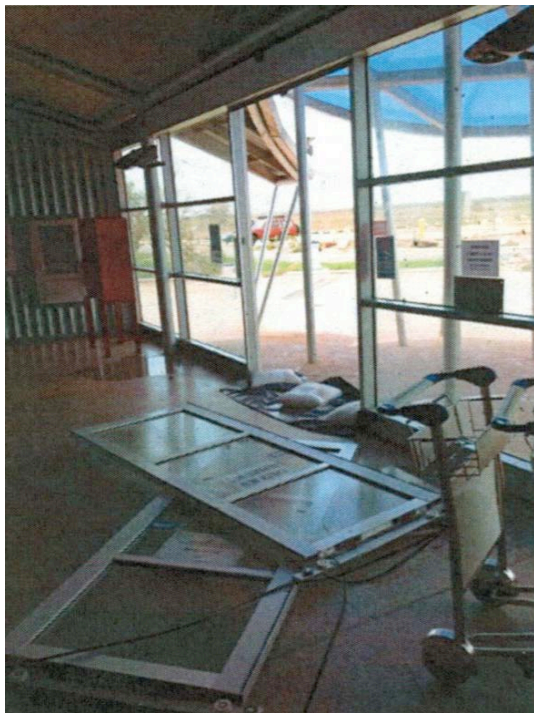
Figure 3.12 shows failure of entrance doors in a large public building. These doors were on the windward face of the building in the early part of the cyclone. Security vision showed that they failed before the peak gust was experienced. The same vision shows that after they failed, they were blown at least 5 metres into the building and substantial volumes of water were allowed in over a tiled floor. Following the loss of the doors, air currents within the building moved papers and blew over potted plants in other parts of the interior space.

*Figure 3.12 – Failure of entrance doors (photo Jenny Kox, Shire of Exmouth)*

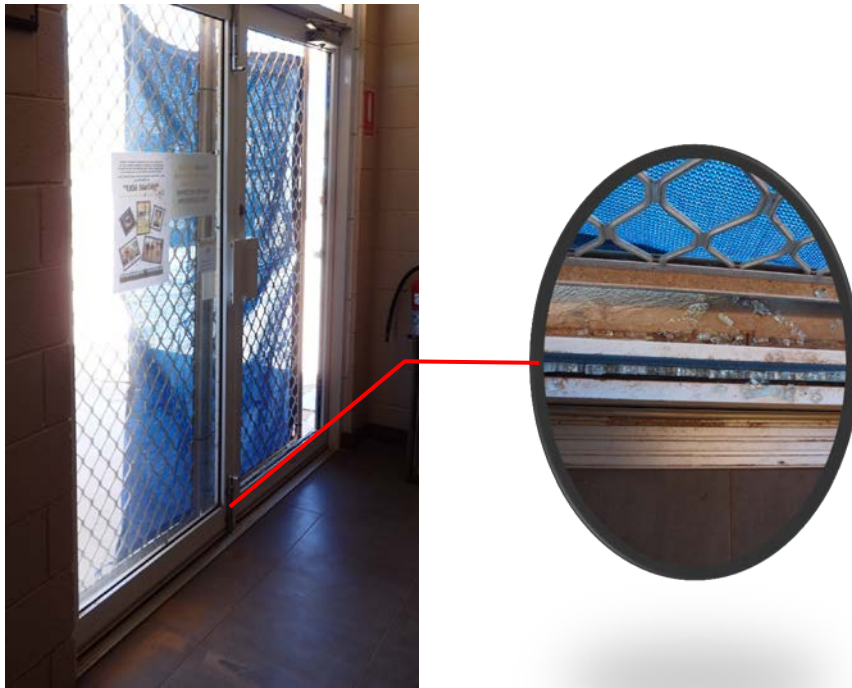
Following failure of the doors, water and wind-driven sand was admitted to the carpeted area behind them. Five suspended ceiling panels were blown upwards into the ceiling space and the underside of the roof sheeting would have experienced internal pressure from the dominant opening.

**Figure 3.13 – Failure of toughened glass in doors**

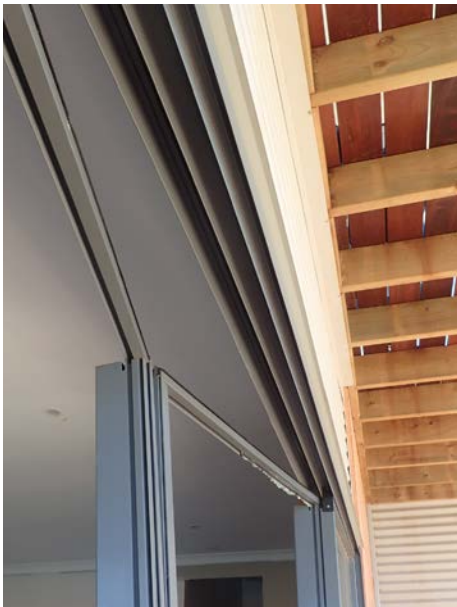
Three houses were seen in which sliding sashes had come out of their frames. In each of these cases, the frames had deflected under the windward wall pressures towards the inside of the house. The sashes detached from the frames and blew into the house. Figure 3.14 shows a damaged frame in house almost ready for handover that had previously held two full height glass sliding door sashes. The frame had permanently deformed at both the top and bottom. Once the sliding door sashes had blown in and lost their glazing, the internal pressures caused some windows on a side wall to also distort the frame (Figure 3.15) and blow out of the building. There was no label that indicated the window rating visible on this window.

**Figure 3.14 – Inward failure of glass door frames**

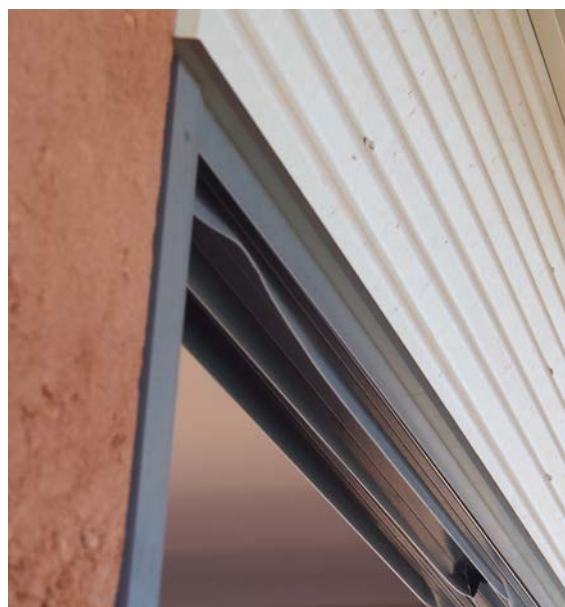
**Figure 3.15 – Outward failure of glass door frames**

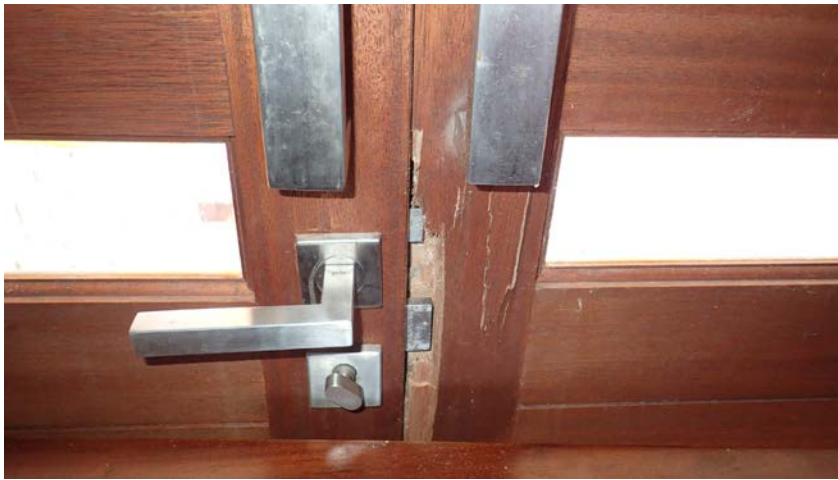
Inward opening, double front doors on windward walls that had no bolts or inadequate bolts into the door header and floor failed in several houses (Figures 3.16 and 3.17) at the latches due to the prising forces as the doors are forced inwards.

*Figure 3.16 – Failure of double front door*

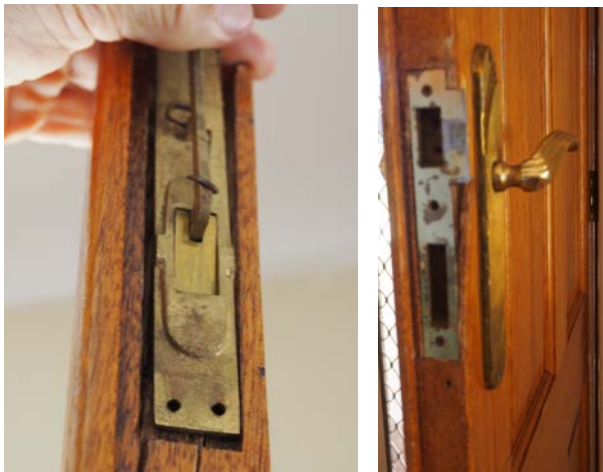
*Figure 3.17 – Failure of latches on double front door*

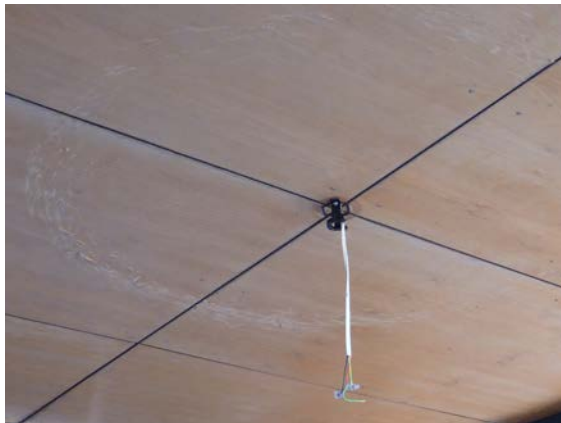
However, there were a number of ceiling fans in outdoor areas that were damaged or that caused damage to the linings of alfresco or balcony areas. An example is shown in Figure 3.18.

*Figure 3.18 – Loss of ceiling fan and damage to soffit*

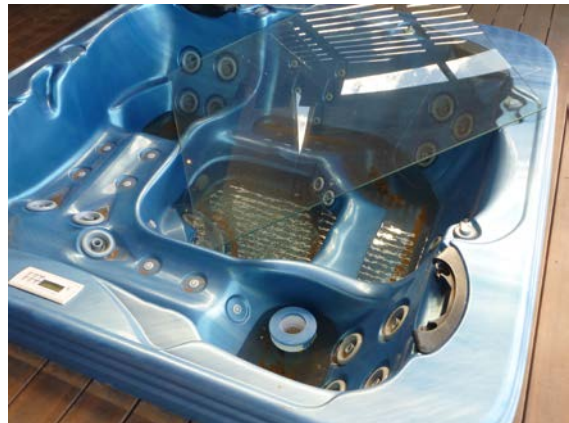
*Figure 3.19 – Damage to glass spa fence*

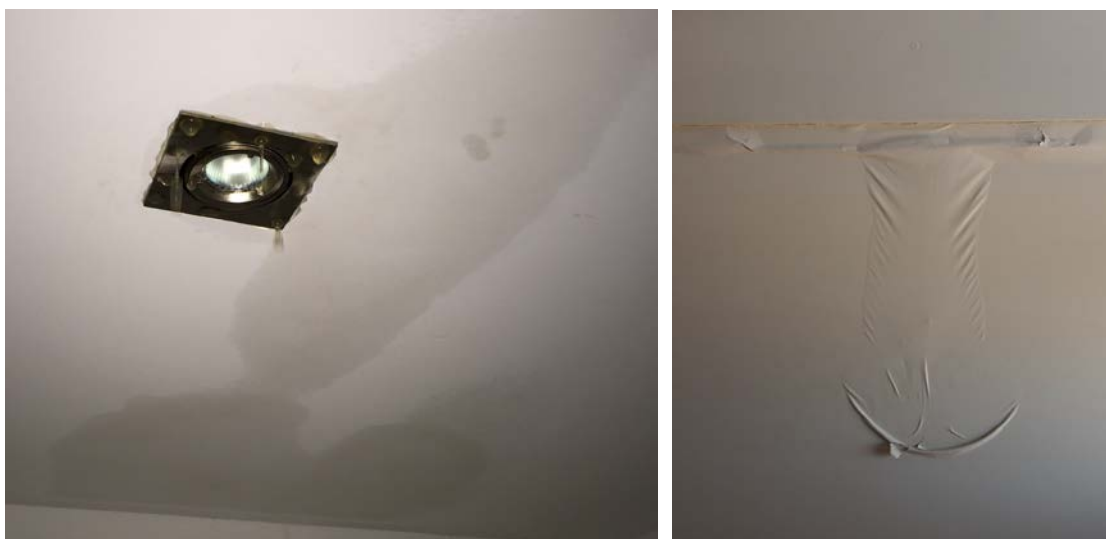
Some wall and ceiling linings such as plasterboard are particularly sensitive to water ingress. Where the ingress was above a ceiling, water pooled on the ceiling or soaked insulation that saturated ceilings. People reported water running from light fittings (Figure 4.2 (a)) and smoke detectors. In some cases, the water also ran down wall cavities, causing damage to plasterboard wall linings.

*(a) Water through light fittings (Photo Shannon Bailey) (b) Damage to wall lining*  
**Figure 4.2 – Water damage to ceiling and wall linings**

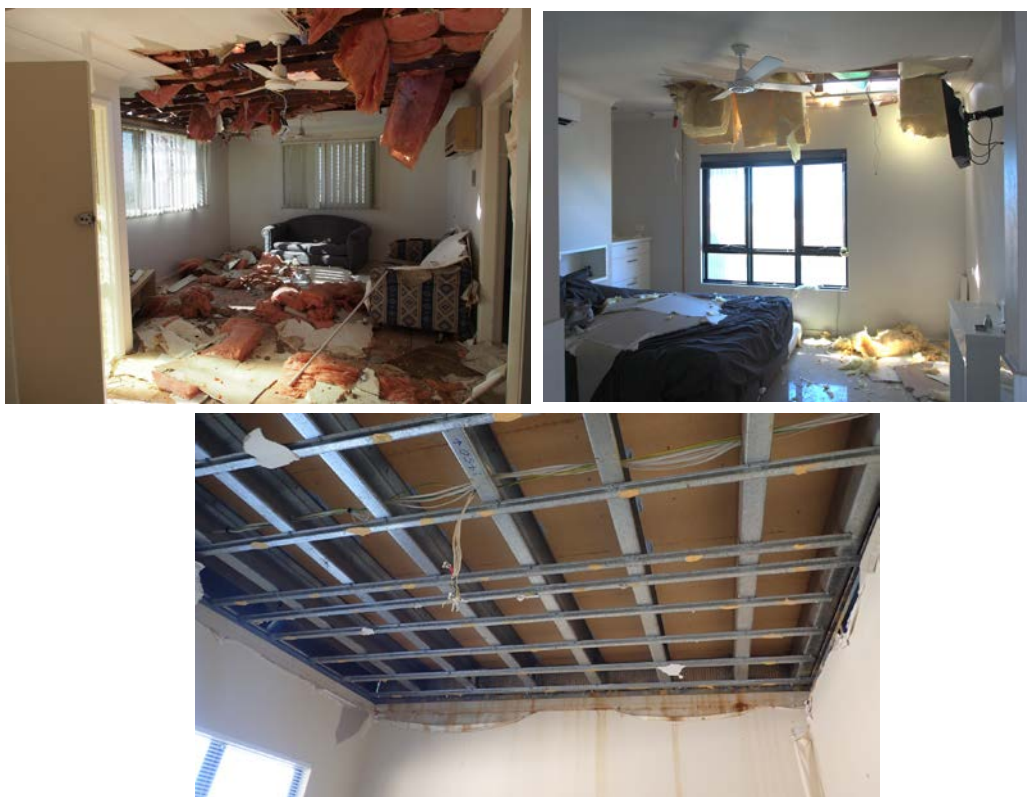
As the ceiling acts as a structural diaphragm to redistribute lateral loads to the tops of bracing walls in severe wind events, structural performance may be compromised by loss of the ceiling. There were no cases of structural performance being affected by diaphragm loss reported to the investigators.

*Figure 4.3 – Examples of water damage to ceilings*

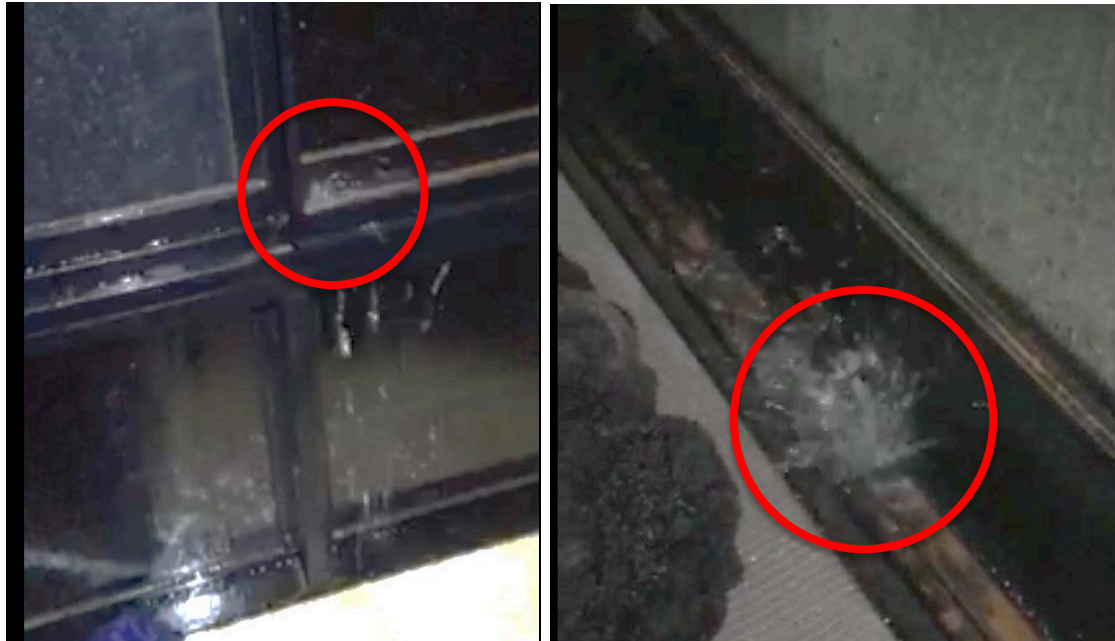
Some occupants reported a steady spray of water from the base of windows into rooms on the windward side of the house.

*Figure 4.5 – Water ingress through weepholes (Photos Toby Scholl)*

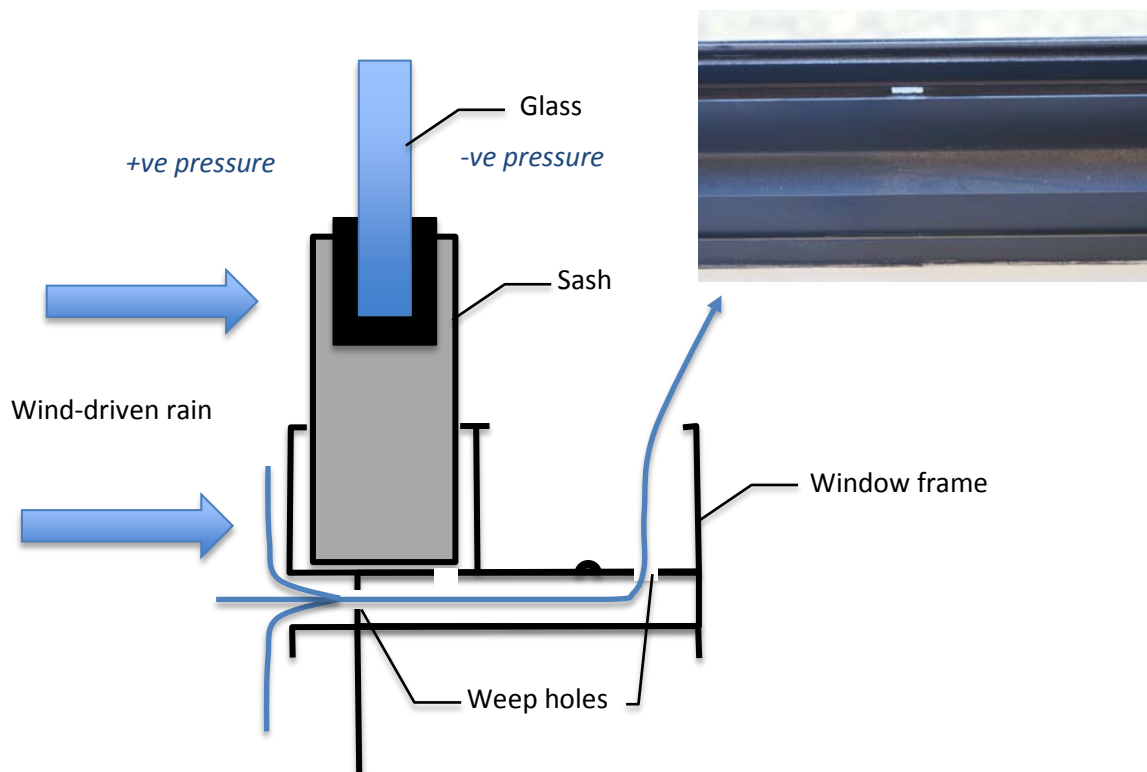
The weep holes in windows (small drain holes in the frame) are designed to allow condensation and minor leakage around seals to pass through to the outside of the building. However in high winds, Figure 4.6 shows that on windward walls, horizontally driven rain is forced through the weep hole by the air pressure (in the opposite direction to its intended path). Some people reported that the water was spurting two metres from the window, and compared the jet of water with a garden hose.

*Figure 4.6 – Weep holes in sliding window assembly*

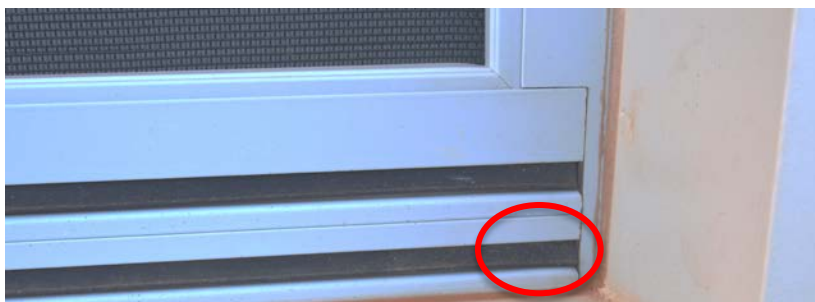
One type of sliding window had a rubber flap on the outside of the frame that covered the weep holes. This successfully reduced water ingress on a recently constructed house in this event. However, some minor deterioration in the rubber was noted. If the seals deteriorate further, performance of the windows in future cyclones may be affected. (Figure 4.7)

*Figure 4.7 – Weepholes covered by rubber flap*

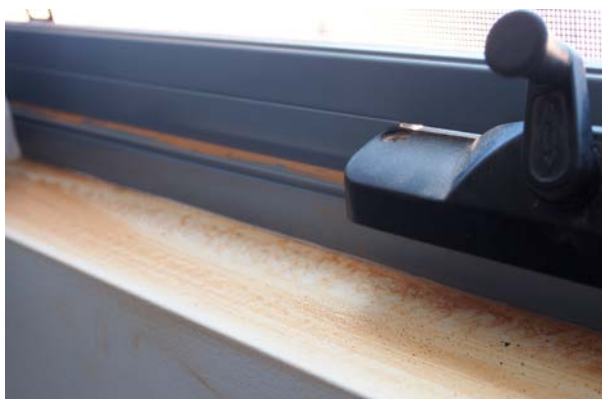
In general, awning windows with rubber seals performed better than those with wool pile or mohair seals as shown in Figure 4.9.

*(a) Damage from water ingress through wool pile or mohair seals*

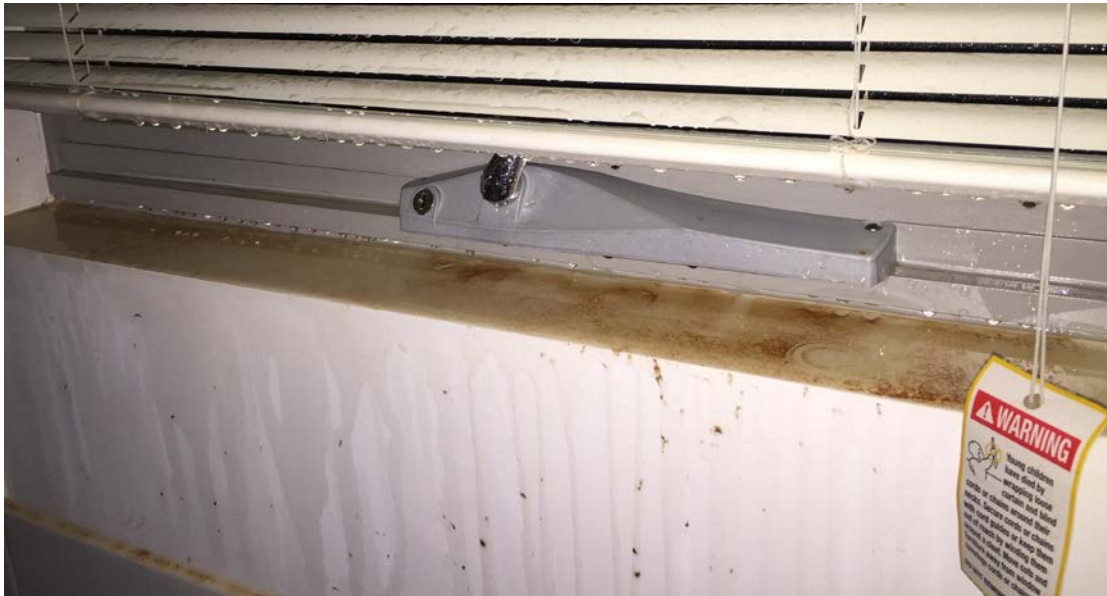
However, significant water that had passed through or around the seals, penetrated through the opening mechanism in some awning windows, as shown in Figure 4.10.

*Figure 4.10 – Water ingress through opening mechanism in awning window (Photo Shannon Bailey)*

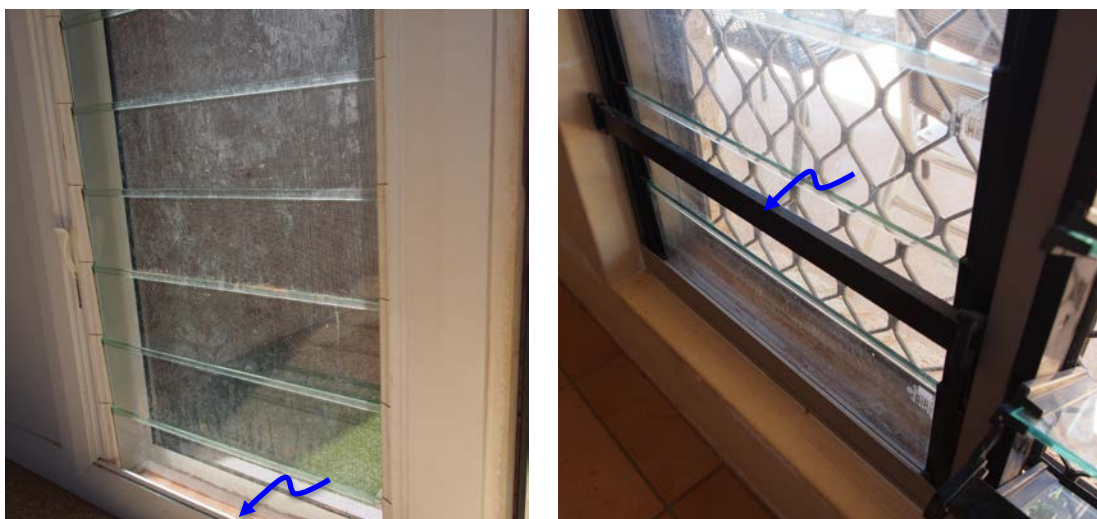
In general, contemporary louvre windows performed well during TC Olwyn. Home-owners reported that only small amounts of water leaked into houses either between the panes or over the bottom lip of the louvre frame as shown in Figure 4.11.

*Figure 4.11 – Water ingress through louvres*

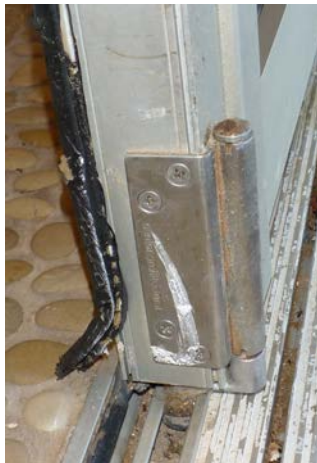
Owners of a commercial building reported that a large volume of water entered through their outward opening bi-fold doors. The seals of these doors (Figure 4.13) had been damaged before the event by workers moving furniture in and out of the building.

**Figure 4.13 – Damaged seals in multi-fold doors**

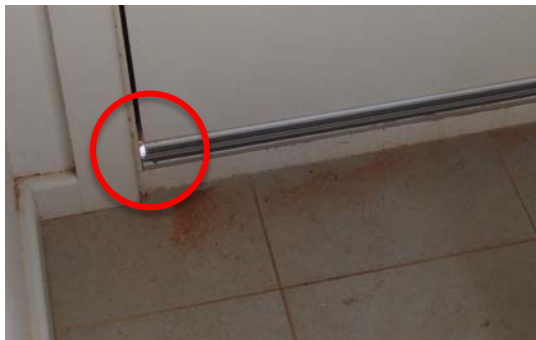
- Flexibility in the door allowing the top and bottom edges of inward opening doors to move away from the frame and seals under wind pressure. Once the door had moved away from the seal, a leakage path between the door and the seal was established. This type of leakage was not reported where there were strong bolts at the top and bottom of doors.
- Incomplete seals in either outward or inward swinging doors allowed water to enter the house. (Figure 4.14)
- Damage to door furniture that allowed the doors to swing fully or partially open (see Section 3.2.4)
- Damage to seals and frames due to wind action. (Figure 4.15)

*Figure 4.14 – Leakage paths through gaps in seals on swinging doors*

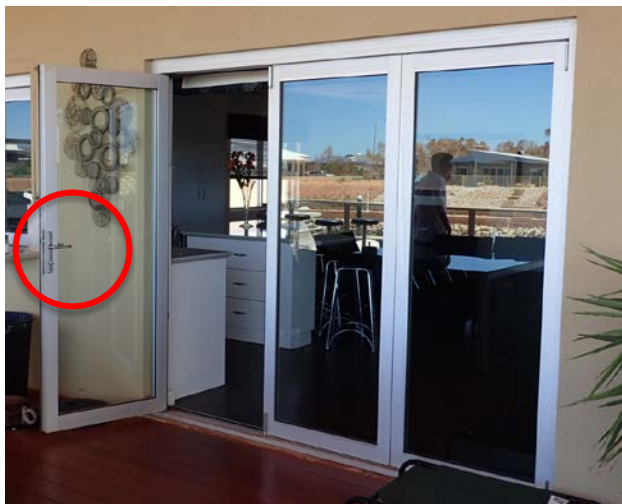
*(a) Damaged seal near lock*

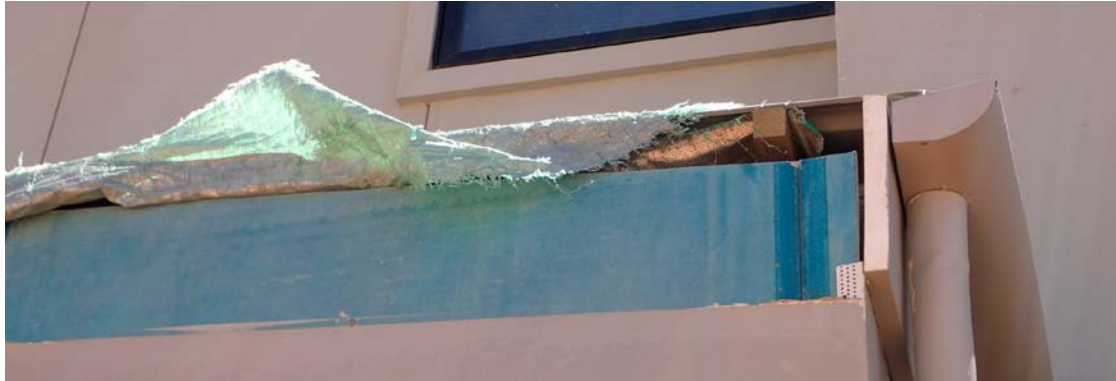
Loss of flashings due to wind loads where flashing is inadequately fastened can cause partial loss of roof sheeting, and allow significant amounts of water into the building. As flashings are often used above the ceiling, the loss of the flashing causes damage to ceilings as shown in Figure 4.16.

*(a) External view of flashing loss*

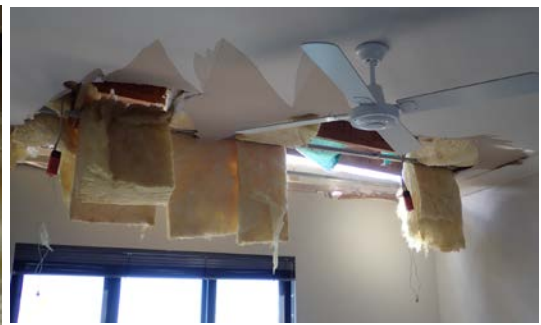
*(c) Ceiling damage from flashing loss*

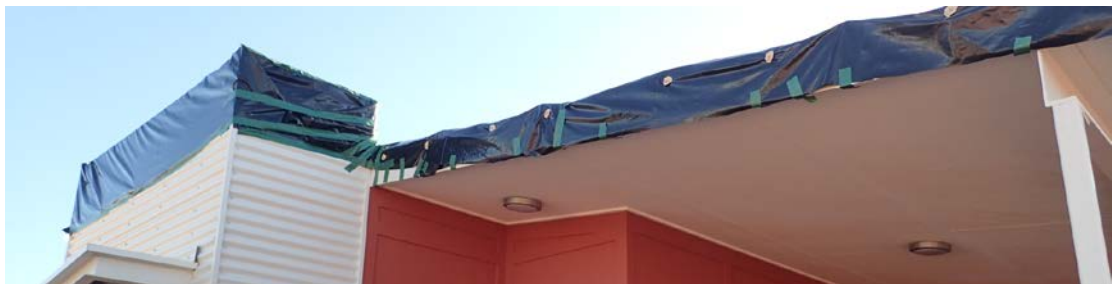
Figure 4.17 shows a building that had lost flashing from all windward edges of the roof.

*Figure 4.17 – Extensive loss of flashings*

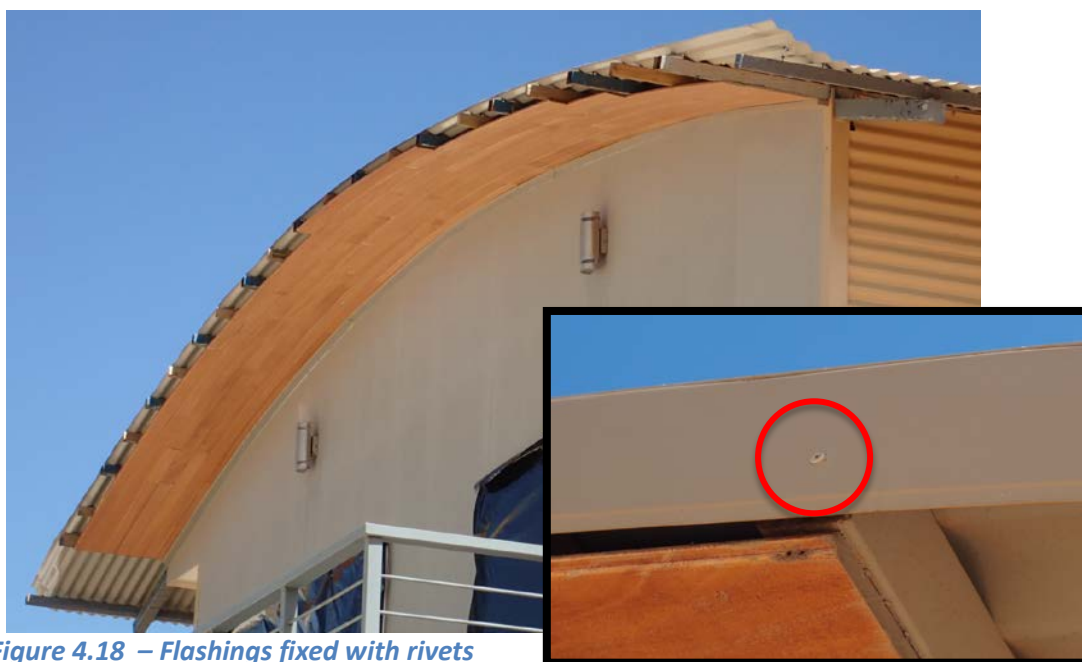
Figure 4.18 shows a house with loss of flashing and other minor roof damage. The same flashing across the width of the house on the leeward side was fixed to the eaves with only four pop rivets. It was fixed to the upper surface with the roofing screws, but as the flashing on the windward side peeled back under wind loads, some screws pulled out of the battens (shown on corner in the larger photo) and others pulled through the flashing.

**Figure 4.18 – Flashings fixed with rivets**

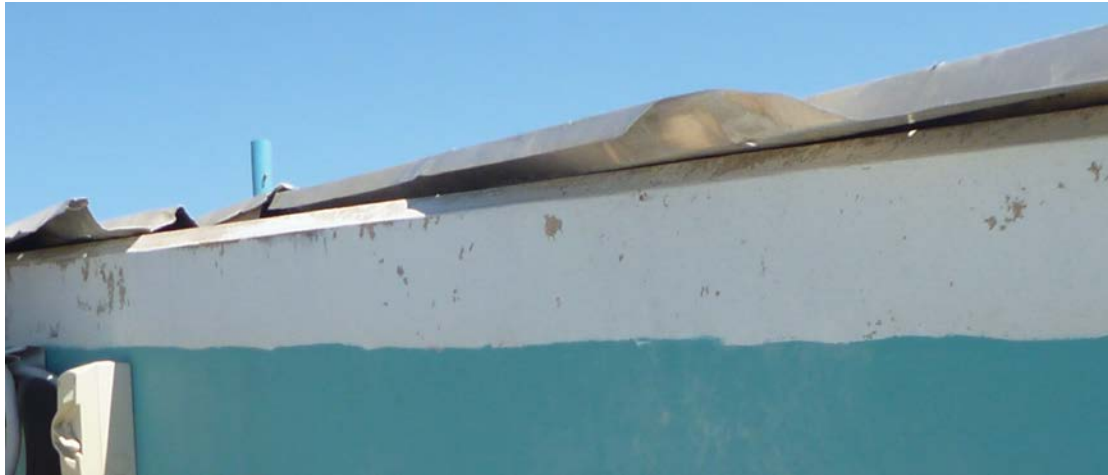
*Figure 4.20 – Flashings at an acute angle to the ribs of the roof sheeting*

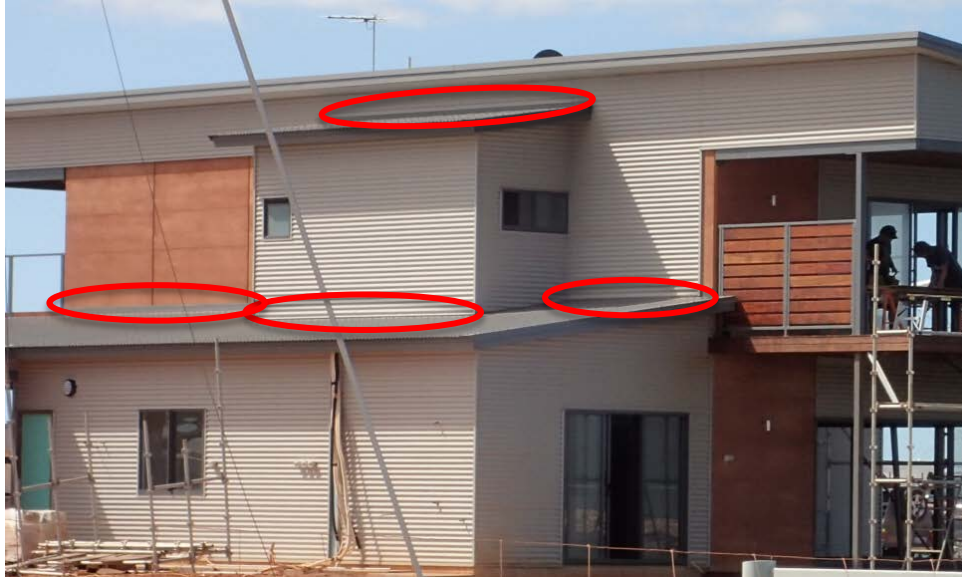
*Figure 4.23 – Flashing between roof and wall panel*

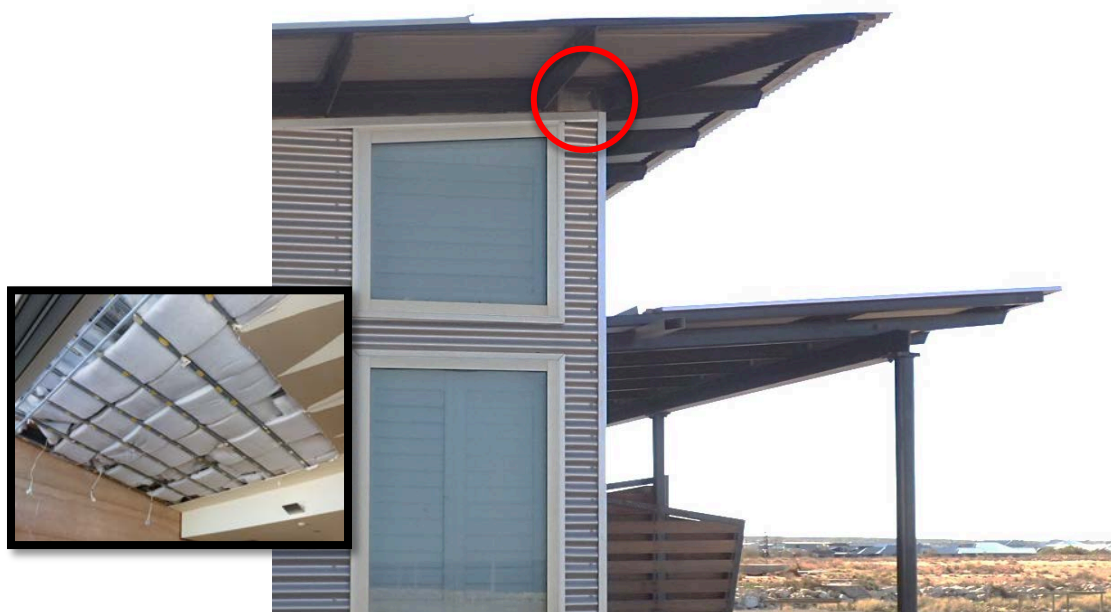
*Figure 4.26 – Building with flashing failure (inset photo shows ceiling damage)*

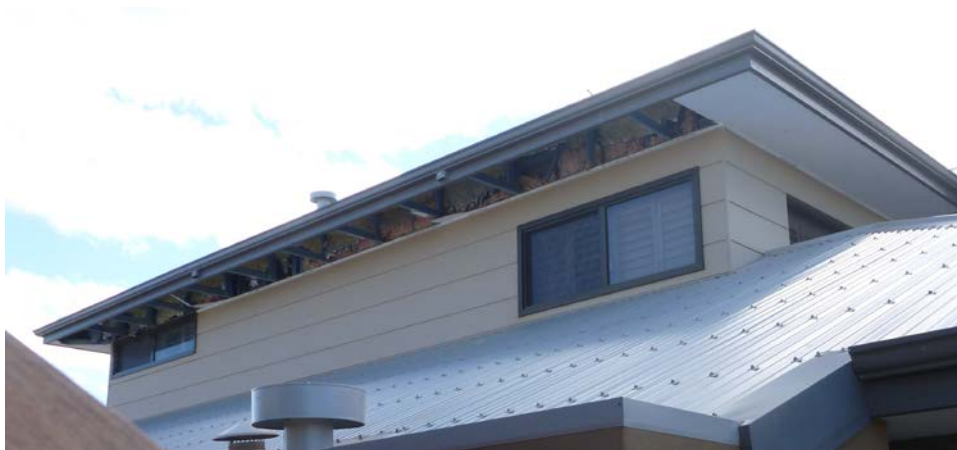
*Figure 4.29 – Damage to soffits*

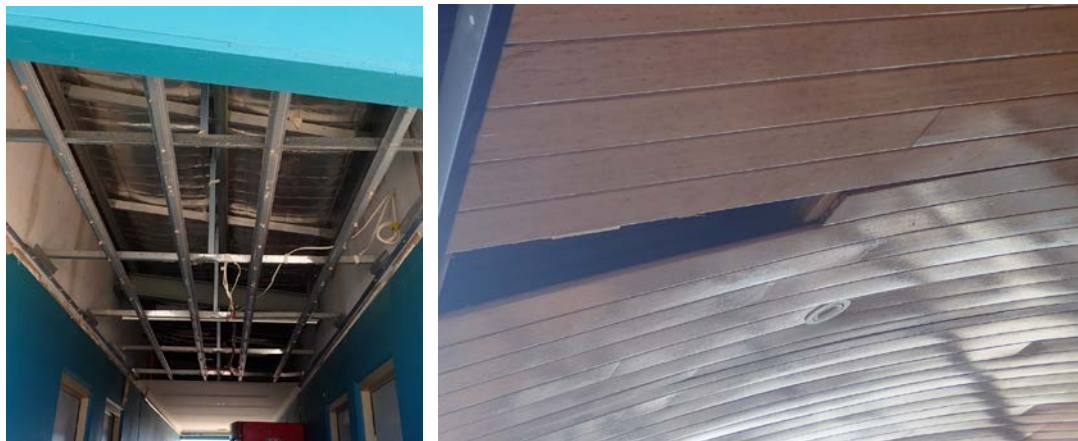
*Figure 4.30 – Damage to soffits in breezeway and above alfresco*

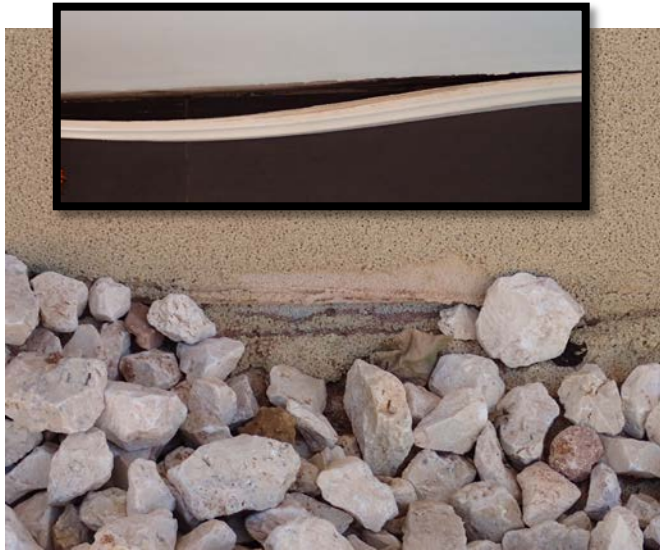
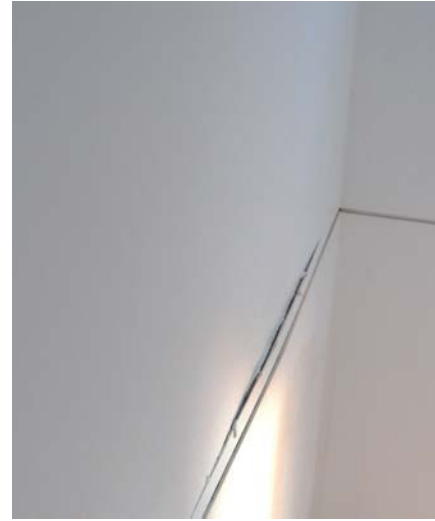
*(a) Joint between wall and concrete floor slab  
(inset shows damage to skirting board)*
