Perth Storm – 31 July 2017

Geoff Boughton and Debbie Falck

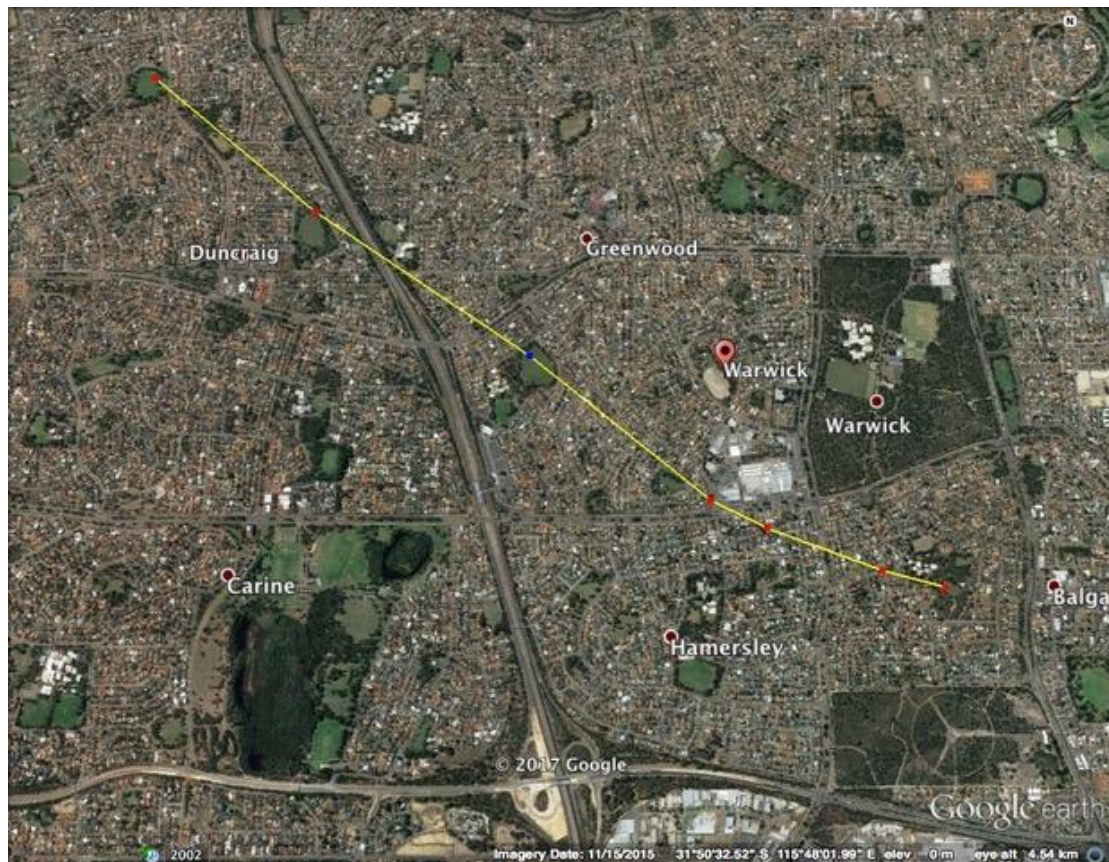
Approximate path of tornado determined by tree and building damage

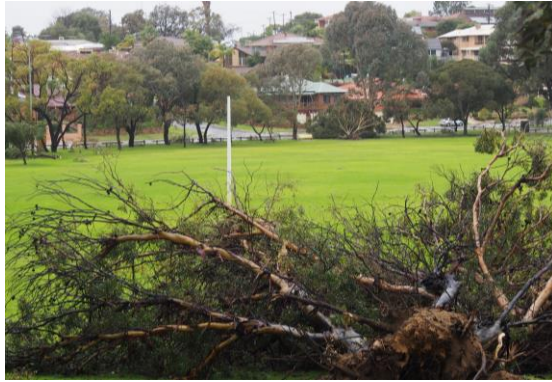
Tree damage

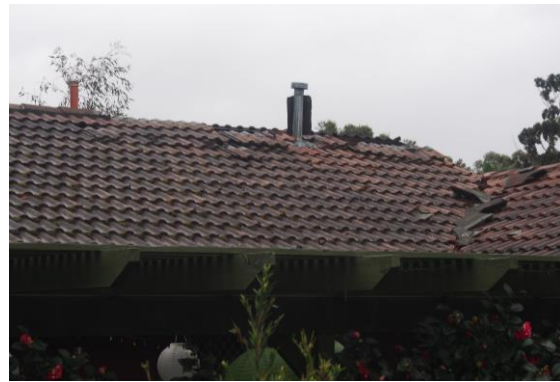
Tile damage

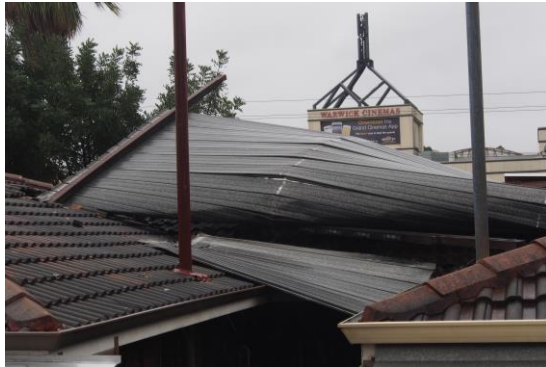
Secret-fixed roof sheeting on a carport became detached from its clips and folded back over the house roof

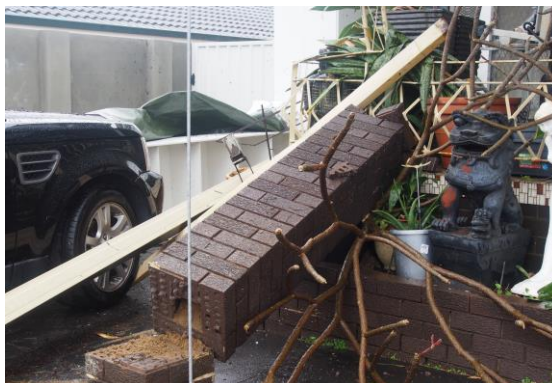
(a) Damaged carport brick pillar

Unreinforced brick pillar attached to a carport was lifted onto and through a house roof. It is highlighted in the red circle

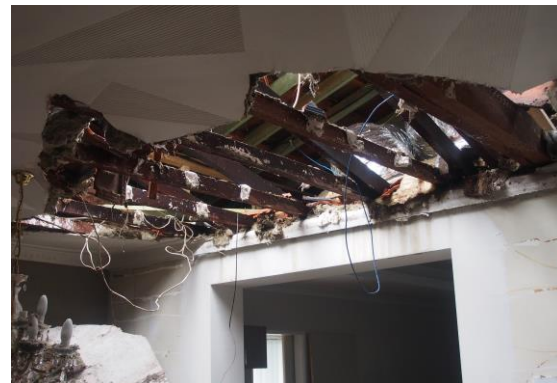
(b) Damage to ceiling

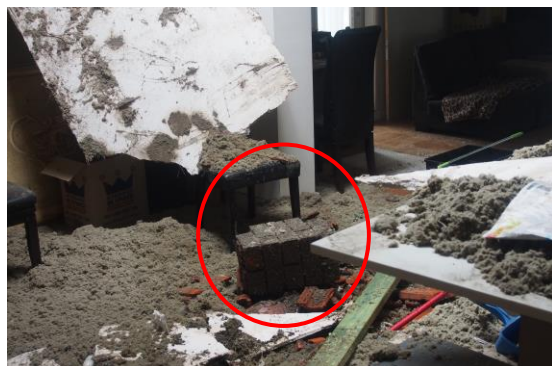
(c) Brick pillar (circled) inside dining room

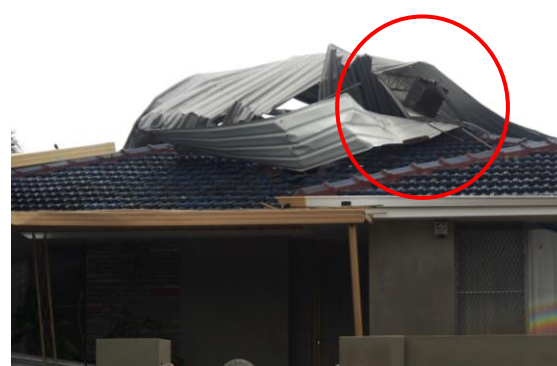
(d) Brick pillar on roof
