## Severe Wind Hazard Preliminary Assessment

Tropical Cyclone Debbie, Whitsunday Coast, QLD, Australia

28<sup>th</sup> March 2017

**Rev. 1**

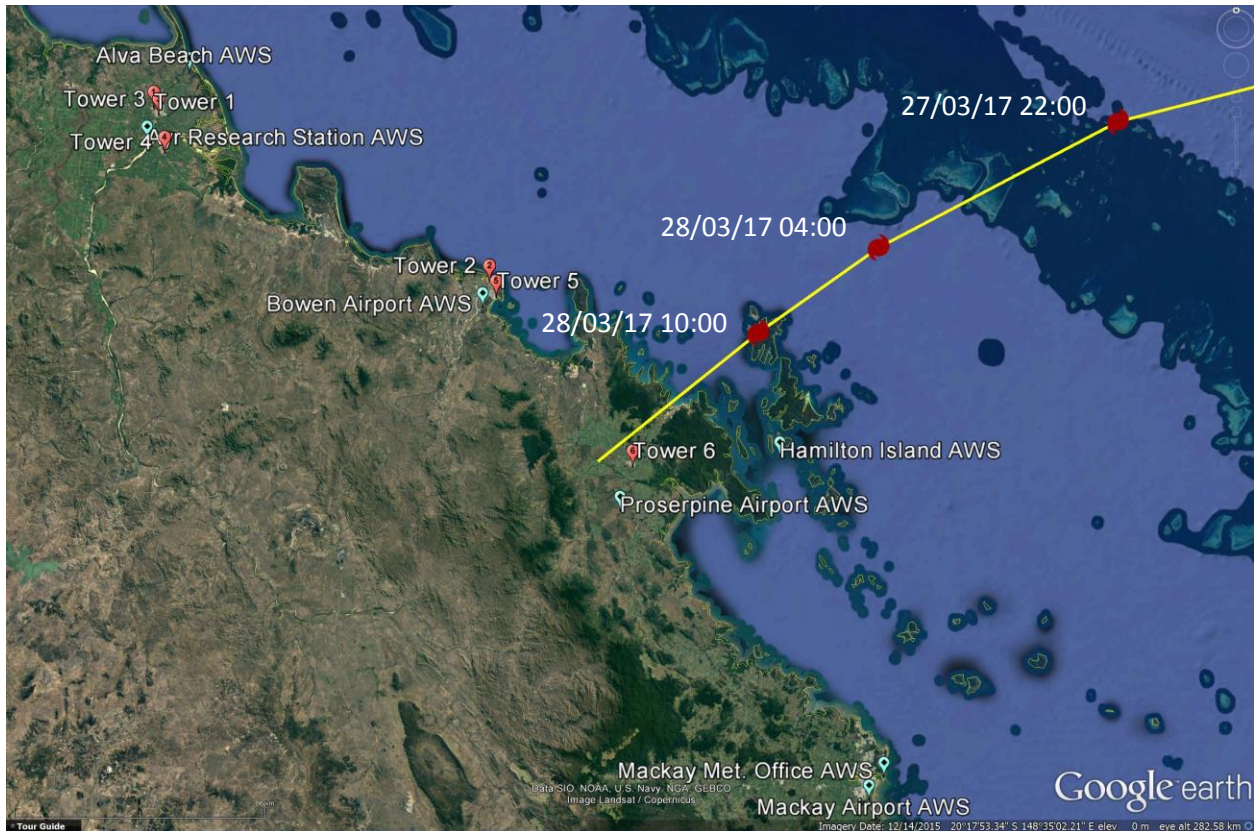
**Figure 2.** Best track for Severe Tropical Cyclone Debbie (track courtesy of the Joint Typhoon Warning Center). Dates and times are in Australian Eastern Standard Time.

This section includes preliminary analysis of wind and pressure data from the Cyclone Testing Station's SWIRLnet portable anemometers. The team deployed six anemometers (Towers 1 to 6) from Ayr to Proserpine (Figure 2). Each tower has an RM Young propeller anemometer mounted at 3.2 m height to measure wind speed and direction, a Vaisala pressure transducer and a CSL shrouded temperature and relative humidity sensor mounted at 1 m. All towers record wind data locally at 10 Hz, with 10 minute summary data files sent to an FTP (file transfer protocol) site via mobile internet networking cards. SWIRLnet anchor sites were graciously provided by the Whitsunday Shire Regional Council and Burdekin Shire Council.

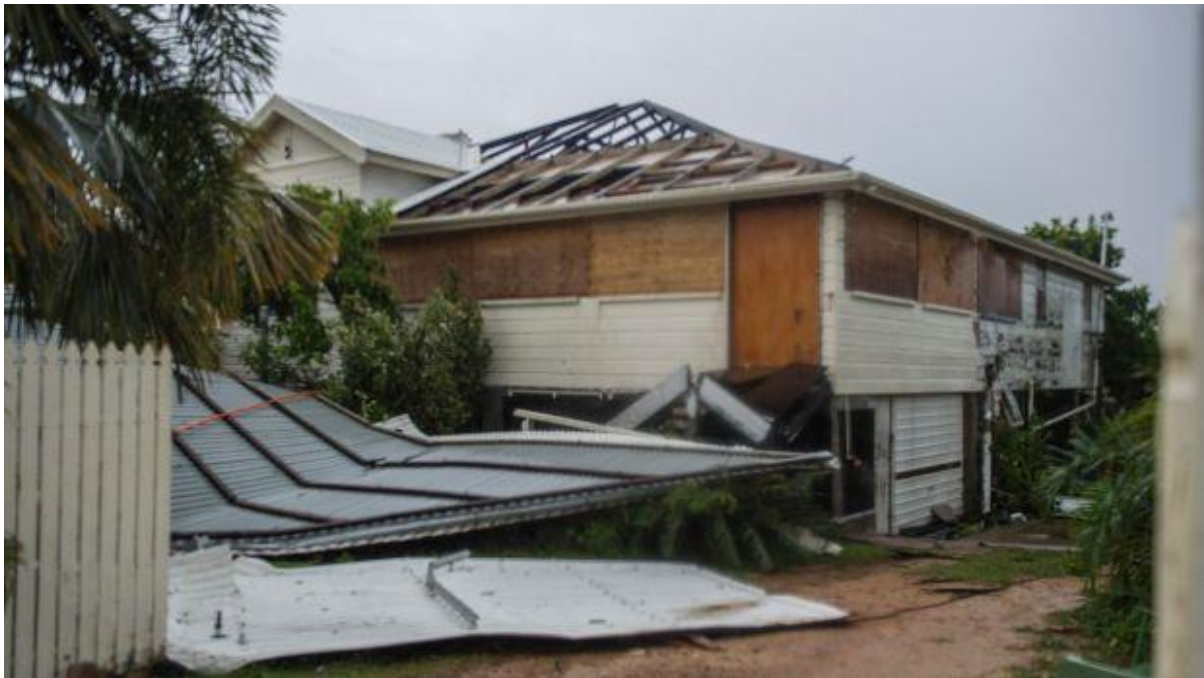
**Figure 11.** Structural failure of batten to rafter connections supporting metal cladding of an older high-set timber framed house (Bowen).

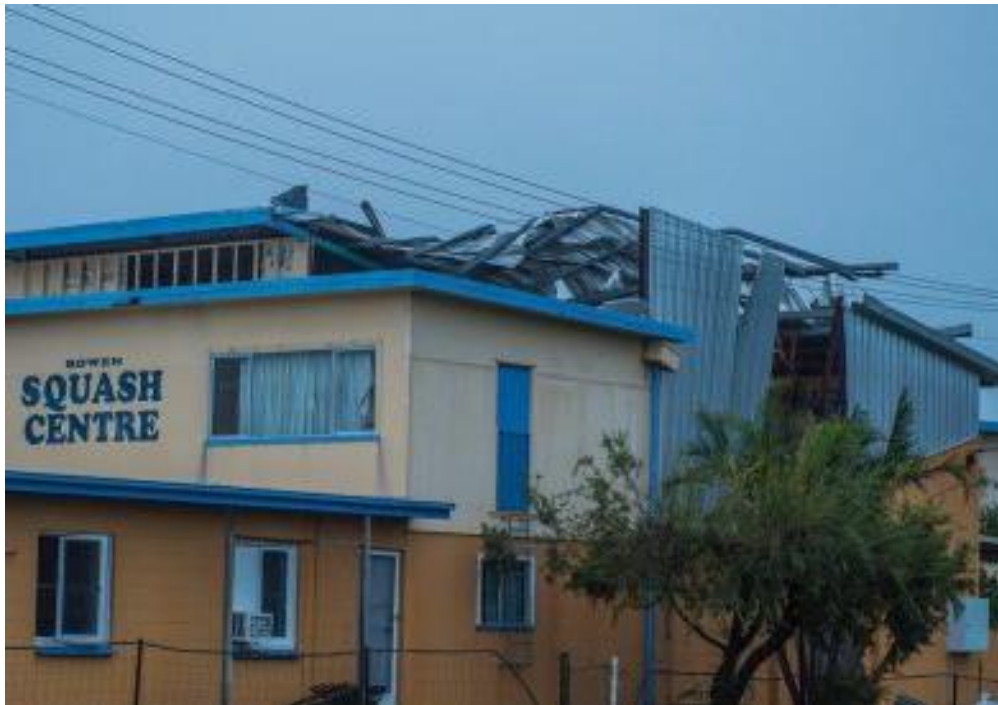
**Figure 12.** Failure of roof cladding and support connections due to severe wind loading (Bowen)

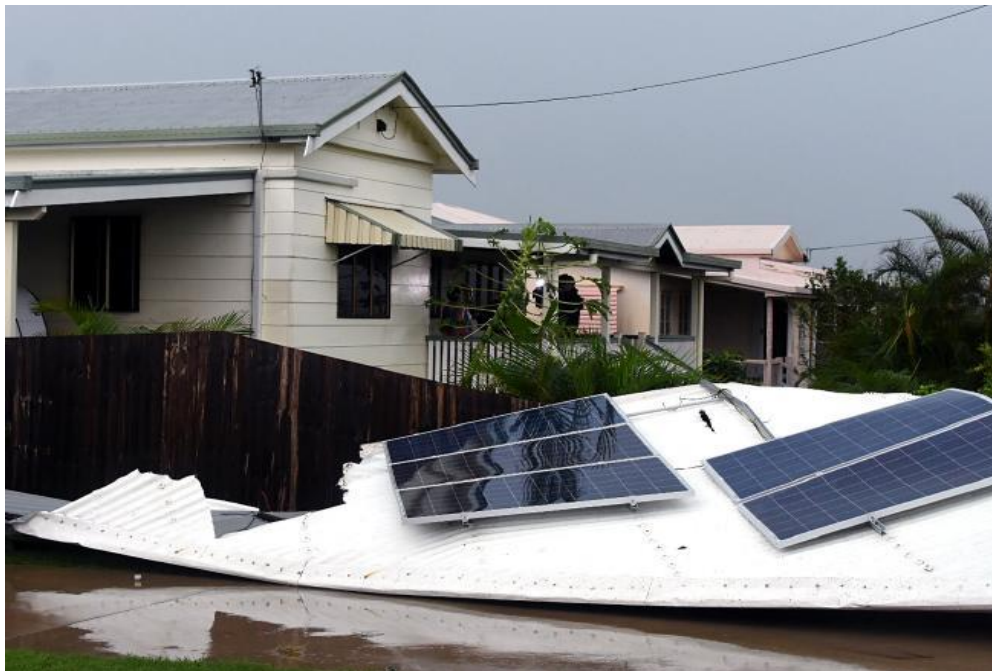
**Figure 13.** Large section of metal cladding (and possibly batten) failure in Bowen. Solar panel connections appear to have performed well.

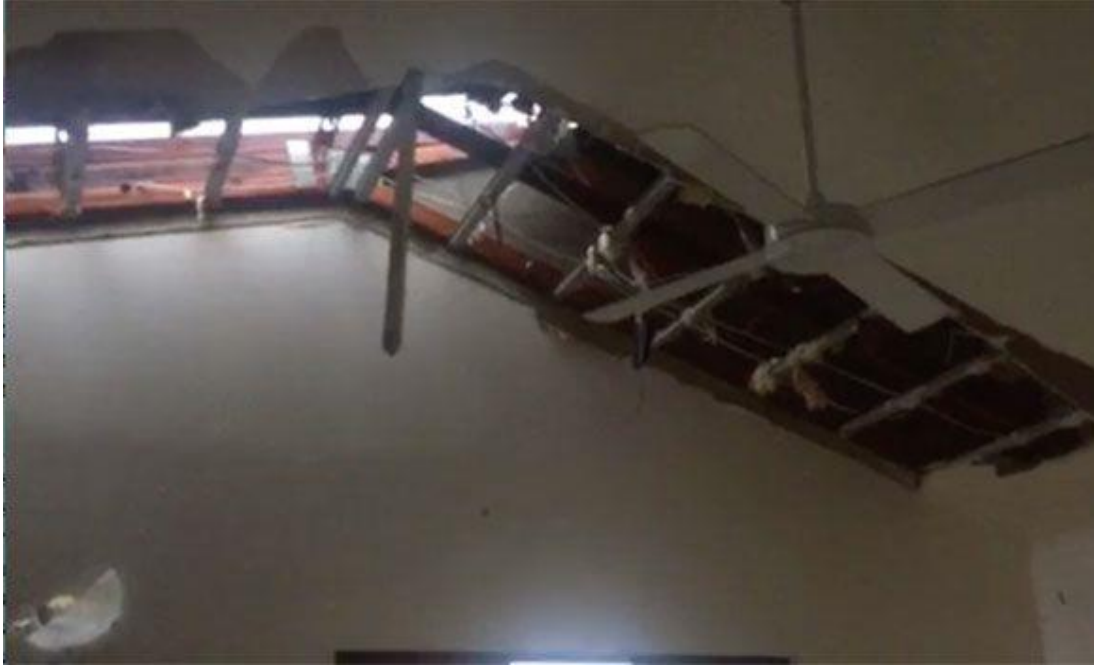
**Figure 14.** Damage to metal cladding resulting in water damage to a ceiling in Hamilton Island  
<https://au.news.yahoo.com/a/34817344/cyclone-debbie-continues-to-weaken-after-unleashing-on-mainland-queensland-hitting-bowen-after-smashing-whitsundays/#page1>

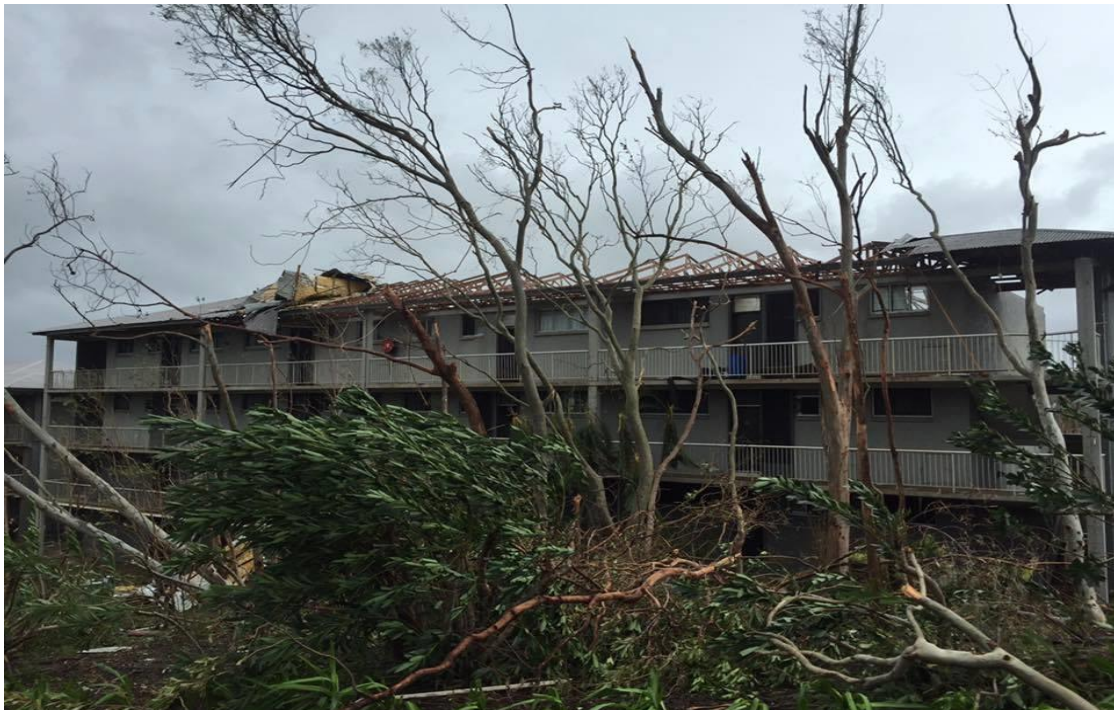
**Figure 15.** Loss of roof battens and cladding for a three storey unit on Hamilton Island  
<https://www.facebook.com/7NewsBrisbane/photos/pcb.1462910670388447/1462908637055317/?type=3&theatre>

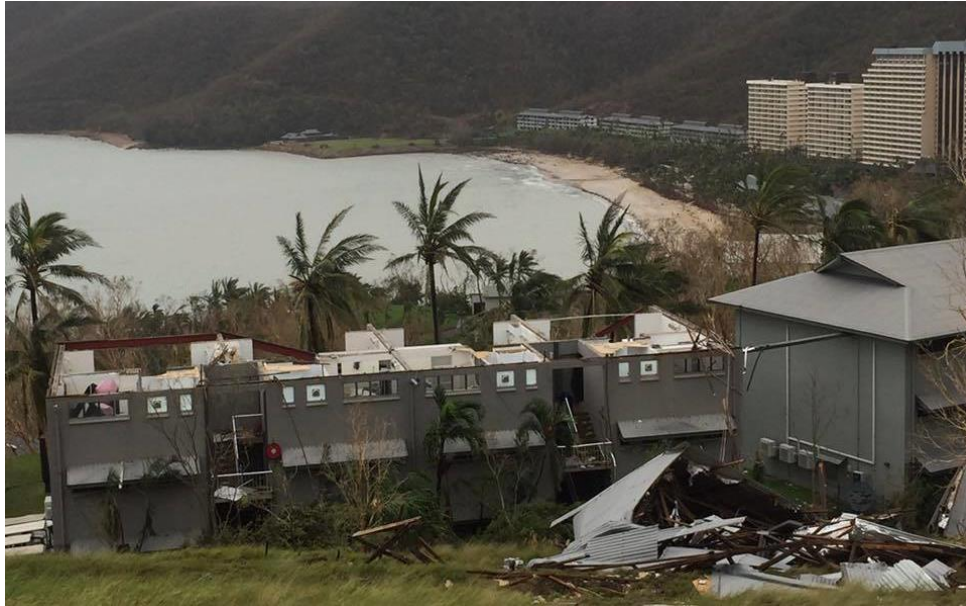
**Figure 16.** Complete loss of roof cladding and structure of a resort unit on Hamilton Island (likely) due to failure at roof to wall connections

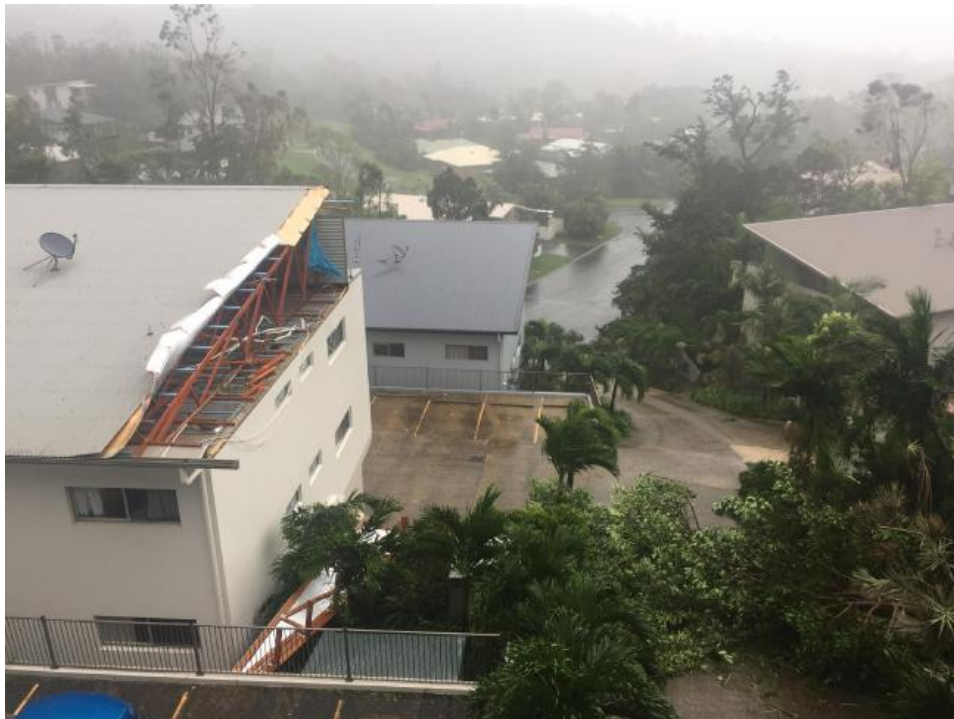
**Figure 17.** Failure of roof structure in the edge region for a modern apartment unit in Airlie Beach

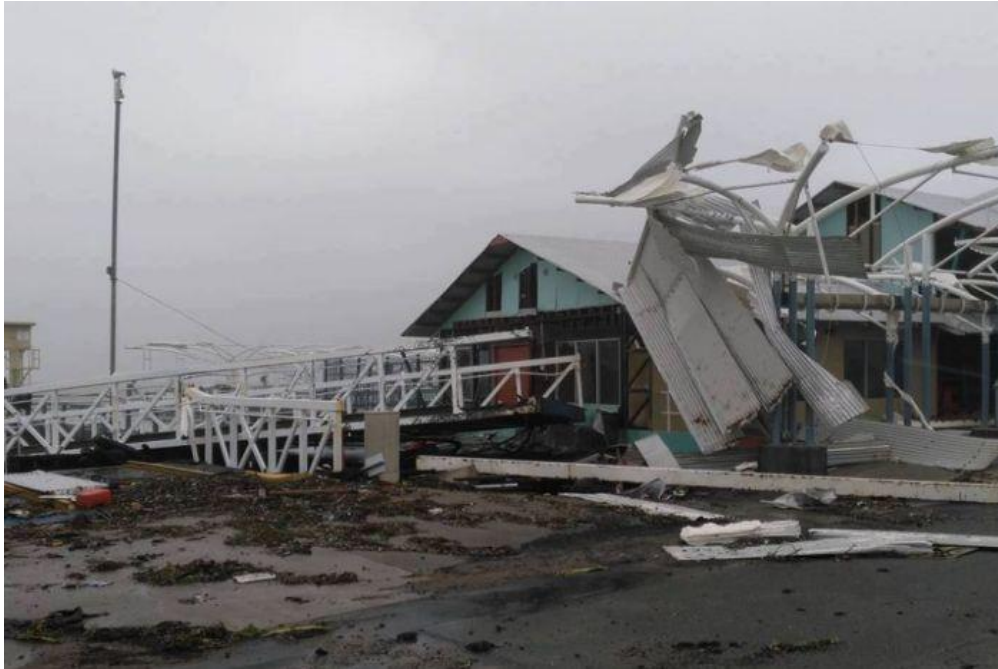
**Figure 18.** Failure of a canopy roof near Shute Harbour near Airlie beach

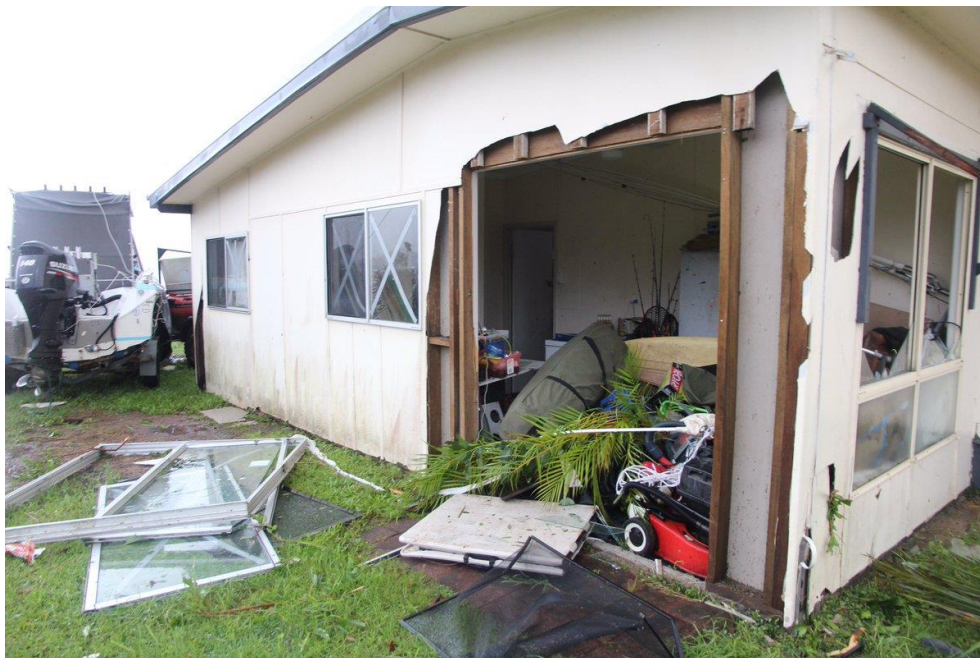
**Figure 19.** Failure of a large sliding door in Airlie Beach possibly due to internal pressurization following failure of the window in the windward wall (on the right in the photo)

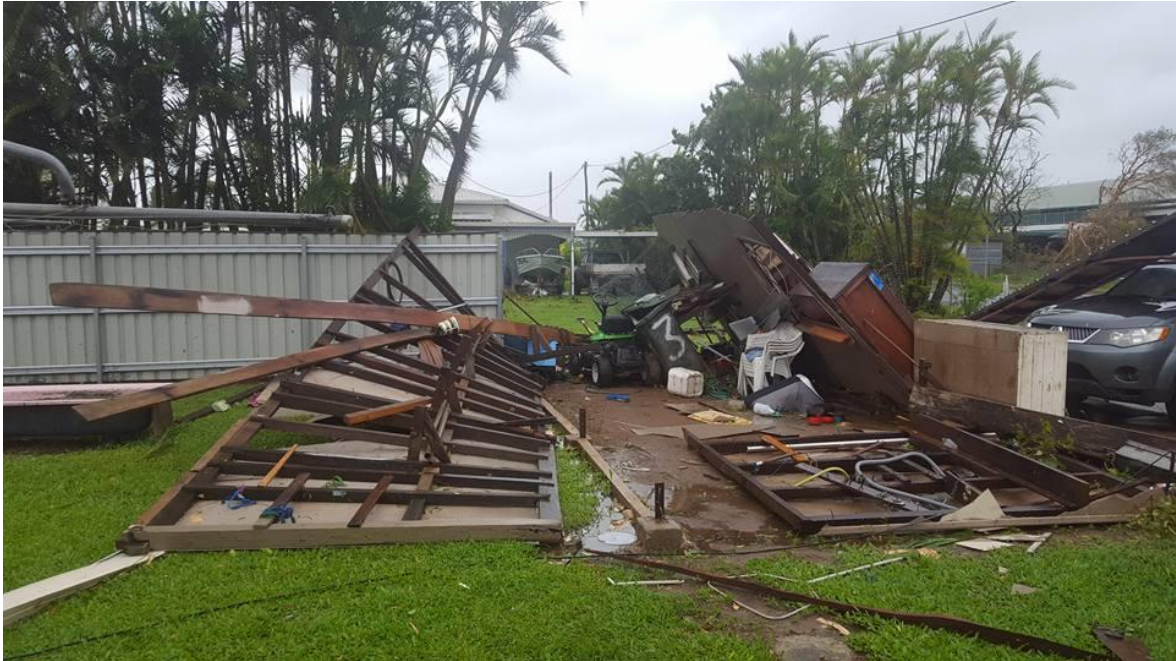
**Figure 20.** Failure of a timber frame carport in Airlie Beach

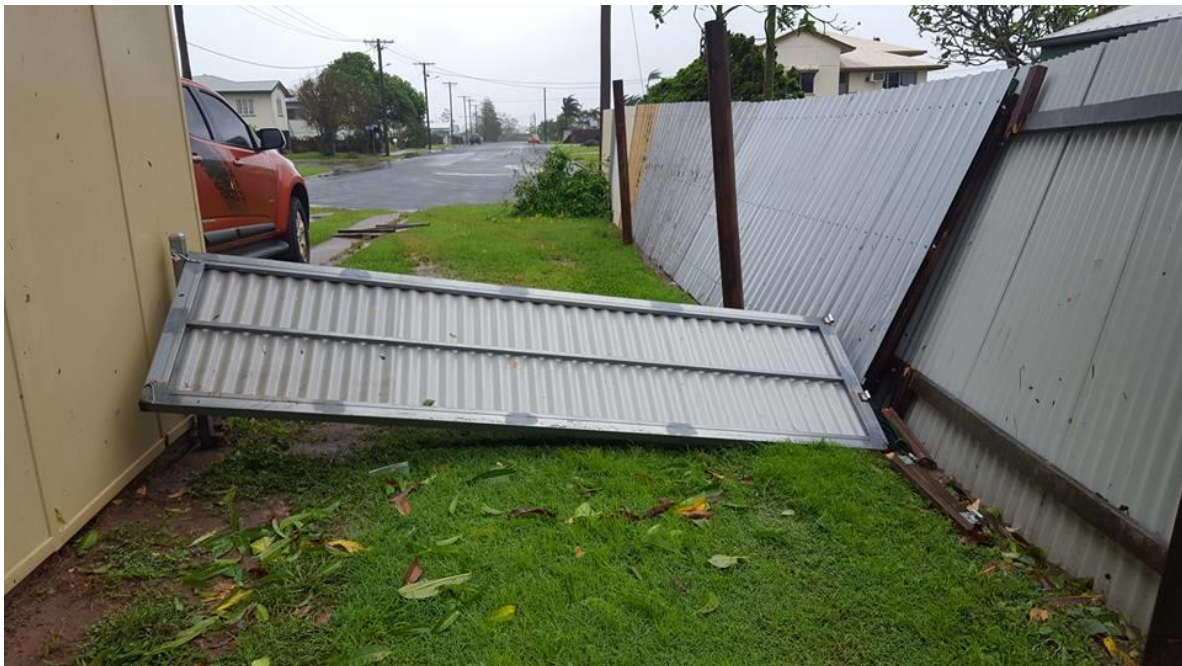
**Figure 21.** Damage to fencing and gates in Airlie Beach (typical)

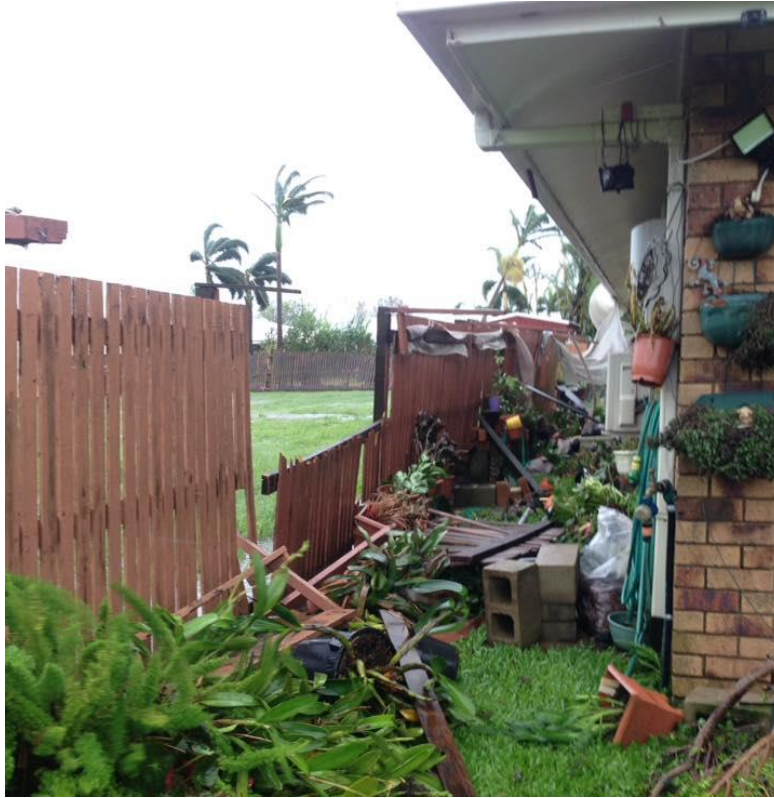
**Figure 22.** Damage to fencing in Proserpine

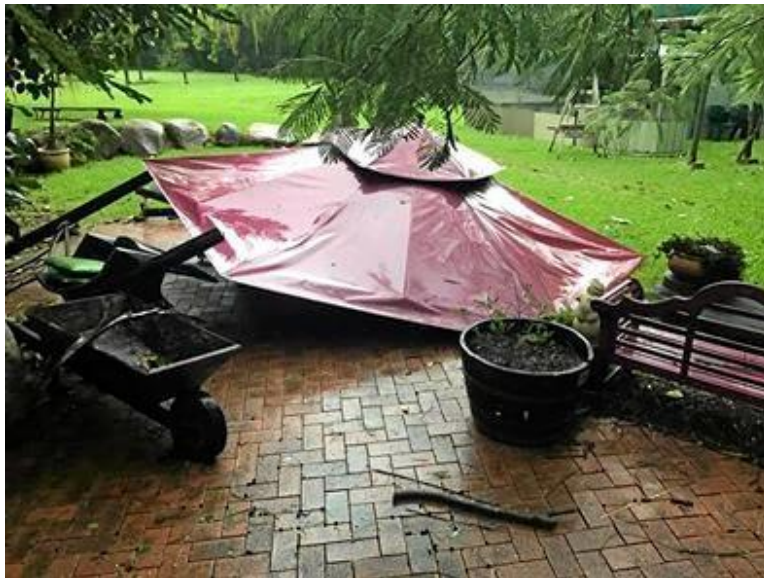
**Figure 23.** Damage to outdoor furniture in Mackay

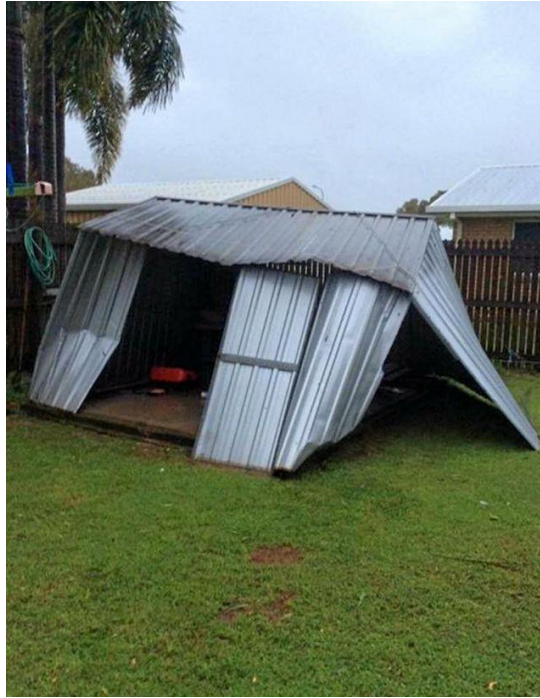
**Figure 24.** Damage to shed in Mackay
