Weak links let down strong buildings

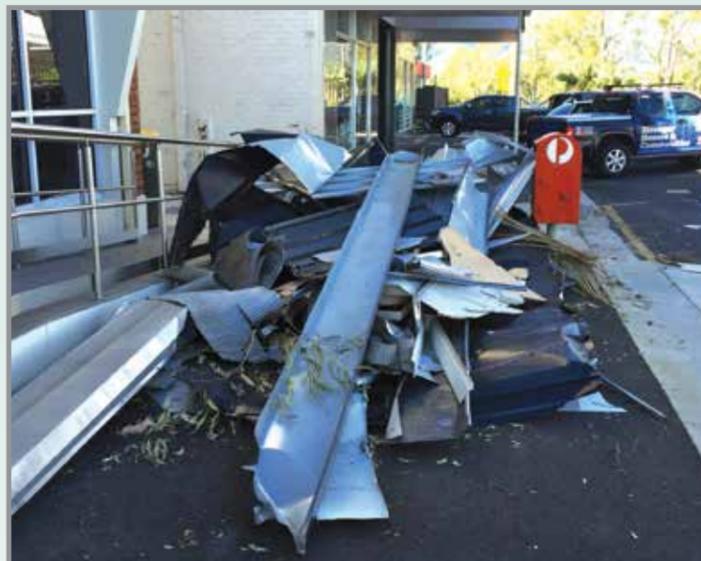
Flashings, fascias and eave linings from new buildings sometimes ended up on the street.

Areas for improvement include ensuring these “secondary” elements are actively considered in the wind engineering design, according to Heywood. *Marcia* has demonstrated that simply screwing exposed air-conditioning equipment into the roof sheeting is inadequate, he said. Substantial flashings also require wind engineering design, if they are to remain intact in edge zones where the wind pressures are highest. Likewise, vent covers need to have demonstrated compliance for wind loads and ultra violet exposure.

Heywood also said that flashings, fascias and soffits are part of the envelope of the building and need to be designed to withstand wind loads. *Marcia* had demonstrated that compromising these elements leads to water ingress and changes in internal pressure in the building with potentially damaging consequences to ceilings, walls and roofs, he said.

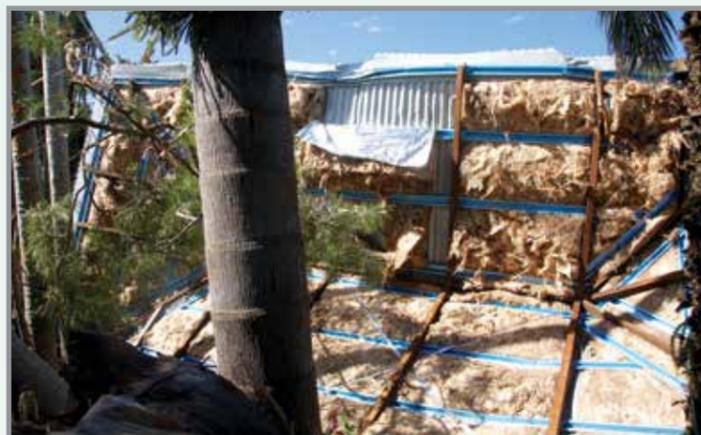
Inattention to load paths left what was a newly installed roof, essentially intact upside down among the trees.

Another significant issue was the failure of roofs that had been replaced on older buildings. There were numerous examples of new roof cladding still with battens and rafters attached, essentially intact, being blown off the house leaving the walls still standing and the contents of the house open to the elements.

Heywood said “There is something inherently wrong when owners make an investment in a new roof, only to see it blown away because the next link in the tie-down chain was not upgraded at the same time. When roofing is replaced, the complete load path from roofing to foundations needs to be considered, and not just from roof cladding to battens”.

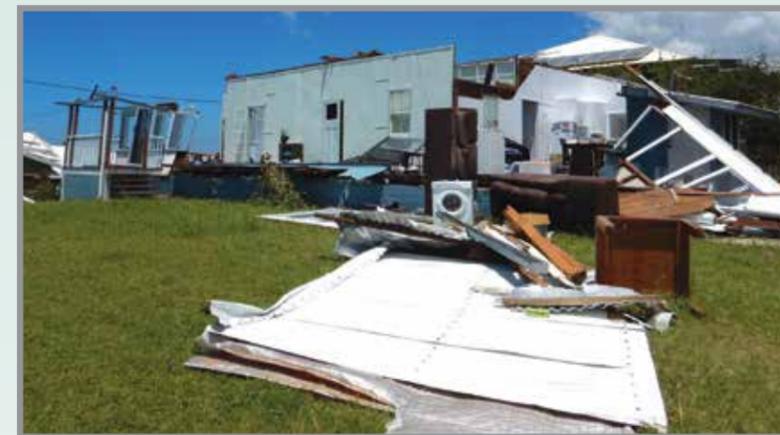
Structural damage to houses left them open to the elements, causing a high insurance bill.

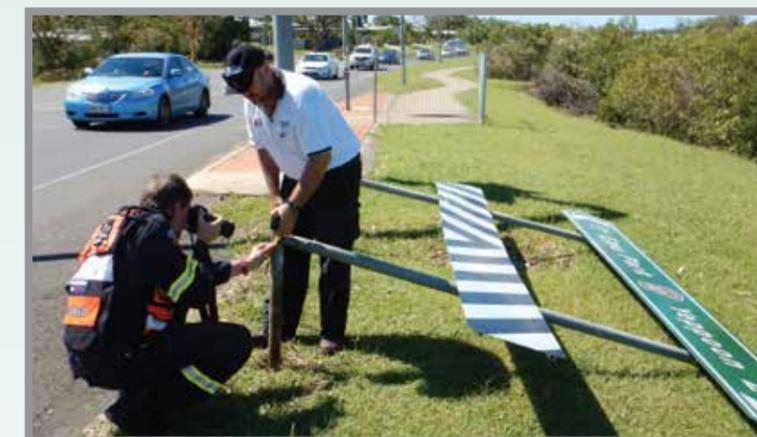
Rob Heywood (L) and David Henderson inspecting a damaged road sign in order to provide a lower bound estimate of wind speed.
